CIVIL AERONAUTICS BOARD

AIRCRAFT ACCIDENT REPORT

NORTHWEST AIRLINES, INC.
BOEING 720B, N724US
NEAR MIAMI, FLORIDA
FEBRUARY 12, 1963

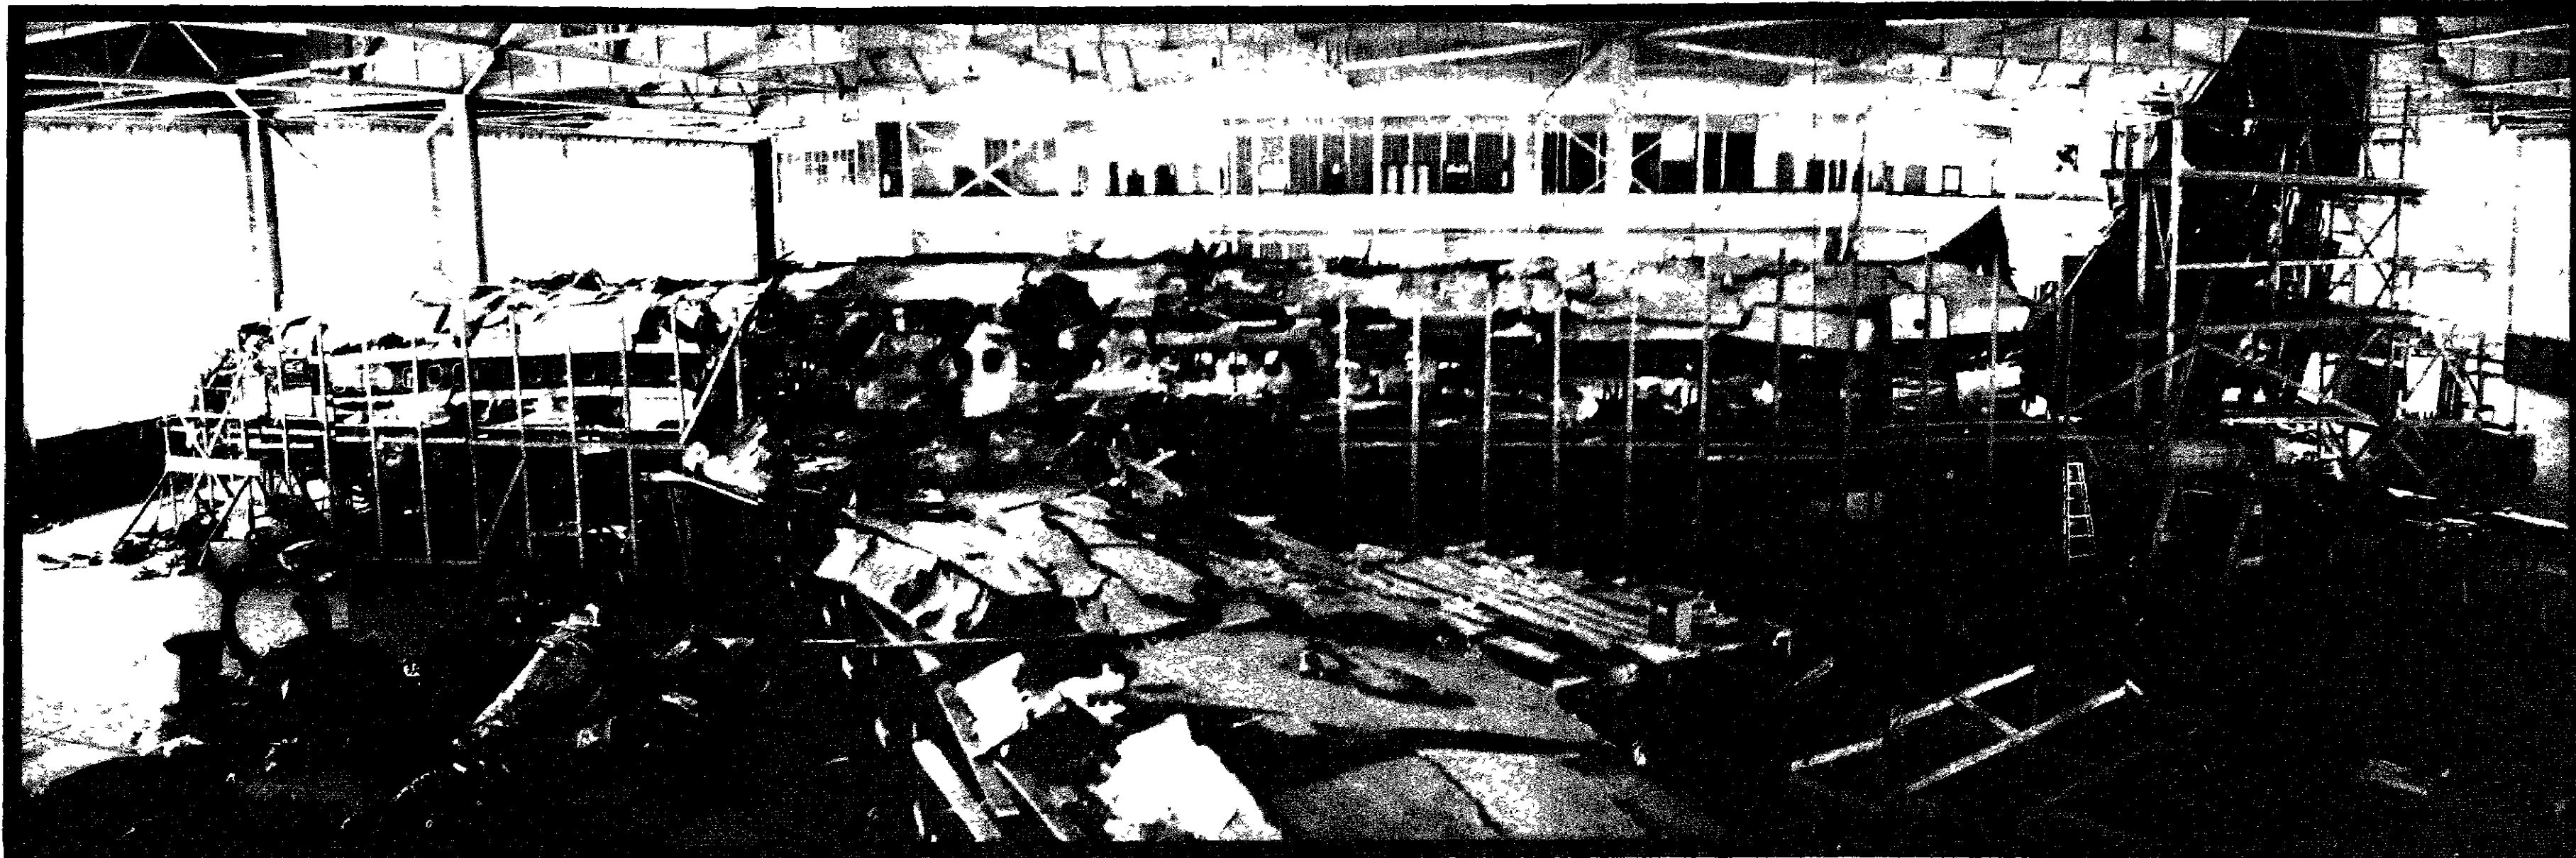
CIVIL AERONAUTICS BOARD
WRECKAGE MOCKUP
NWA BOEING 720B, N724US
MIAMI, FLORIDA, FEBRUARY 12, 1963

A mockup (see attachment C) of the aircraft was completed on April 1, 1963, and the detailed study, was resumed. The main failures in both wings and horizontal stabilizers were in a downward direction, and virtually symmetrical. The forward fuselage broke upward and the vertical stabilizer failed to the left. All four engines generally separated upward and outboard; however, certain peculiarities in the No. 3 engine separation generated considerable interest during the investigation. The reverser on this engine landed approximately 1,300 feet from the main engine section. The No. 3 engine also varied in that its final position was 150 feet on an azimuth of 015 degrees relative to its initial impact point. The other engines bounced approximately 40-45 feet on azimuths of 055, 080, and 060 degrees from their respective craters. Approximately four feet of the right wing, from the leading edge aft to the front spar, and inboard of the No. 3 nacelle, was broken away. Collision of the reverser with this leading edge section was indicated in the pattern of scratches found within the creases which resulted at ground impact. The main engine mount fractures were examined for fatigue, which might have resulted from damage sustained at the Fort Lauderdale accident,^{6/} but none was found
