Area Remaining to be Filled

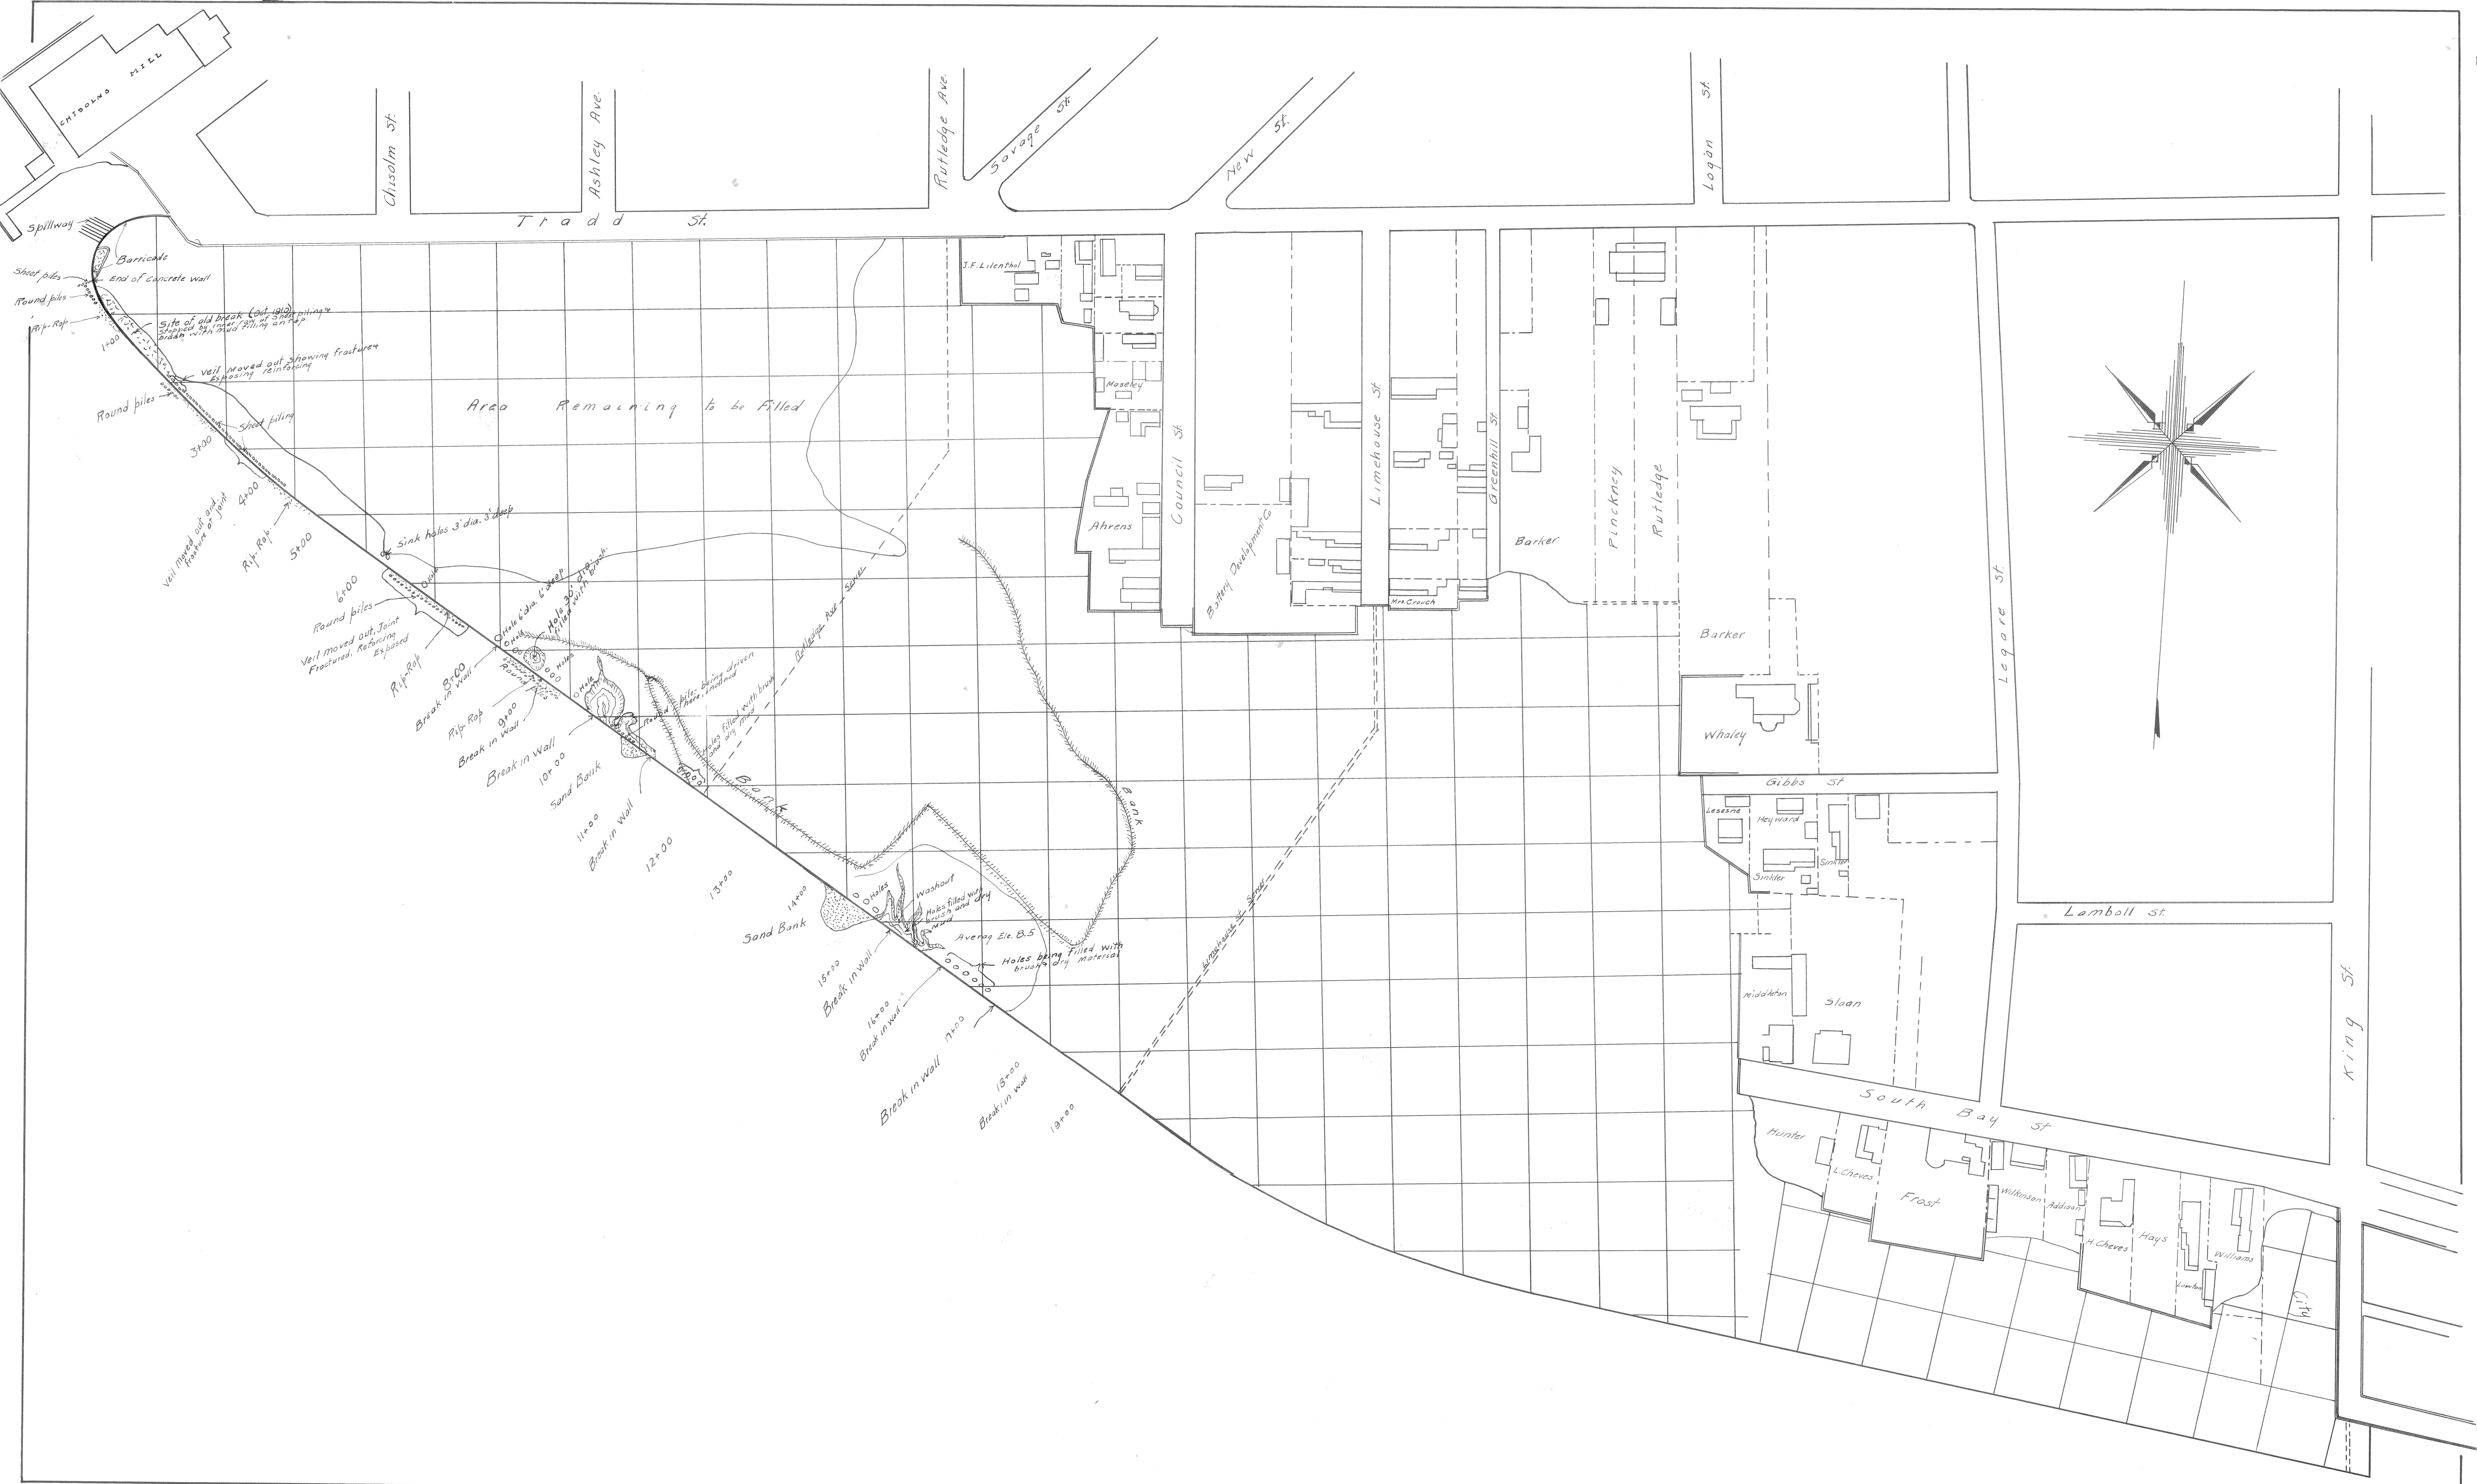
Spillway  
Barricade  
end of concrete wall  
Sheet piles  
Round piles  
Rip-Rap  
1+00  
Site of old break (lost 1912)  
shipped in, mud filling and  
break wall  
Veil moved out showing fracture  
Exposing reinforcing  
Round piles  
Sheet piling  
3+00  
Veil moved out at  
fracture joint  
4+00  
Rip-Rap  
5+00  
Sink holes 3' dia. 3' deep  
6+00  
Round piles  
Veil moved out, joint  
fractured, reinforcing  
exposed  
Rip-Rap  
Break in wall  
8+00  
Rip-Rap  
Break in wall  
9+00  
Break in wall  
10+00  
Sand Bank  
11+00  
Break in wall  
12+00  
13+00  
14+00  
Sand Bank  
15+00  
Break in wall  
16+00  
Break in wall  
17+00  
18+00  
Break in wall  
19+00

0.0 holes  
Washout  
Holes filled with  
brush and dry  
material  
Average Ele. 8.5  
5.00  
Holes being filled with  
brush and dry material

Fill being driven  
these installed  
Piles filled with brush  
and dry material
