Airplane Performance Study Korean Air Flight 801 DCA97MA058

Airplane Performance Study

NTSB #:	DCA97MA058
Location:	Nimitz Hill, Guam
Date:	August 6, 1997
Time:	Approximately 1542 GMT, 0142 Guam Local Time
Aircraft Type:	Boeing 747-300, HL-7468, s/n 22487
Operator:	Korean Air (FAR Part 129)

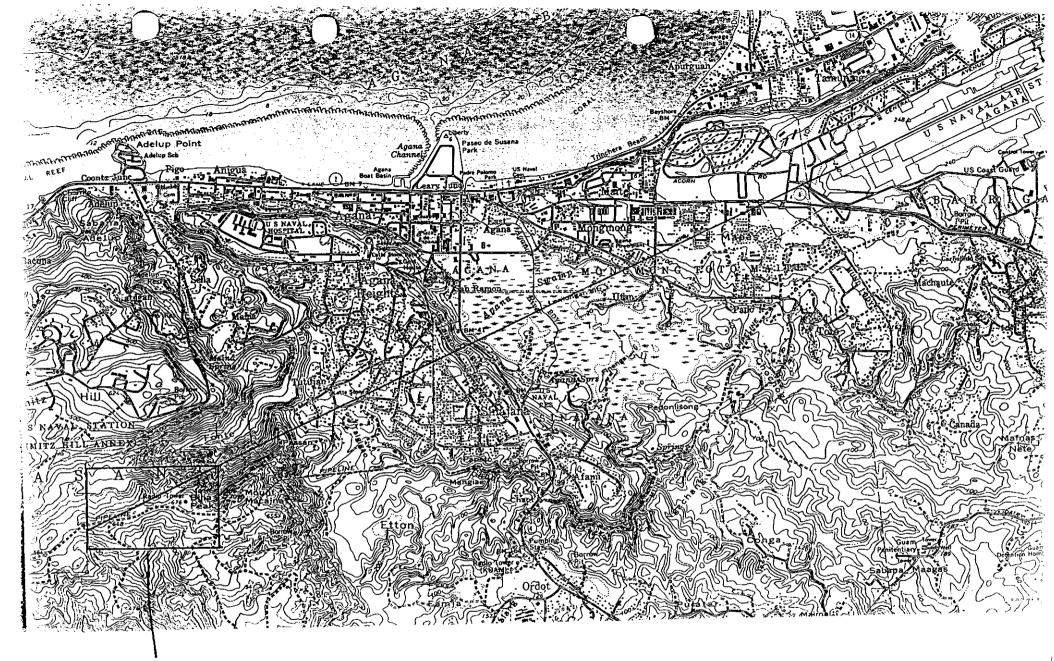
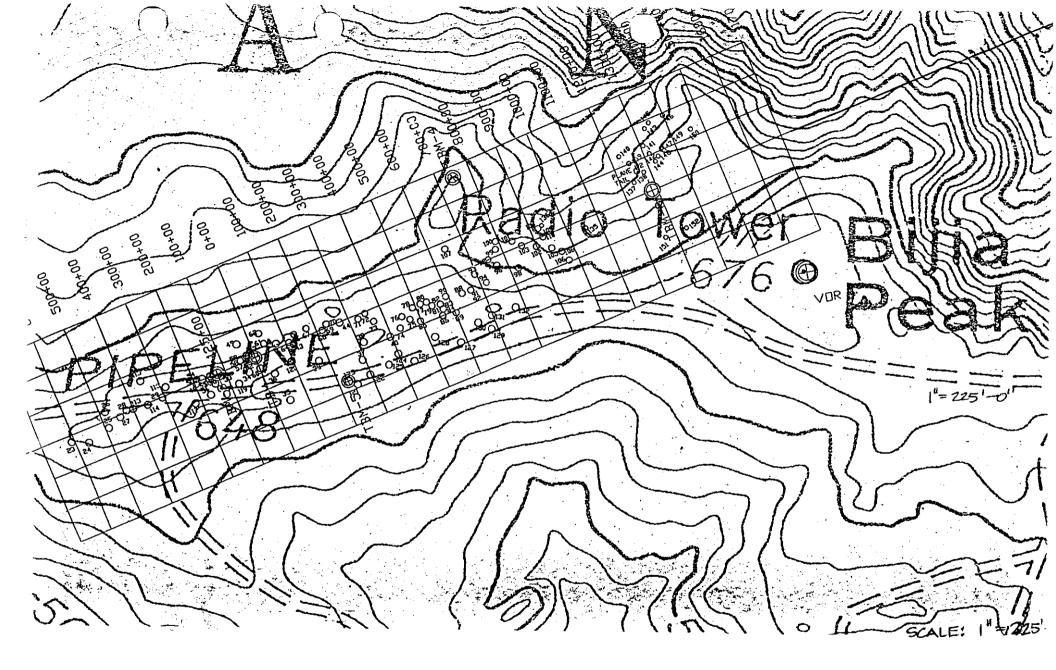
Ground Scar and Wreckage Location Data

The United States Air Force conducted a survey of the accident site using a transit survey system. Their data were overlaid onto a 1:24,000 scale topographic map of the accident area for horizontal reference, and a vertical cross section of the terrain and accident site data was generated using the approximate center of the wreckage path as the cross section line (see Attachment I). The survey data indicate that KA801 first struck a small tree limb at a surveyed elevation of 673 feet msl. The #1 engine struck the ground hard approximately 415 feet later at a surveyed elevation of 662 feet msl. The landing gear tires struck the fuel pipeline approximately 440 feet after the first tree strike at a surveyed elevation of 650 feet msl. Subsequent deep landing gear ground scars were located approximately 485 feet after the pipeline contact at a surveyed elevation of 653 feet msl. The #1 engine resting place was approximately 965 feet beyond the initial tree strike and a surveyed elevation of 654 feet msl. tailcone in the main wreckage area

was located approximately 1870 feet beyond the initial tree strike at a surveyed elevation of 582 feet msl.

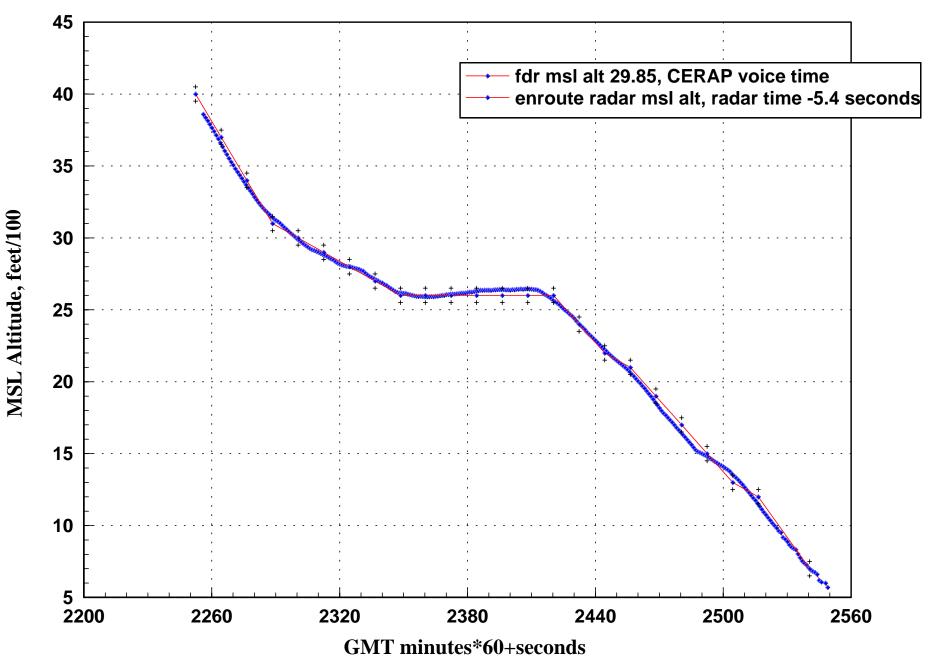
KAL 801 FDR MSL ALTITUDE (29.85 in Hg) vs. TIME

FDR altitude data and FAA radar altitude data were then aligned in order to establish a time correlation between the FDR/CVR times and the radar data times (see Attachment IV). The alignment established that 5.4 seconds must be subtracted from the FAA ARSR radar data times in order to correlate with the FDR/CVR times (CERAP voice recording GMT).

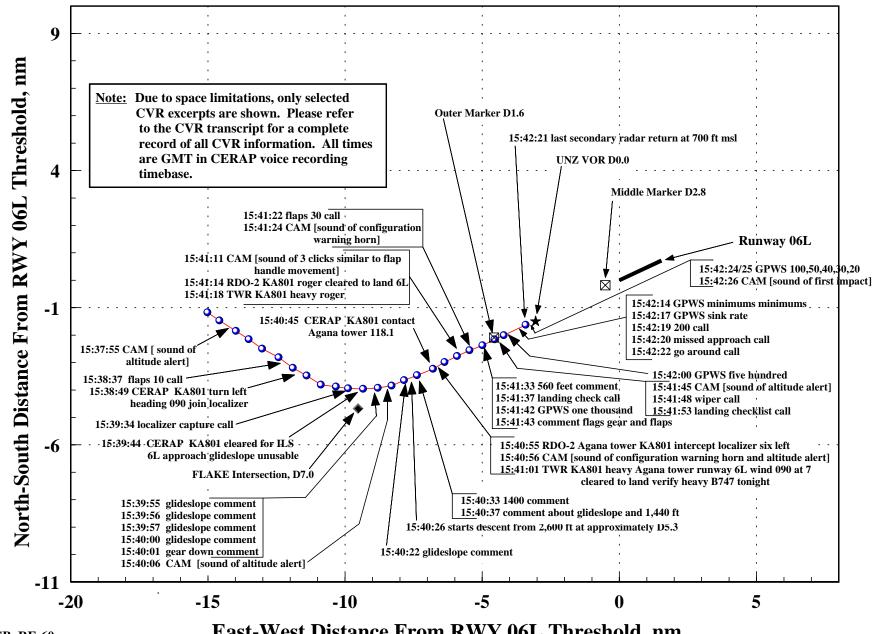
Korean Airlines B747-300 At Guam, 8/6/97 **Overhead View Of FAA Radar Data With Selected ATC And CVR Communication Excerpts**

transcript were used to make annotated plots of the horizontal and vertical flight path of KA801 (see Attachment VI).

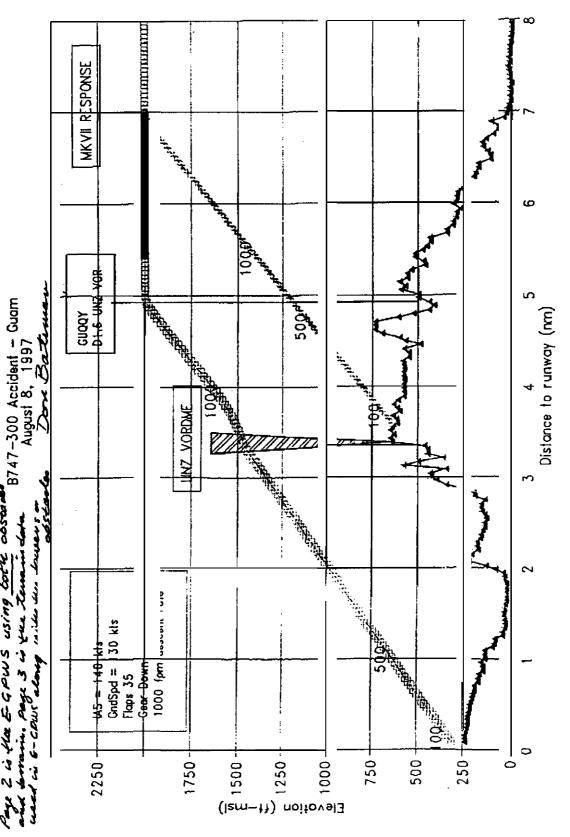
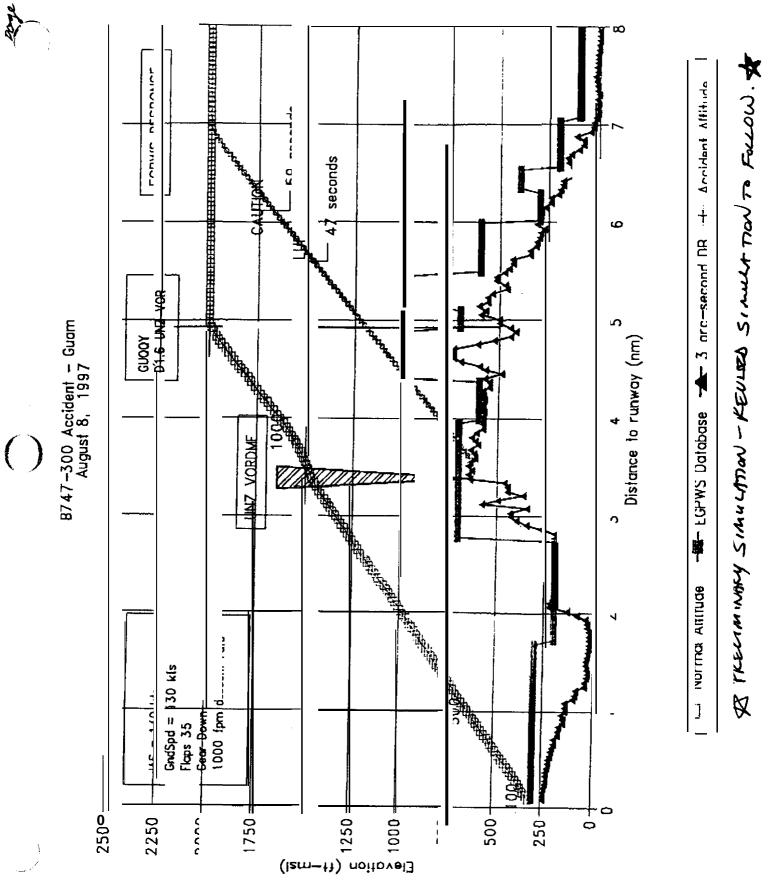
The simulation results (see Attachment VIII) indicate that KA801's GPWS functioned as designed and did not provide terrain or pull-up warnings due to the landing configuration. Radio altitude callouts, "minimums" callouts, and a sink rate callout were appropriate for the flight path. The EGPWS simulation showed that EGPWS would have provided aural and visual terrain warnings to KA801 as much as 60 seconds prior to initial impact.

The following GPWS/EGPWS simulation data were performed by AIIied Signal prior to their obtaining radar and other data for this accident from the NTSB. Therefore, these data are preliminary and do not accurately reflect the flight path and warning times. Updated simulation results based on NTSB radar and other data for K A 80 will be provided as soon as they become available. However, the warning times and types of warnings shown here are expected to closely approximate the updated simulation results.
