FEDERATION OF NIGERIA

**Report by Board of Investigation
into
Accident to West African Airways
Corporation Aircraft
BRISTOL 170 VR-NAD**

Held in February and March 1955

Accident Report

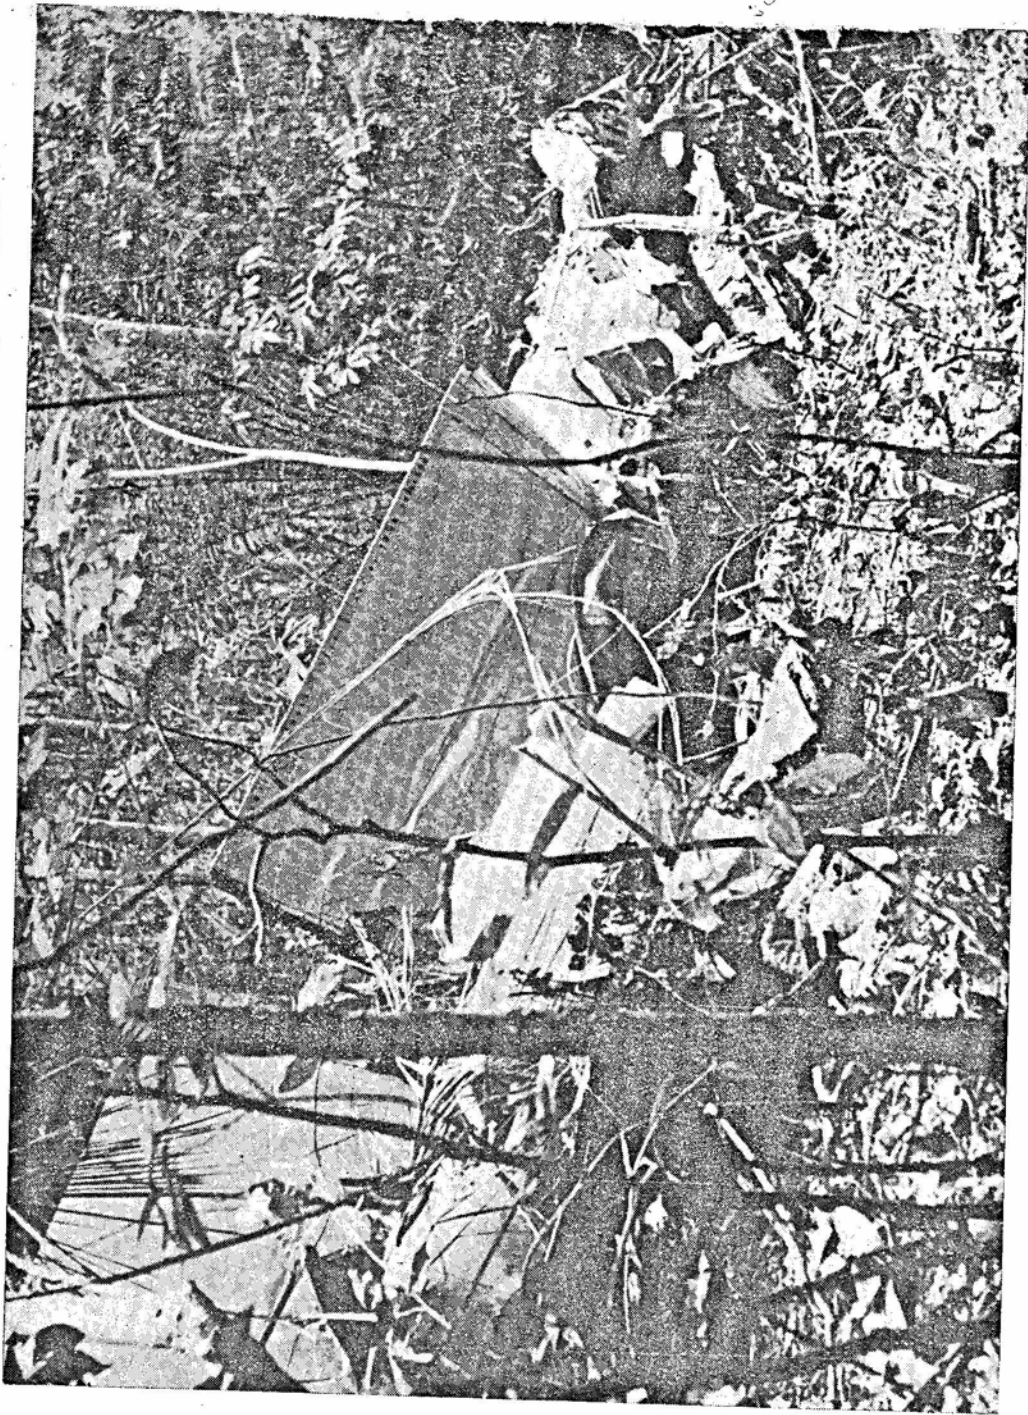
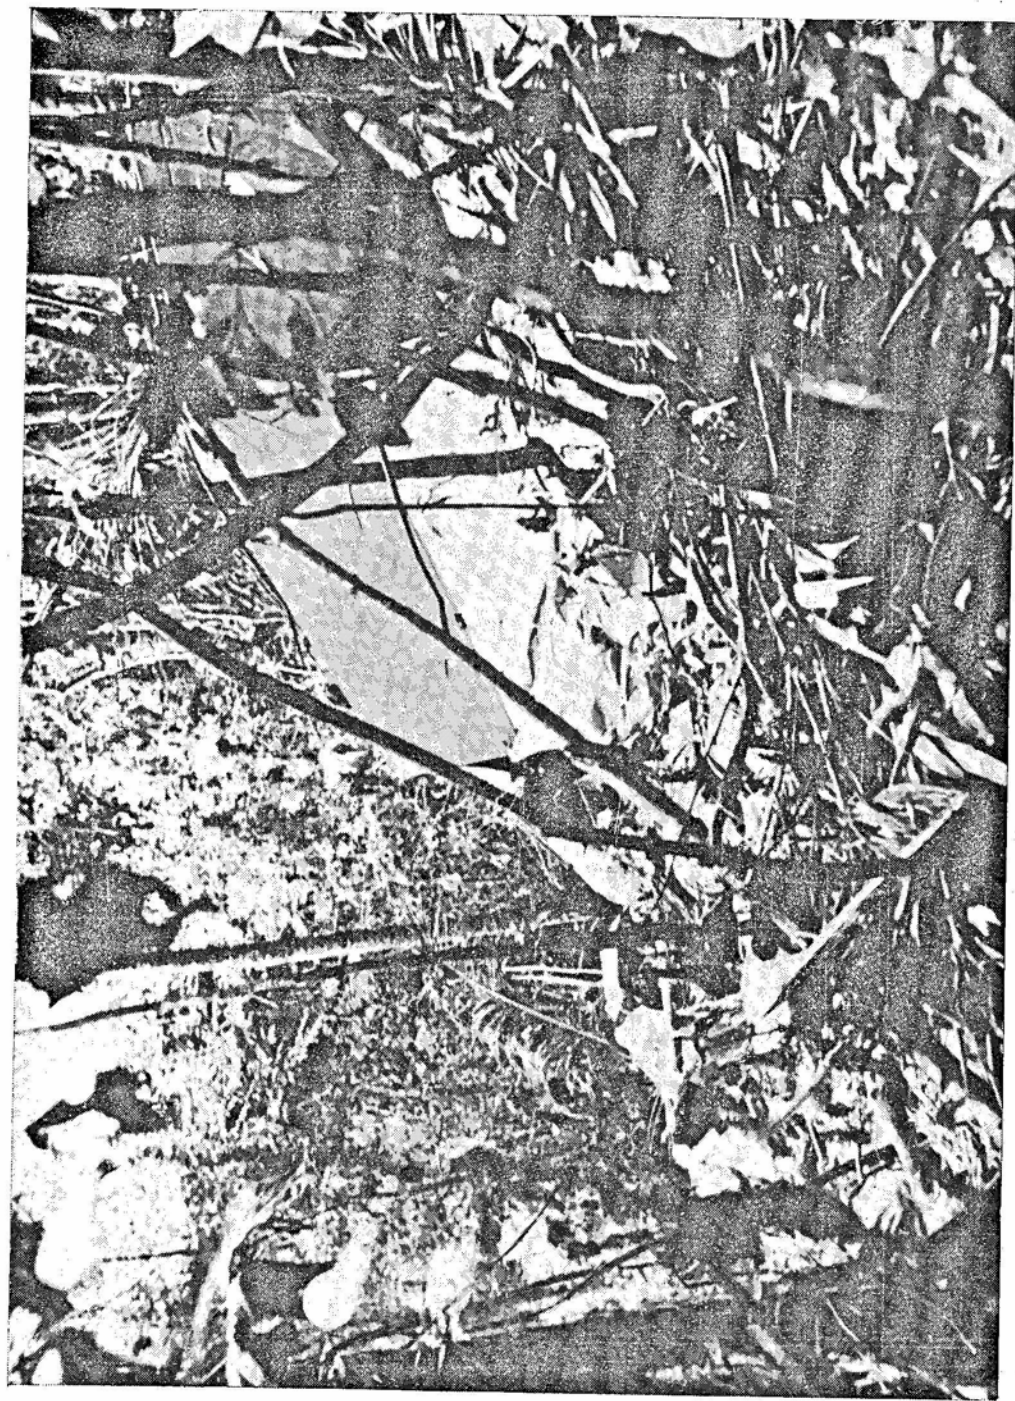
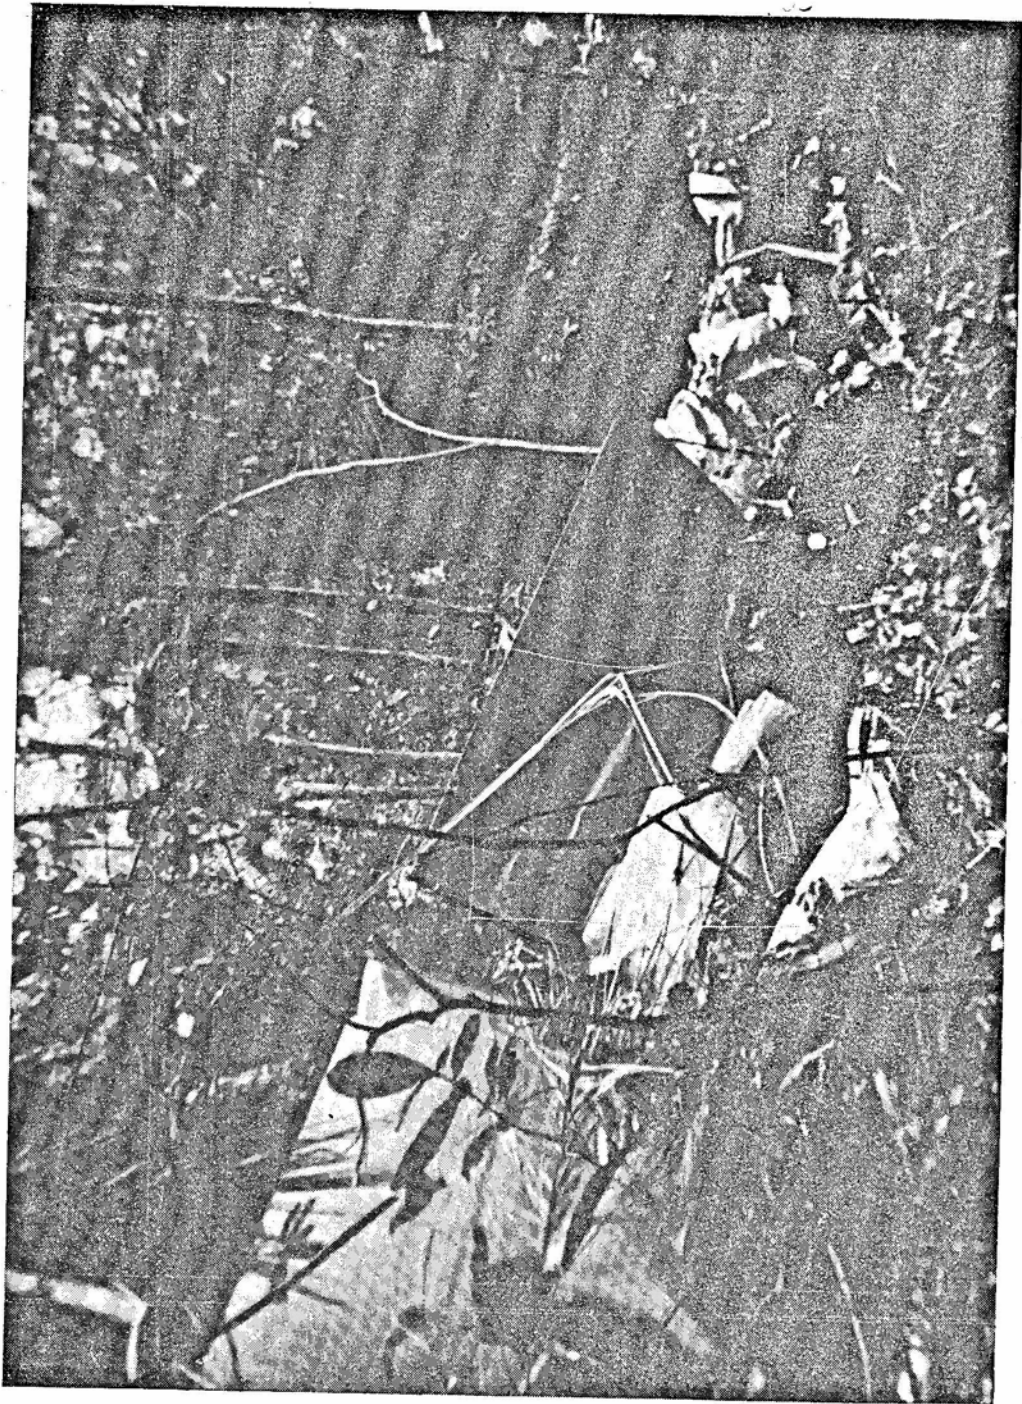
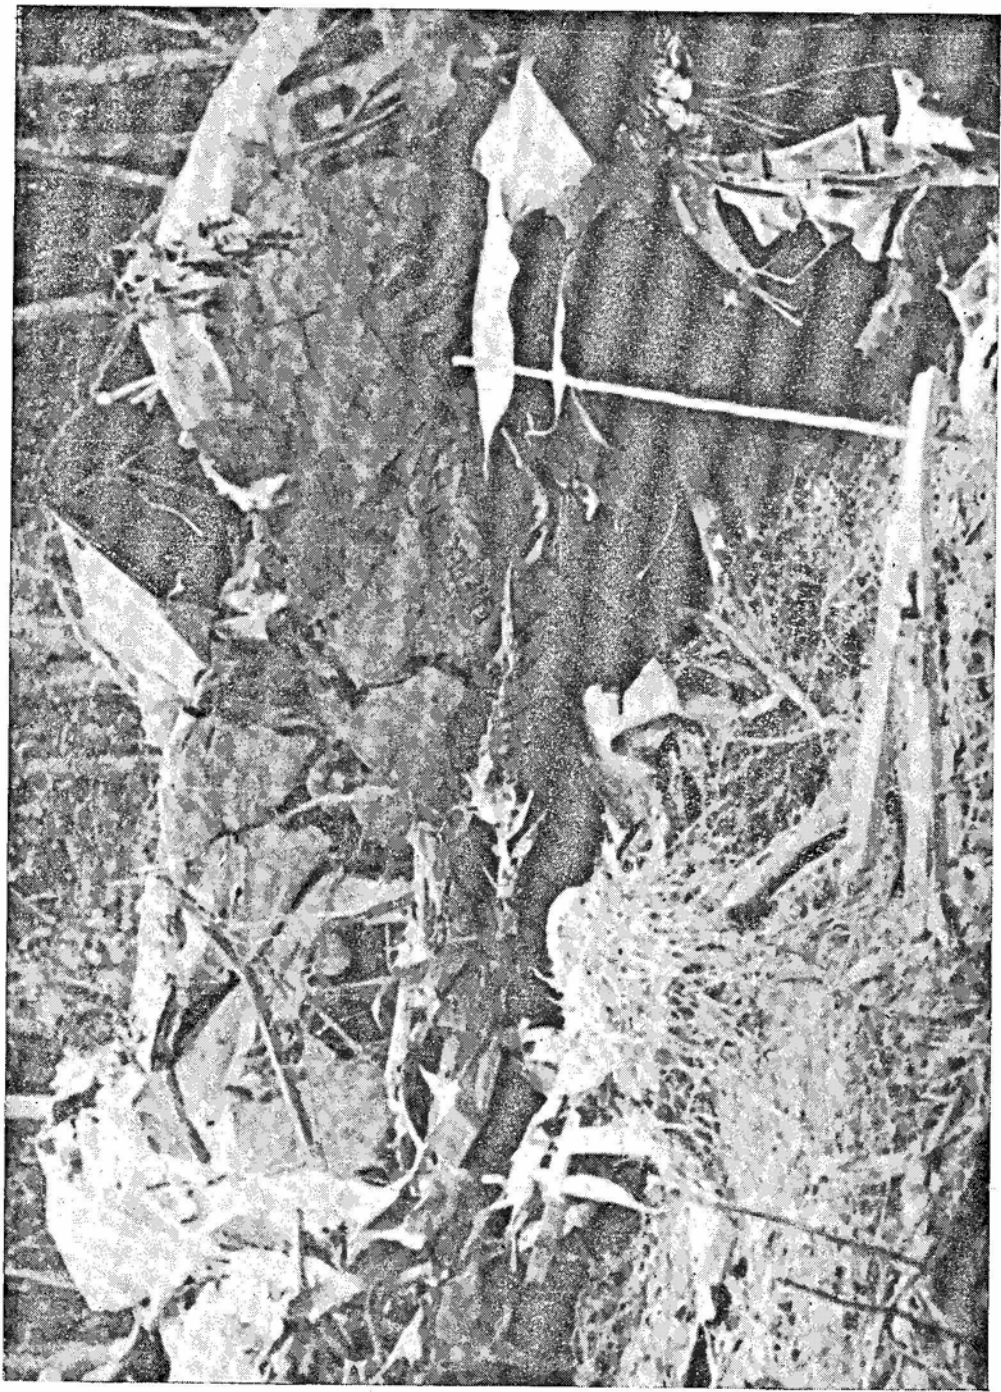
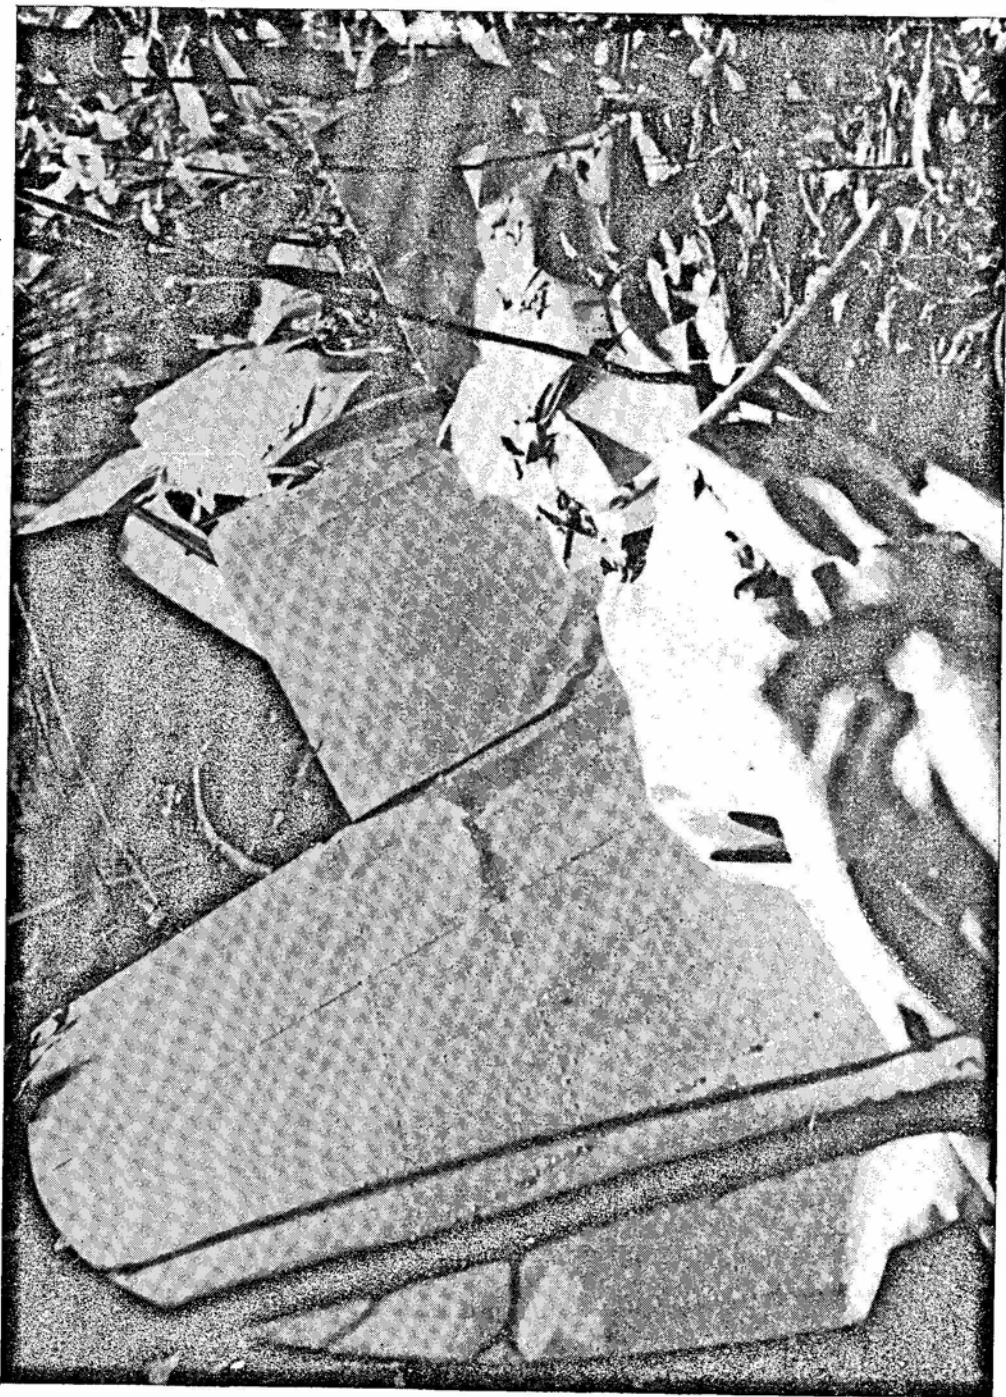
EXHIBIT 'A'

The following five photographs show main wreckage as found at the scene of the accident

Wreckage as found at the scene of accident

Wreckage as found at the scene of the accident

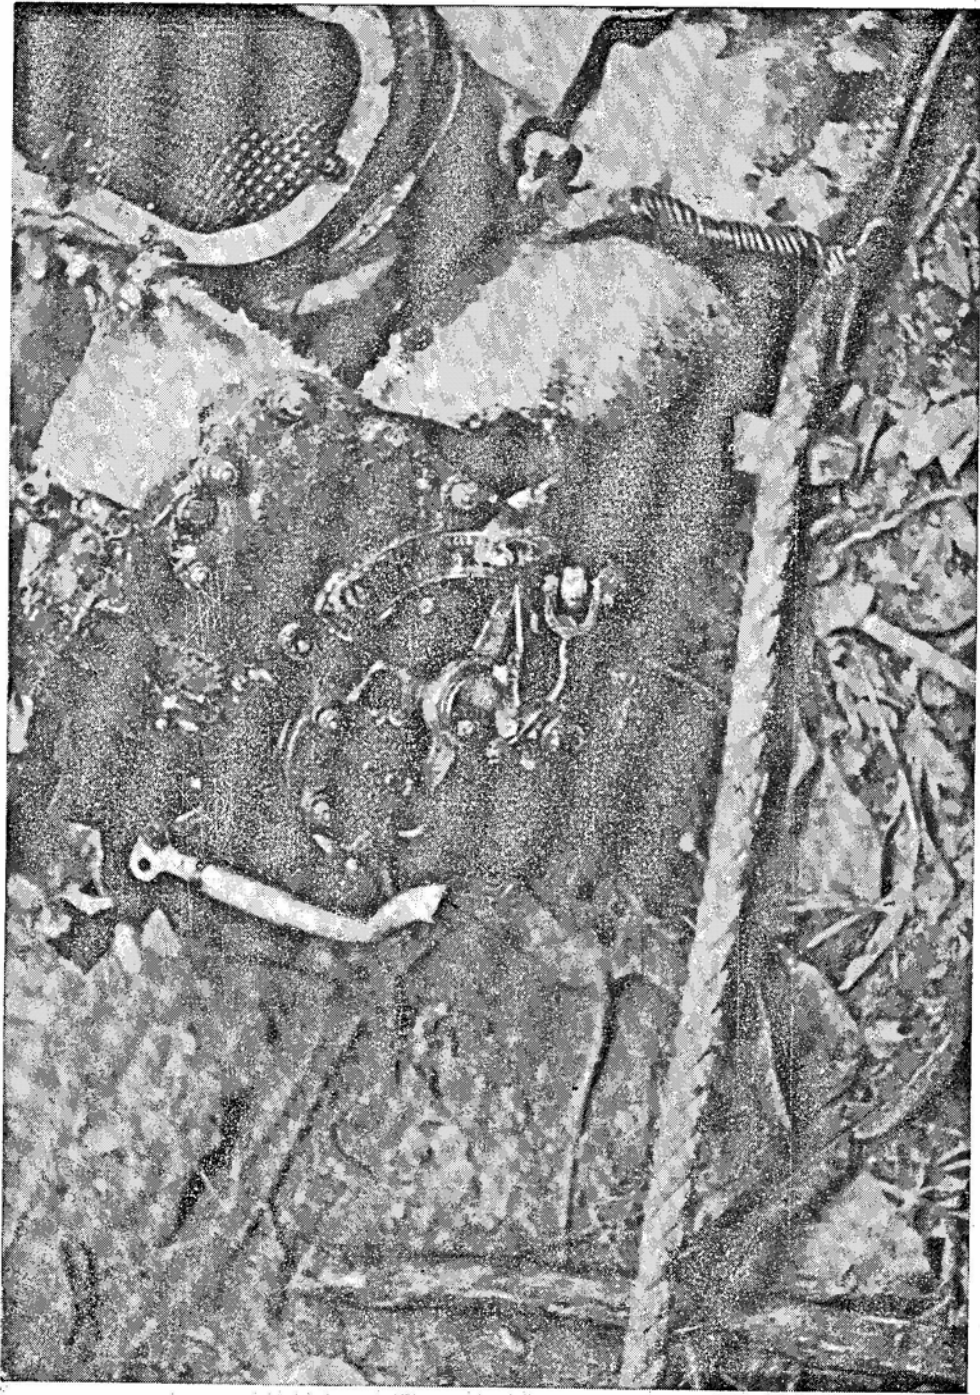
EXHIBIT 'B'

Both engines were completely buried in the ground and approximately 18 inches only of one blade of each propeller were visible above the surface. As it was necessary to determine whether these engines were rotating and whether they were delivering power at the moment of impact, it was decided that they must be dug out. When this had been done the appearance of the propeller blades indicated that the starboard engine was rotating and delivering power and that the port was rotating but that no significant degree of power was being developed. This port engine was examined therefore for evidence of pre-crash mechanical defect or failure. No such evidence was found and the filters were clean and free from metal or extraneous matter. The throttle barrels were found broken off from the engine by force of the impact and the throttle valves were found to be in the closed position (Exhibit B). Impact marks on the barrels showed that the valves were in this position at the moment of impact and it is considered therefore that the pilot had closed the port throttle before the aircraft struck the ground. Under these circumstances the existence of pre-crash engine failure was dismissed.

Port engine throttle barrels with valve shaft indicator in "closed" position

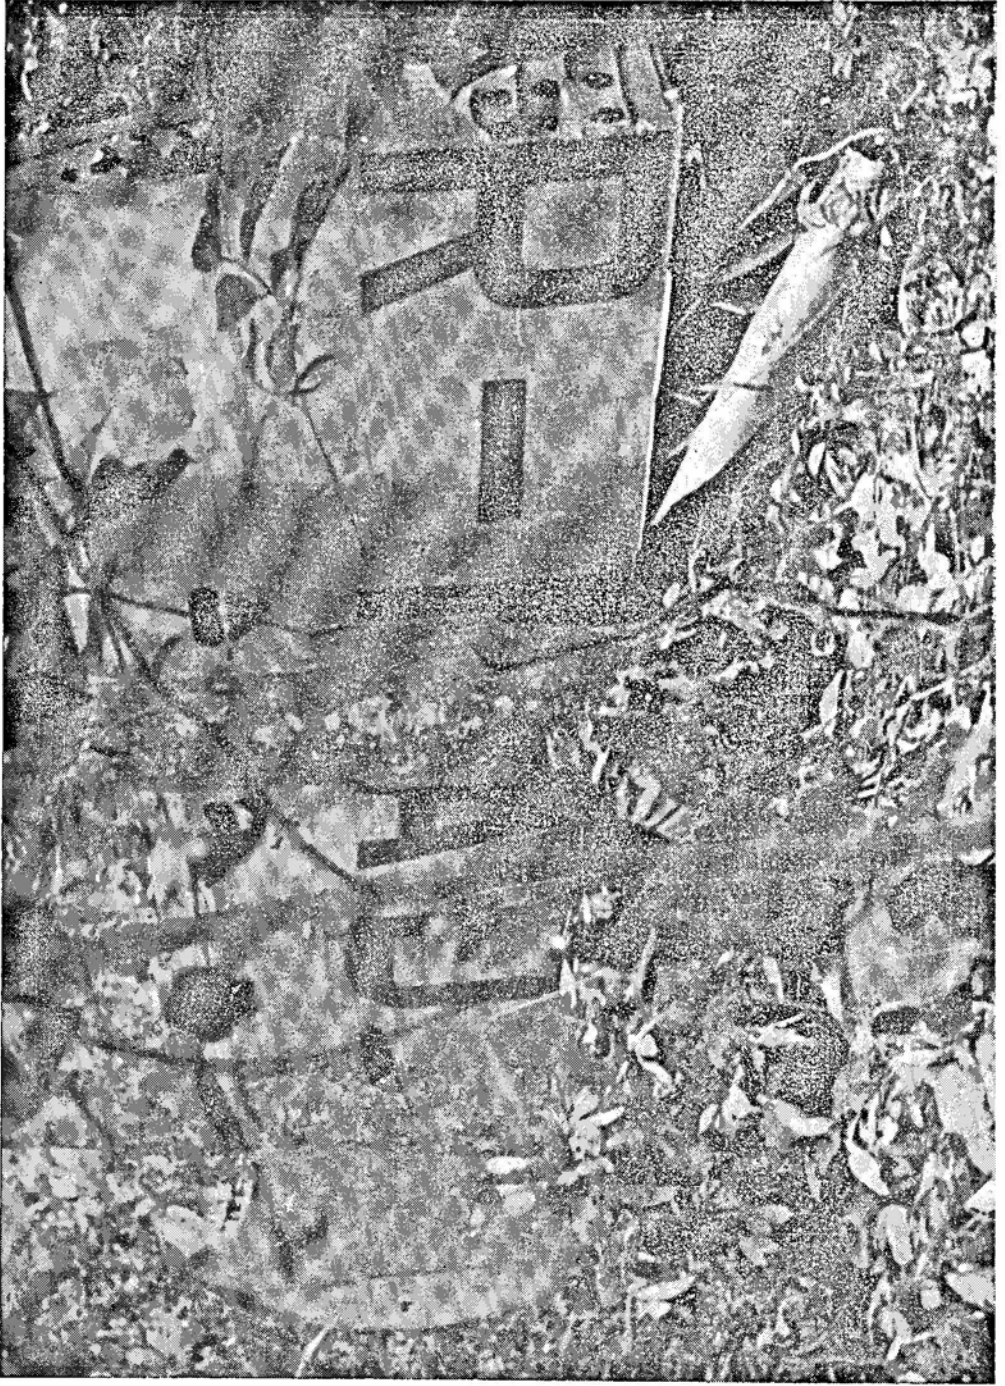
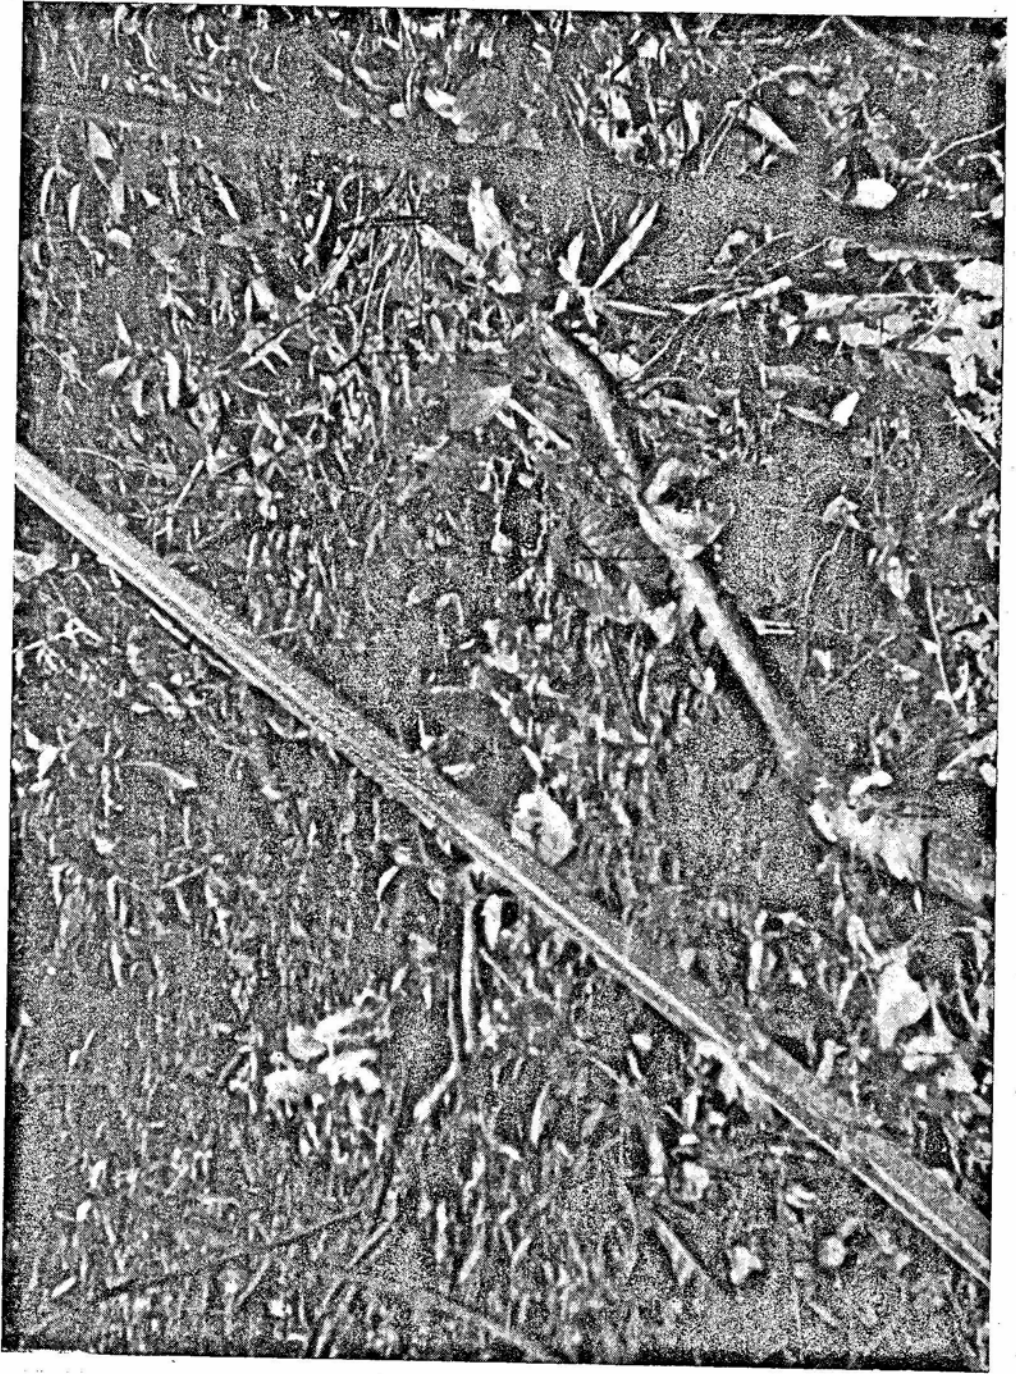
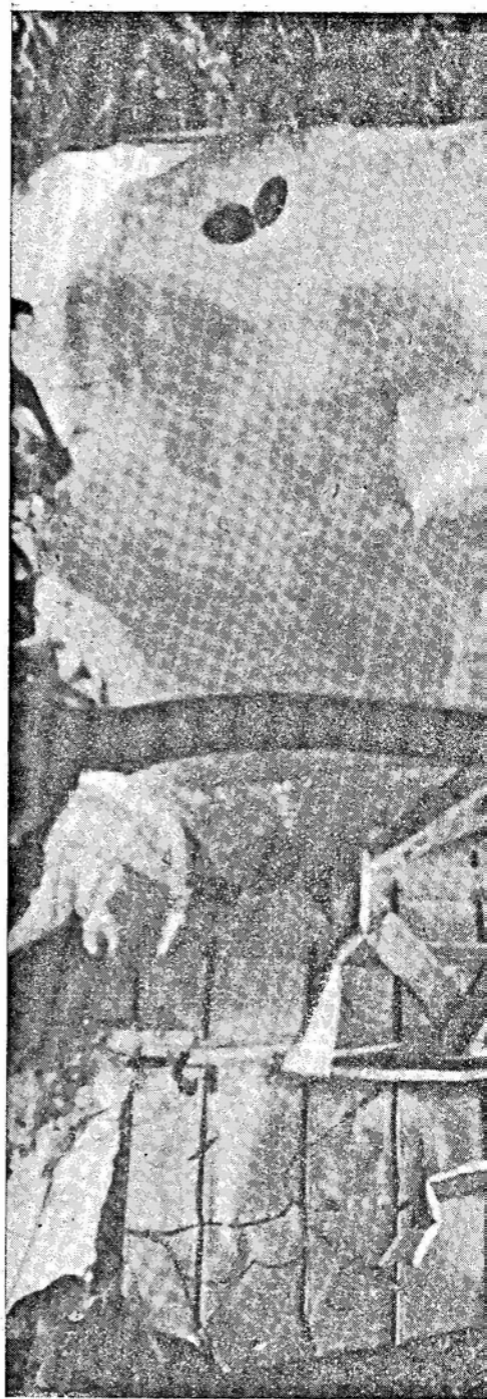
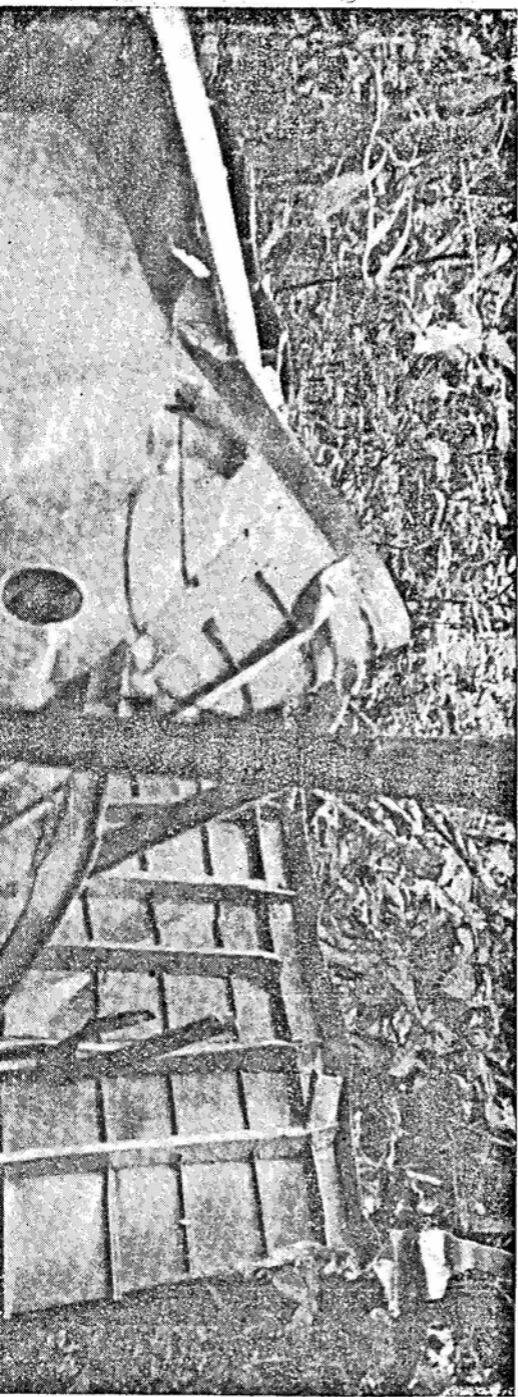
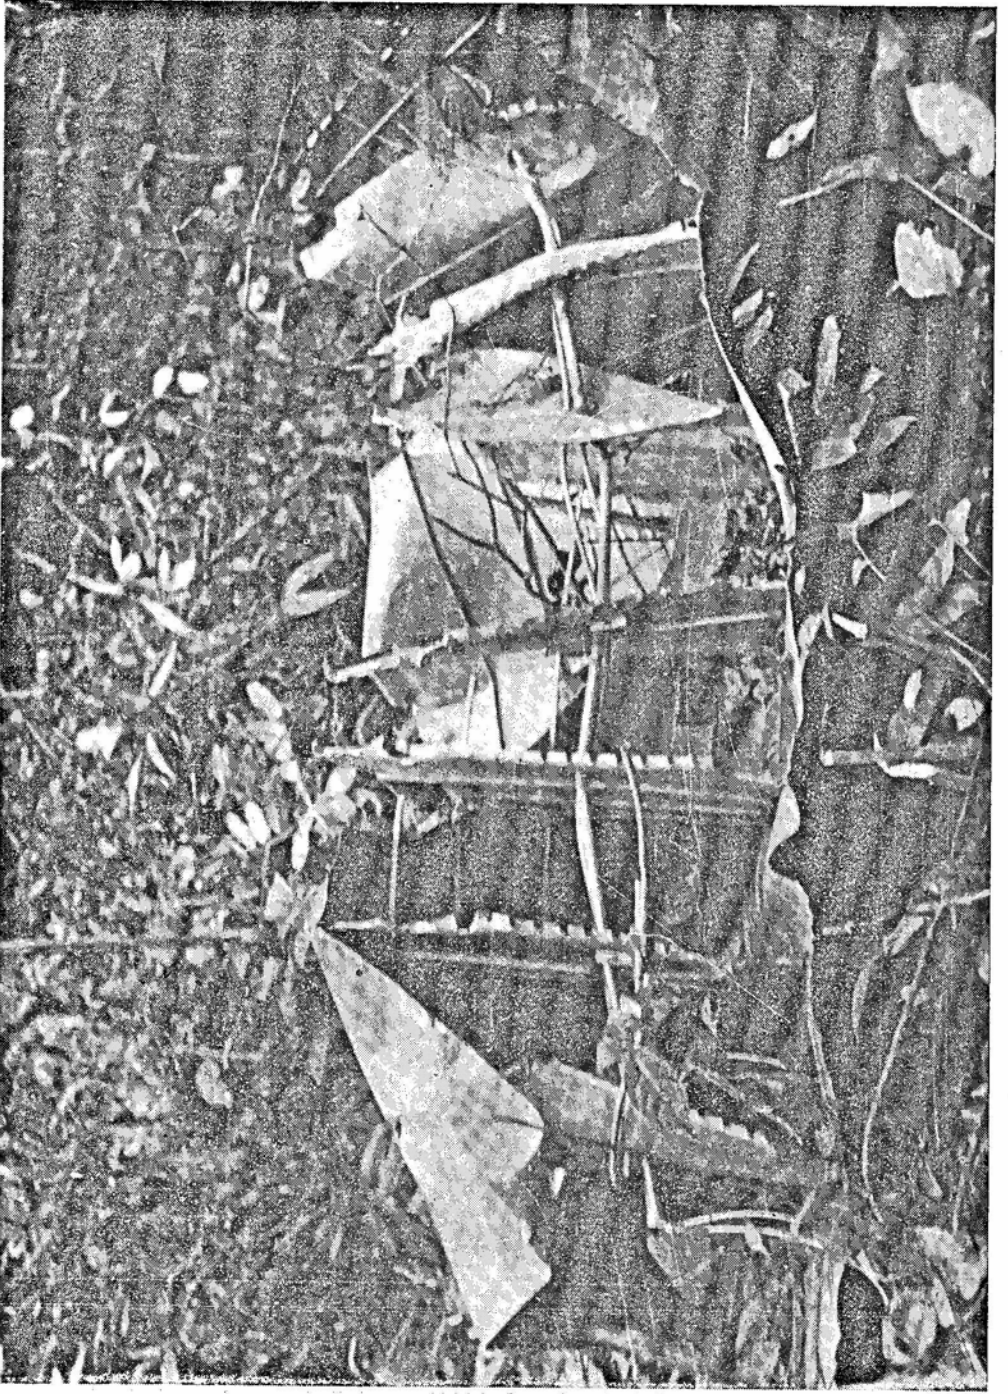
EXHIBIT 'C'
The following four photographs show parts of port mainplane detached in air

Meanwhile the work of bringing the airframe components to the top of the slope and of examining them was proceeding, and on the 23rd February it was established that the major portion of the port mainplane could not be in the main wreckage. It was decided therefore to institute a search and parties were provided by the Survey Department, assisted by the Forestry Department, to do this. They were advised that the parts required would most probably be in an area somewhere between a quarter of a mile and $1\frac{1}{2}$ miles back along the aircraft's track and that the area might be some half a mile in width. The search should be conducted using 340° Magnetic (the reciprocal of the aircraft's track) as the centre-line. The result of this search was the finding of the port mainplane in five main portions distributed as shown at Appendix 3. These were in dense, untracked bush, in an area stretching from approximately 900 yards to approximately 1,500 yards from the main wreckage (Exhibit C).

Part of port mainplane detached in the air

Parts of port mainplane detached in the air

Parts of port main plane detached in the air

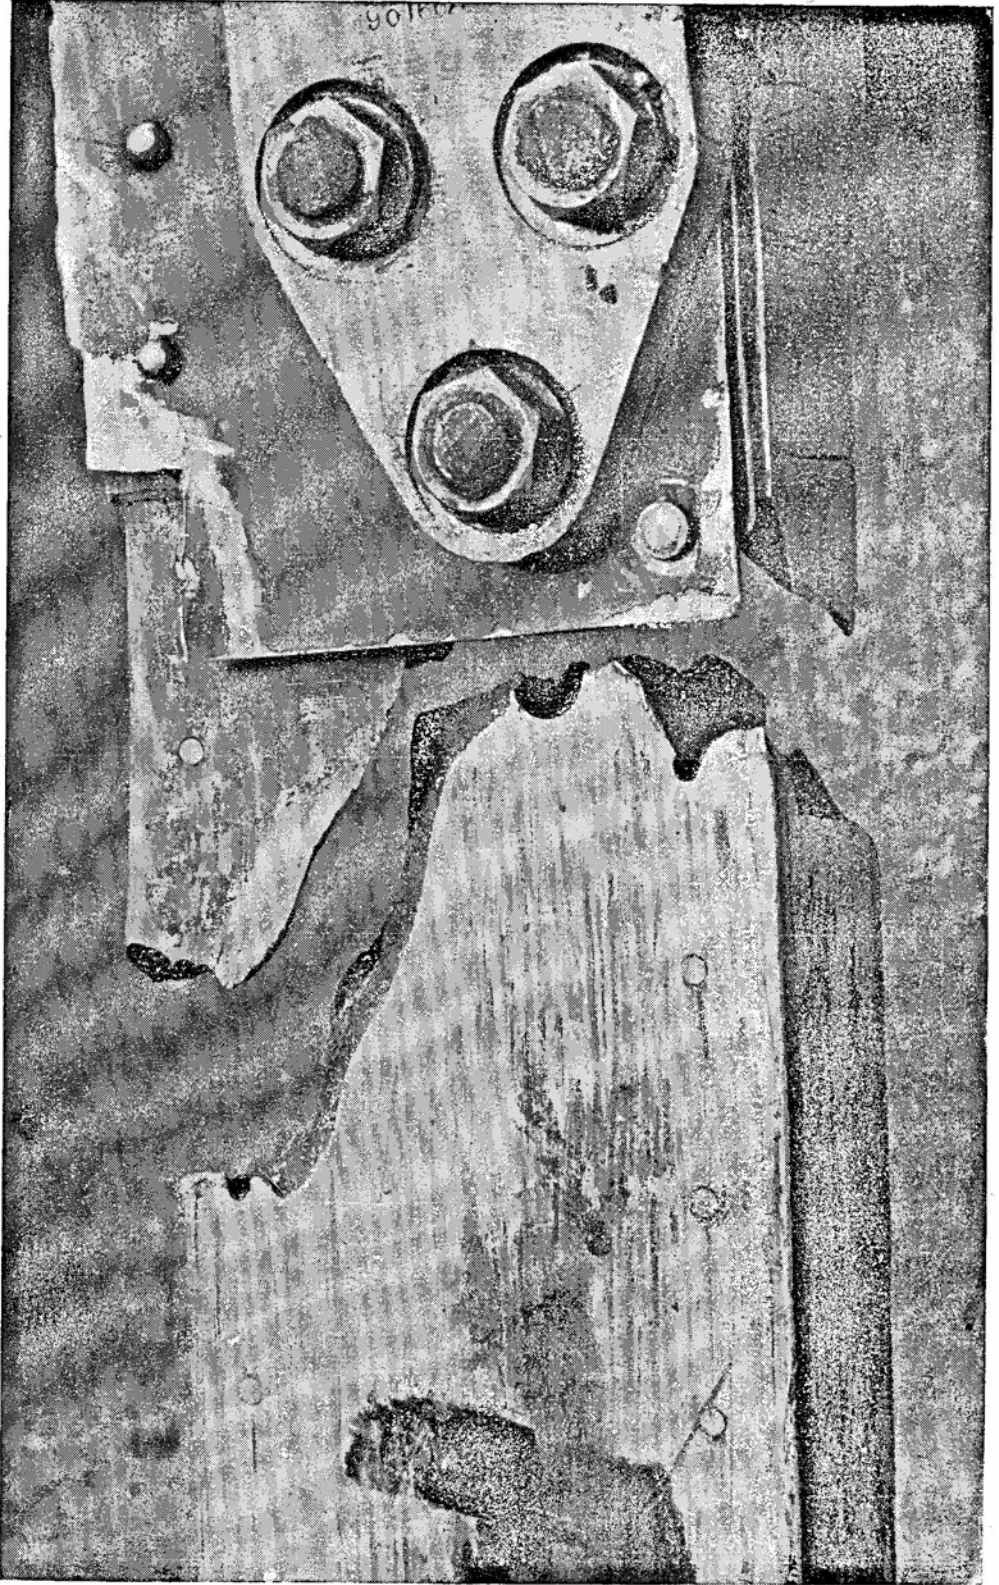
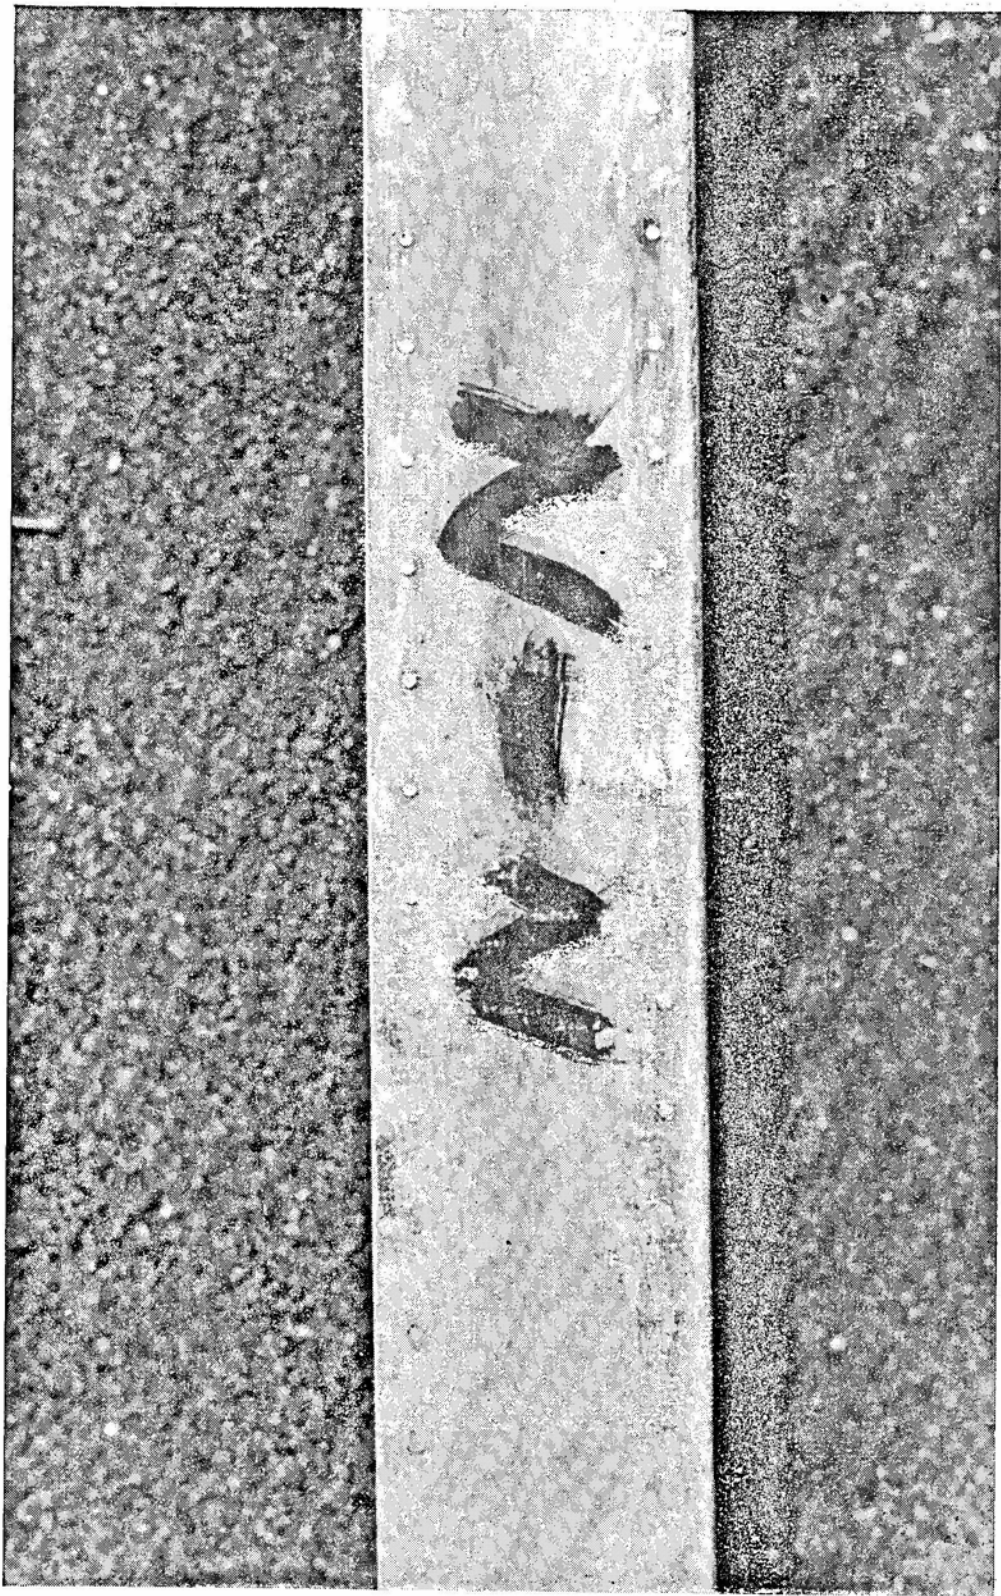
EXHIBIT 'E'

Fractured in upward bending at outboard bolt-hole of root joint fitting.

All rivets attaching boom to web sheared spanwise in the sense of boom moving inboard, web moving outboard. This pattern was continued across the upward bending failure (Exhibit E).

The consistency of direction of shear across the bottom boom fracture of rivets attaching boom to web indicates that these rivet failures preceded the boom fracture. This is further confirmed by fretting on the boom face which indicates that some rivets had failed over a period of time.

Port main front spar bottom boom fracture

Front spar bottom boom fretting

The significant parts of the wreckage have been forwarded to the Royal Aircraft Establishment, Farnborough, England, where they should be subjected to a detailed examination to determine the reason for the structural failure.

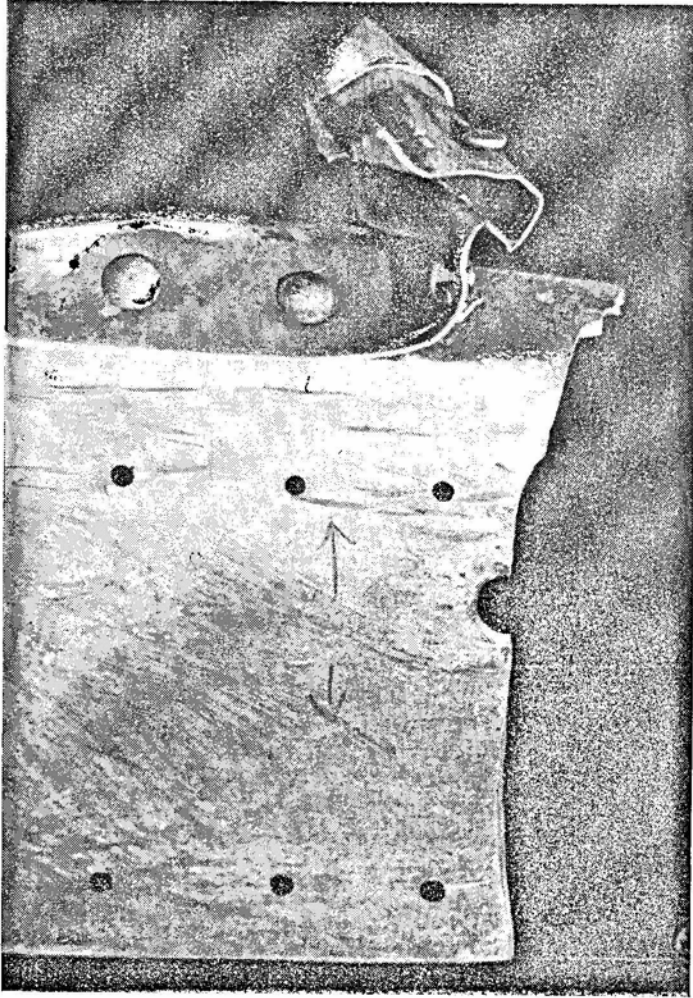
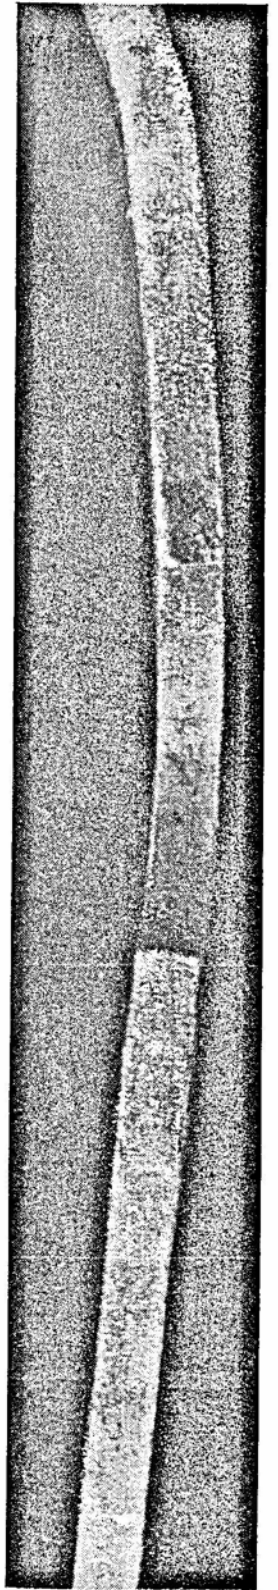
EXHIBIT 'F' (i)

The skin angle was fractured at the same point as the boom, through the outboard bolt-hole of the root joint fitting and this fracture showed evidence of fatigue on both sides of the bolt-hole (Exhibit F).

Front spar, bottom boom skin angle at root attachment fitting.
Fracture showing some fatigue

Cross section of piece
between rivets

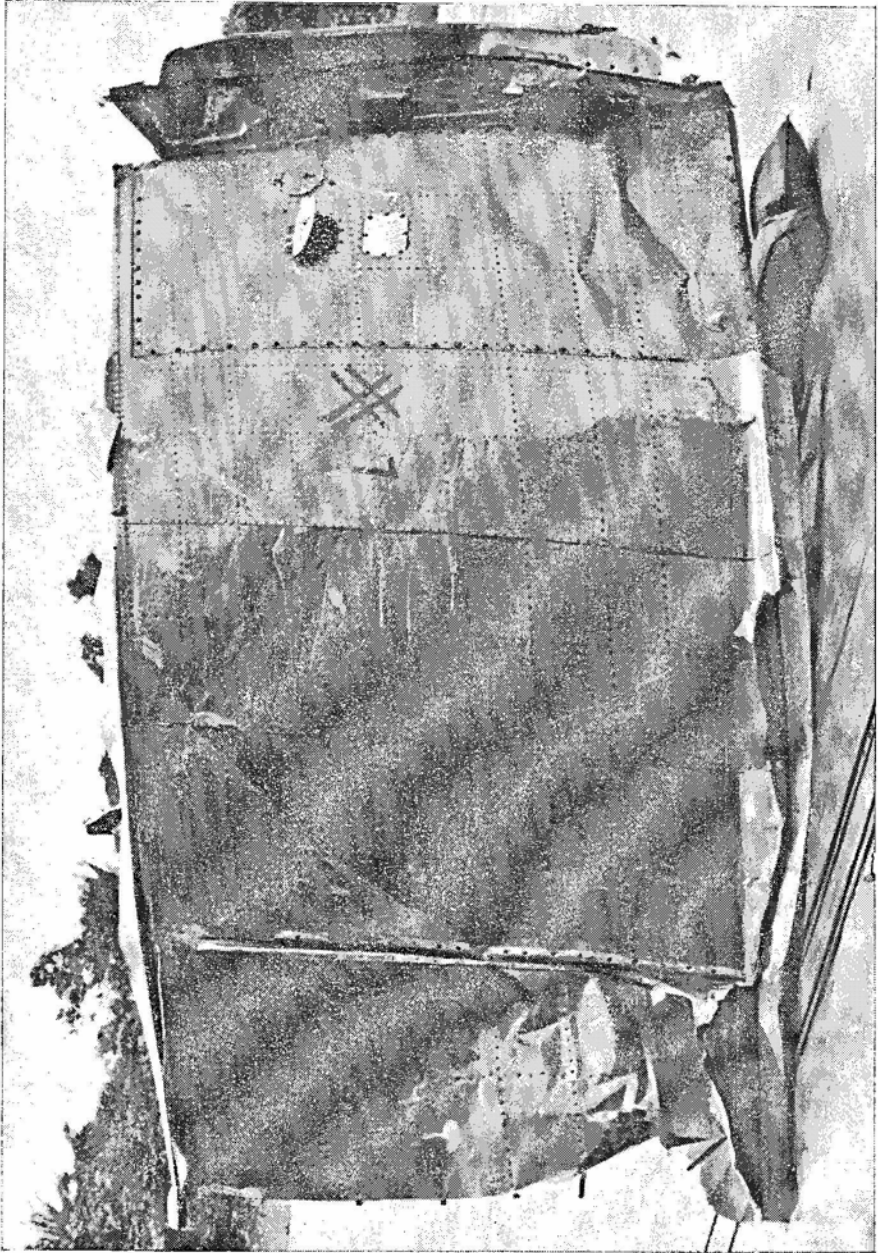
EXHIBIT 'G'

The direction of the shear wrinkles in the top surface of the between spars structure from root to Station 144 indicates a failure of the front spar near the root at a time when the rear spar was virtually intact.

Port wing, between spars structure root to Station 144

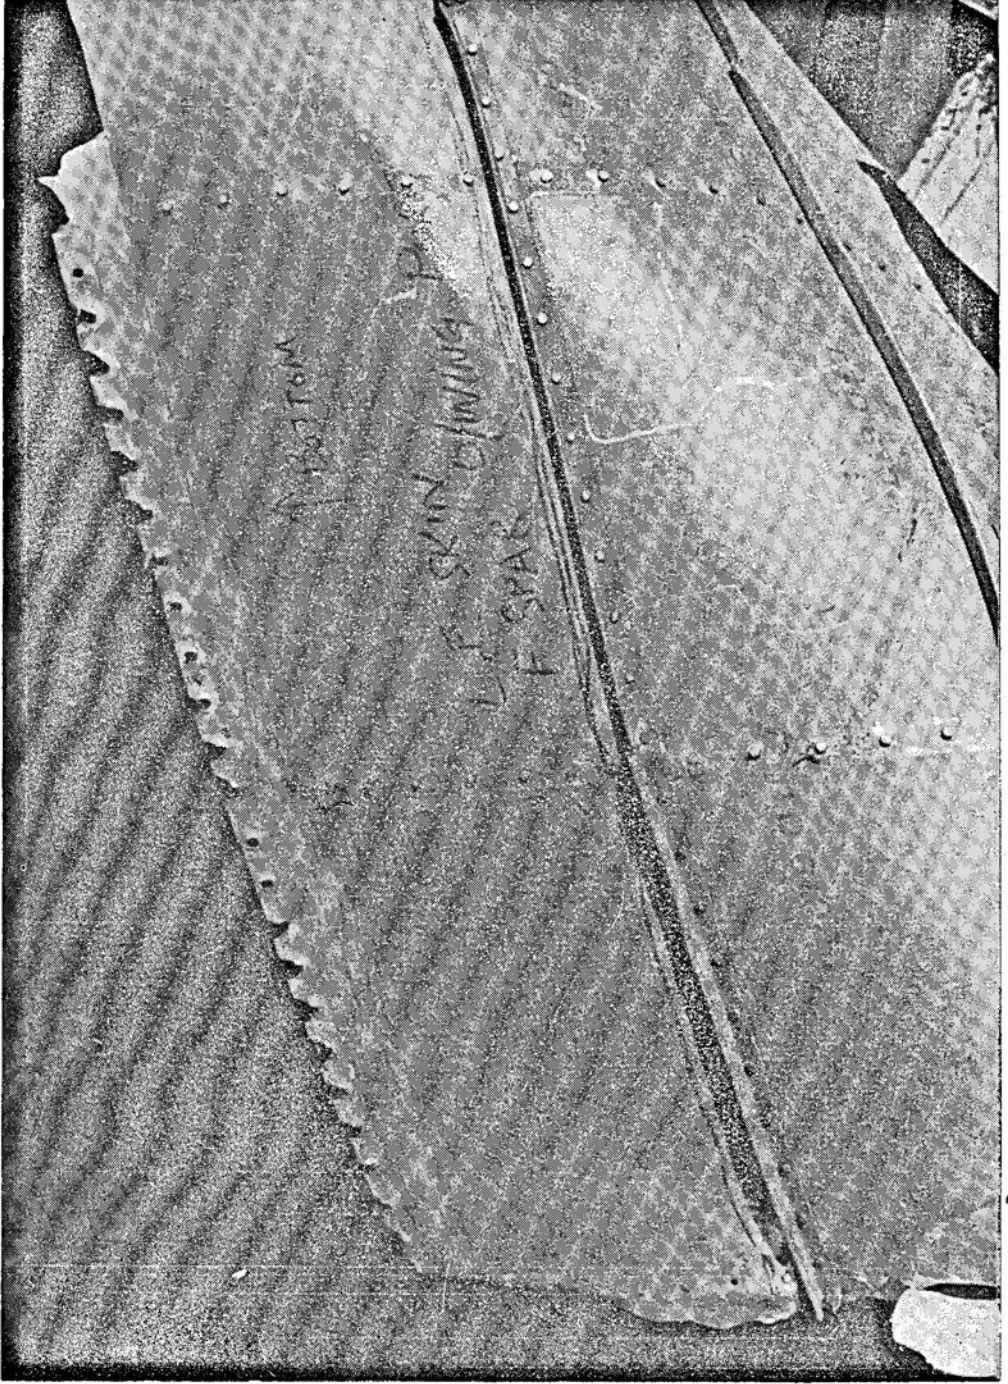
EXHIBIT 'H'

Leading edge, lower surface, Station 'O'
