FEDERATION OF NIGERIA

**Report by Board of Investigation
into
Accident to West African Airways
Corporation Aircraft
BRISTOL 170 VR-NAD**

Held in February and March 1955

Accident Report

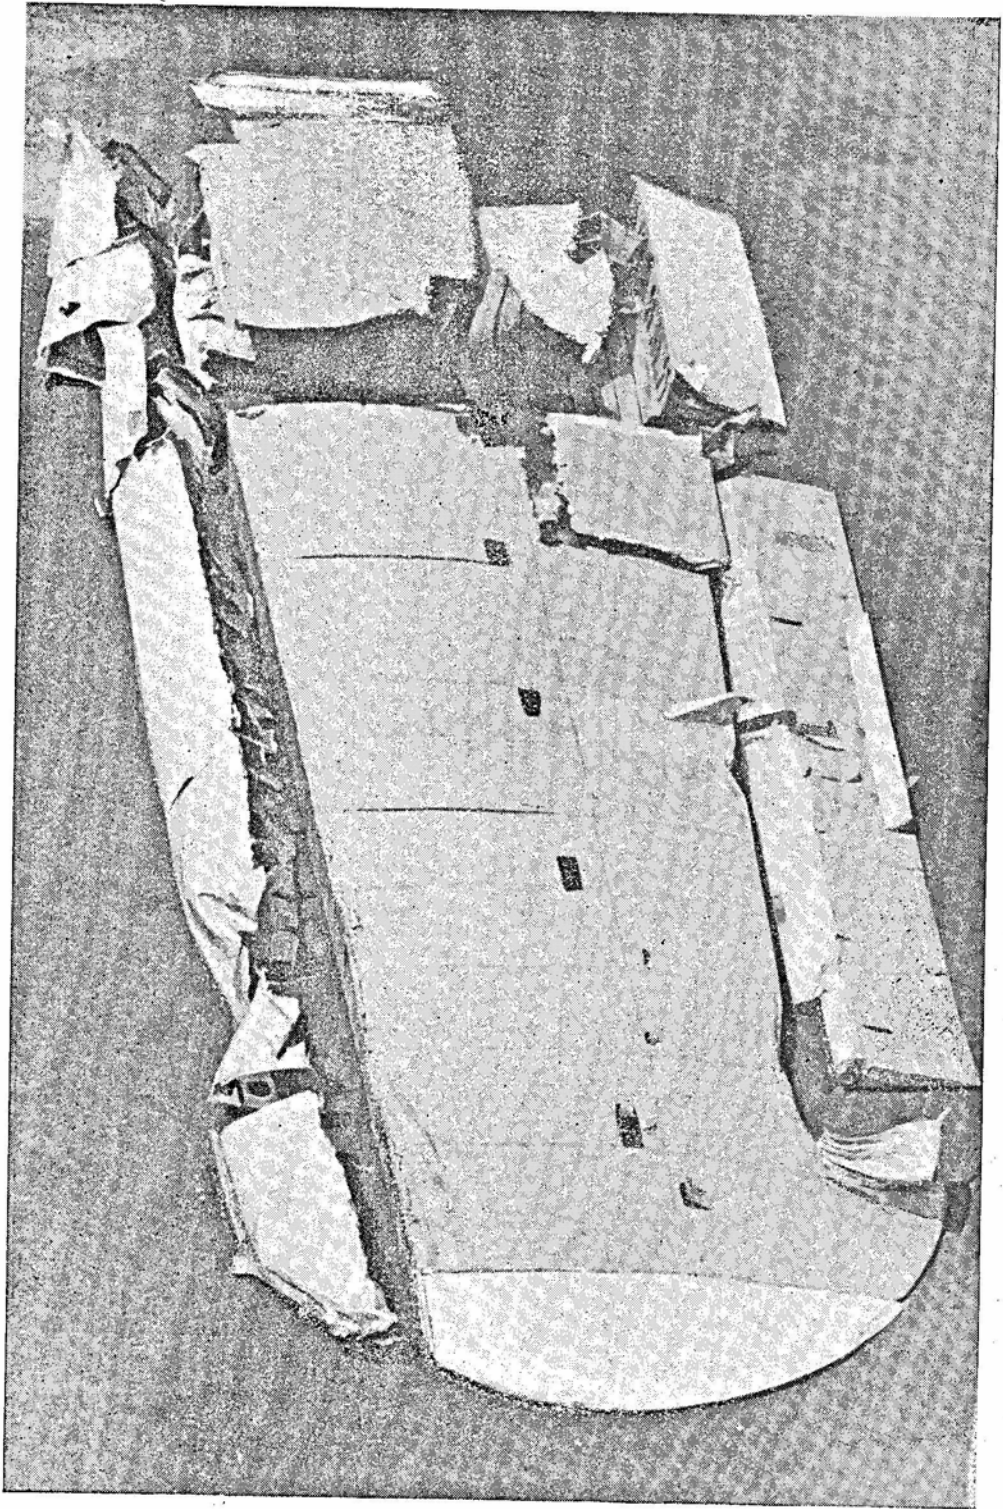
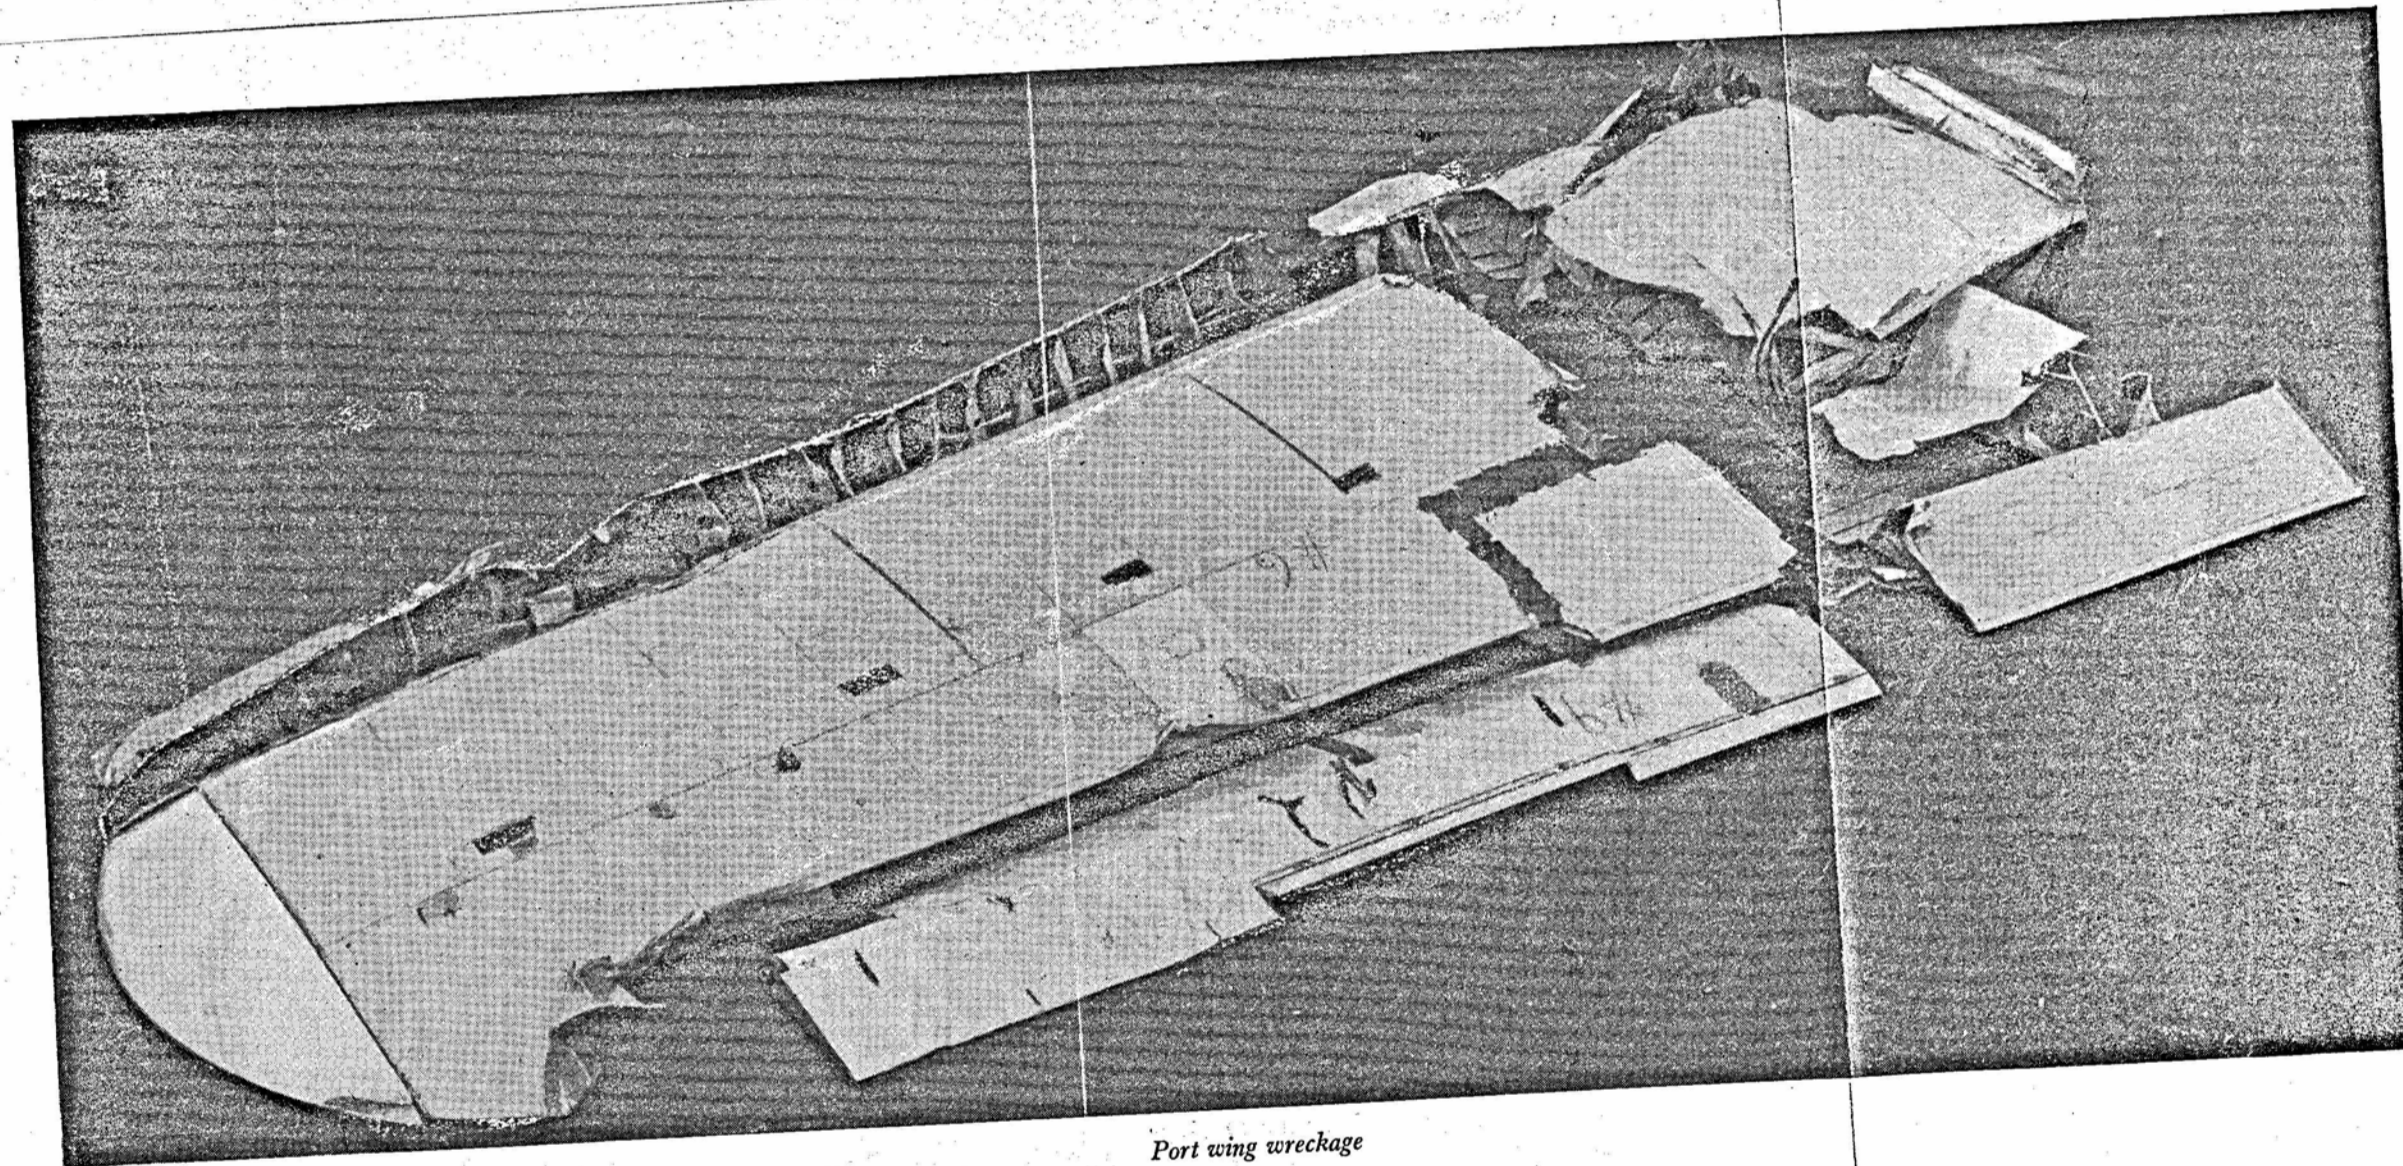
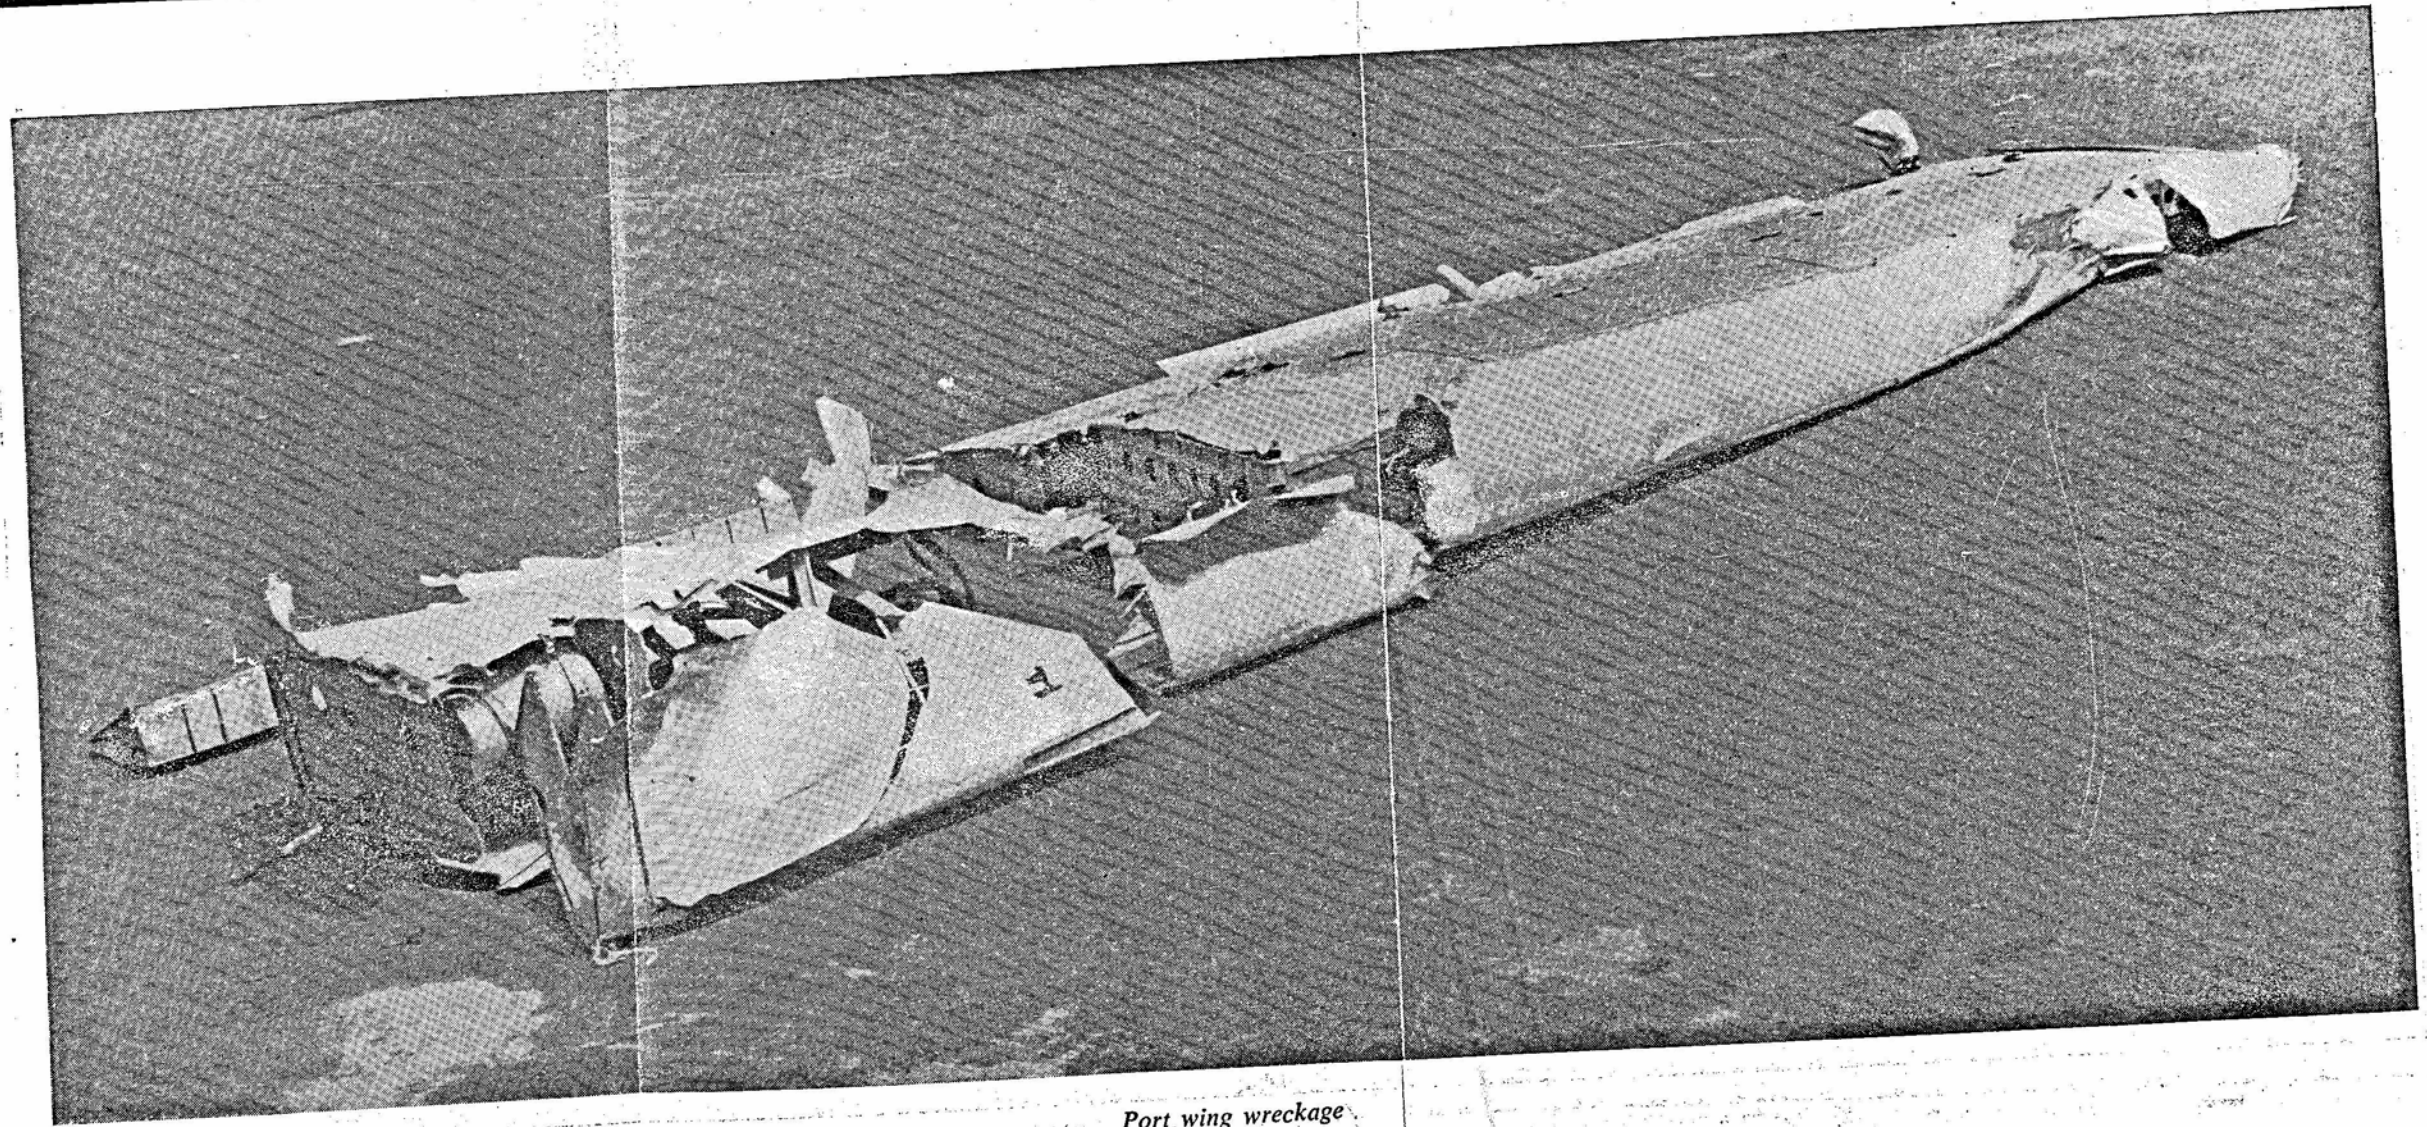
EXHIBIT 'I'

The following three photographs show the port wing wreckage, leading edge removed for ease of removal from bush

Port wing wreckage

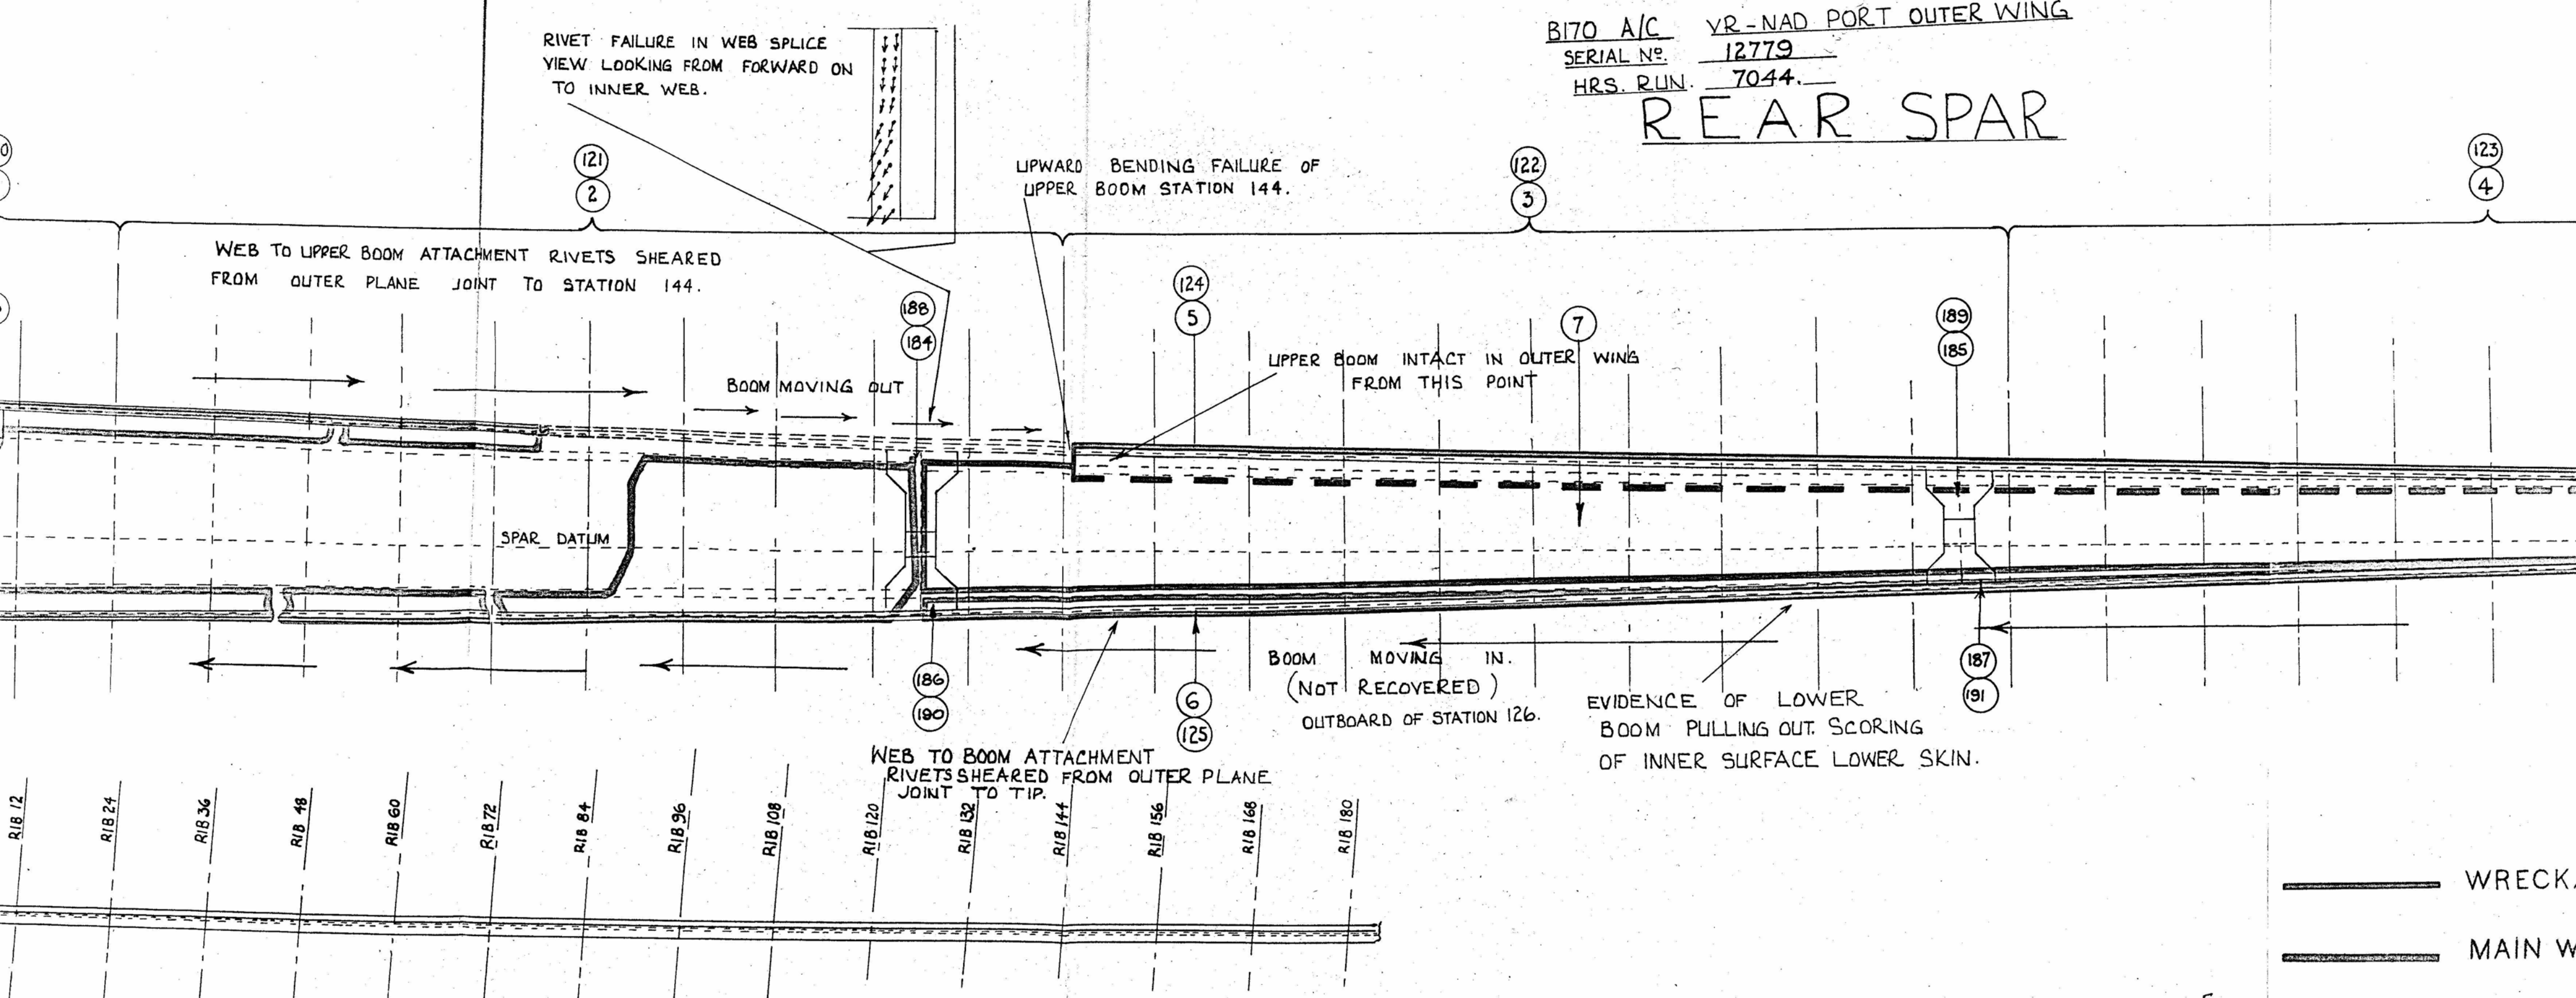
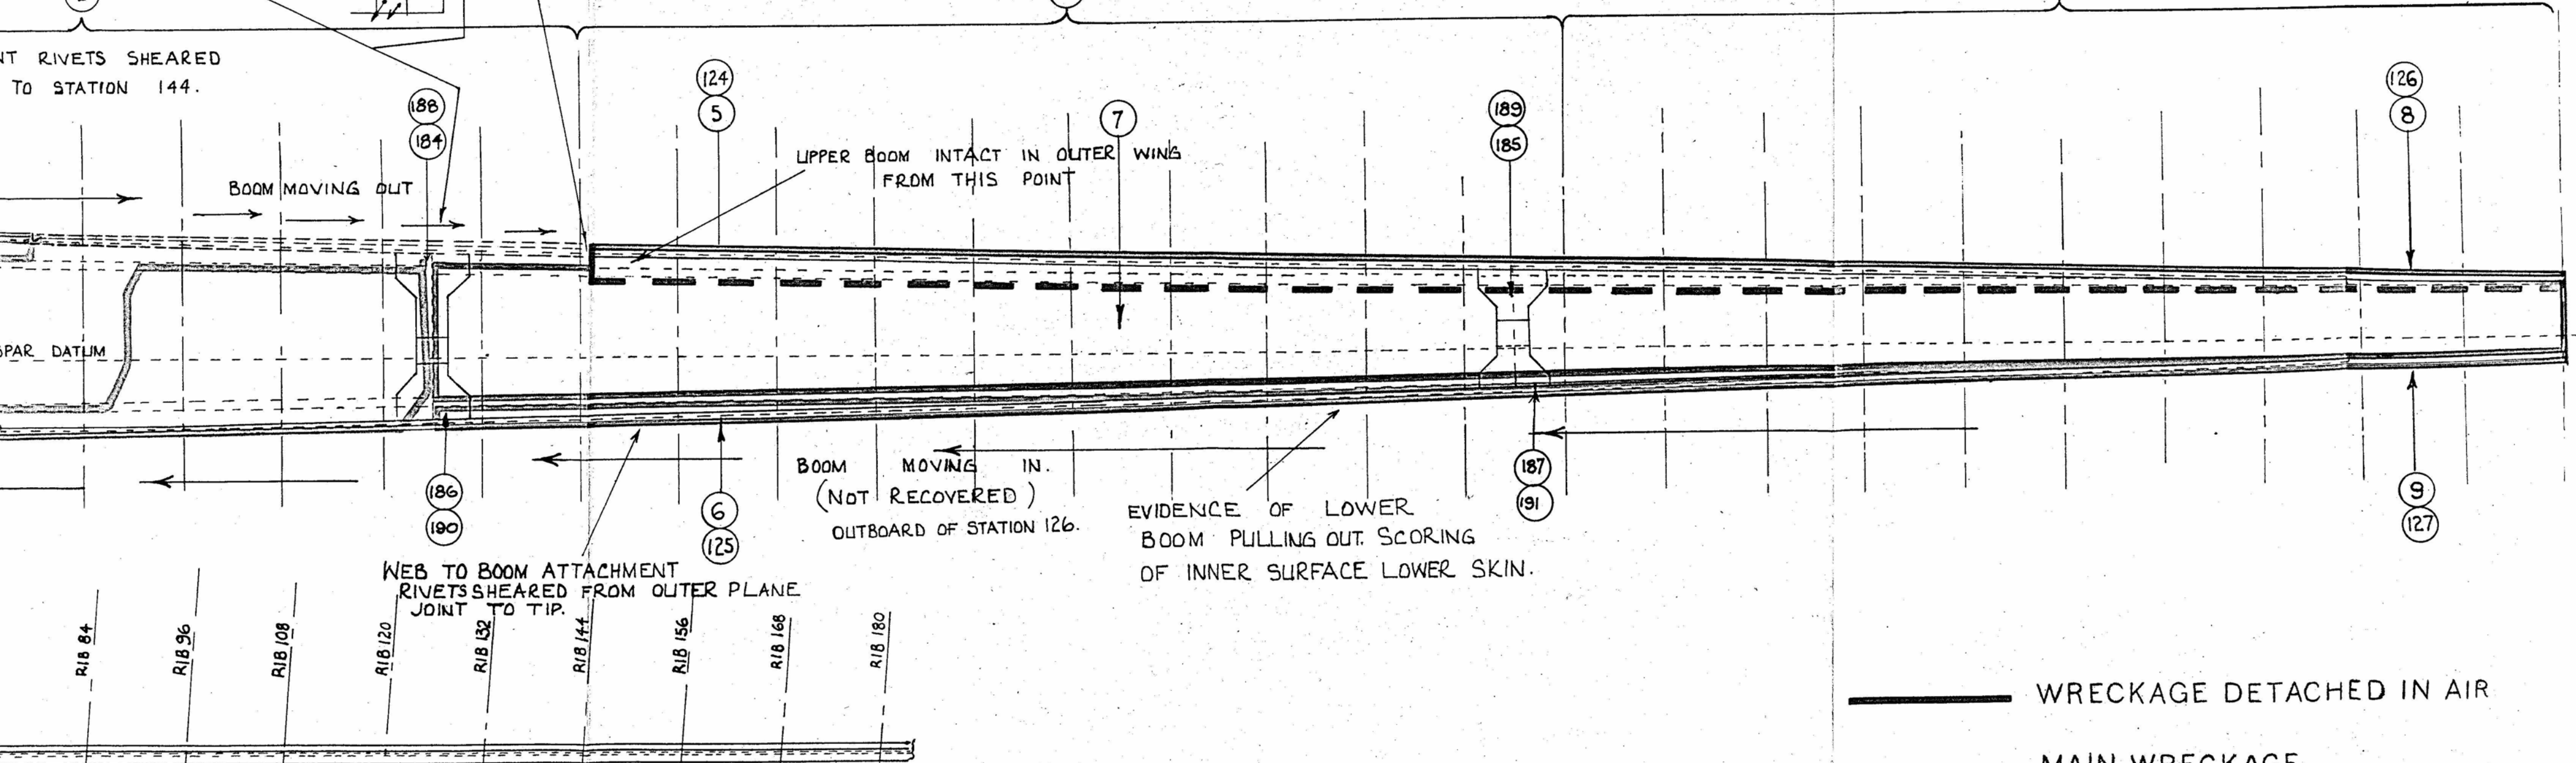
REAR SPAR

The consistency of direction of shear across the Station 144 butt joint of rivets attaching boom to web of the rear spar indicates that detachment of boom from web preceded failure of the butt joint, but this was secondary to failure of the front spar.

RIVET FAILURE IN WEB SPLICE
 VIEW LOOKING FROM FORWARD ON
 TO INNER WEB.

LIPWARD BENDING FAILURE OF
 UPPER BOOM STATION 144.

ALL RIVETS SHEARED
 TO STATION 144.

BOOM MOVING IN.
 (NOT RECOVERED)
 OUTBOARD OF STATION 126.

EVIDENCE OF LOWER
 BOOM PULLING OUT SCORING
 OF INNER SURFACE LOWER SKIN.
