CADASTRAL SURVEY MONUMENTATION
MANUAL

To: Director, DSC
From: Richard B. Case, Mechanical Engineer, Division of
of Scientific Systems Development (D-440)
Subject: Field Trip Report

Covering Travel To:
Salt Lake City, Utah

To inspect and report on conditions of Cadastral Survey Monuments located at Utah Test sites No. 1A and No. 2.

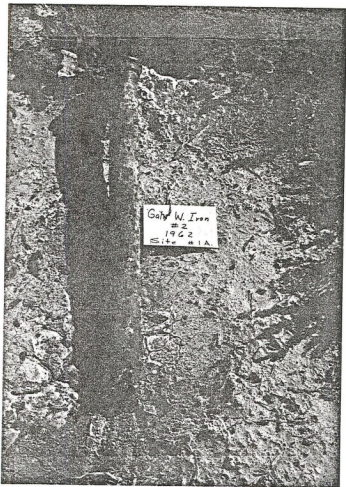
- A. Galvanized Wrought Iron
Monument Test Set - No. 2
Set in 1962
Inspection Date - October 1980

Top of monument (above ground level) is rusty, but looks good.

Below ground level the monument has severe corrosion and rust buildup. The flange has corroded away and there is much metal loss on the pipe body. Corrosion appears as etched parallel lines.

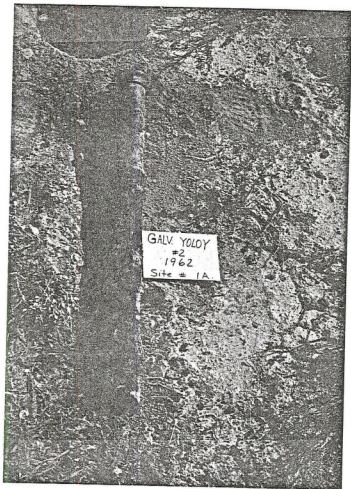
- B. Galvanized Yolo
Monument Test Set - No. 2
Set in 1962
Inspection Date - October 1980

Top of monument (above ground level) looks good.

Below ground level the monument has severe corrosion with many continuous deep pits and much rust buildup. The lower two inches of the monument has corroded away.

This monument is in very poor condition.

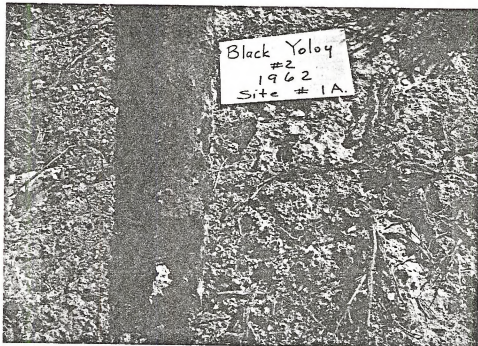
- C. Black Yolo
Monument Test Set No. 2
Set in 1962
Inspection Date - October 1980

Top of monument (above ground level) is slightly rusty, but looks good.

Below ground level the monument has severe continuous pitting and much rust buildup. The lower portion of the monument is in very poor condition with thin metal and several large holes. The lower three inches of the pipe have corroded away.

Corrosion on this monument was worse than any other monument inspected.

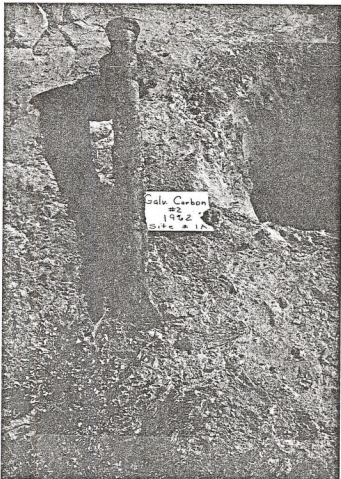
- D. Galvanized Carbon
Monument Test Set - No. 2
Set in 1962
Inspection Date - October 1980

Top of monument (above ground level) looks very good.

Below ground level the monument has severe pitting and much rust buildup. The lower part of the pipe is thin and most of the flange has corroded away.

This monument is in poor condition.

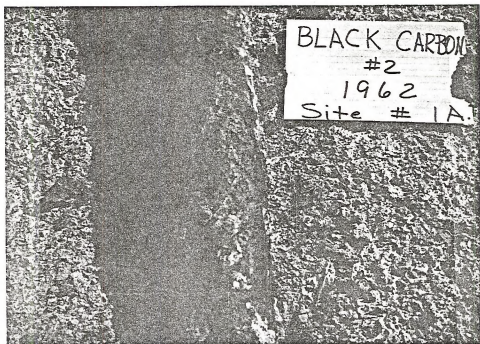
- E. Black Carbon
Monument Test Set - No. 2
Set in 1962
Inspection Date - October 1980

Top of monument (above ground level) is rusty but looks good.

Below ground level the monument has large continuous pitting and severe rust buildup. Holes have appeared in the lower portion of the pipe and the remaining metal is very thin. The flange and lower one to two inches of the pipe have corroded away.

Only one other monument (Black YoLoy) had more extensive corrosion than this monument.

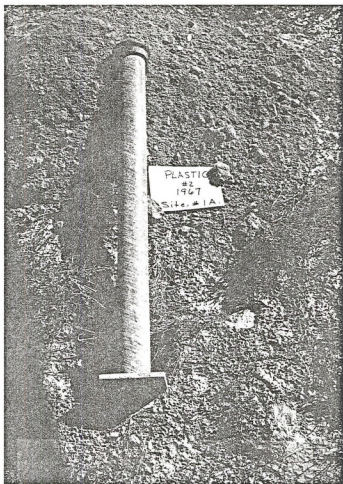
F. Plastic
Monument Test Set - No. 2
Set in 1967
Inspection Date - October 1980

This monument appears to be fiber glass and is in excellent condition both above ground and below ground level. The only evidence of corrosion is a small area on the foot pad.

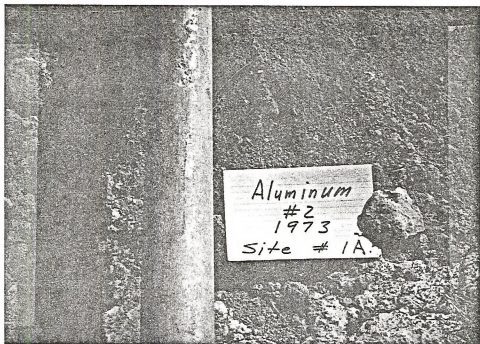
- G. Aluminum Pipe
Monument Test Set - No. 2
Set in 1973
Inspection Date - October 1980

Top of monument (above ground level) is dark in color but is in very good condition.

Below ground level the monument has a few large deep pits with some dark spots. The pits are only in isolated areas and are not continuous. There is some pitting in the flange also.

This monument is in very good condition.

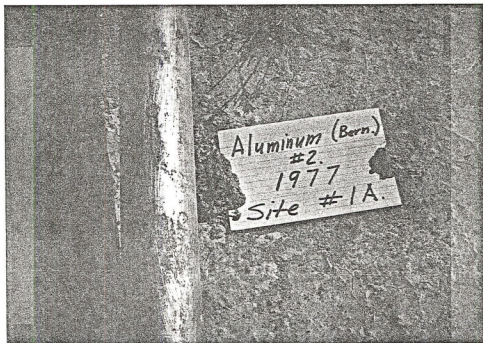
- H. Aluminum Pipe
Monument Test Set - No. 2
Set in 1977
Inspection Date - October 1980

Top of monument (above ground level) is in excellent condition.

This monument is in very good condition.

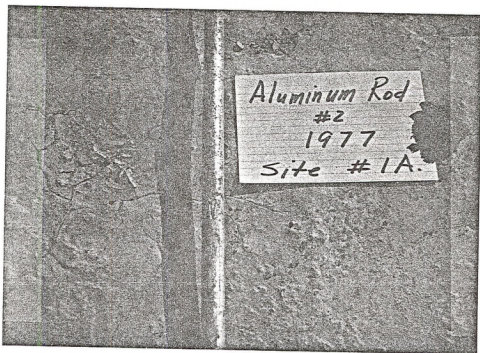
- I. Aluminum Rod
Monument Test Set - No. 2
Set in 1977
Inspection Date - October 1980

Top of monument (above ground level) is in excellent condition.

Below ground level there are many dark spots and one small area has deep continuous pits. There is also some corrosion near the point.

This monument is in very good condition.

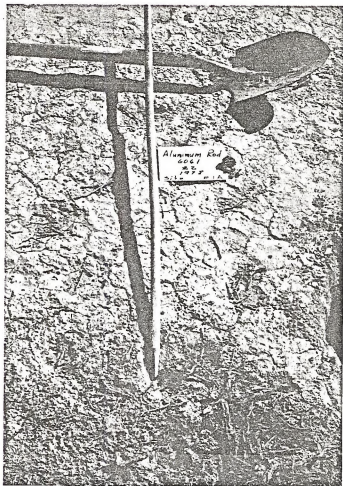
J. Aluminum Rod (Type 6061 A1) - 3/4"
Monument Test Set - No. 2
Set in 1978
Inspection Date - October 1980

Top of monument (above ground level) is in excellent condition.

Below ground level there are a few dark spots and slight corrosion near the point.

This monument is in excellent condition.

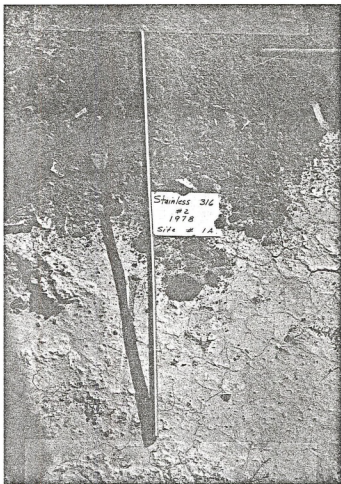
- K. Stainless Steel (Type 316)
Monument Test Set - No. 2
Set in 1978
Inspection Date - October 1980

This monument is in excellent condition. The metal is bright and looks as it did when it was installed. There is no corrosion, discoloration, or pitting present.

This monument is in better condition than any other monument being tested.

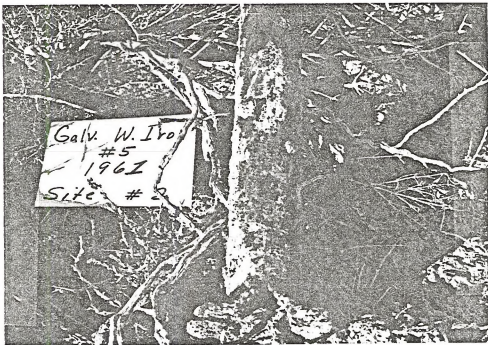
- A. Galvanized Wrought Iron (1961 contract)
Monument Test Set - No. 5
Set in 1962
Inspection Date - October 1980

Top of monument (above ground level) looks good.

Below ground level the monument galvanizing has corroded away. The corrosion appears as parallel grooves that are etched to varying depths.

This monument is still in good condition.

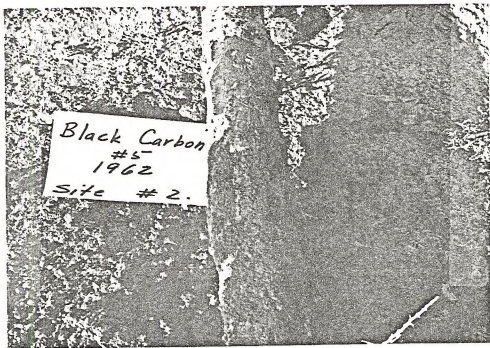
- B. Black Carbon
Monument Test Set - No. 5
Set in 1962
Inspection Date - October 1980

Top of monument (above ground level) has some rust spots but looks good.

Below ground level the monument has a black appearance. Corrosion is active and metal appears to be flaking off. The rust appears to be taking on a crystallization form.

This monument is still in fairly good condition.

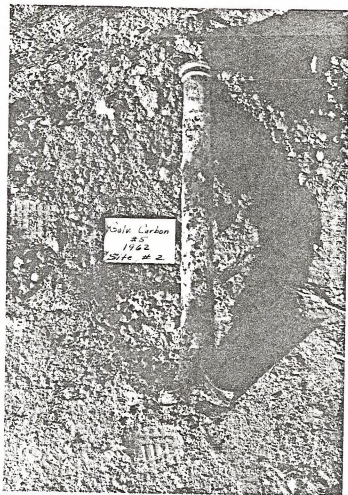
- C. Galvanized Carbon
Monument Test Set - No. 5
Set in 1962
Inspection Date - October 1980

Top of monument (above ground level) is rusty but very solid.

Below ground level the monument galvanizing has corroded away and thin layers of metal appear to be flaking off in form of rust. There are many parallel grooves etched into the pipe.

This monument is still in fairly good condition.

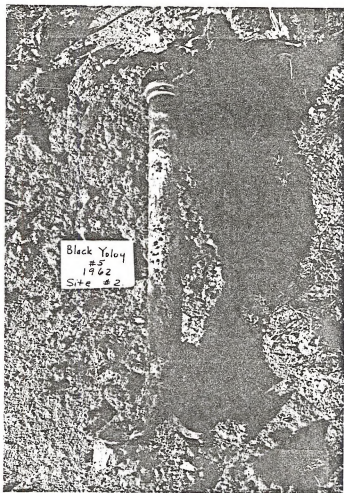
- D. Black Yoloy
Monument Test Set - No. 5
Set in 1962
Inspection Date - October 1980

Top of monument (above ground level) is rusty but solid.

Below ground level the monument has many large pitted areas. Metal has been corroded away and much rust is present. The flange is thin and breaking away. Minor parallel grooving is present.

This monument is in fair to poor condition.

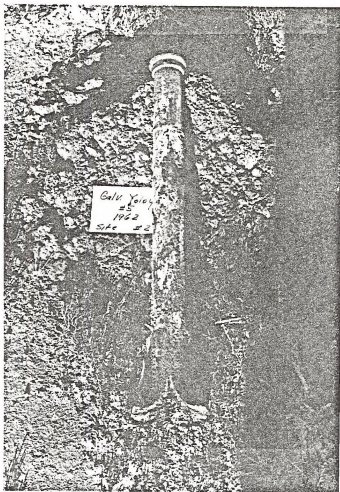
- E. Galvanized Yolo
Monument Test Set - No. 5
Set in 1962
Inspection Date - October 1980

Top of monument (above ground level) is rusty but looks good.

Below ground level the monument is very rusty with small pitting. The flange is in fairly good condition.

This monument is still in good condition.

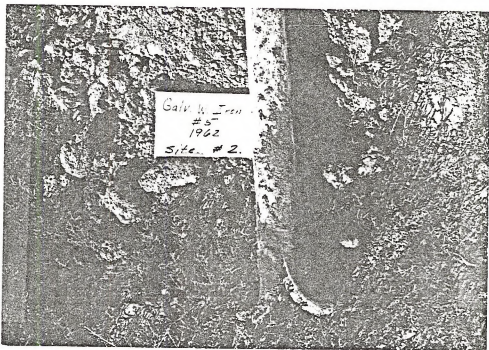
- F. Galvanized Wrought Iron
Monument Test Set - No. 5
Set in 1962
Inspection Date - October 1980

Top of monument (above ground level) is rusty but looks good.

Below ground level the monument has some pits and rusty areas. Corrosion is worse near the bottom with more pits having deeper depths. Metal is corroding away near the lower portion with parallel grooved type etching being present.

This monument is in fairly good condition except for the lower section of the pipe.

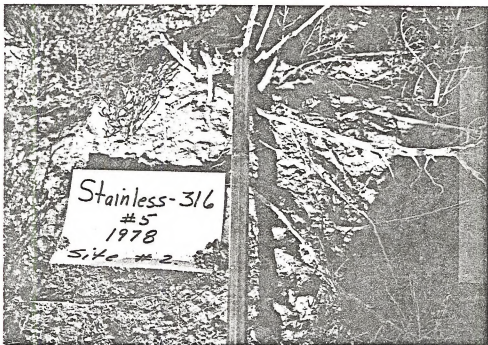
- G. Stainless Steel
Monument Test Set - No. 5
Set in 1978
Inspection Date - October 1980

Top of monument (above ground level) is excellent.

Below ground level the monument is bright an in excellent condition. There are two small brown spots measuring approximately 1/4 inch in diameter on the lower portion of the rod.

At the ground line there appears to be slight corrosion. There is a small groove around the entire rod that measures only a few thousandths of an inch deep.

This monument is in excellent condition and looks better than any other monument that was inspected from this test site.

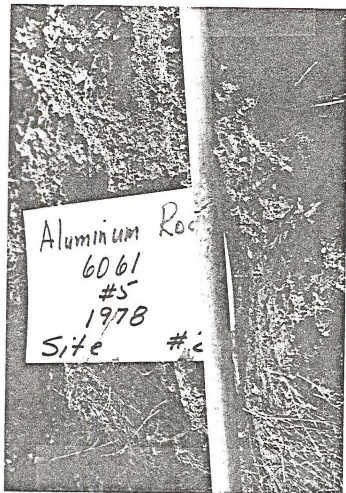
- H. Aluminum Rod (Type 6061)
Monument Test Set - No. 5
Set in 1978
Inspection Date - October 1980

Top of monument (above ground level) has some small pits but is in very good condition.

Below ground level the monument is dark in color but looks solid and in very good condition.

At the ground line corrosion is present with continuous pitting where metal has been removed around the entire rod. The worse pits are approximately 1/32" to 1/64" deep.

This rod is in very good condition.

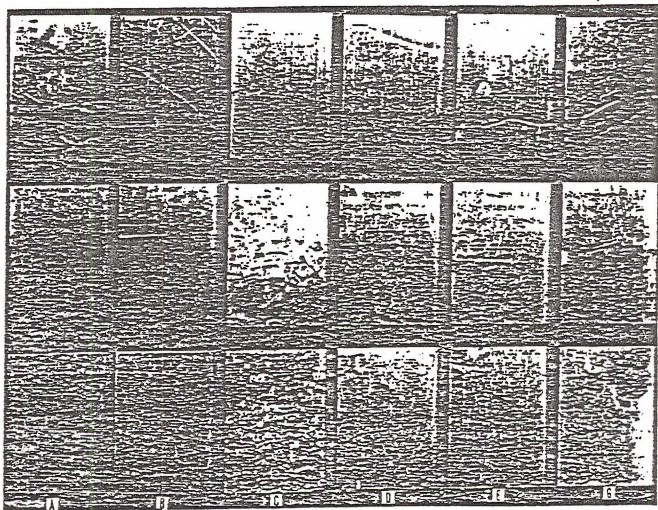
FIGURE 2 - Noncoupled stainless steel control panels. Top: 26Cr-6.5Ni alloy, 3 year exposure; middle: Type 304, 4 year exposure; and bottom: Type 409, 4 year exposure. Sites: A, B, C, D, E, and G.

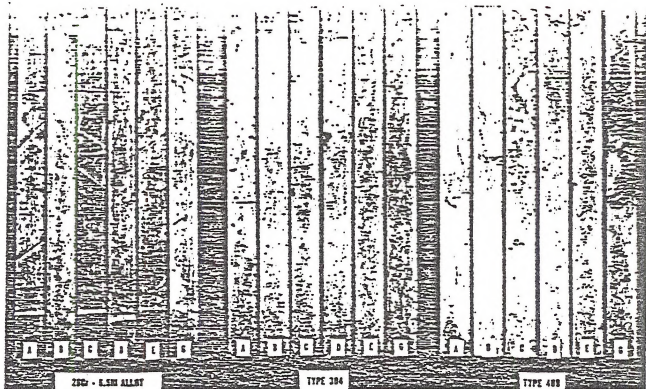
FIGURE 3 — Coupled stainless steel strips, 25Cr-6.5Ni alloy—3-year exposure. Types 304 and 409—4.5-year exposure.
