# FLOOD PLAIN MANAGEMENT STUDY

## **PALOMINAS-MIRACLE VALLEY AREA**

Cochise County, Arizona

AUGUST 1987

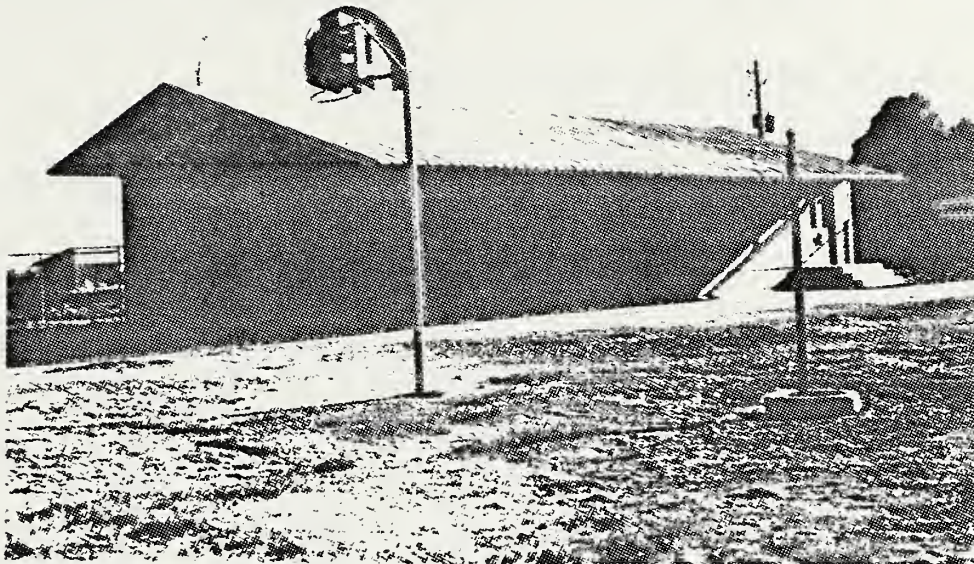
Local people have not kept a flood history of the area, but older residents point out that flooding has been a problem for a long time. As noted by the high floor on the only original school building remaining, shown in Figure 3, special provisions were made to elevate the lower floors of the buildings.

**Figure 3**  
Floor in Early School Building Elevated for Flood Protection

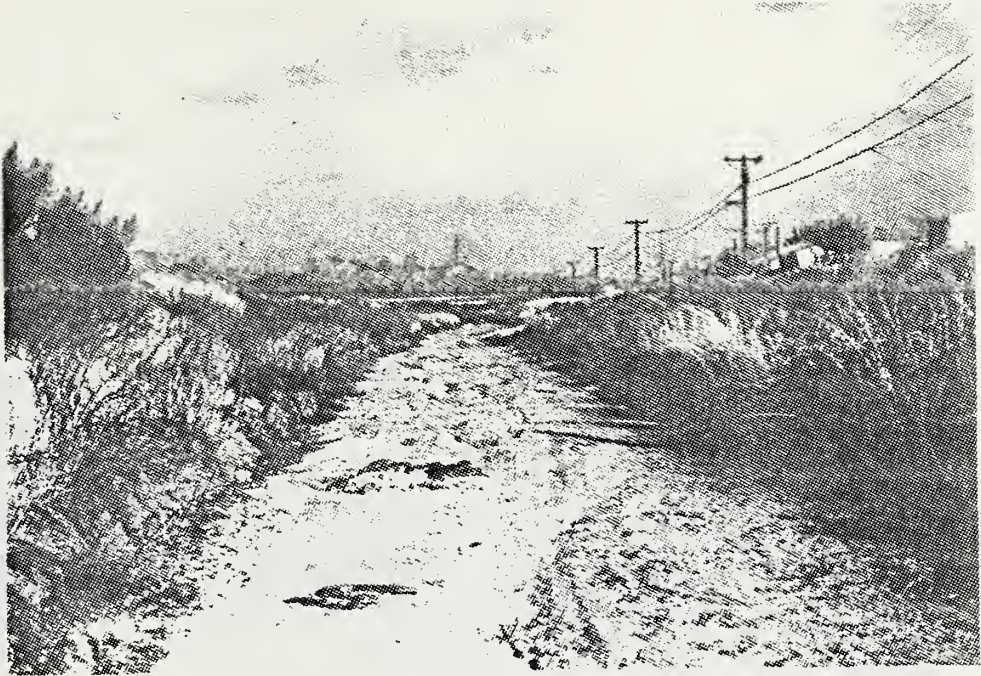
A channel was constructed along the northern edge of the Miracle Valley subdivisions to convey School House Wash by the development. Construction of this channel was apparently done with little advanced planning and design. Consequently, the channel decreases in carrying capacity as it proceeds eastward. Refer to Figures 4, 5 and 6.

**Figure 4**  
School House Wash near Loaves and Fishes Drive  
Maximum Capacity about 1900 cfs

**School House Wash**--The decreasing ability of this channel to convey floodwater as the channel proceeds downstream would be corrected by enlargement. A trapezoidal channel following the existing gradient but shaped to stabilize sides and to convey flow at nonerosive velocities was considered. In lieu of channel enlargement a flood wall located along the south bank of School House Wash was also considered. Either structure would protect the northern part of the Miracle Valley Subdivisions throughout their length. The cost of either system could not be justified by the expected benefits.

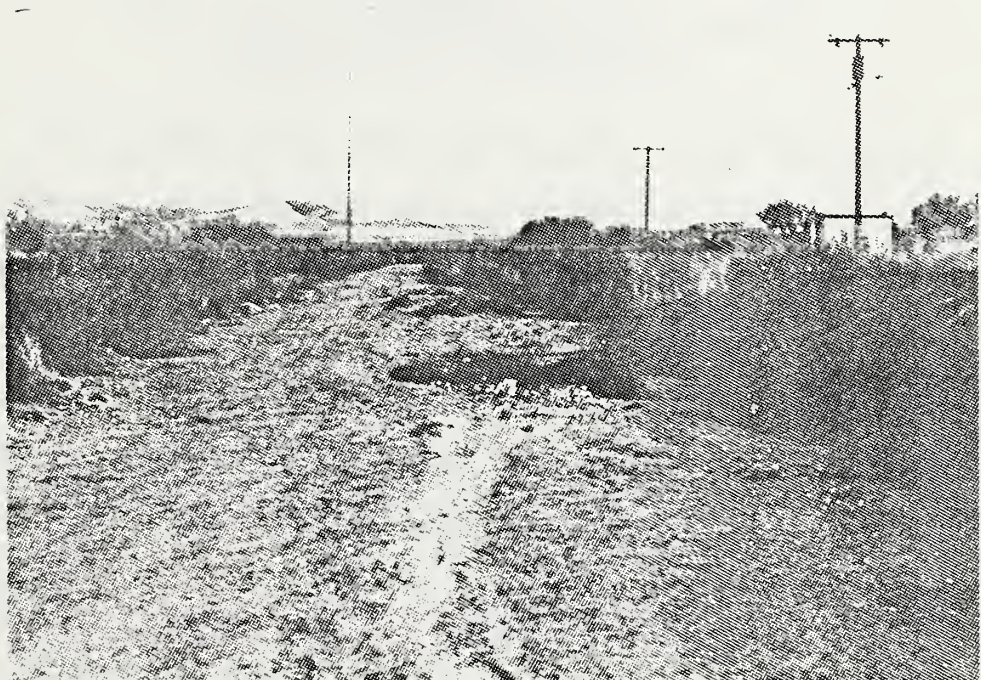
**Figure 5**  
School House Wash Near Deliverance Way Drive  
Maximum Channel Capacity about 600 cfs

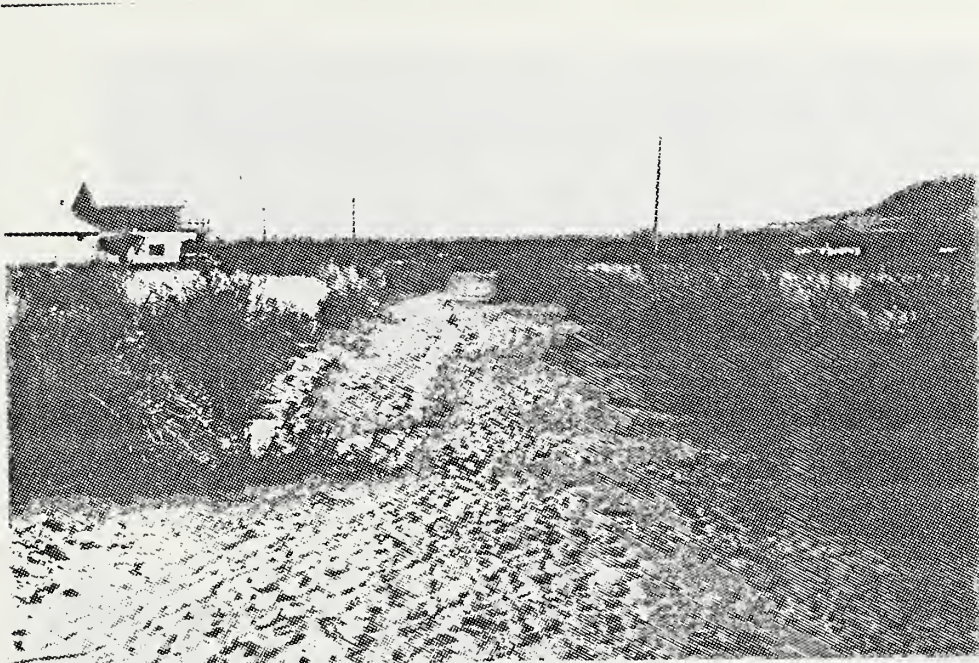
**Figure 6**  
School House Wash Upstream from Dip Crossing  
Maximum Capacity about 200 cfs

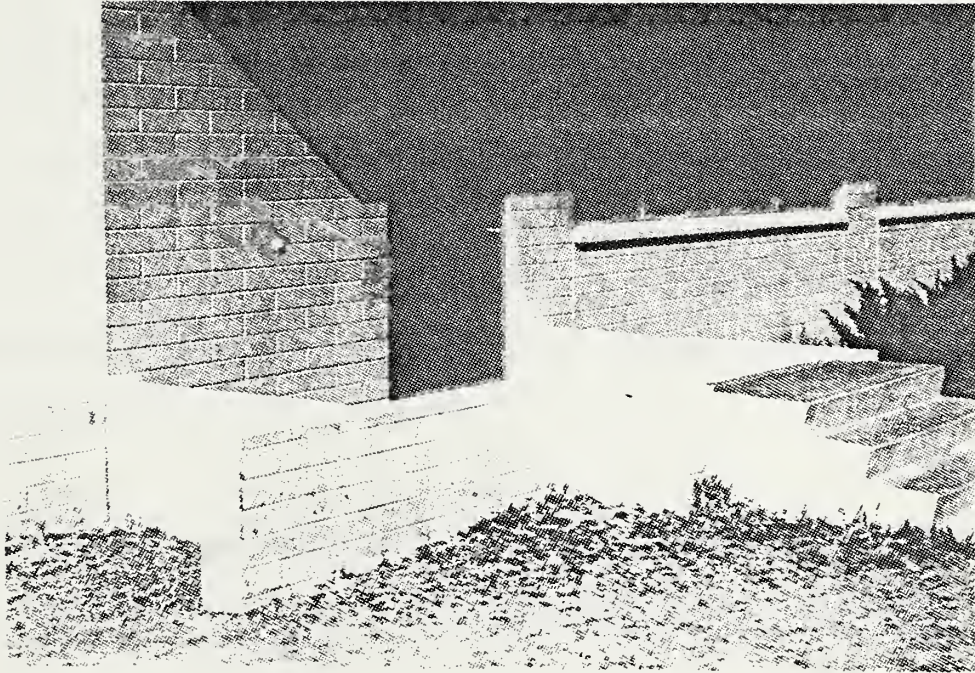
Palominas School has added some flood proofing features to the buildings. Refer to Figure 7. Some low dikes and walls have been put up to protect houses, refer to Figure 8.

**Figure 7**  
Flood Proofing Junior High Building, Palominas School

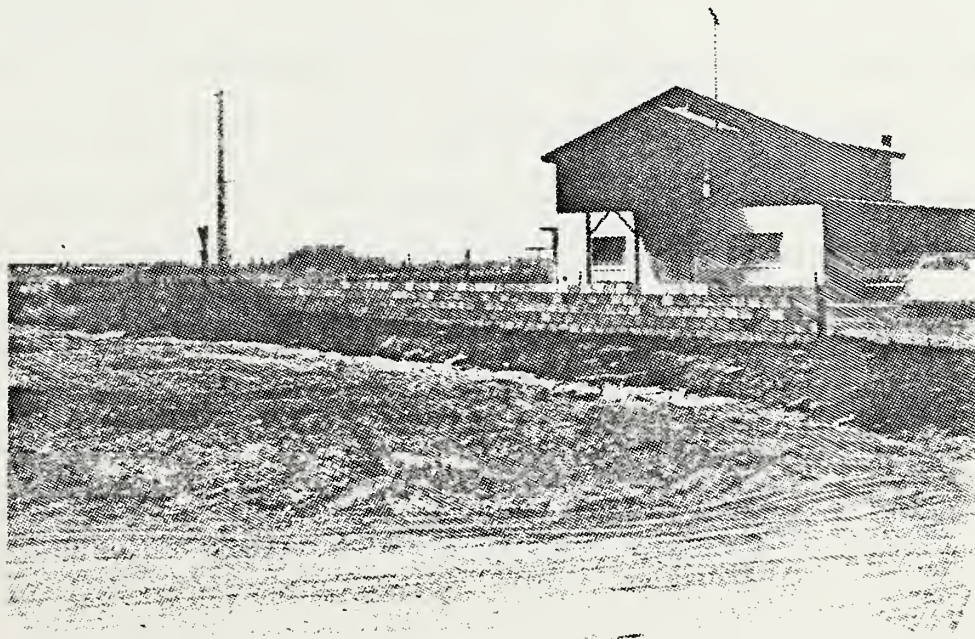
**Figure 8**  
Flood Proofing of House North of and Adjacent to School House Wash

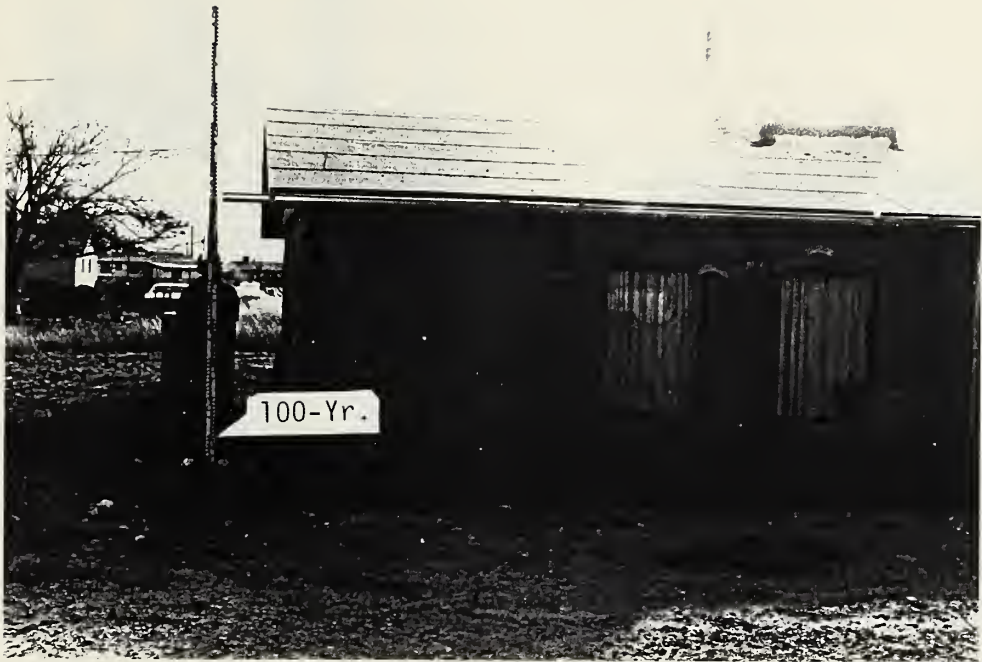
Along Healing Way Road between Second and Third Avenue looking east. Depth, 1.0 ft.

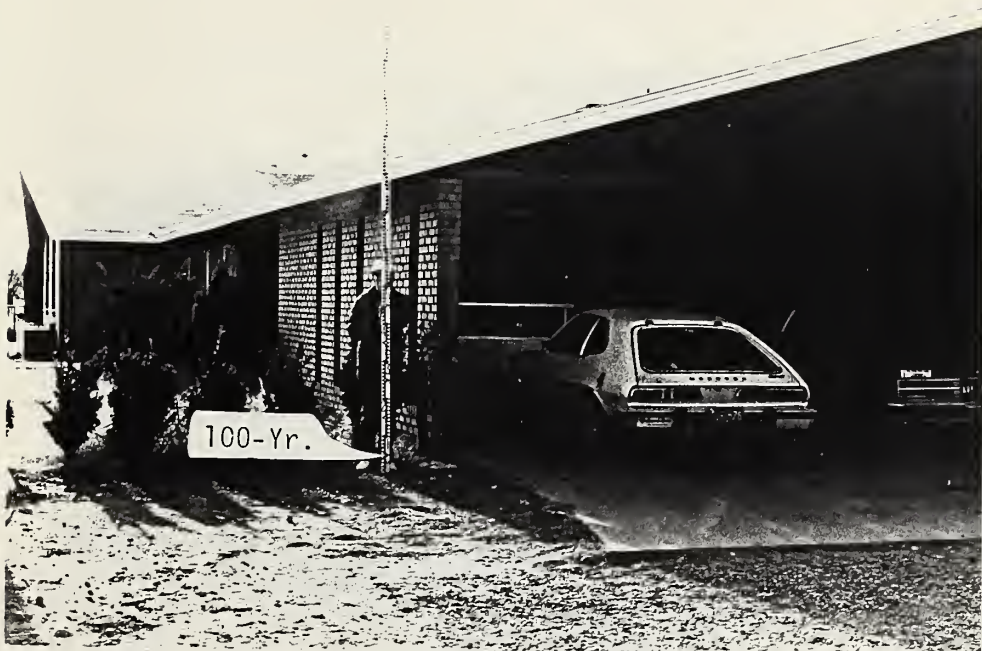
Near Fourth Avenue along Loaves and Fishes Street, looking south. Depth, 0.5 ft.

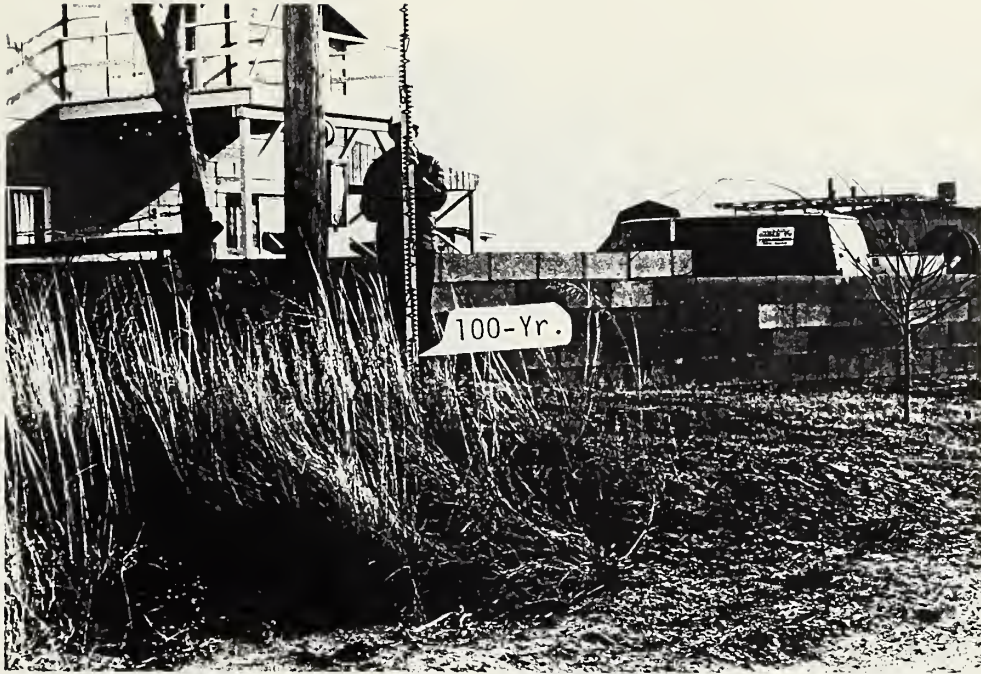
House on north side of School House Wash near junction of Third Avenue and the Wash, looking northeast. Depth, 0.7 ft.

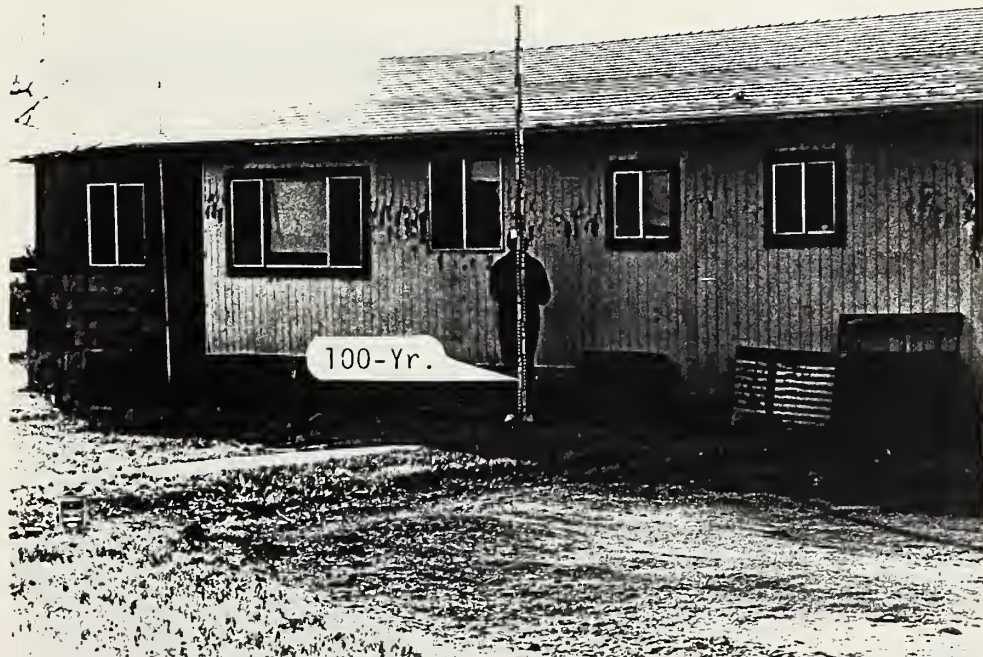
House on south side of School House Wash near junction of Third Avenue and the Wash, looking southeast. Depth, 1.3 ft.

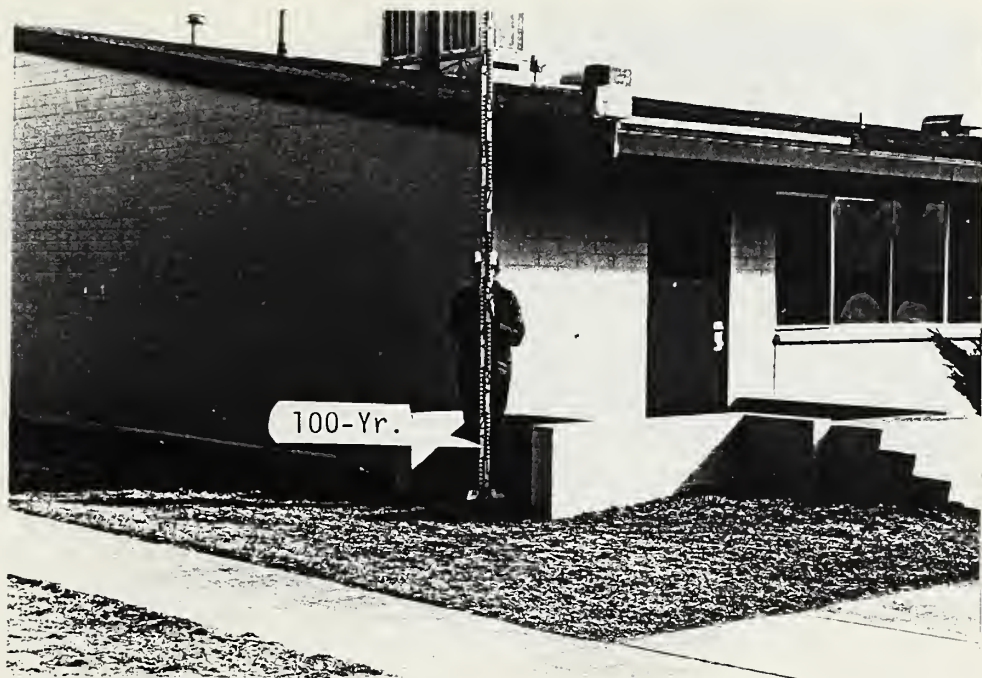
Junior High Building, Palominas School Complex, looking northeast. Depth, 1.2 ft.

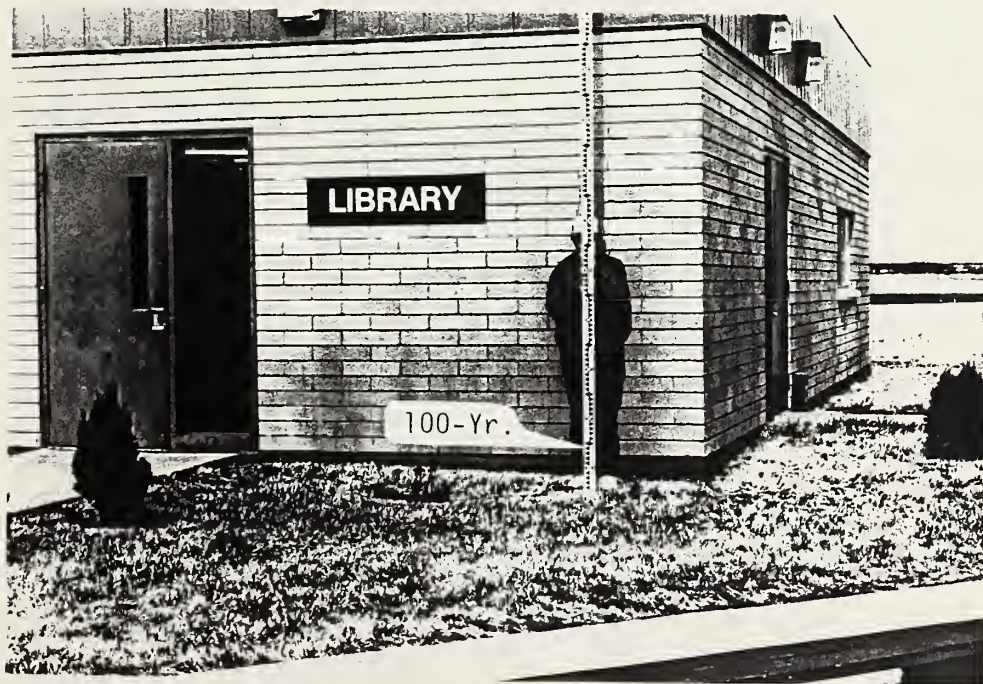
Library Building, Palominas School Complex, looking west. Depth, 0.9 ft.

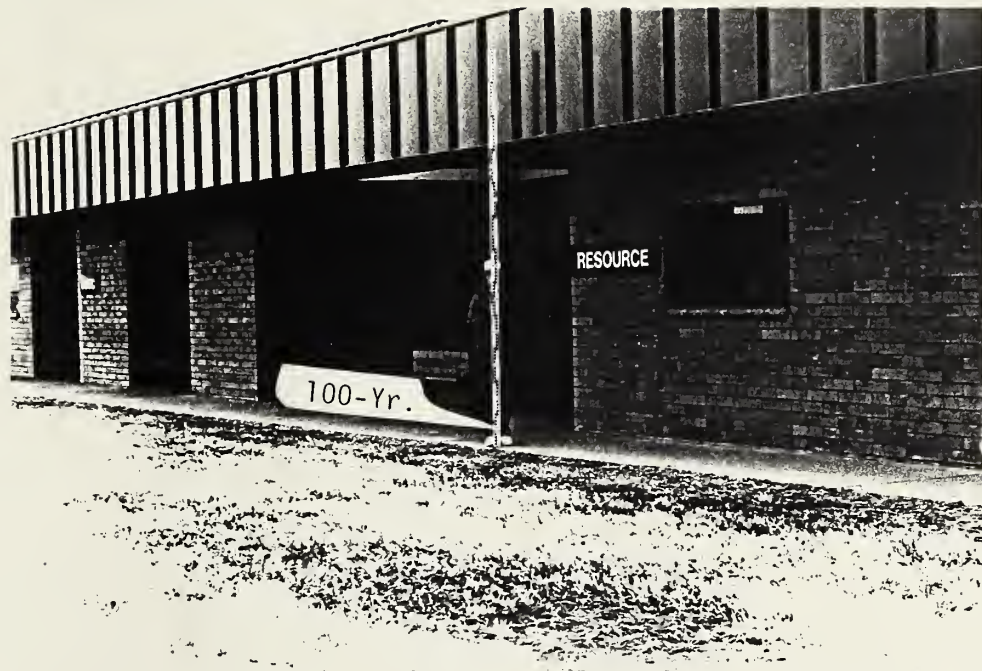
Special Education and 5th Grade Building, Palominas School Complex, looking northeast. Depth, 0.5 ft.
