# THE NIGHT THE EARTH SHOOK

A GUIDE TO THE MADISON RIVER CANYON EARTHQUAKE AREA

U.S. Department of Agriculture Forest Service Miscellaneous Publication No. 907 August 1962

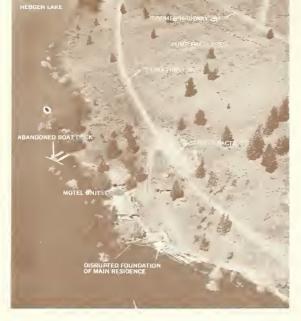
Left: Aerial view of Hilgard Lodge showing intense fracturing of ground, and partial submergence of motel units. Main dwelling has slid into lake and floated away.

Right: Inundation of lake front at Hilgard Lodge.

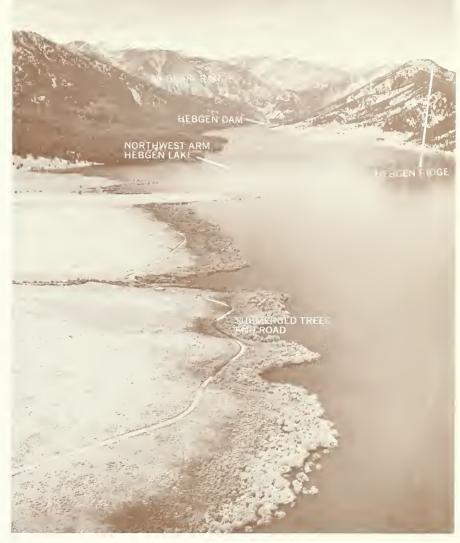
Aerial view looking northwest toward Hebgen Dam showing the submergence of the northwest arm of Hebgen Lake.

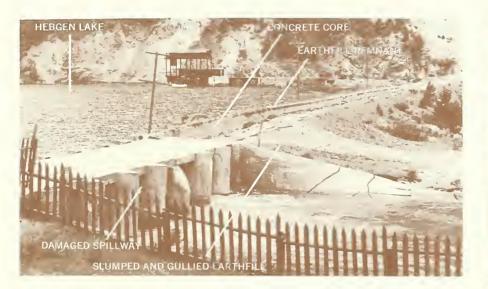
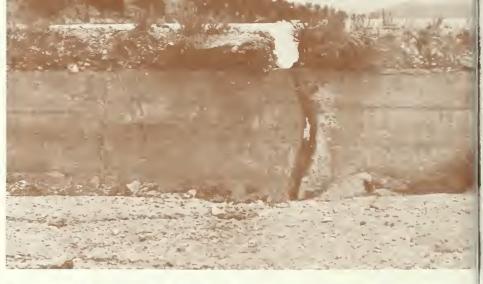
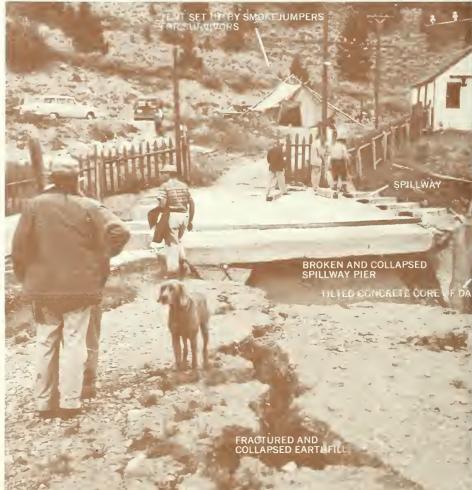
Though it did not fail, the structure was heavily damaged. The concrete core was cracked in at least four places, and locally tilted and twisted out of line (p. 12). The concrete spillway was cracked but still intact, although one of its piers was pushed askew. The earthfill on both sides of the concrete core had settled unevenly, the greatest settlement (about 5 feet) being at the northeast end.

Damage to Hebgen Dam. Photographs taken on August 18, 1959, the day after the earthquake.

General view of Hebgen Dam showing uneven slump of earthfill away from concrete core.

Top right: Crack in concrete core; remnant of earthfill is still preserved on concrete core.

Bottom right: The collapsed earthfill and a damaged concrete spillway pier. The twisted and tilted concrete core shows along right edge of photograph. Originally the core was vertical and alined with right edge of spillway.

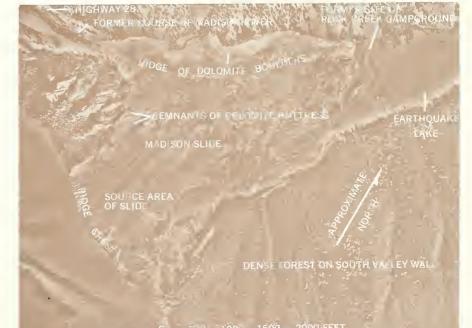
Aerial photograph of the Madison Slide.

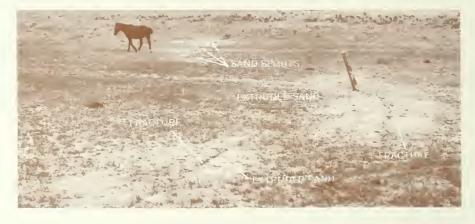
Sand squeezed out along narrow fractures near Parade Rest Ranch.

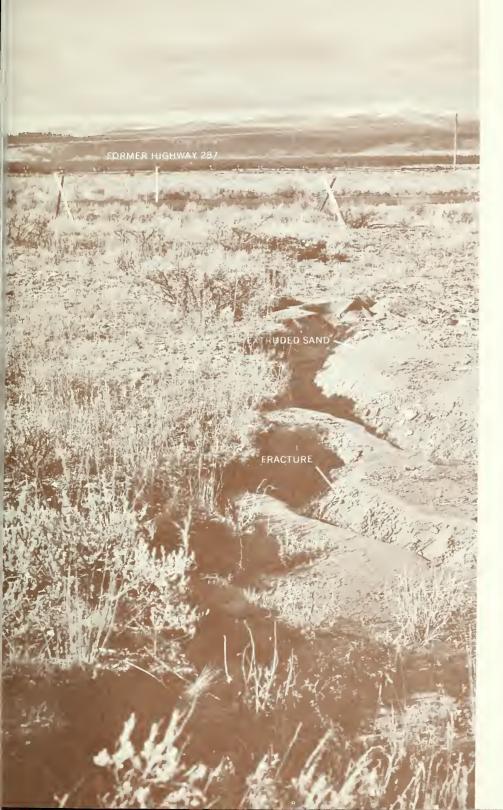
## Sand spout near former highway 287 where it crosses Parade Rest Ranch.

These sand spouts are probably the result of shaking during the earthquake. The shaking compacted the loose sand and gravel, drastically reducing the pore space between grains. In the water-bearing layers, this squeezing put tremendous pressure on the minute droplets of water which filled the pores. Wherever a fissure (formed by the alternating compression and dilation of the ground due to the earthquake waves) tapped one or more of these water-bearing formations, the water pressure forced the water and sand to spew out and form a sand spout.

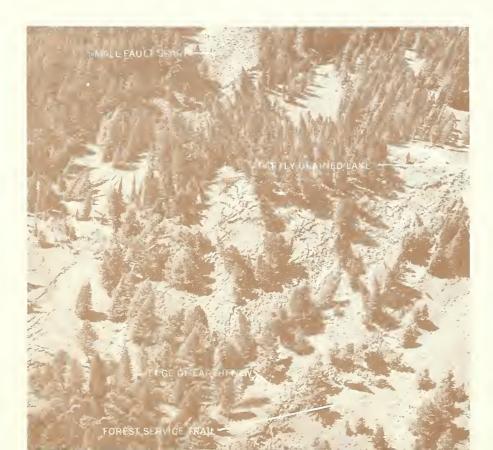
The Kirkwood Canyon earthflow at the end of August 1959. Slump has formed ground cracks, and caused the trees to tilt at all angles. Small lake, now partly drained, is at right edge of photograph. Small fault scarp is visible at top center of photograph.

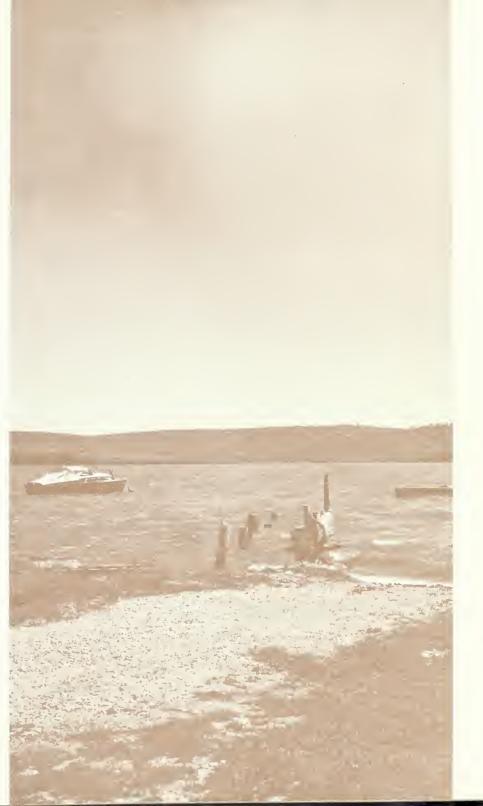
Submerged dock at "The Narrows" resort. The platform of this dock, formerly well above the water level, is now concealed under about 2 feet of water.

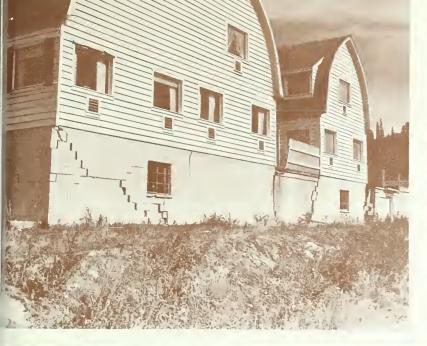
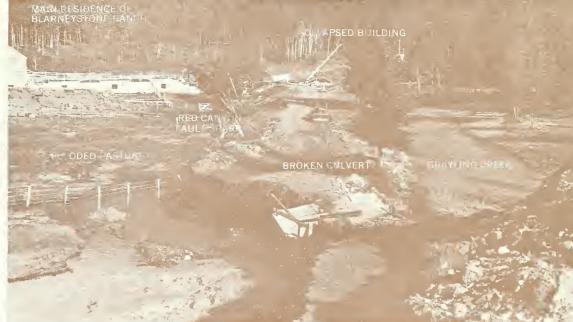
The main residence at the Blarneystone Ranch (index map) was astride the old Red Canyon Fault, which was concealed in this area beneath broad deposits of sand and gravel. On the night of the earthquake the major part of the house south of the fault dropped about 10 feet and was severely damaged. Part of the domestic quarters and a storage shed north of the fault were intensely shaken, and collapsed (p. 23).

Damage to Blarneystone Ranch. The main residence was astride the Red Canyon Fault and was severely damaged when the fault moved again. Top left: Structural damage to walls of the main residence. Top right: The fault scarp where it cuts across Grayling Creek and extends toward the main residence. Fault scarp gives way at base of treecovered hill to small fissures which break surficial cover. Bottom: The fault scarp where it passes beneath the dwellings. The buildings to the right of the scarp have collapsed; the buildings to the left have dropped about 10 feet.
