## REPORT ON CUSTODIAL PERSONNEL AT REPARATIONS PLANT

20 July, 1950.

CODE NO. : 34 - 57  
PLANT NAME : Kageyama Kikai Seisakusho  
LOCATION : Oyaguchi, Urawa-shi, Saitama Pref.

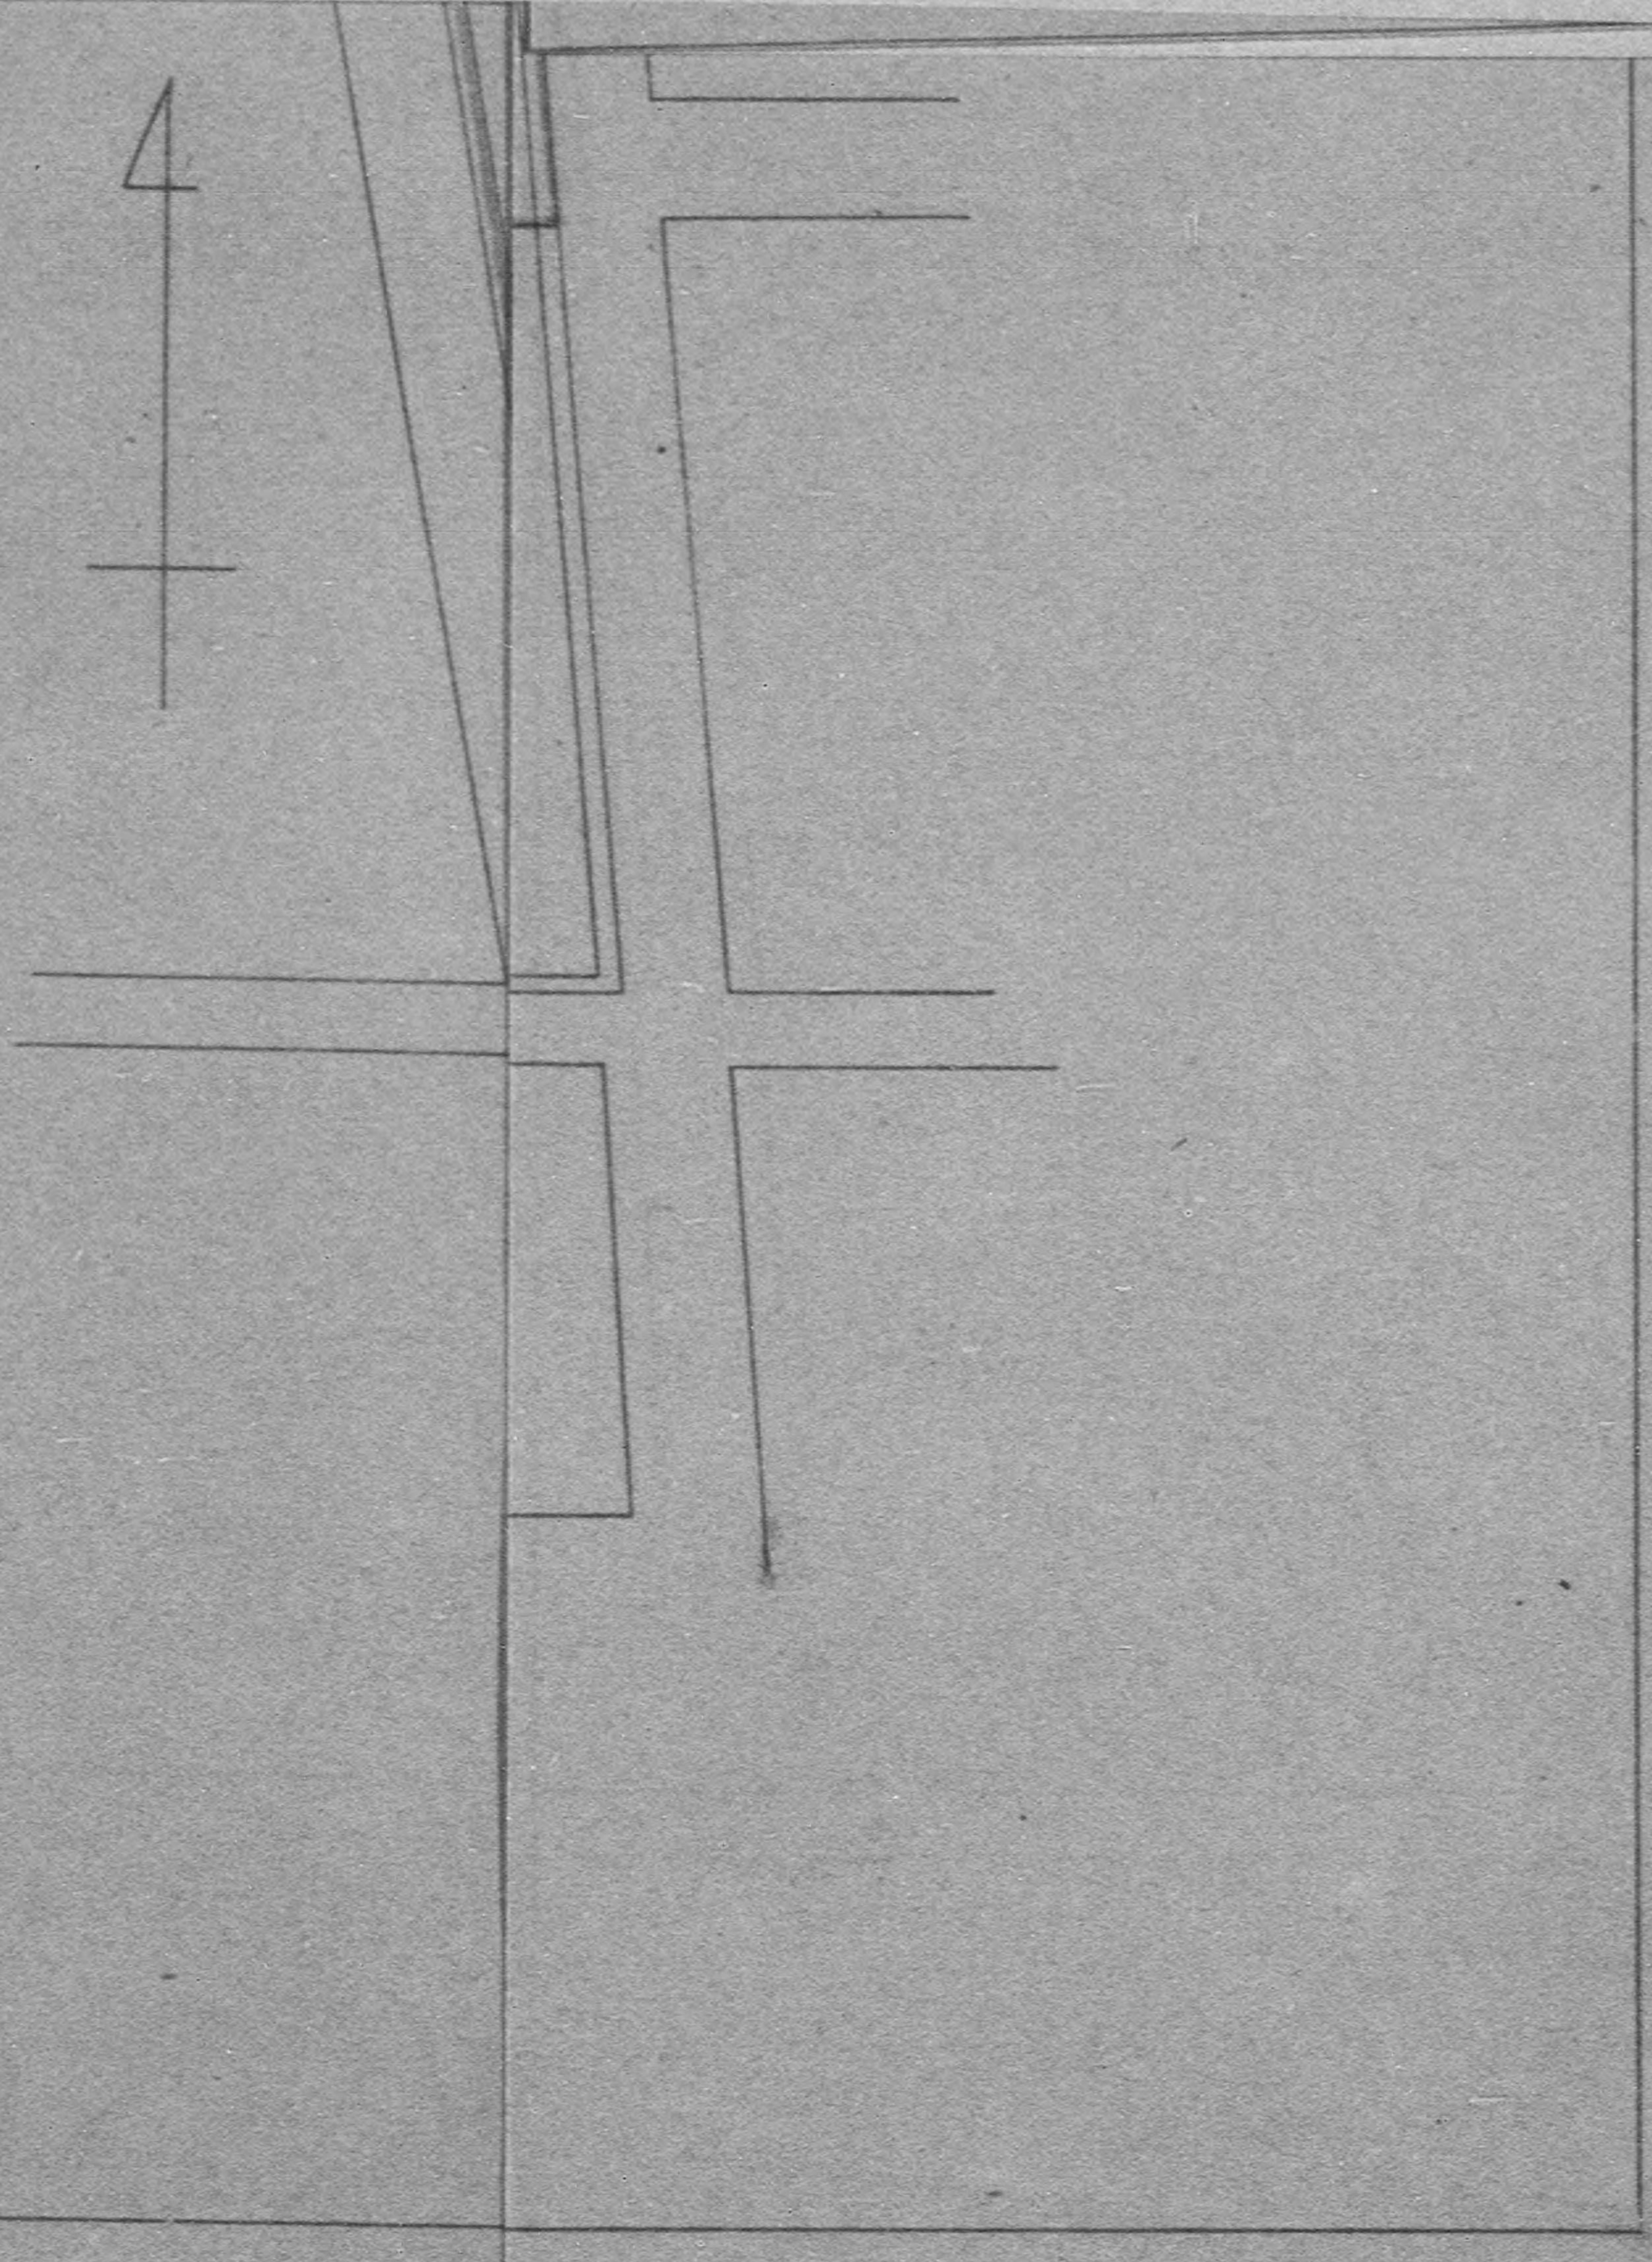
Code No. 34-57

Few machines are old and worn out.

6 wooden slate-roofed buildings.  
Condition is good.

Size of plant area 8,500 tsybo.  
Strong hedge.

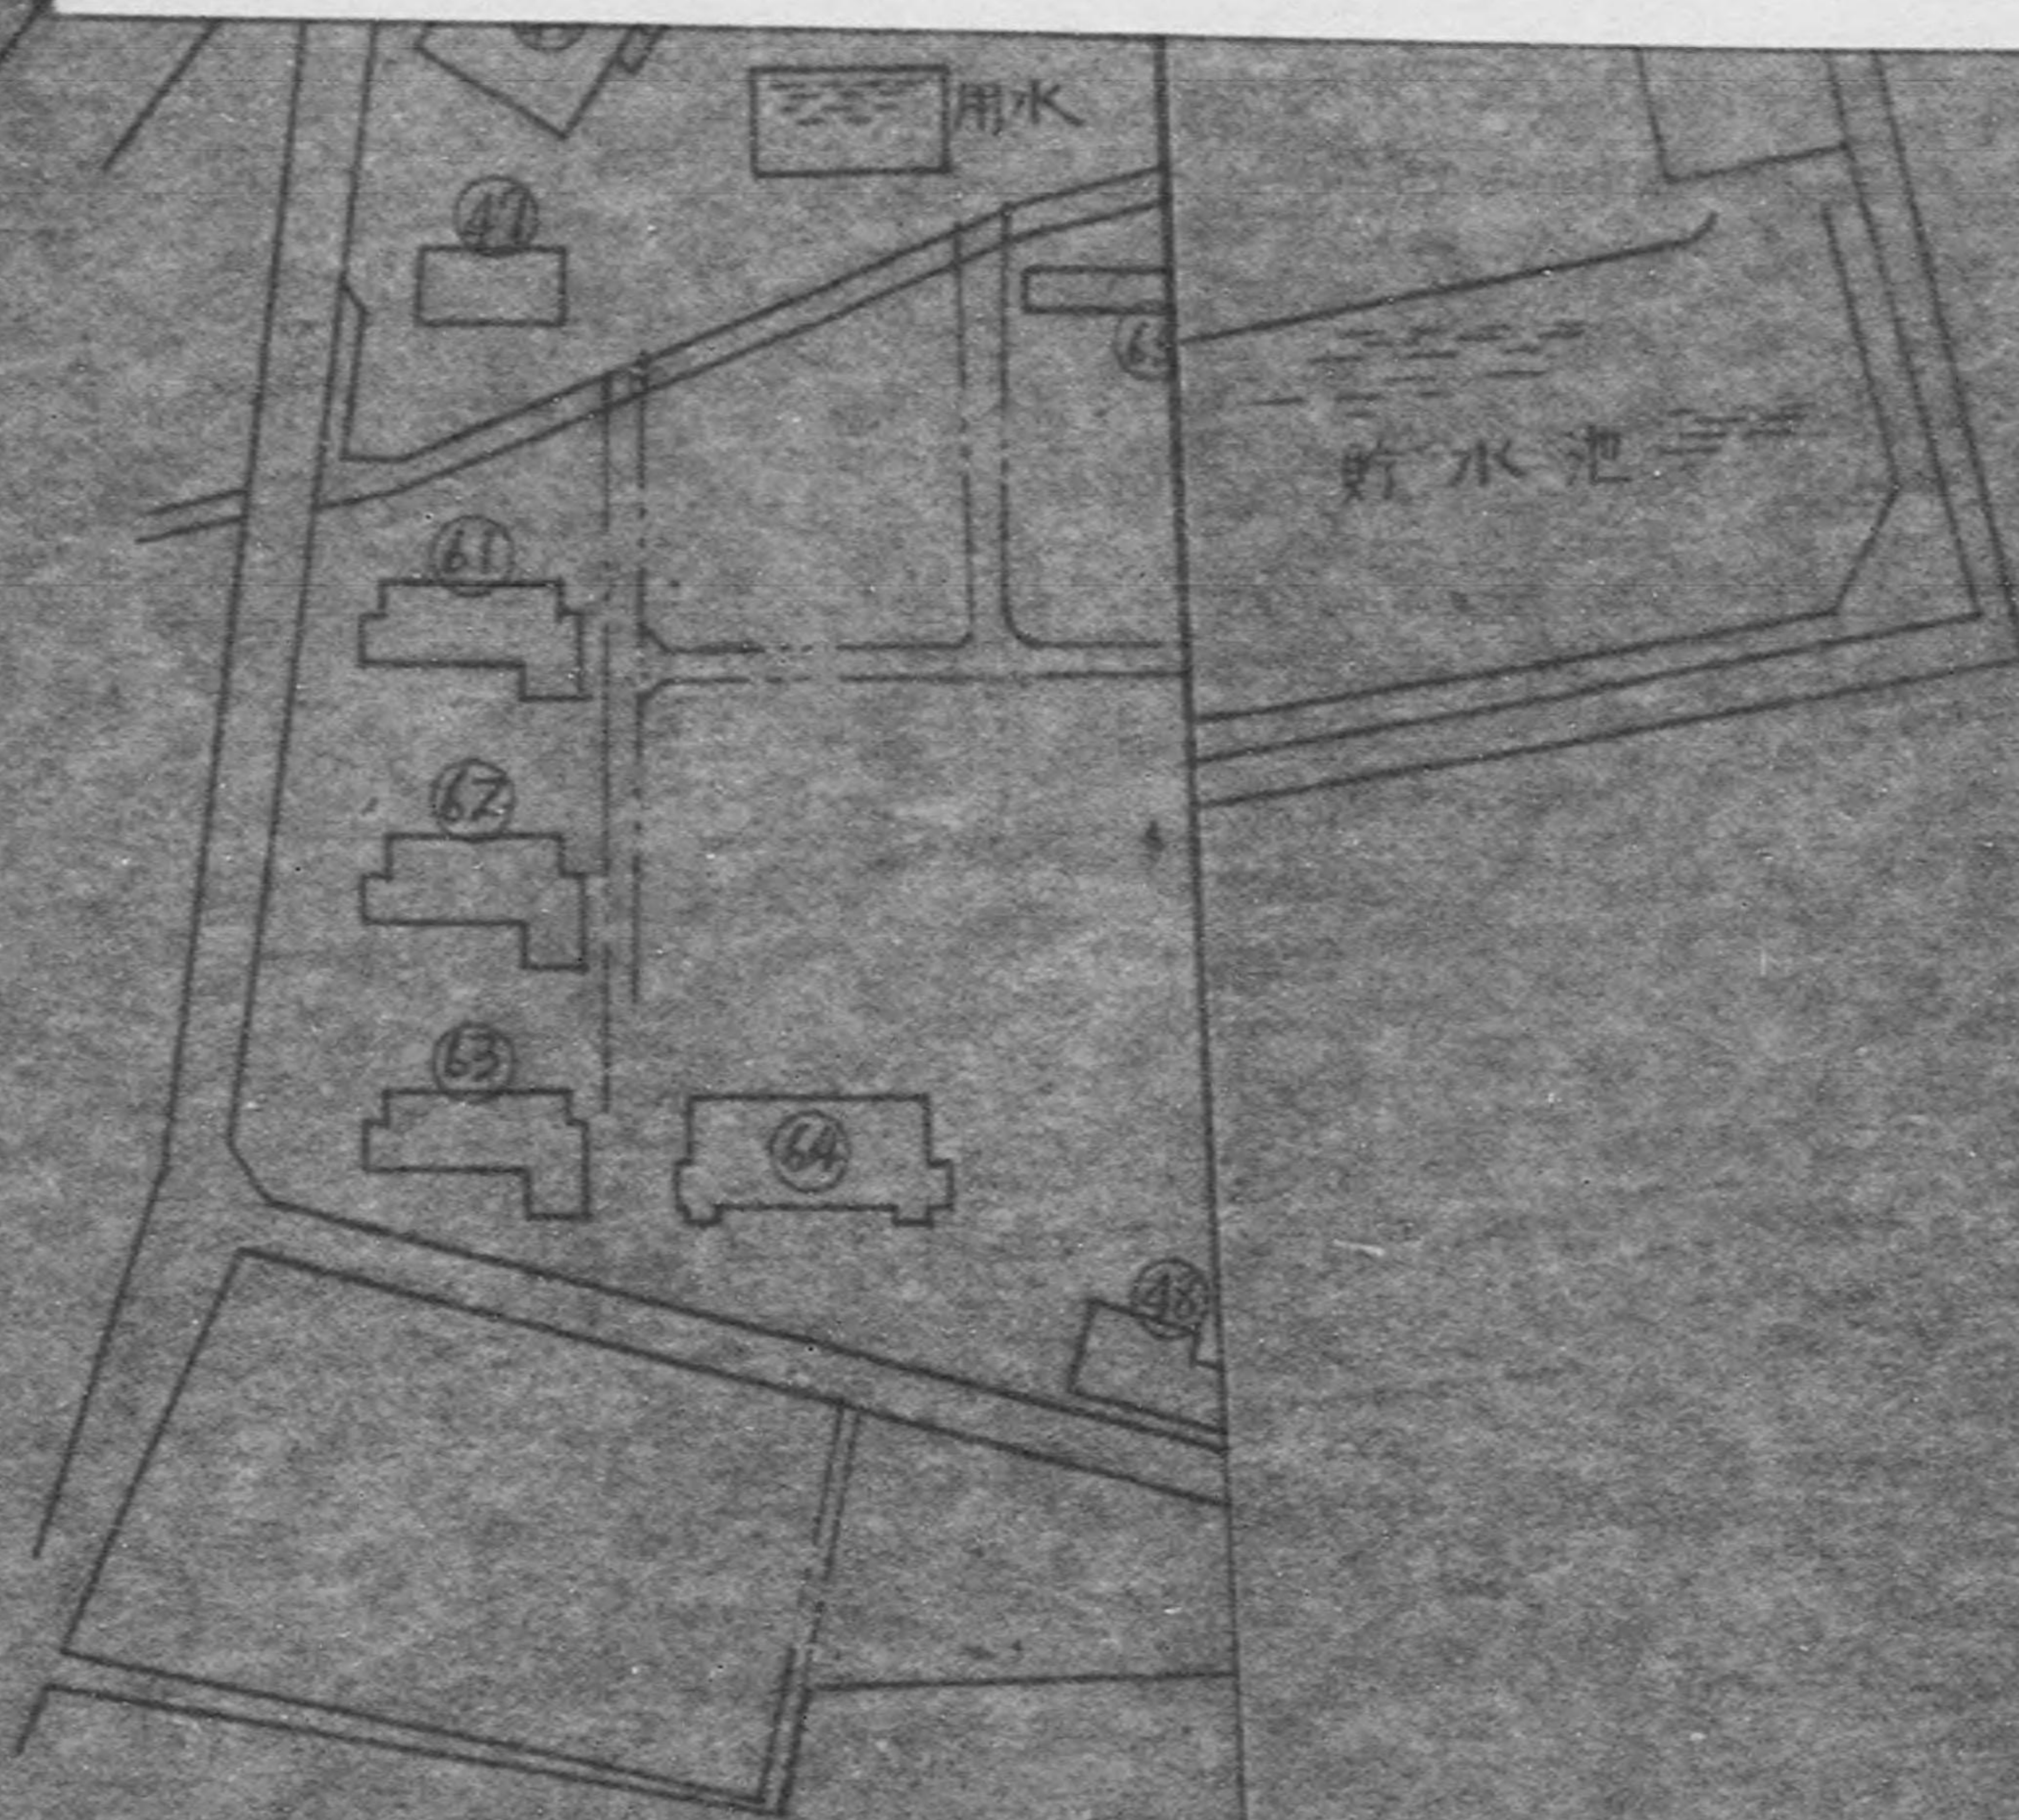
Code No. 34-56

About 10% machines are old and worn out.

8 wooden slate-roofed buildings.  
 Condition is good.

Size of plant area 2,500 tsubo.  
 Strong wooden inclosure.

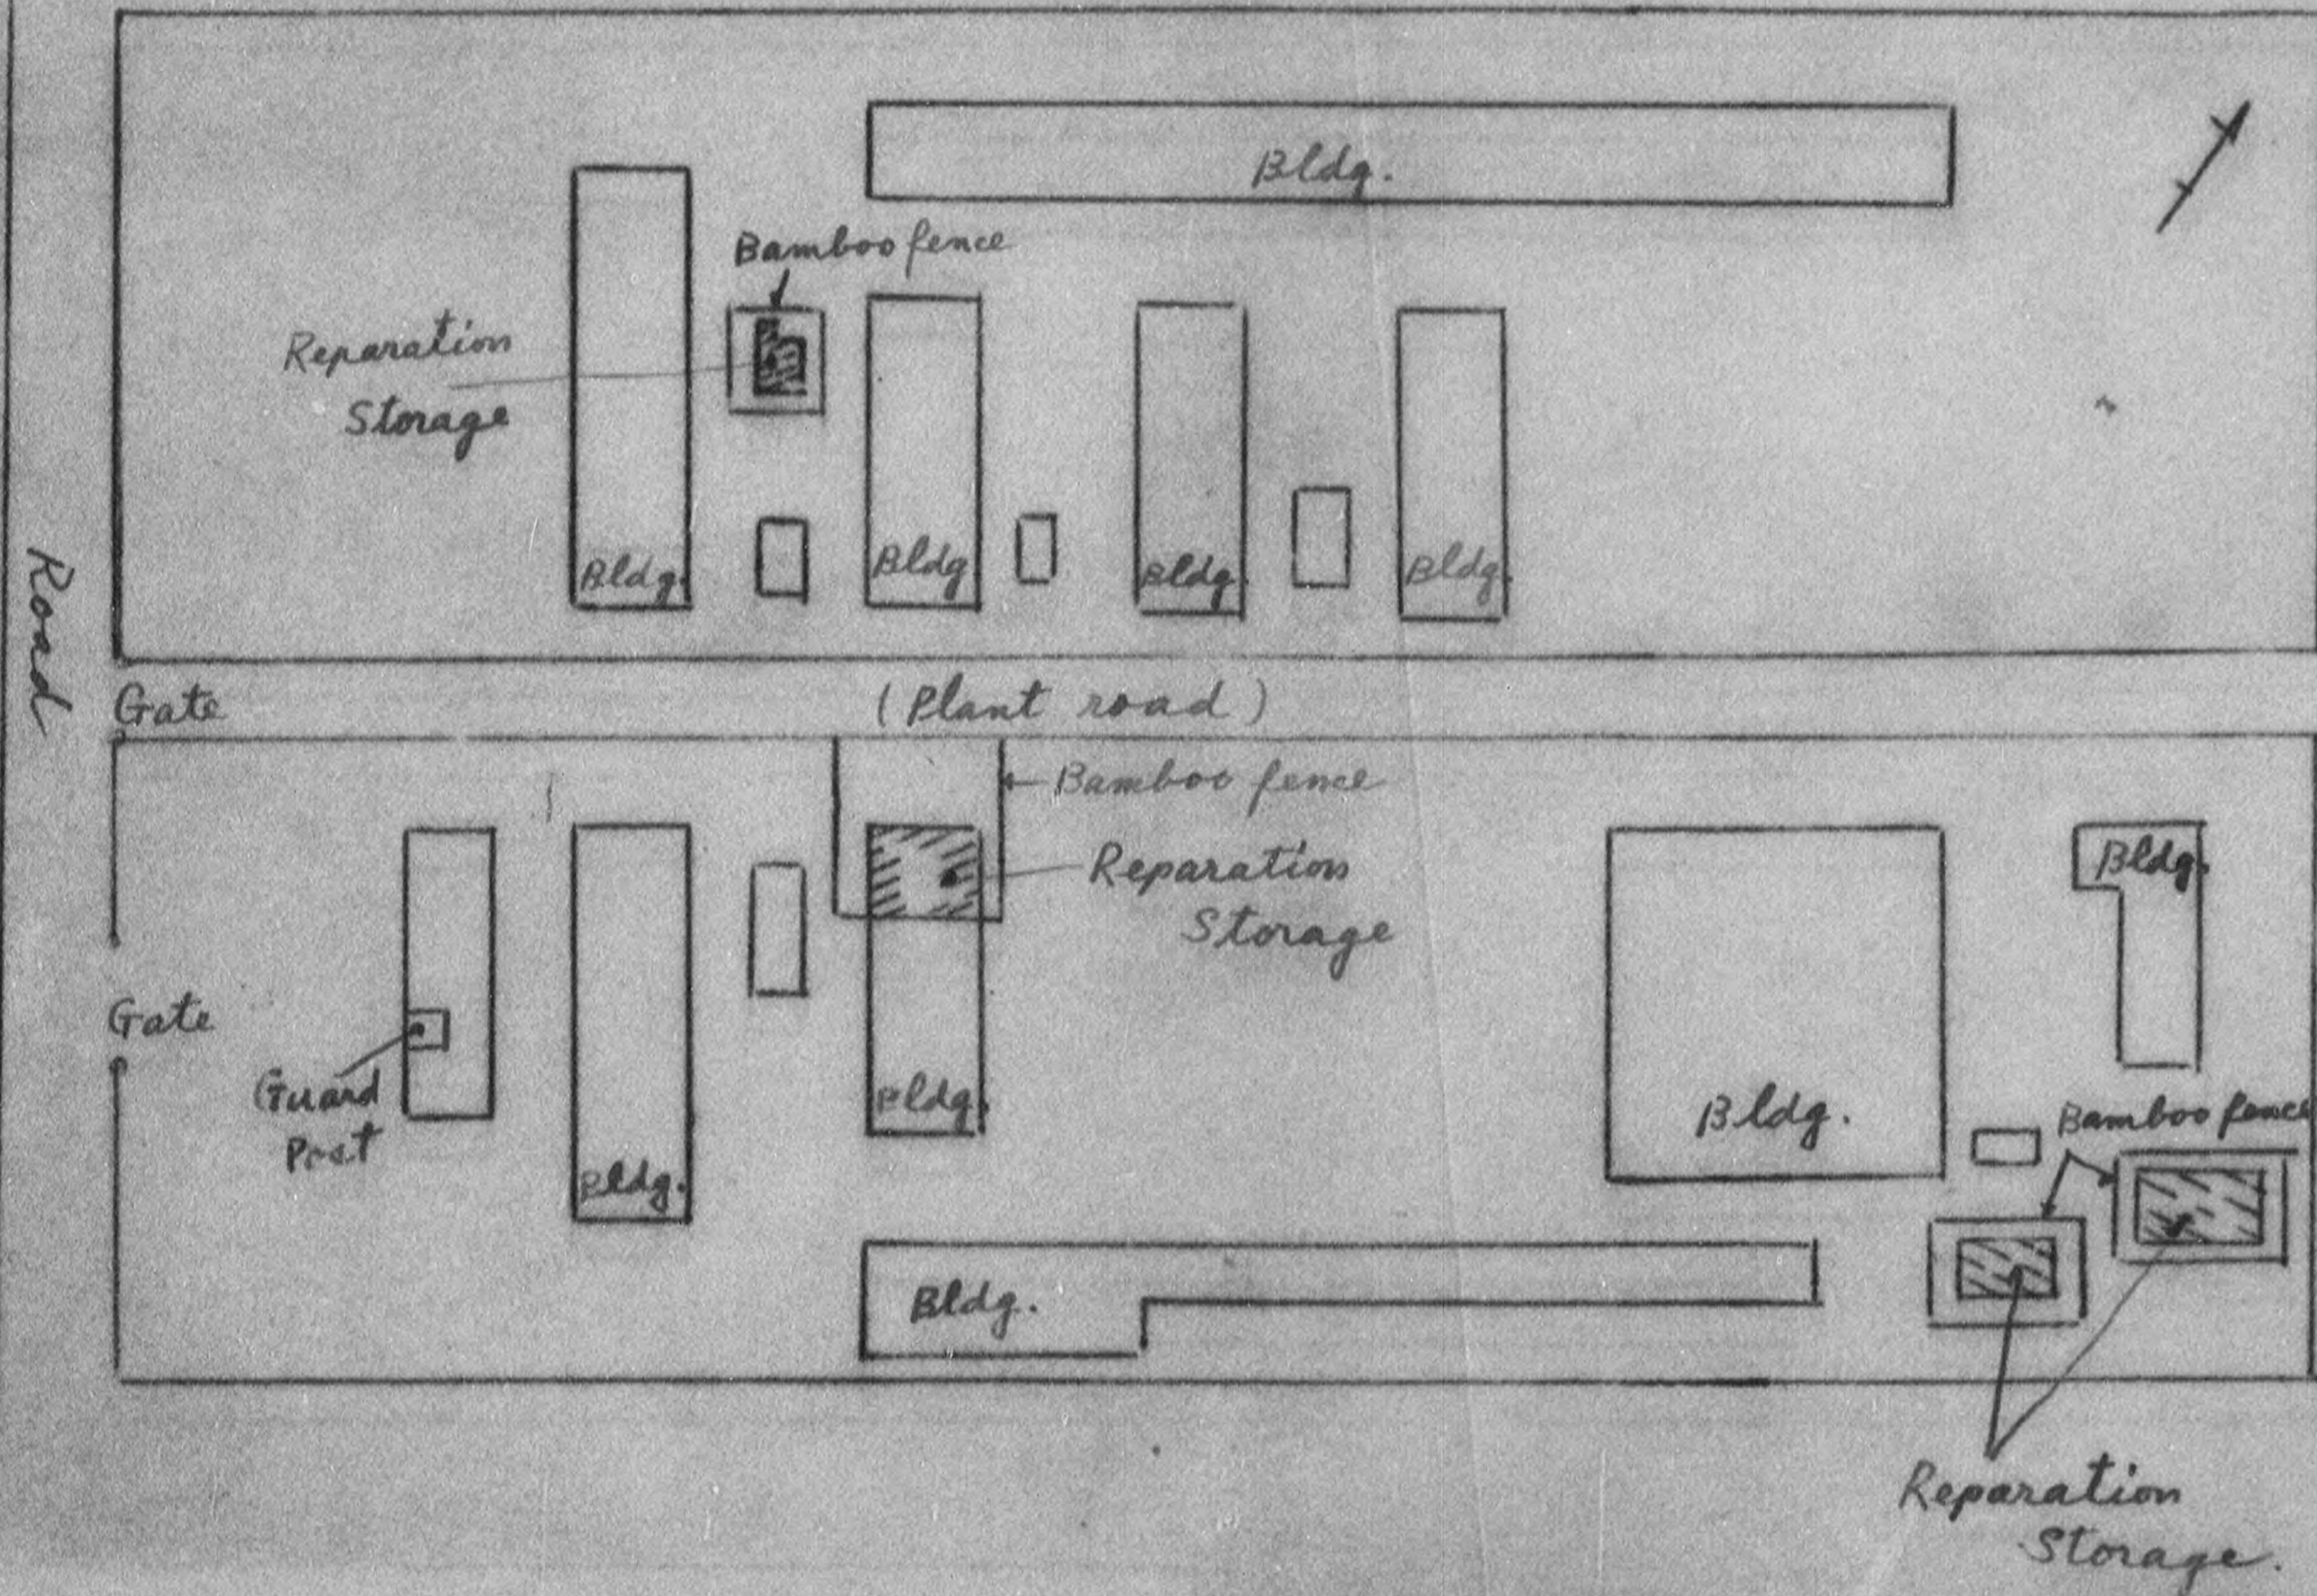
# Plant Layout

About 30% machines are old and worn out.

2 concrete buildings.  
2 wooden slate-roofed buildings.  
Condition is good.

Size of plant area 278 tsubo.  
Weak bamboo inclosure.
