# AIRCRAFT ACTION REPORT

REPORT No. **20**

- (a) Target(s) and Location(s) **Tokuno Shima A/F - Iansai Shoto** (b) Time Over Target(s) **0857** (Zone) **-10**  
(FOR SHIPS INCLUDE ALL IN AREA UNDER ATTACK)
- (c) Clouds Over Target **8/10 at 12,000 feet - unobstructed below that.**  
(BASE IN FEET, TYPE AND TENTHS OF COVER)
- (d) Visibility of Target **Clear** (e) Visibility **20 Miles**  
(CLEAR, HAZY, PARTIALLY OBSCURED BY CLOUDS, ETC.) (MILES)
- (f) Bombing Tactics: Type **Glide** Bomb Sight Used **Mark 8**  
(LEVEL, GLIDE OR DIVE) (TYPE)
- Bombs Dropped per Run **All 10 or 12** Spacing **Select** Altitude of Bomb Release **2500-3000**  
(NUMBER) (FEET) (FEET)
- (g) Number of Enemy Aircraft Hit on Ground: Destroyed **One** Probably Destroyed **None** Damaged **None**

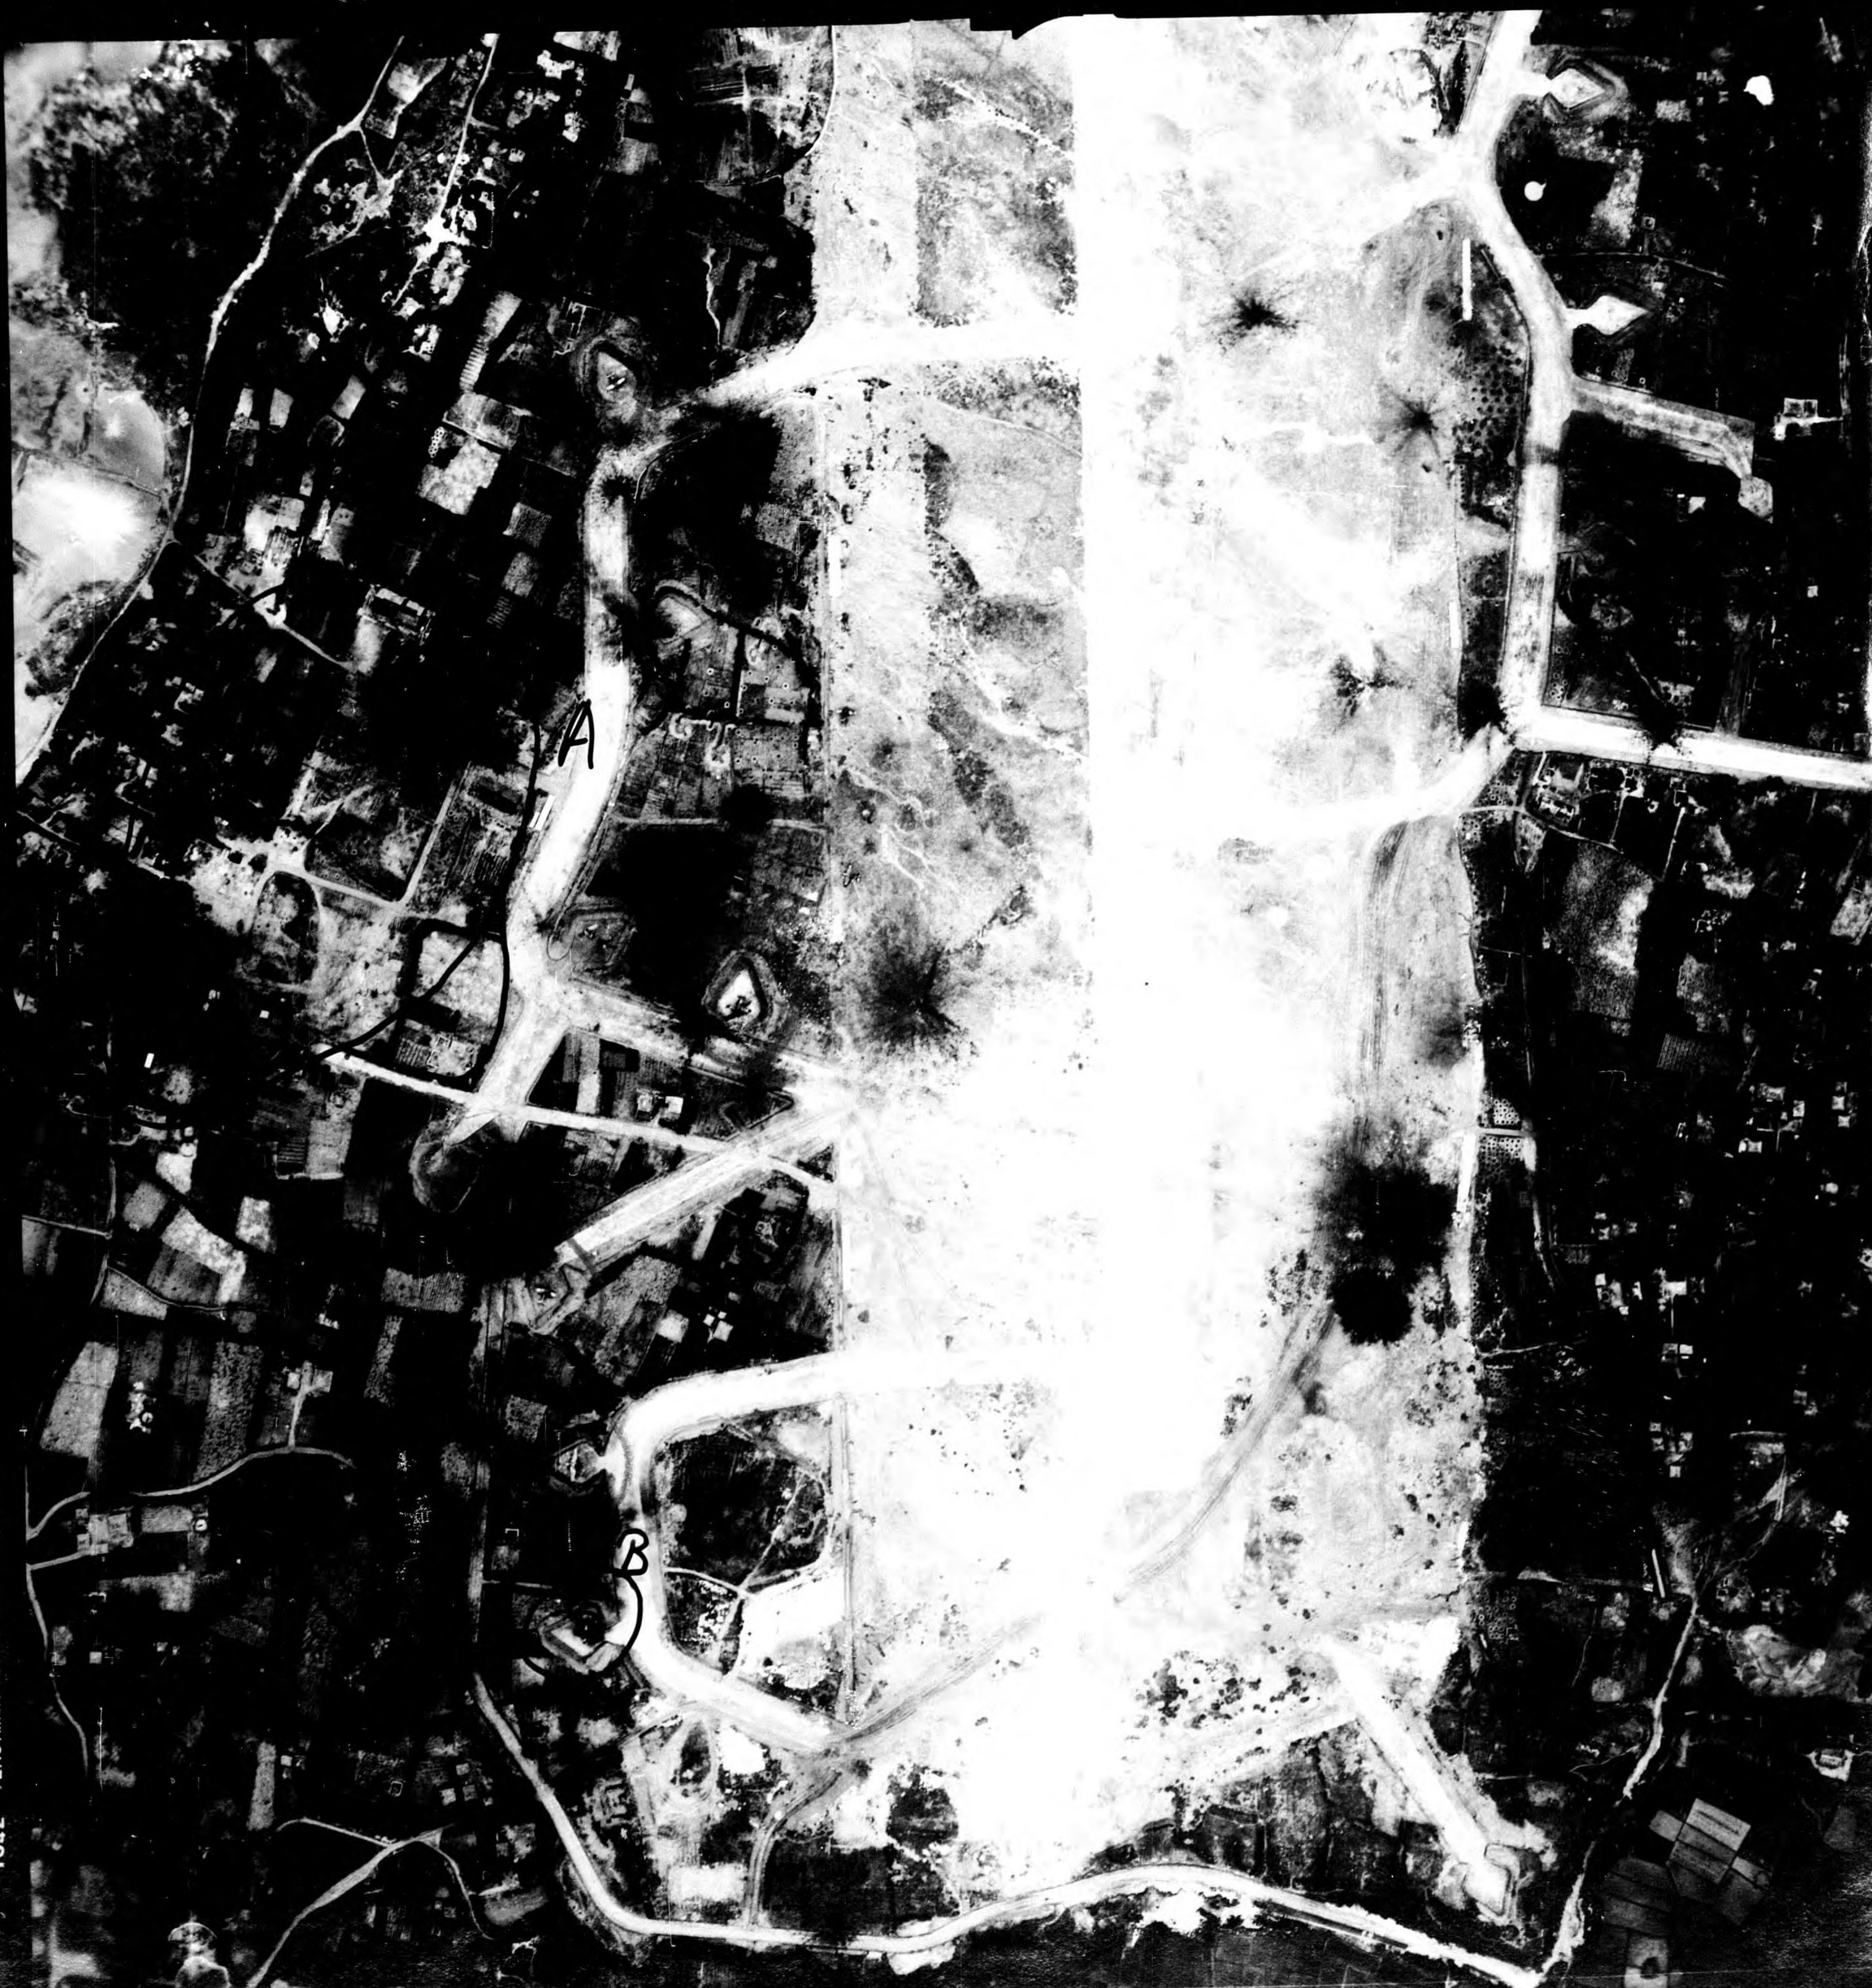
30 SAN JAC 55) (1, MAR 1945 0905-10) (K17 12" VERT 4000'-8000') (TOKUNO, AMAMI SHIMA, NANSEI SHOTTO) (CONF)

After these planes had delivered an accurate glide bombing attack on this particular area, the installations situated in it were almost all completely destroyed. The attached photograph shows the A/C repair portion of this area shortly after the attack as a barren waste with no buildings remaining and it shows at least three of the barracks buildings eliminated and the administration building is gone. Pilots and crewmen reported that the area appeared intact prior to the attack. Specific claim to destruction on this attack is limited to four 20' X 25' A/C Repair buildings, two barracks, one 32' X 65' and one smaller, and severe damage to another large barracks building because these results are confirmed by photographic interpretation of the attached photograph as having been achieved just prior to the taking of the picture. The other buildings which are missing may or may not have been removed previously. In any event, the area has been obliterated.

One of the pilots saw two enemy planes in revetments at the S.W. corner of the field as he went in on his run on the Repair area. He dropped four 100# G.P. bombs select on these revetments and obtained one direct hit in a revetment occupied by a Jap S/E fighter. See area encircled and marked "B" on attached photograph. This plane is claimed as destroyed.

Lieutenants Piegari, Osborne, Van Hoven and Bertoglio, Lieutenant (j.g.) Laughlin and Ensigns Dysert, Sharp, Robertson and Jefson participated in this strike against the airfield on Tokuno Shima, an island about 12 miles south of Amami O Shima in the Nansei Shoto. The object of the strike was to bomb any concentrations of enemy aircraft which might be found on the field or, in the absence of any such target, to bomb the aircraft repair and parts area to the west of the field, which was considered the most important installations area adjacent to the field. The planes arrived at the island, which is about 16 miles long and 10 miles wide, and quickly located the airfield on the northwestern shore. As an examination of the field showed only 5 badly wrecked planes on the field, the Repair area became the target. The planes commenced their run from 6,000 feet and made a 30 to 35 degree glide angle attack during which they attained an average speed of 280 knots. Some light anti-aircraft was observed firing at them from the south end of the field but it was not in great volume and the planes pressed in their attack to 2,500 to 3,000 feet before dropping. Bombs were dropped select and were dropped in quite rapid succession in order to blanket the specific target area. Very few bomb bursts were observed short of the specific target area and none were observed beyond it. The whole Repair area seemed to explode in the faces of the last pilots in as the entire bomb load of most of the preceding planes hit the target area. The bombing was above the average in accuracy and it is estimated that 86 100# G.P. bombs exploded within this area, which measured only 750 feet by 500 feet, within the space of a few seconds. On their run in, the pilots had observed the various buildings in the area located practically the same as the photographs from CinePac-CineFoa Bulletin No. 163-44 had indicated they would be and no pilot had any difficulty in locating the area for this reason. No pilot could report exactly what damage he had done because of the smoke and dust from the concentrated explosions over the target area as the torpedo planes withdrew. The attached photograph, which was taken by a VF-45 photo plane shortly afterwards, however, demonstrates graphically the destruction which this strike had wrought. The specific area attacked is encircled on the photograph and marked "A".

Ensign Sharp dropped four of his bombs select on revetted planes just south of the aircraft repair area. One of these bombs hit within a revetment occupied by a single engine Jap fighter plane and the destruction of the plane is claimed. This hit is encircled on the photograph and marked "B".
