The Front Range Pine Type

A 40-Year Photographic Record of Plant Recovery on an Abused Watershed

Howard L. Gary and Pat O. Currie

USDA Forest Service
General Technical Report RM-46
November 1977

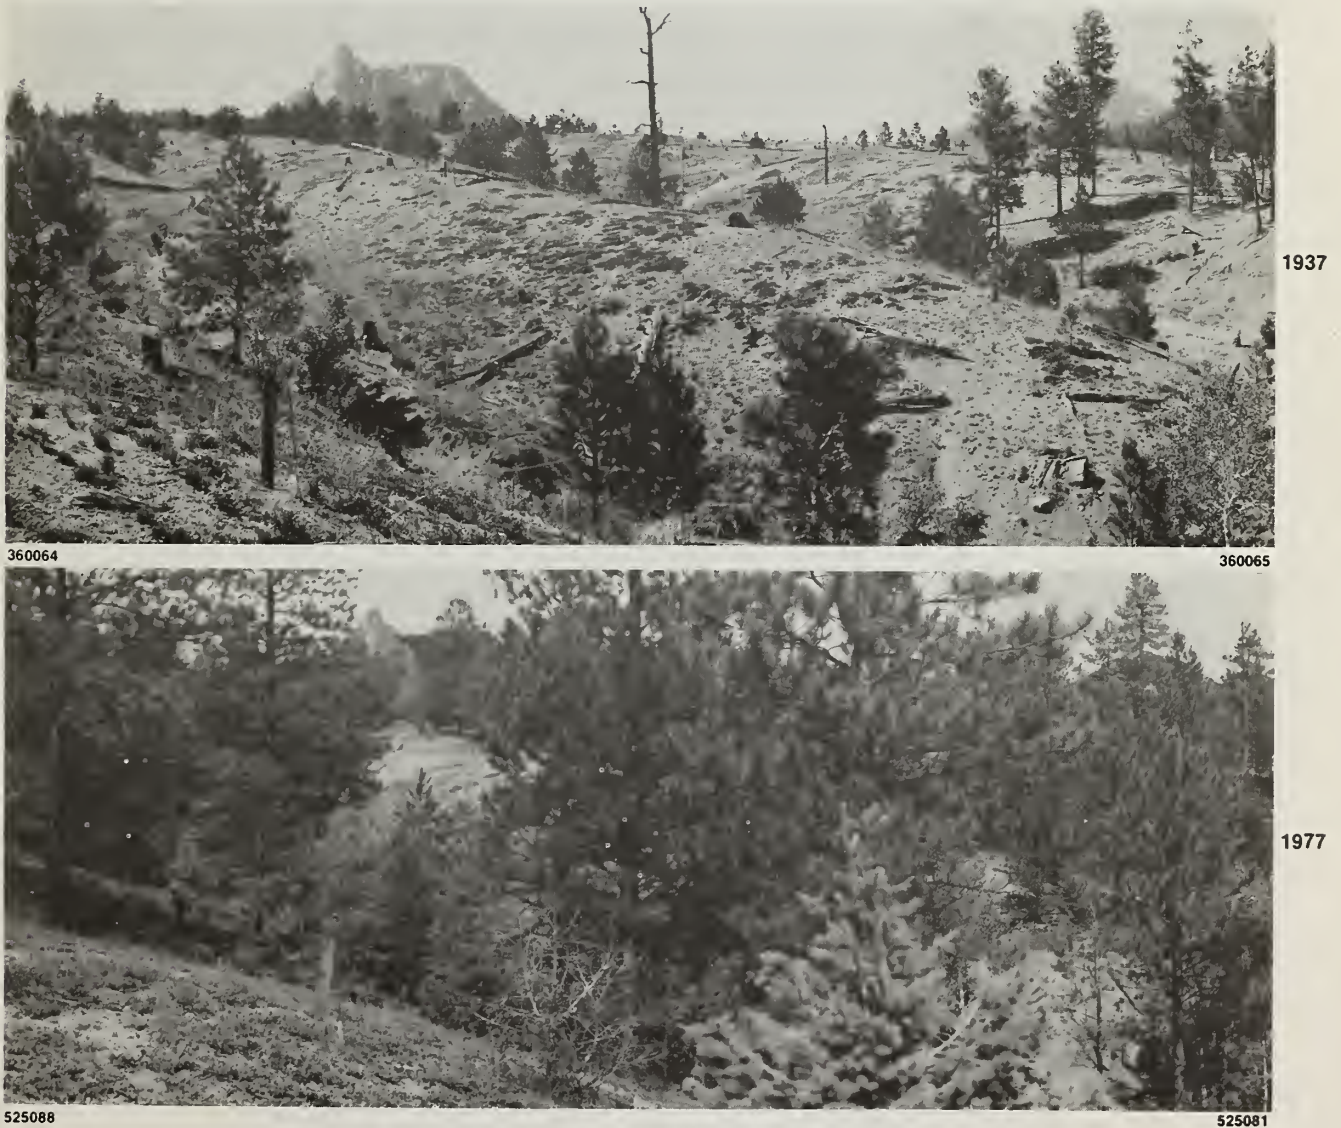
Figure 3.—Panoramic view from camera point No. 9. Sheep Nose is in the left background.

After 40 years of recovery and soil stabilization, a panoramic view of the central portion of the Trail Creek watershed as it appeared in 1937 and 1977 is best illustrated from camera point 9 west and northwest (fig. 3). Most of the stumps visible in the 1937 photographs were fire scarred. Their spacing

indicates the original pine forest was rather open. Topography is typical of the entire watershed and shows the easy accessibility for early logging and downhill skidding using teams of horses. Ground cover in 1937 was mainly bearberry, mountain muhly, and blue grama. The tree cover in 1977 masks the topography but shows the land has capacity for natural regeneration and low grade timber growth, if given sufficient time. A high density mat of bearberry dominates the lower left foreground of the 1977 photos and shows local stabilization of the site.

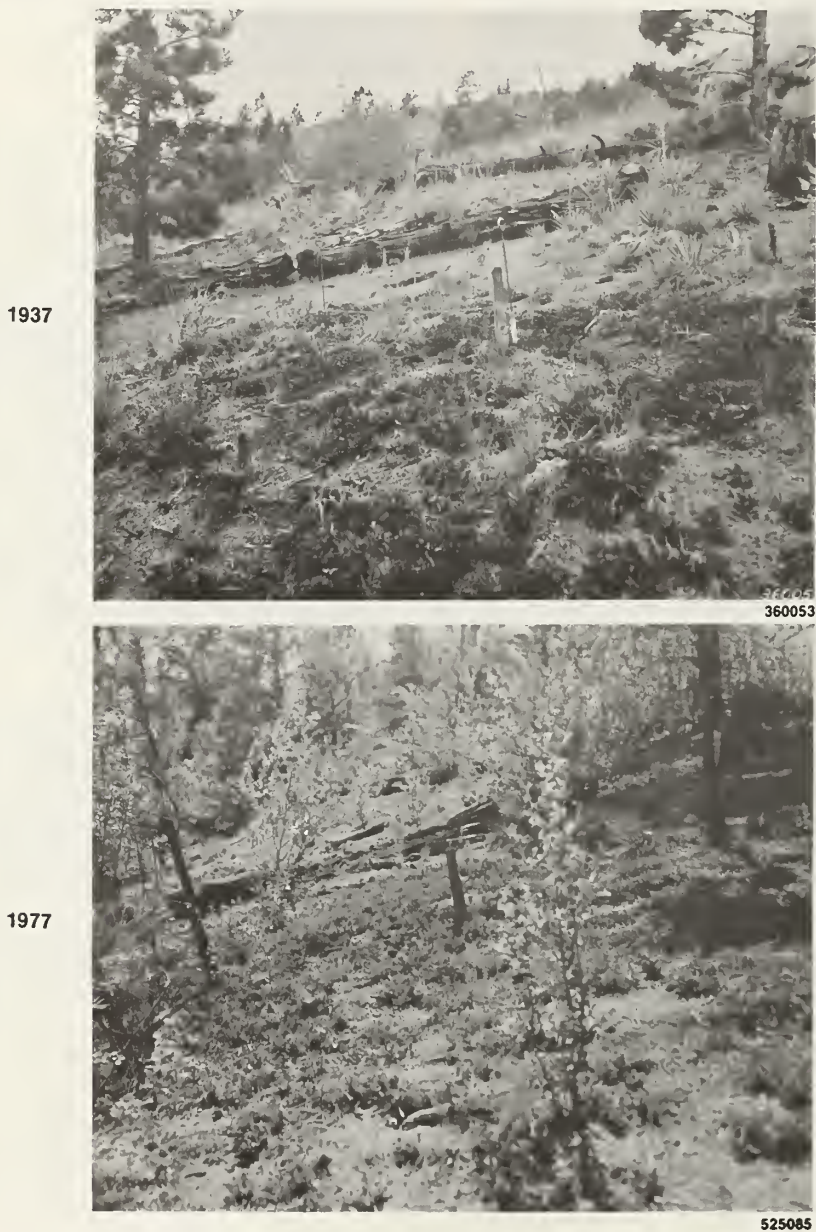
Figure 4.—Bearberry cover at camera point No. 38.

Widely scattered mats of bearberry were present in most of the early photographs, and most mats

were still present and had expanded by 1977 (camera point 38, fig. 4). Bearberry appears to be a long-lived plant when left undisturbed, is tolerant of partial shade, and provides good local soil stabilization. True mountainmahogany, a desirable browse plant, is also now plentiful in the same area. Yucca and some of the grasses appear to have decreased because of partial shade provided by the surrounding trees.

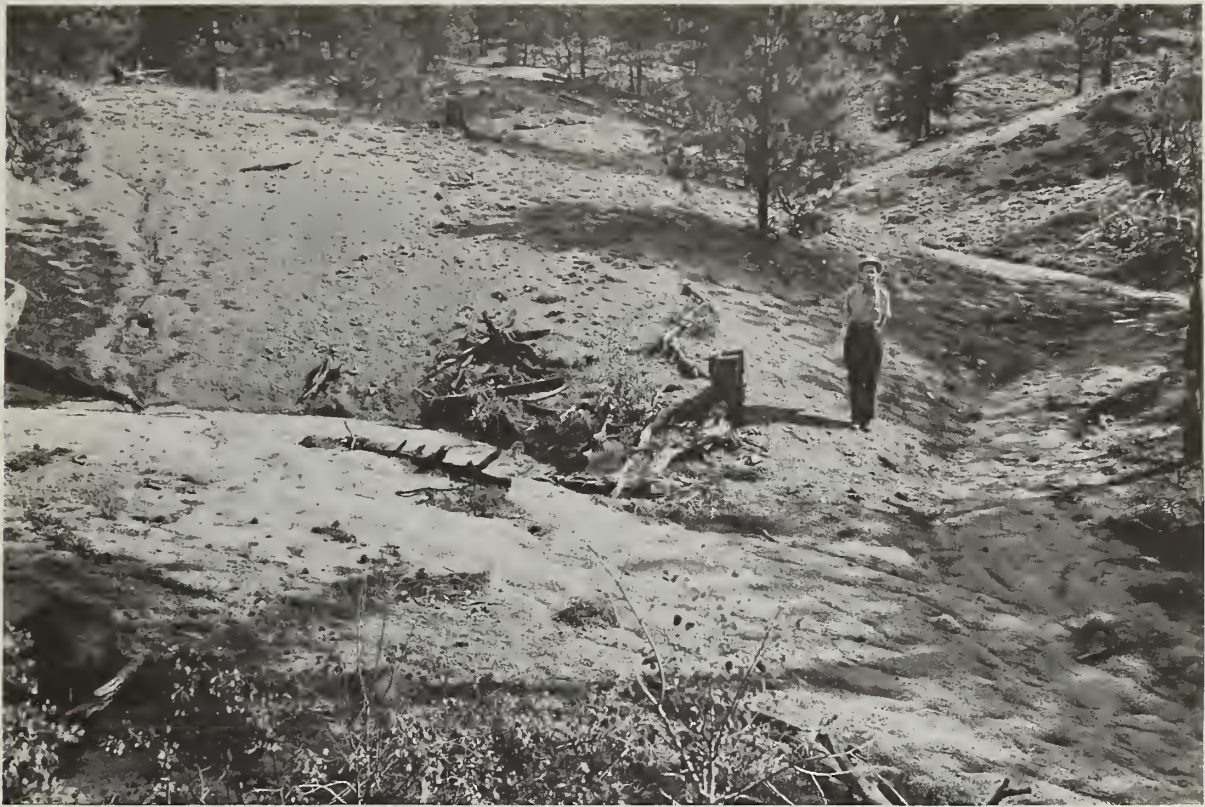
Figure 5.—Confluence of two drainages at camera point No. 2.

It is of interest to note that areas of bare ground visible in 1937 were generally bare in 1977 (camera point 2, fig. 5). The lack of cover attests to the harshness and shallow soils of many sites which

inhibit natural plant establishment. Also, as shown in camera point 7 west (fig. 6), the steep bare slopes which today one might expect to have eroded because of lack of vegetation have changed little in 40 years. Close examination reveals that some sheet erosion has occurred, but the steep slope has not

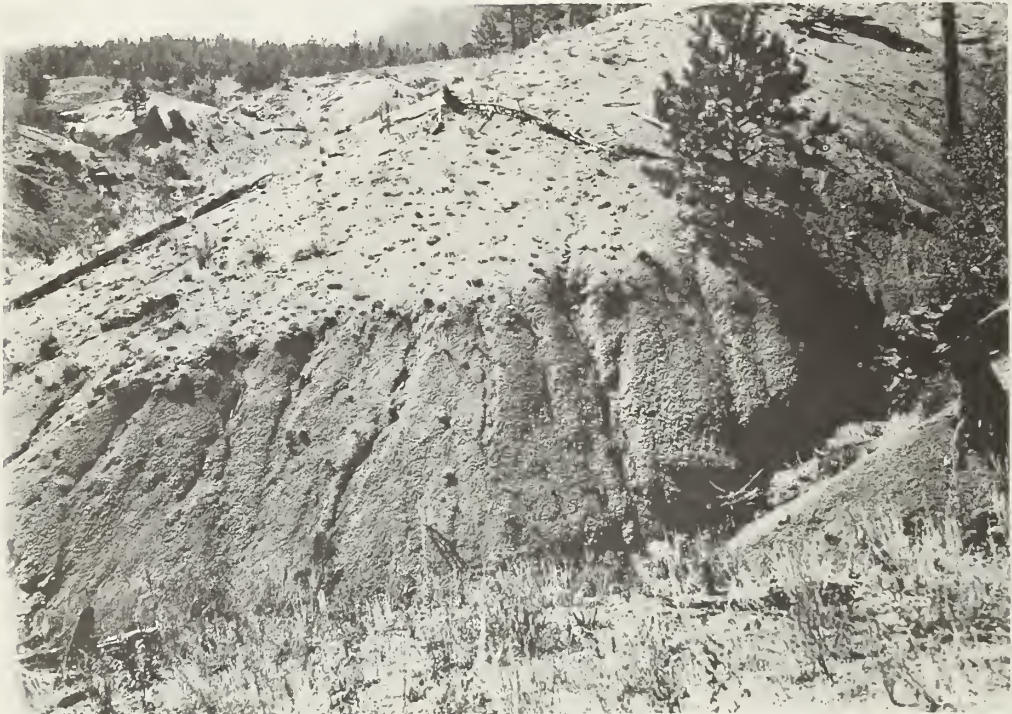
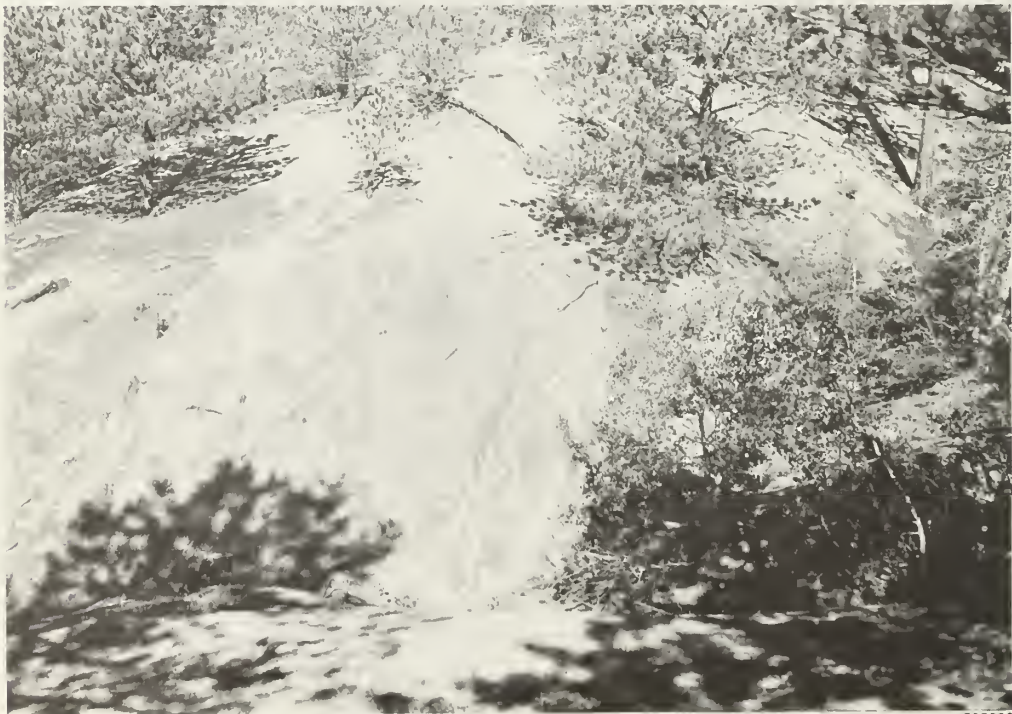
Figure 6.—Steep slope west of camera point No. 7.

been deeply incised with new gullies. The steep slope was somewhat more rounded in 1977 but appears relatively stable for the average local climate. It appears that regeneration of trees and resultant needle drop have helped stabilize the topography.

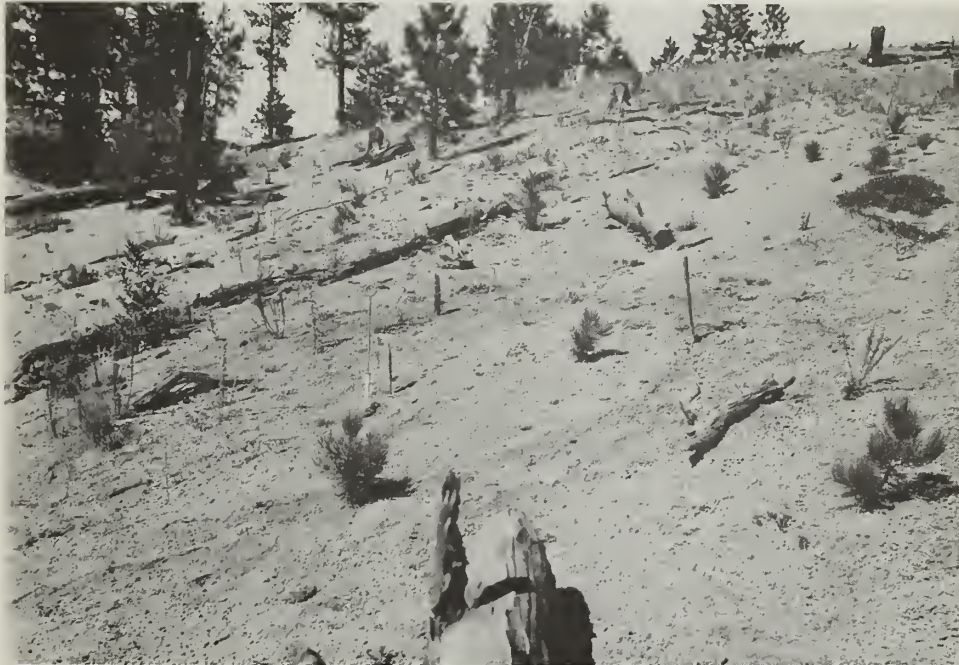
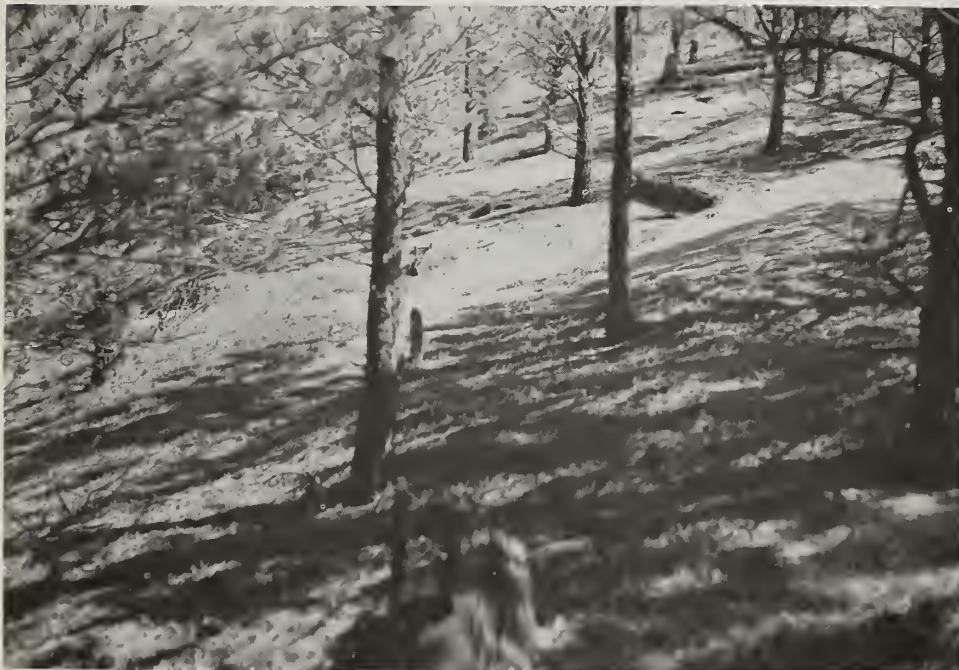
Figure 7.—Reforested south facing slope at camera point No. 7.

In the same area, at camera point 7 north (fig. 7) tree growth was also slow on the bare south facing slope planted to ponderosa pine. Estimated tree heights averaged 4.2 m (13.8 feet), and measured diameters averaged 11.7 cm (4.6 inches). This slow growth appears to be a reflection of the harsh dry microclimate of south slopes. This harshness also limits understory plant growth, and little vegetation was present in 1977. A protective cover of pine

needles was forming, however, and in time will add further protection to the site. All photos at camera point 7 (figs. 6 and 7) illustrate that without disturbance these areas are rather stable even though vegetation recovery is slow. Based on the 40-year time span, the amount of cover vegetation or dead organic matter, will be limited for many more decades and will be critical to the preservation of the soil resource.

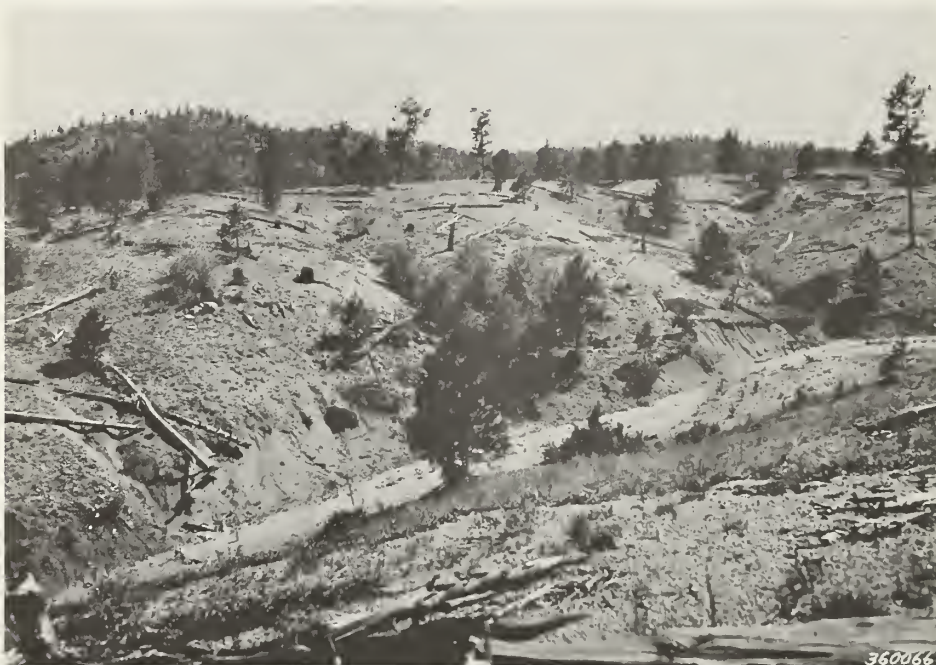
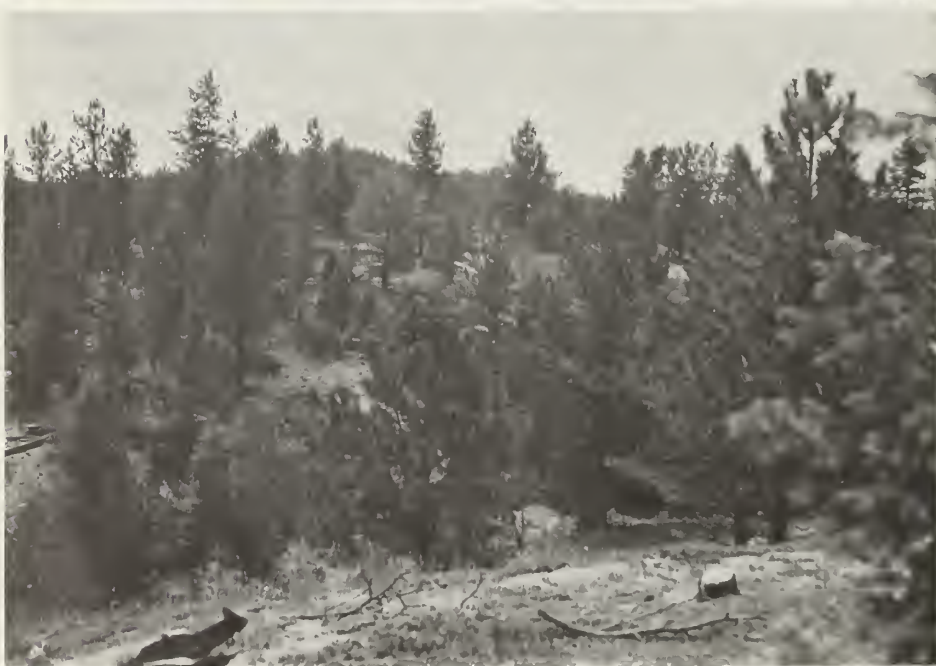
Figure 8.—View south of camera point No. 9.

Examples of artificial and natural reforestation on two north facing slopes near the center of the watershed are shown in camera points 9 south and 13 south (figs. 8 and 9). The site shown in figure 8 was planted to ponderosa pine in the early 1930's, and growth of the surviving trees was rated good for the site. The understory vegetation consisted mainly of bearberry and mountain muhly which changed little in 40 years. The apparently more moist site shown in figure 9 was not planted to

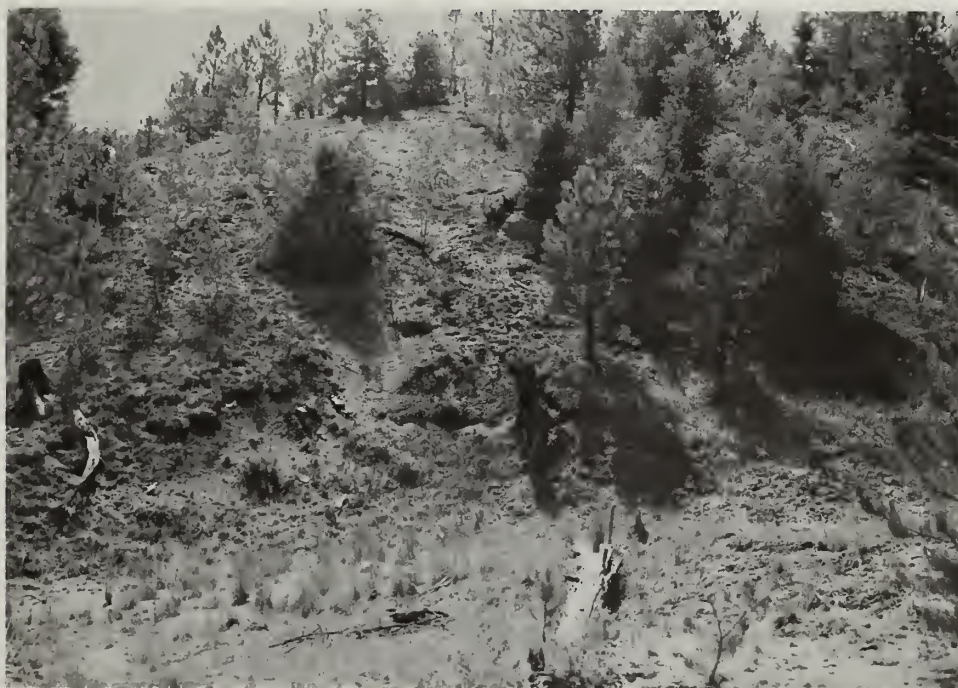
Figure 9.—North facing slope at camera point No. 13.

trees. It may have been thought adequately stocked and that aspen would dominate and stabilize the site, or that protection from grazing alone would allow reforestation to occur. At any rate, the stage of natural reforestation with conifers on this site appears many years younger than that observed on the planted site shown in figure 8. In time, the Douglas-fir also present on the site shown in figure 9 will outgrow any trees now on the planted site.

Minor soil sloughing is still occurring near the toe of the slope shown in figure 9, but the bankside present 40 years ago appears to be stabilizing. Based on comparison of the two sites shown in figures 8 and 9, it is clear that early successful tree planting on depleted sites will result in earlier watershed stabilization and earlier recovery of wood production. Apparently because of higher

soil moisture for the site shown in figure 9, there was a greater diversity of ground cover than at any other photo station. The principal plants were mountain muhly, little bluestem, blue grama, prairie junegrass, *Stipa* spp., *Bromus* spp., Kentucky bluegrass, *Carex* spp., fringed sagebrush, and other *Artemisia* spp.

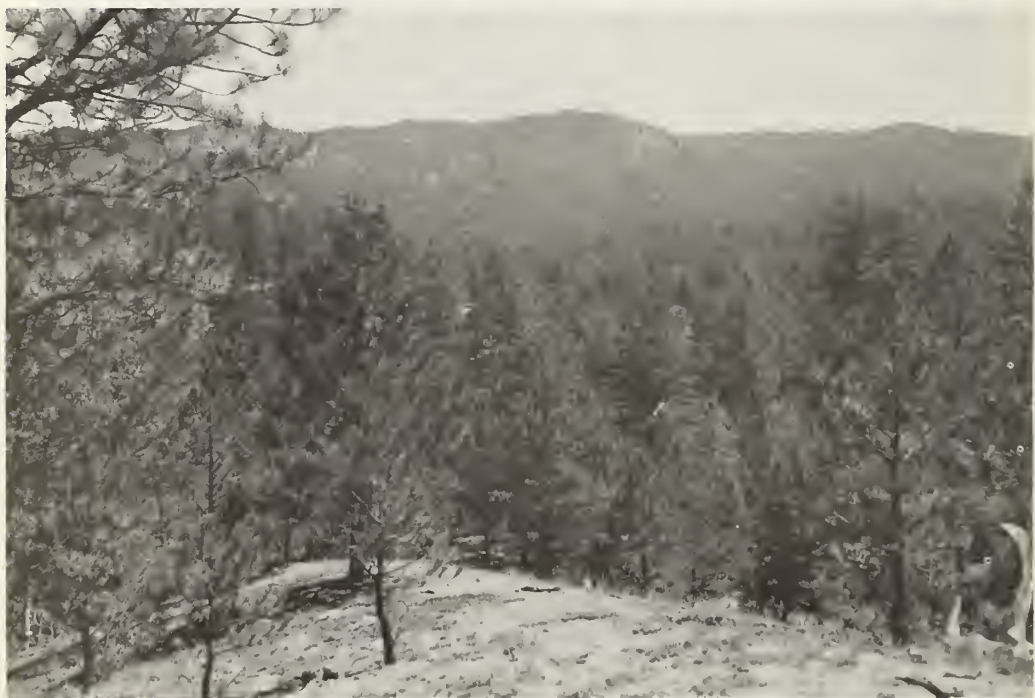
Figure 10.—View east of camera point No. 9.

The eastern boundary of the Trail Creek watershed was visible from camera point 9 east (fig. 10). The mountain range on the skyline was not heavily logged during the late 1800's because of low quality trees and steep terrain. The foreground area was successfully planted to ponderosa pine in the early 1930's. As observed in most other areas of the

watershed, ground cover has changed little as a result of protection from grazing. In the immediate foreground of figure 10, it appears that density of blue grama and *Yucca* spp. has increased slightly and that bearberry has declined. Observations on the ground substantiate this photographic impression.

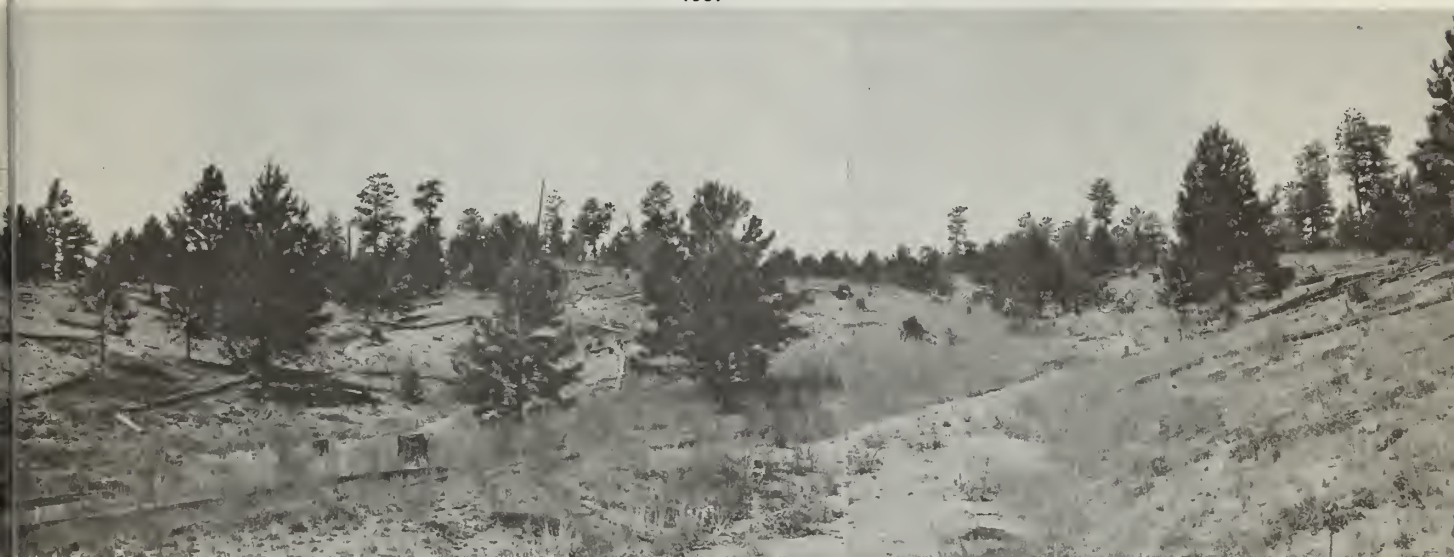
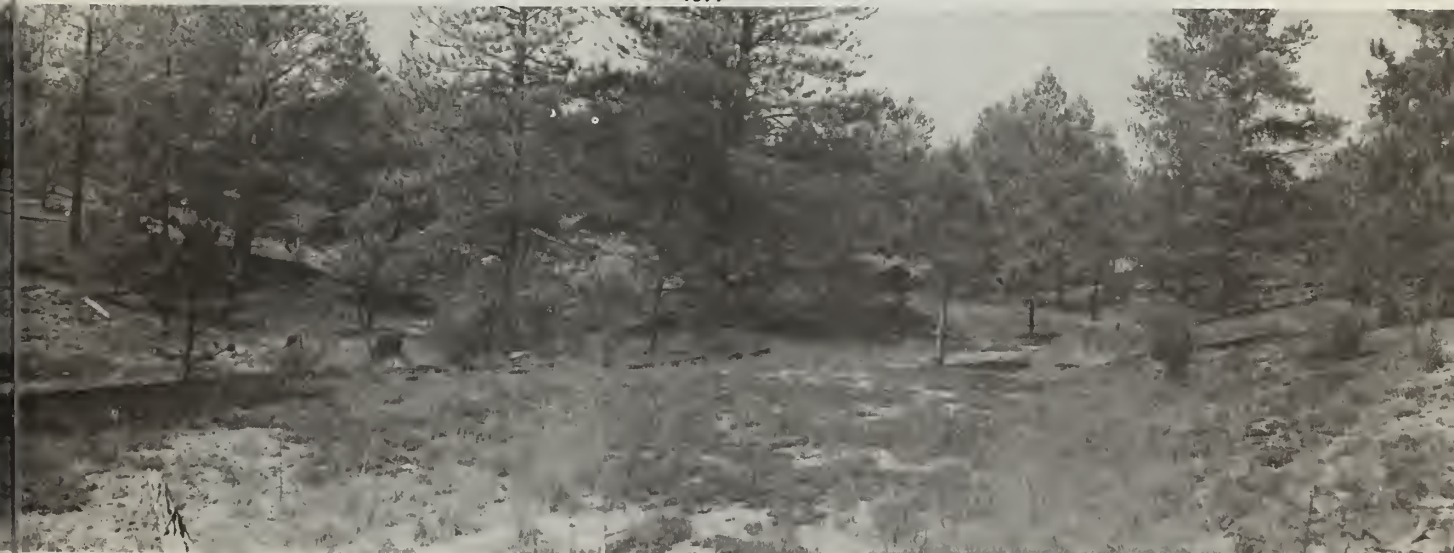
Figure 11.—Panoramic view west from camera point No. 18.

A panoramic view of plant community change in an open ponderosa pine stand is illustrated by the west-southwest views from camera point 18 (fig. 11). The density of the herbaceous ground cover shown in the foreground increased substantially in the drainage bottom, but only slightly on the slopes after 40 years of protection. The watercourse seems to have stabilized with the increased vegetation. The main grasses today are little bluestem, blue grama and mountain muhly. Bearberry density

appears to have increased more than the density of the palatable grasses listed above. True mountainmahogany plants are in greater abundance today than in 1937. Some specific plants are in the same locations, suggesting long-lived plants and some capability to recover from severe overbrowsing. The new trees present in figure 11 in 1977 were the result of natural regeneration, and, in time, true mountainmahogany and ponderosa pine will likely occupy the grassy foreground.

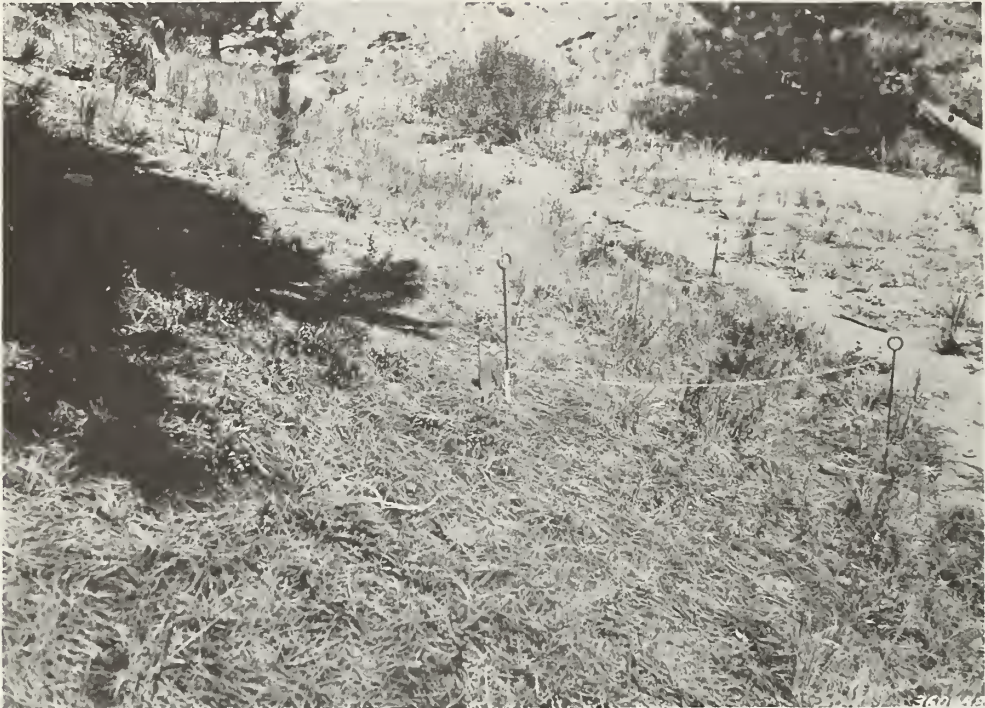
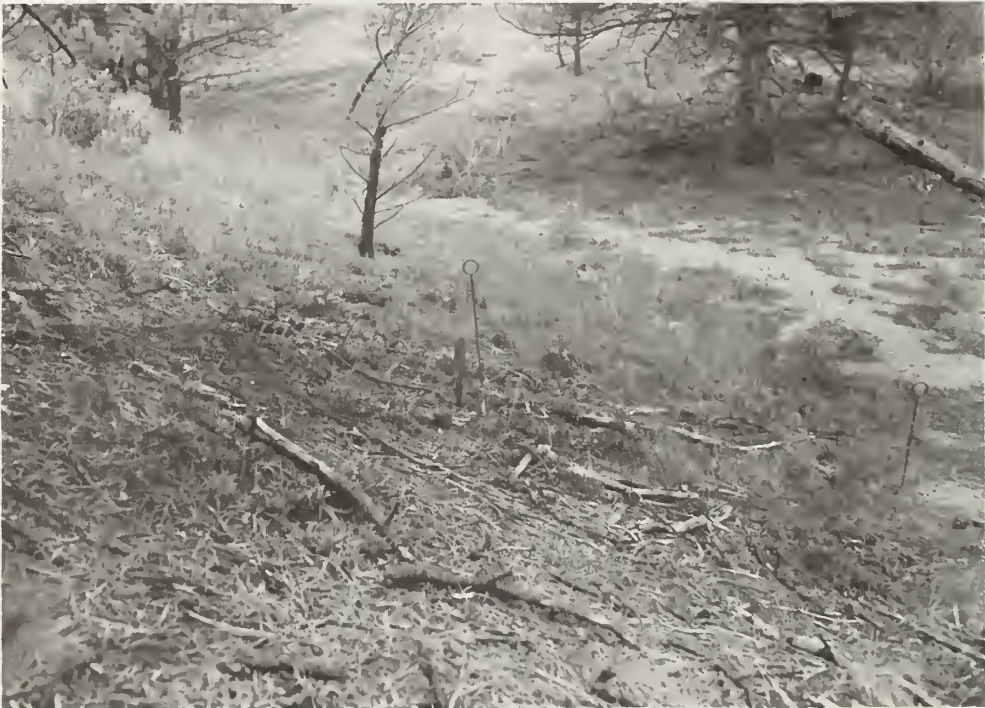
Figure 12.—Litter mat under ponderosa pine at camera point No. 25.

itself for some period beyond the life of the trees. An example of a heavy litter cover was present at camera point 25 (fig. 12) where encroachment by herbaceous vegetation has changed little in 40 years. The small draw also shows little evidence of sedimentation or erosion.

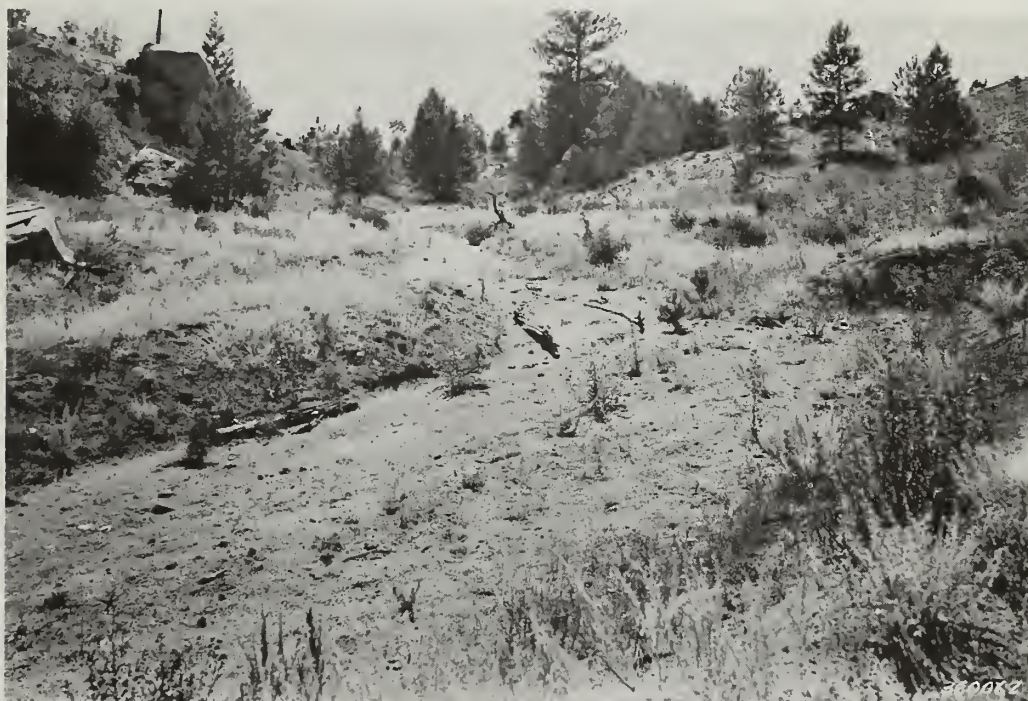
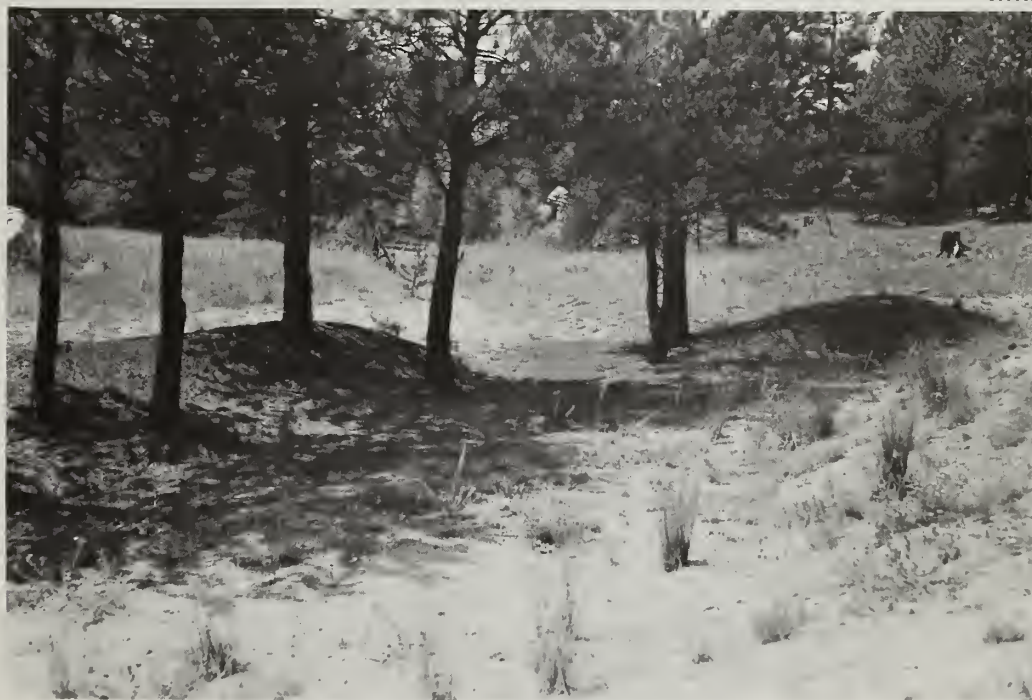
Figure 13.—Drainage west of camera point No. 13.

No widespread accelerated erosion was found in any of the arroyos within the watershed. At camera point 13 west (fig. 13), the photograph for 1937 shows a definite channel and general evidence that water periodically flowed down the channel. The channel is well defined today, but there was no apparent evidence of recent water flows. The lack of

any recent flows may simply reflect storm size and frequency of occurrence. The lack of erosion may also reflect recent stability of the site. The average diameter of trees in the foreground is 20.6 cm (8.1 inches) and estimated average height is 6.6 m (21.5 feet).

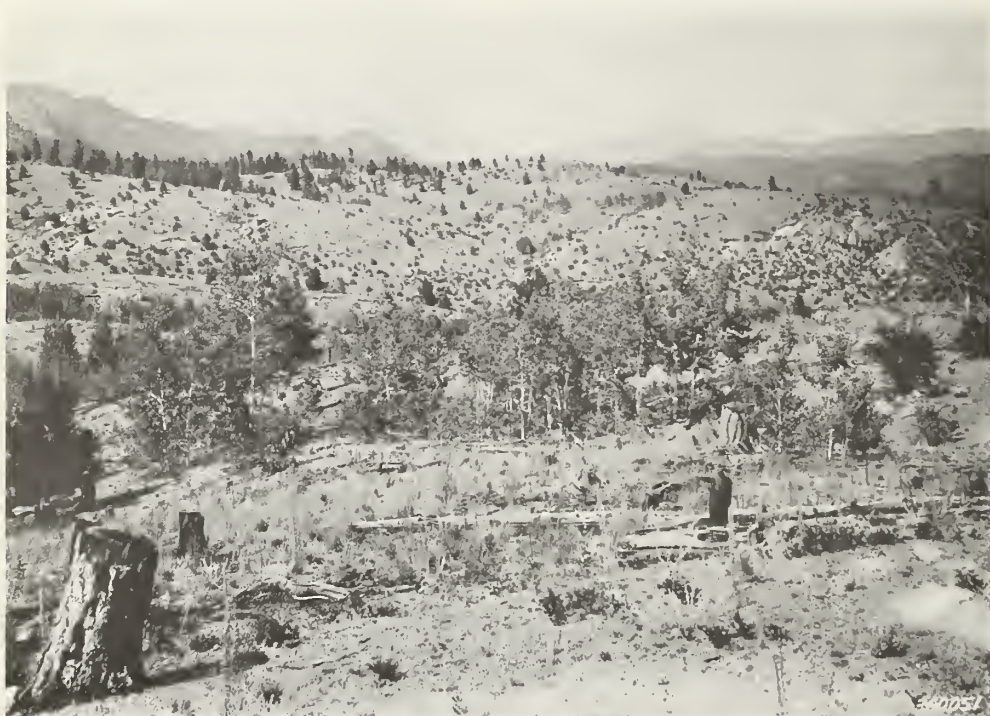
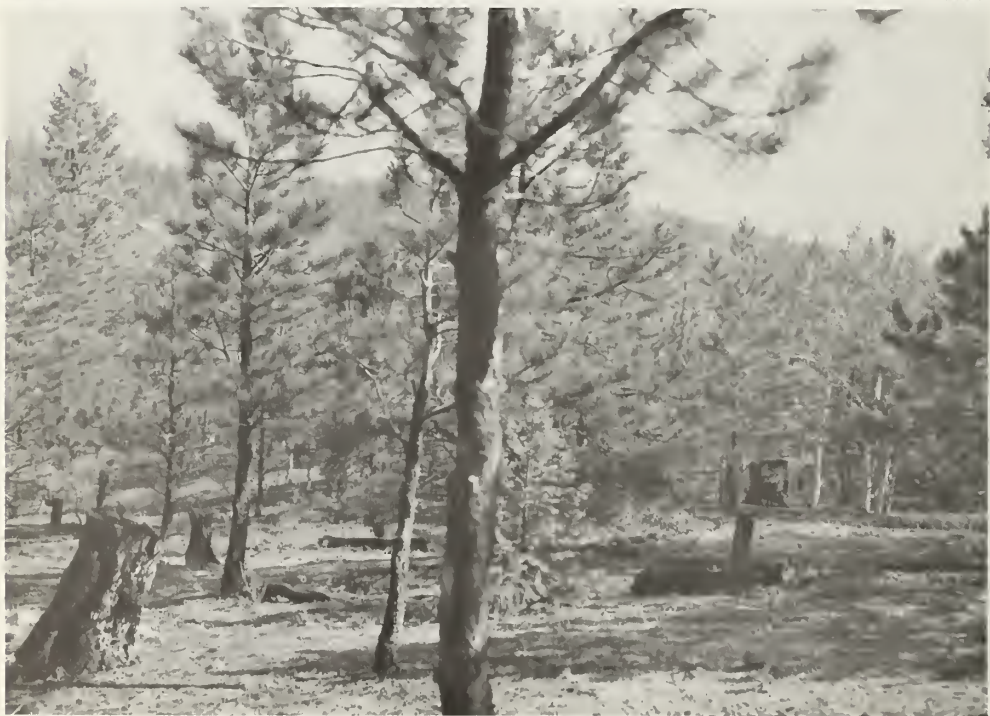
Figure 14.—View north of camera point No. 39. Sheep Nose is in the left background.

Two views at the upper reaches of the watershed are shown from camera point 39 north and west (figs. 14 and 15). Most of this area was replanted to ponderosa pine in the early 1930's. The area shown in fig. 15 was also planted at the same time. The presence of aspen on both sites in 1937 provided

evidence of good sites for the reforestation efforts. Estimated average tree height in both areas is 3.6 m (11.9 feet) and measured diameter averages 8.7 cm (3.4 inches). The herbaceous ground cover that was present in 1937 appears to be on the decline.

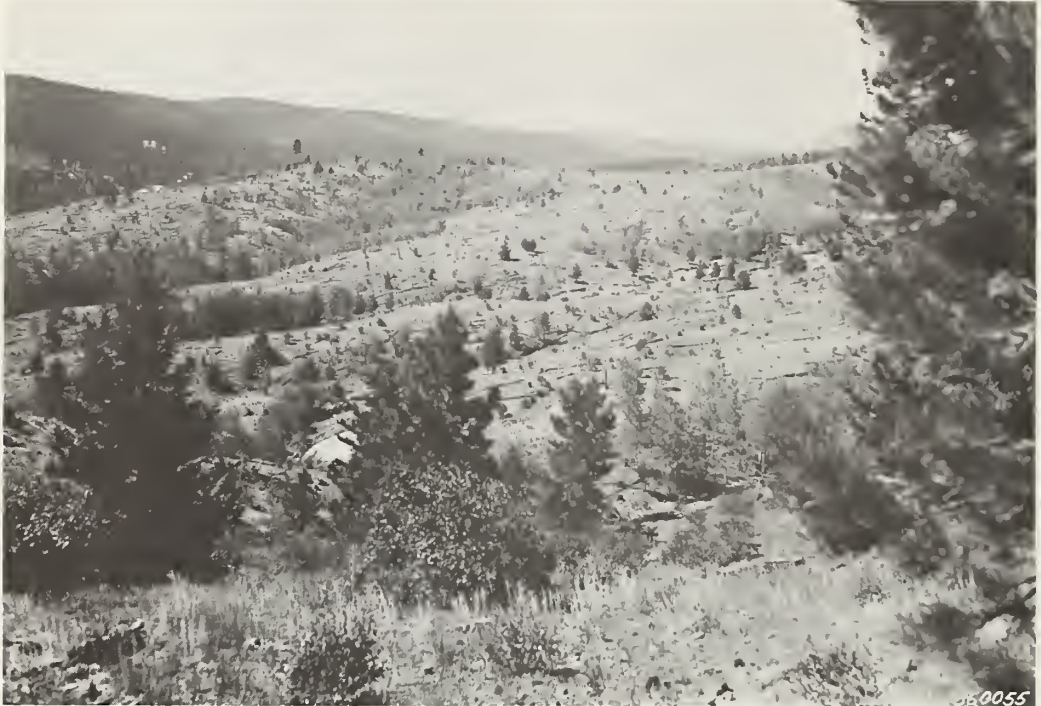
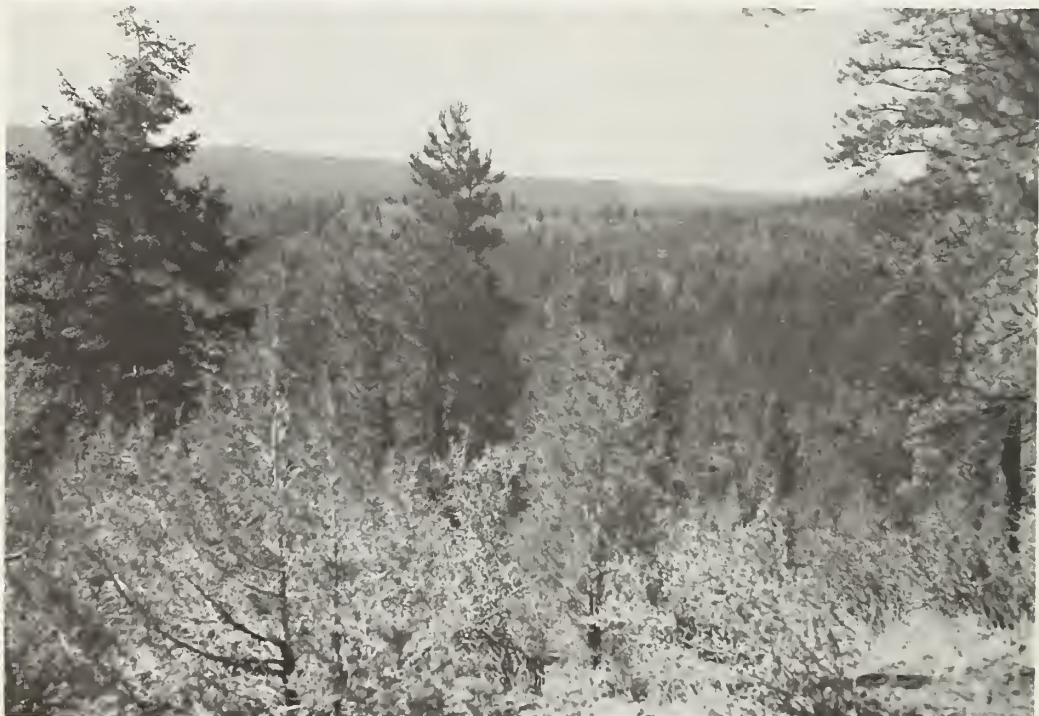
Figure 16.—View south of camera point No. 44. Signal Butte is in right background and near upper reaches of the watershed.

A south facing aspect (camera point 44 south) in the same general area as shown in figures 14 and 15 was also planted to both ponderosa pine and Rocky Mountain juniper (fig. 16). Stumps present over the general region shown in figures 14, 15, and 16

further illustrate that usable timber was produced in the past. Successful reestablishment of ponderosa pine and juniper over the area gives some assurance the area will again produce usable wood products and shrubby ground cover.
