Vol. VIII, No. 9
September, 1948

the Lineman

RURAL ELECTRIFICATION ADMINISTRATION - U. S. DEPARTMENT OF AGRICULTURE

MEMBERS OF CREW, TRAINED IN FIRST AID, APPLY ARTIFICIAL RESPIRATION IMMEDIATELY, BUT UNSUCCESSFULLY

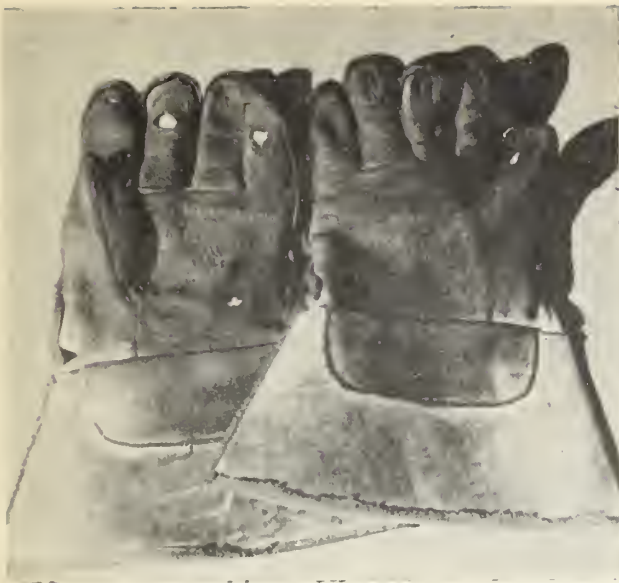
Burns on the hands indicated the path of current through his body was into his right hand and out the left. He was holding onto the cross arm brace with his left hand and had grabbed the energized jumper coming from the bottom of the breaker, with his right hand. To do this, he had to step up from the position he was in when last seen by the foreman..

The gloves victim was wearing at the time of the accident. Burns on hand correspond to holes burned in gloves.

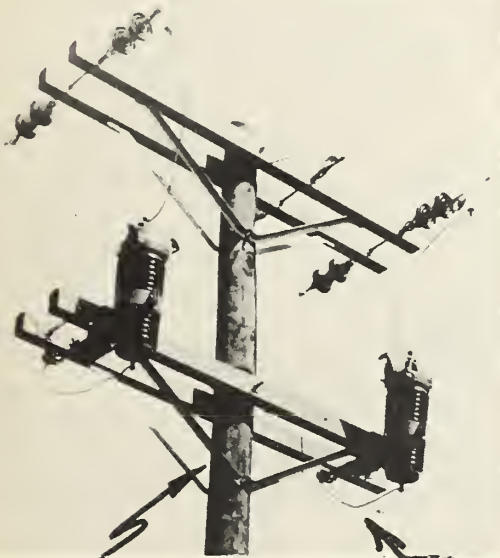
Smudged spot on brace indicates position of left hand.

Point at which victim grabbed jumper with right hand.

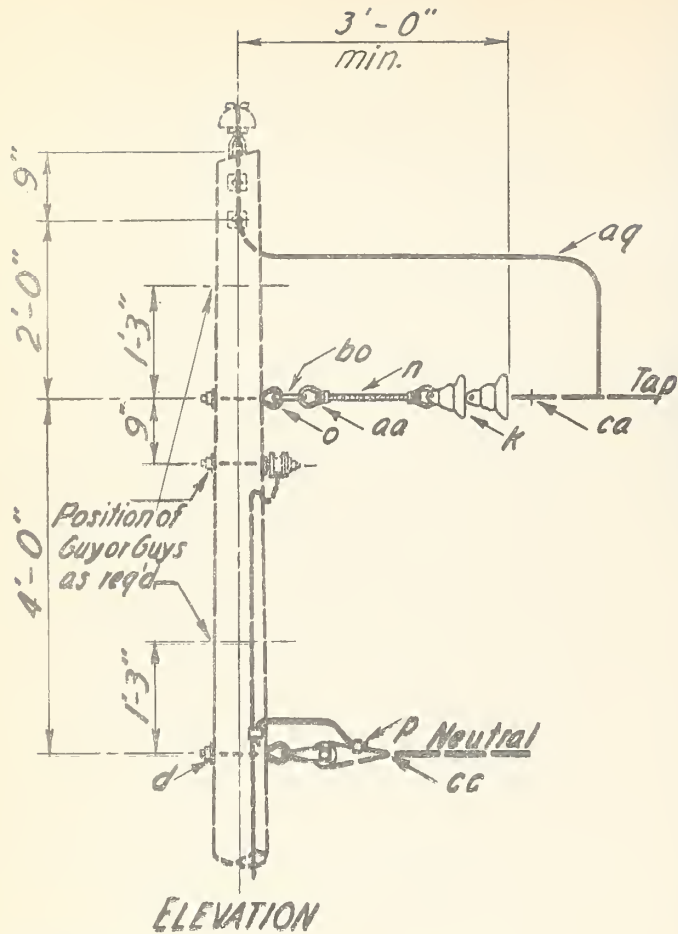
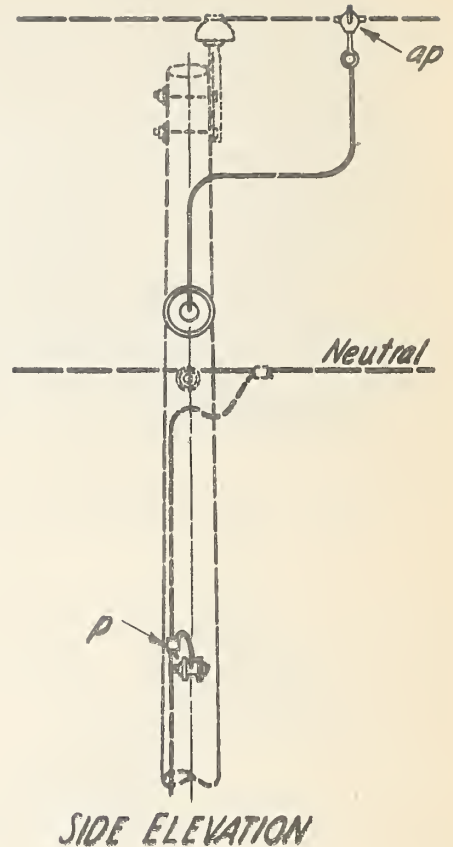
A2-2

At the Safety and Job Training Conference in Washington last fall the State Safety and Job Training instructors requested REA to change its specifications so that the eyebolt supporting the primary take-off of an A-5 addition to an A-1 or A-2 specification be lowered to a point 6 inches below the bottom of the pole top pin. This suggestion was made to provide more working clearance for the lineman boring the hole for the eye bolt. Several electric shock accidents had occurred in connection with the boring of this hole on energized lines.

After discussing the suggestion in Technical Standards Committee 'A', REA engineers felt that the suggestion had merit. It was unanimously agreed to accept the recommendation of the State safety instructors. To provide the maximum safety factor, it was decided to lower the eyebolt location to a point 33 inches below the top of the pole which materially increased the clearance requested.

A similar arrangement of tap and neutral position should be used for taps from two and three phase lines in preference to those now shown for such assemblies on drawings B21, B22, B23, B24, B27R, C21, C22, C23, C24, C25, C26, C27R, C28R, C29.
