Space Shuttle Orbiter Thermal Protection System Design and Flight Experience

Donald M. Curry

July 1993

Presented at the
First ESA/ESTEC Workshop on Thermal Protection Systems
Noordwijk, the Netherlands, May 5-7, 1993

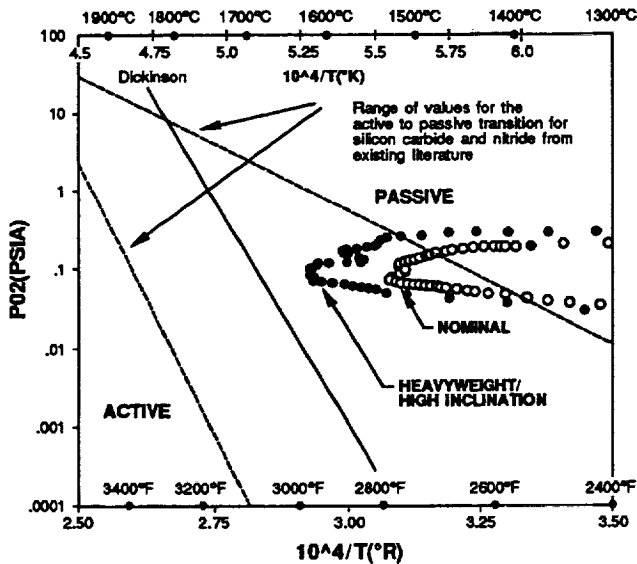
FIGURE 13: ACTIVE-PASSIVE TRANSITION OXYGEN PRESSURES COMPARISONS WITH FLIGHT CONDITIONS

Radiometer measurement of WLE inner mold-line temperature (IML) as a function of semispan (figure 9) provided the data to establish WLE heating distribution (figure 10). The maximum heating zone at the 55-percent semispan results from the interaction of the nose cap bow shock and wing shock, which results in higher boundary layer pressures and heating rates. A comparison of measured temperatures of the RCC attachment hardware, internal insulation, and wing span structure are shown in figure 11. Predicted wing leading edge RCC surface temperatures for a nominal and high inclination, heavy weight entry are shown in figure 12. RCC is protected from oxidation by a silicon carbide coating which maintains a passive oxidation condition on the surface necessary for a multimission capability. A comparison of the active-passive transition oxygen pressures for SiC to nominal flight conditions (figure 13) indicates a passive state of oxidation during entry.

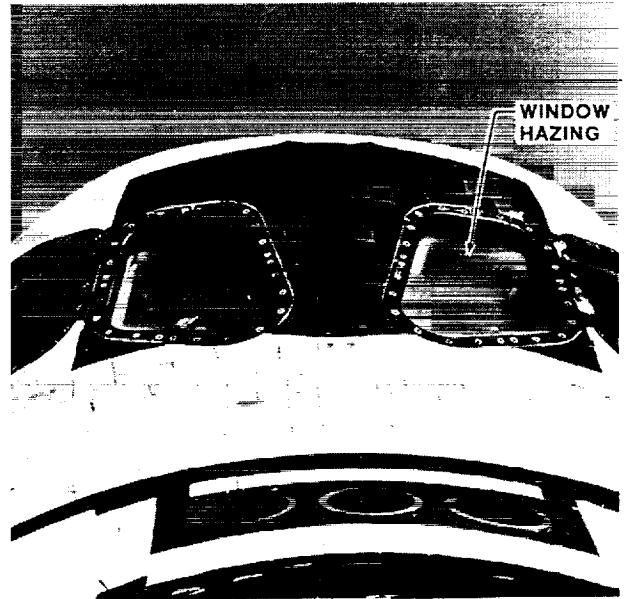
FIGURE 25: ORBITER WINDOW CONTAMINATION

Another critical area on the Orbiter, not generally considered part of the TPS, is the window system. As shown in figure 25, the Orbiter has 11 windows (6 forward, 2 overhead, 1 side hatch and 2 rear view). The forward windows consist of three panes each:

thermal, redundant, and pressure. Hazing or contamination (mainly from SRB separation) of the outer thermal pane occurs during each flight (figure 25). A cleaning procedure has been developed to remove the haze and maintain required visibility. The outer panels are also subject to impact, and very detailed inspections are performed after each flight to ensure structural integrity of the glass. Through flight STS-54, a total of 35 window panels have been replaced, 34 due to impact damage and 1 due to hazing.
