MISSION #25 TACHIARI "OPENHOUSE 1"
6 Jan 45 Omura

Tactical Mission Report

No. 25

TARGET: OMURA AIRCRAFT PLANT

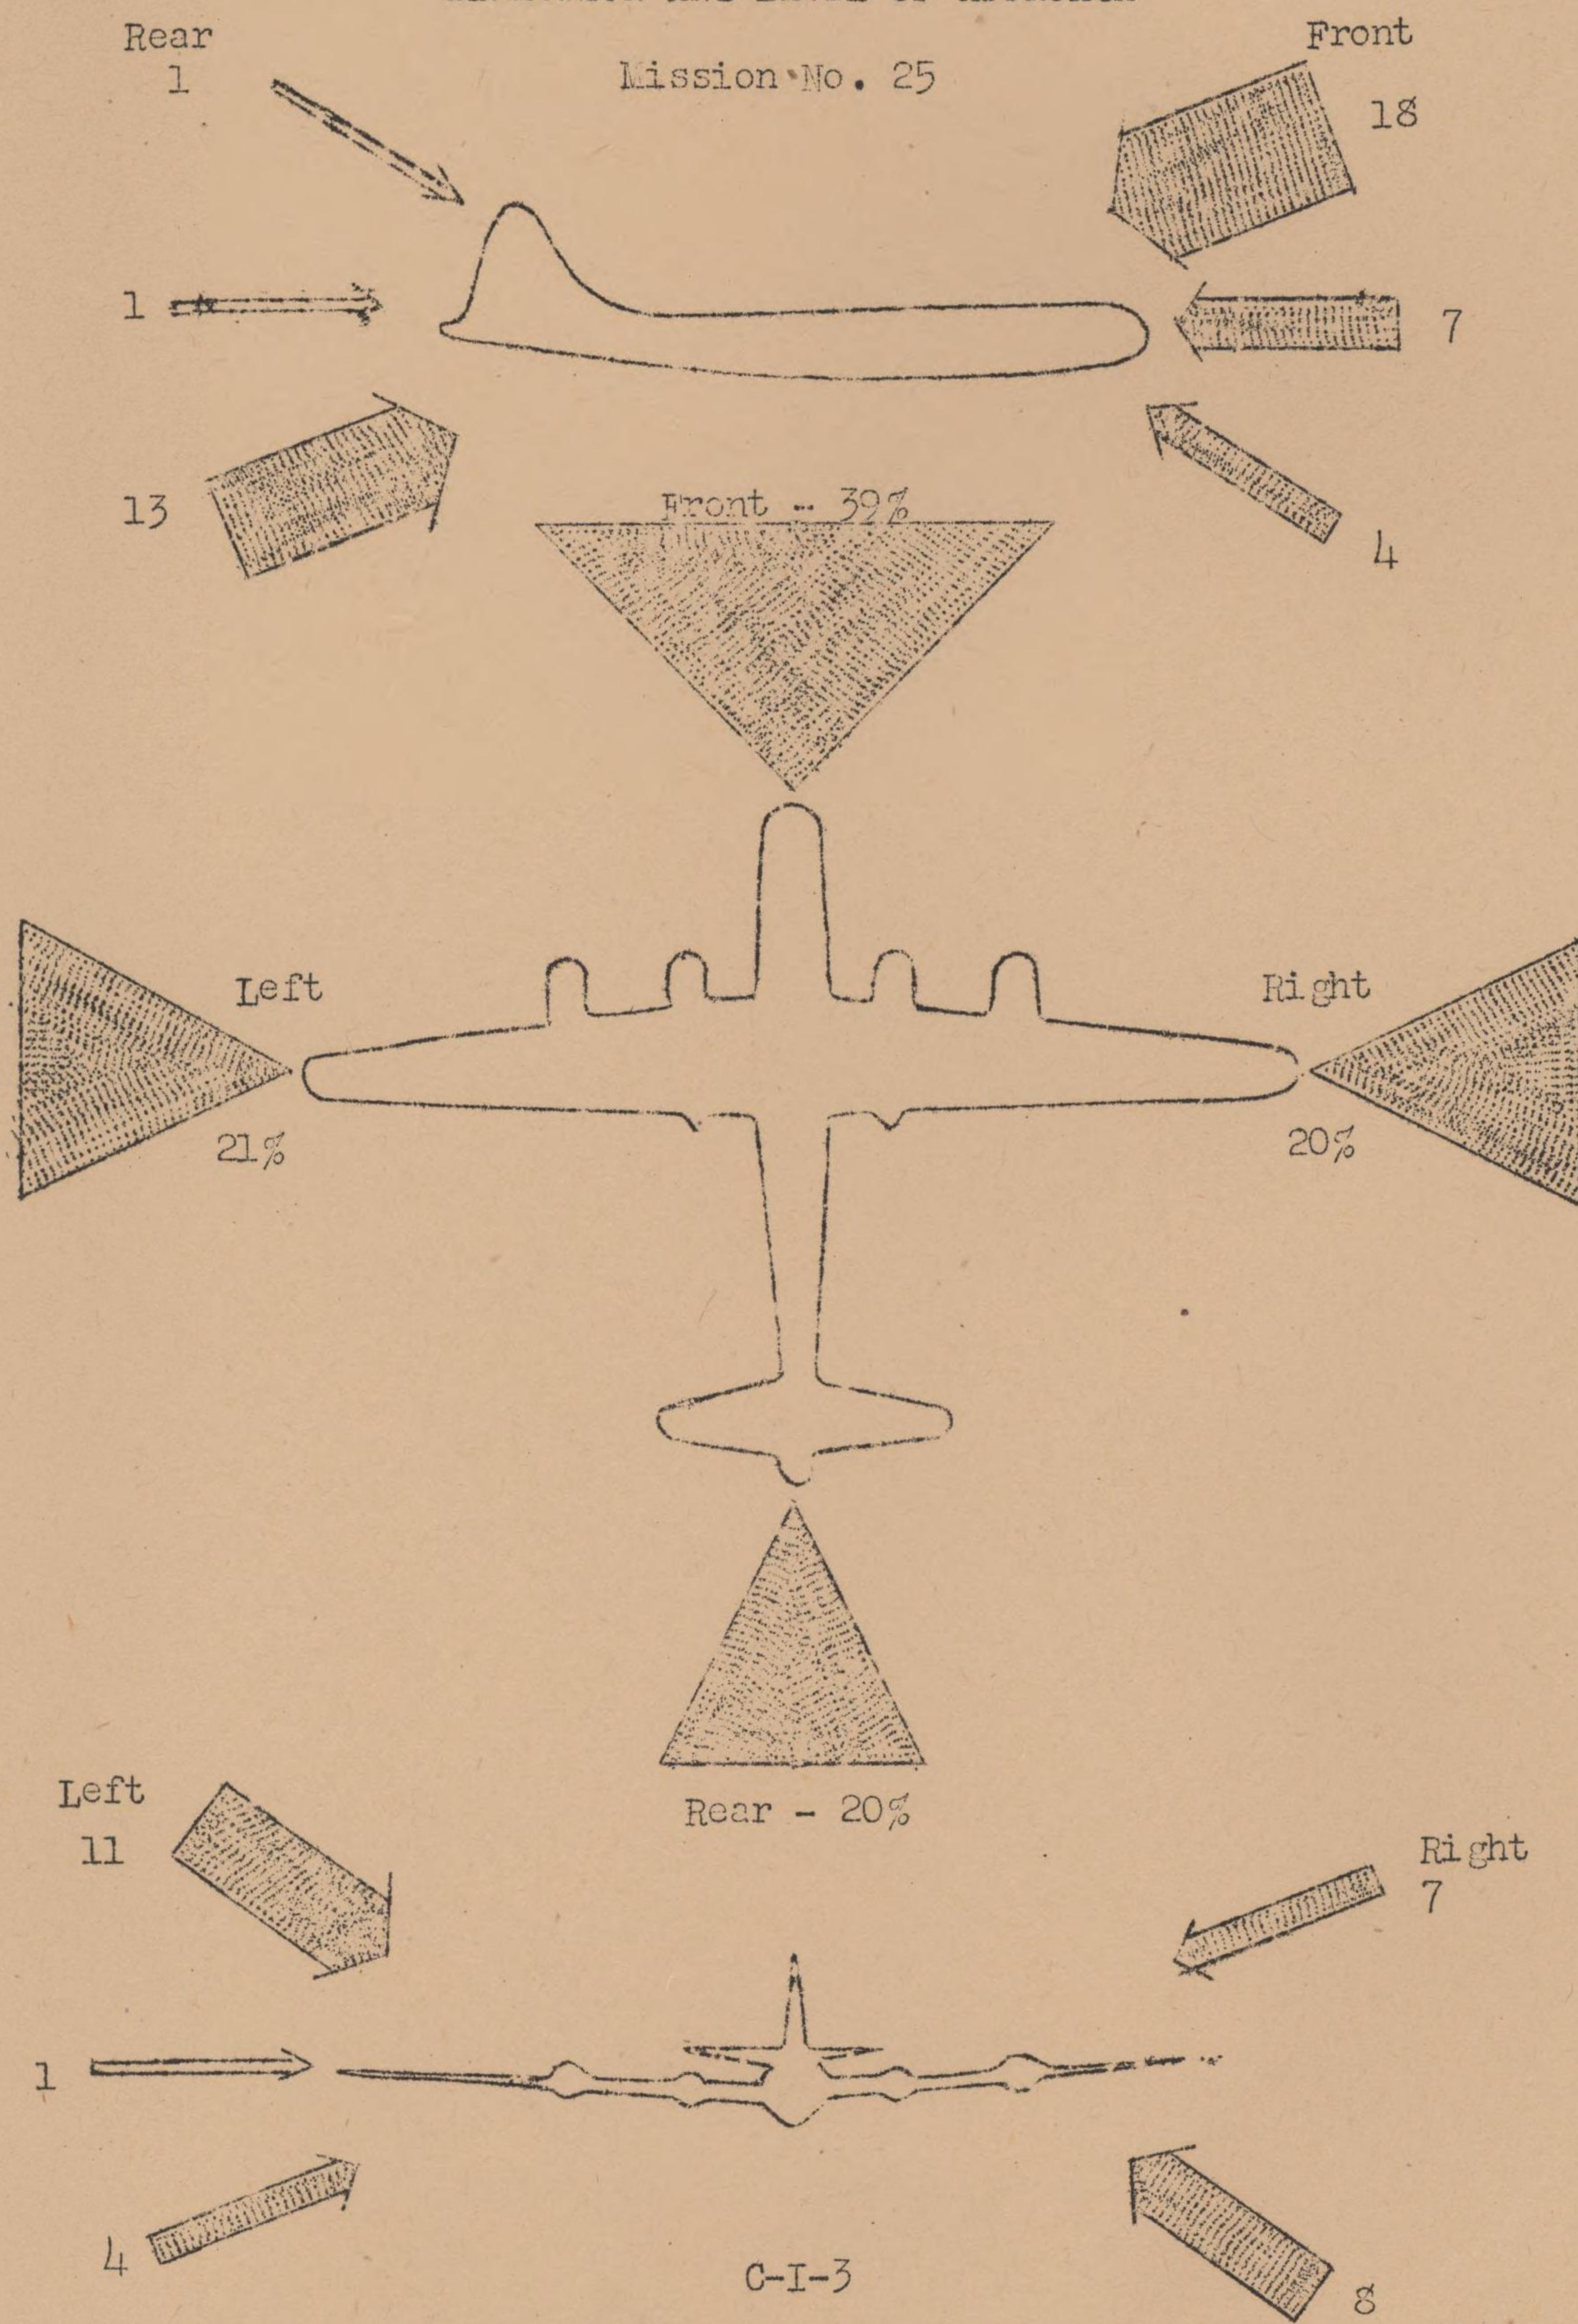
Exhibit B

DIRECTION AND LEVEL OF APPROACH

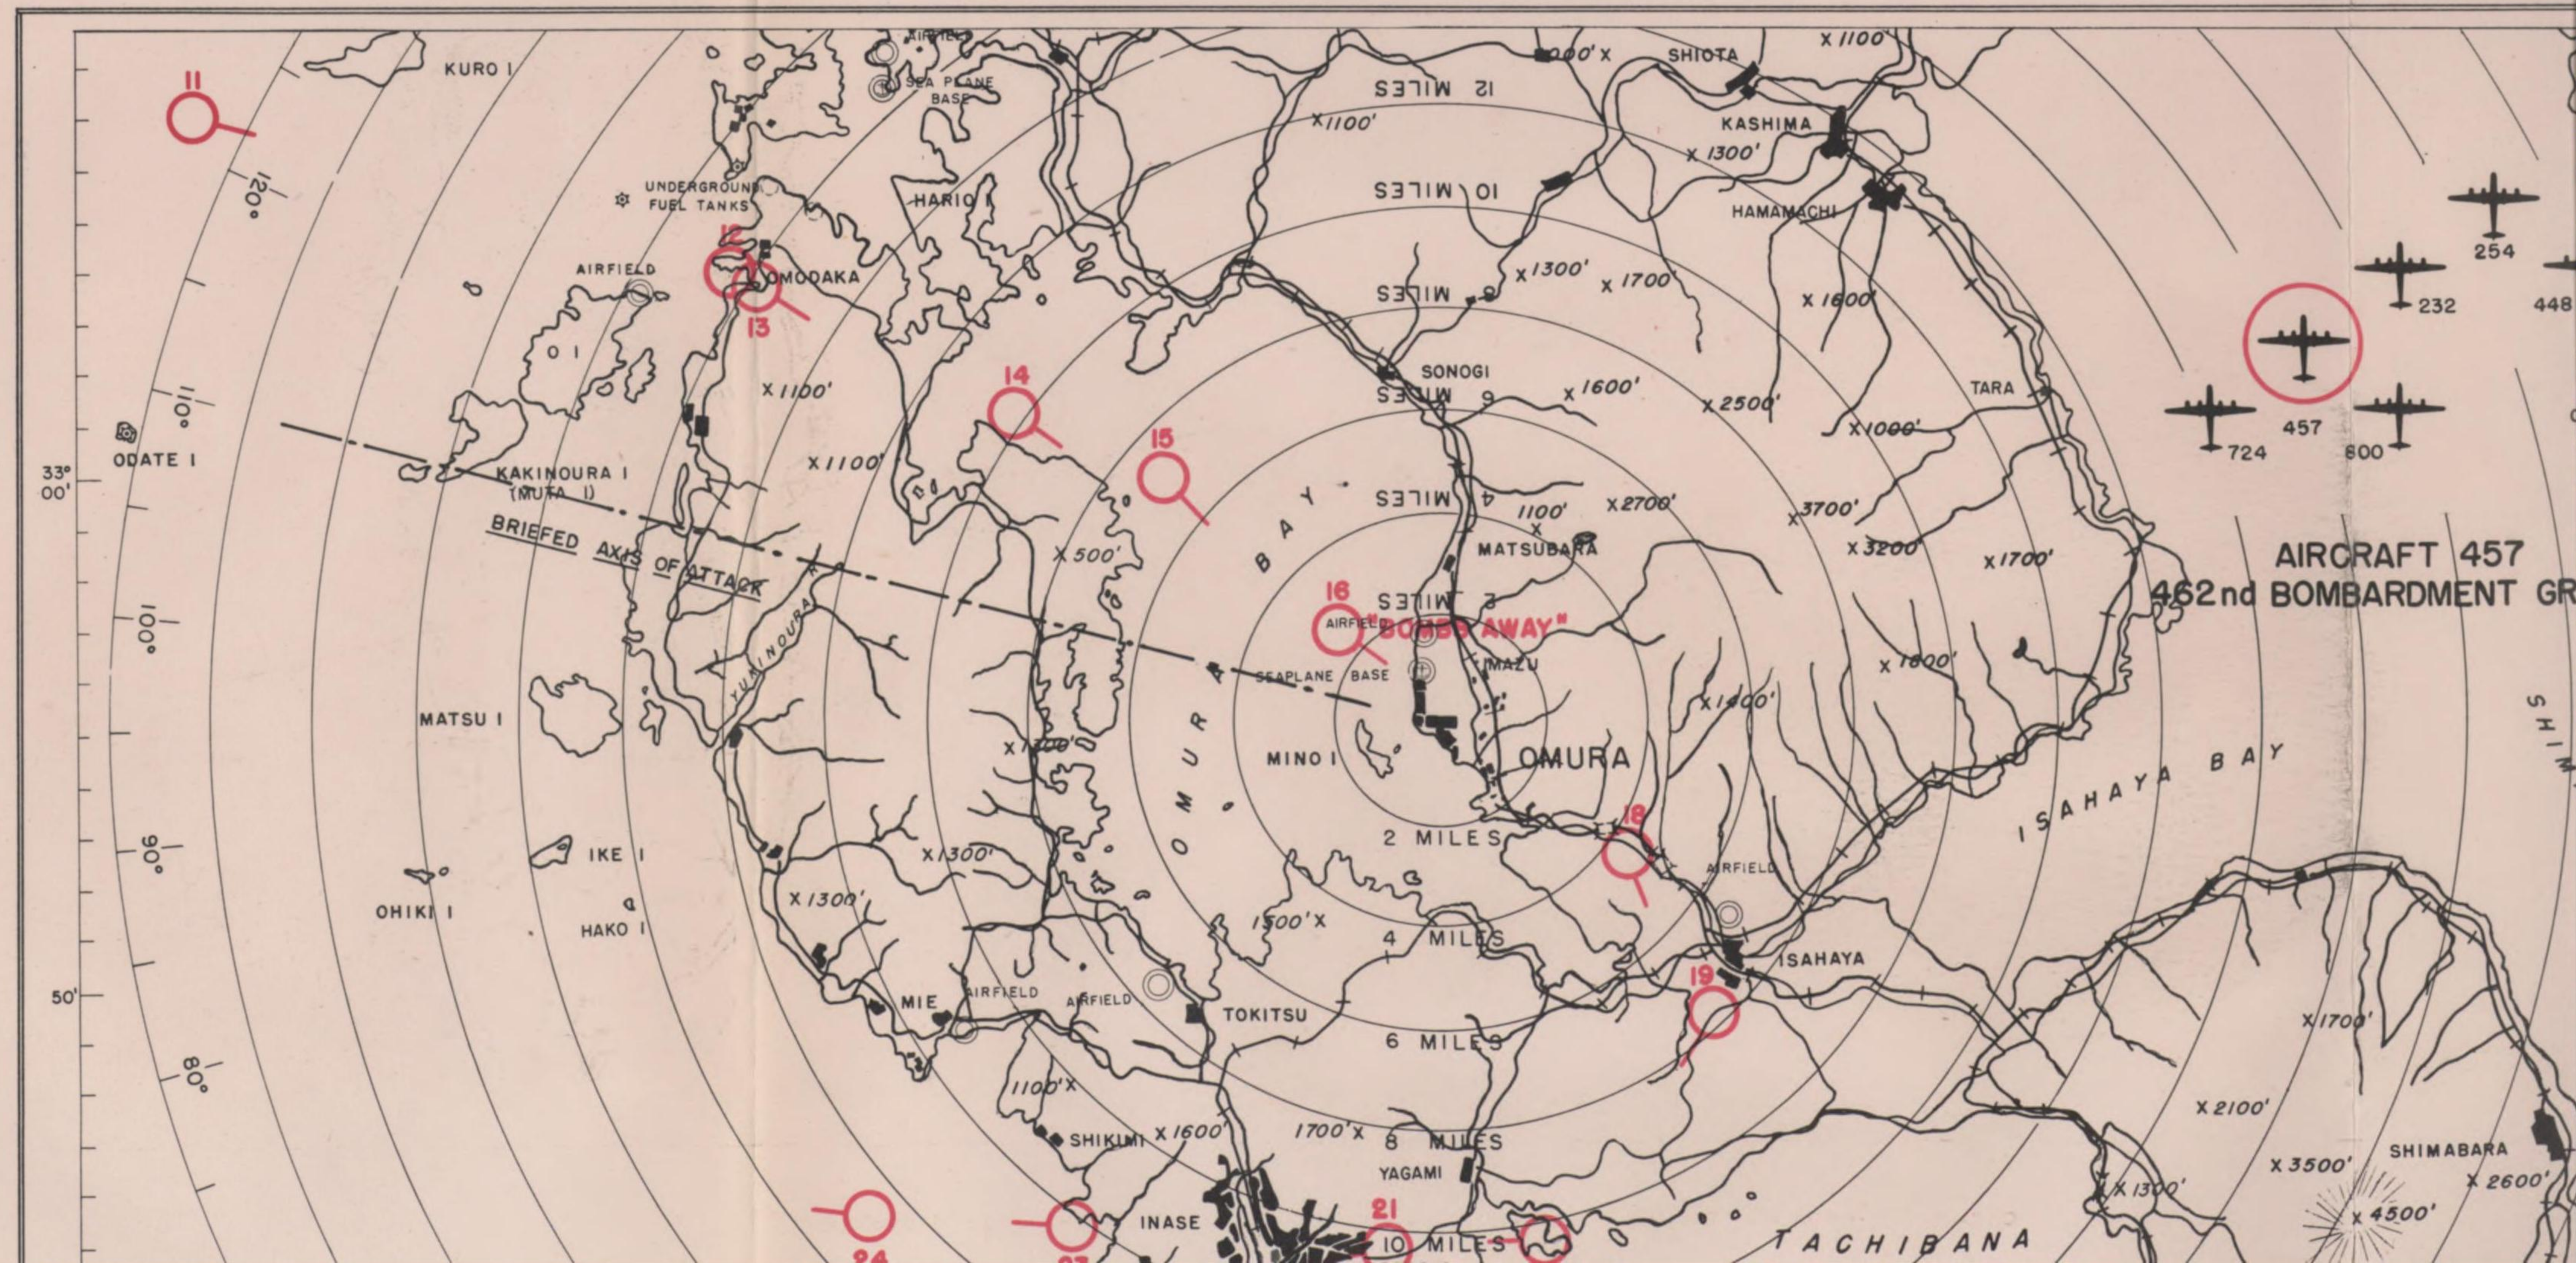
RADAR PHOTOGRAPH ANALYSIS OMURA AREA - JAPAN

MISSION NO. 25 - TARGET: OMURA AIRCRAFT PLANT (33°55'15"N-129°56'30"E)
