# INVESTIGATION REPORT

**A319 cockpit windshield de-icing system**

N° 19-DGATA-MTI-P1400227009008-F-A

This document presents the results of the investigations conducted on the power braids from the cockpit windshield de-icing system of the Sichuan Airlines A319 n° B-6419 following the loss of the windshield during the 3U8633 flight of May 14th 2018.

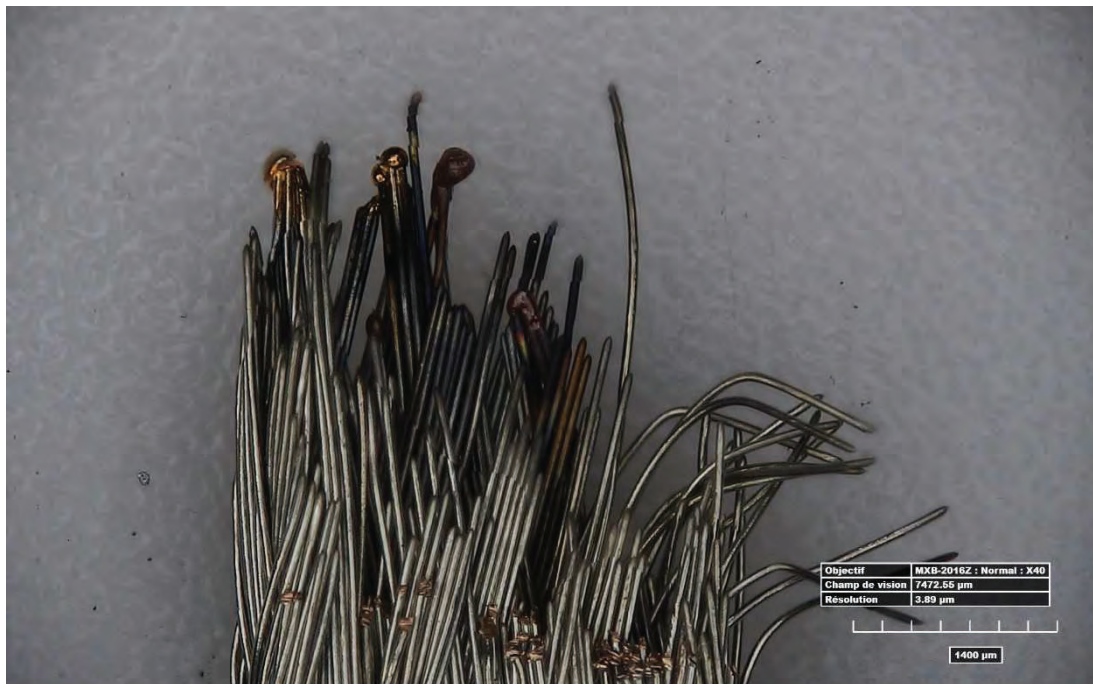
Figure 4 : Tensile test sample T1 – Fractographic examination

Sample T3 after failure

On the test with electric current T3, a serial arc occurred at failure (Figure 2). On the broken sample T3, some wires exhibit a melted aspect due to heating of the copper induced by electric current (Figure 3).

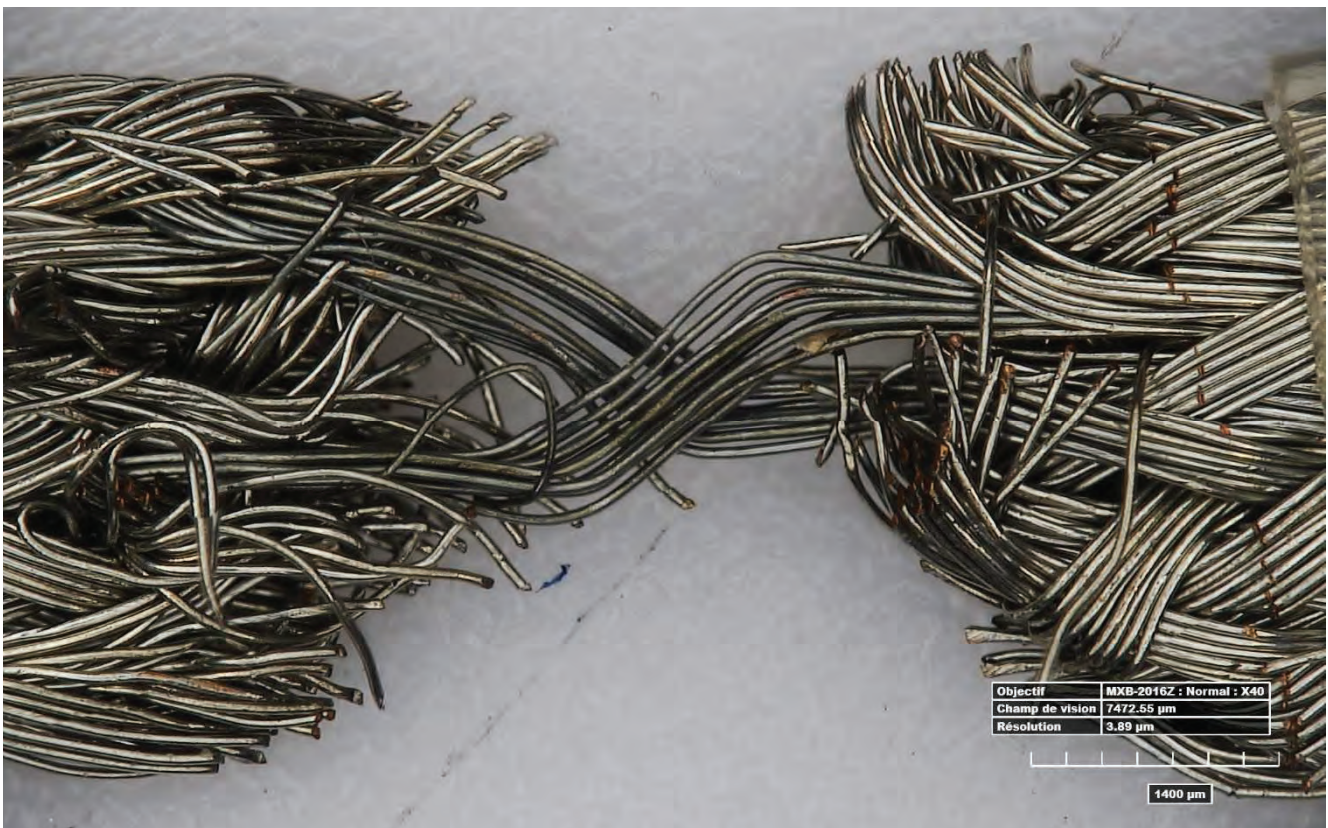
Figure 8 : Serial arc test in air results – SS1 sample 6%

Sample after test – Light coloration of remaining wires

During the test with SS1 sample, no arcing occurred. A slight dark coloration of the remaining wires is visible (Figure 8).

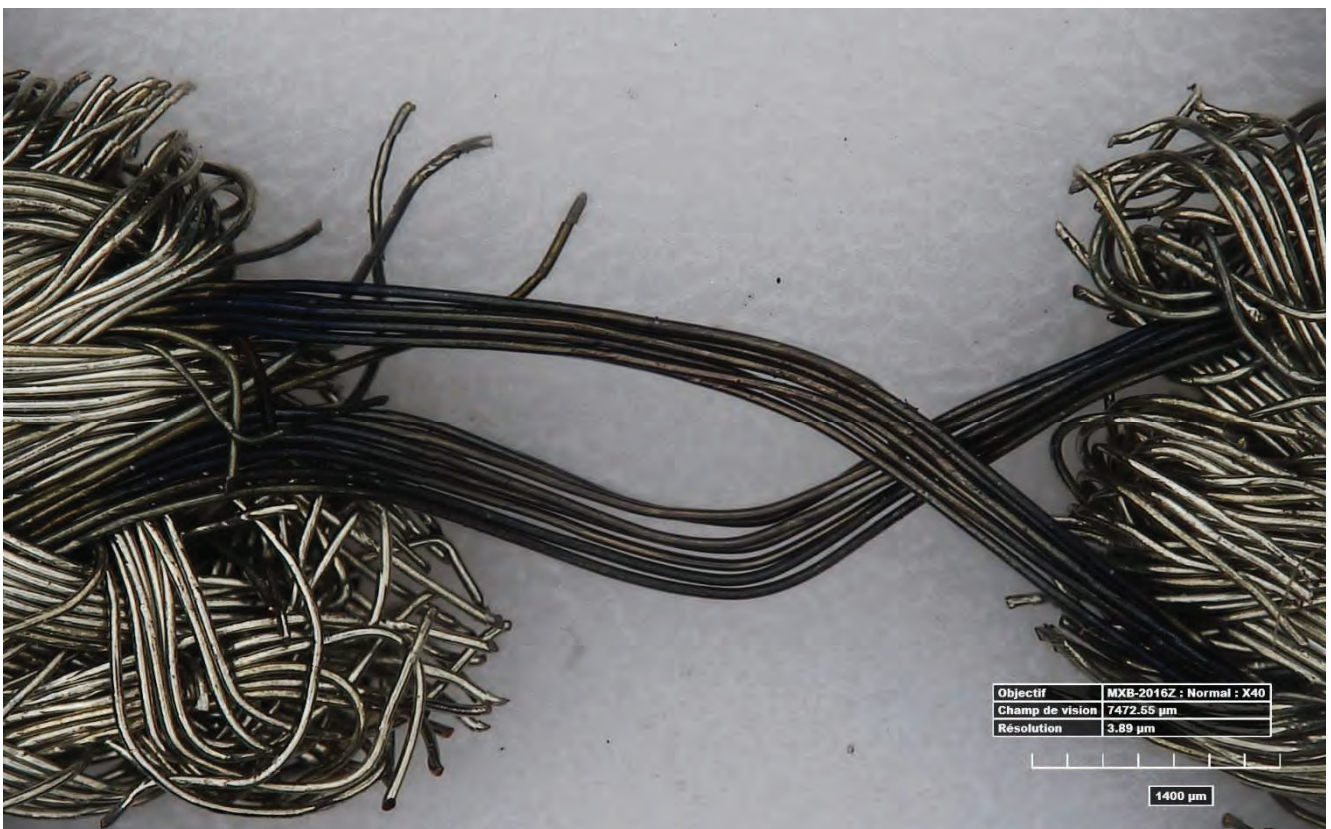
**Figure 9 :** Serial arc test in air results – SS2 sample 4%

Sample after test – Significant coloration of remaining wires

The SS2 sample exhibits an important dark coloration but no arcing happened (Figure 9).

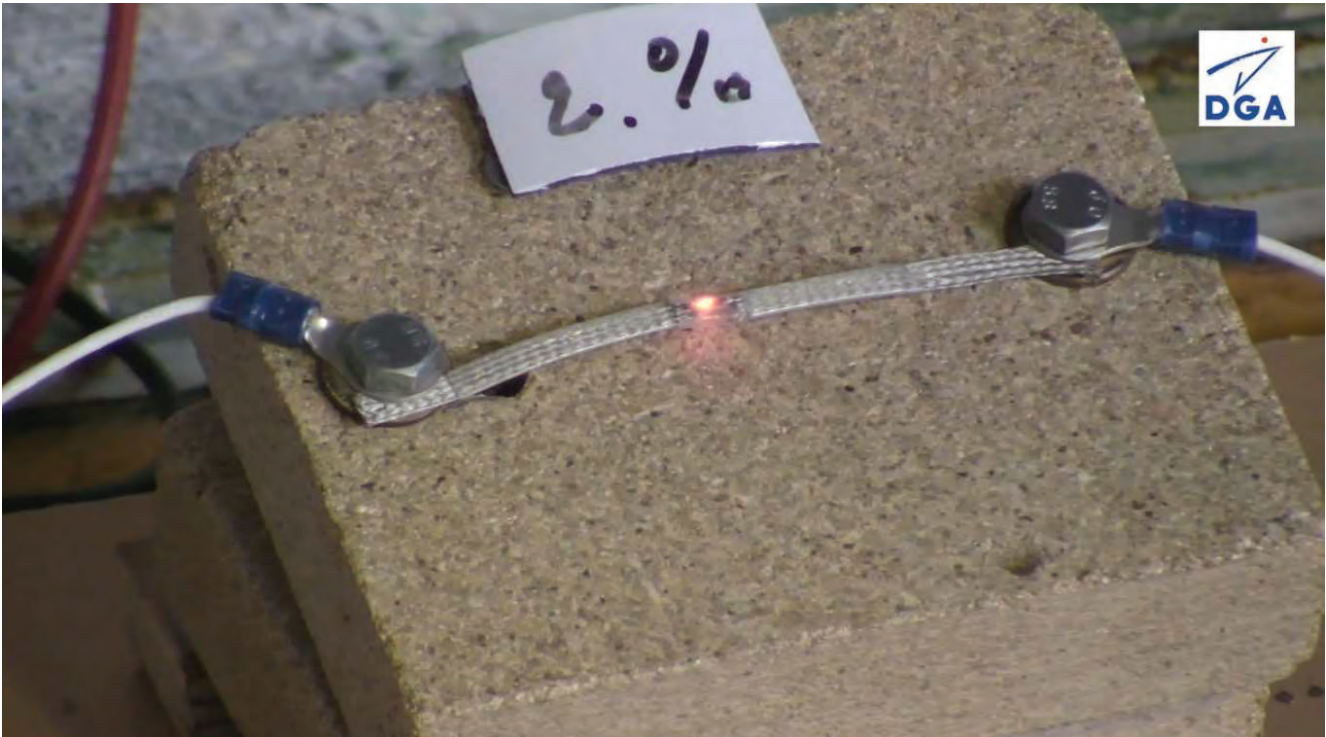
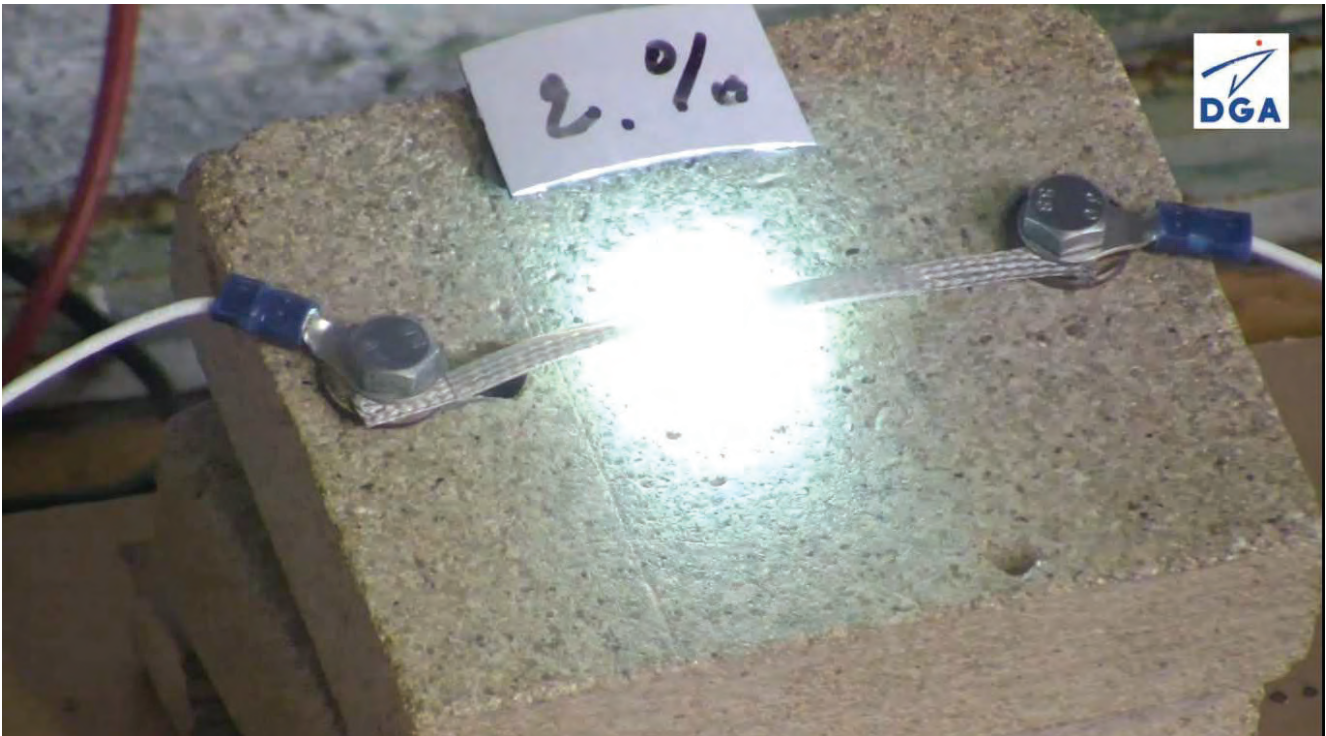
Figure 10 : Serial arc test in air results – SS4 sample 2%

Red glowing braid just before arcing

Serial arcing

With the SS4 sample, the power braid started to glow red until a serial arc occurred (Figure 10). Some wires exhibit a melted aspect due to the serial arc (Figure 11).

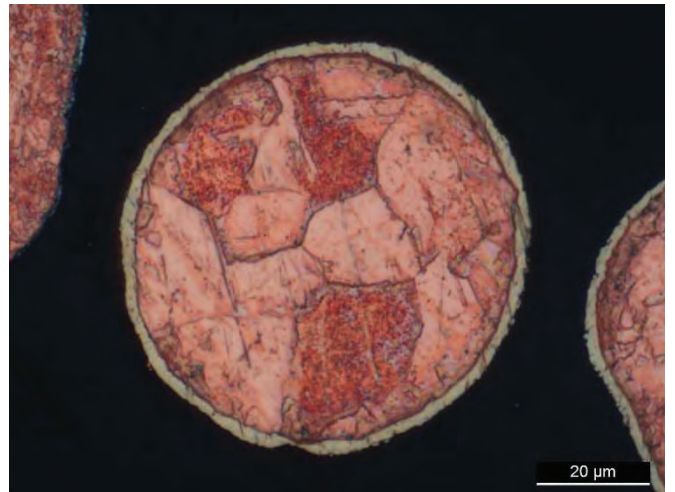
Figure 17 : Serial arc test in air – SS4 sample 2% – Micrographic examination

Grain size far from failure zone

Grain size in failure zone

Total Nombre	319	Approuvé par:
Moyenne (µm)	3,121765935	
Total (µm)	995,8433333	
Inférieur à la Limite Nombre	0

Total Nombre	21	Approuvé par:
Moyenne (µm)	12,61135417	
Total (µm)	264,8384375	
Inférieur à la Limite Nombre	0

The grain size measurements show no significant growth happened during the test on SS1 and SS2 samples, with values about 3µm (Figures 15 and 16). However, some wires on the SS4 sample exhibit an important increase in grain size with a value of 12µm (Figure 17). It is correct to conclude that, depending on the remaining section of the braid, the Joule effect could be important enough to heat the wires in which the current goes through and provoke an increase of grain size.

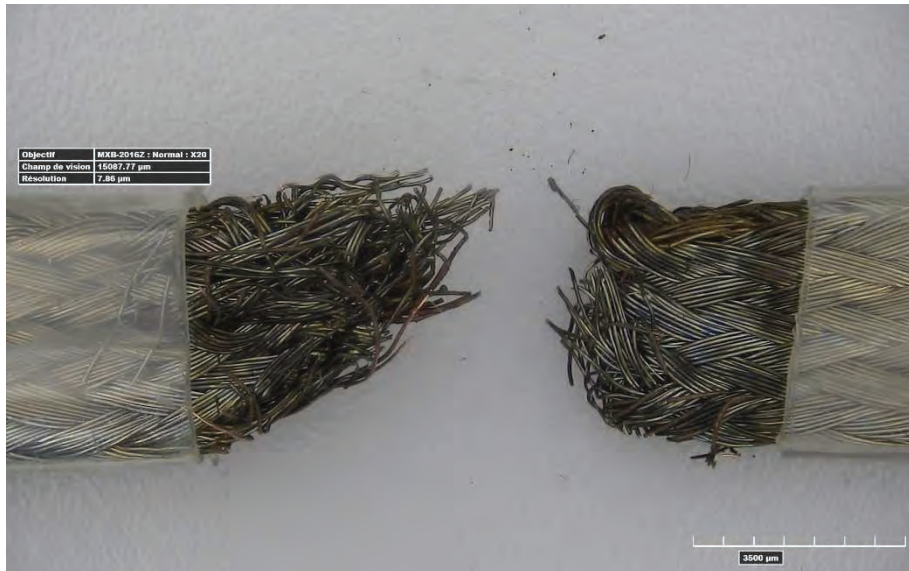
**Figure 25 :** Serial arc test in solution – HS4 sample 4% in pH9 without PR

The cut wires are in contact

Test n°	Remaining section of braid	PR1829	Type of sample	Observations	pH	Acidification of the solution	Release of Fluorine/Sulfur
HS1	6%	No	Cut wires in contact	No heating of the solution	4	No	No
HS2	2%	No	Cut wires in contact	Gas formation, heating of solution	4	No	No
HS3	2%	No	Cut wires not in contact	Gas formation, heating of solution, serial arcs occurring	4	No	Fluorine (33 mg/L) Maybe sulfur
HS4	4%	No	Cut wires in contact	Light heating of the solution	9	Light acidification (pH 8.90 to 8.74)	No
HS5	2%	Yes	Cut wires in contact	Gas formation, heating of solution, serial arcs occurring	9	Light acidification (pH 8.90 to 8.77)	No
HS6	2%	Yes	Cut wires not in contact	Gas formation, heating of solution	4	No	Fluorine (80 mg/L)

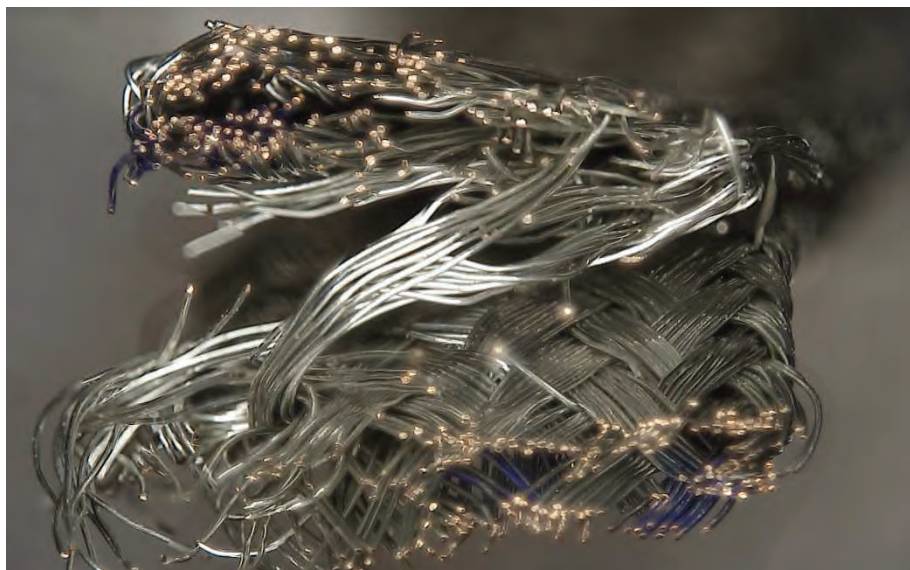
Figure 26 : Serial arc test in solution – HS5 sample 2% in pH9 with PR

The cut wires are in contact

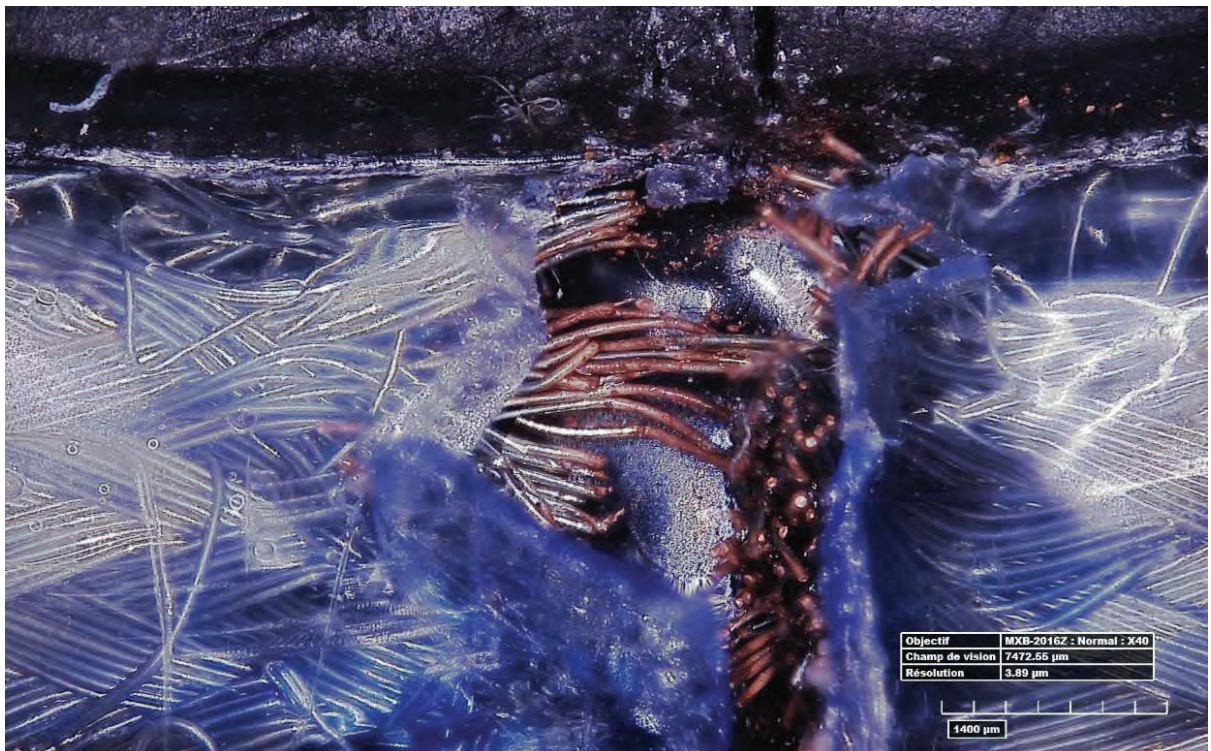
**Figure 27 :** Serial arc test in solution – HS6 sample 2% in pH4 with PR

The cut wires are not in contact
