CHAPTER VII

STRUCTURAL CONSIDERATIONS

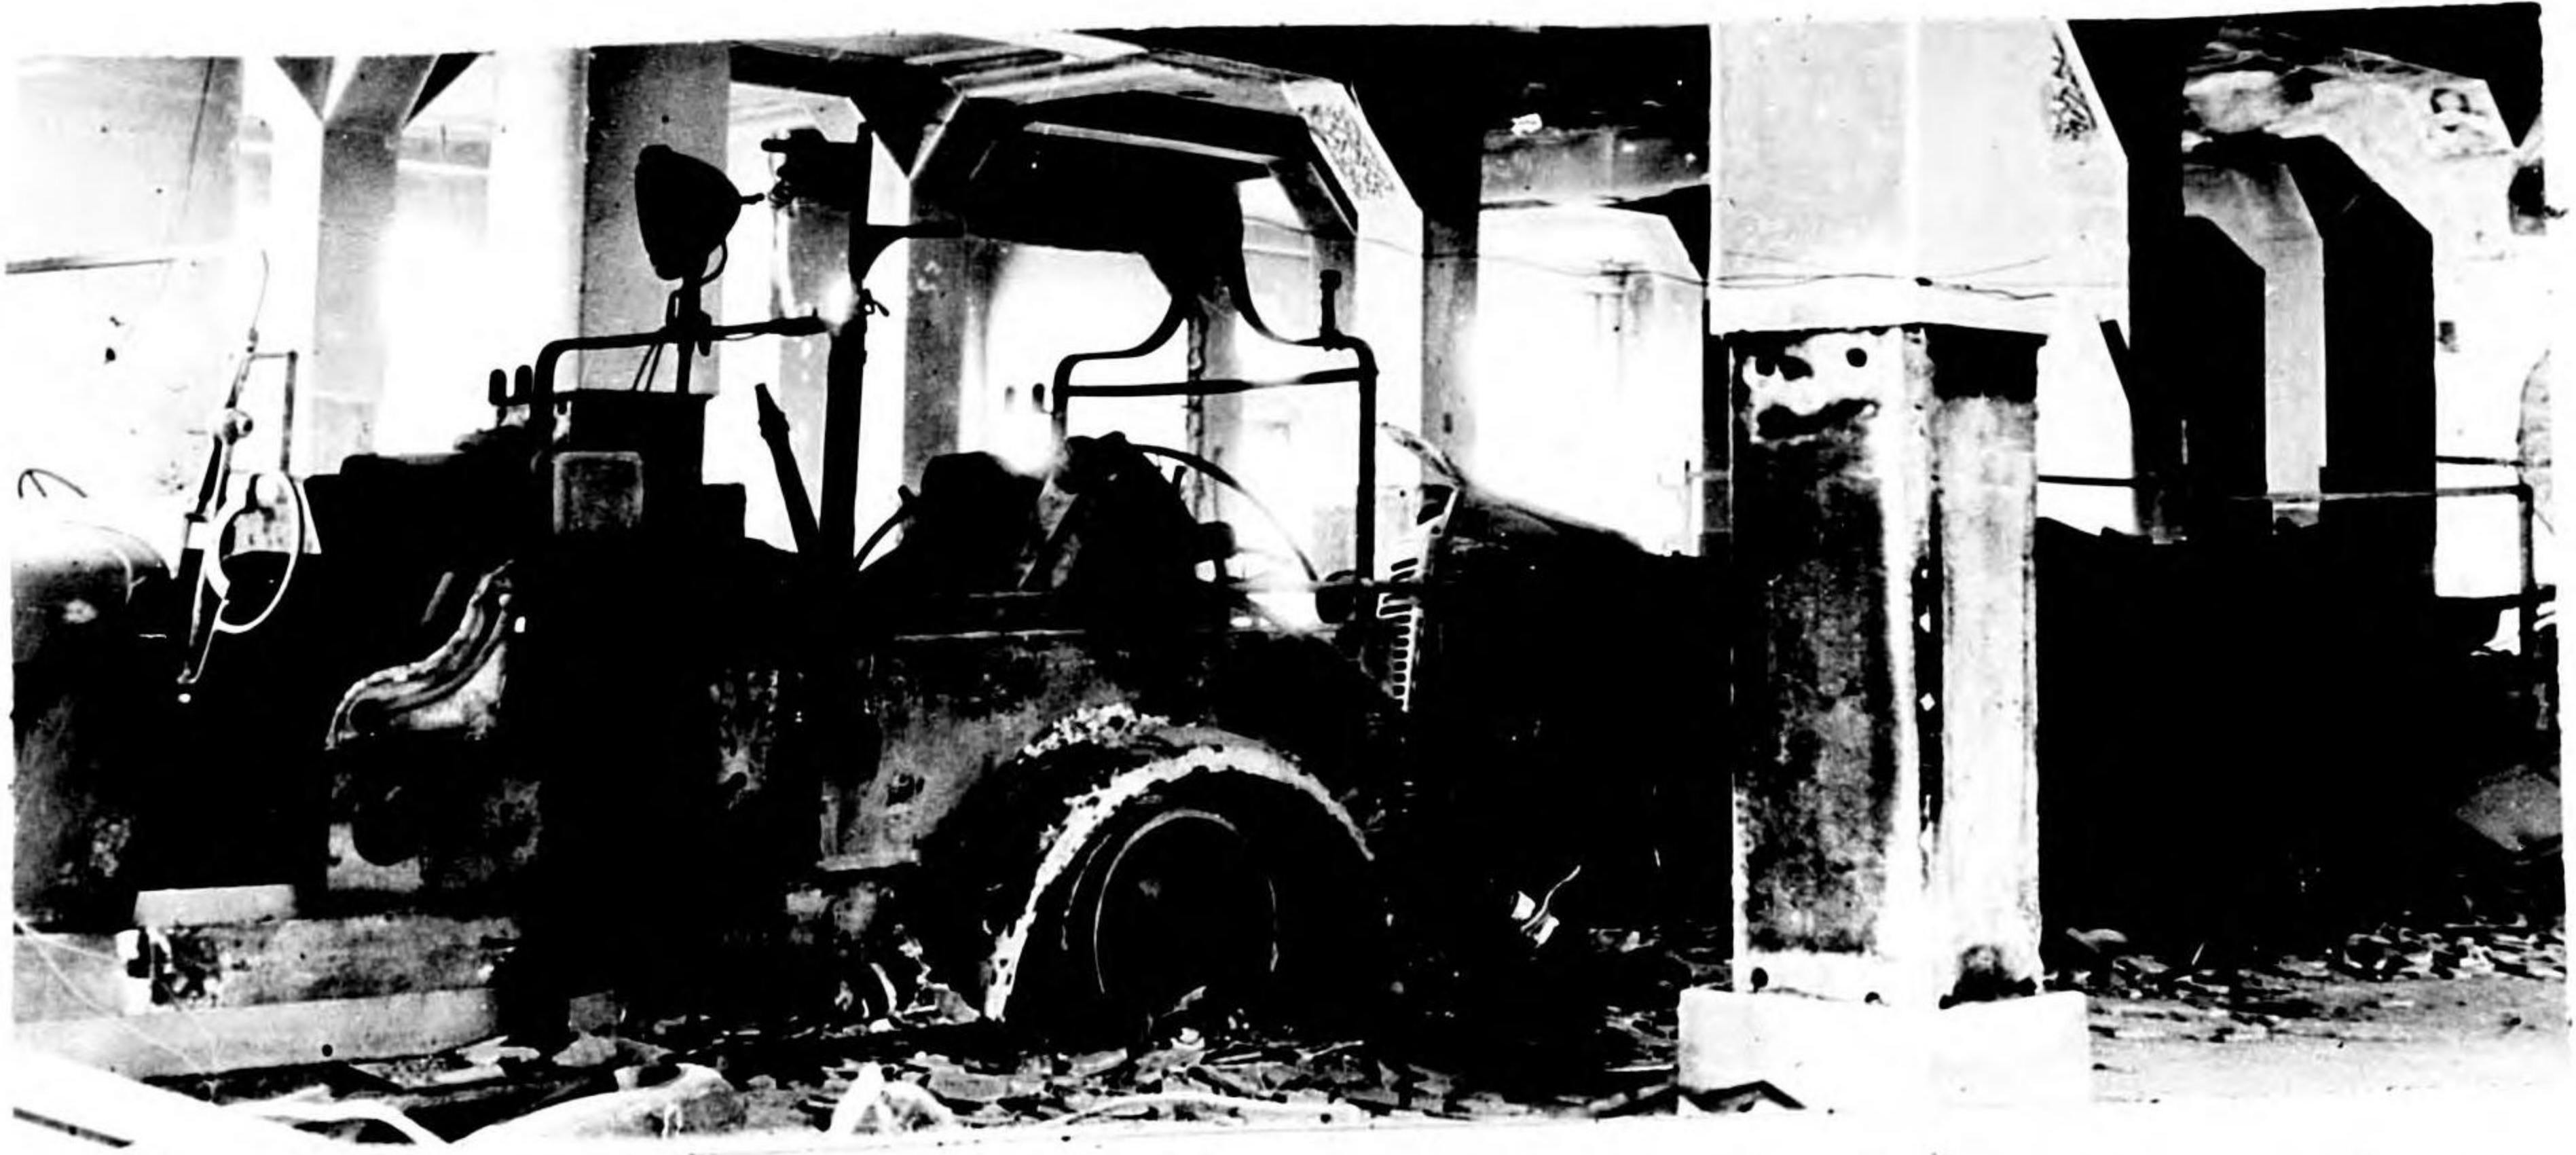
Photo 185. Hiroshima. One of the reasons why the fire department was unable to function.

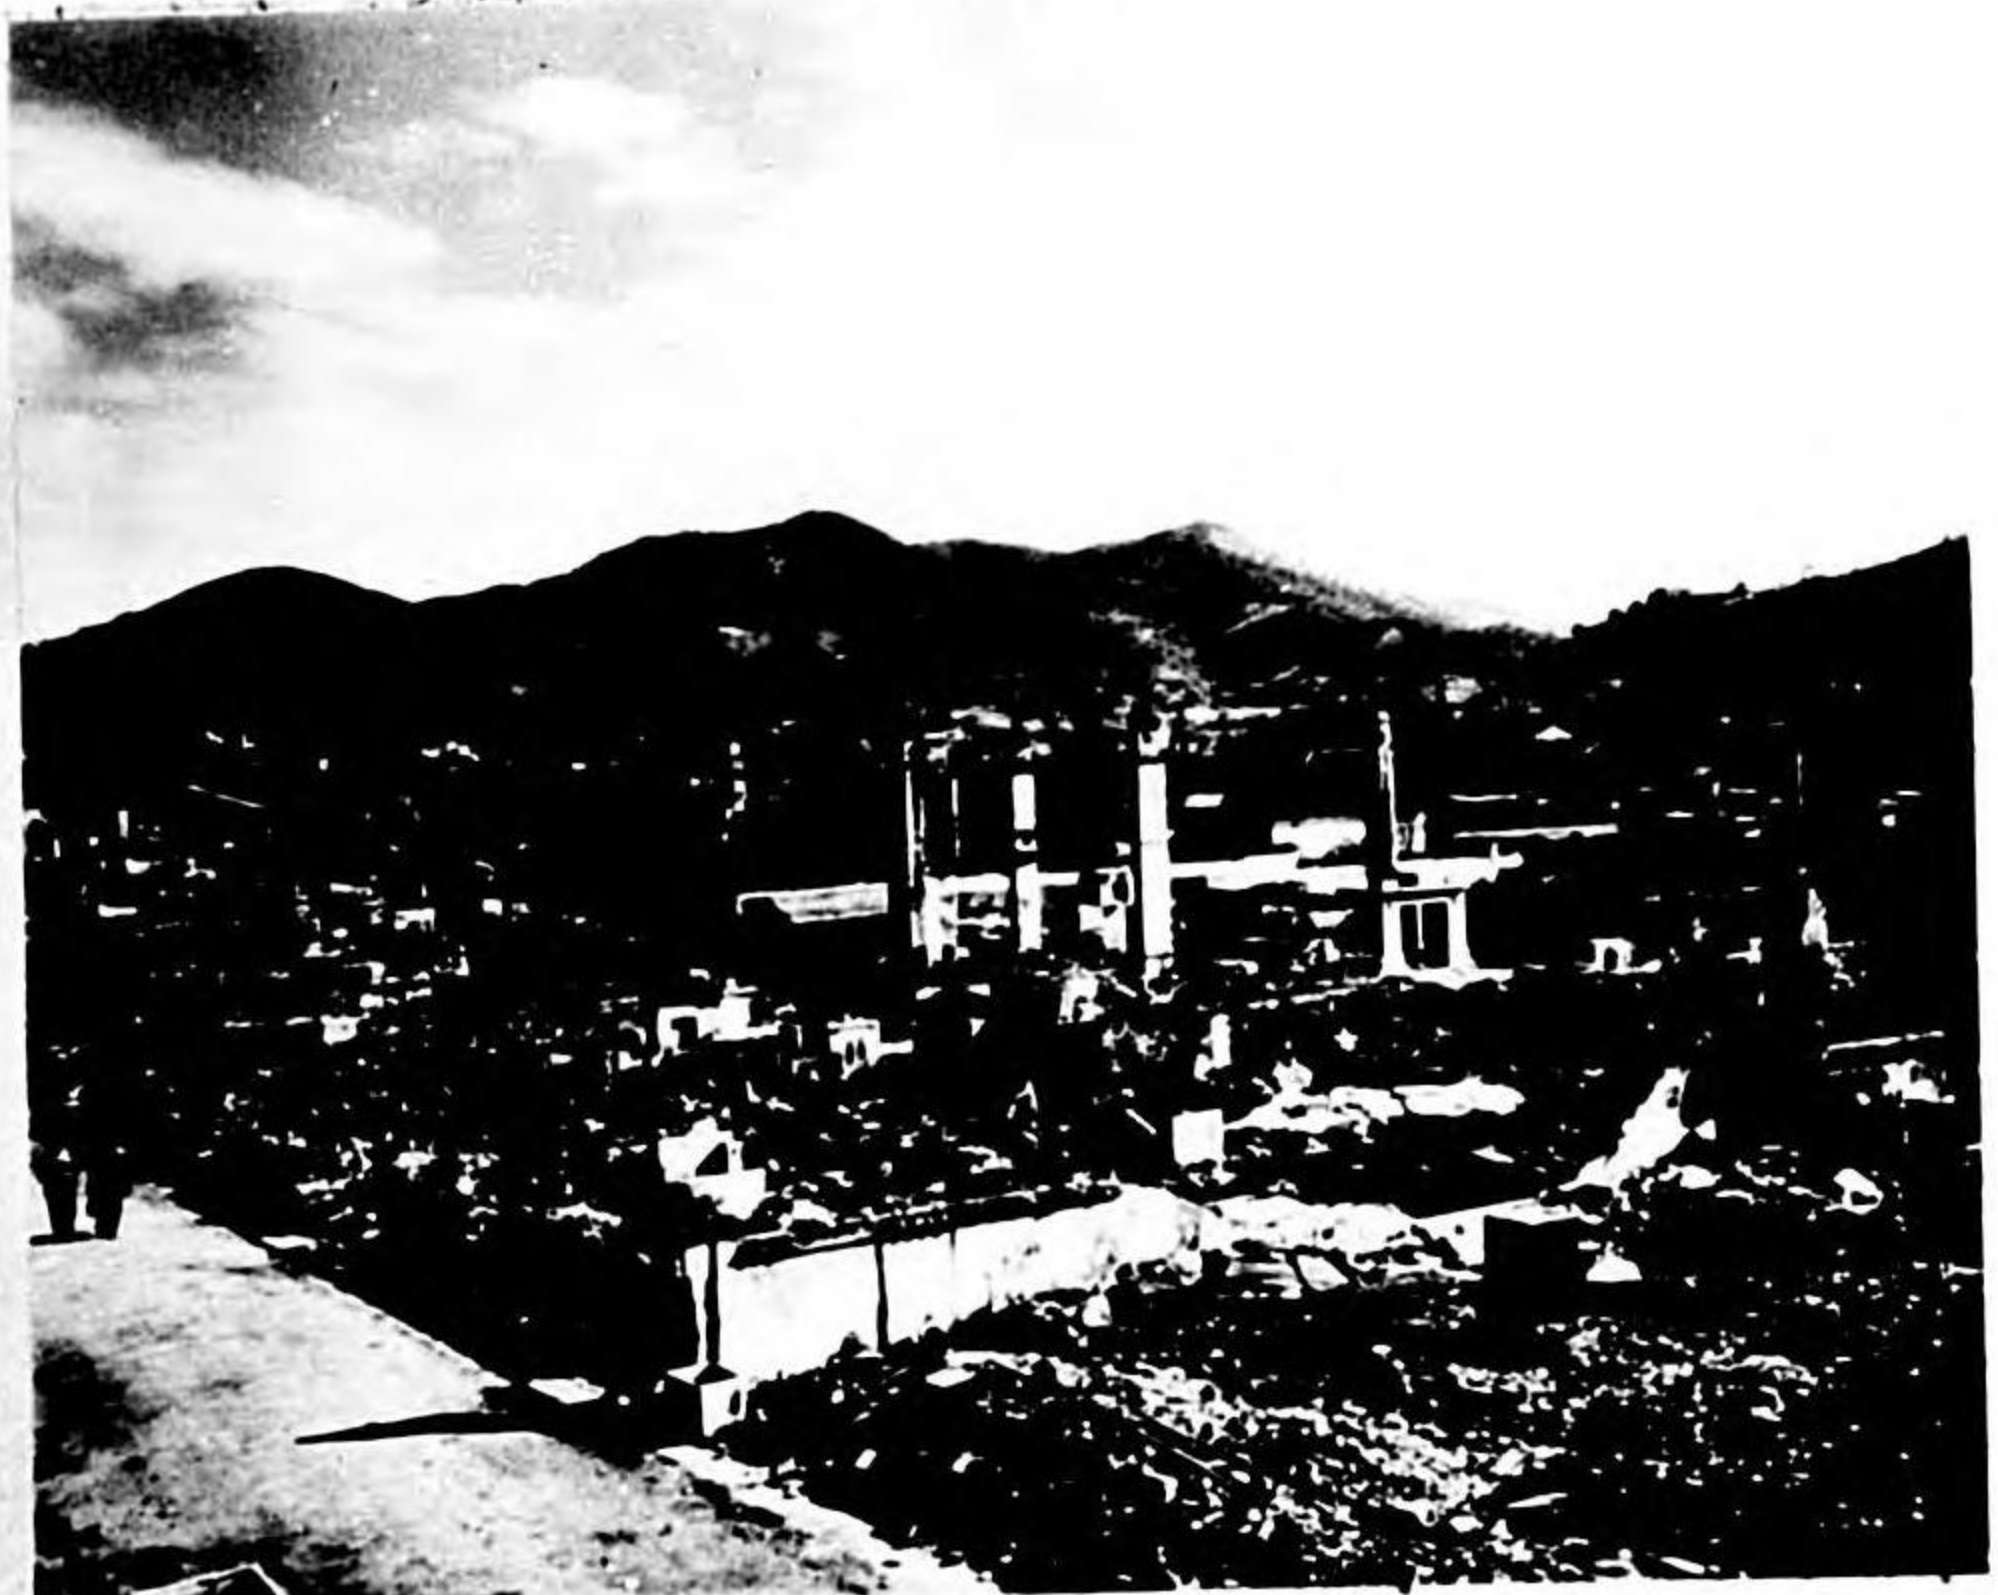
Photo 187. Nagasaki. Same as Photo 186.

(1) Fire-Resistive Buildings. Except in three buildings in Hiroshima, all structural damage to fire-resistive buildings in both cities was caused by blast. On the other hand, fire damage to the interiors and contents of fire-resistive buildings greatly exceeded damage by blast and debris. ^(Photos 177-189) Most of these buildings had combustible interior construction as well as a considerable amount of combustible contents, and combustion in the parts of the buildings which burned out was practically complete. Structural damage to the three fire-resistive buildings in Hiroshima was the result of intense heat of long duration which was dependent

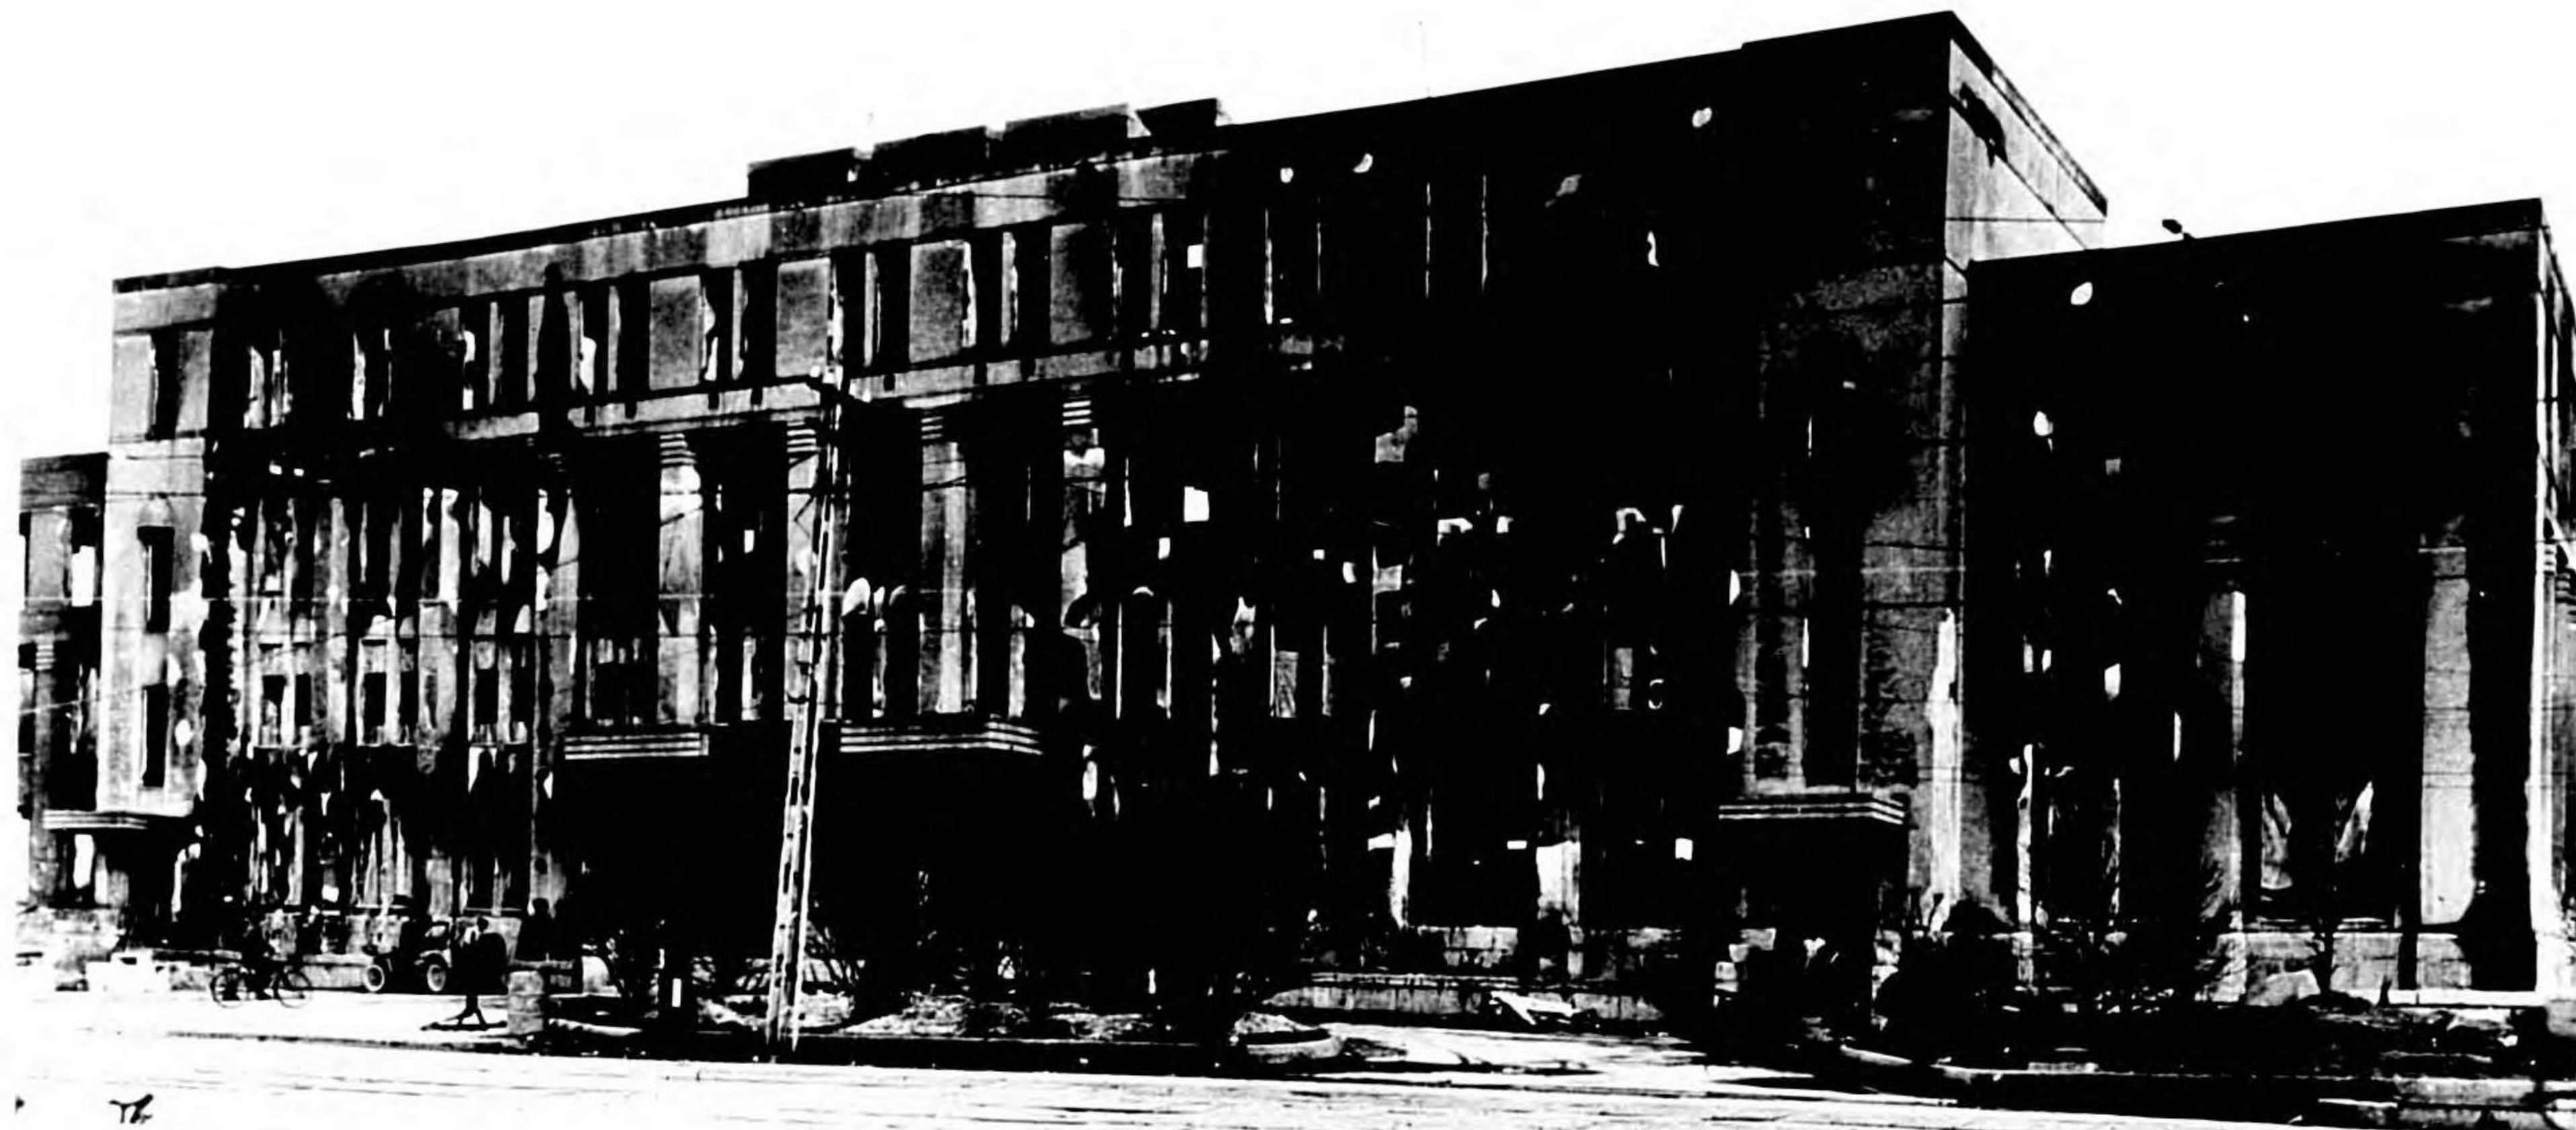
Photo 188. Hiroshima City Hall, 3,300 feet from GZ. West elevation of reinforced-concrete building--minor damage only: sash blown out, trim and finish consumed by fire. Few tile partitions blown out.

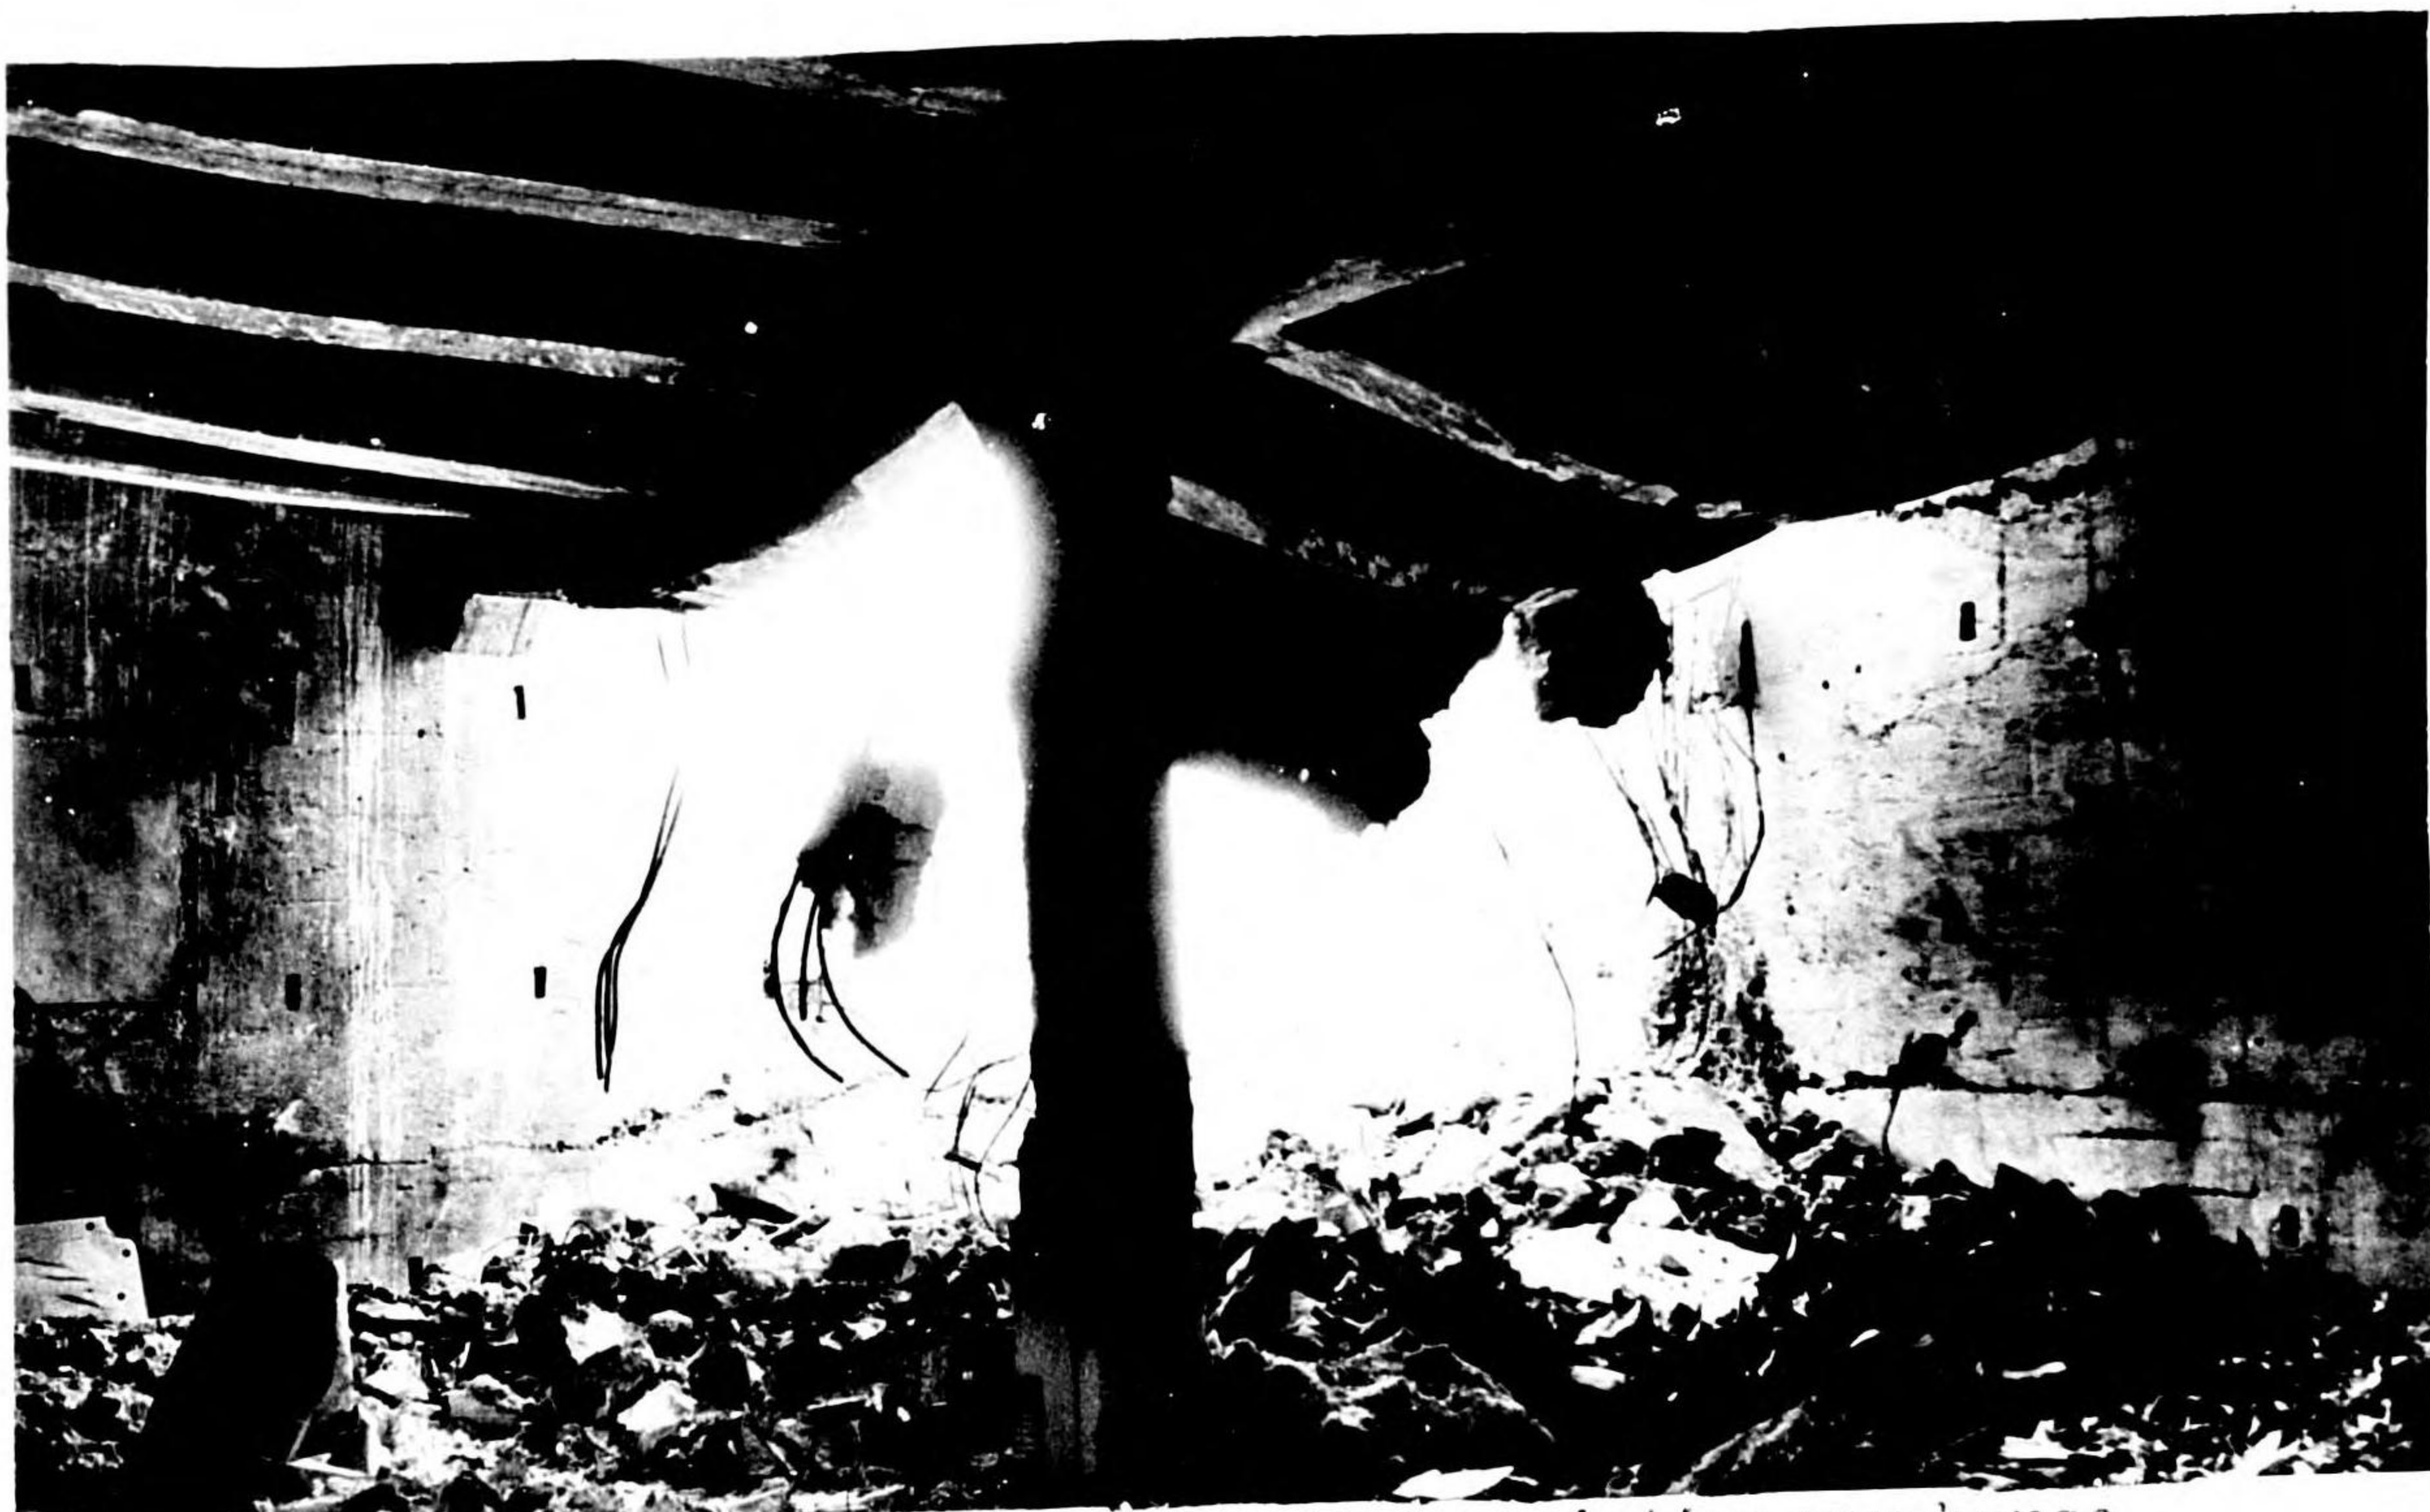
Photo 190. Hiroshima. Misasa Credit Association warehouse, reinforced-concrete building 5,800 feet from GZ. Second story of east section showing structural fire damage to roof, cracks in walls spalling of concrete on columns, and deep ashes on floor.

upon the nature of the contents (grain in two cases, and books in the other) and confinement of the heat. ^(Photos 190-191)

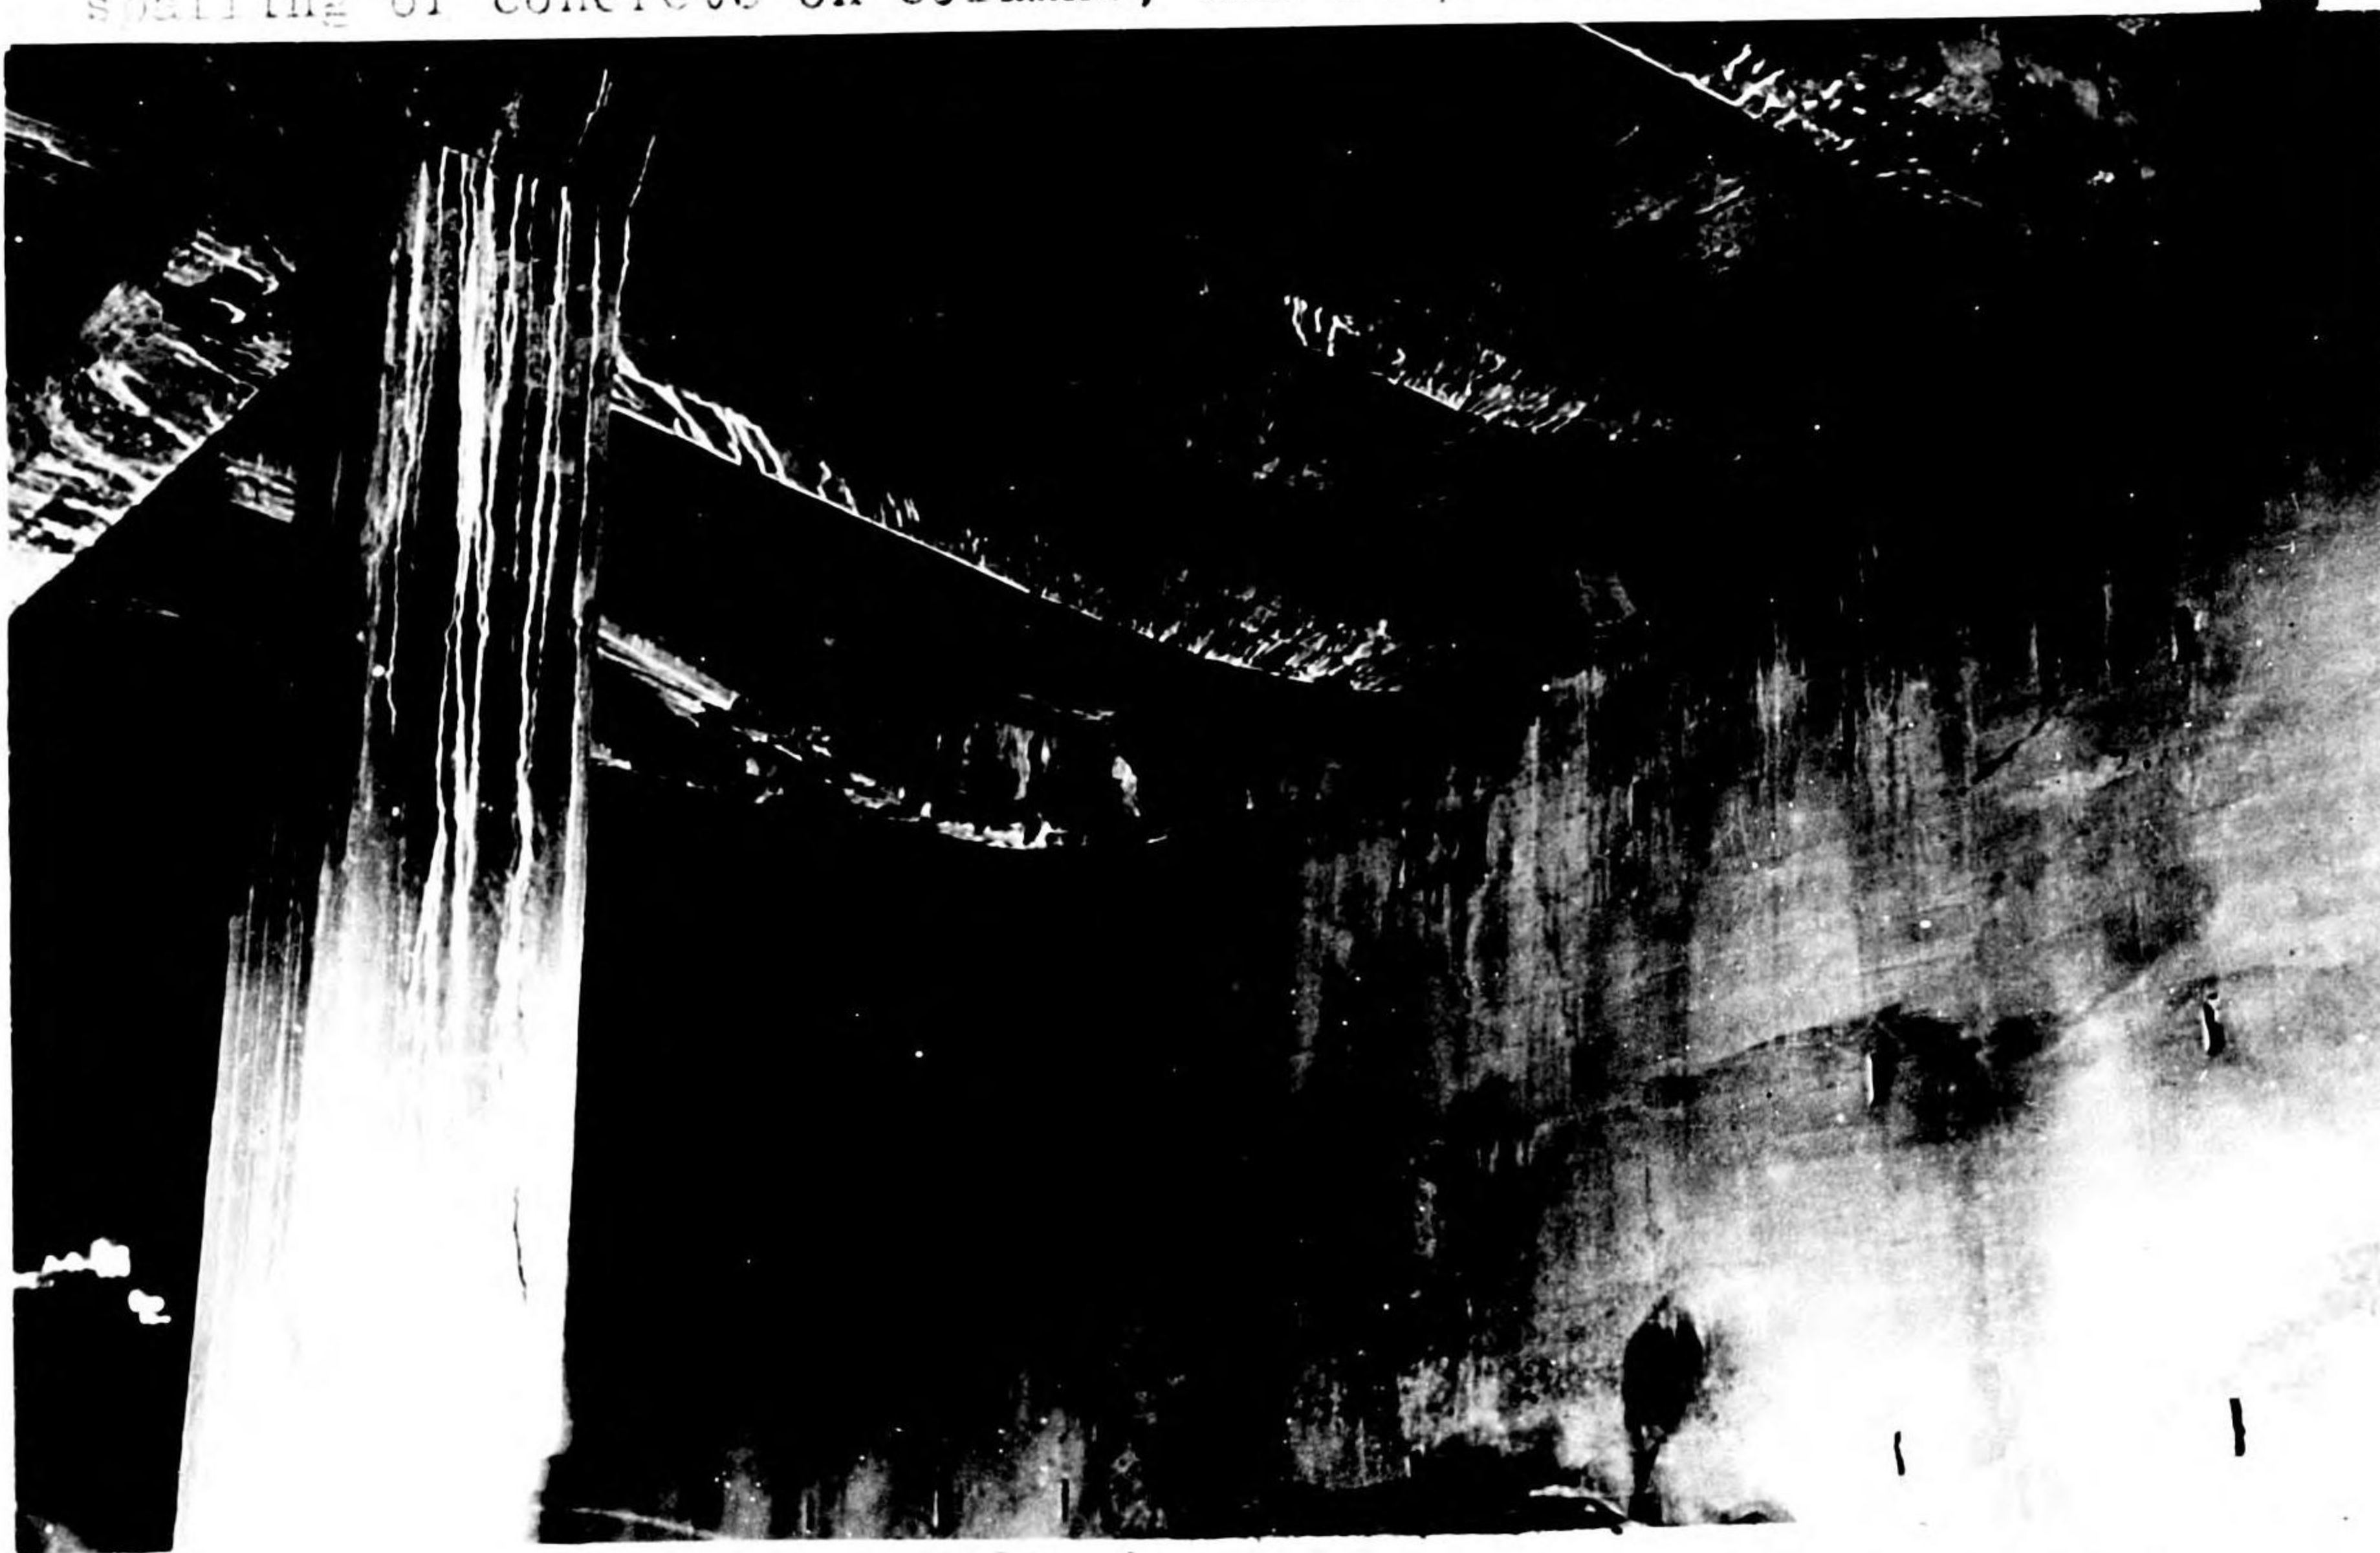
Photo 191. Same as Photo 190. View of first story showing structural damage to second floor by fire: spalling and disintegration of concrete.

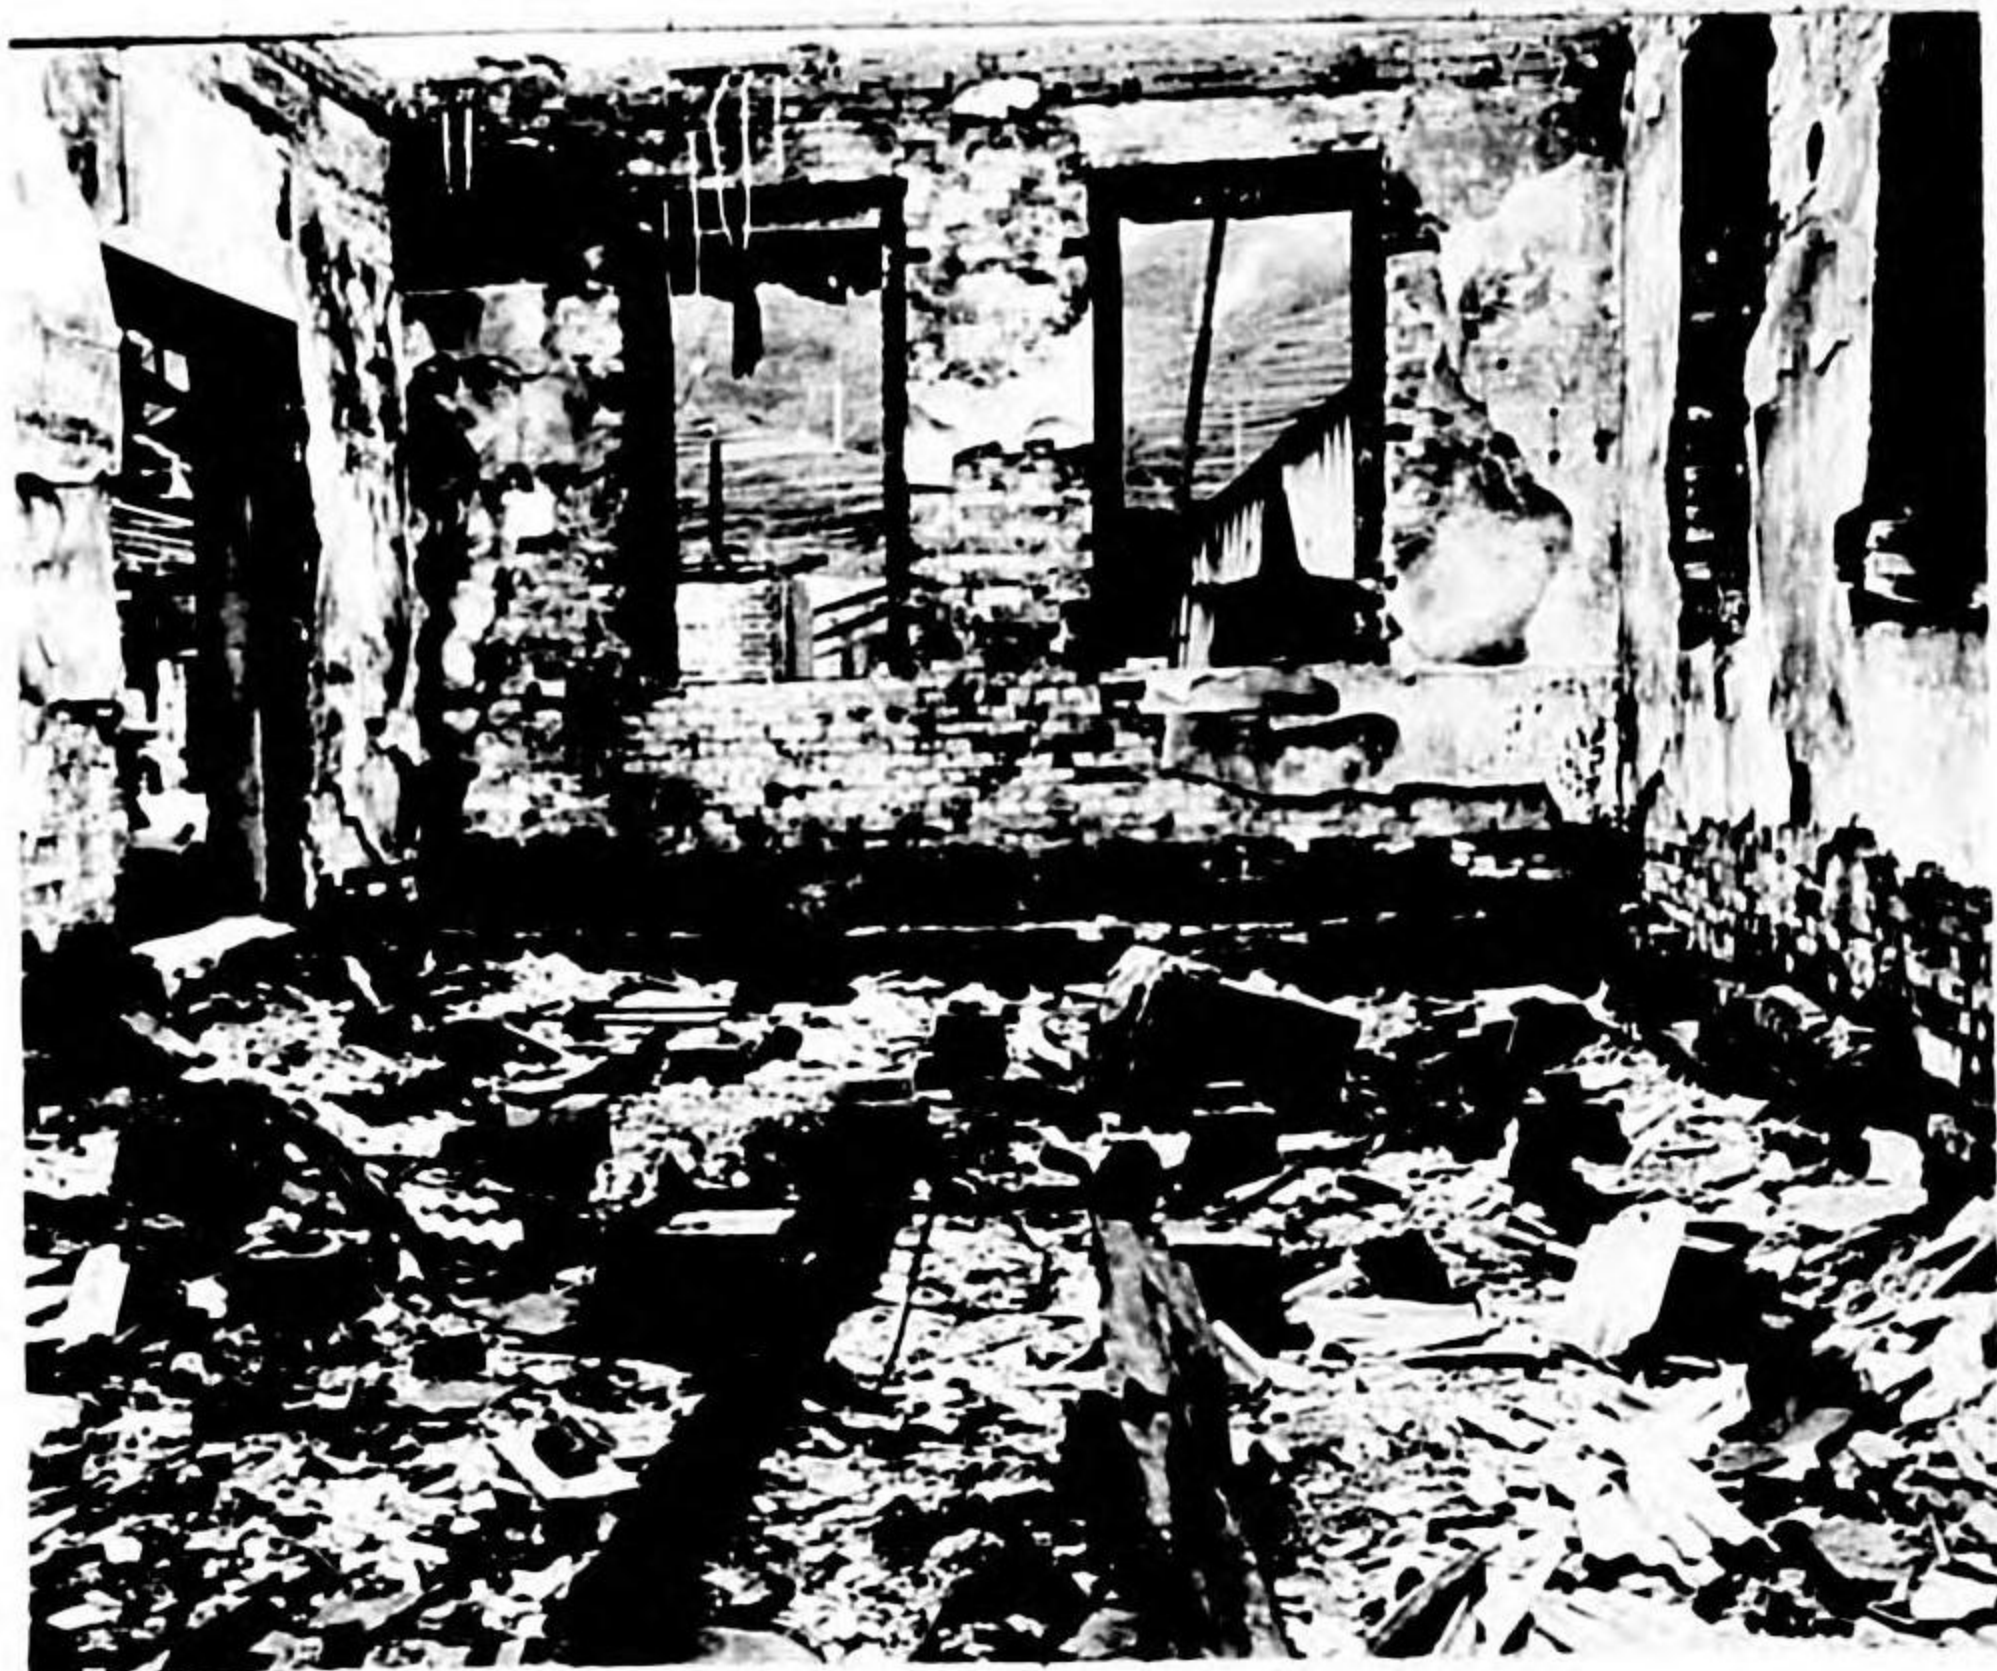
Photo 194. Nagasaki. Load-bearing brick-wall structure, 6,400 feet from GZ. Roof and contents destroyed by fire.

Nagasaki were totally damaged by fire. ^(Photo 194)
