CHAPTER VII

STRUCTURAL CONSIDERATIONS

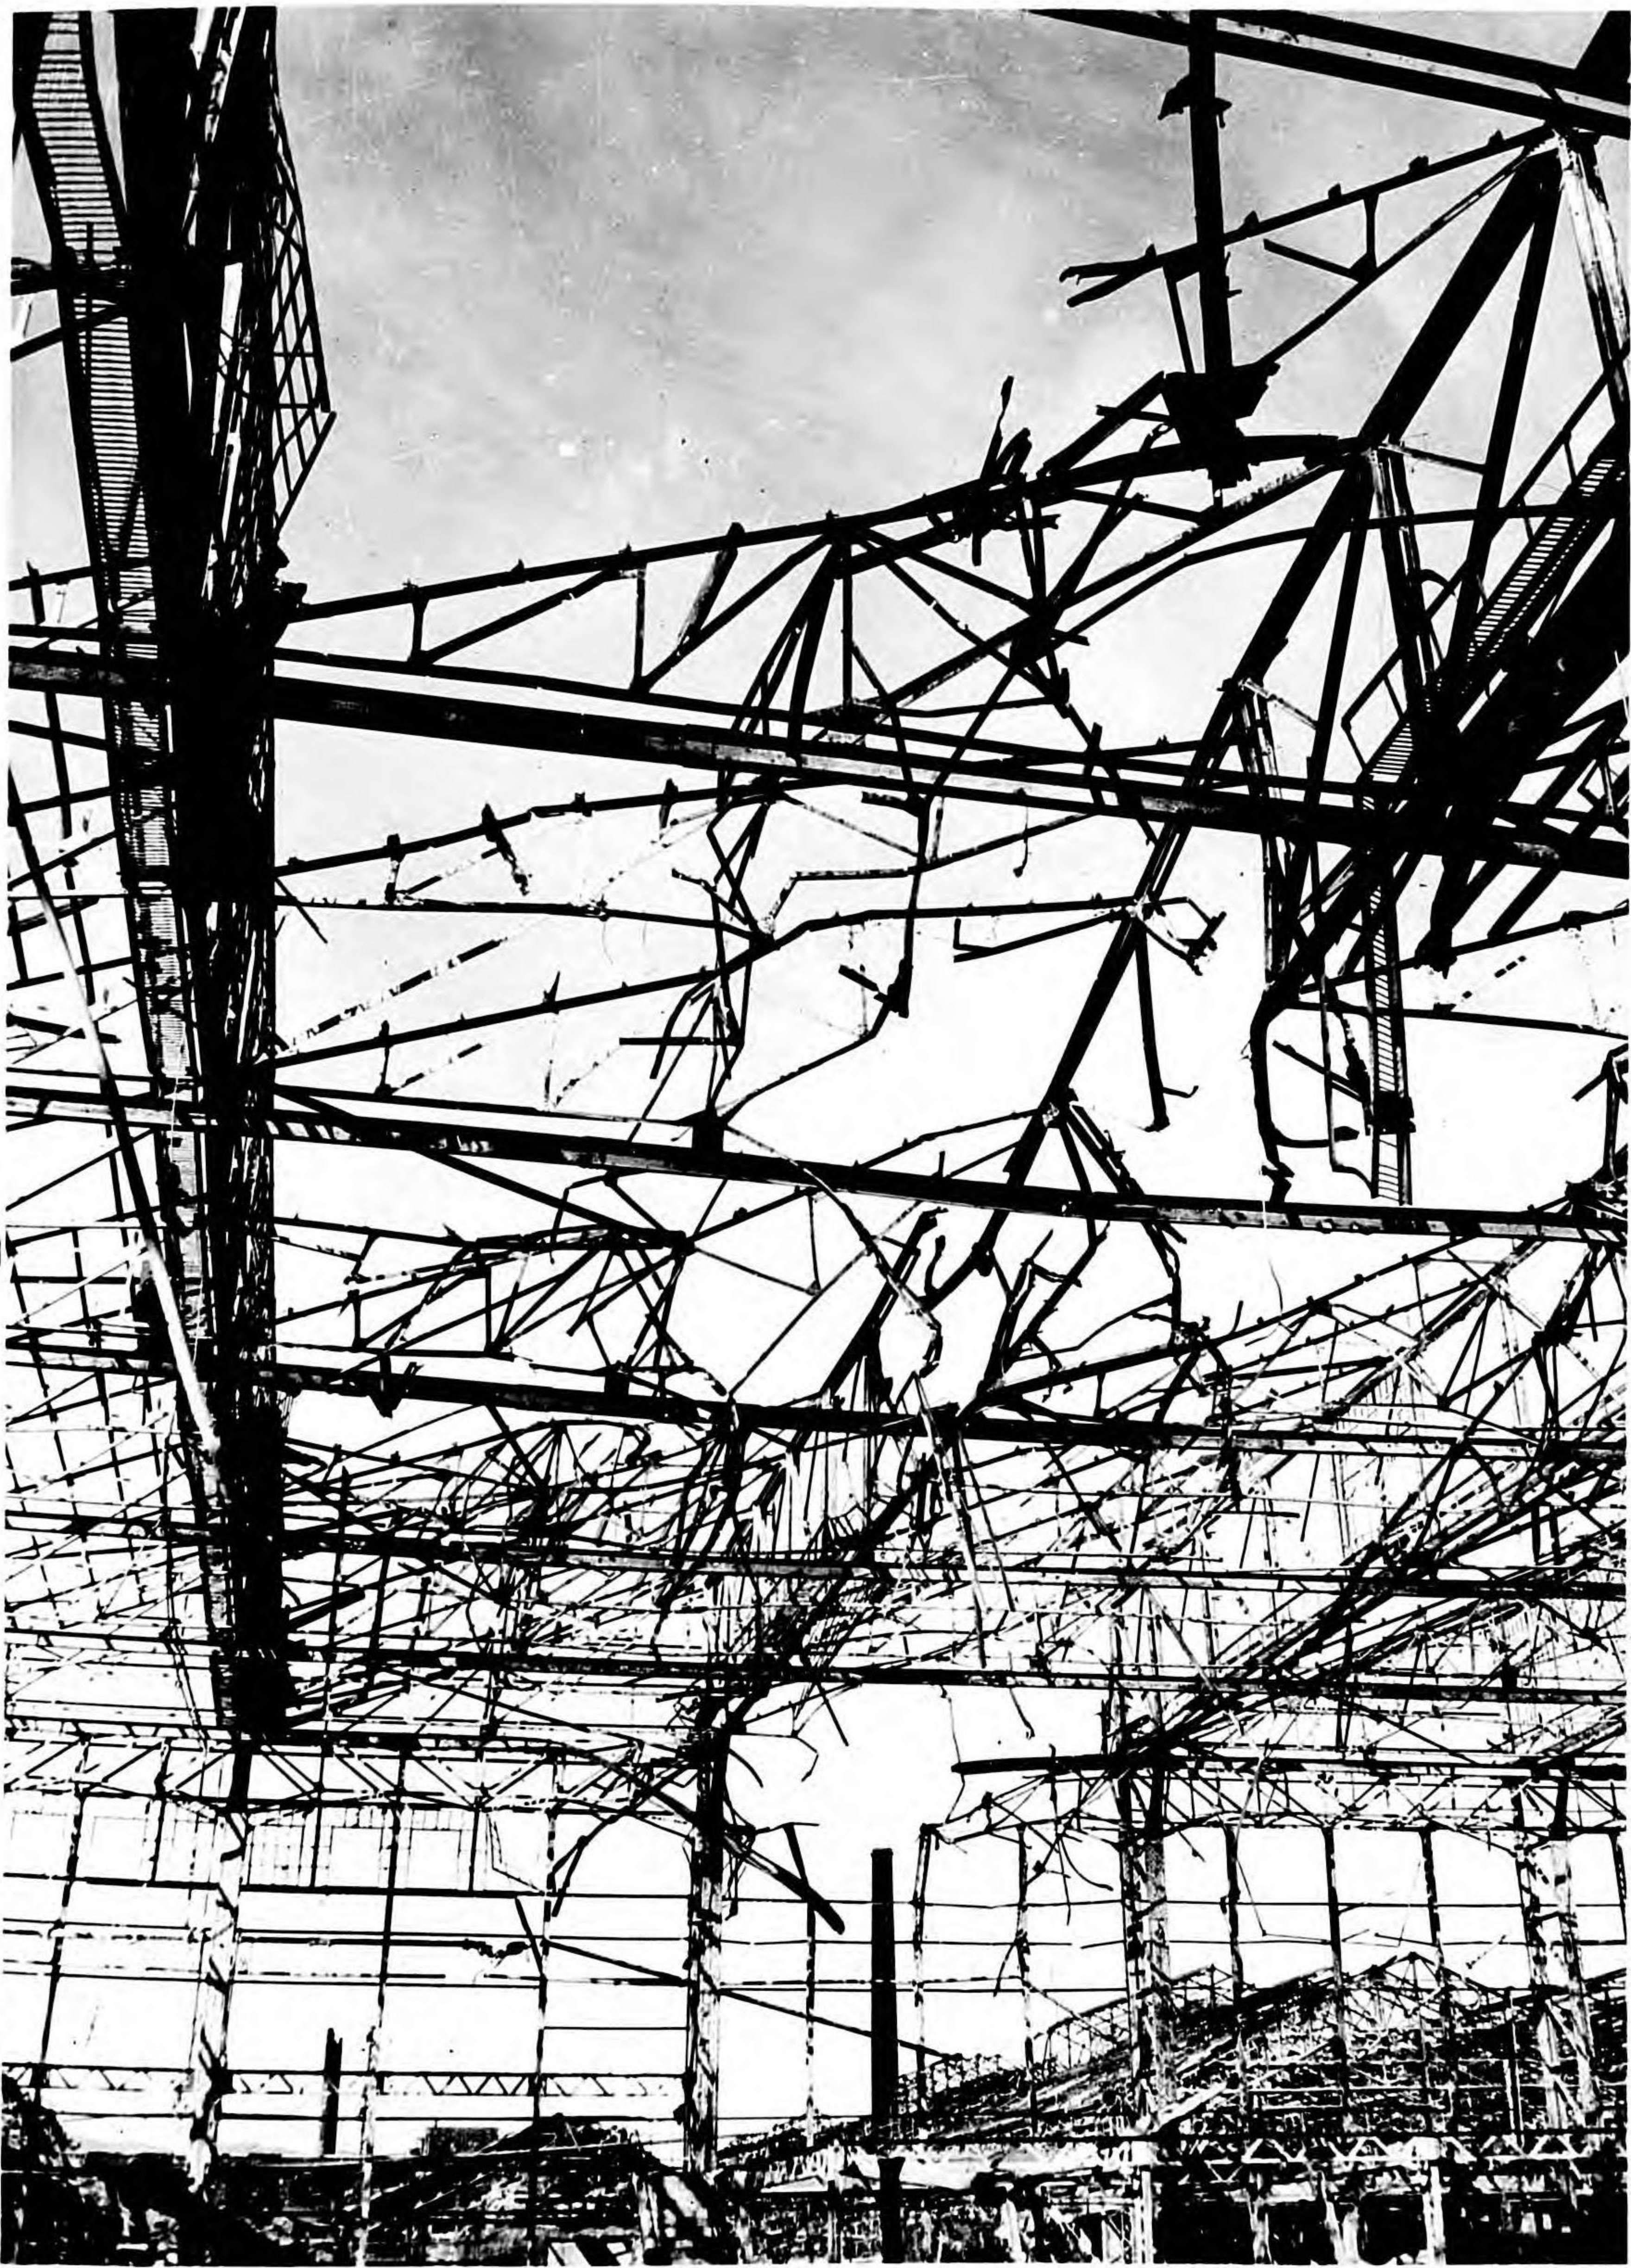
Photo 195
578

Photo 195. Gnawing action of four 500-pound bombs.

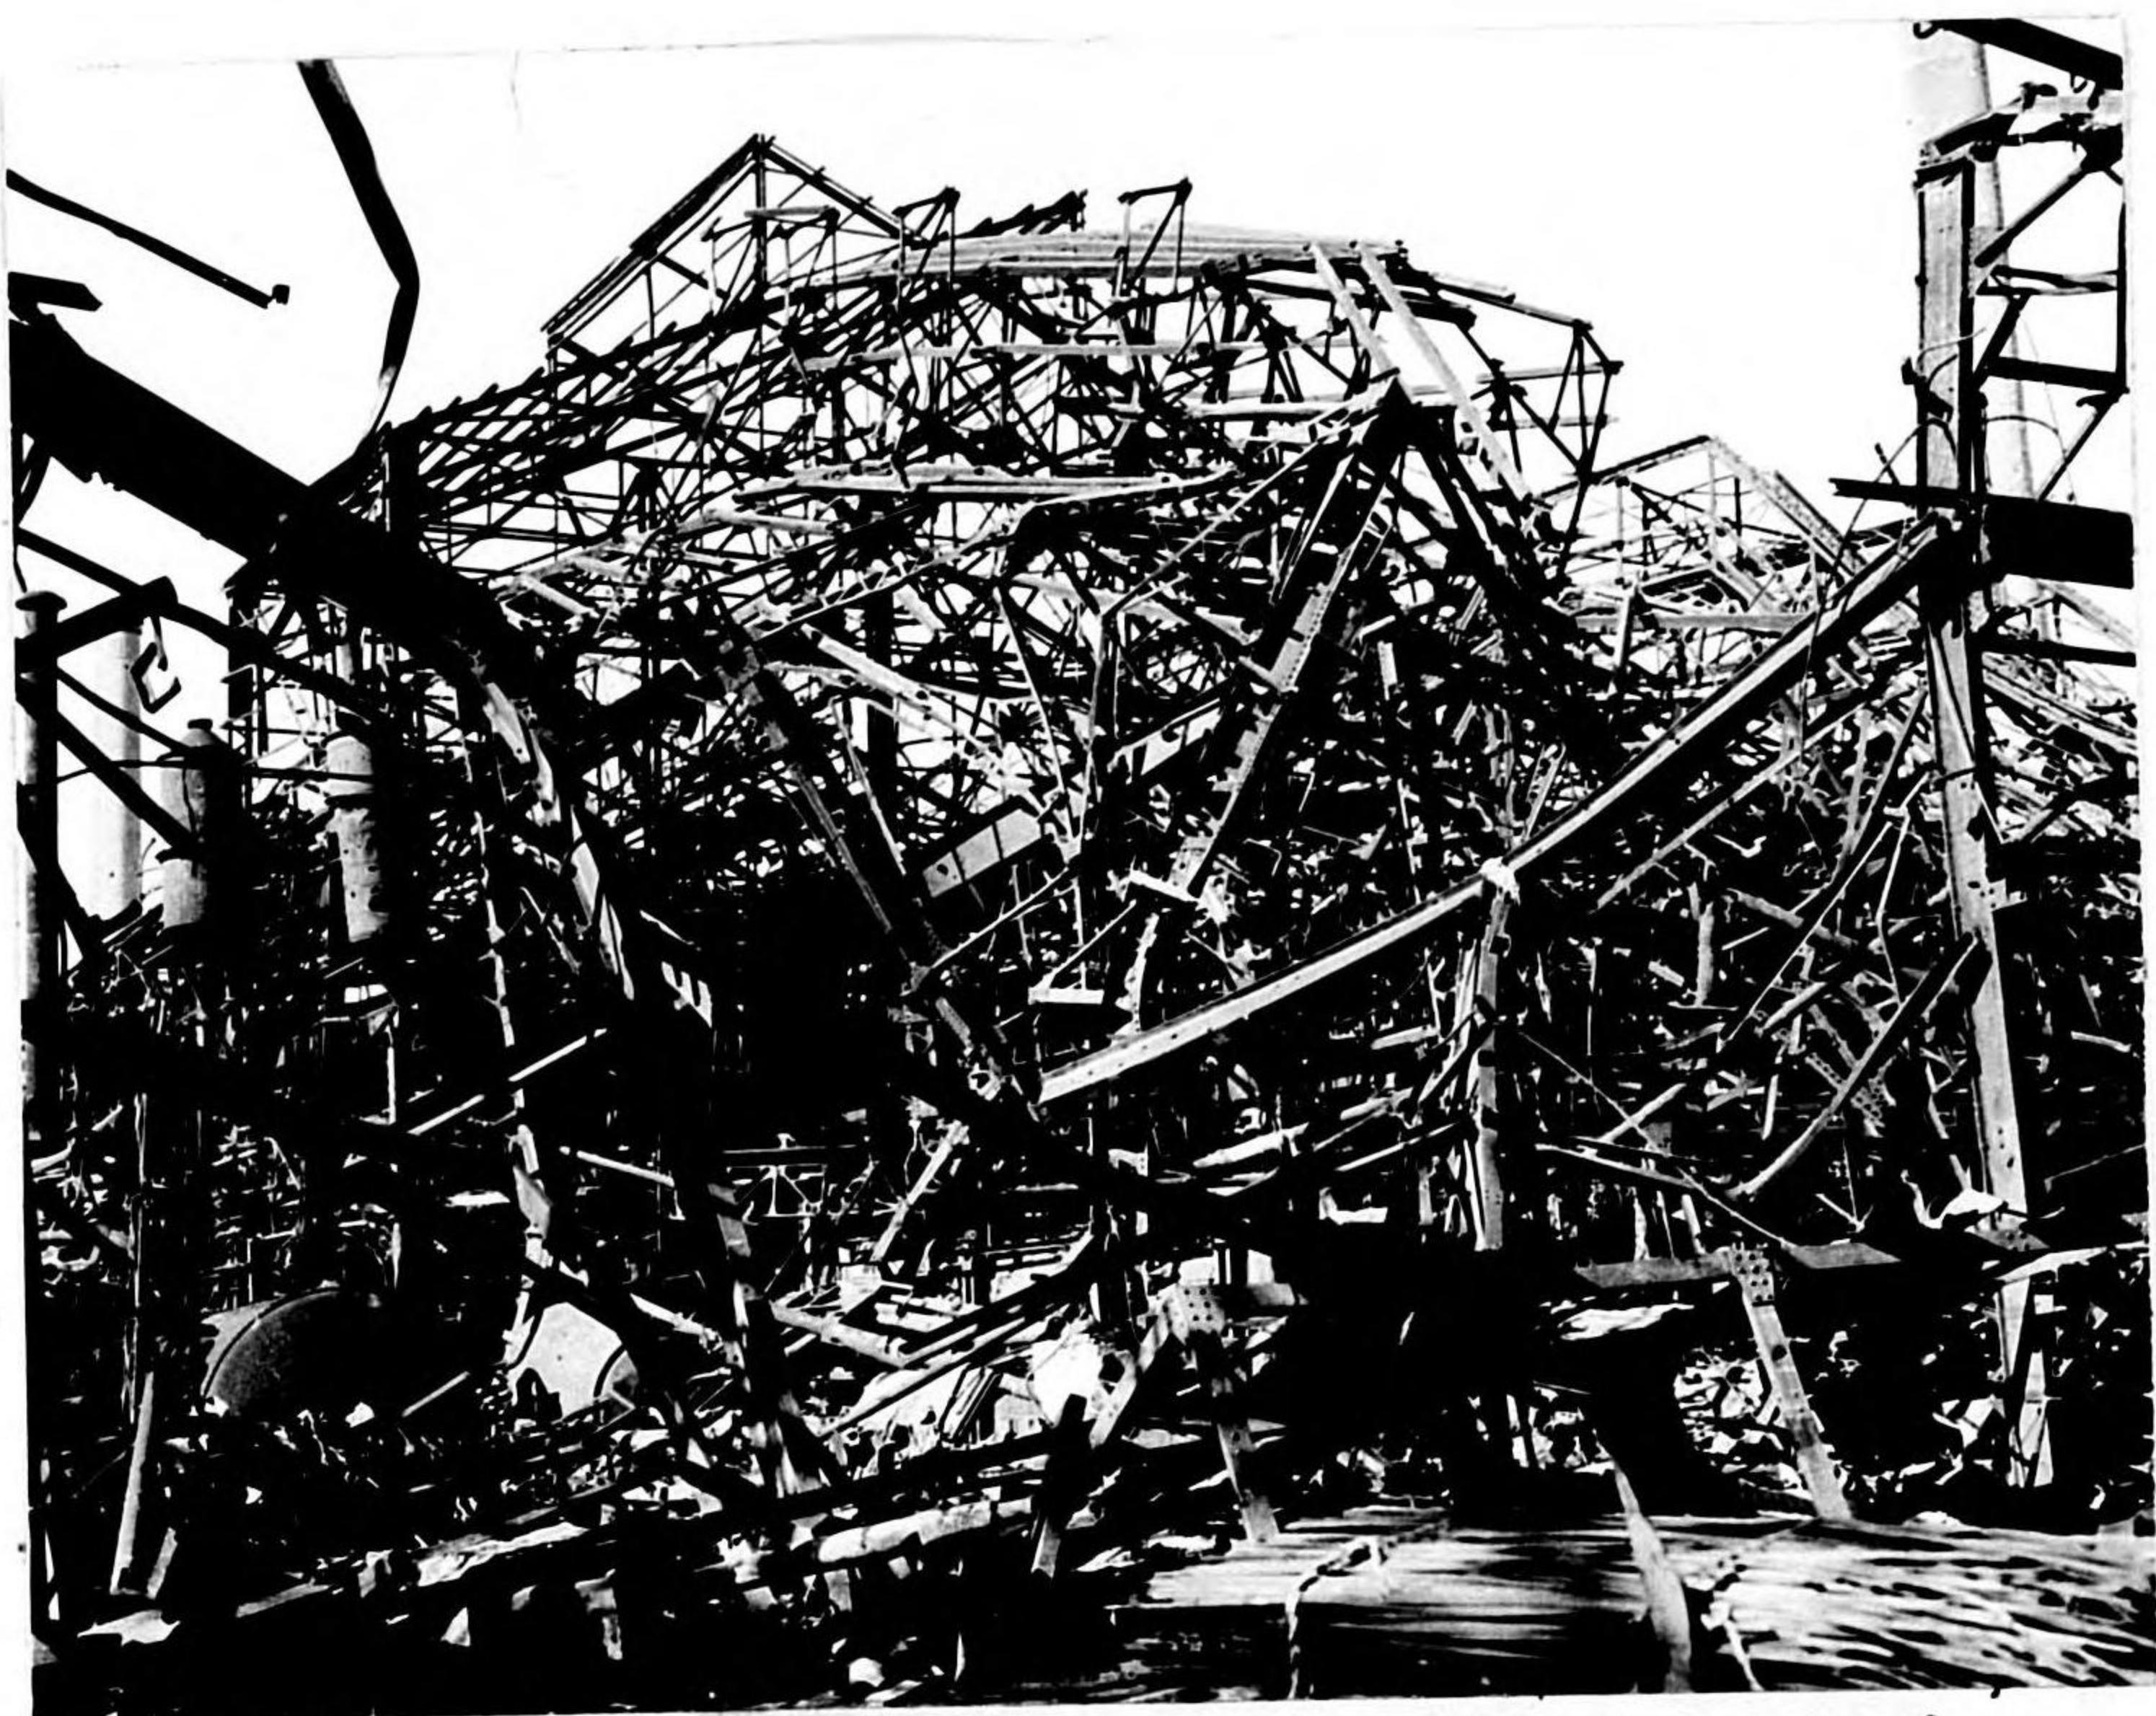
Photo 196. Blast action of a 4,000-pound bomb.

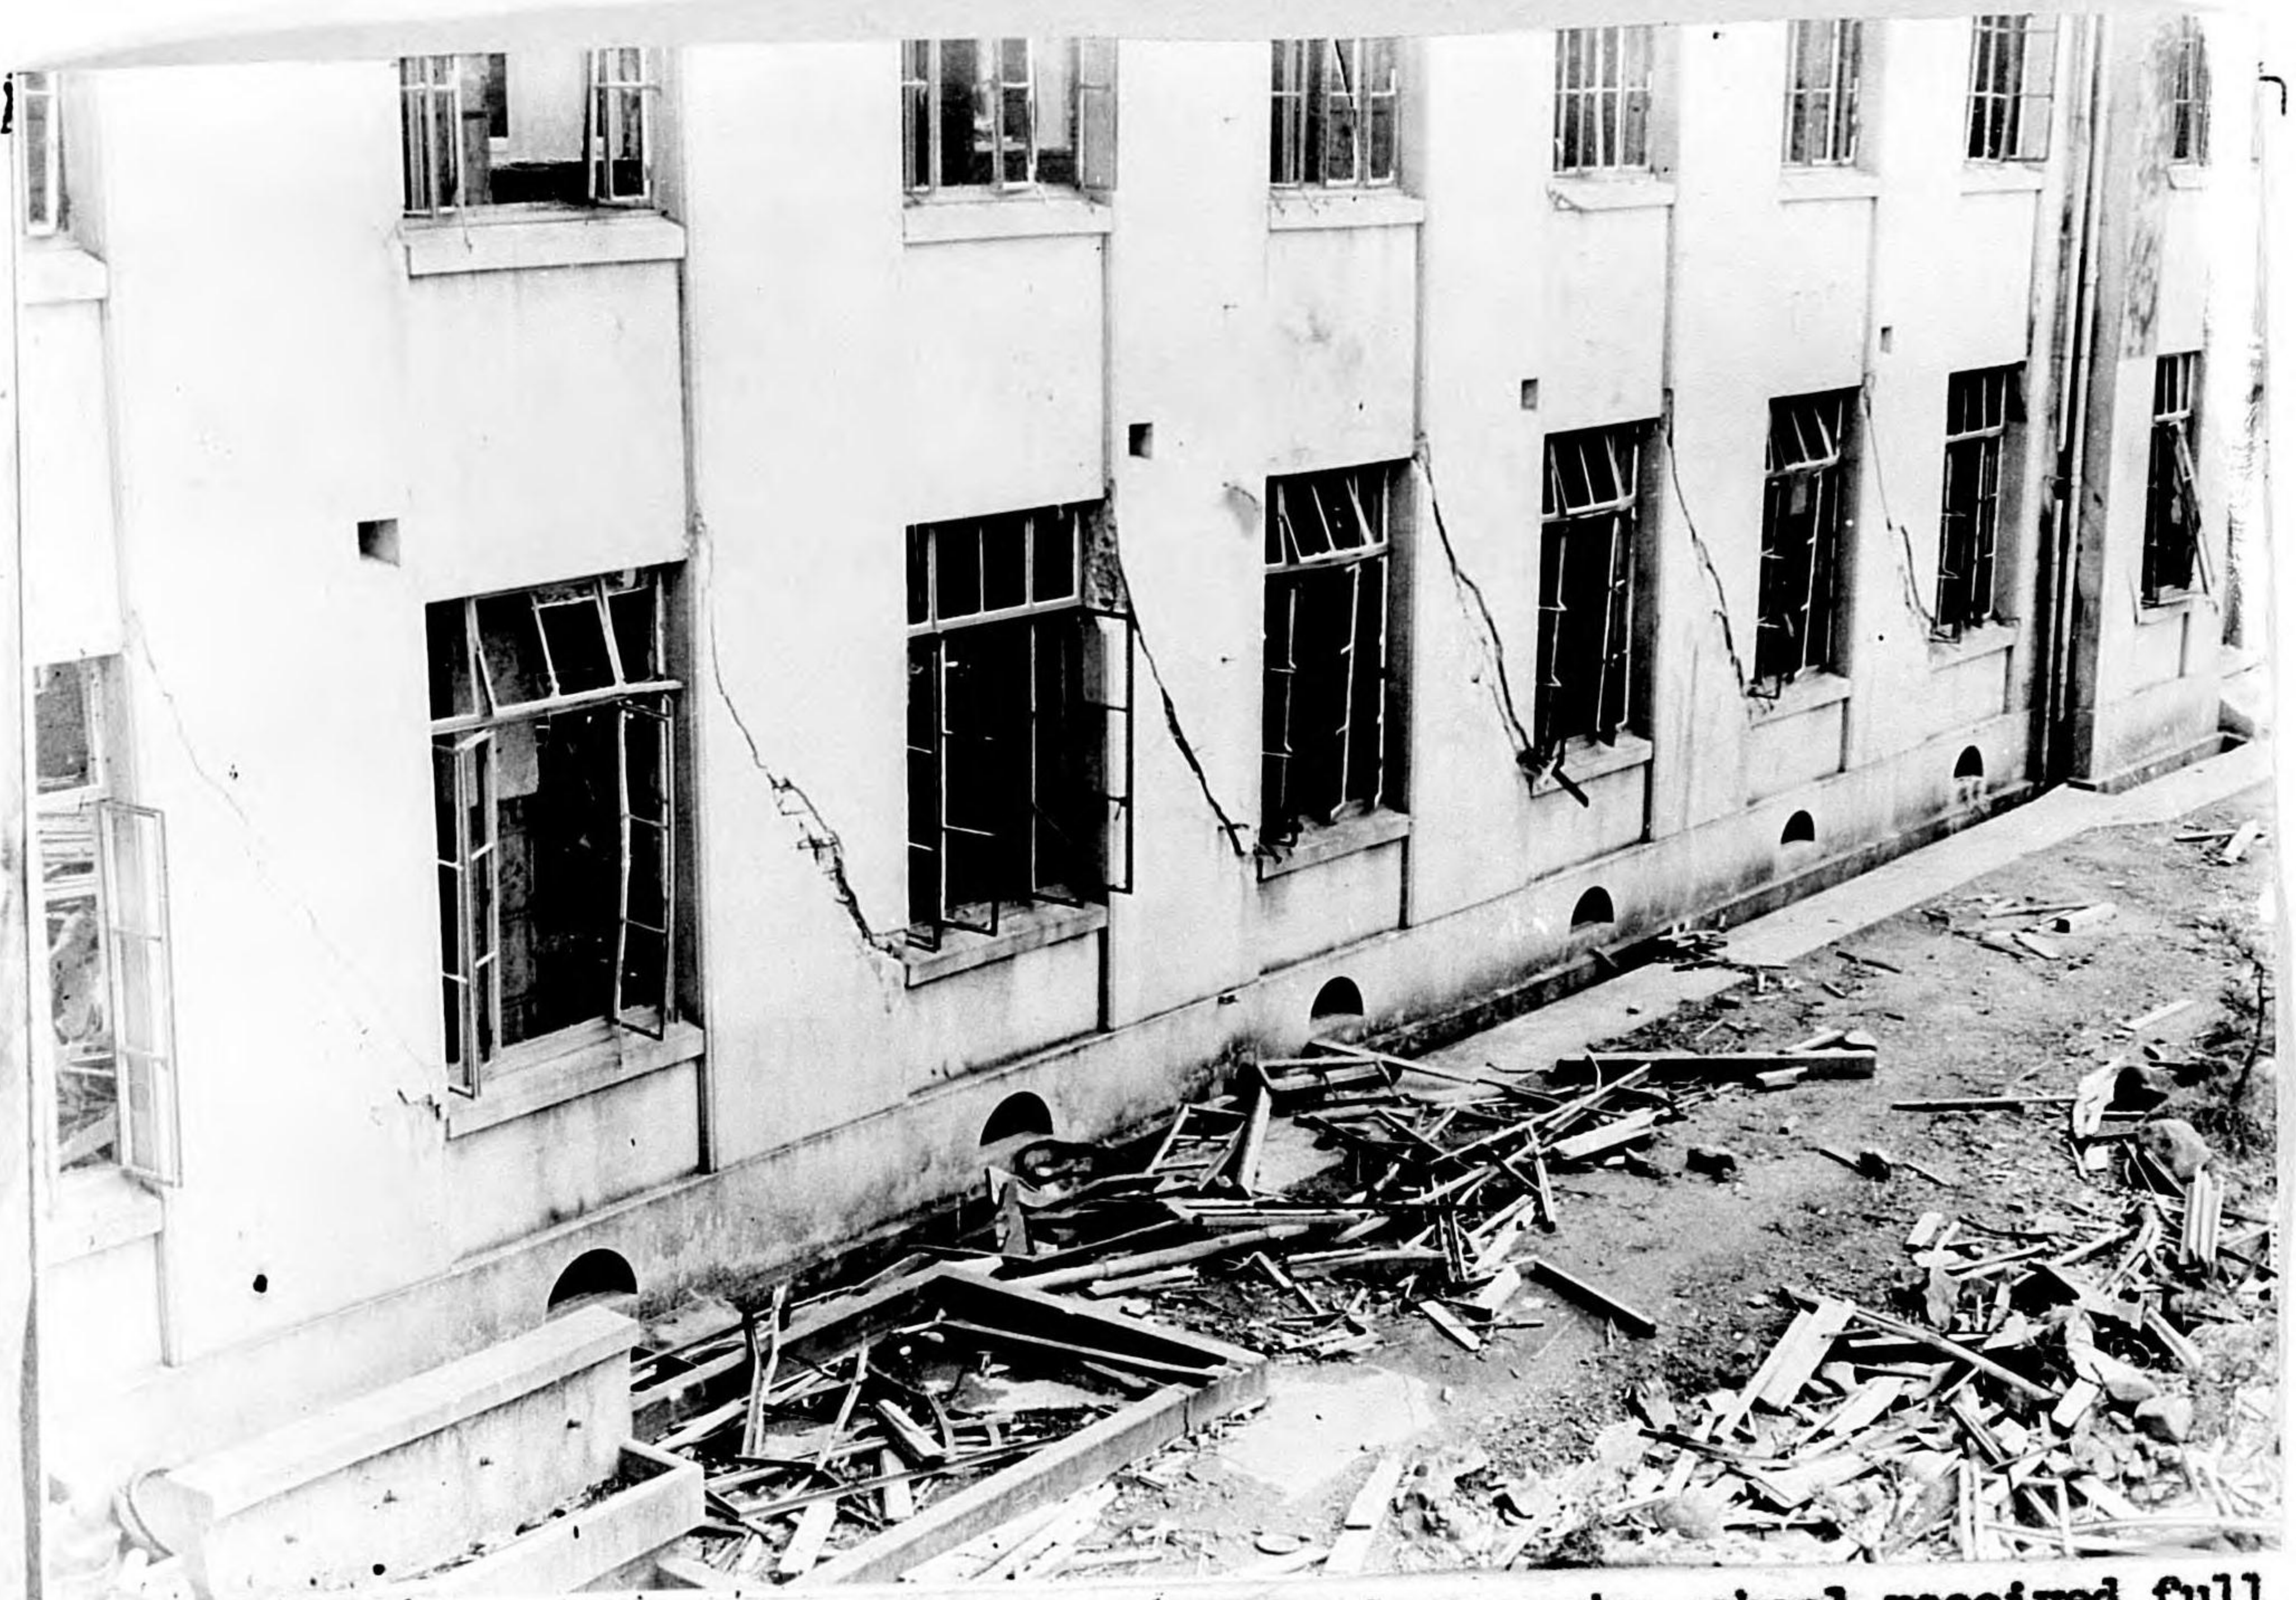
a. An L-shaped, three-story, reinforced-concrete school at Nagasaki received the full blast of the atomic bomb on the outer face of one leg. The pressure was sufficient to cause the heavy columns, each approximately one foot by six feet, on the inner face of the other leg to fail in shear in the ground story (Photo 197).

Photo 197. L-shaped, three-story, reinforced-concrete school received full blast of atomic bomb on outer face of one leg. Pressure caused heavy columns, each approximately 1 by 6 feet, on inner face of other leg to fail in shear in the ground story.

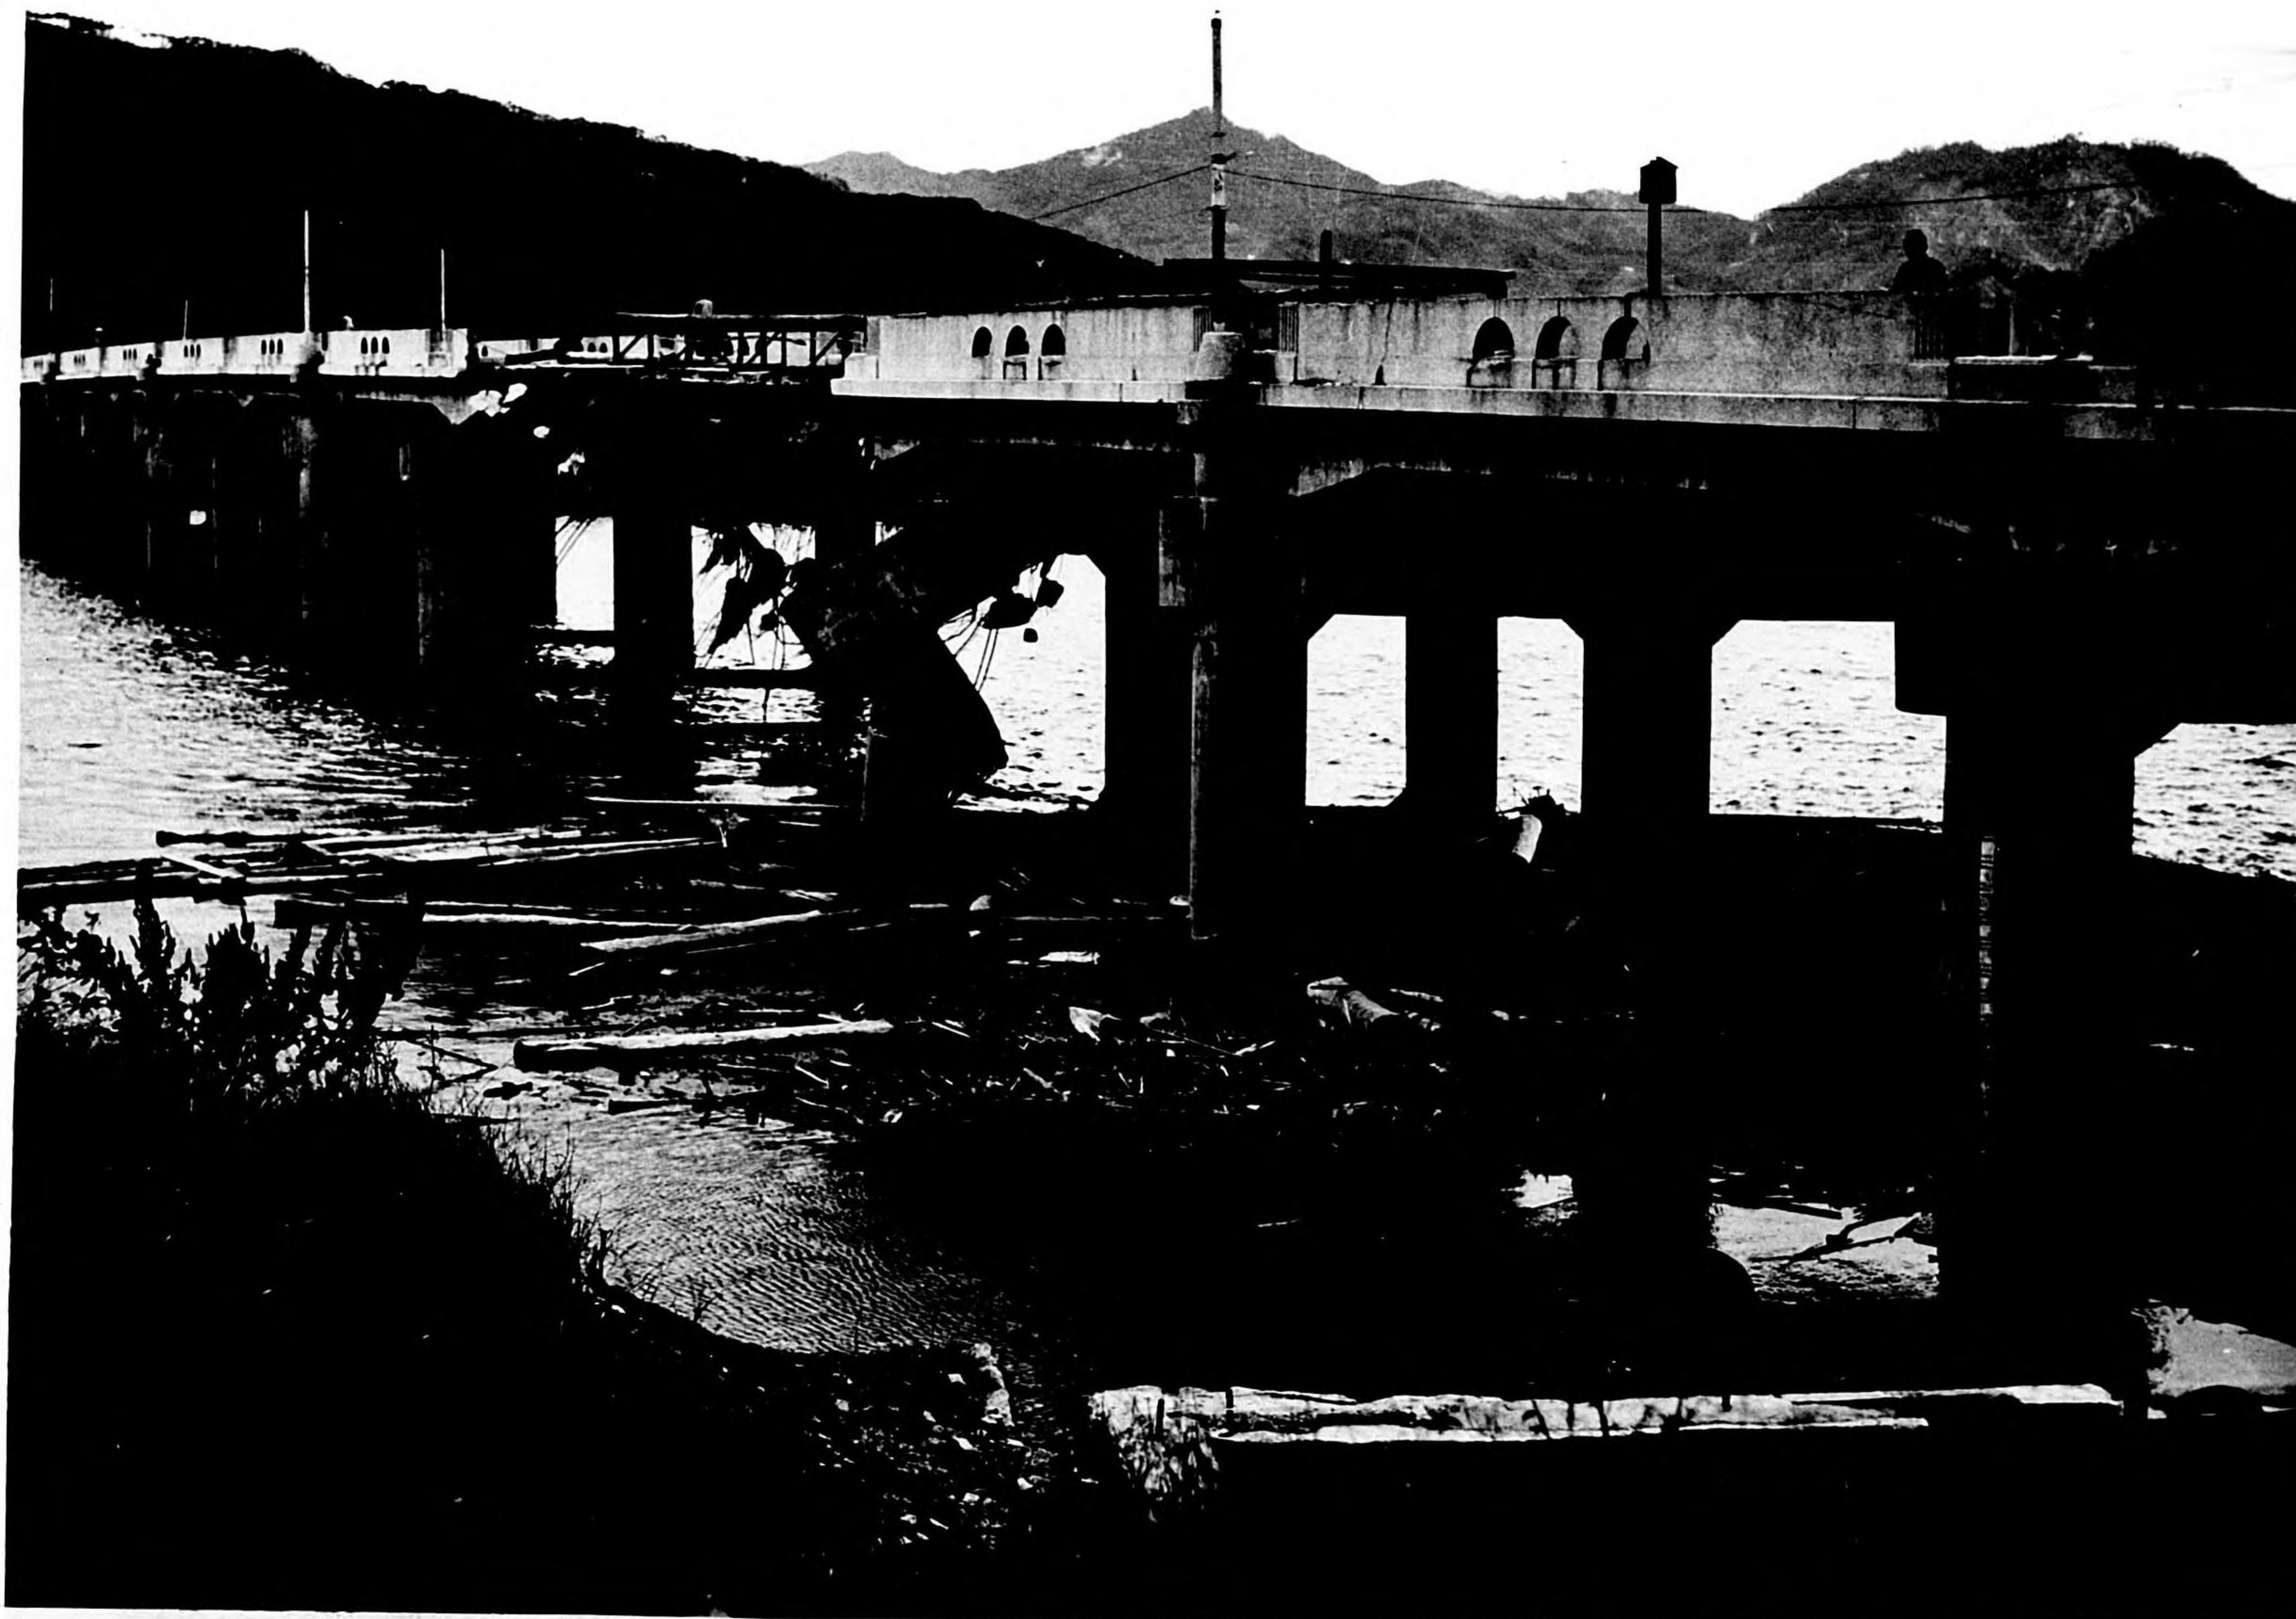
b. A reinforced-concrete T-beam bridge at Hiroshima lost a bent in the flood which followed the hurricane. The adjacent bent was also severely damaged, but one-half of the roadway remained in position and continued to carry unrestricted traffic (Photo 198). Nothing was learned, unfortunately, about the details of the reinforcing.

Photo 198. Reinforced-concrete bridge lost bent in flood. Adjacent bent was also severely damaged, but one-half of roadway remained in position and continued to carry unrestricted traffic.

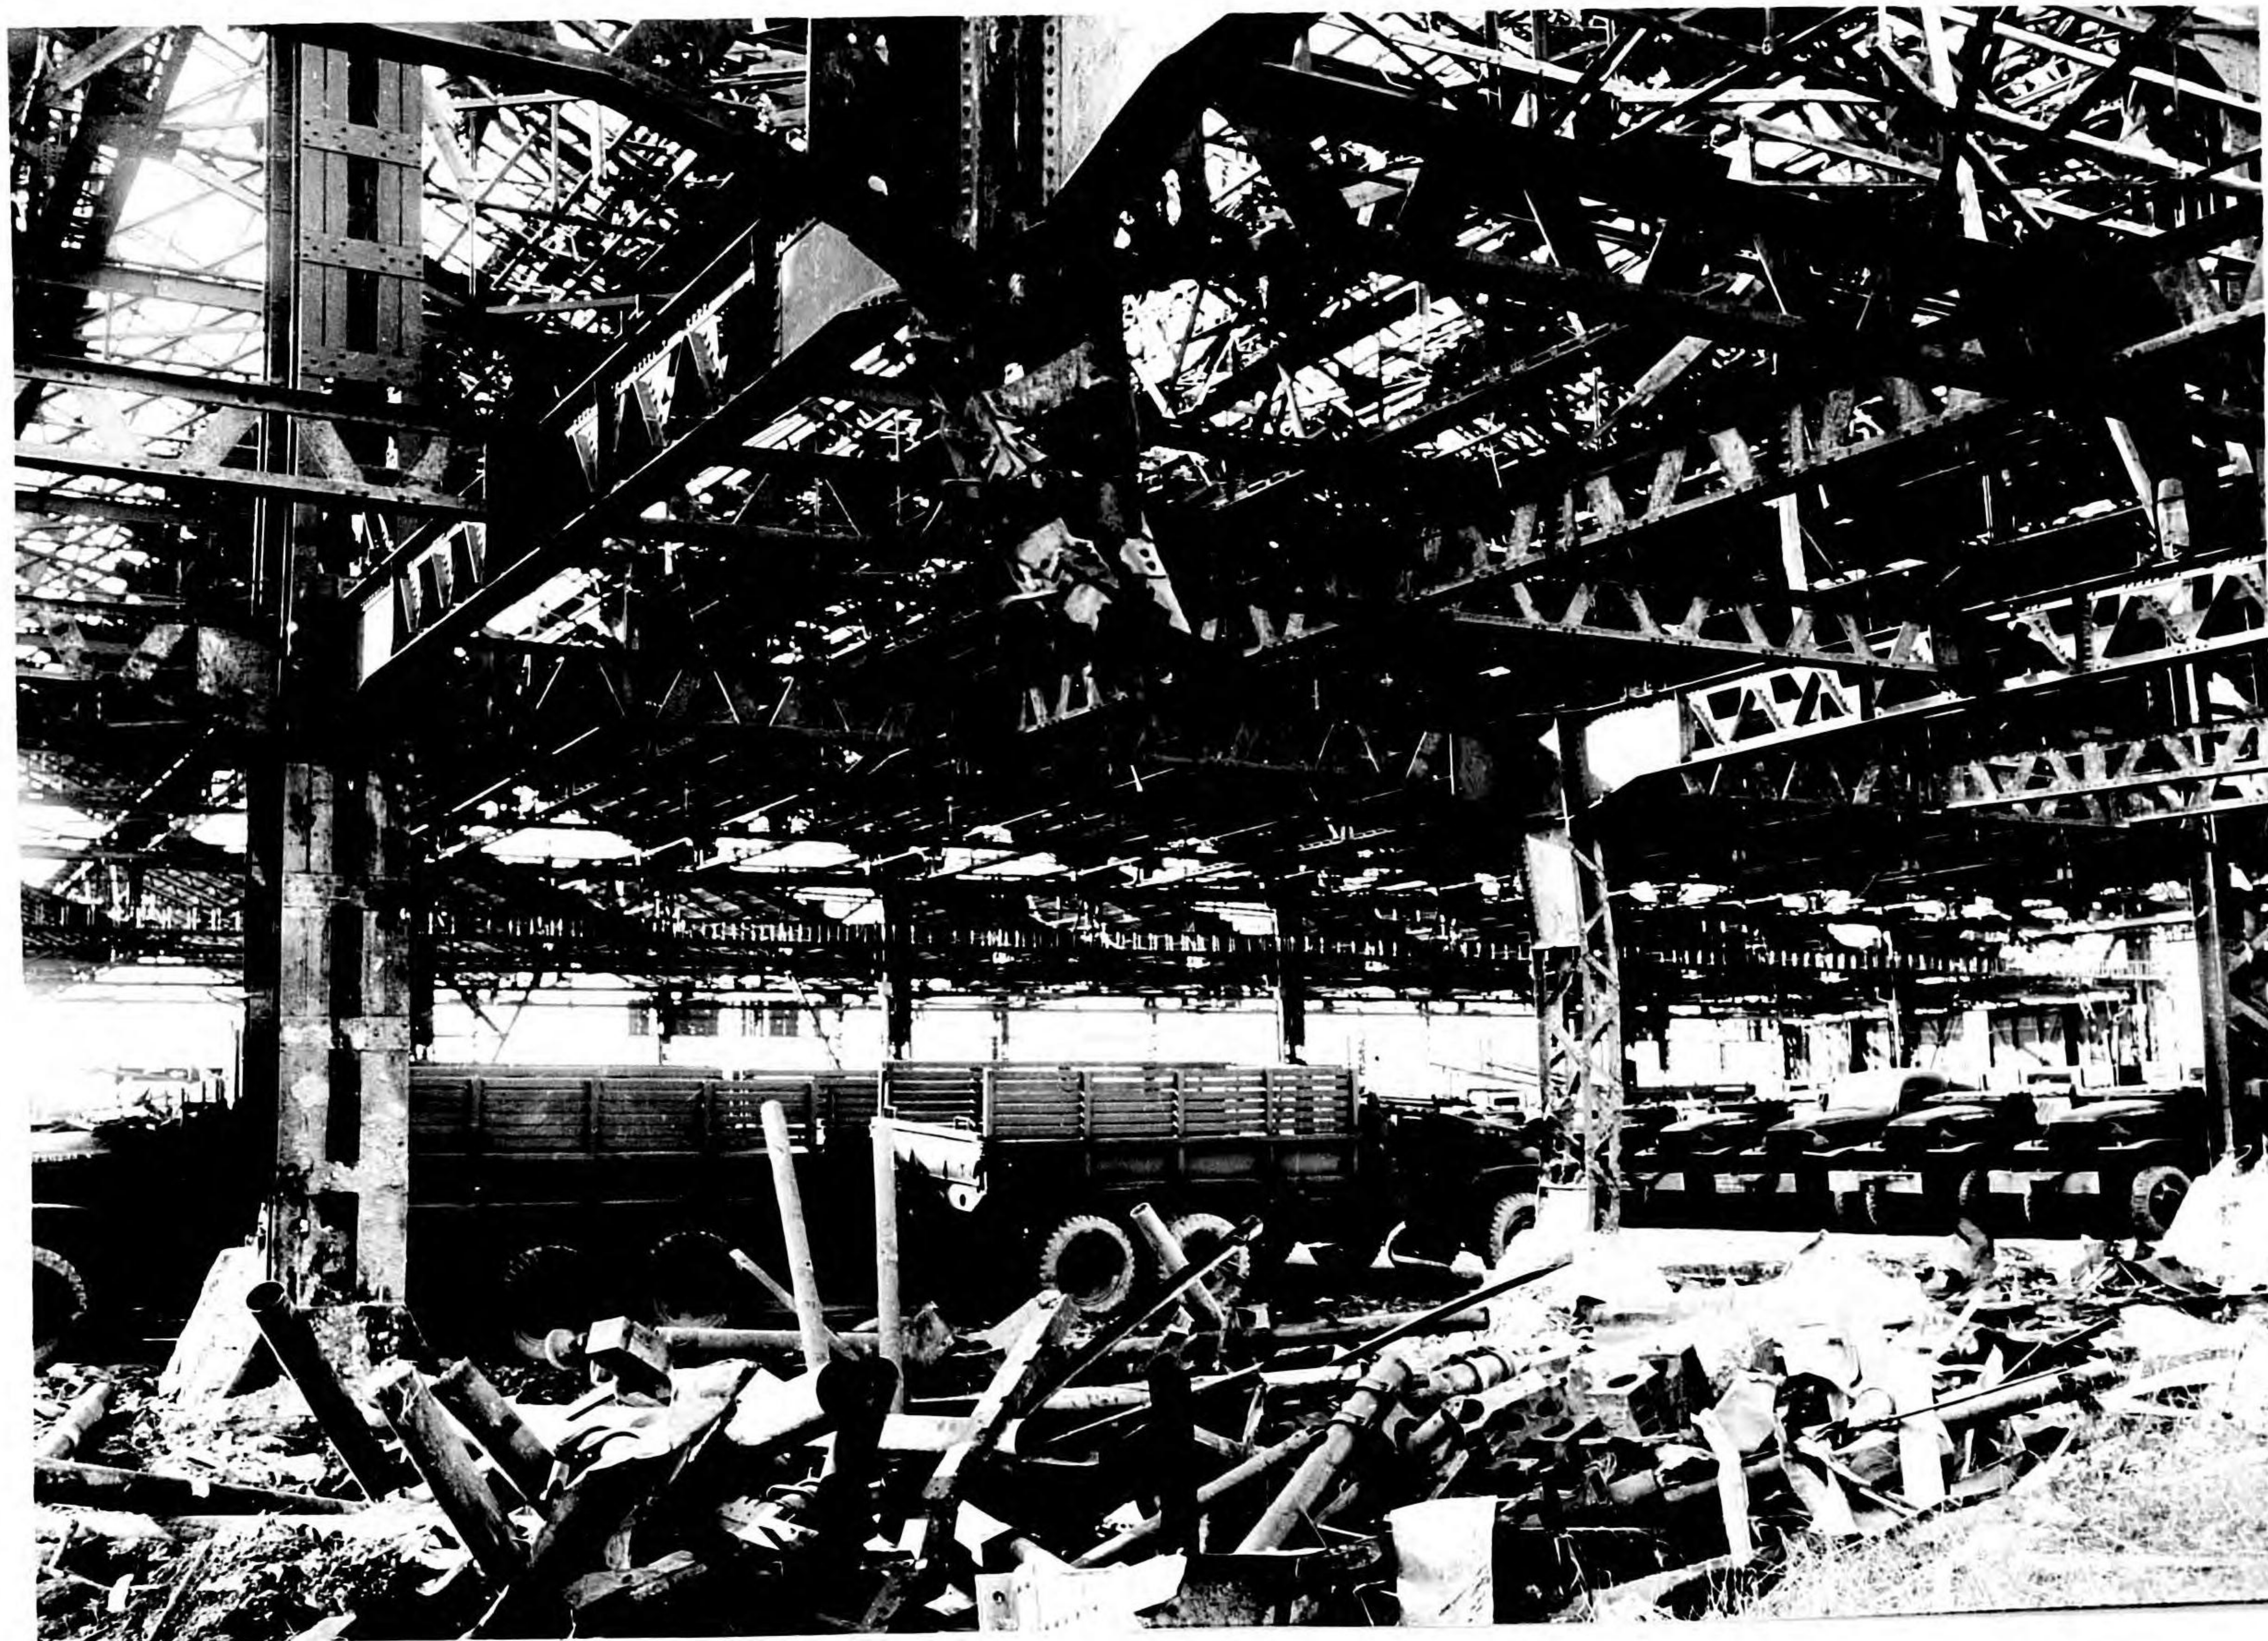
d. Structures were encountered which possessed amazing stiffness after portions of their supports were severed or removed. Large sections of steel buildings stood without apparent distortion after columns were out (Photo 204); others after footings were

Photo 204. Large sections of this steel building stood without apparent distortion after columns were cut.

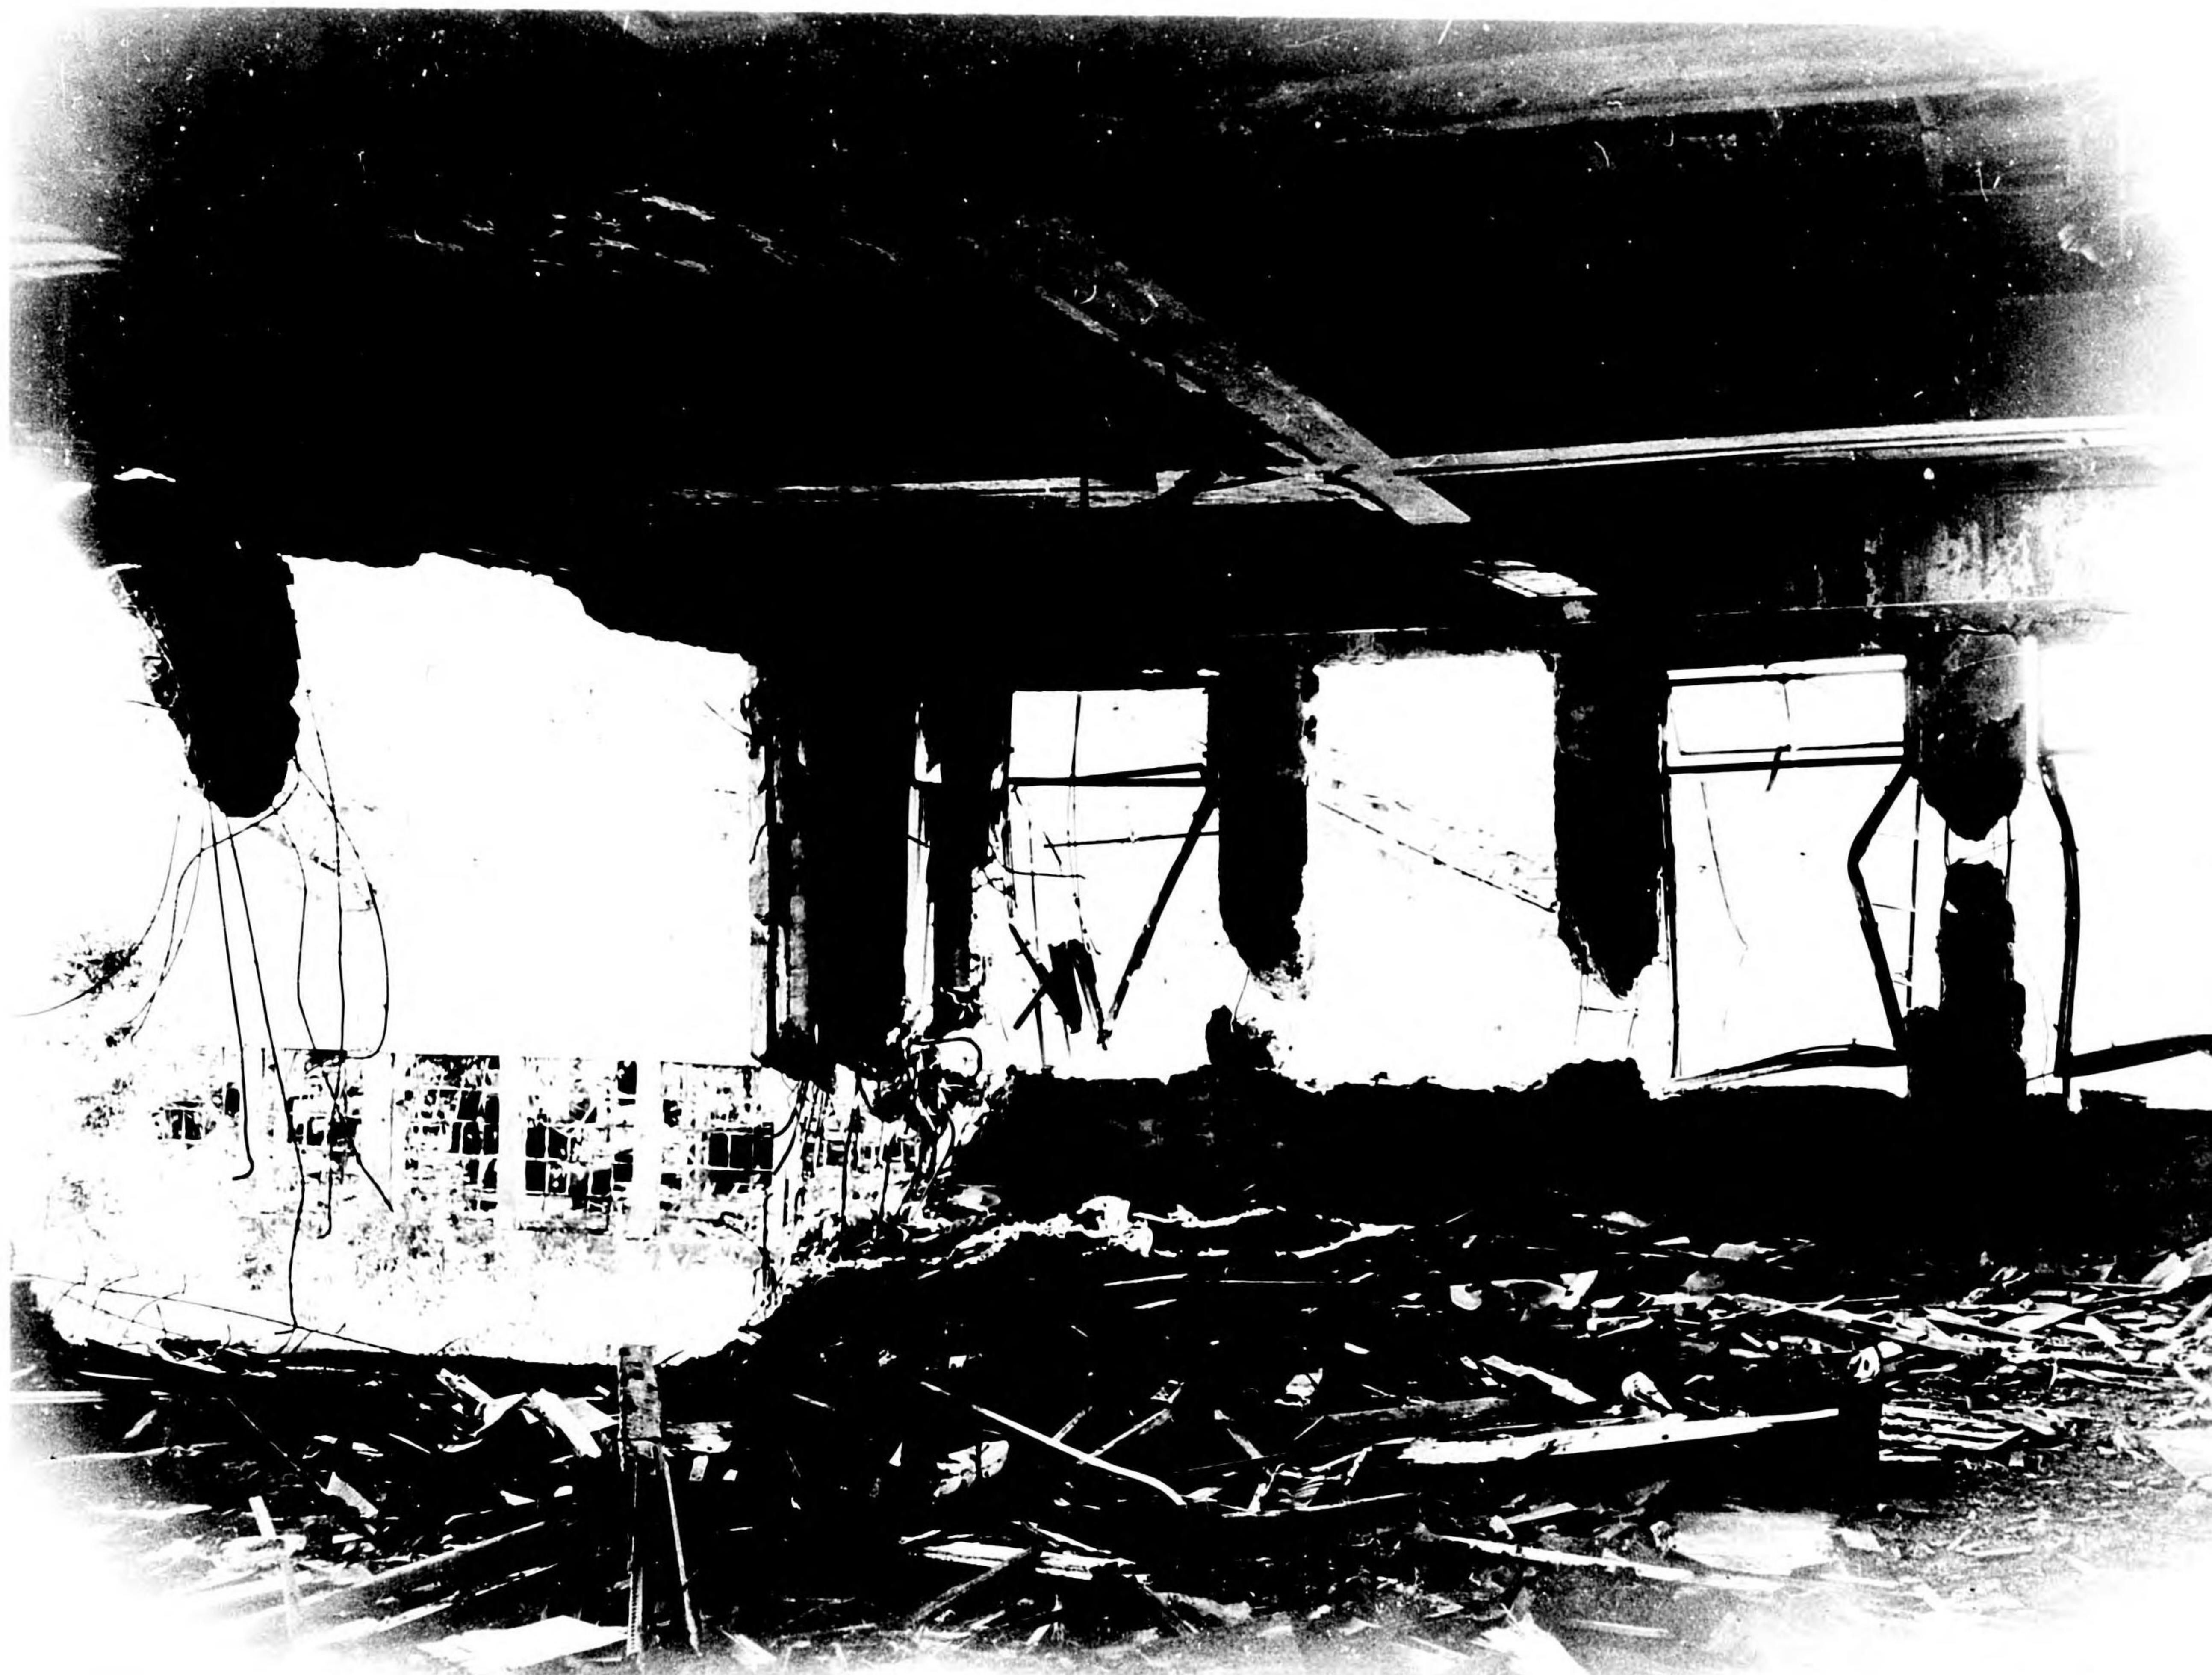
blown from under columns. Likewise, portions of reinforced-concrete structures remained in positions after great holes had been blown in their lower sections. Photo 205 illustrates an example where the interior columns of a three-bay-wide building were severed, as were also a corner column and the sections between windows, but the third-floor and roof section^s cantilevered out from the undamaged part. Photo 206 shows another example at the other end of the same building.

Photo 205. Interior columns of three-bay-wide building severed, also a corner column and sections between windows, but third-floor-and-roof section cantilevered out from undamaged part.
