CHAPTER VII

STRUCTURAL CONSIDERATIONS

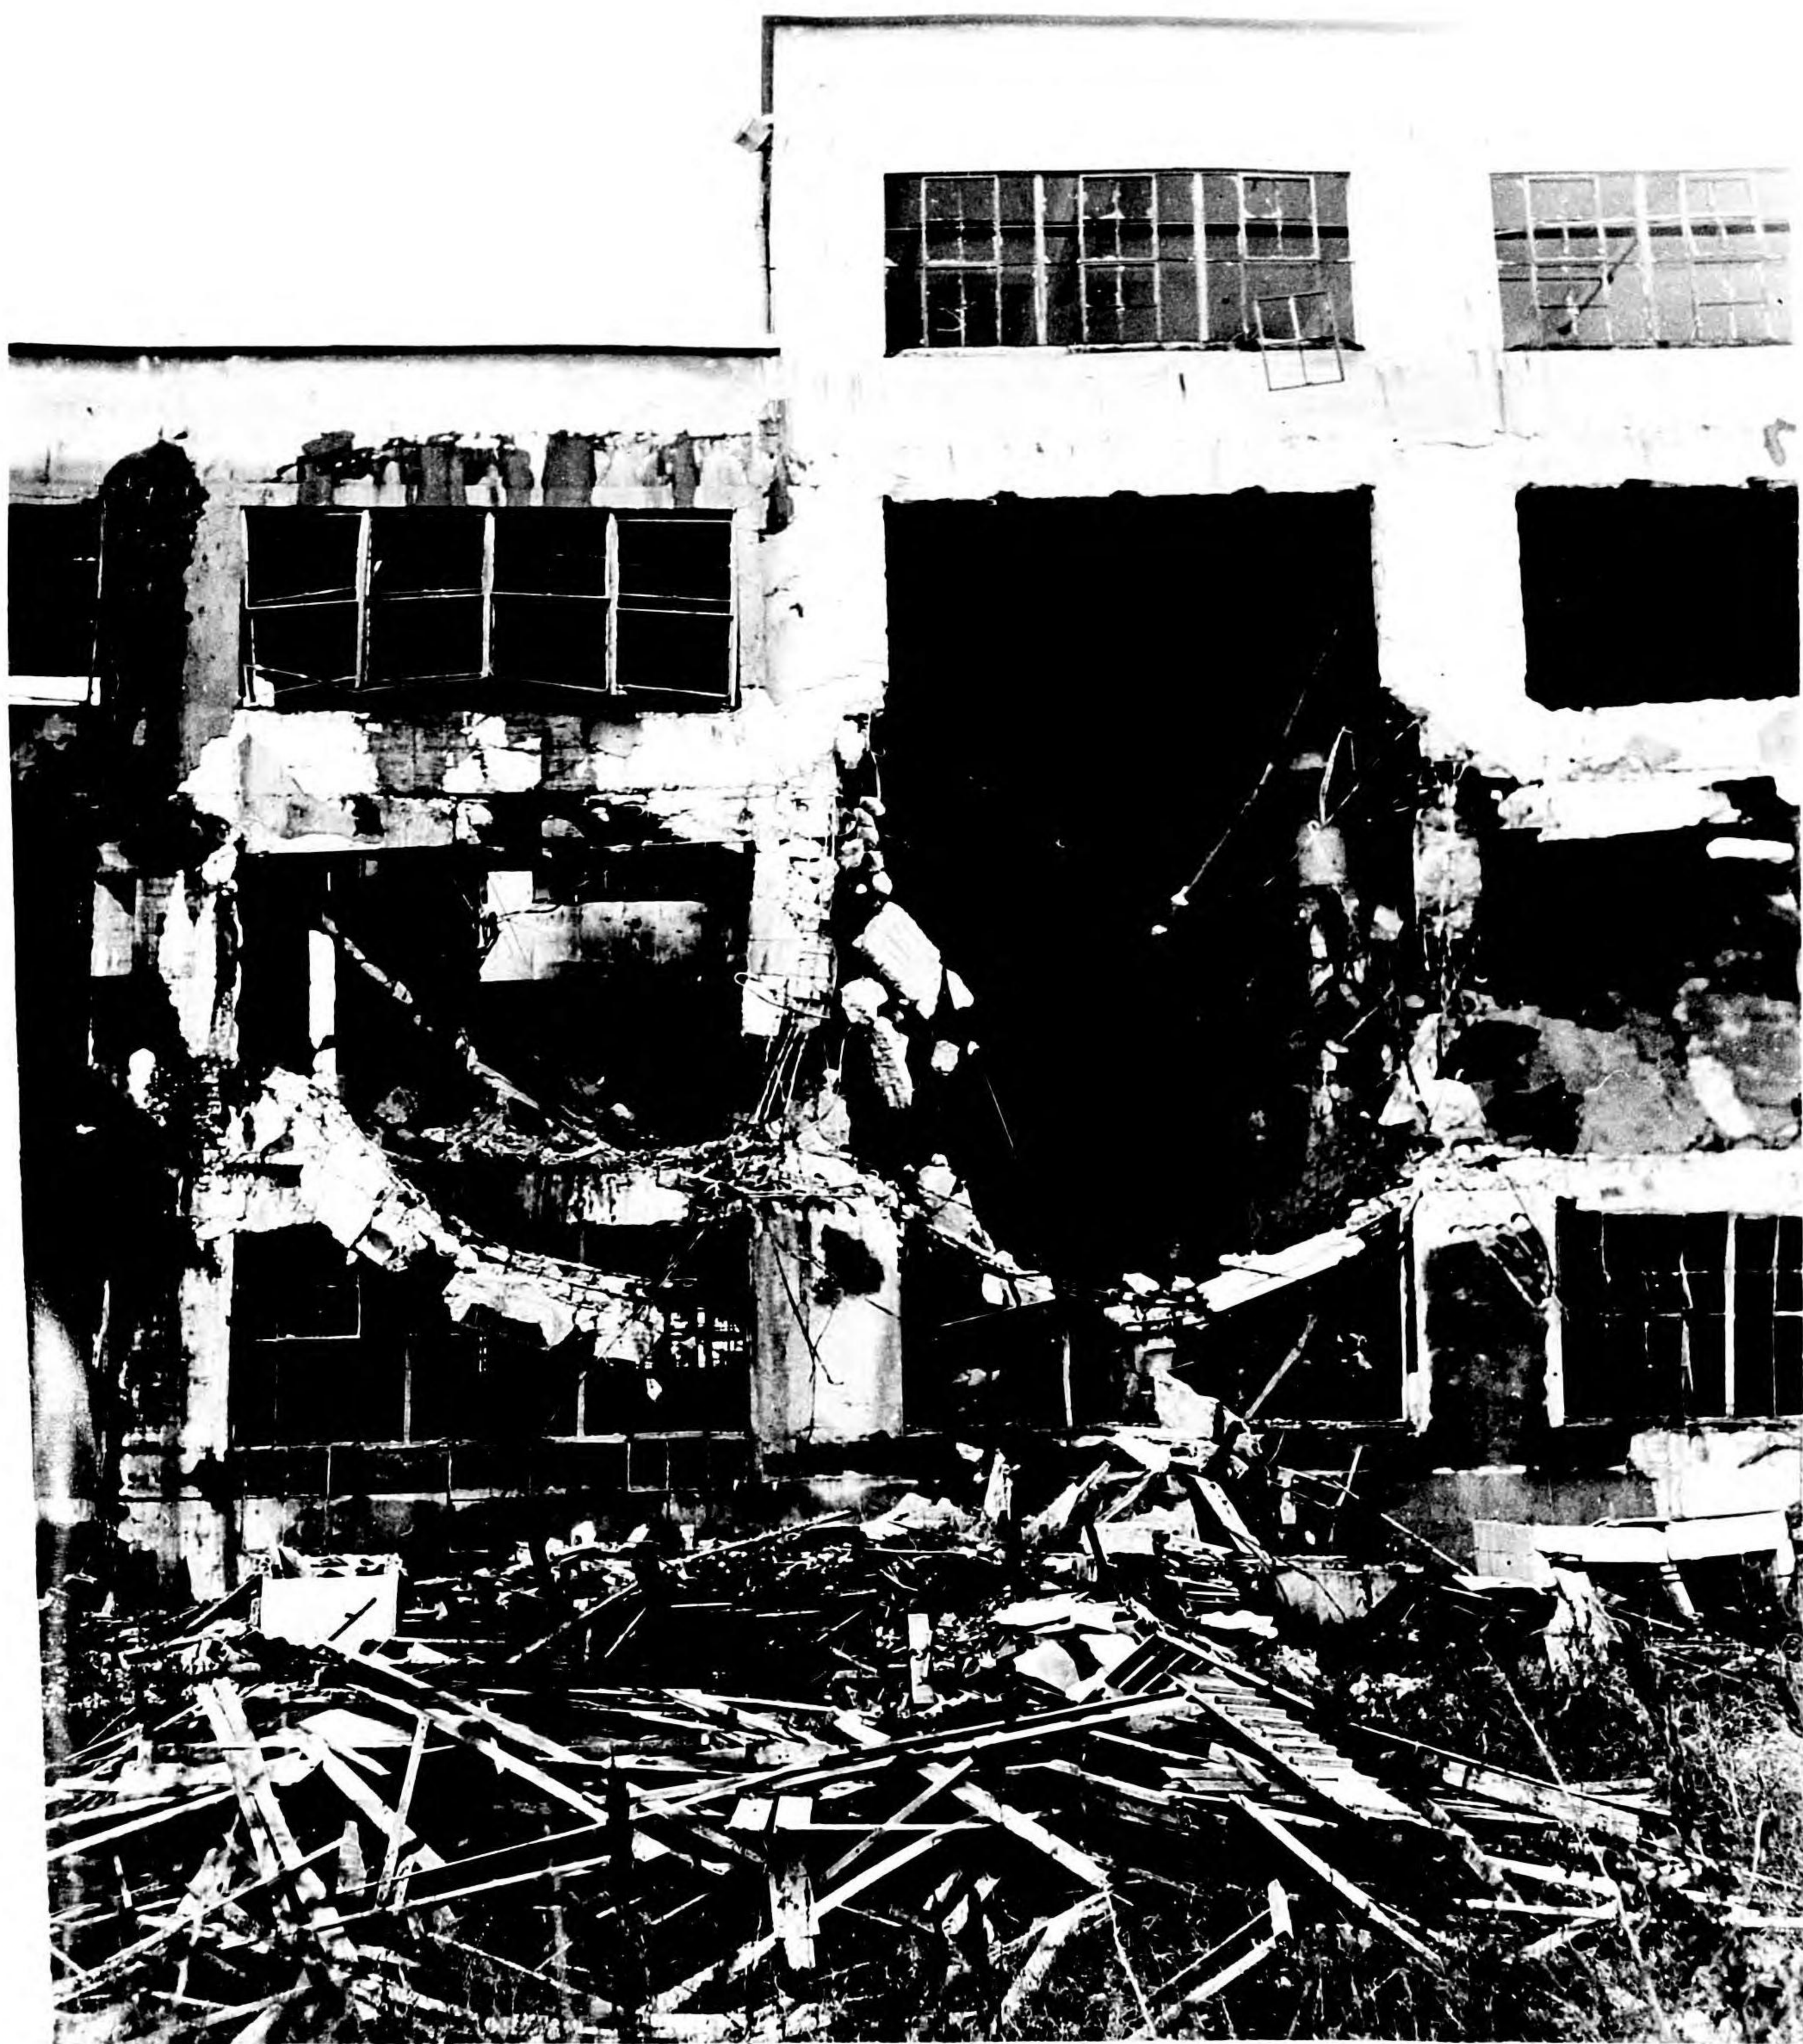
Photo 206. Another example at other end of building shown in Photo 205.

blown from under columns. Likewise, portions of reinforced-concrete structures remained in positions after great holes had been blown in their lower sections. Photo 205 illustrates an example where the interior columns of a three-bay-wide building were severed, as were also a corner column and the sections between windows, but the third-floor and roof section^s cantilevered out from the undamaged part. Photo 206 shows another example at the other end of the same building.

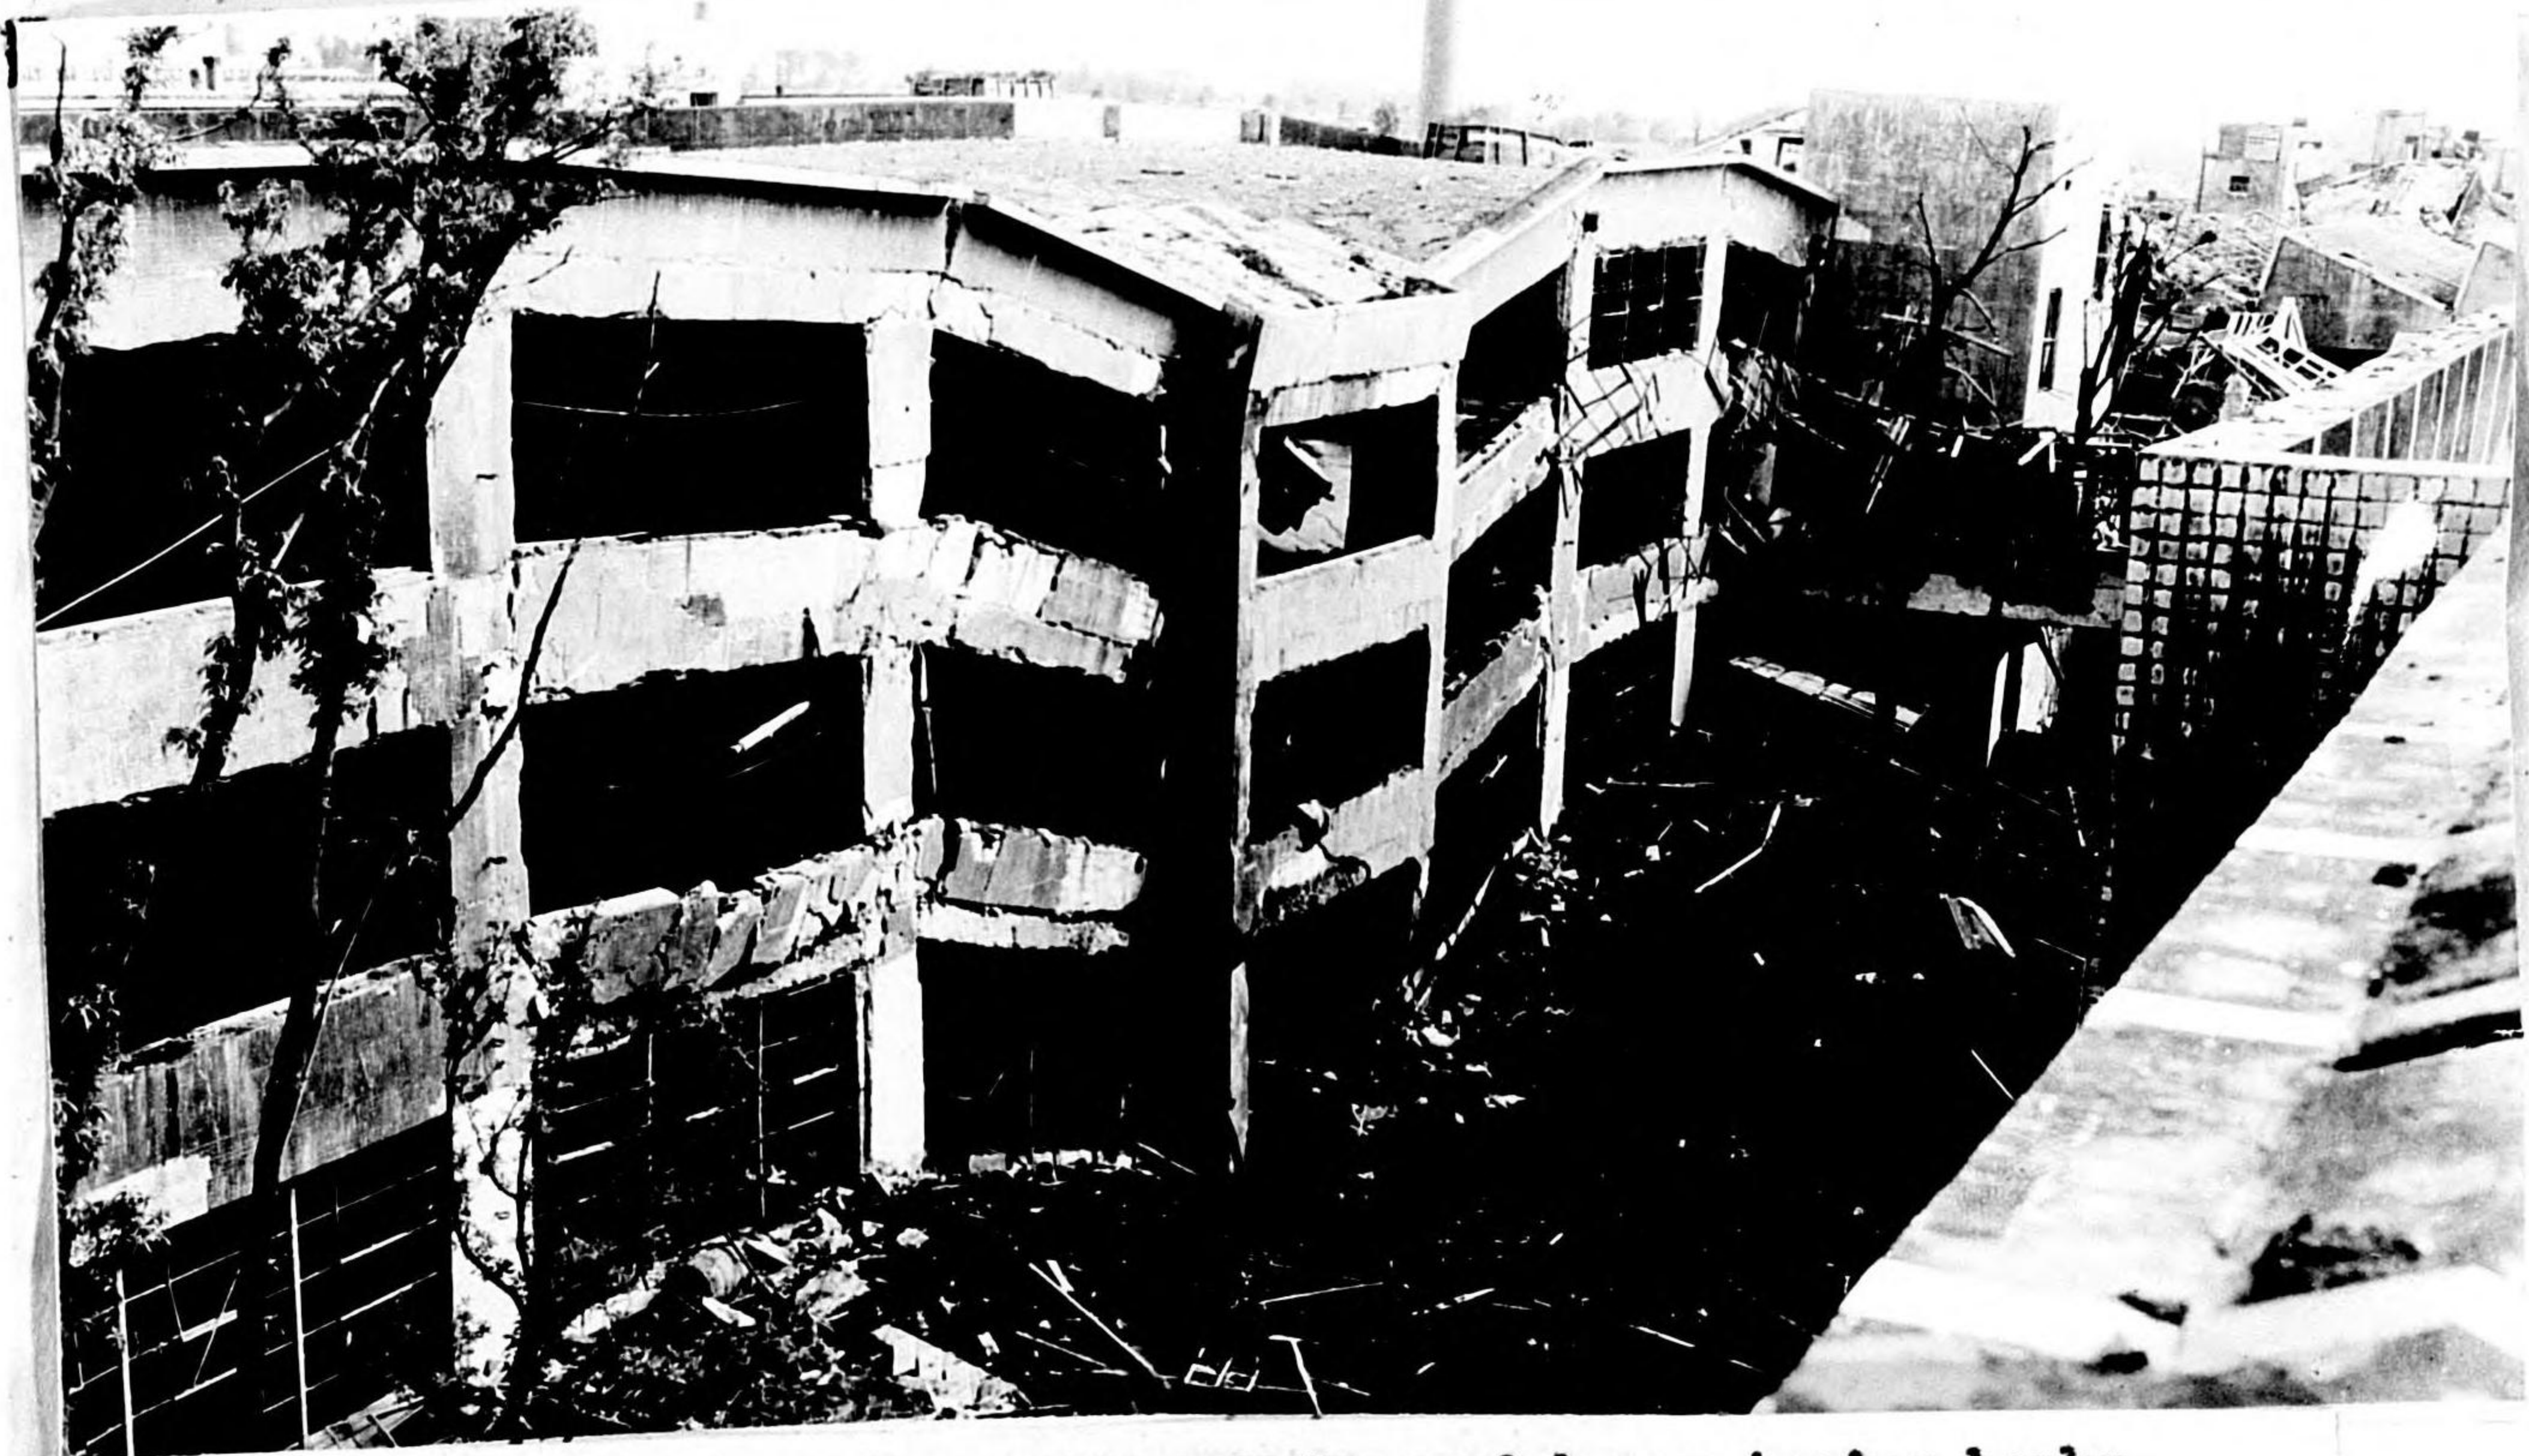
e. Buildings somehow hung together when portions were undermined by bombs. Photo 207 illustrates a bay and a stairwell which were lowered by cratering bombs.

Photo 207. Bay and stairwell lowered by cratering bombs.
