MISSION NO. 18

TACTICAL MISSION REPORT

BANSUE MARSHALLING YARDS, BANGKOK

27 NOVEMBER 1944

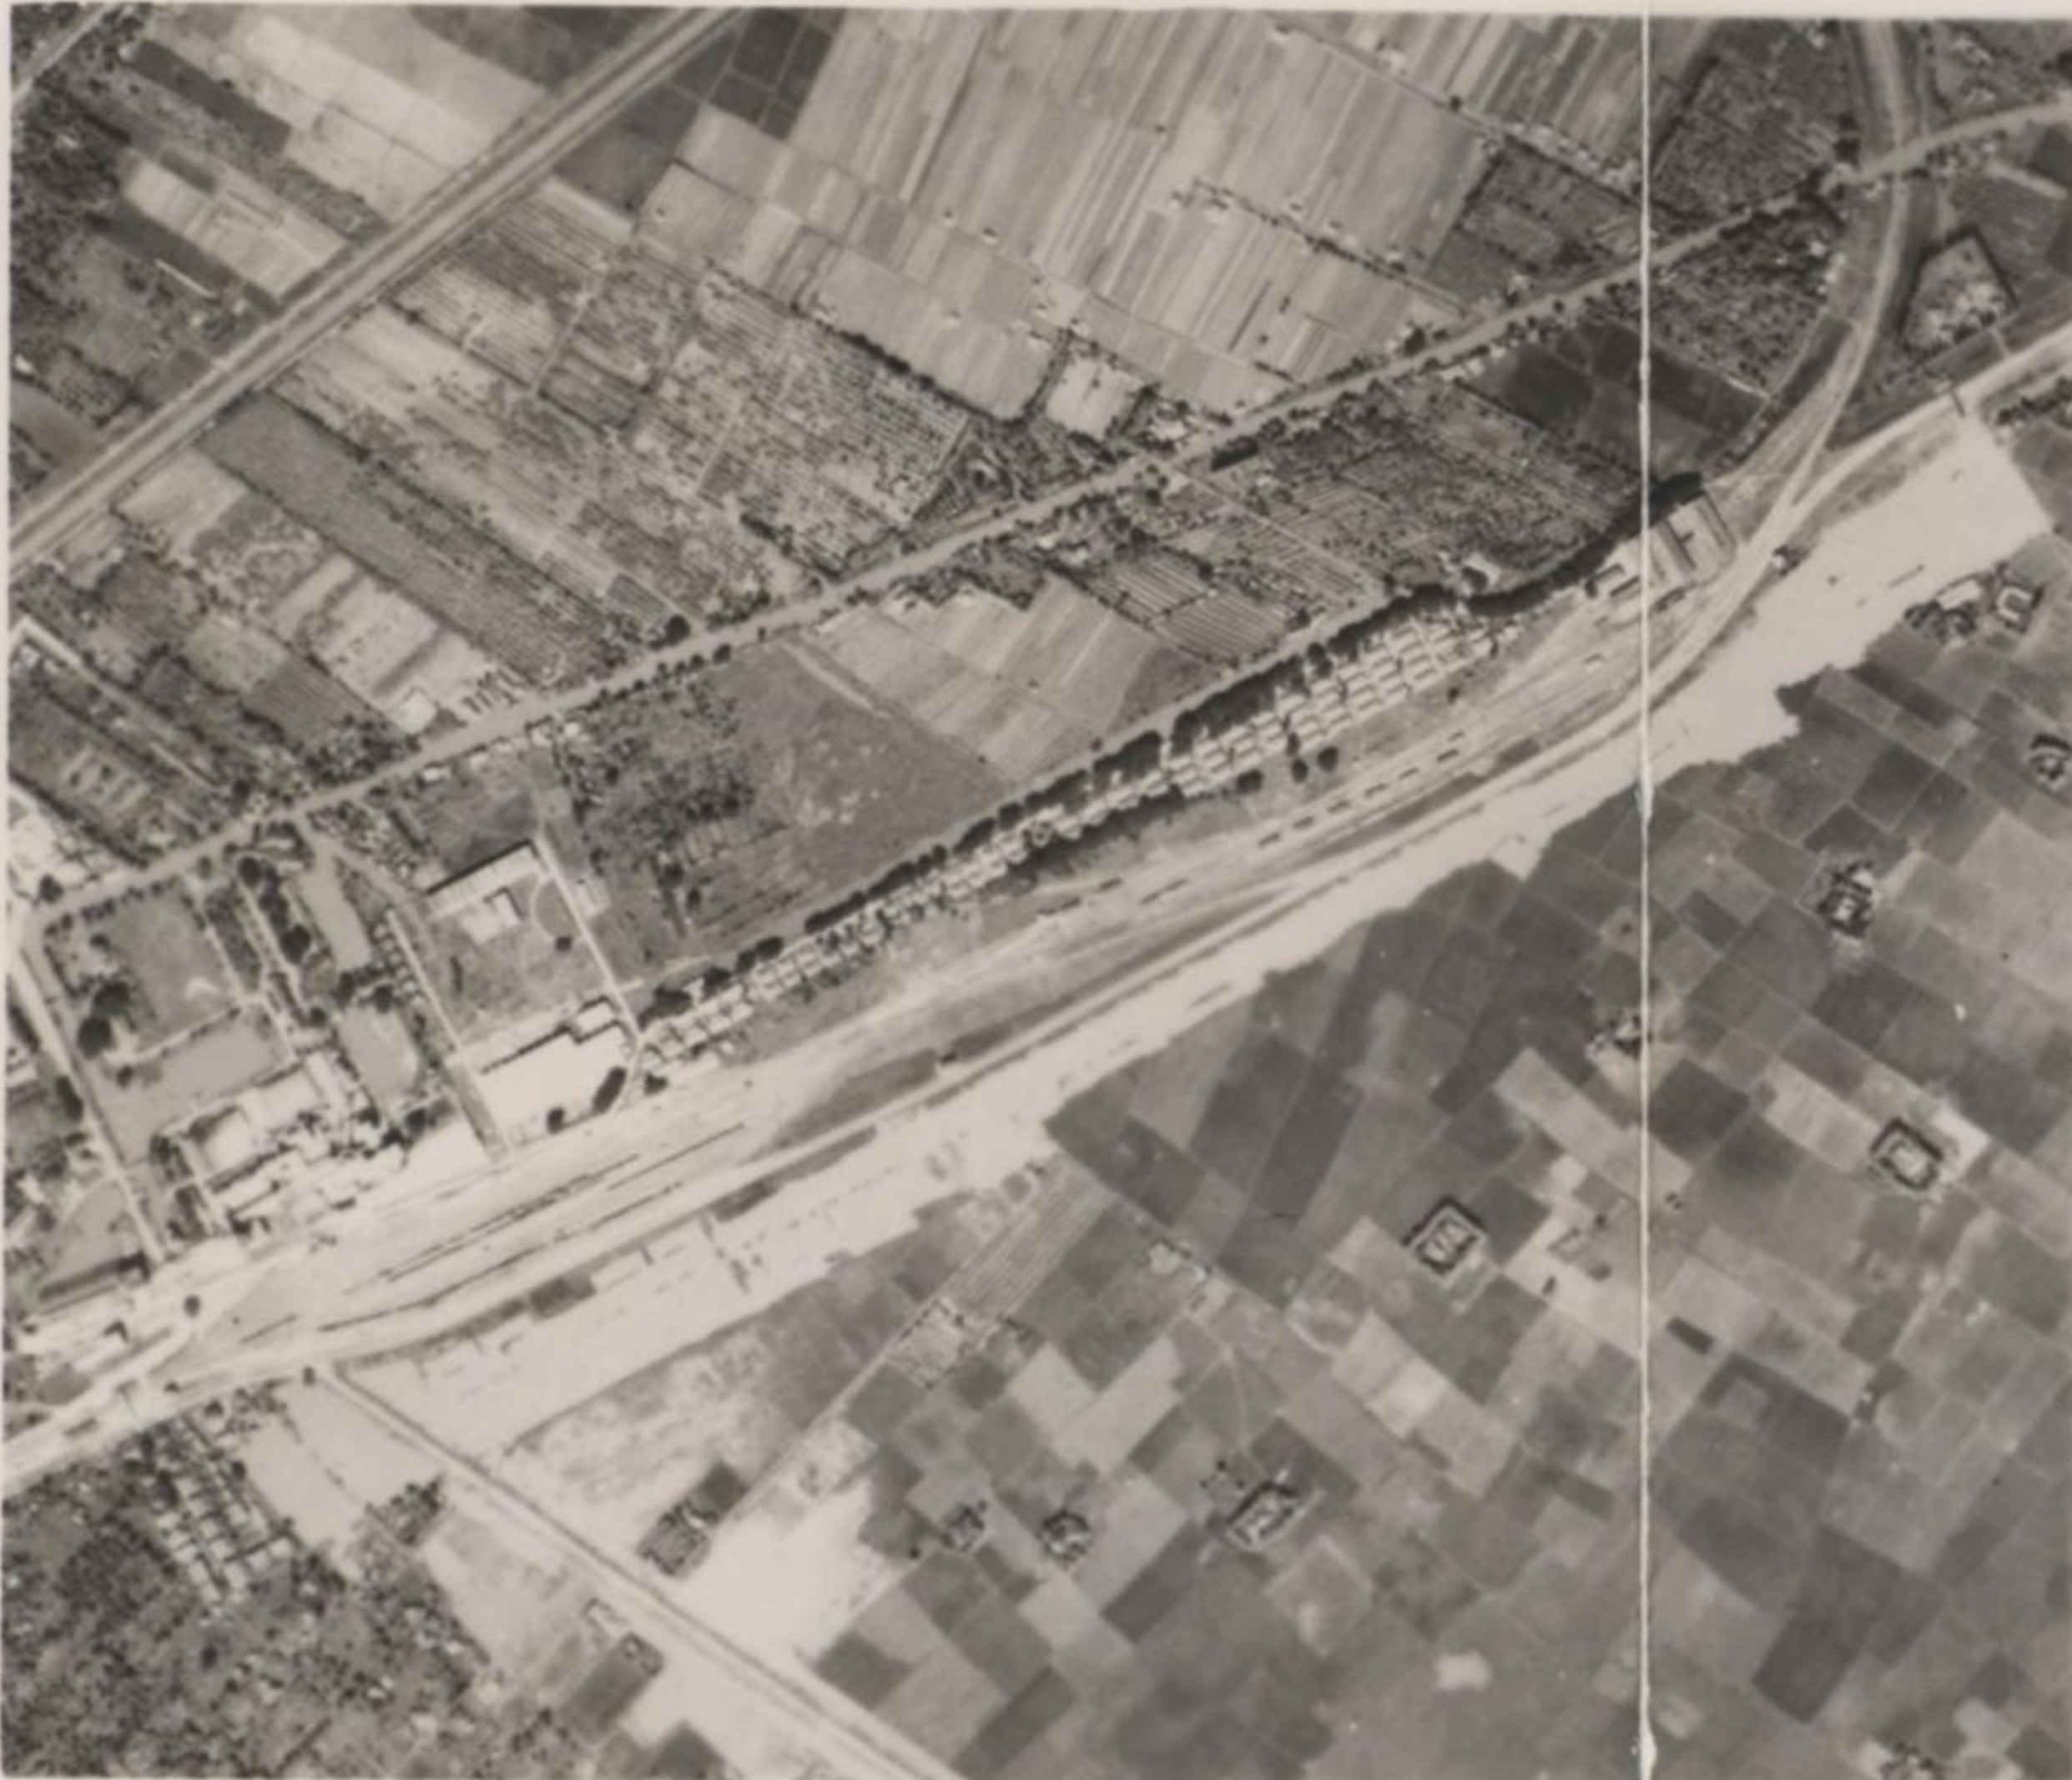
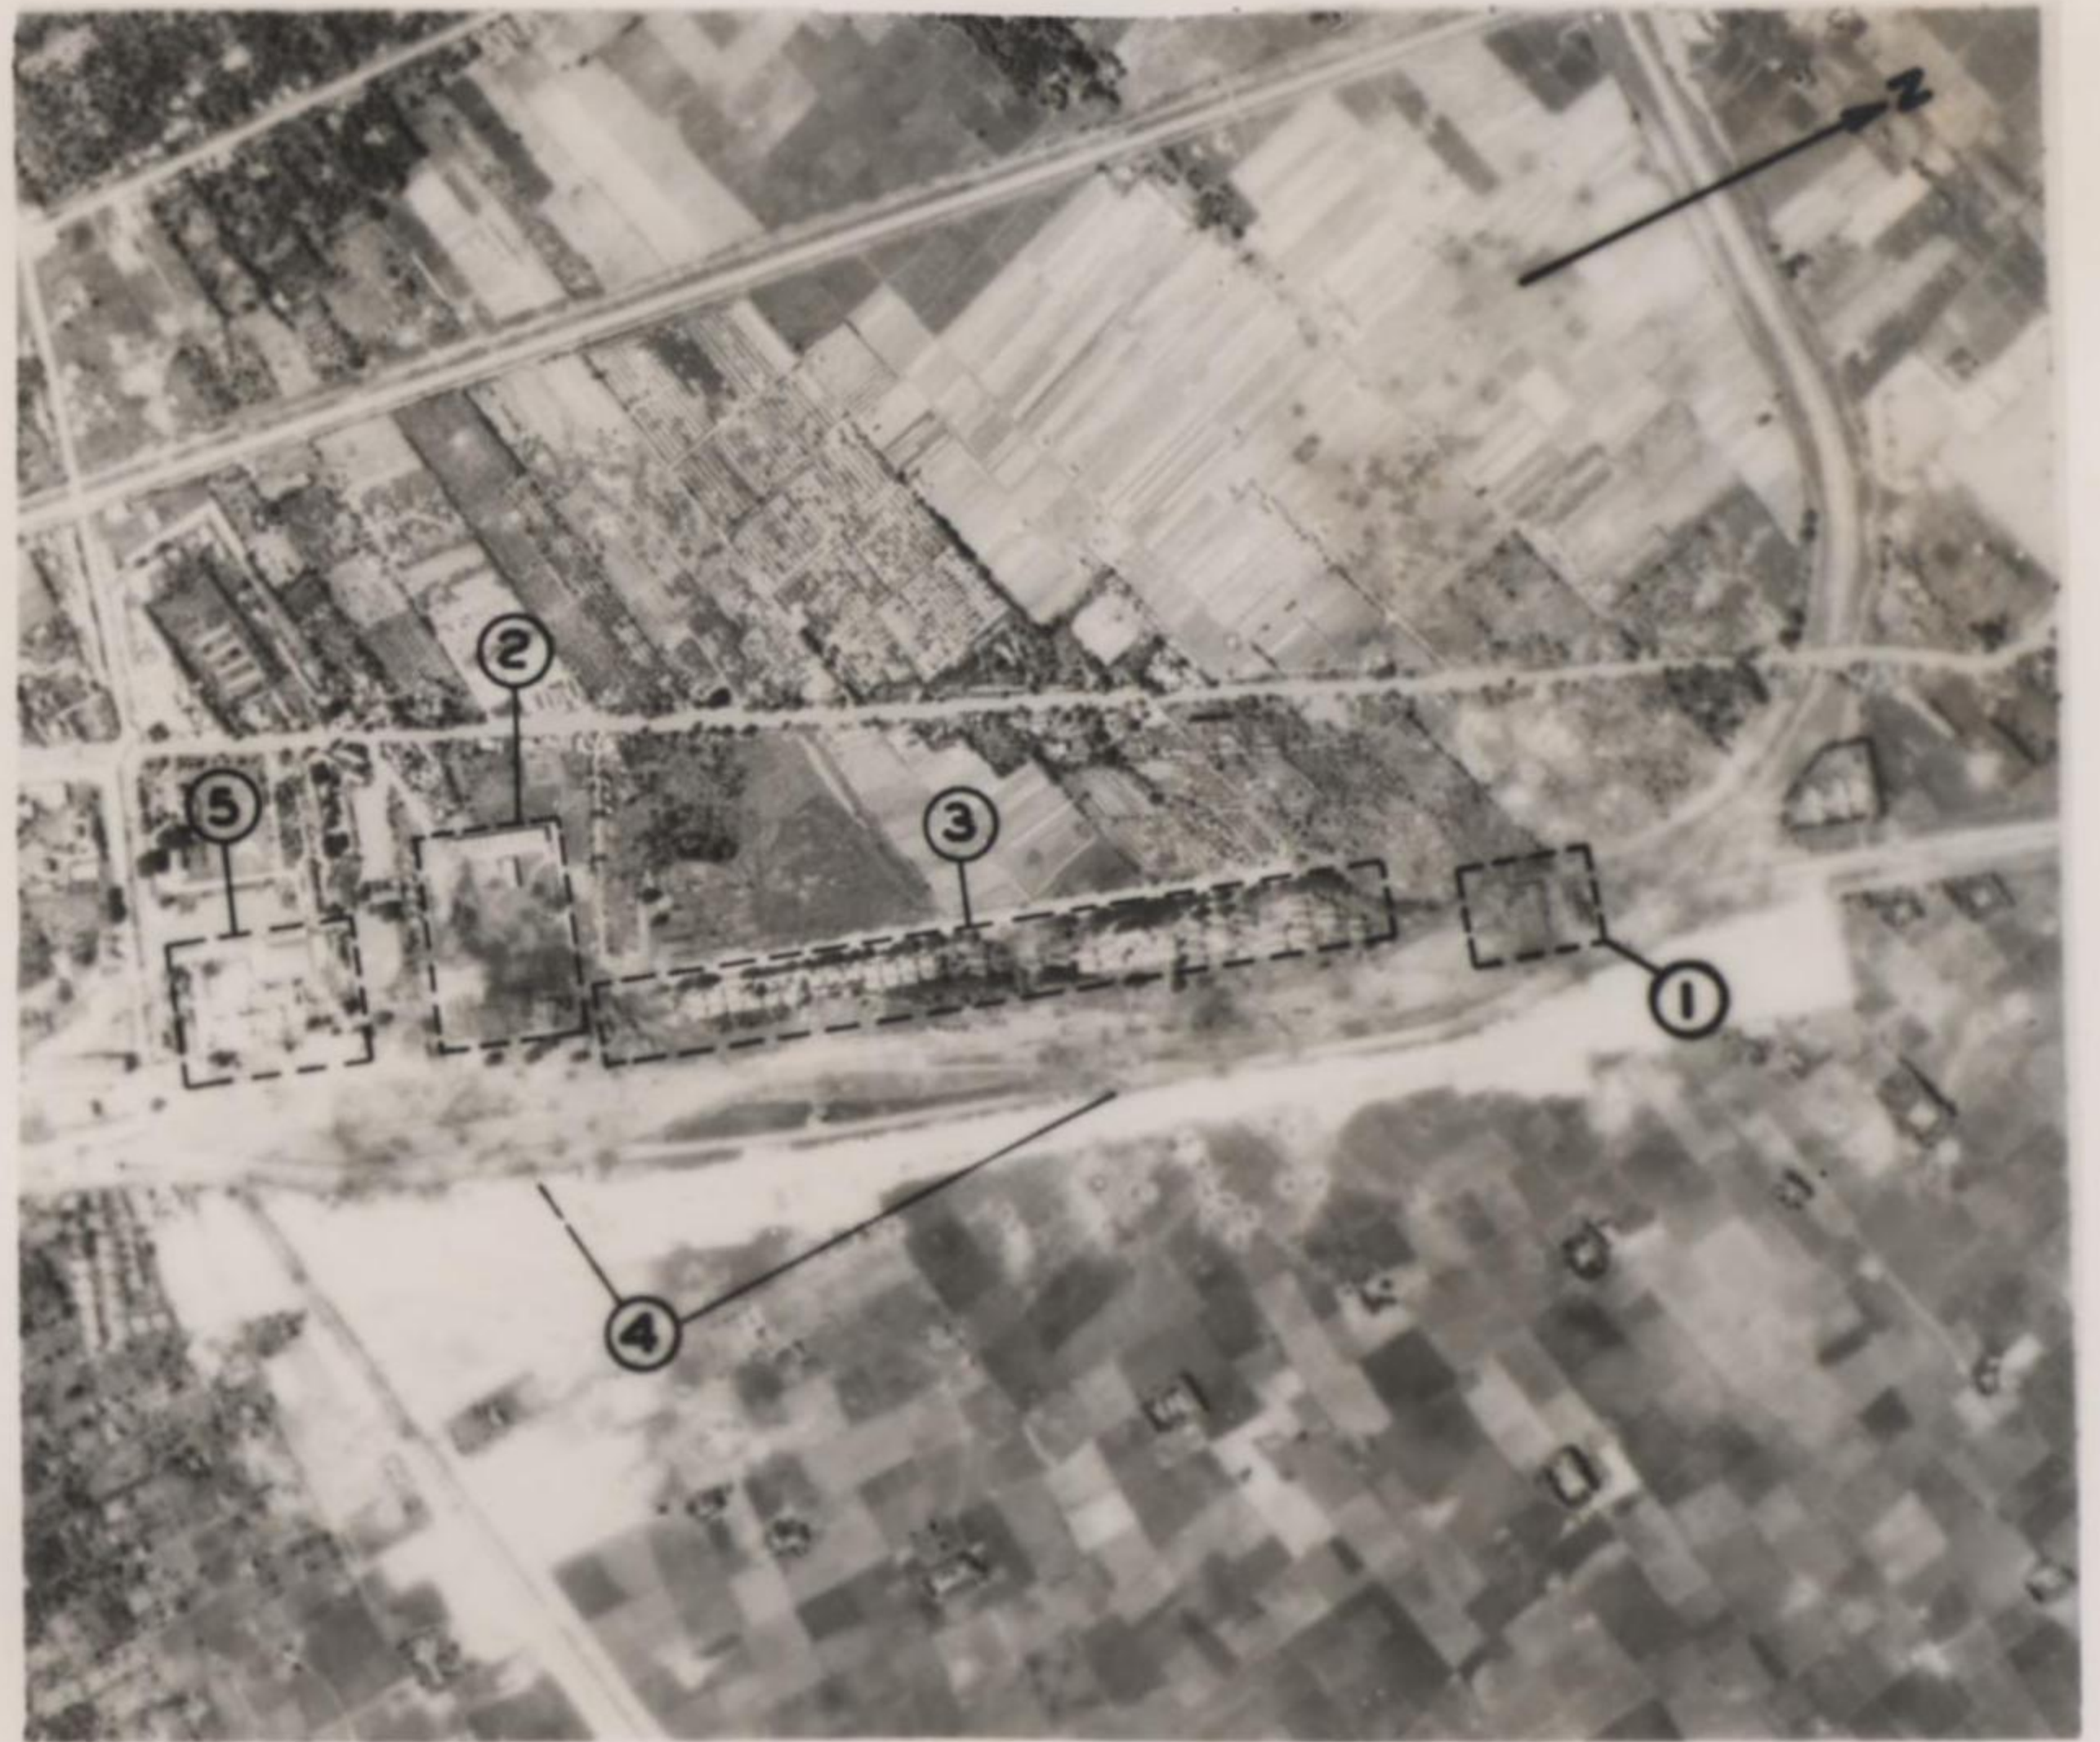
BEFORE

AFTER

(2) Analysis of the photos taken show that excellent results were achieved. Both aiming points were completely destroyed, and in addition several small buildings in the immediate vicinity of the railway shops and warehouse were destroyed and others were damaged. All rail lines were cut in one or more places. Four locomotives were destroyed, 2 probably destroyed, and 3 damaged. At least 90 rolling stock were damaged or destroyed.

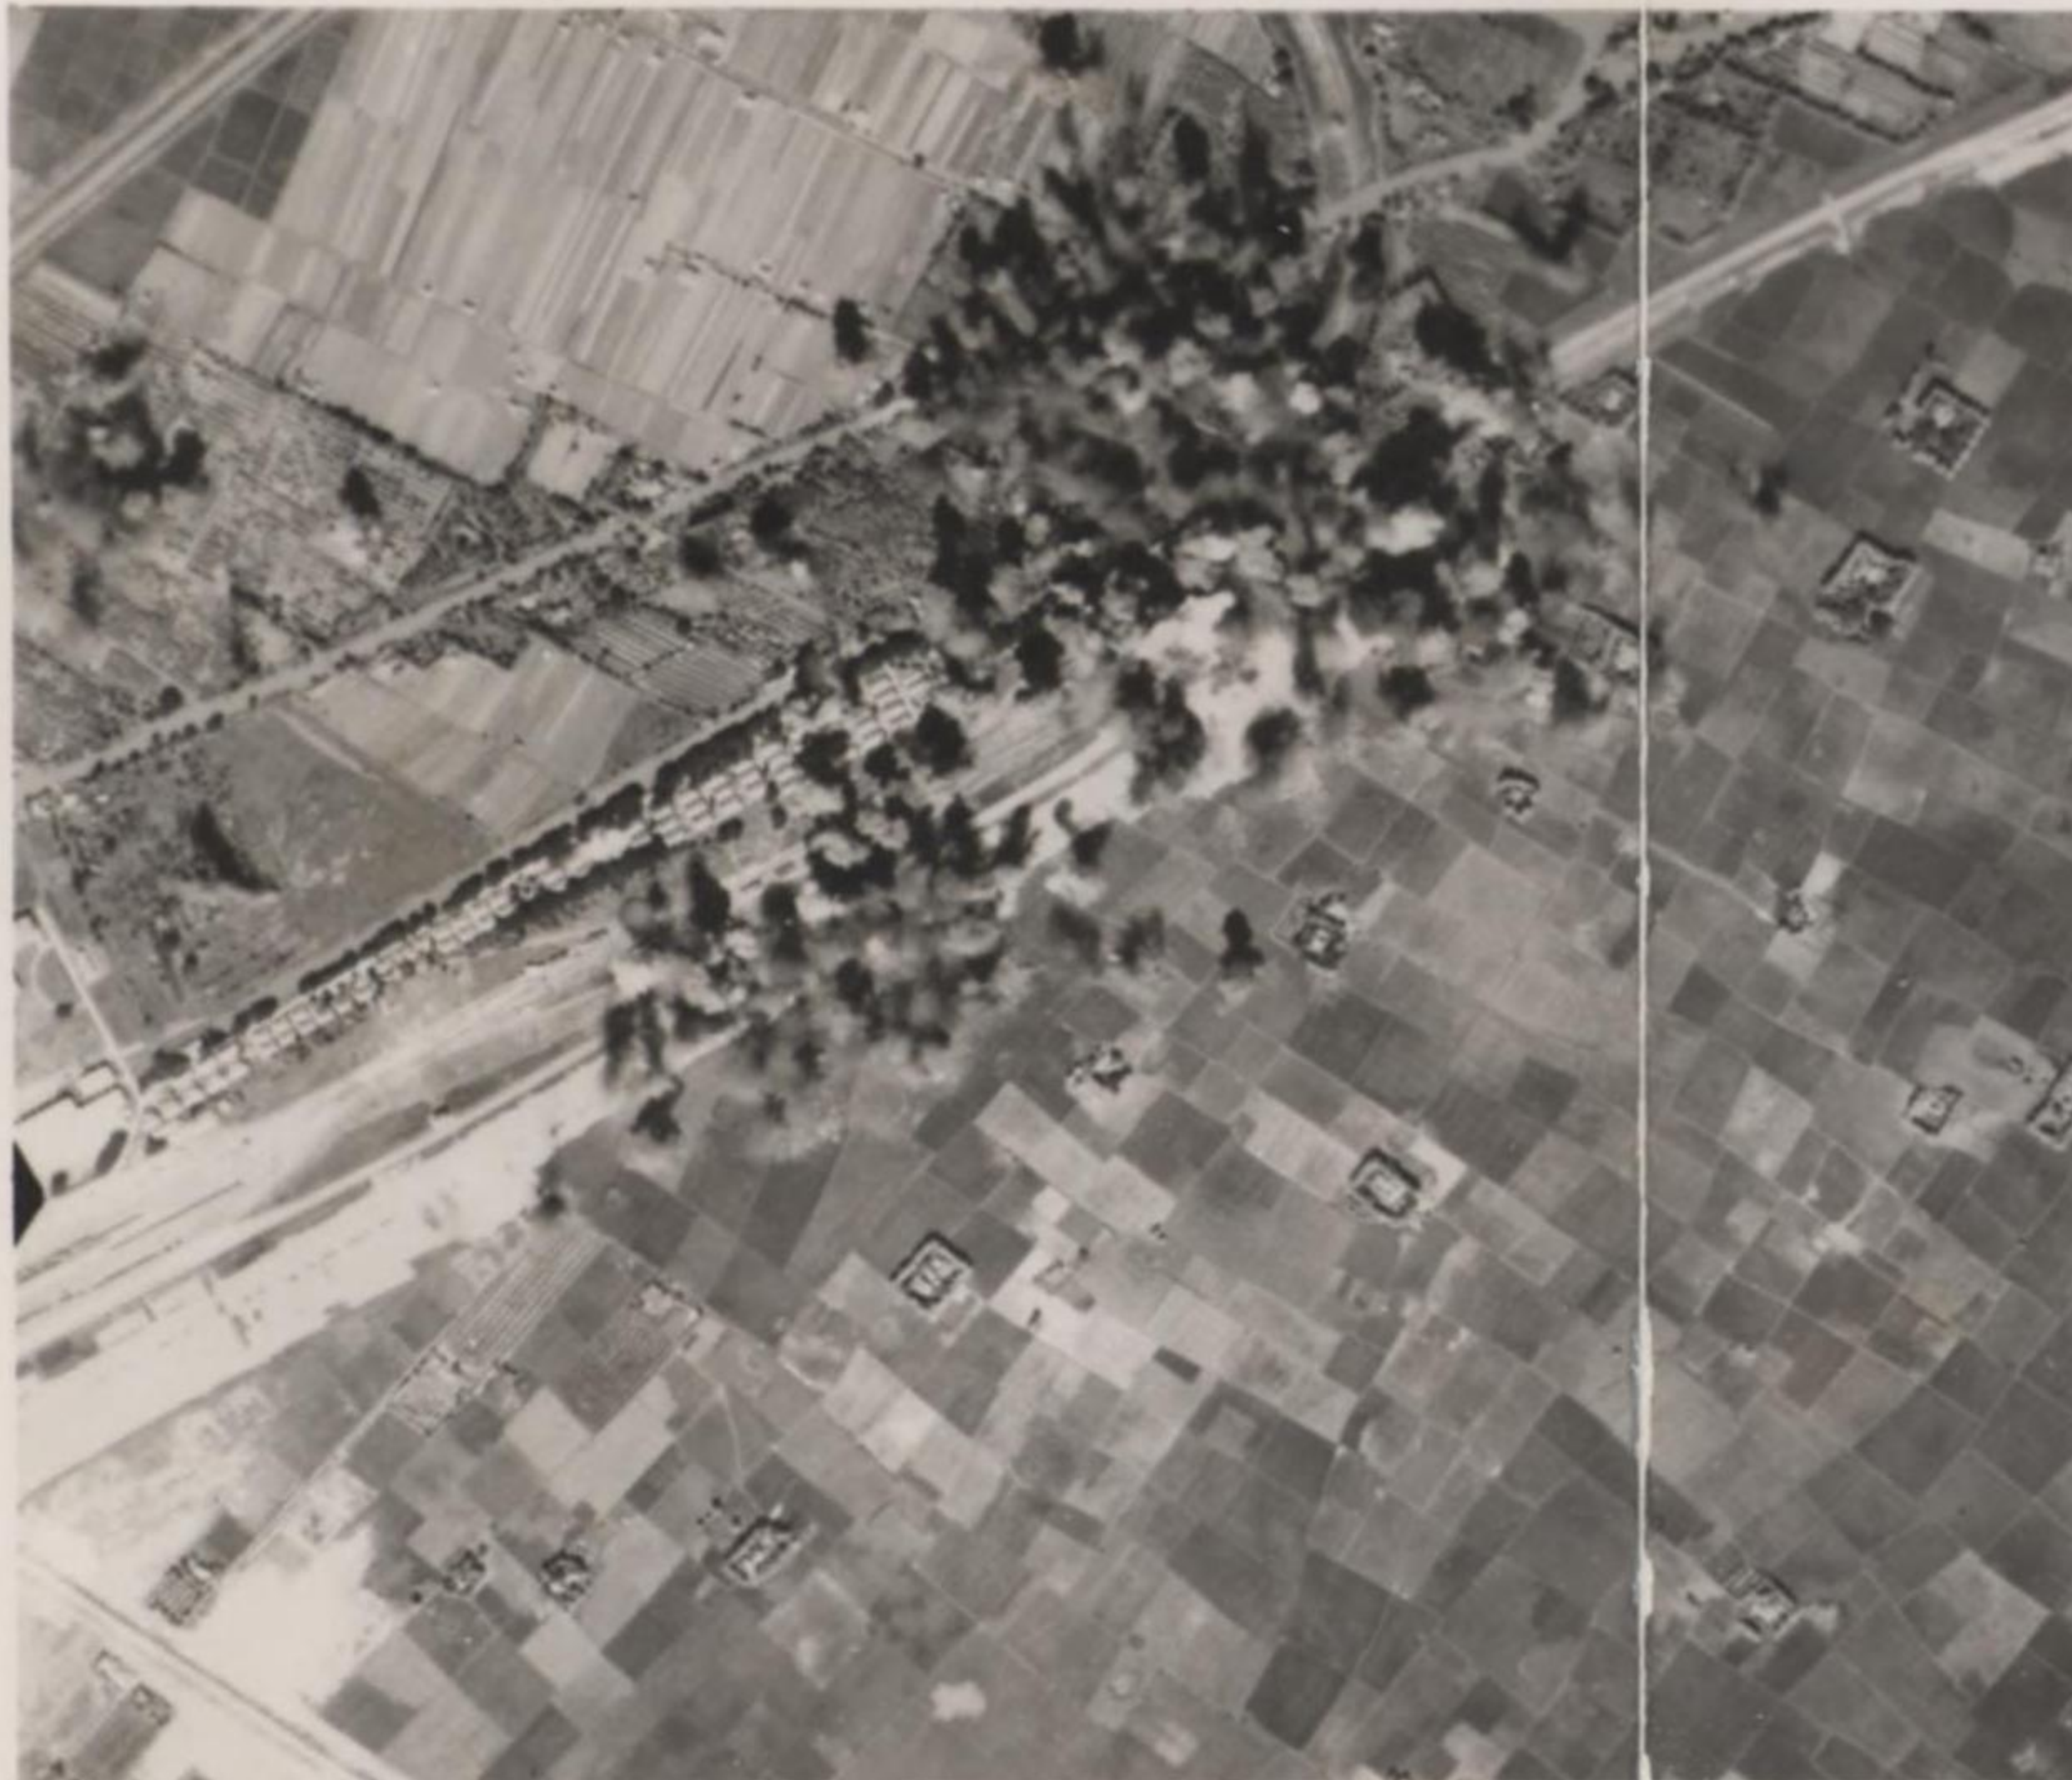
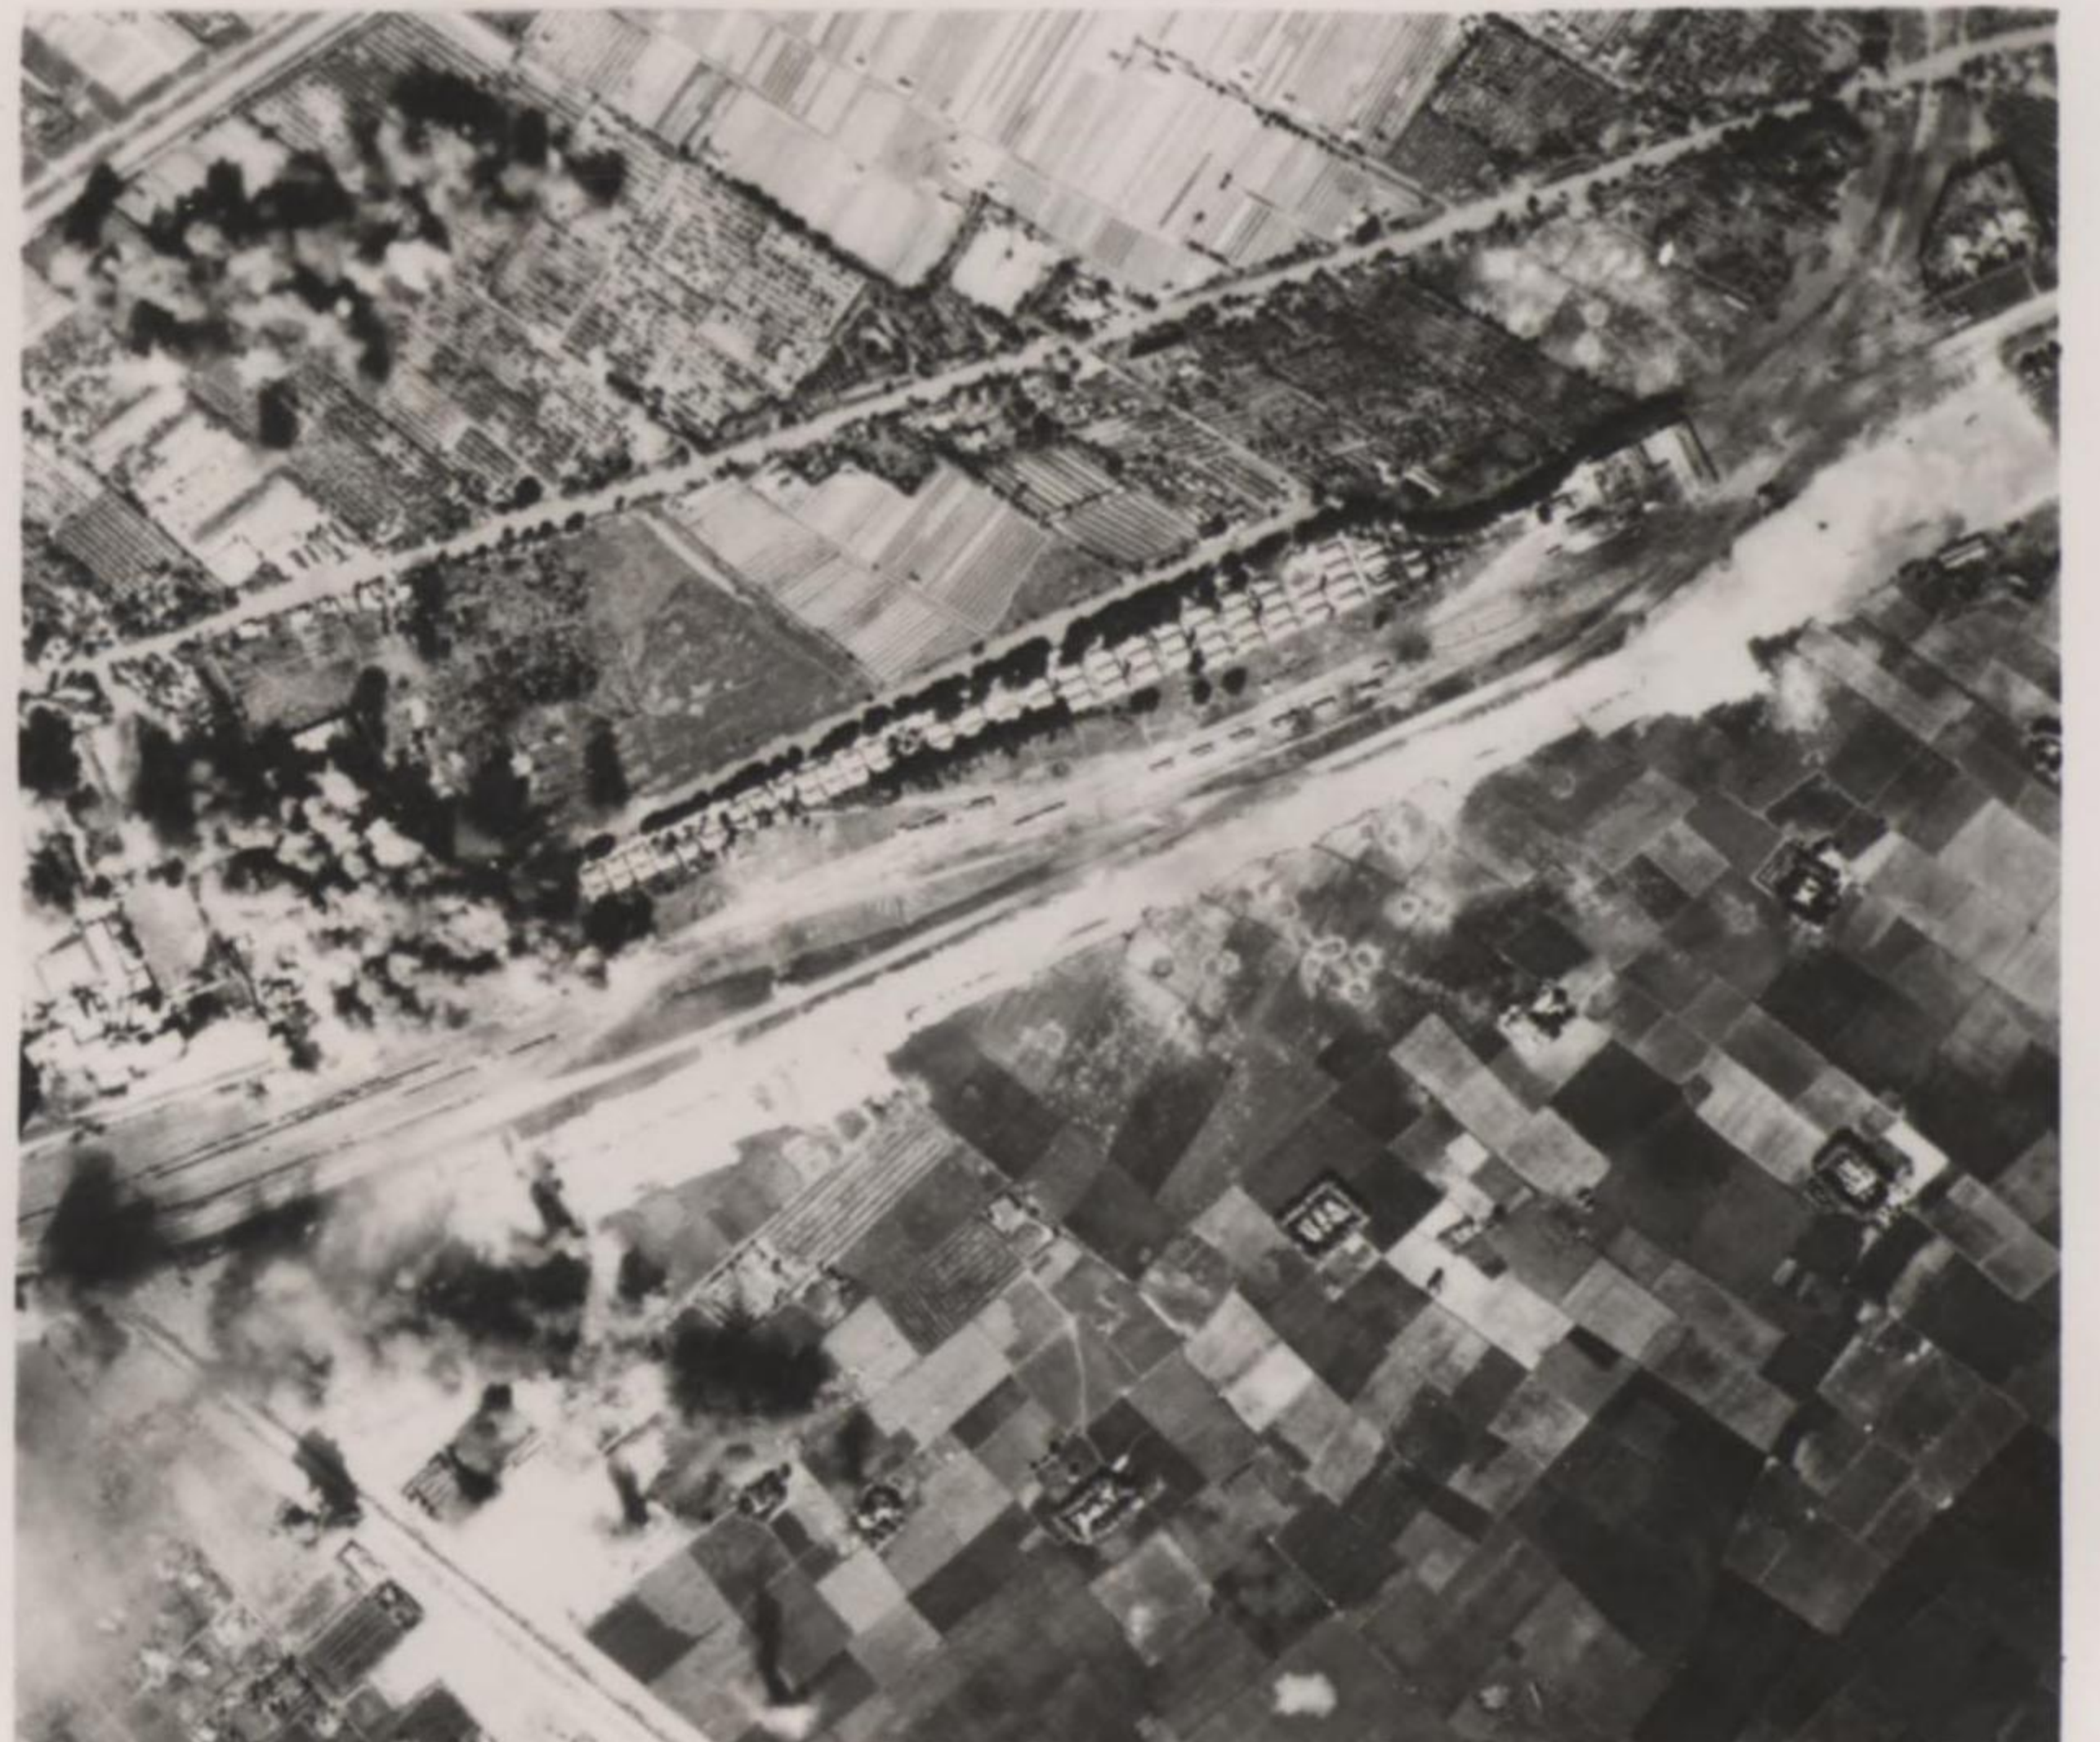
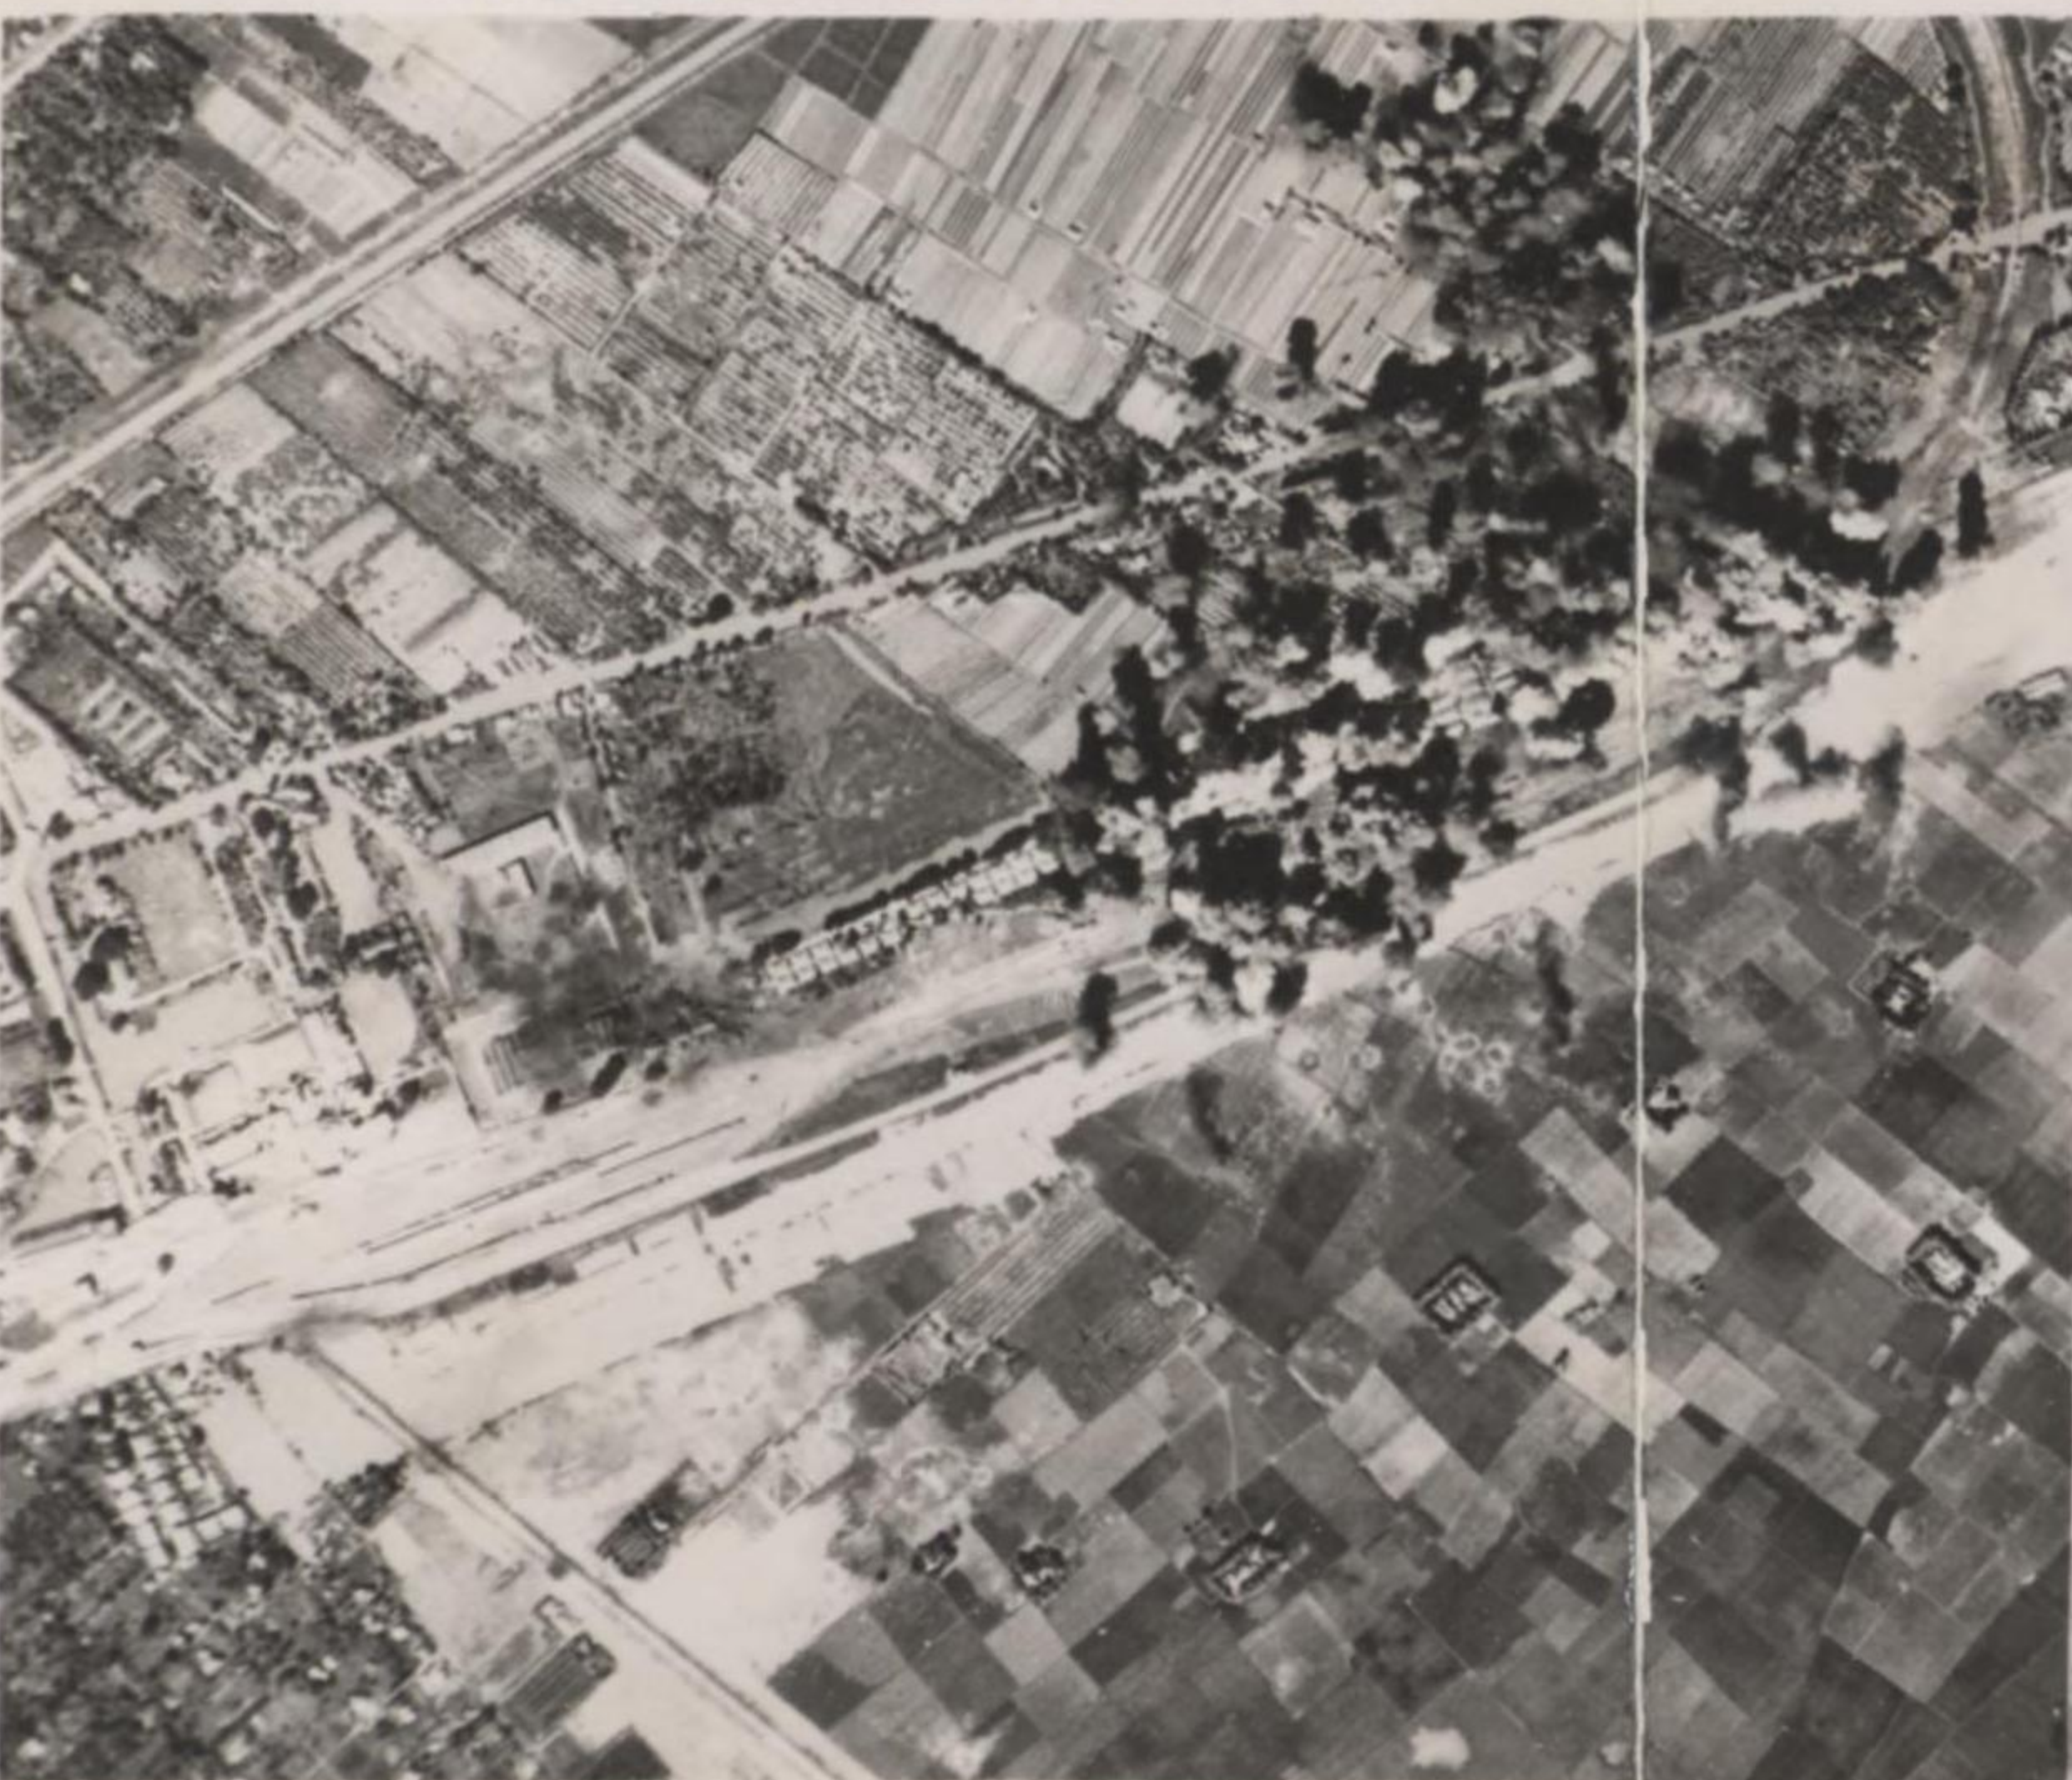
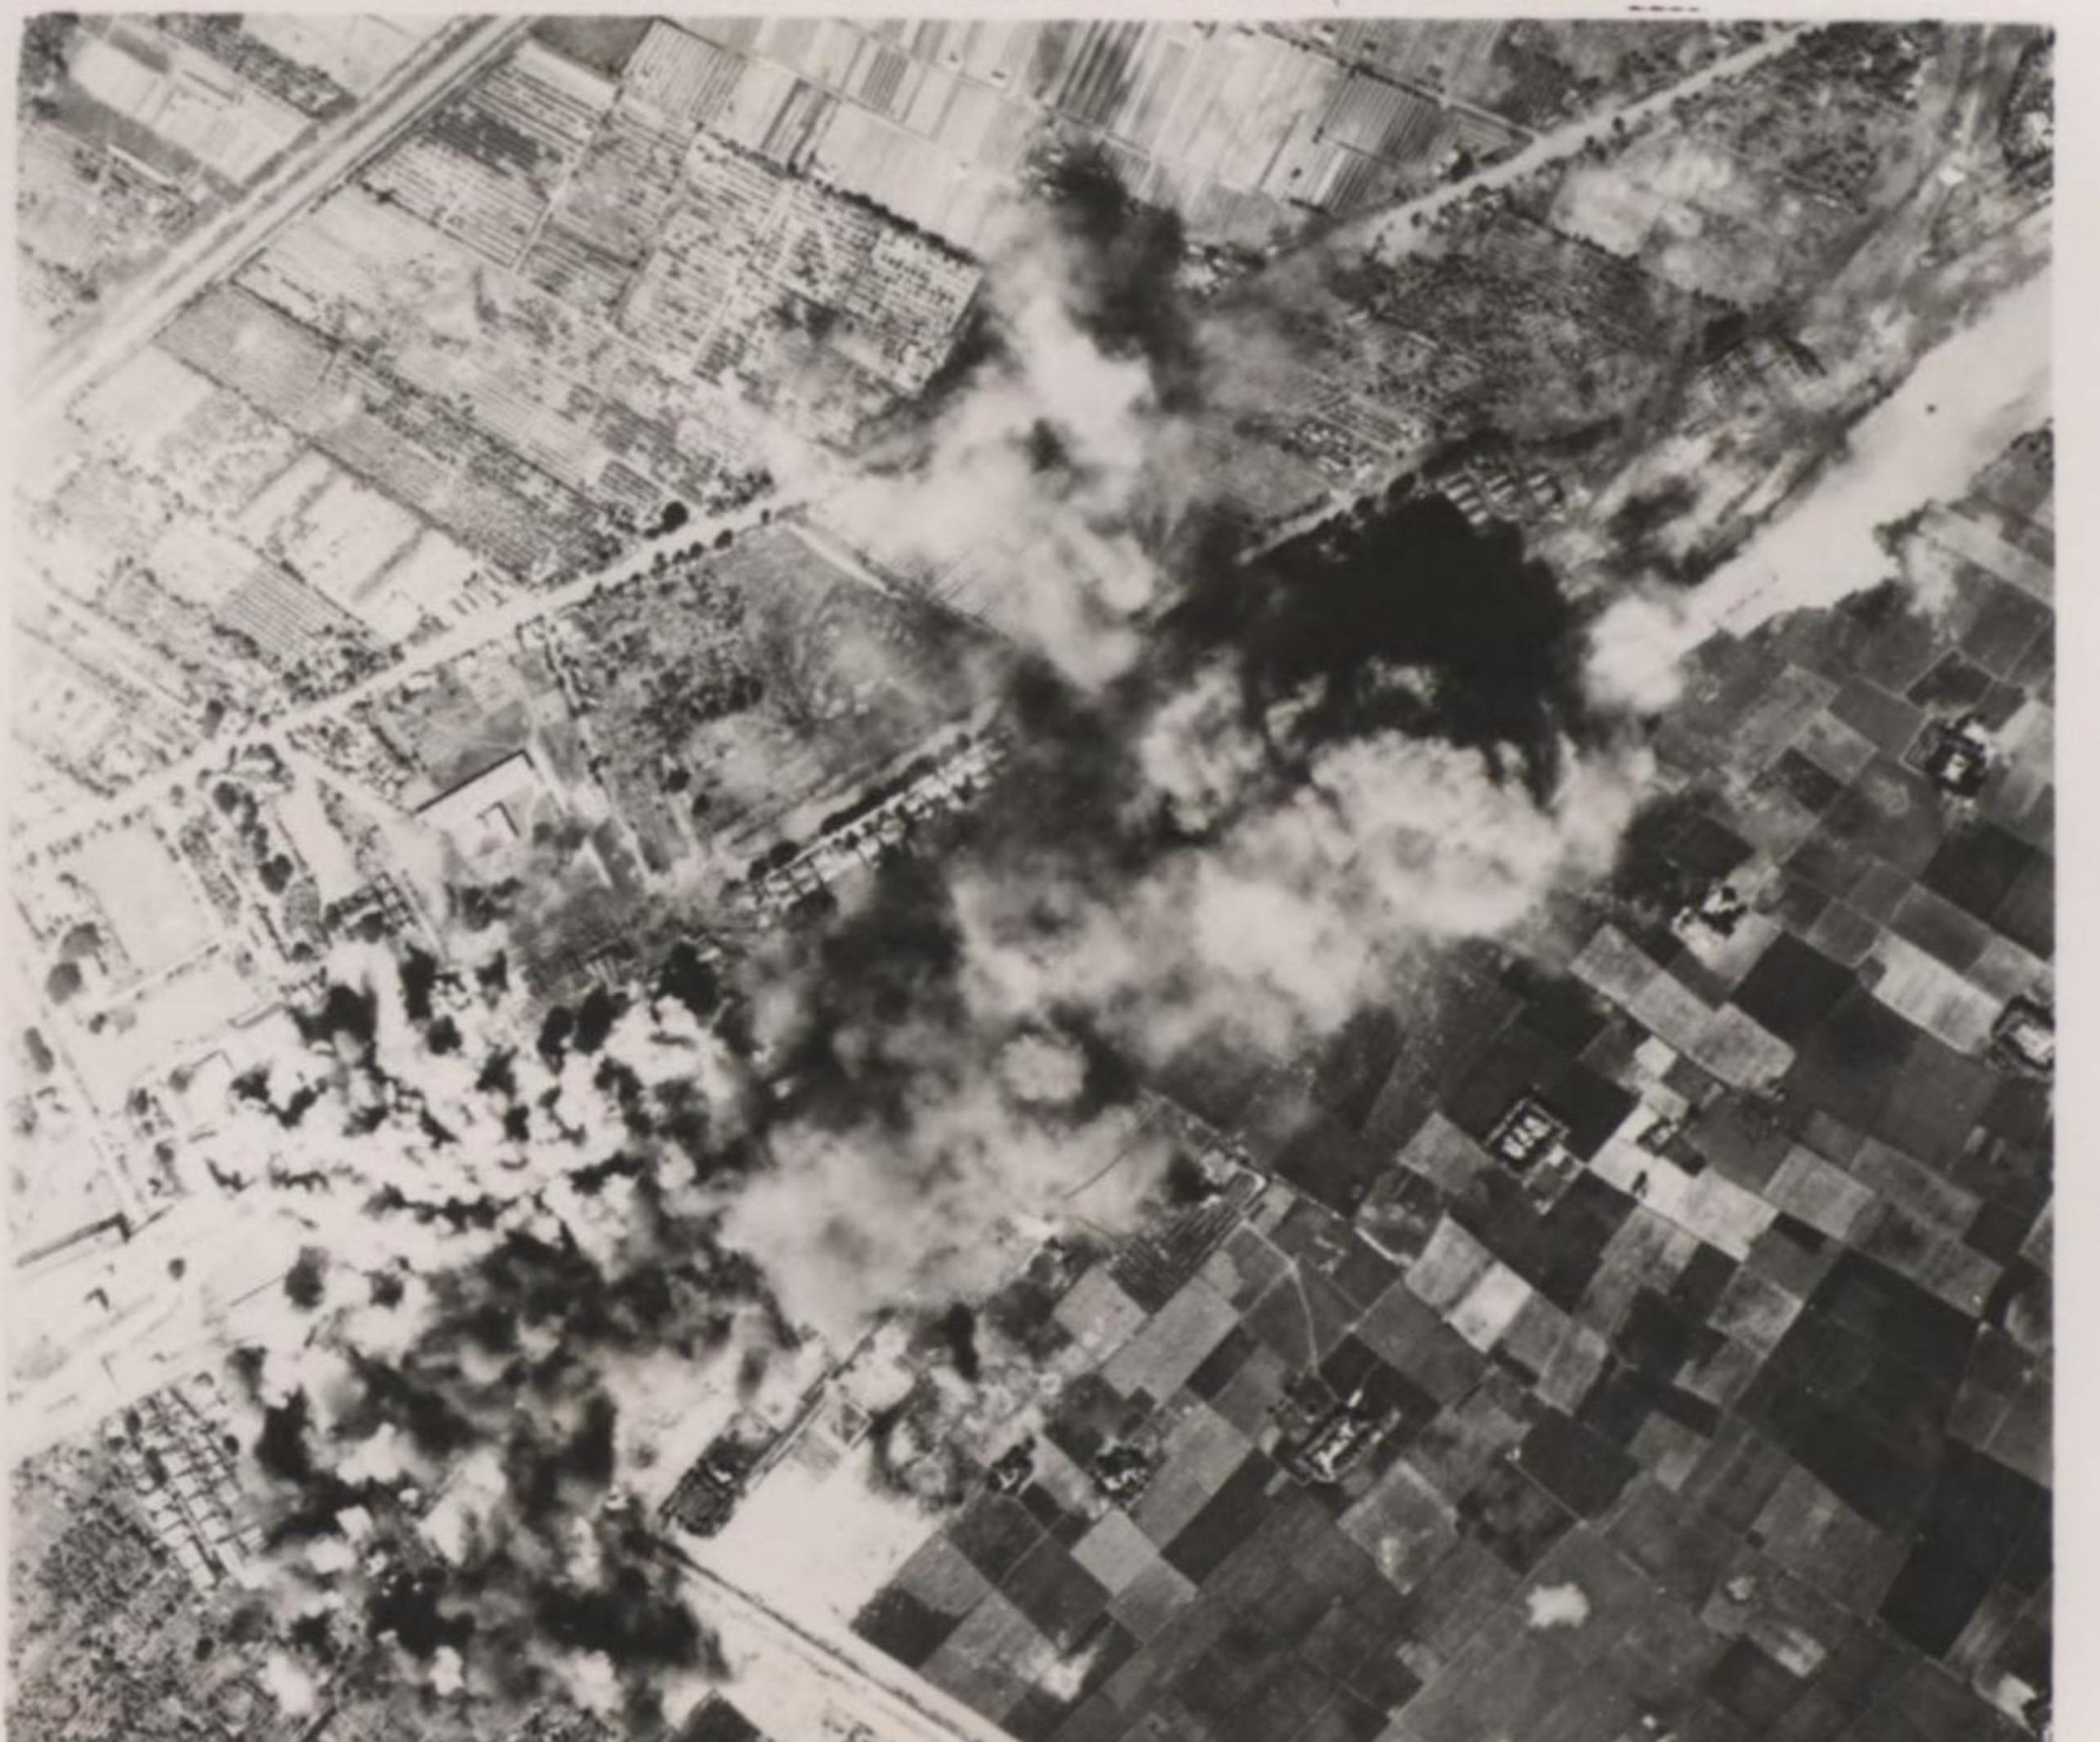
DURING

1 ST. OVER: 444TH BOMB GROUP

2ND OVER: 40TH BOMB GROUP

3RD OVER: 468TH BOMB GROUP

4TH OVER: 462ND BOMB GROUP
