AIRCRAFT ACTION REPORT

REPORT No. 98

XI. ATTACK ON ENEMY SHIPS OR GROUND OBJECTIVES (By Own Aircraft Listed in II Only)

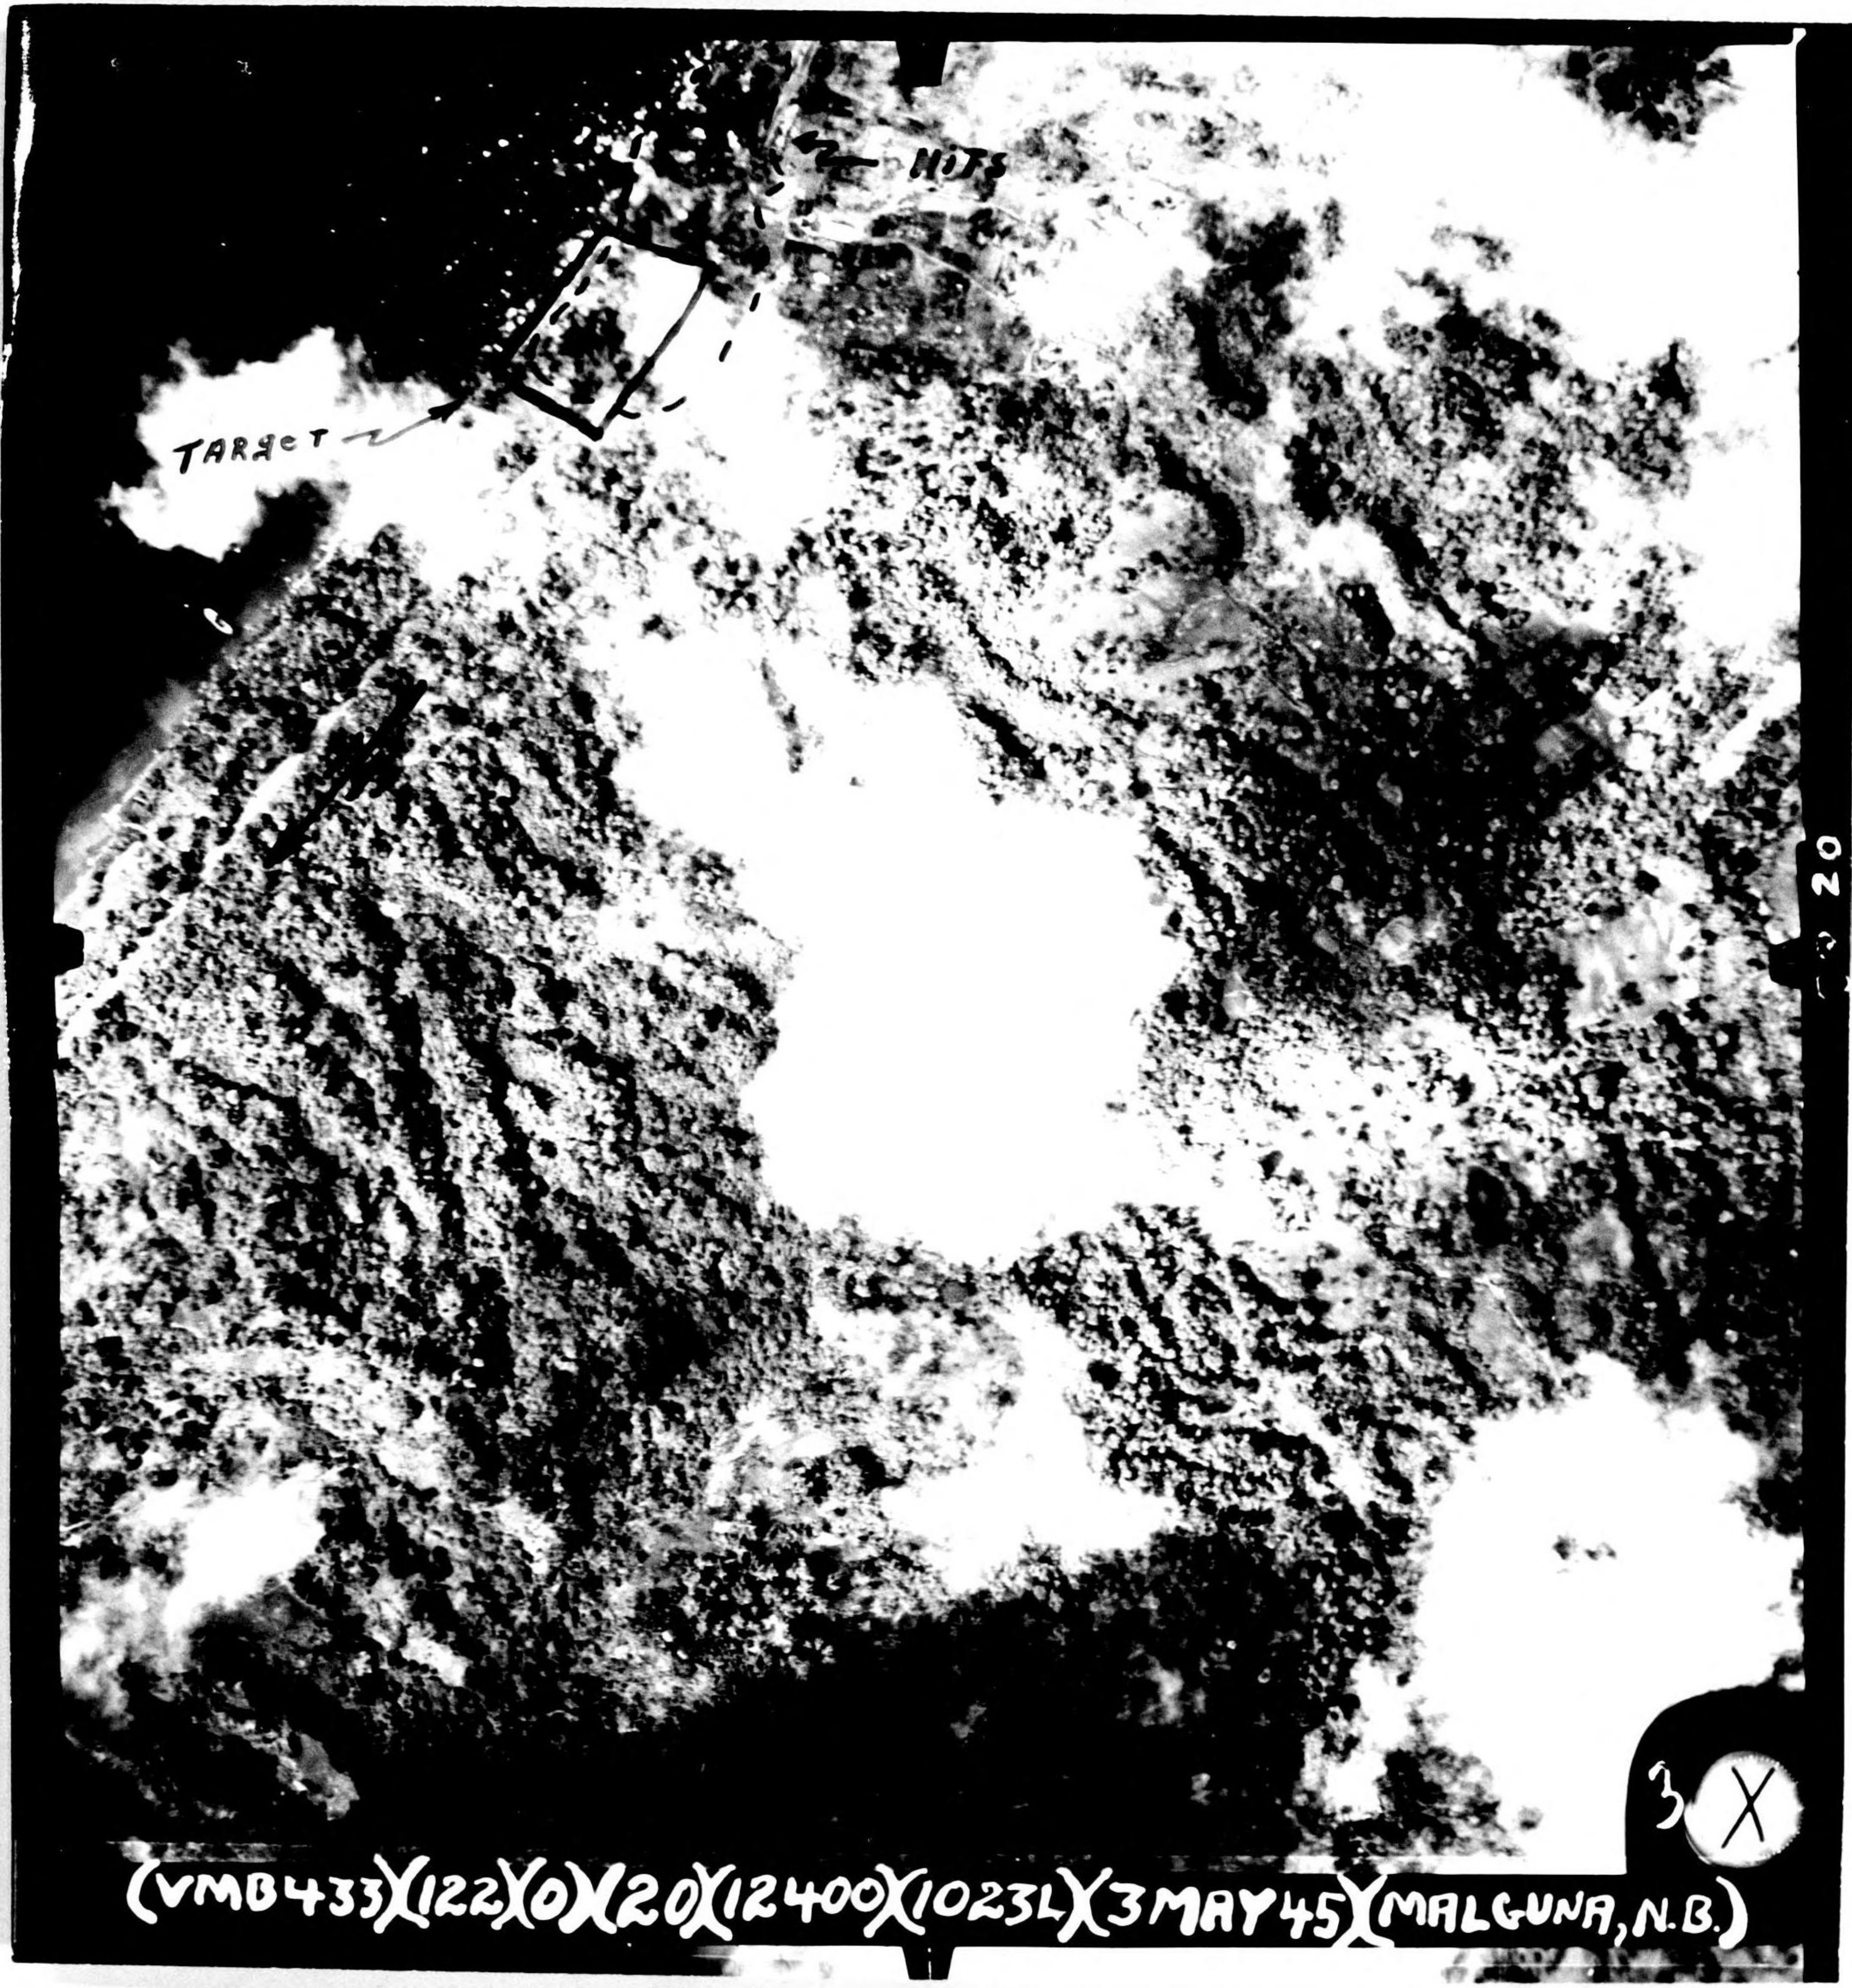
(VMB433)(122)(0)(20)(12400)(1023L)(3MAY45)(MALGUNA, N.B.)

- 1.- 5 x 500 GPs hit in water.
 9 x 500 GPs hit in target.
 28 x 500 GPs hit 100 yards long of target.
 12 x 500 GPs hit 100 yards short of target.
- 2.- 24 x 500 GPs fell along the western edge of the target doing probable damage to three small buildings partially hidden by the trees in the vicinity of the hide.
 12 x 500 GPs fell in southern half of the target doing probable damage to two buildings and hitting the upper end of the plane ramp. A small 50' jetty was also destroyed.
 12 x 500 GPs fell just south of the target doing probable damage to two small buildings.
- 3.- 6 x 500 GPs fell 100 feet off shore near Panapai Airstrip.
 48 x 500 GPs fell on western end of strip covering an area approximately 200' x 200'.
