Vanderbilt Mansion National Historic Site Historic Furnishings Report

Volume III: Implementation Plan

September 2015

JOHN G. WAITE ASSOCIATES, ARCHITECTS

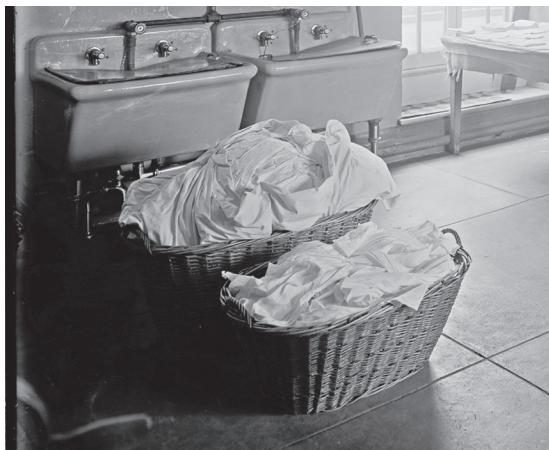
Figure 14. (Left) Detail of a laundry basket from the White House laundry. Library of Congress, Prints and Photographs Division, LC-H25- 3880-HO.

The laundry stove remains *in situ* but a necessary component is missing. The cast-iron superstructure, that held the irons for warming, needs to be restored. Irons should be placed on the restored stove rack. Other important furnishings necessary for a functioning laundry include a coal bucket (hob), laundry baskets, a clothes wringer, and floor mats in front of the laundry tubs. Laundry supplies were kept in the closet and cabinet at the south end of the room. One or two of the drying racks should be extended to display a sampling of the laundry, such as sheets, pillowcases, towels, etc. The windows should include linen roller shades (dark green), and the door to the hall should have the glass panel restored.

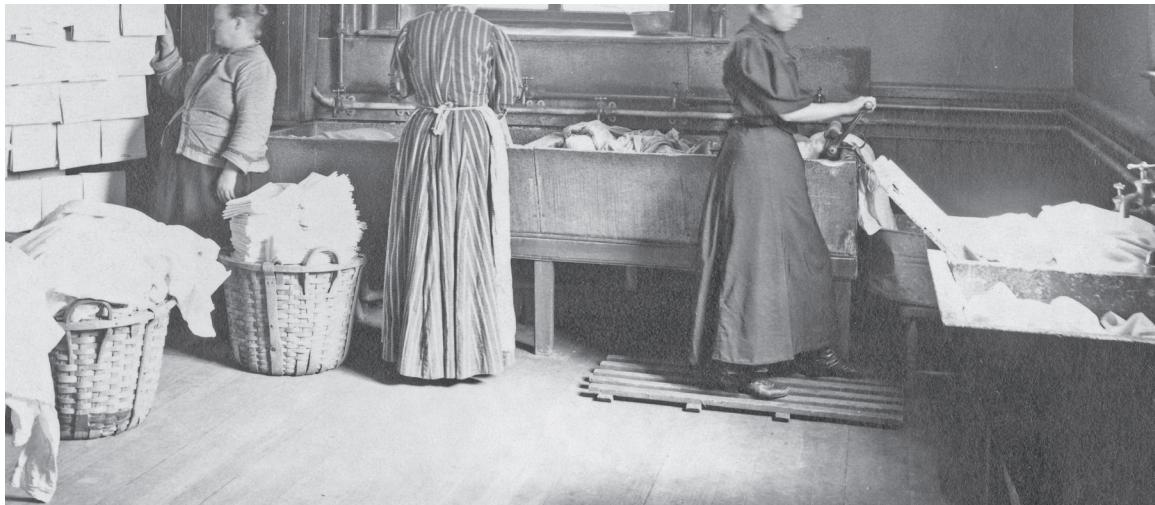
Figure 15. (Below) Detail from circa 1905 photograph of a laundry, showing a mangle, laundry baskets, and a wood platform/mat. Prints and Photographs Division, LC-H25- 3880-HO.

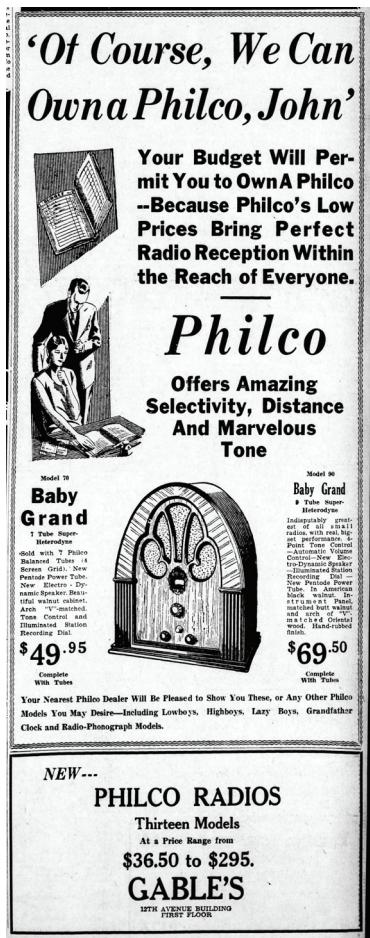
Figure 30. A 1932 advertisement for Philco radios, the kind that Frederick Vanderbilt used in the Den. *Altoona Tribune*, January 6, 1932.

Of the many smaller decorative and utilitarian objects in the room in 1938, the most significant was a small Philco radio. A Philco "cathedral" style radio should be acquired and placed on the upper surface of the two-tiered oval table placed in front of the east window. This prominent position recognizes the importance of this "modern" form of entertainment.

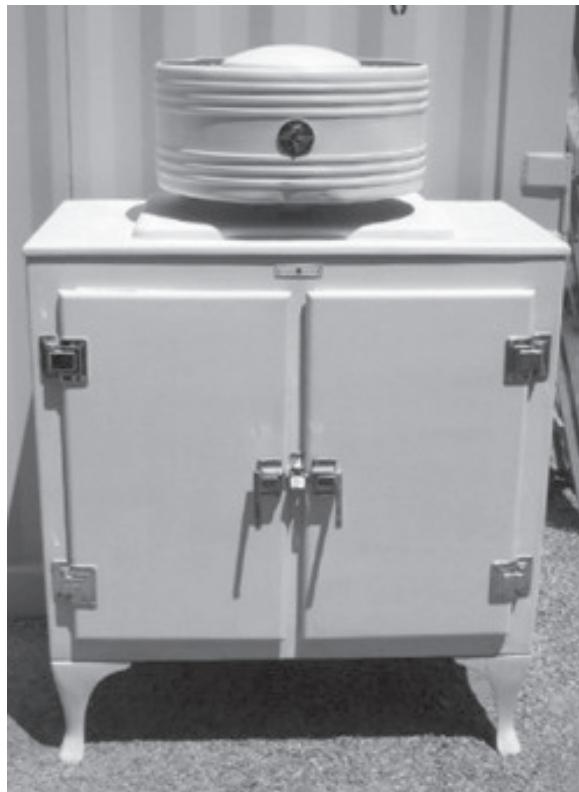
Figure 41. A 1930s General Electric monitor-top refrigerator. www.antiquevintageappliances.com.

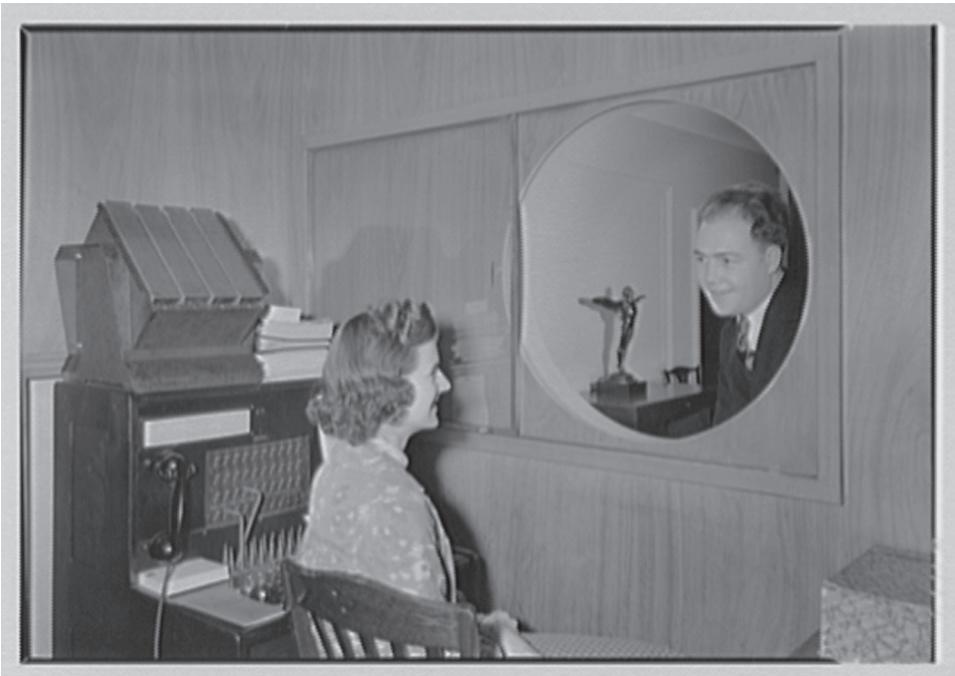
Figure 94. (Above) A telephone switchboard and operator, 1941. Library of Congress.

LOCATION	VAMA #	OBJECT	EVIDENCE	ACTION
1 North wall	N/A	Army cots (2) and mattresses.	Memorandum from Gertrude S. Cooper, Superintendent, August 1, 1942.	Acquire.
2 Beds	N/A	Bedding for army cots (2 sets).	Invoices and memorandums from Gertrude Cooper, superintendent.	Acquire.
3 South wall	N/A	Cabinet switchboard.	Transcript of interview with Louise Hackmeister, September 6, 1951.	Acquire.
4	COLL	Mahogany side chairs with spindle backs and blue chintz seats (2).	1938 Curry inventory.	Install.
5 Table on west wall and switchboard	1123	Mahogany armchair with chintz covered seat and back. Two listed in 1938 Curry inventory.	1938 Curry inventory.	Conserve and install.
6 Northeast	337	Blue wicker side chair.	1938 Curry inventory.	Install in this room (currently in Housekeeper's Office)
7 Northeast	COLL	White enamel table. Two listed in 1938 Curry inventory.	1938 Curry inventory	If in collection, install.

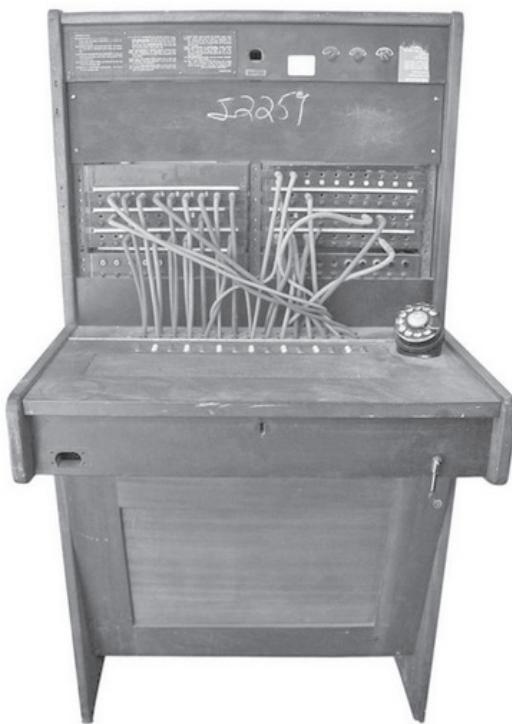
Figure 95. (Left) A Western Electric switchboard, circa 1945, from a recent auction. https://www.1stdibs.com/furniture/more-furniture-collectibles/historical-memorabilia/vintage-western-electric-telephone-switchboard/id-f_899397/.
