MISSION # 36 RANGOON "FESTOONERY 2"  
11 February 1945

# XX BOMBER COMMAND

## Tactical Mission Report

TARGET: DUMP "F", RANGOON AREA

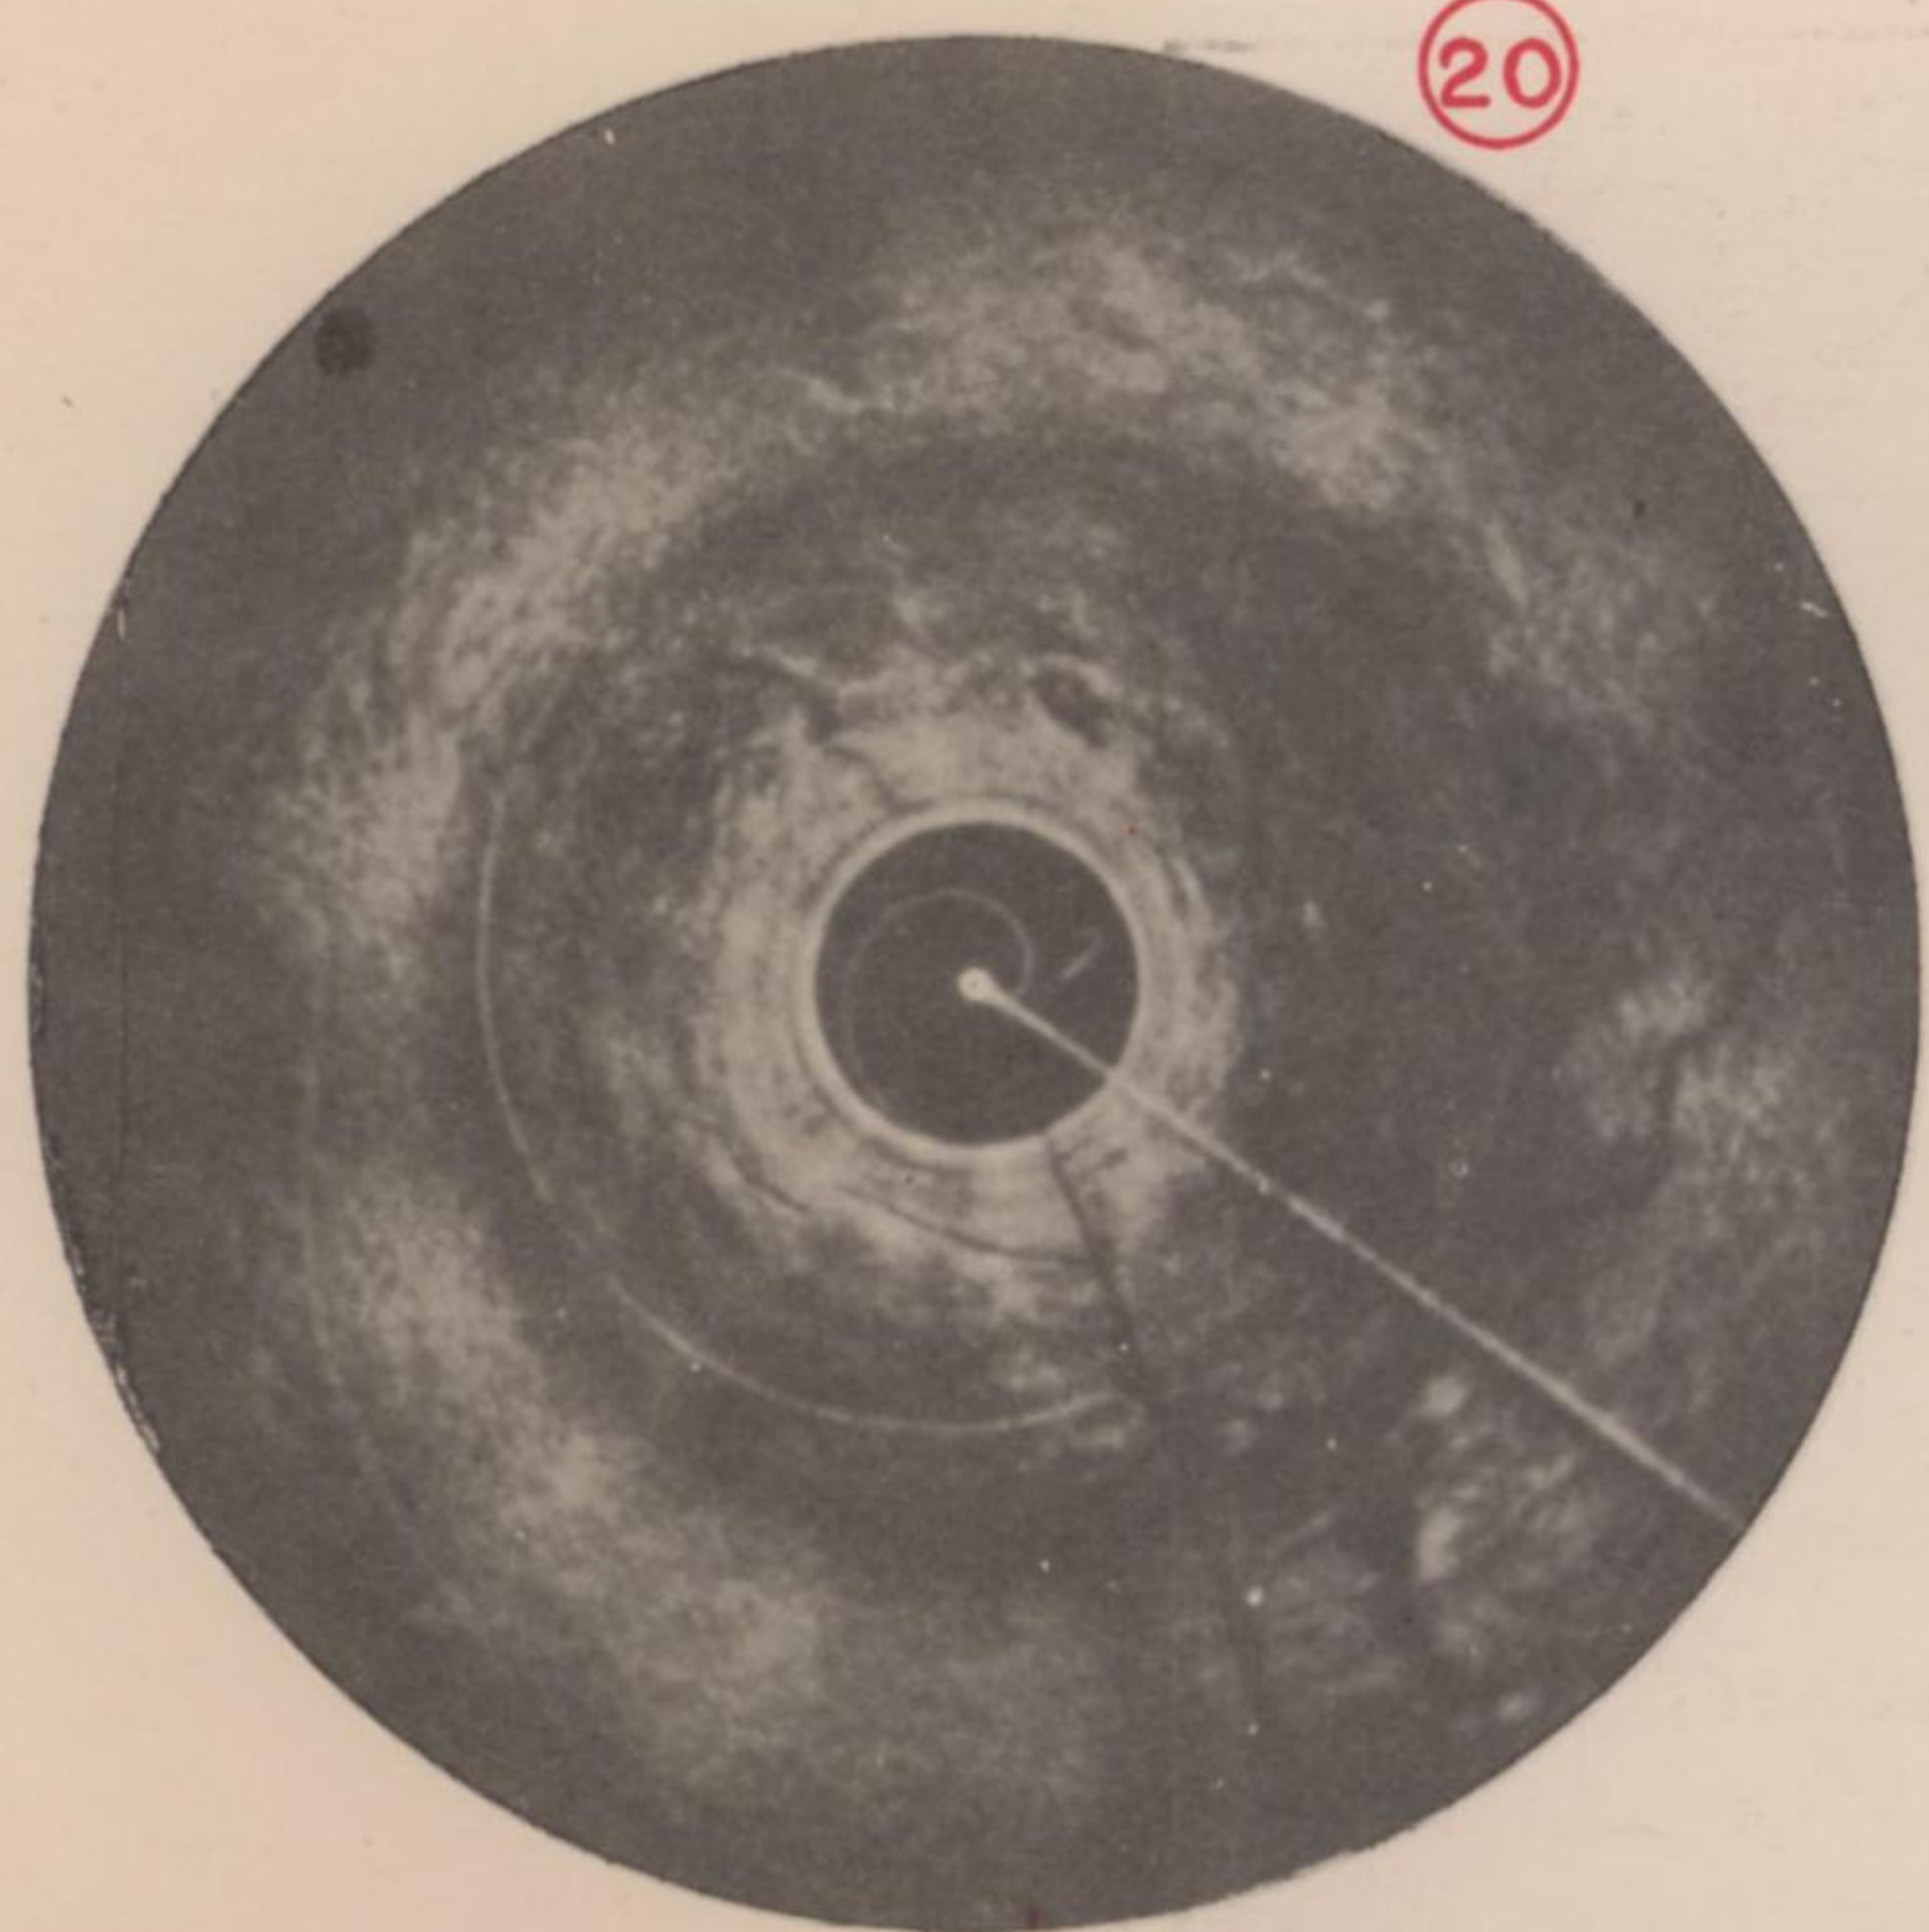
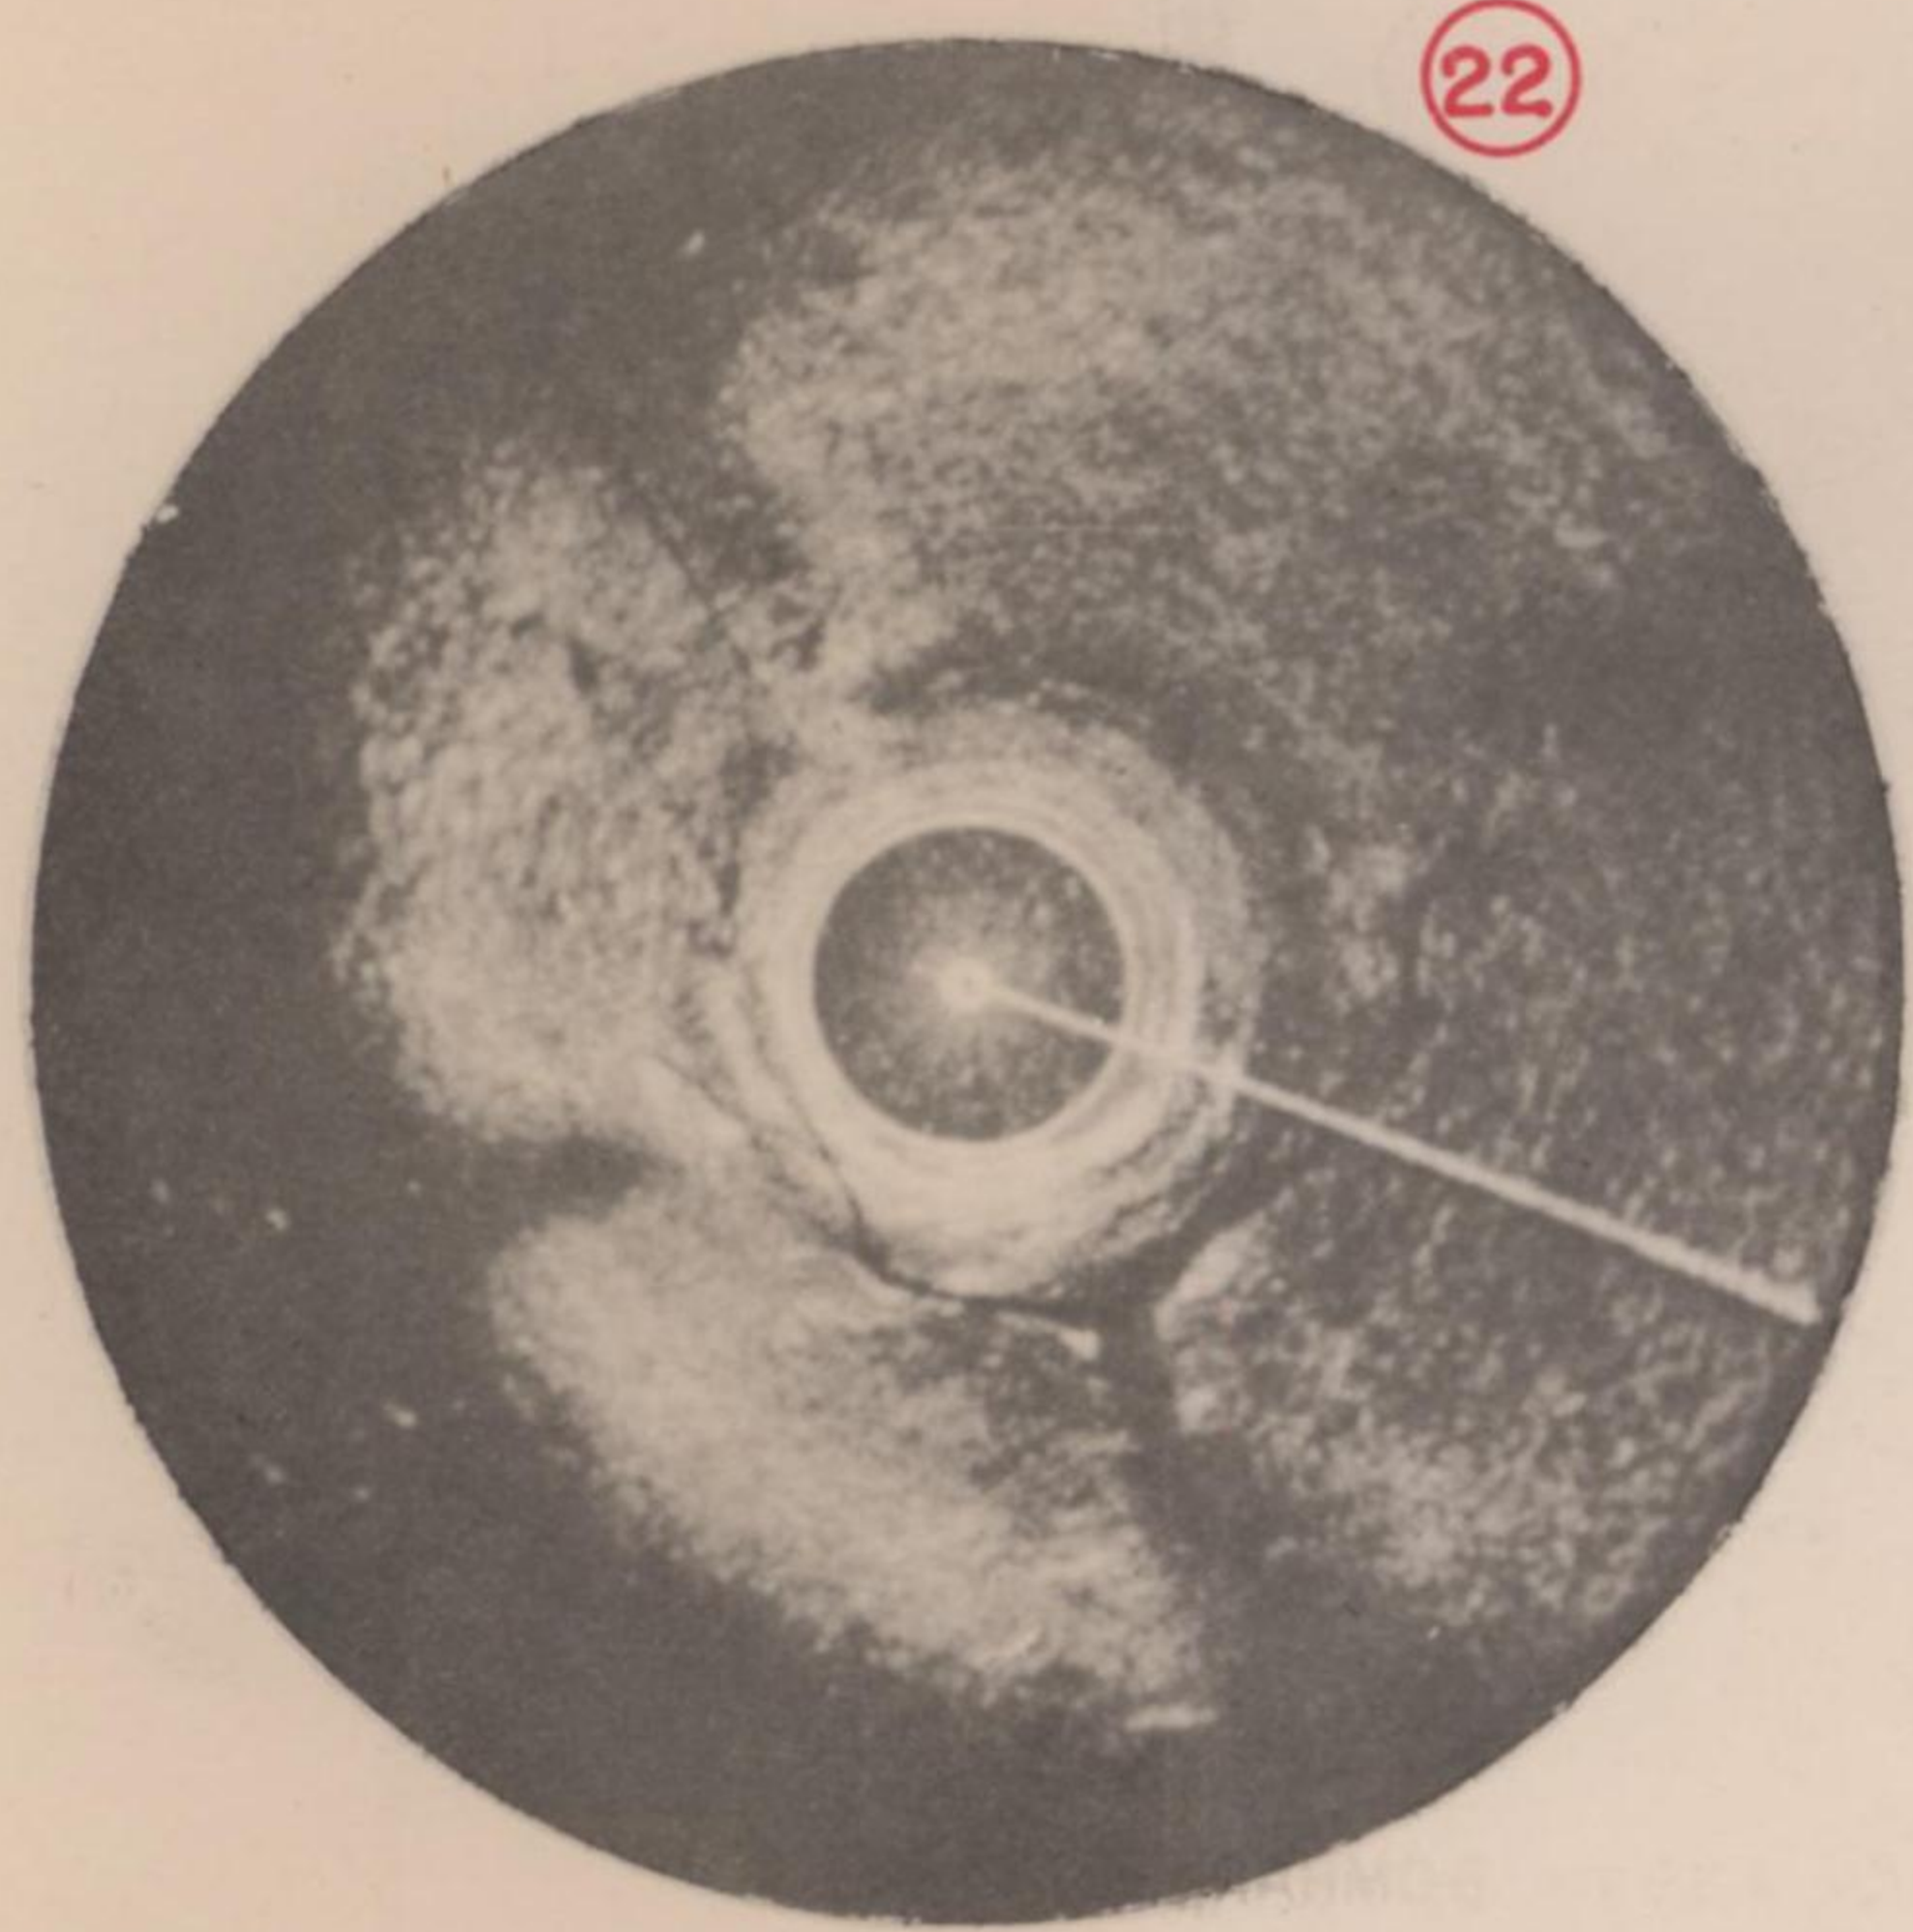
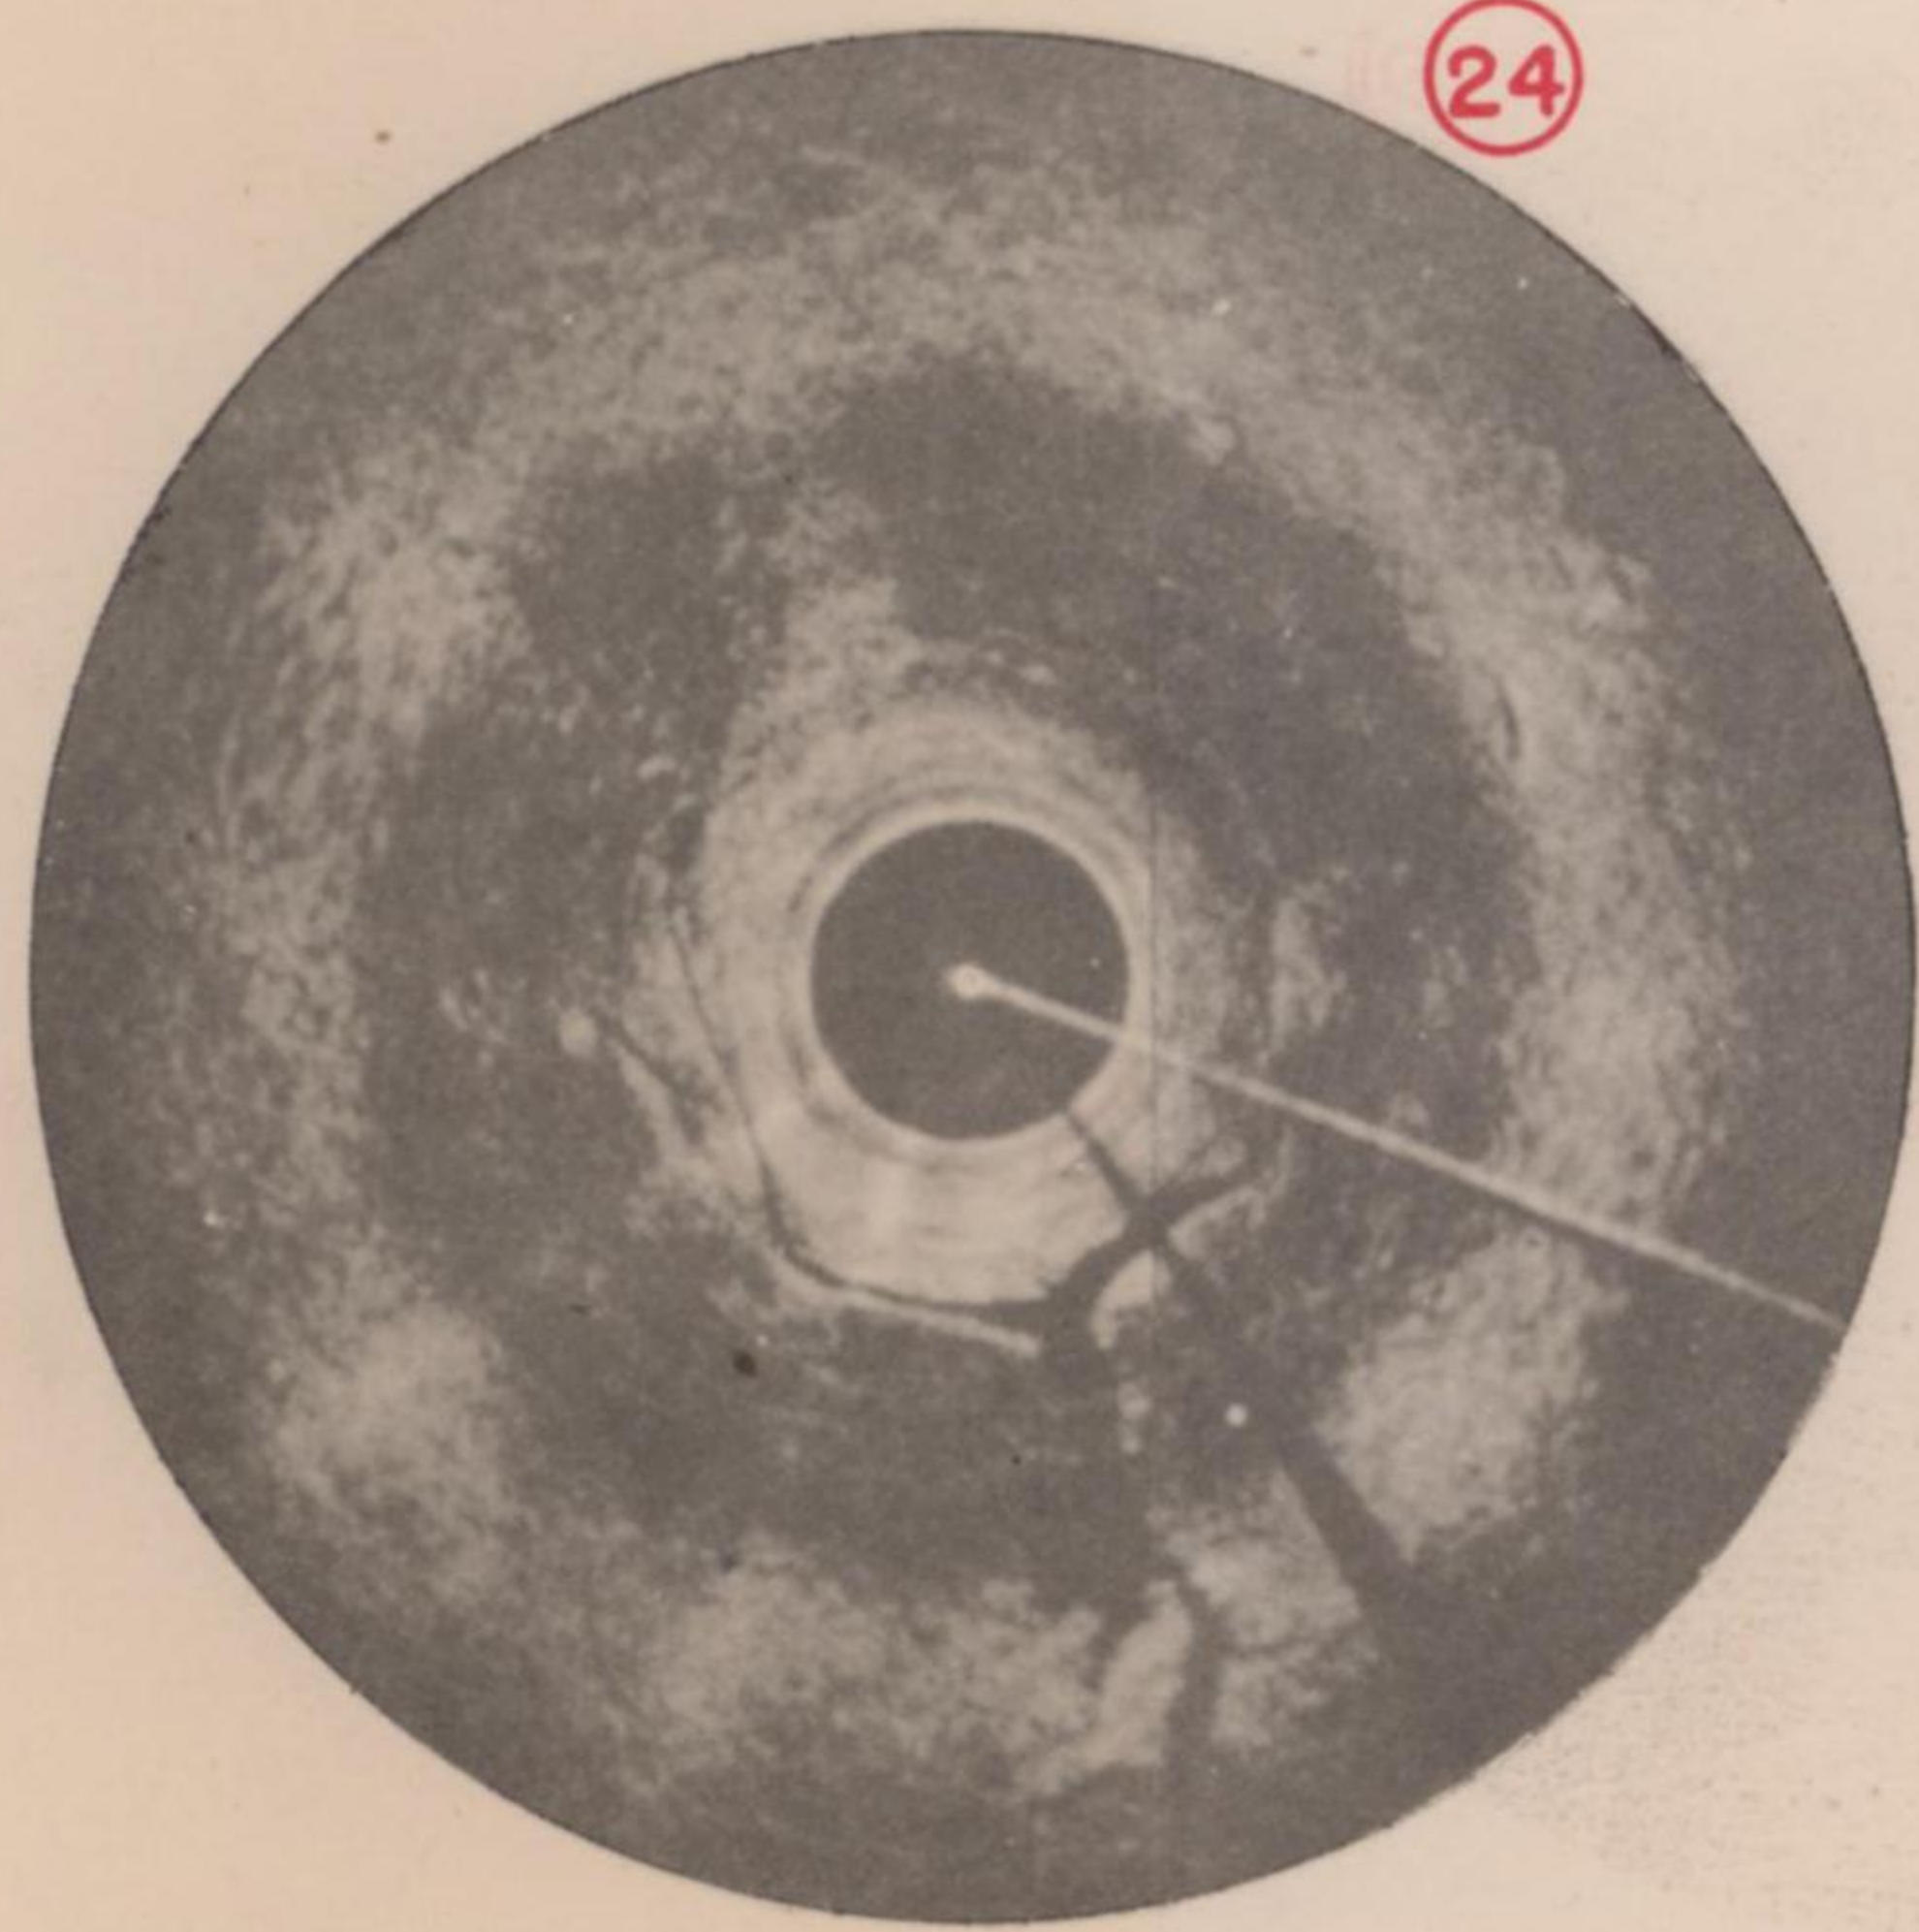
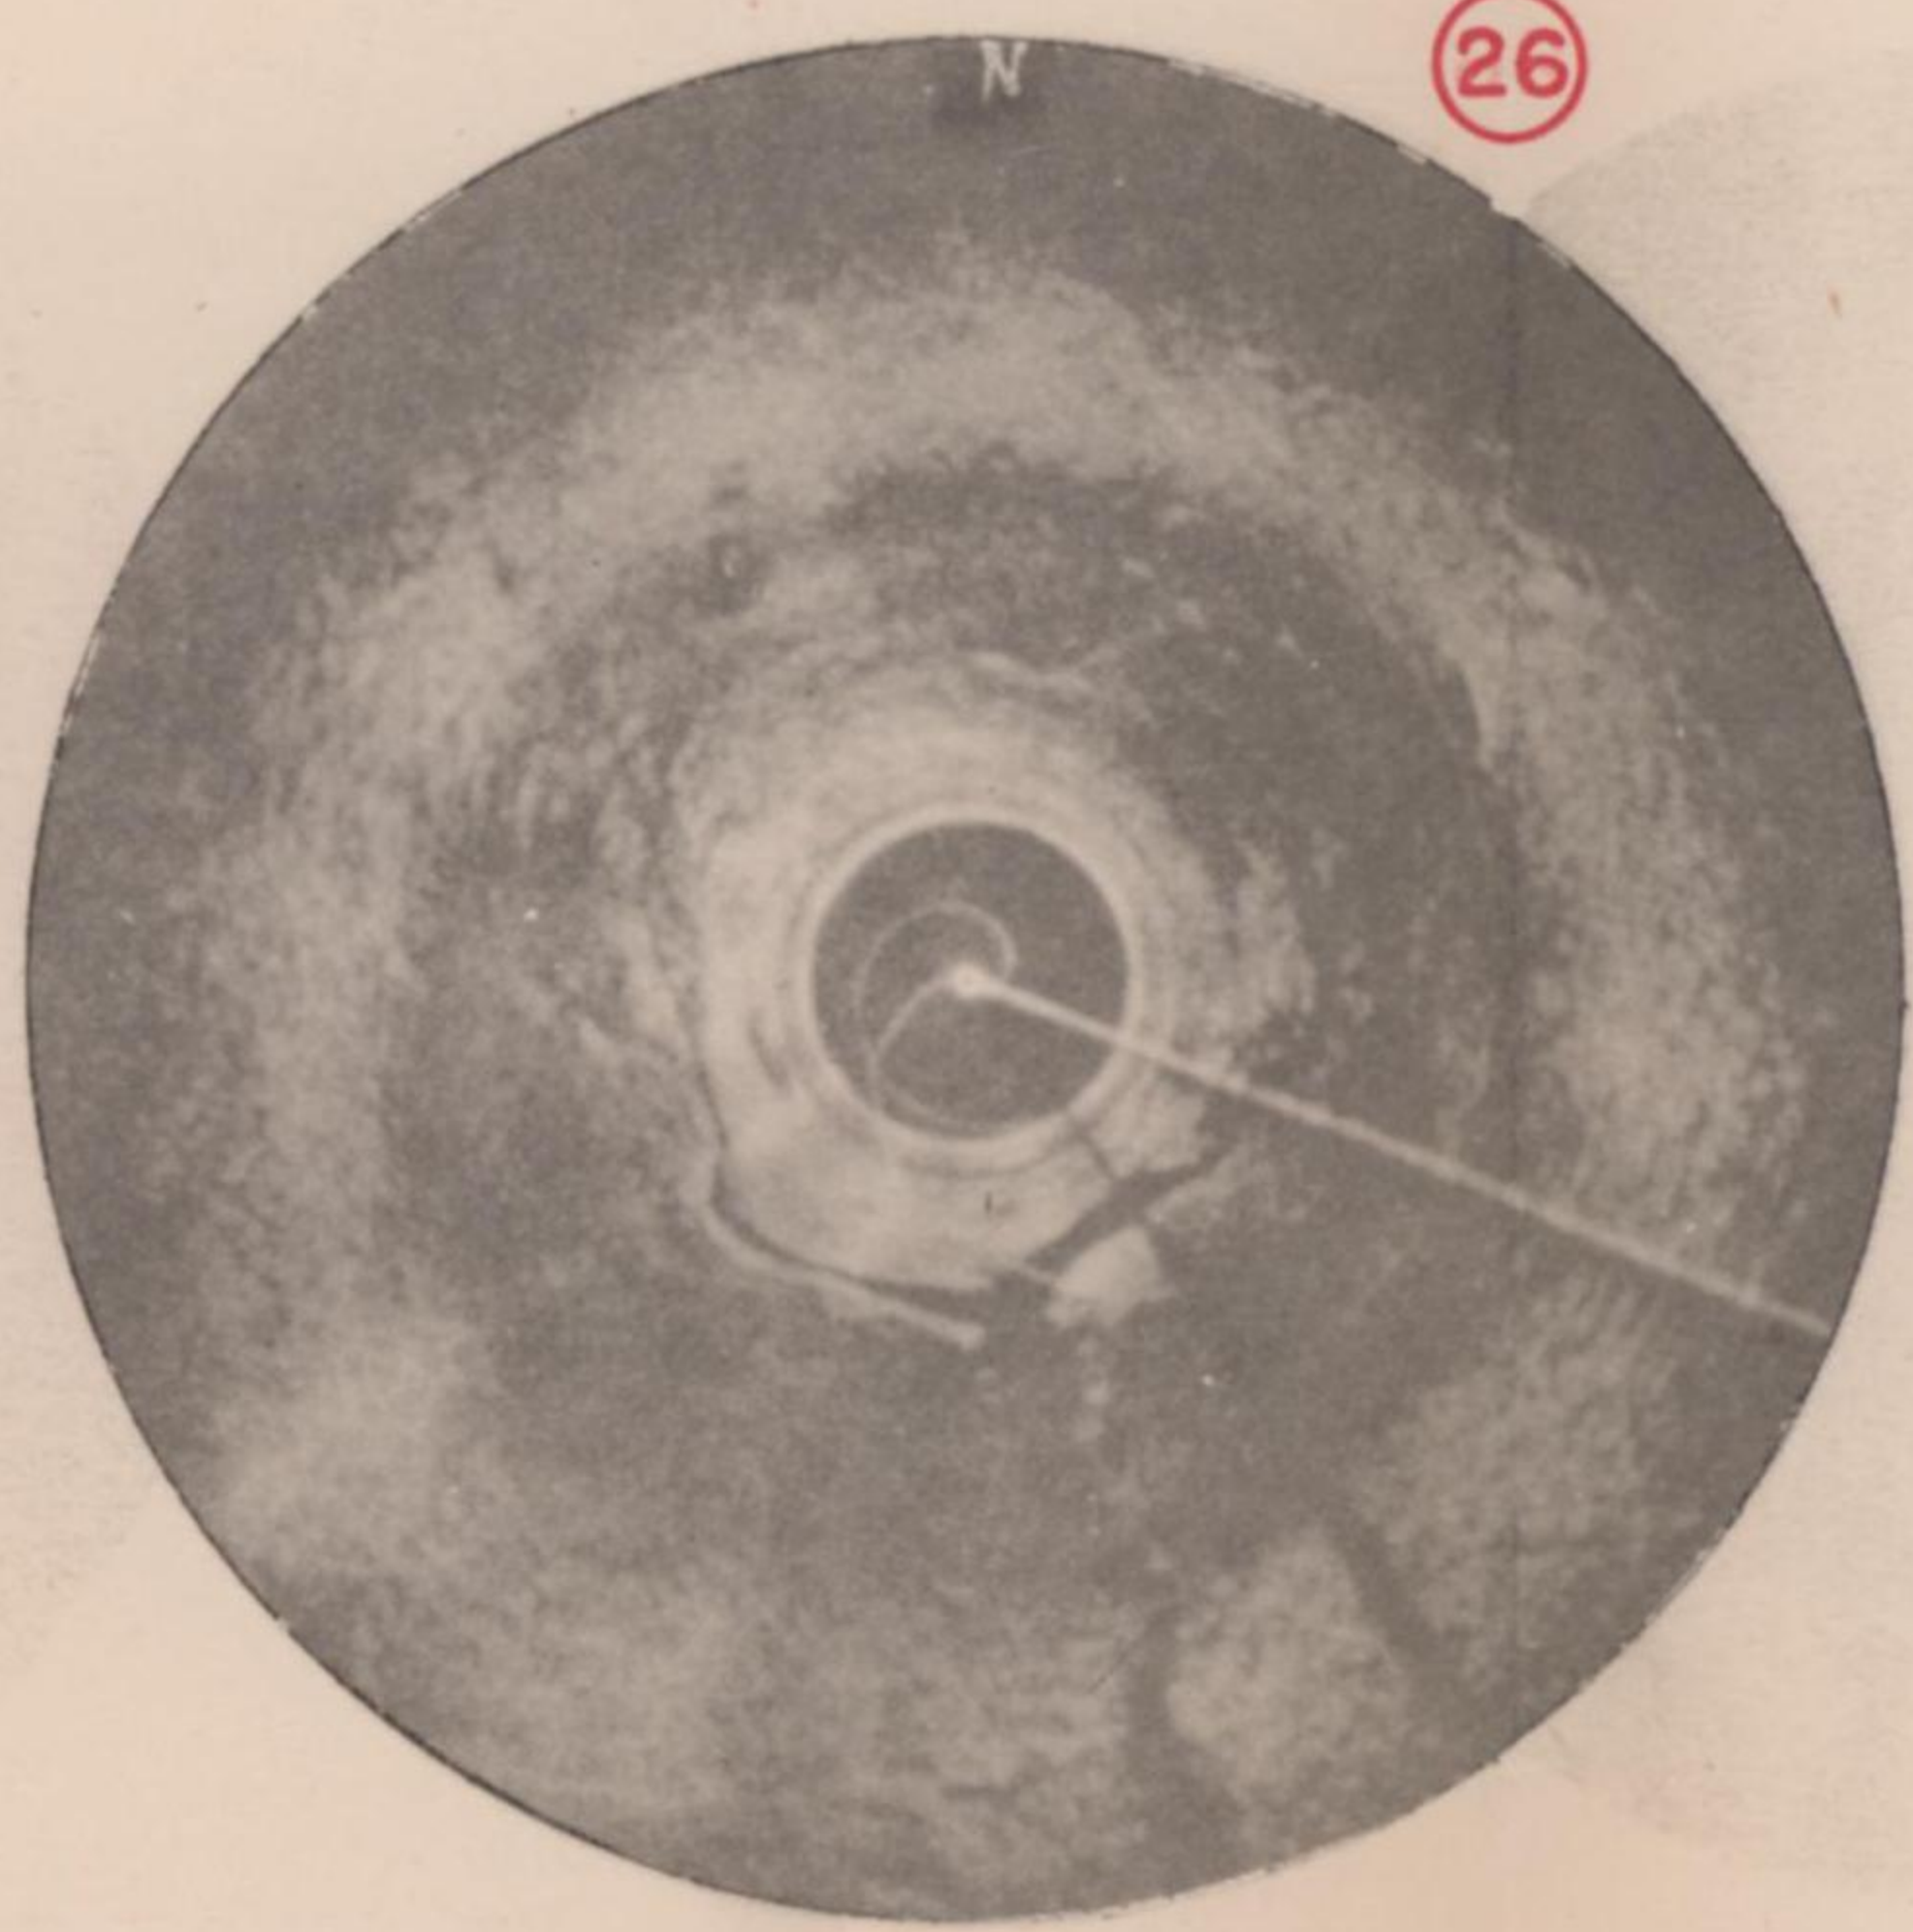
MISSION NO. 36

HEADING 125° MAG.

ALTITUDE 21,000'

HEADING 118° MAG.
