MISSION # 36 RANGOON "FESTOONERY 2"  
11 February 1945

# XX BOMBER COMMAND

## Tactical Mission Report

TARGET: DUMP "F", RANGOON AREA

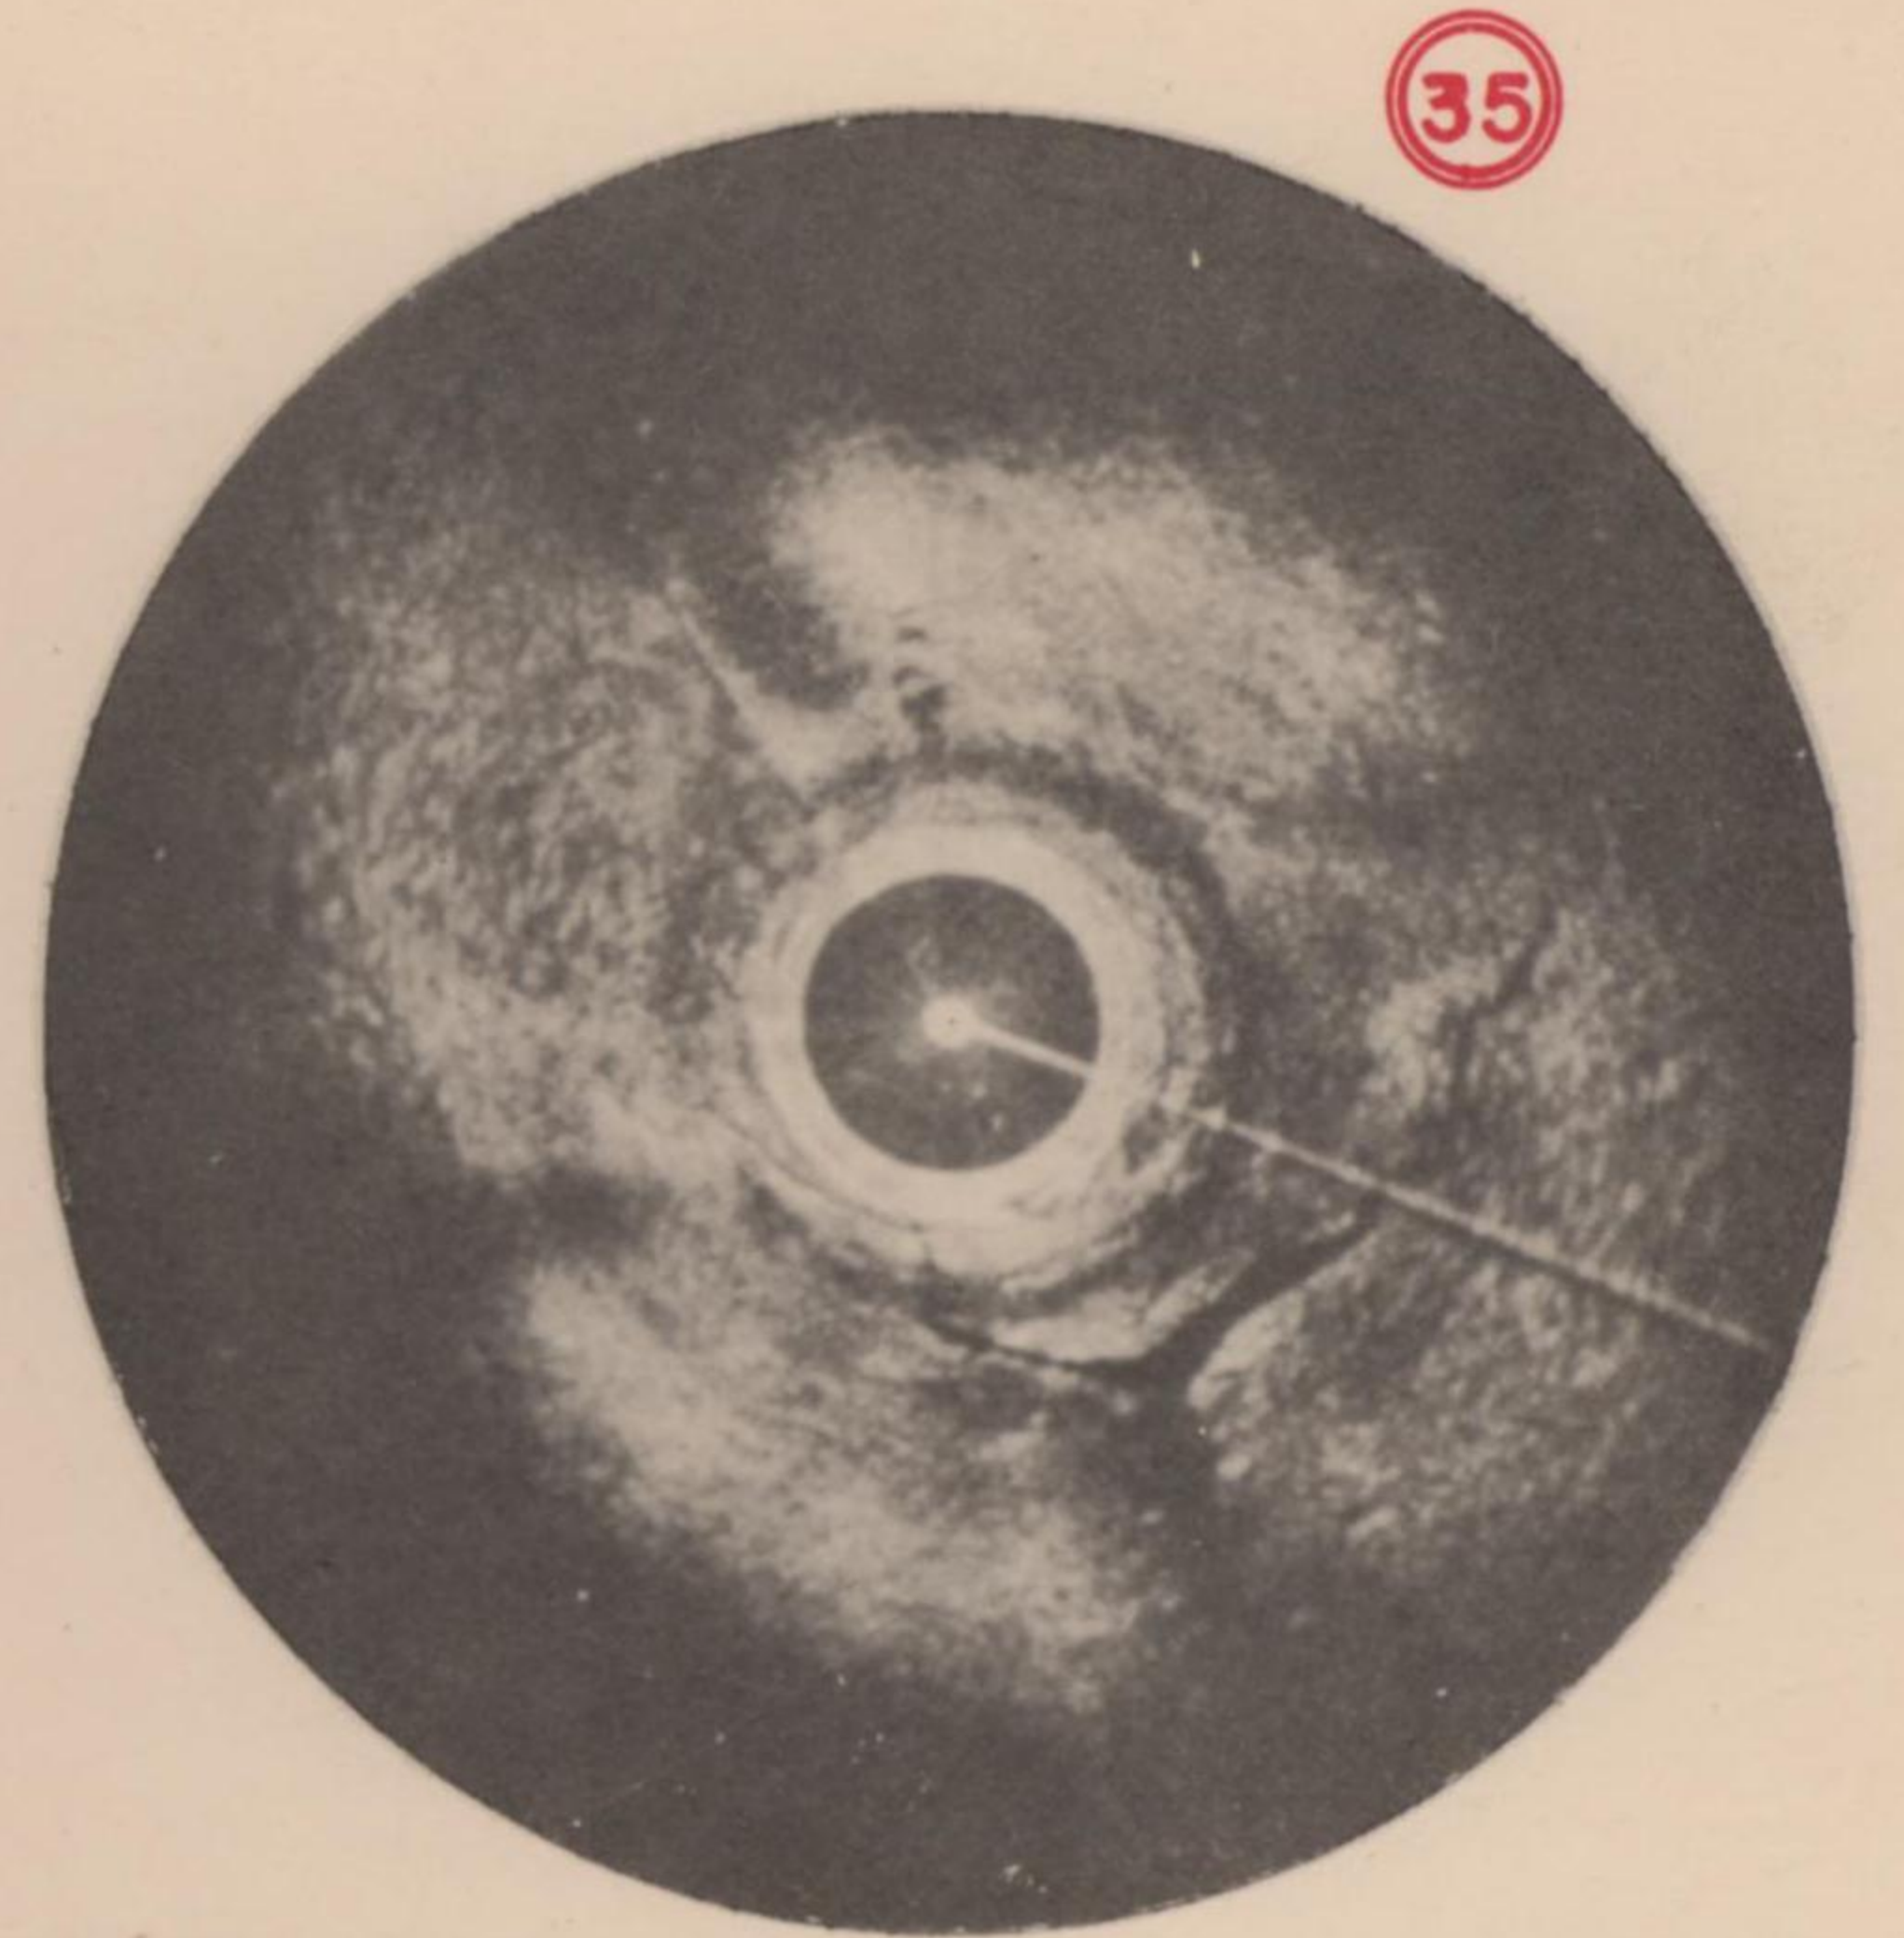
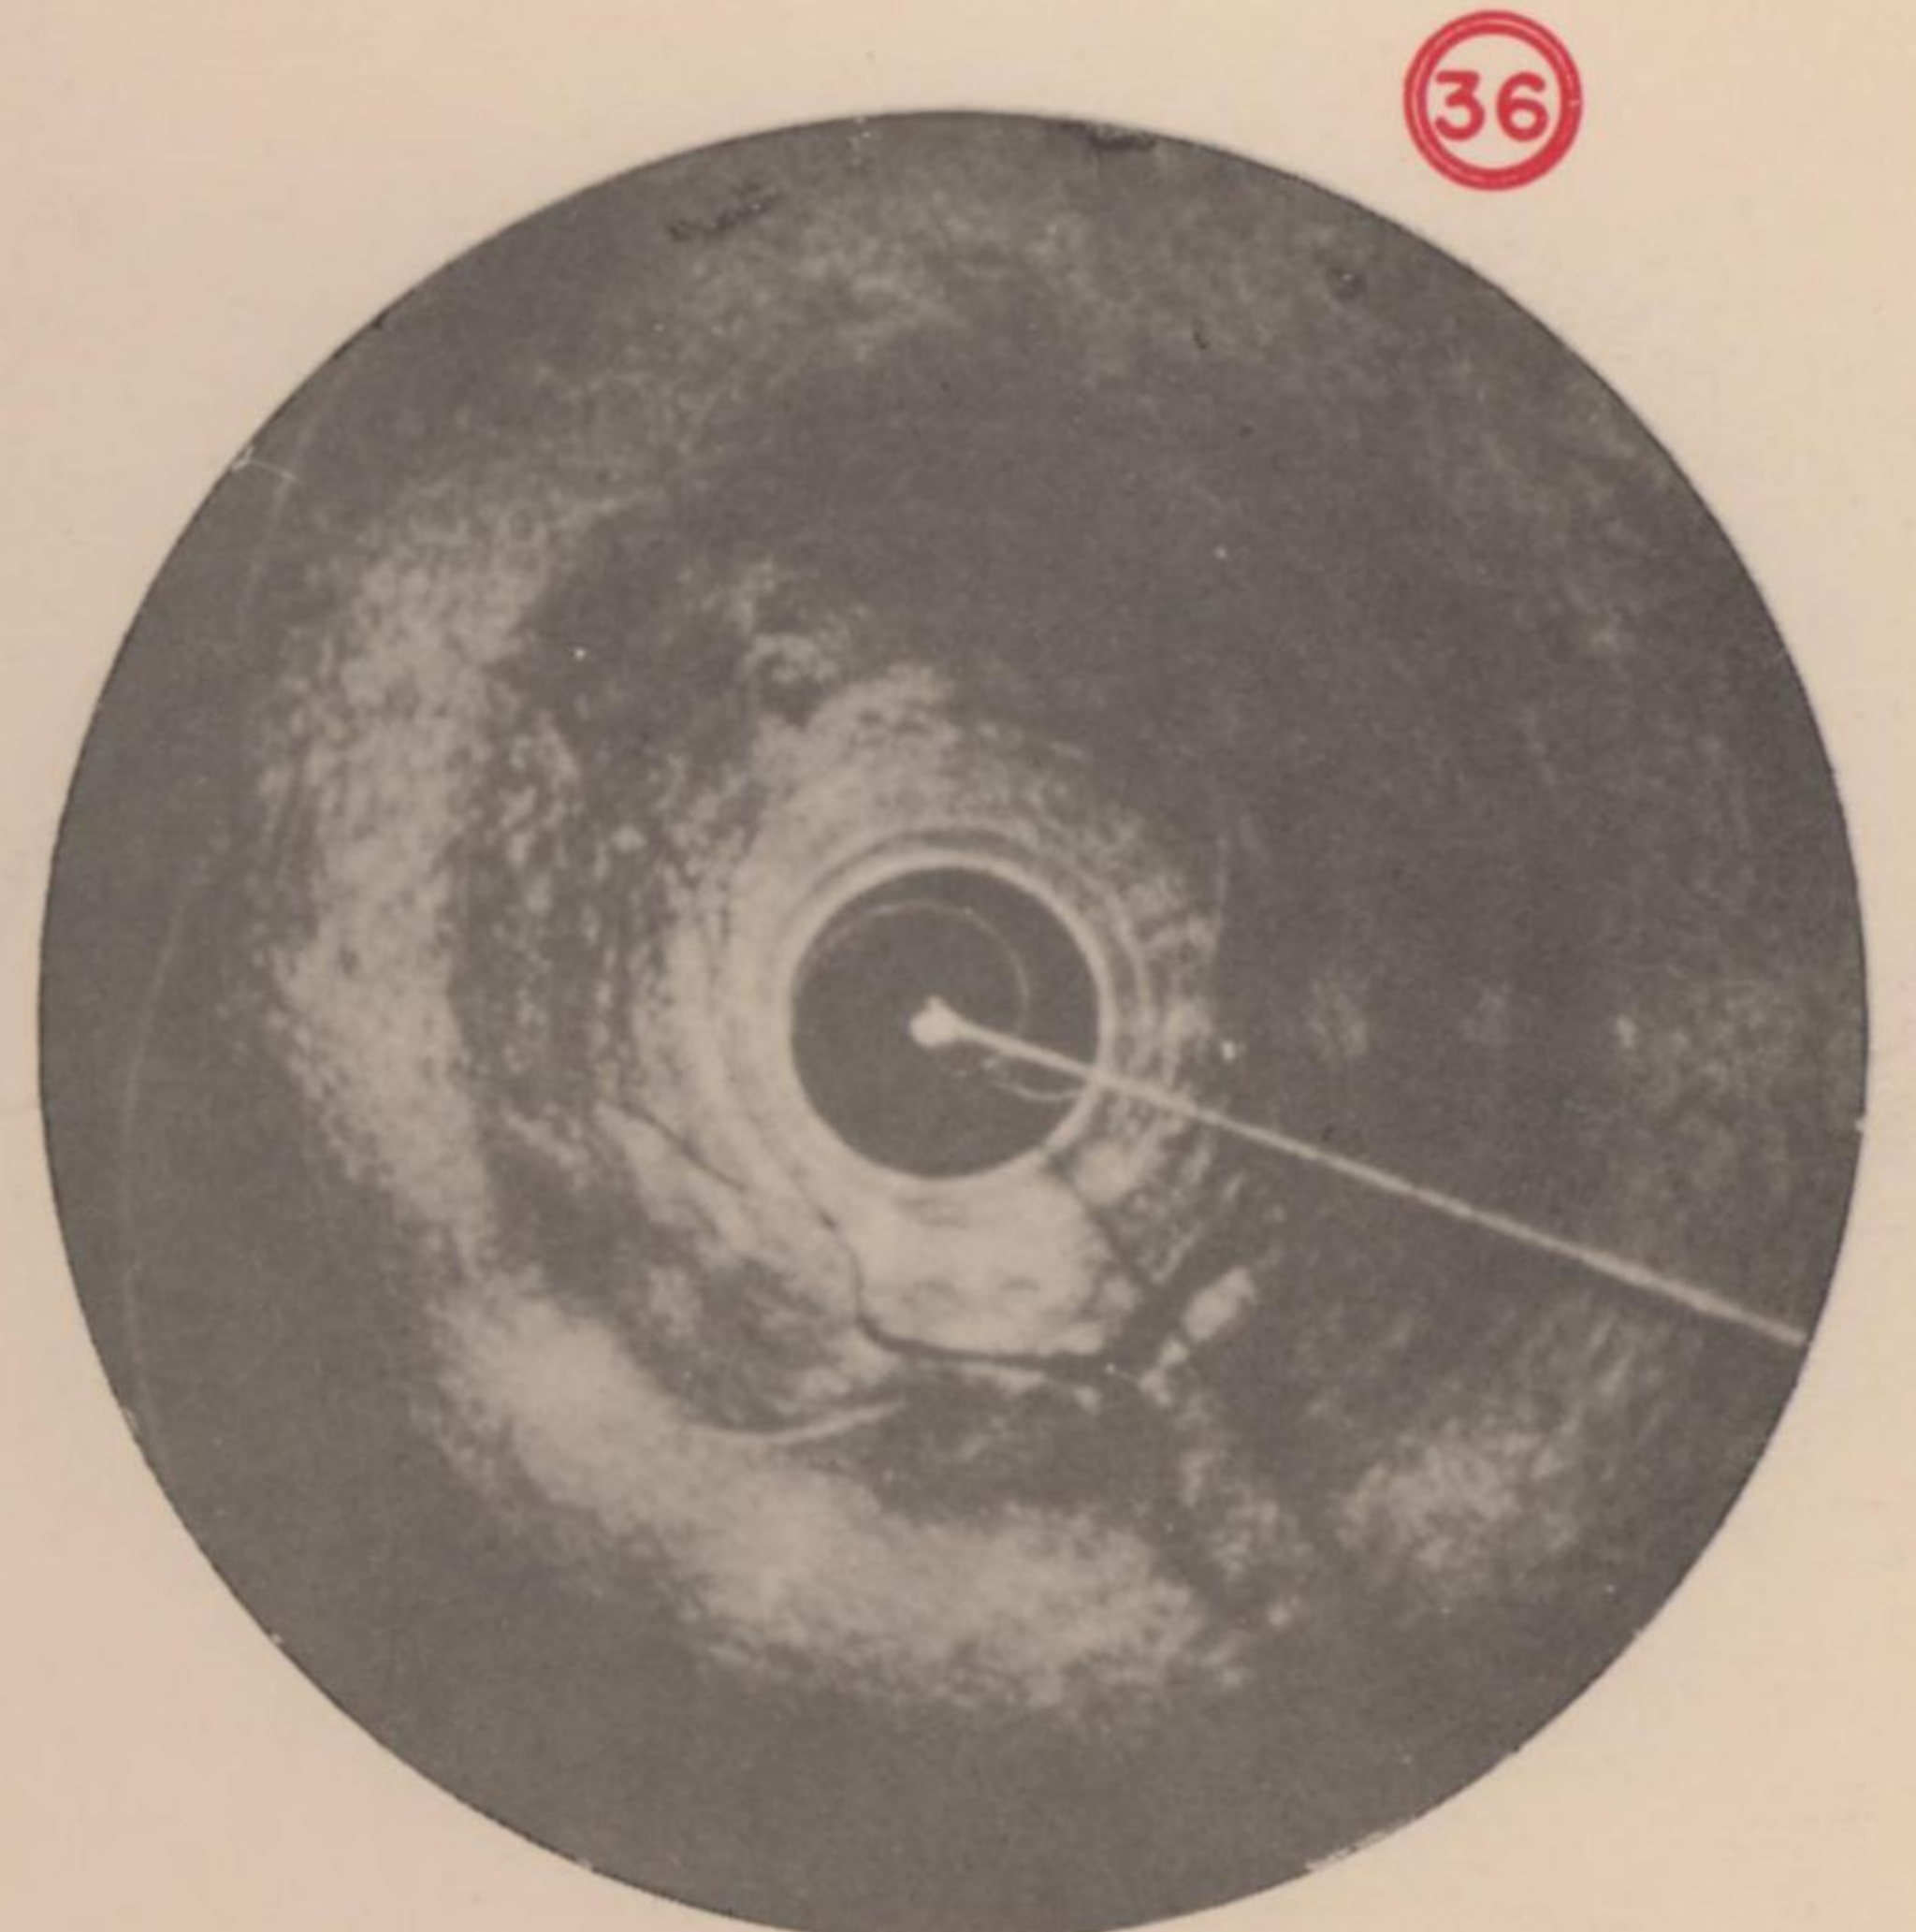
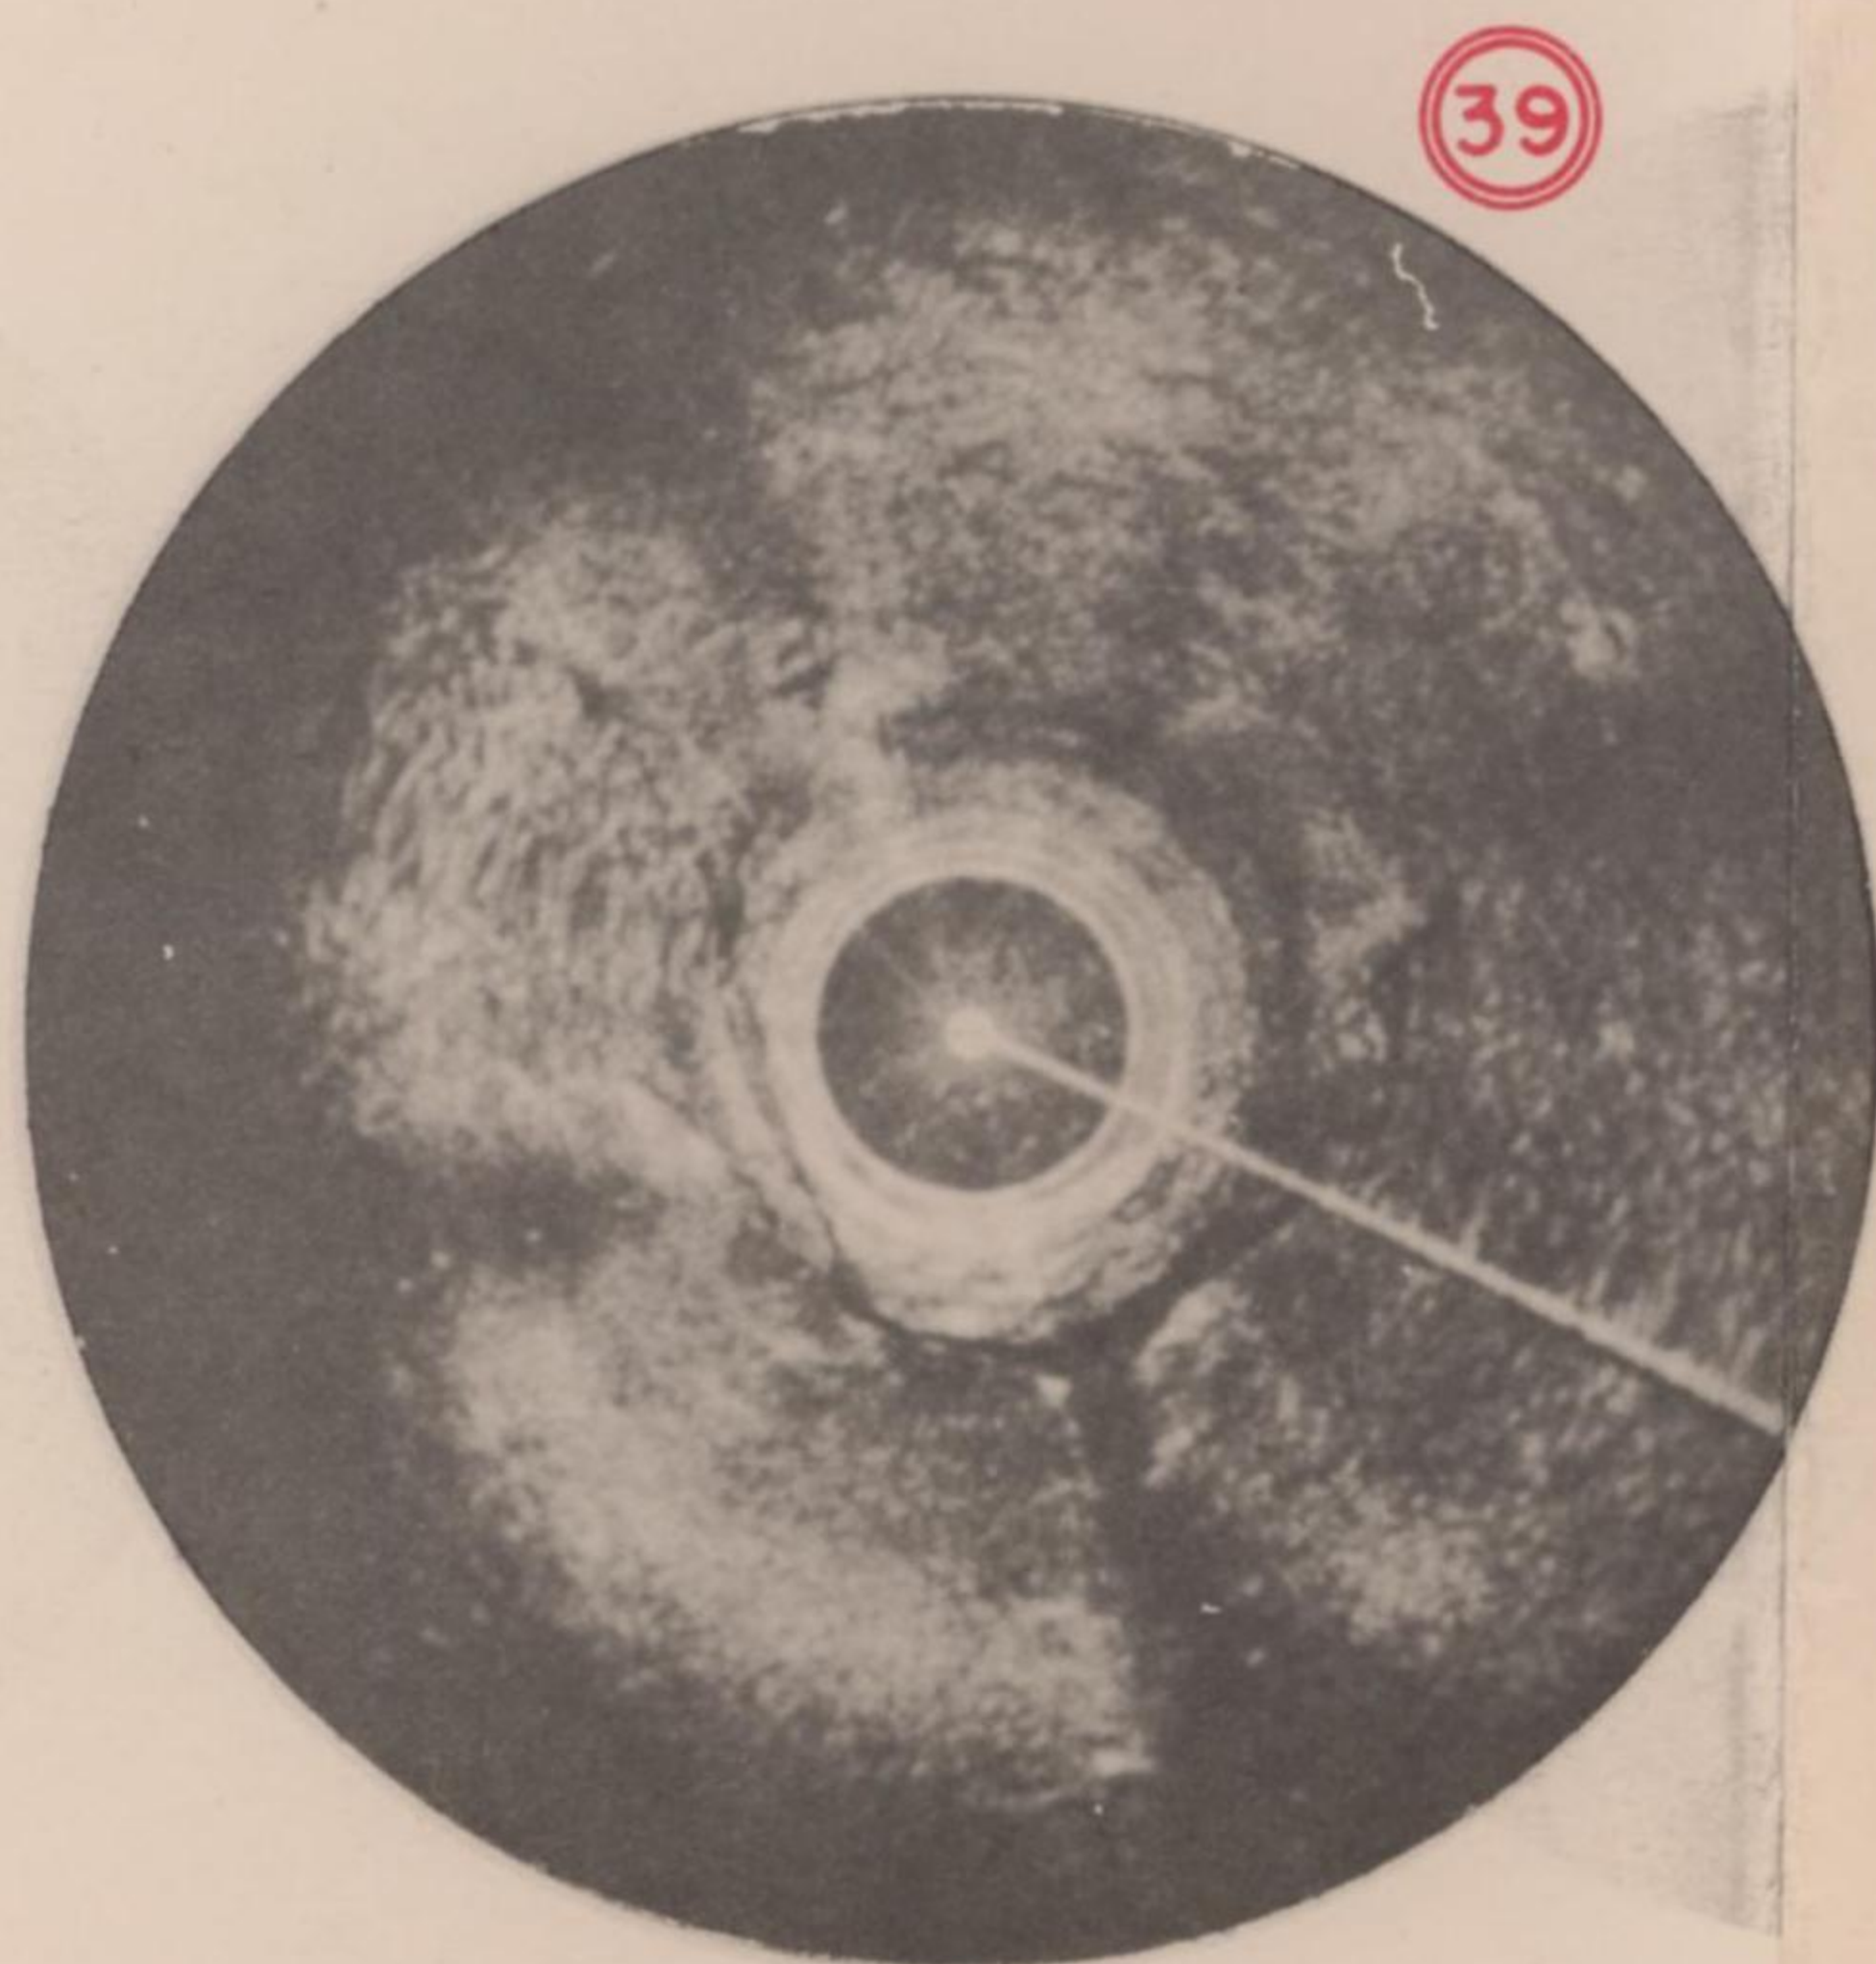
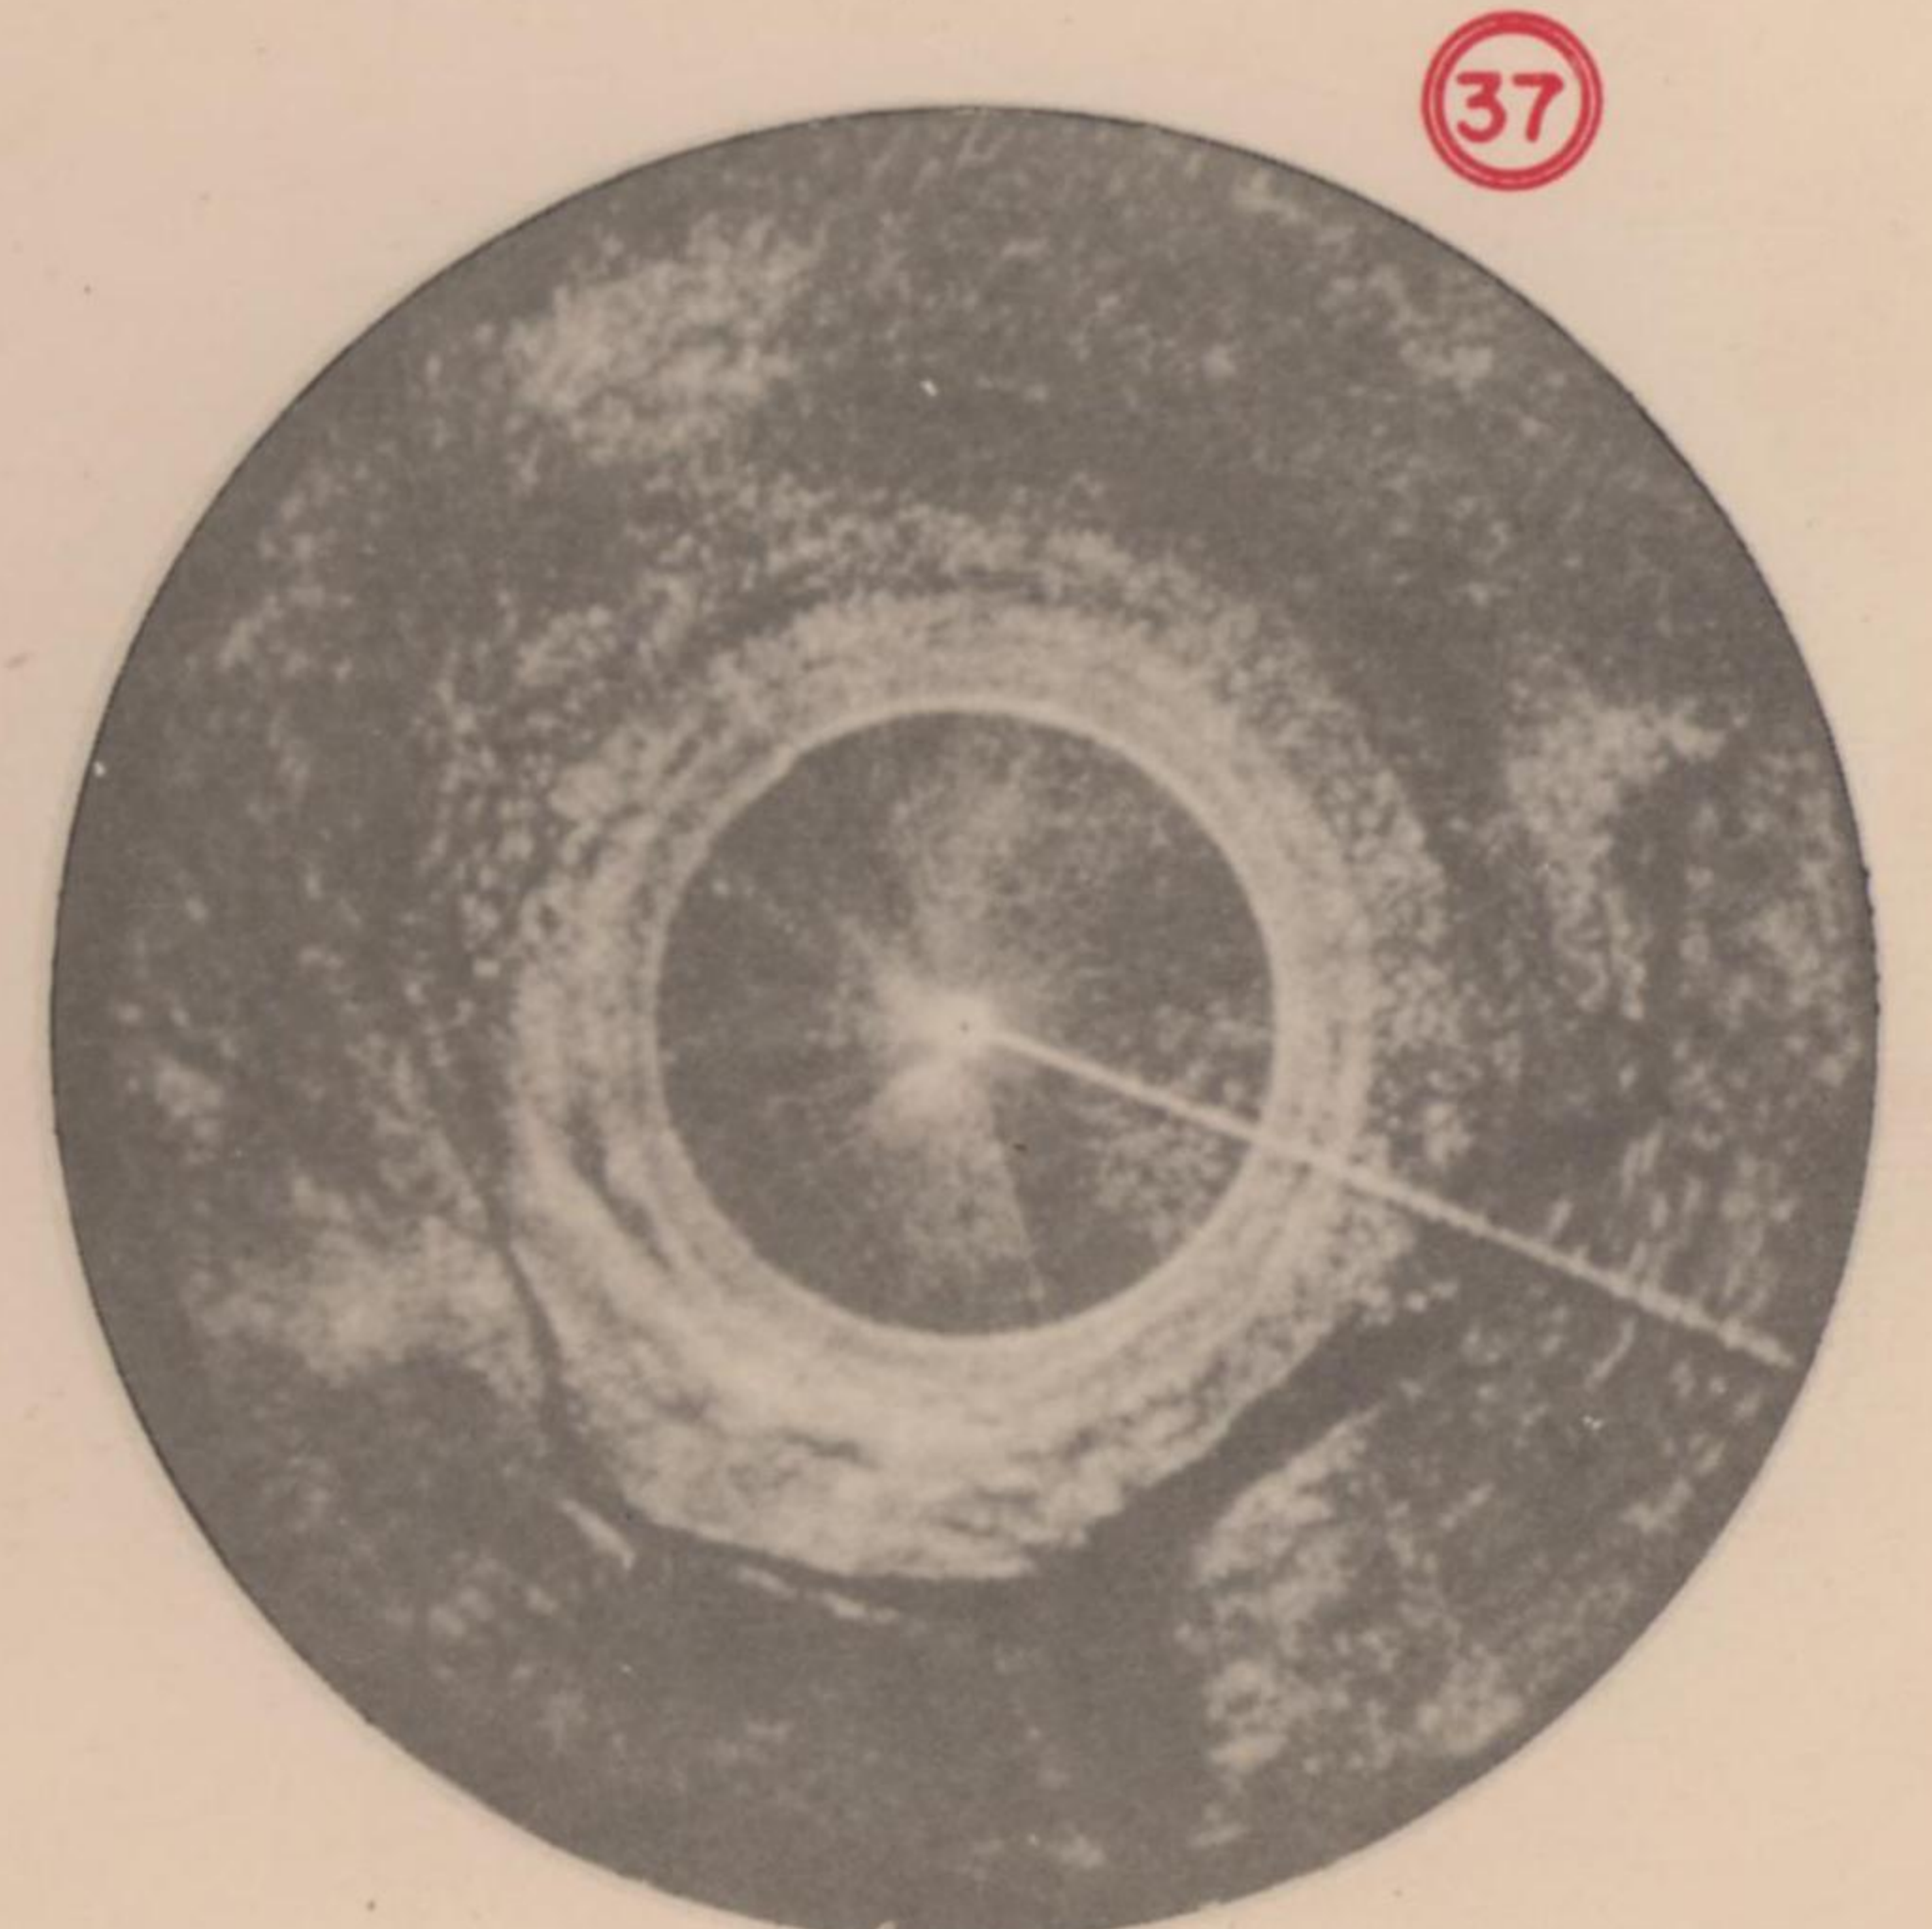
R 82.2 SHEET D

HEADING 109° MAG. ALTITUDE 21,000'

HEADING 110° MAG. ALTITUDE 21,000'

HEADING 115° MAG. ALTITUDE 21,000'

HEADING 111° MAG. ALTITUDE 21,000'

SWEEP 10 MILES
