# AIRCRAFT ACTION REPORT

(a) Unit Reporting **VT-45** (b) Based on or at **U.S.S. SAN JACINTO** (c) Report No. **45**  
 (d) Take off: Date **7 April 1945** Time (LZT) **1025** (Zone); Lat. **27 - 18 N** Long. **129 - 30 E**  
 (e) Mission **Strike Jap Fleet.** (f) Time of Return **1510** (Zone)

REPORT No. **45**

(a) Target(s) and Location(s) **Takanami Class DD, at 31-00N, 128-55E.** (b) Time Over Target(s) **1305** (Zone) **-9**  
(FOR SHIPS INCLUDE ALL IN AREA UNDER ATTACK)

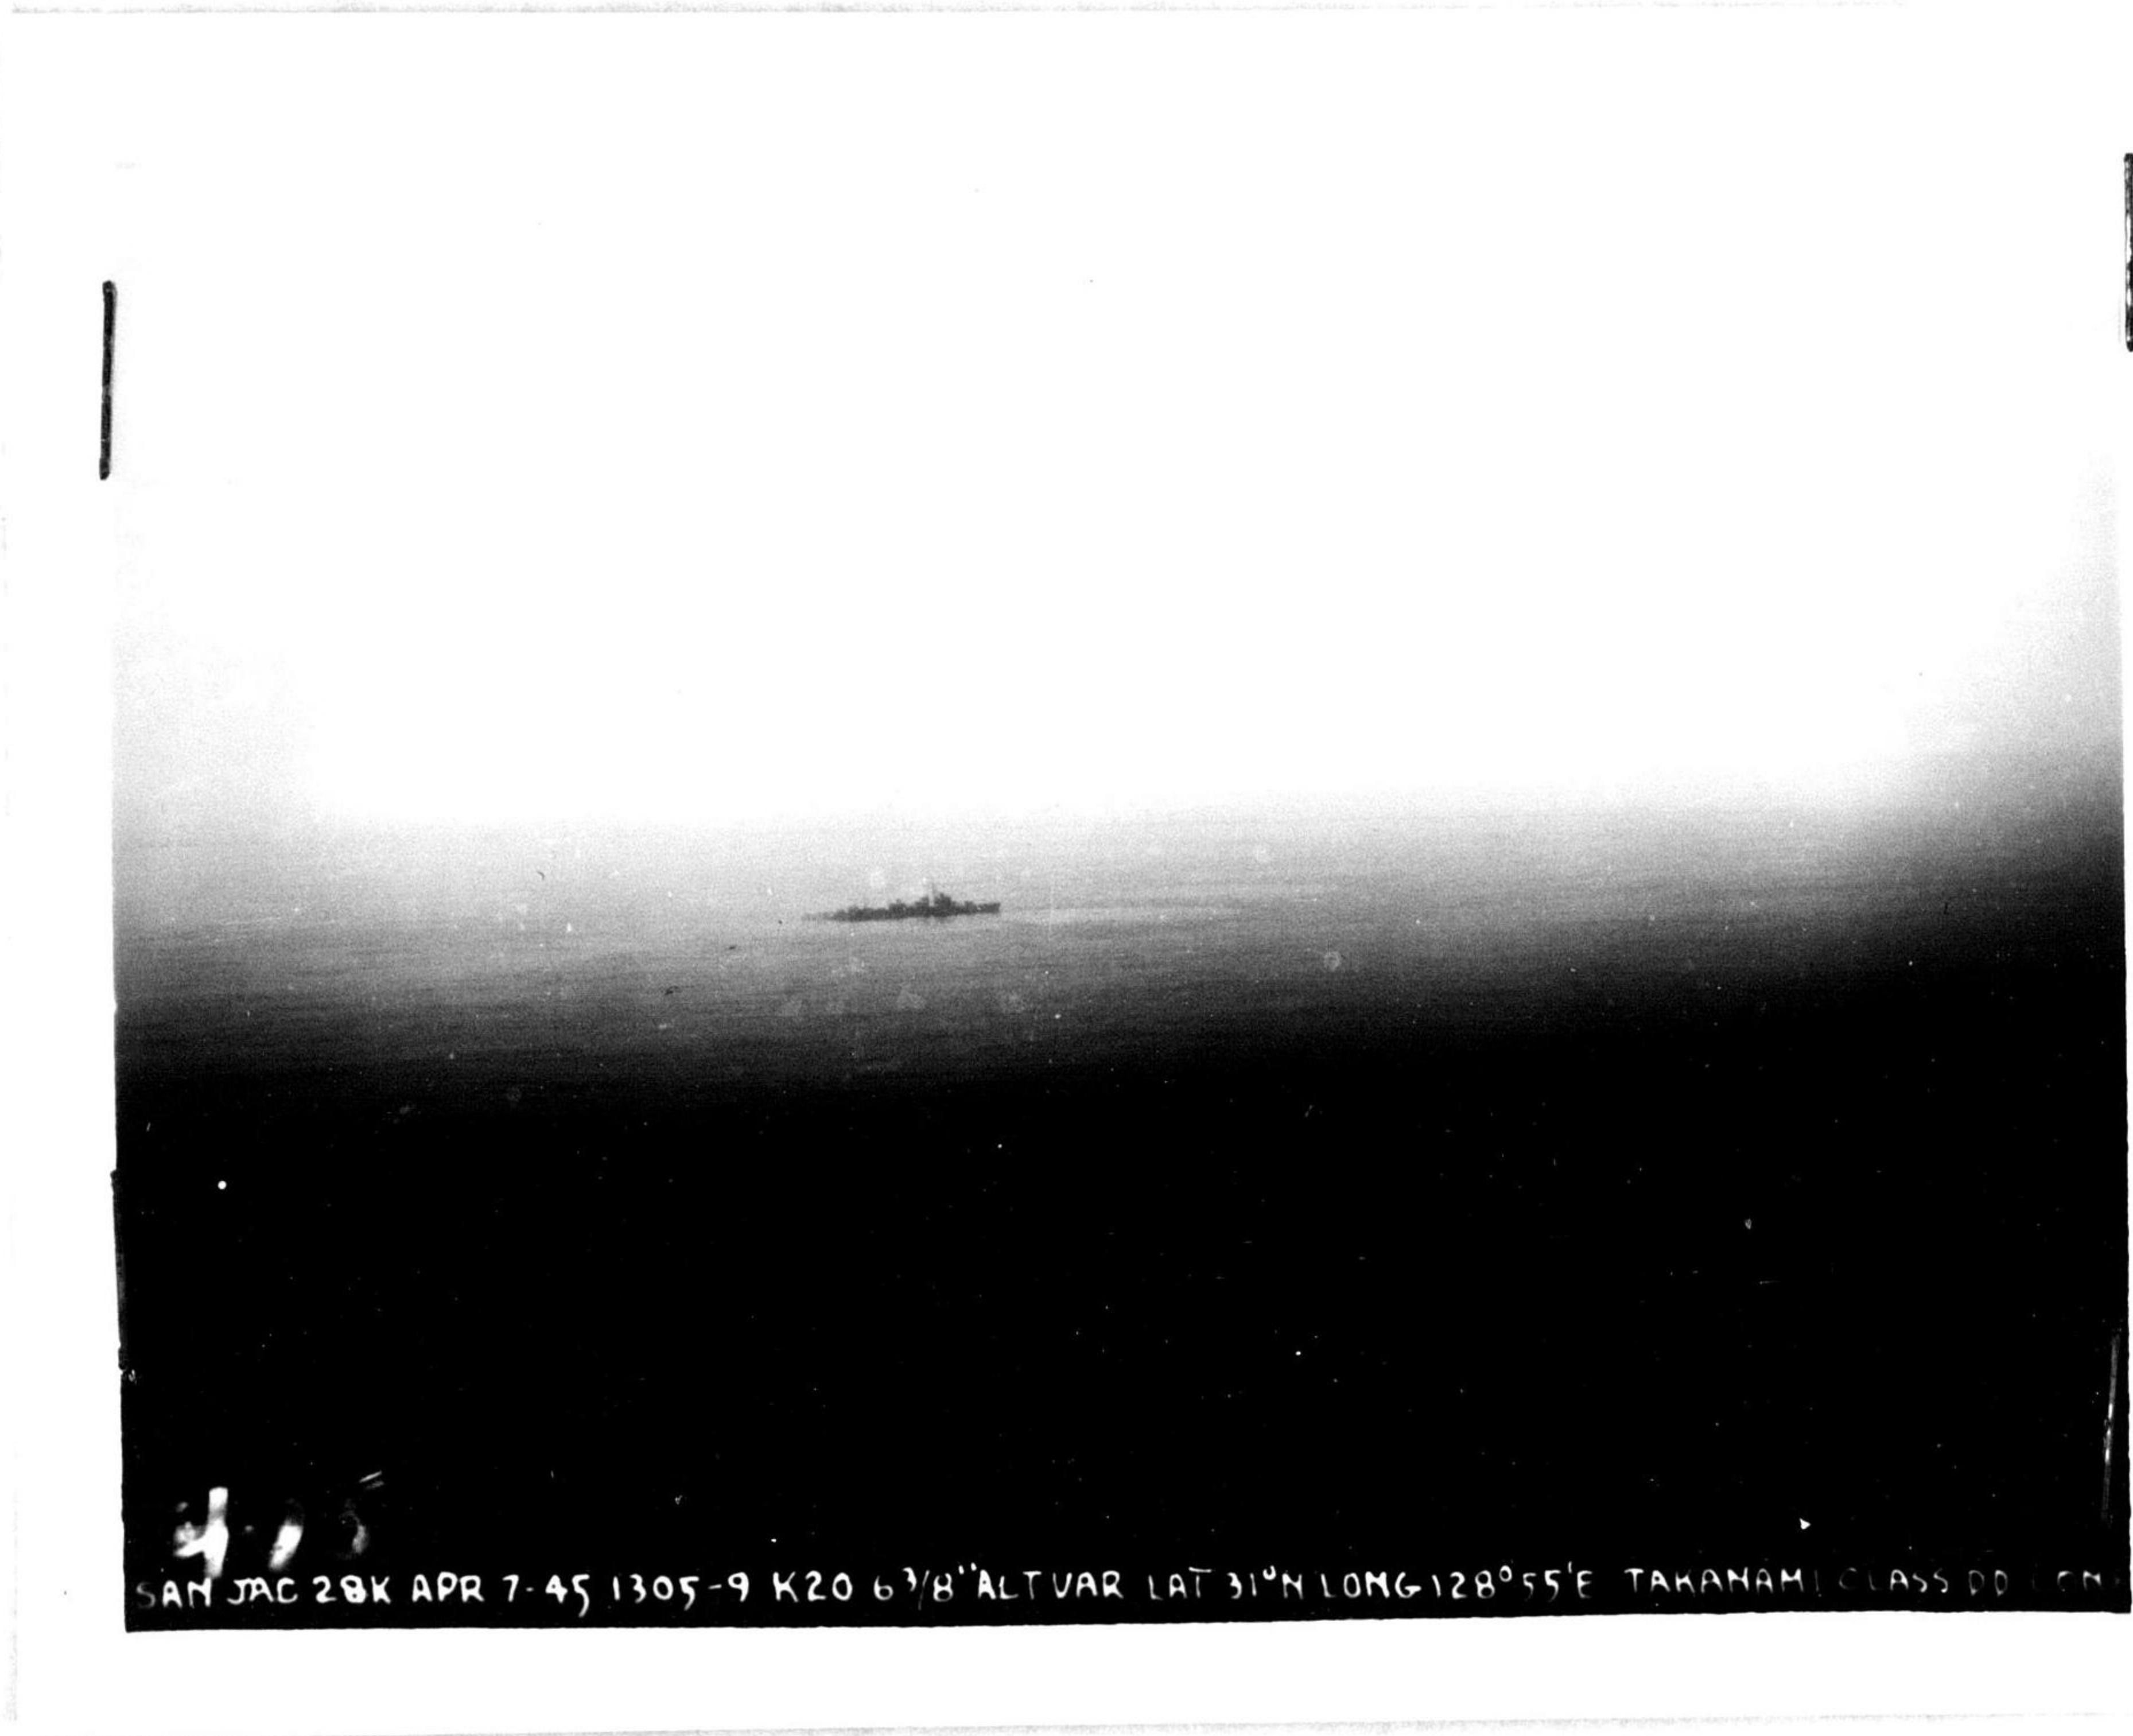
SAN JAC 28K APR 7-45 1305-9 K20 6 3/8' ALT VAR LAT 31°N LONG 128°55'E TAKANAMI CLASS DD-101

**This very large destroyer which is believed to be of the Takanami class was hit on the starboard side by two torpedoes in quick succession at 1305. One torpedo hit it beside the bridge and the other about amidships. The bow reared high up from the water, the ship appeared to break in half just aft of amidships, it started to slide under the water and a terrific explosion pushed it up again and then it completely disappeared. By 1310 only survivors and odd pieces of wreckage could be seen on the surface. The attached photographs are all of this one ship. The first one shows it in profile before it was attacked, the second shows it from above with an oil slick on the water probably caused by near misses which VF-45 planes scored with 1000# G.P. bombs and the third picture shows it as the torpedoes hit it.**

The three photographs attached to this report show the destroyer before it was torpedoed from a profile and a plan view and as it exploded as a result of the two torpedo hits. The first and third photographs were taken with a K-20 camera from the radioman's compartment of one of the torpedo planes. The second photograph was taken by Lieutenant (j.g.) David H. Willis, the Photographer
