MISSION #33 SINGAPORE "PILICAN 3"
1 February 1945

Tactical Mission Report

No. 33

TARGETS: Floating Drydock, Singapore
Drydock in the Naval Base Area, Singapore.

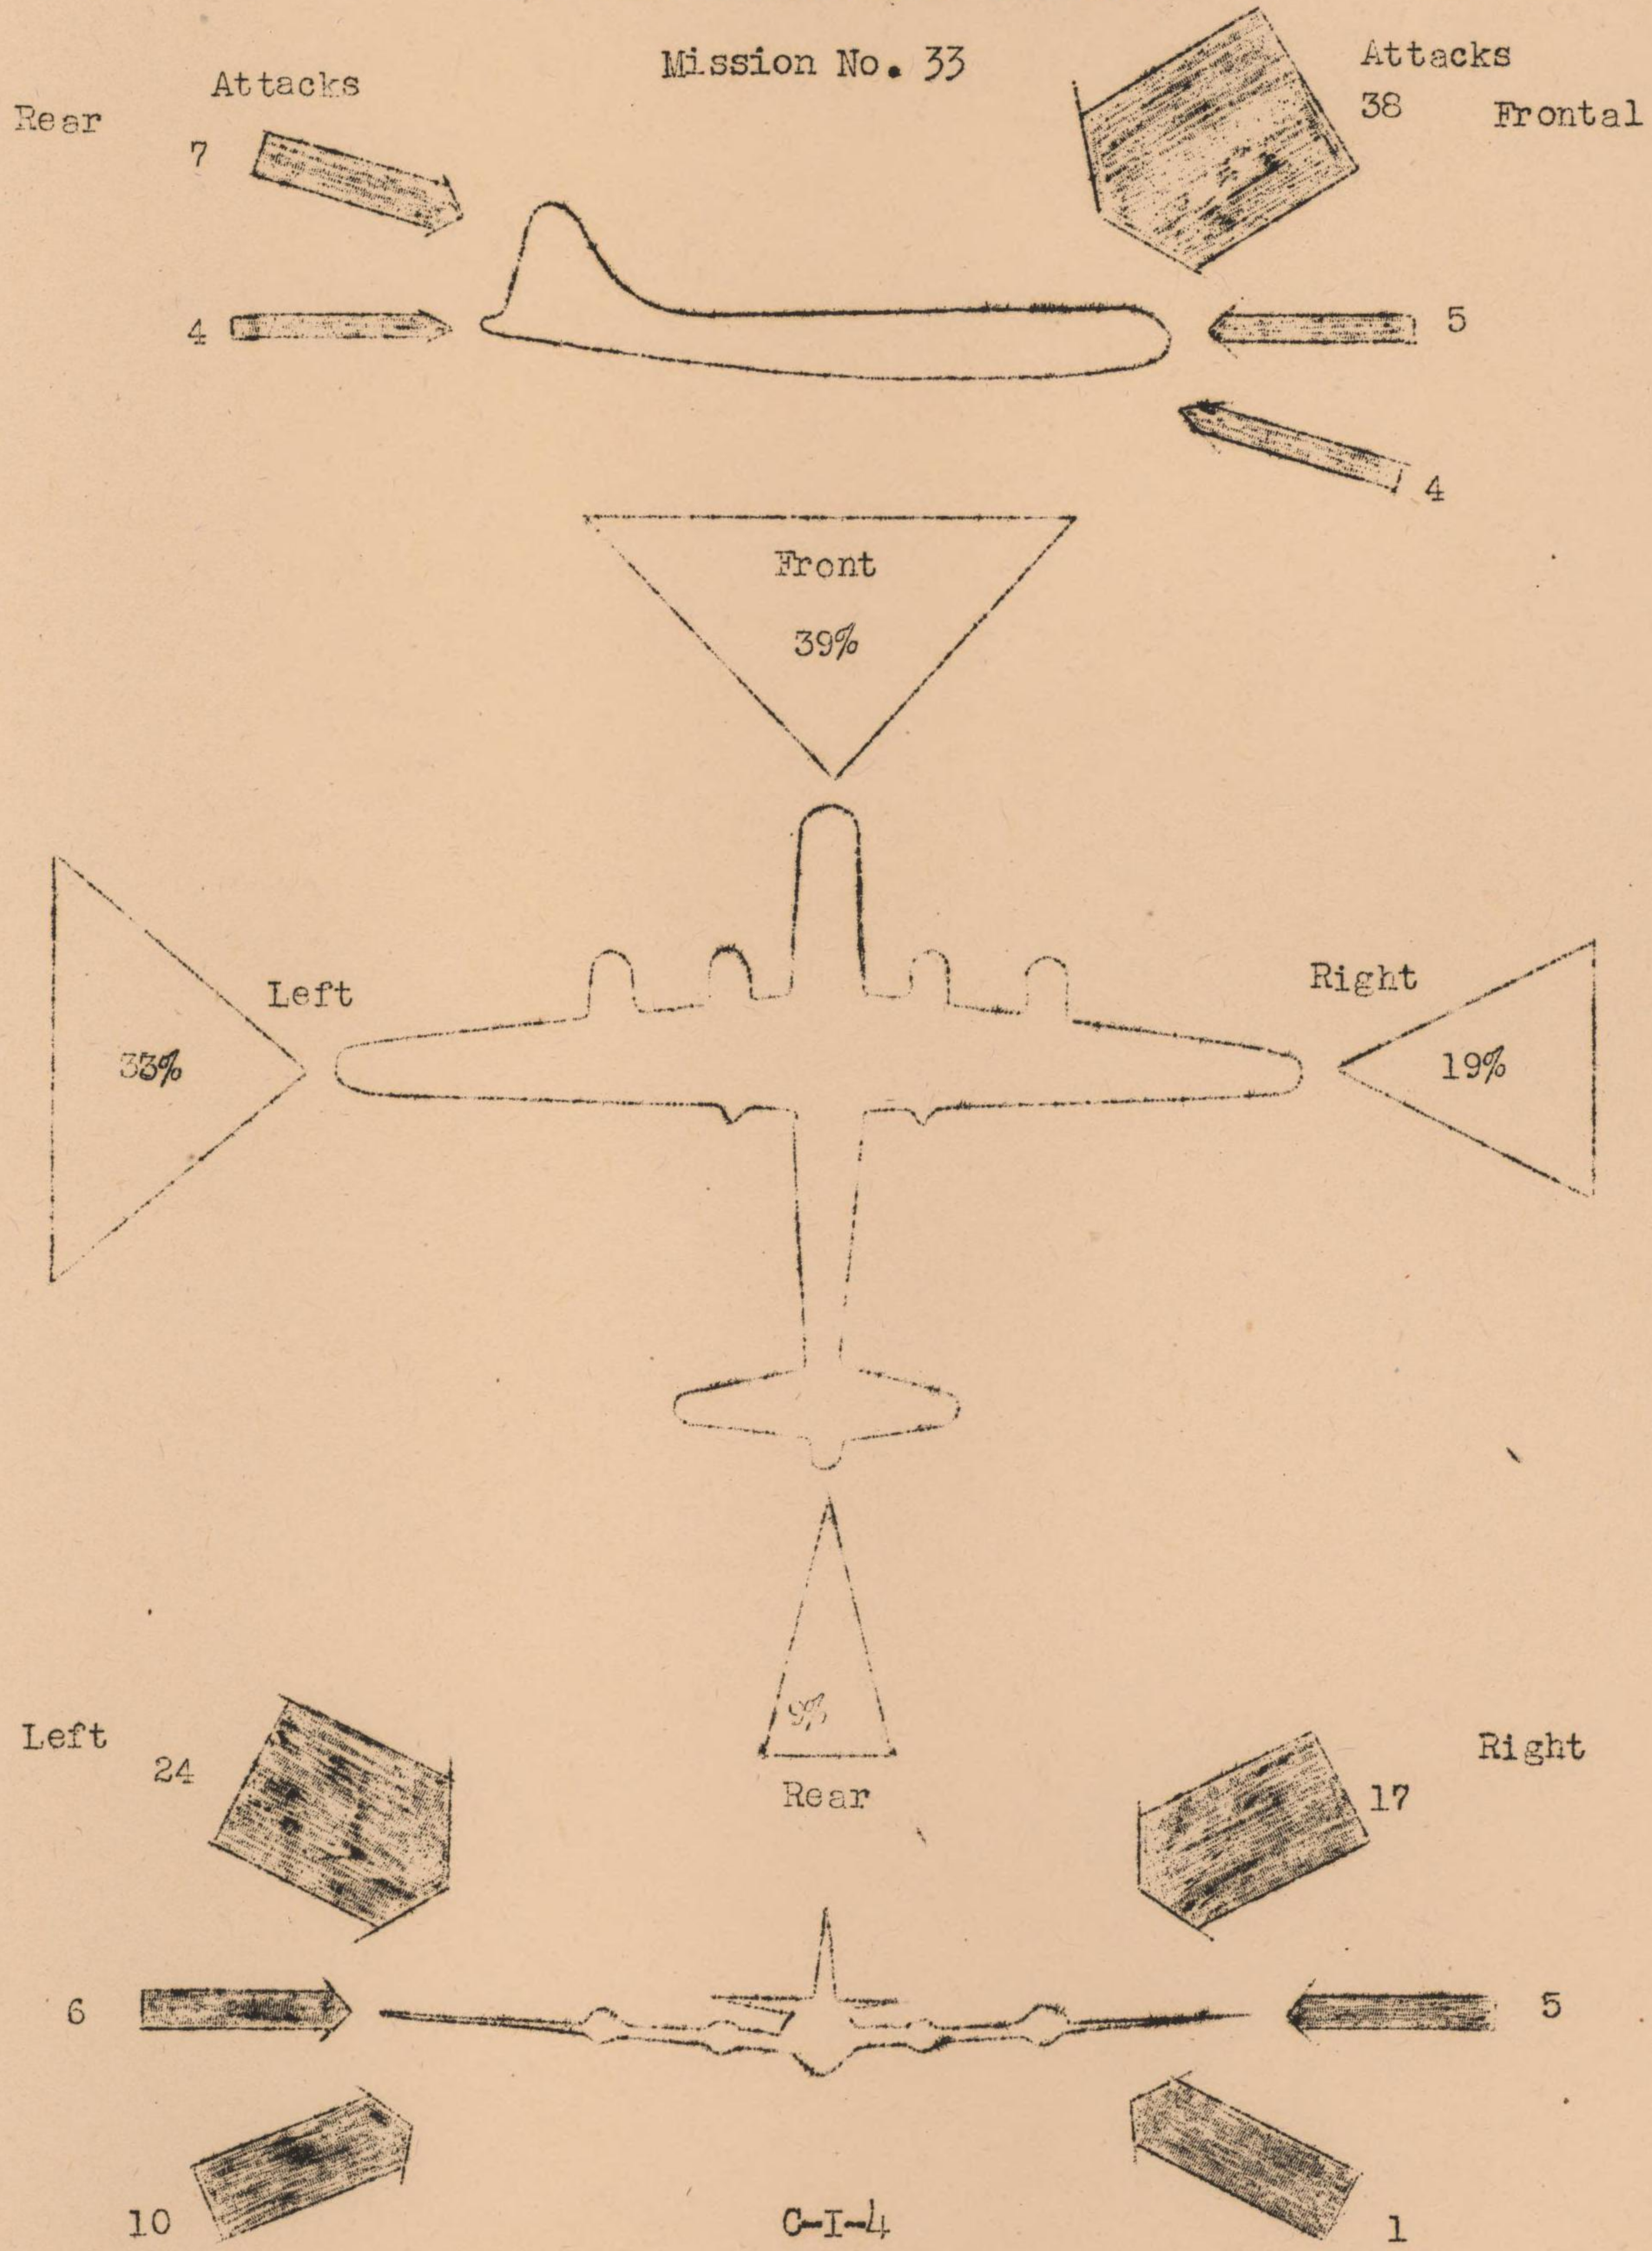
Exhibit A

DIRECTION AND LEVEL OF APPROACH

a. The majority of the encounters, 39 per cent, originated from the frontal quarter, comparing closely to Mission No. 27, when it was 38 per cent. Changes, however, were noted in other quarters, with 19 per cent of encounters originating from the right side, 9 per cent from the rear, and 33 per cent from the left quarter. The percentage of encounters from the left quarter was more than twice that of Mission No. 27 (16%), and encounters on the right quarter were less, comparing to 29 per cent on Mission No. 27. Analysis of directions of approach indicated that a greater than usual number of coordinated attacks on Mission No. 33 originated from the 10 o'clock position, and conversely, a lesser number came from the right side, from the usual 2 and 3 o'clock positions. The azimuth of the sun in relation to the axis of attack and the turn for the course home after bombing was considered in an attempt to determine a reason for the shift, but it was found that left side attacks (from about 10 o'clock) were executed with the sun on the left beam of the enemy fighters before bombs away, and almost directly into the sun after bombs away. Thus, it is difficult to explain the shifting from right side to left side approaches.

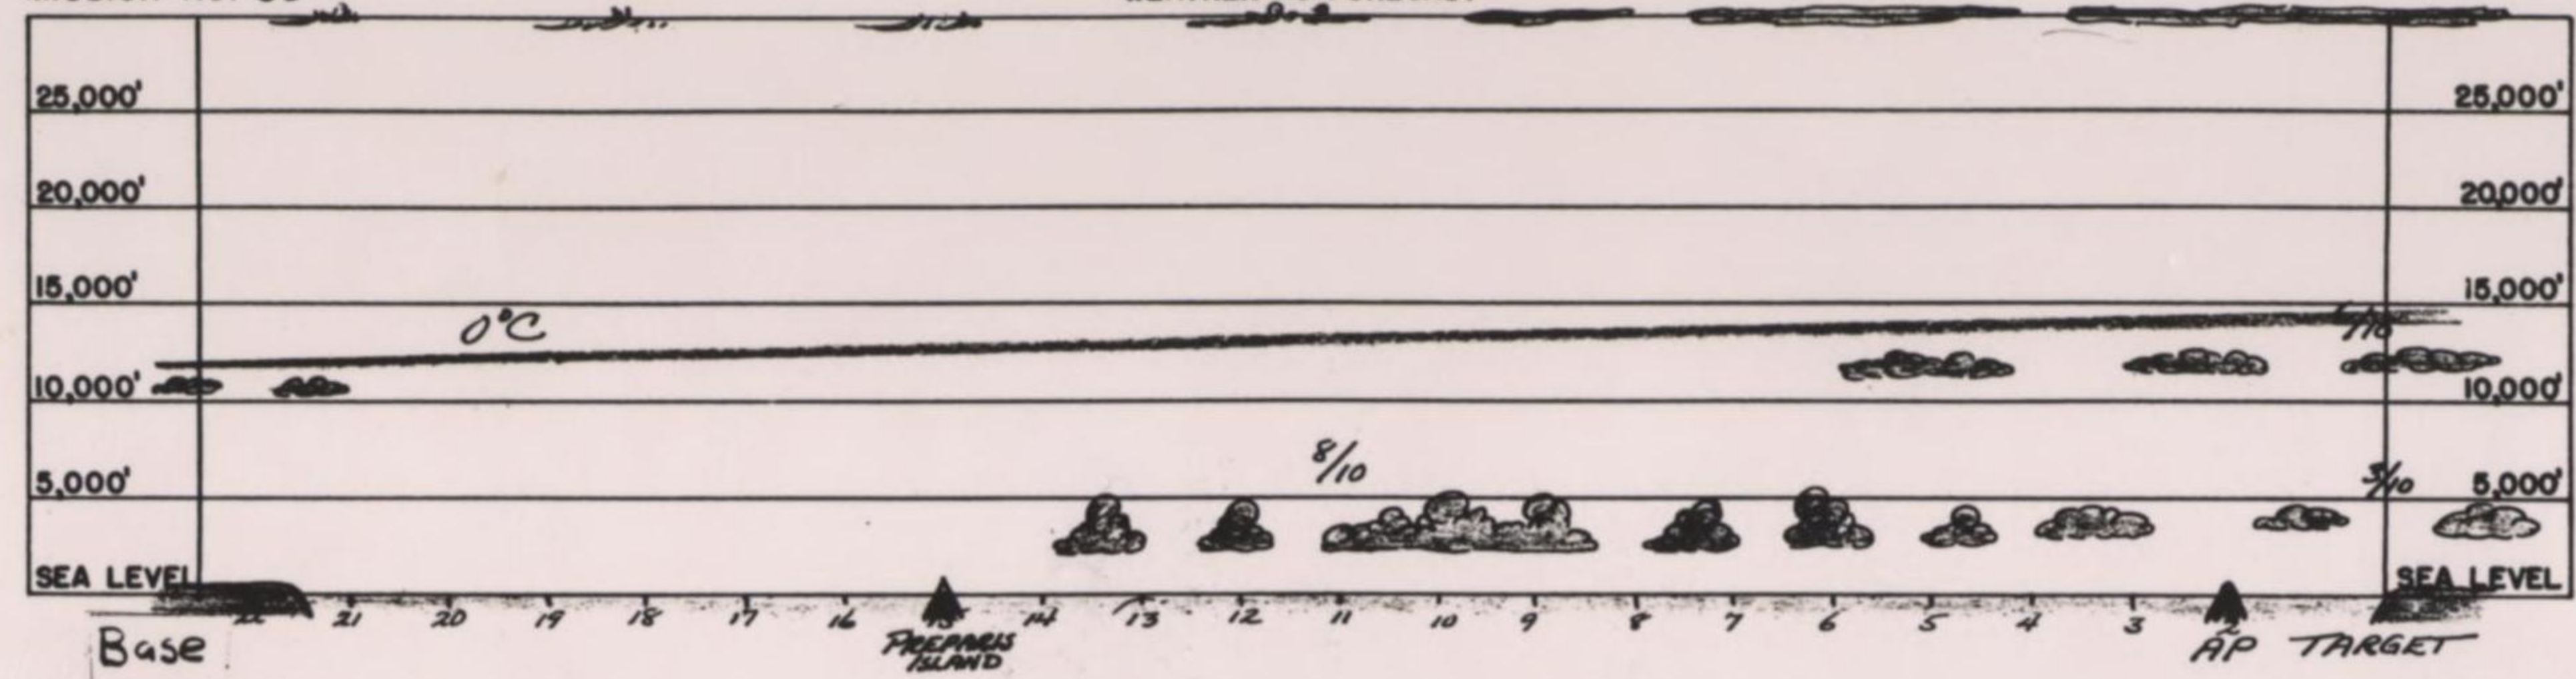
MISSION NO. 33

XX BOMBER COMMAND
 WEATHER AS FORECAST

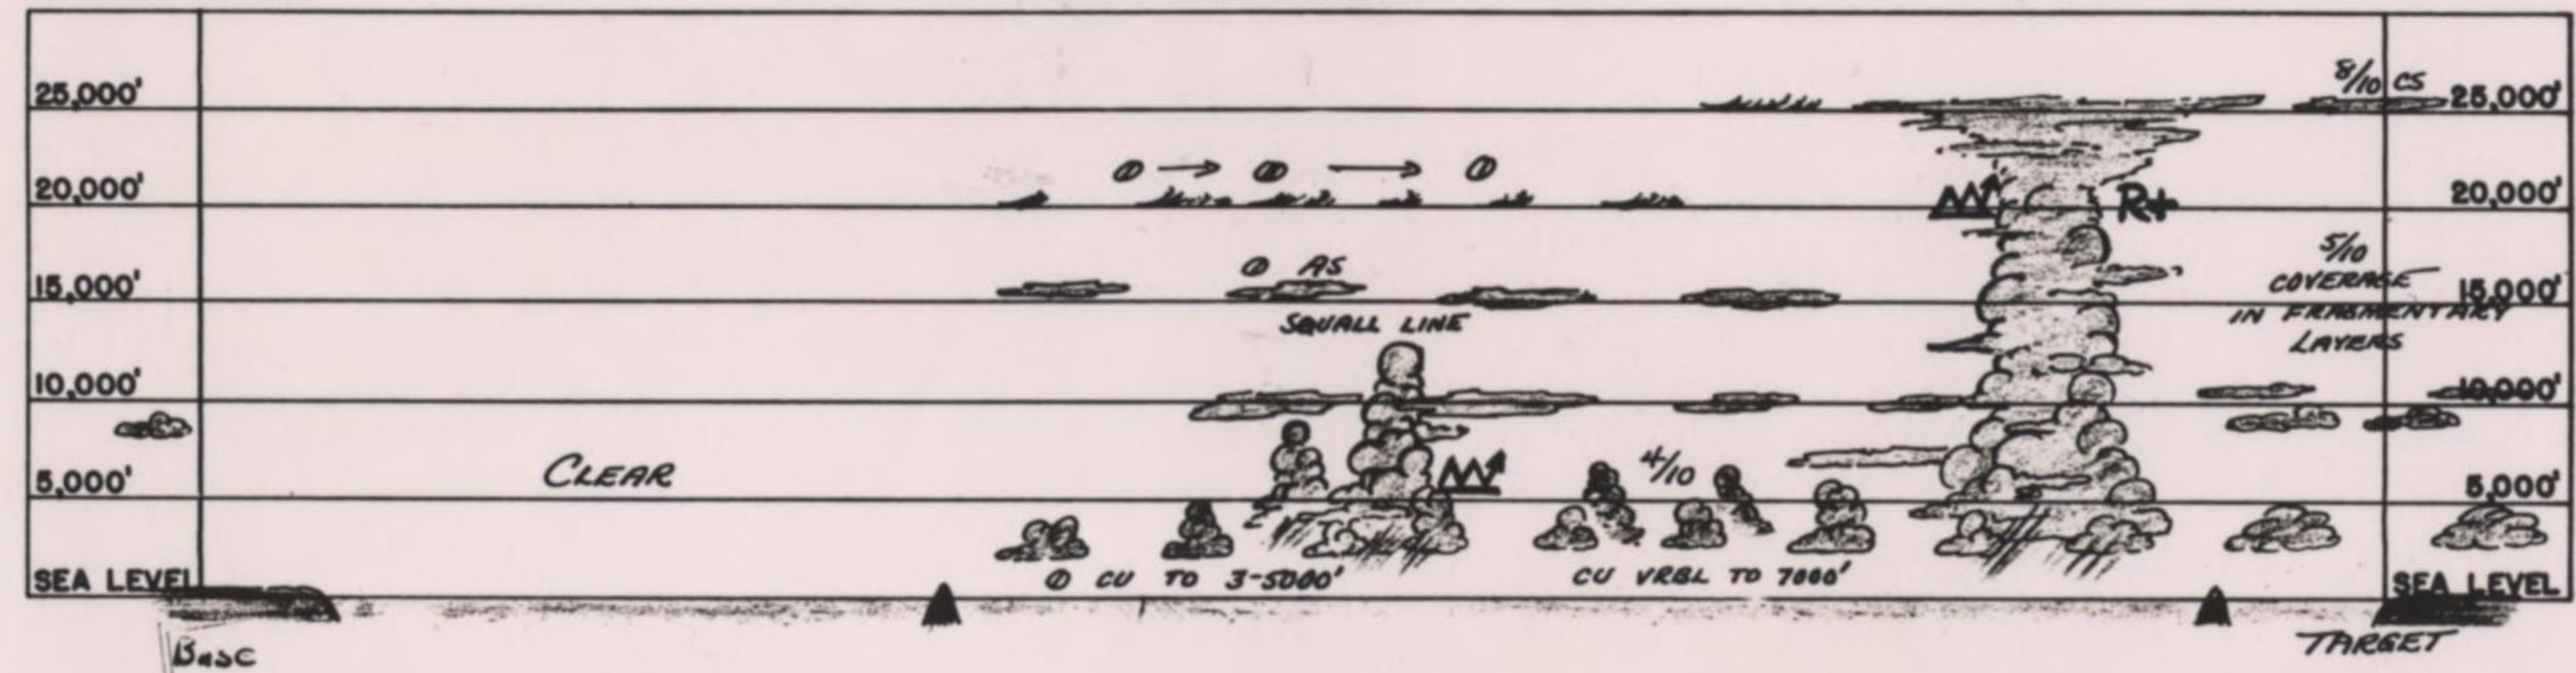
MISSION NO. 33

WEATHER AS ENCOUNTERED
 ROUTE OUT

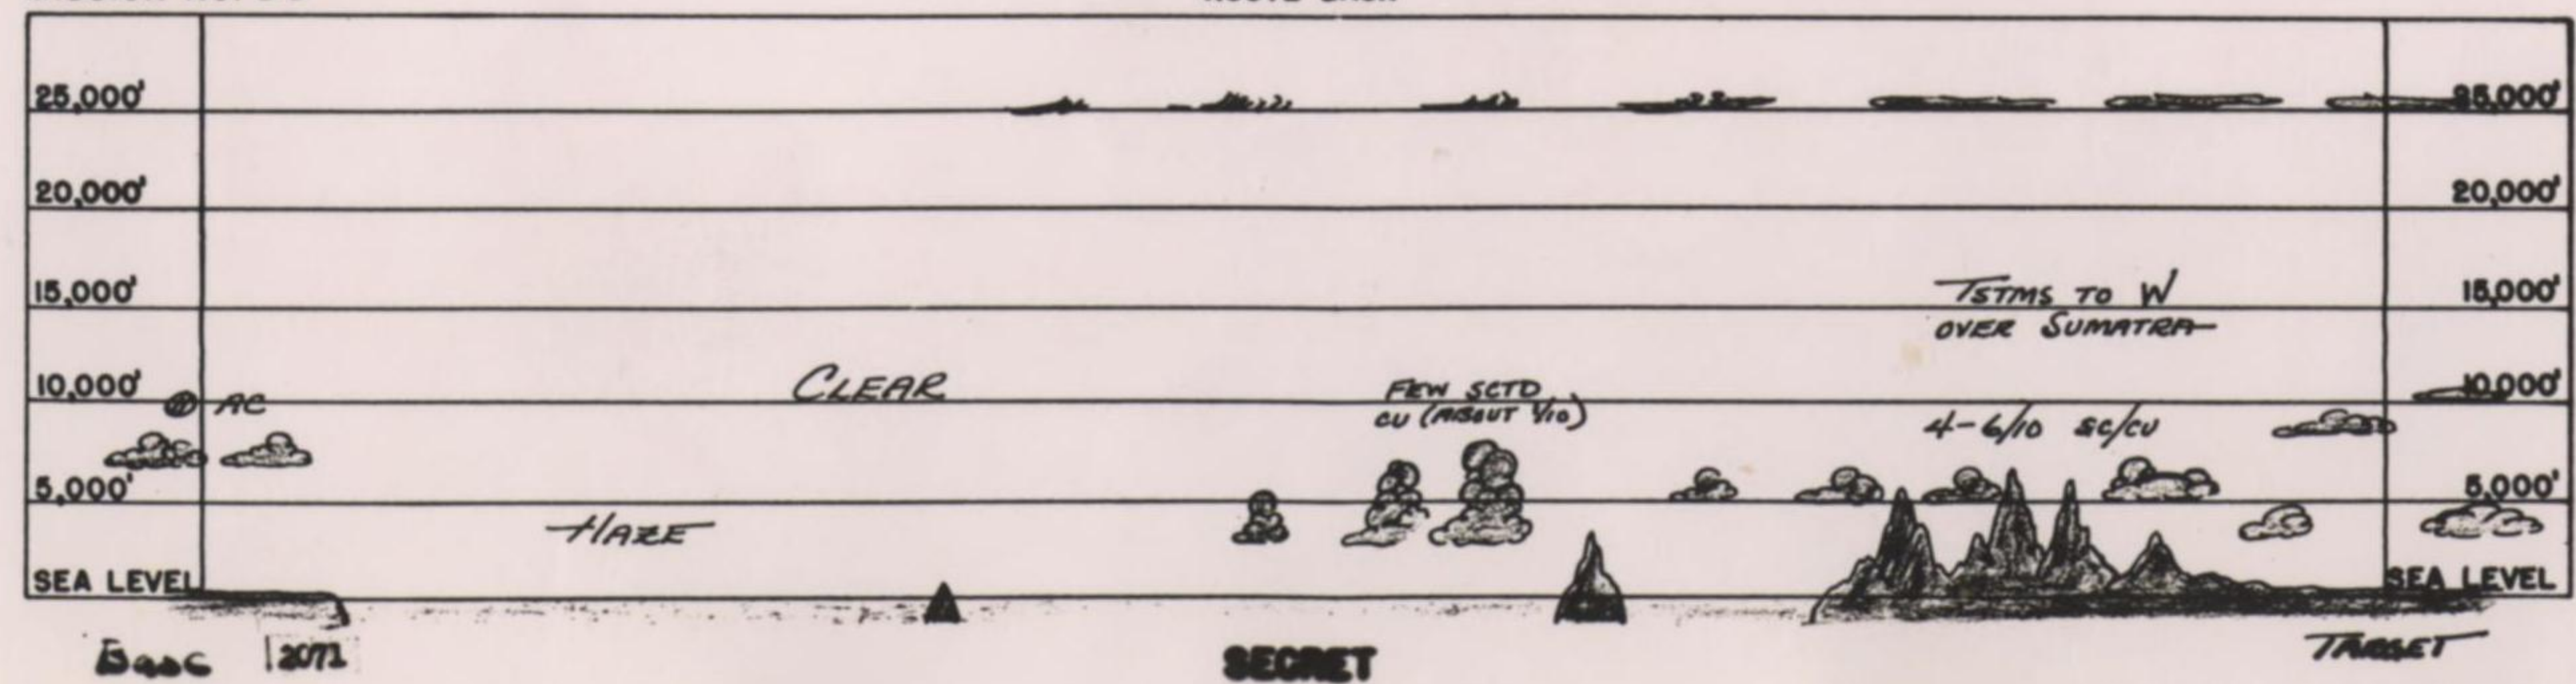
MISSION NO. 33

WEATHER AS ENCOUNTERED
 ROUTE BACK

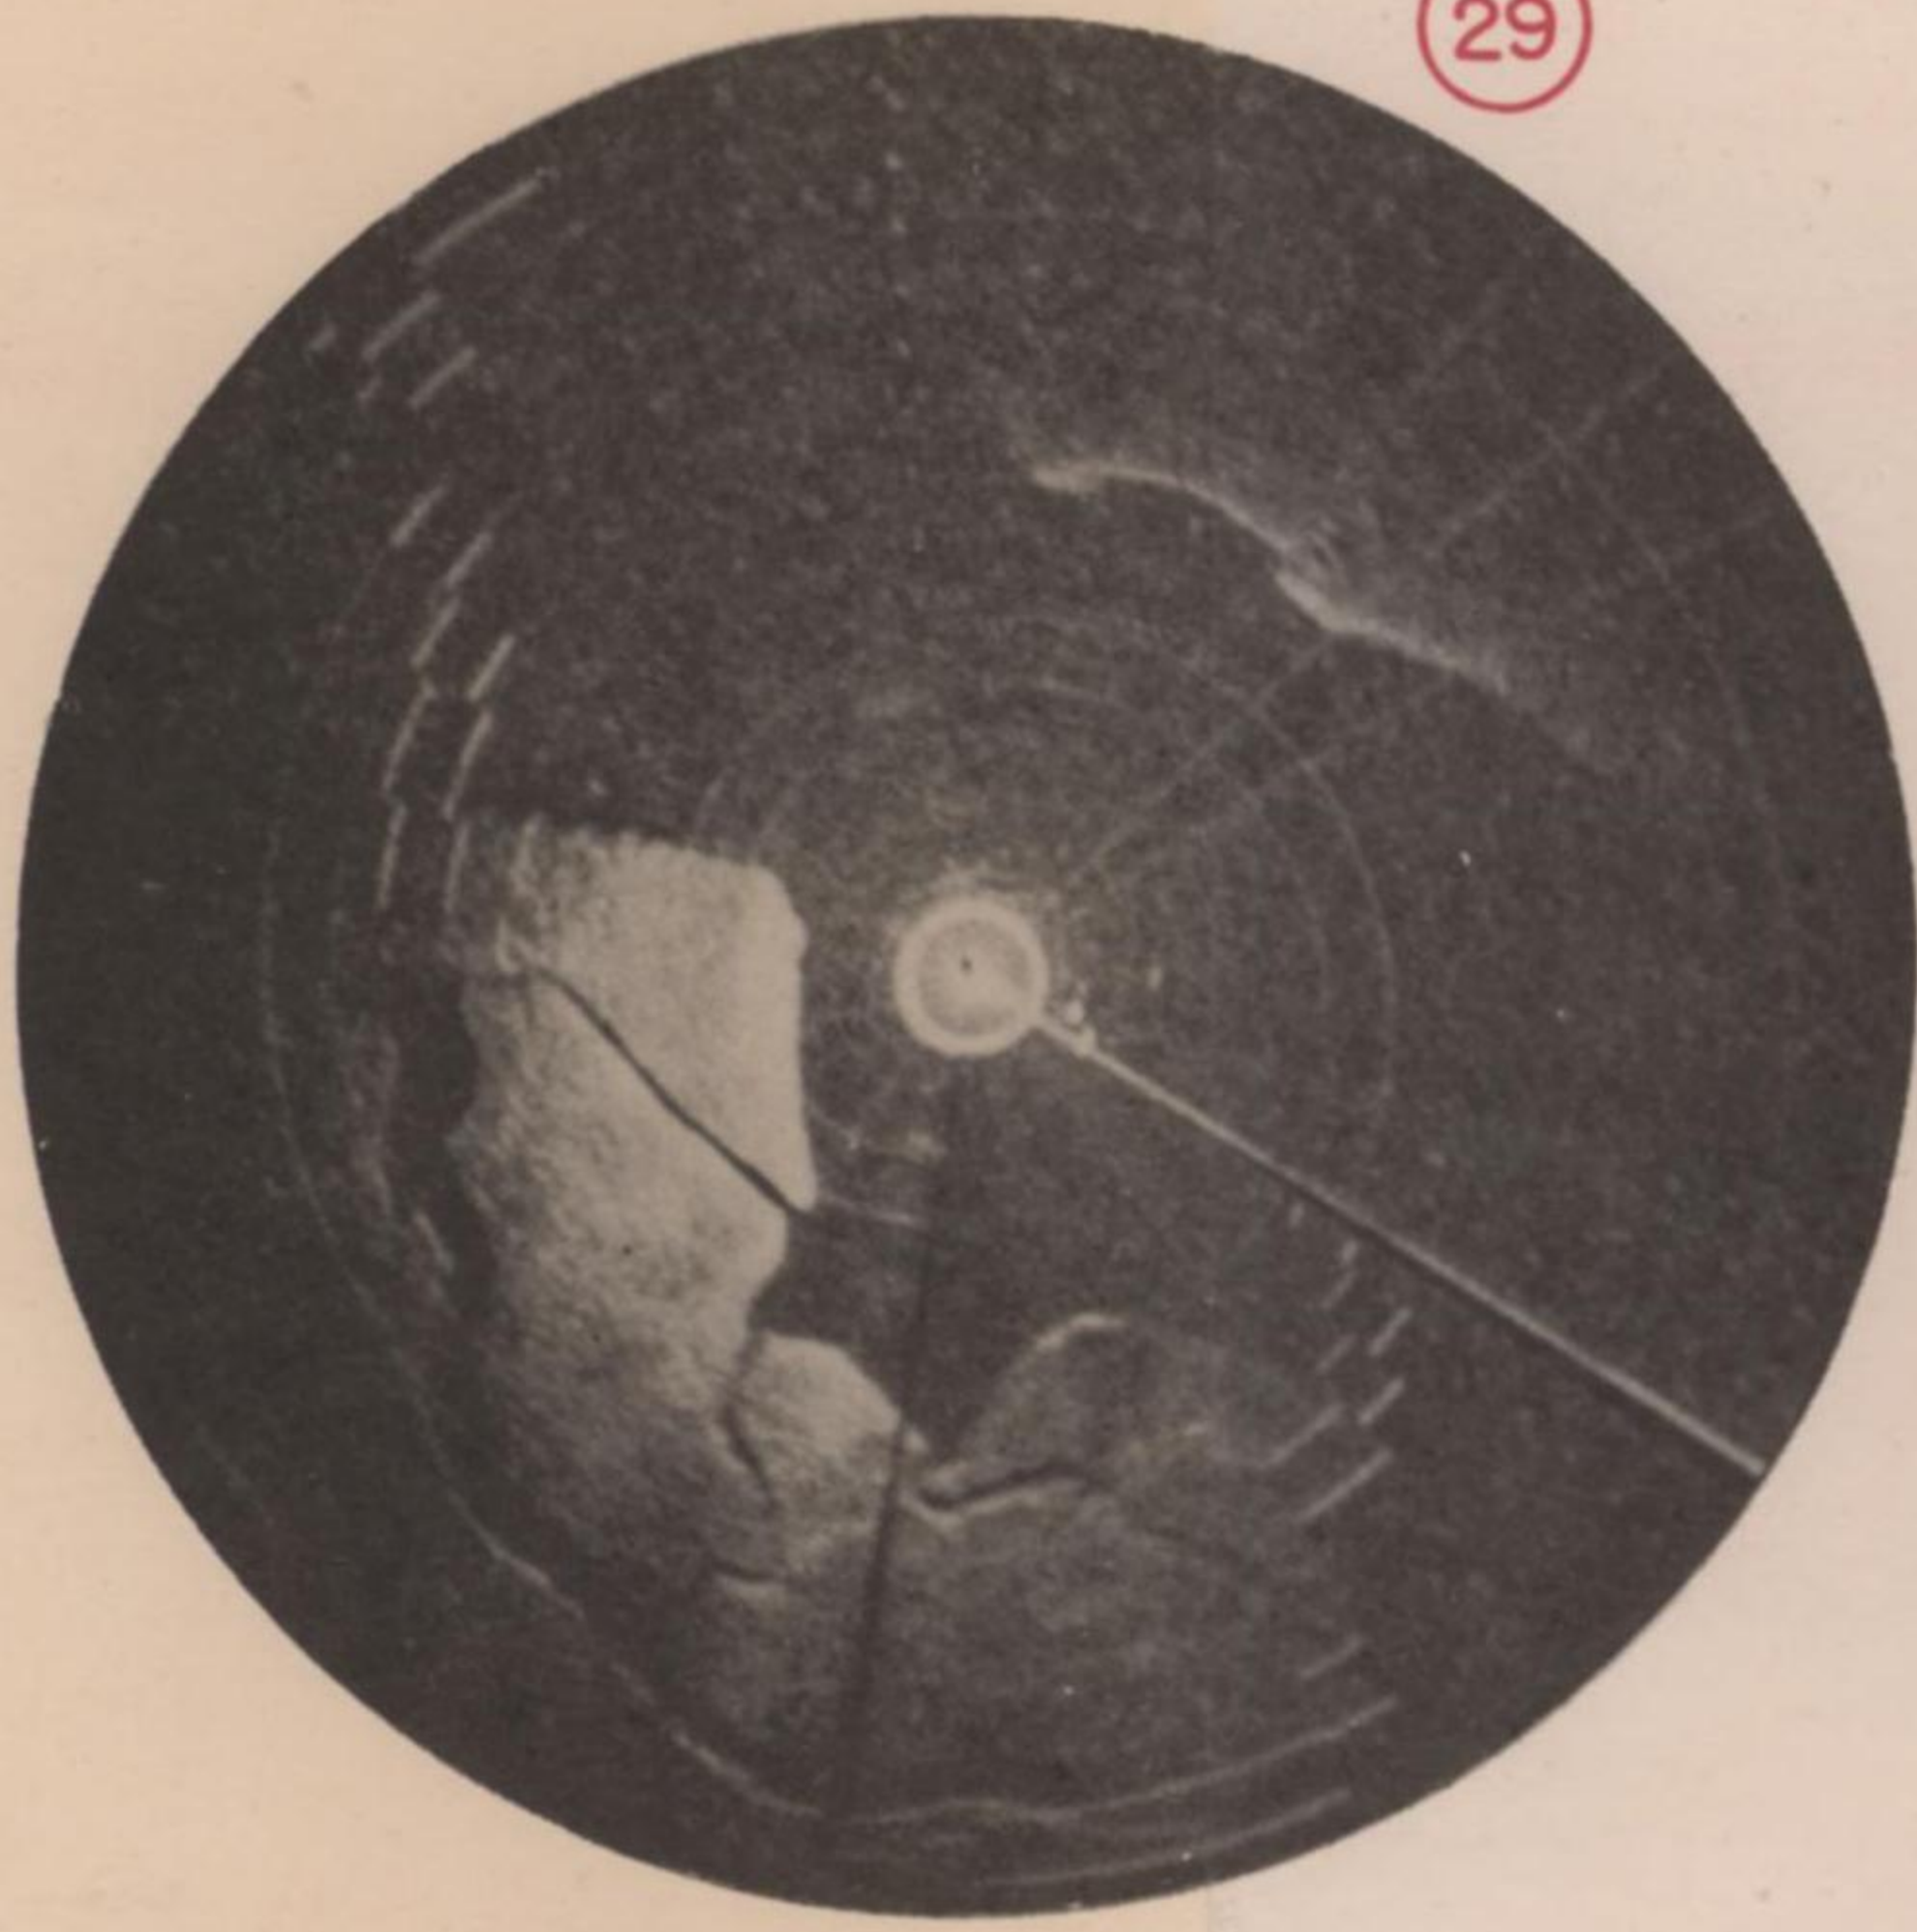
29

RADAR PHOTOGRAPH ANALYSIS
SINGAPORE AREA - MALAY STATES

122° MAG.

50 MILE SWEEP

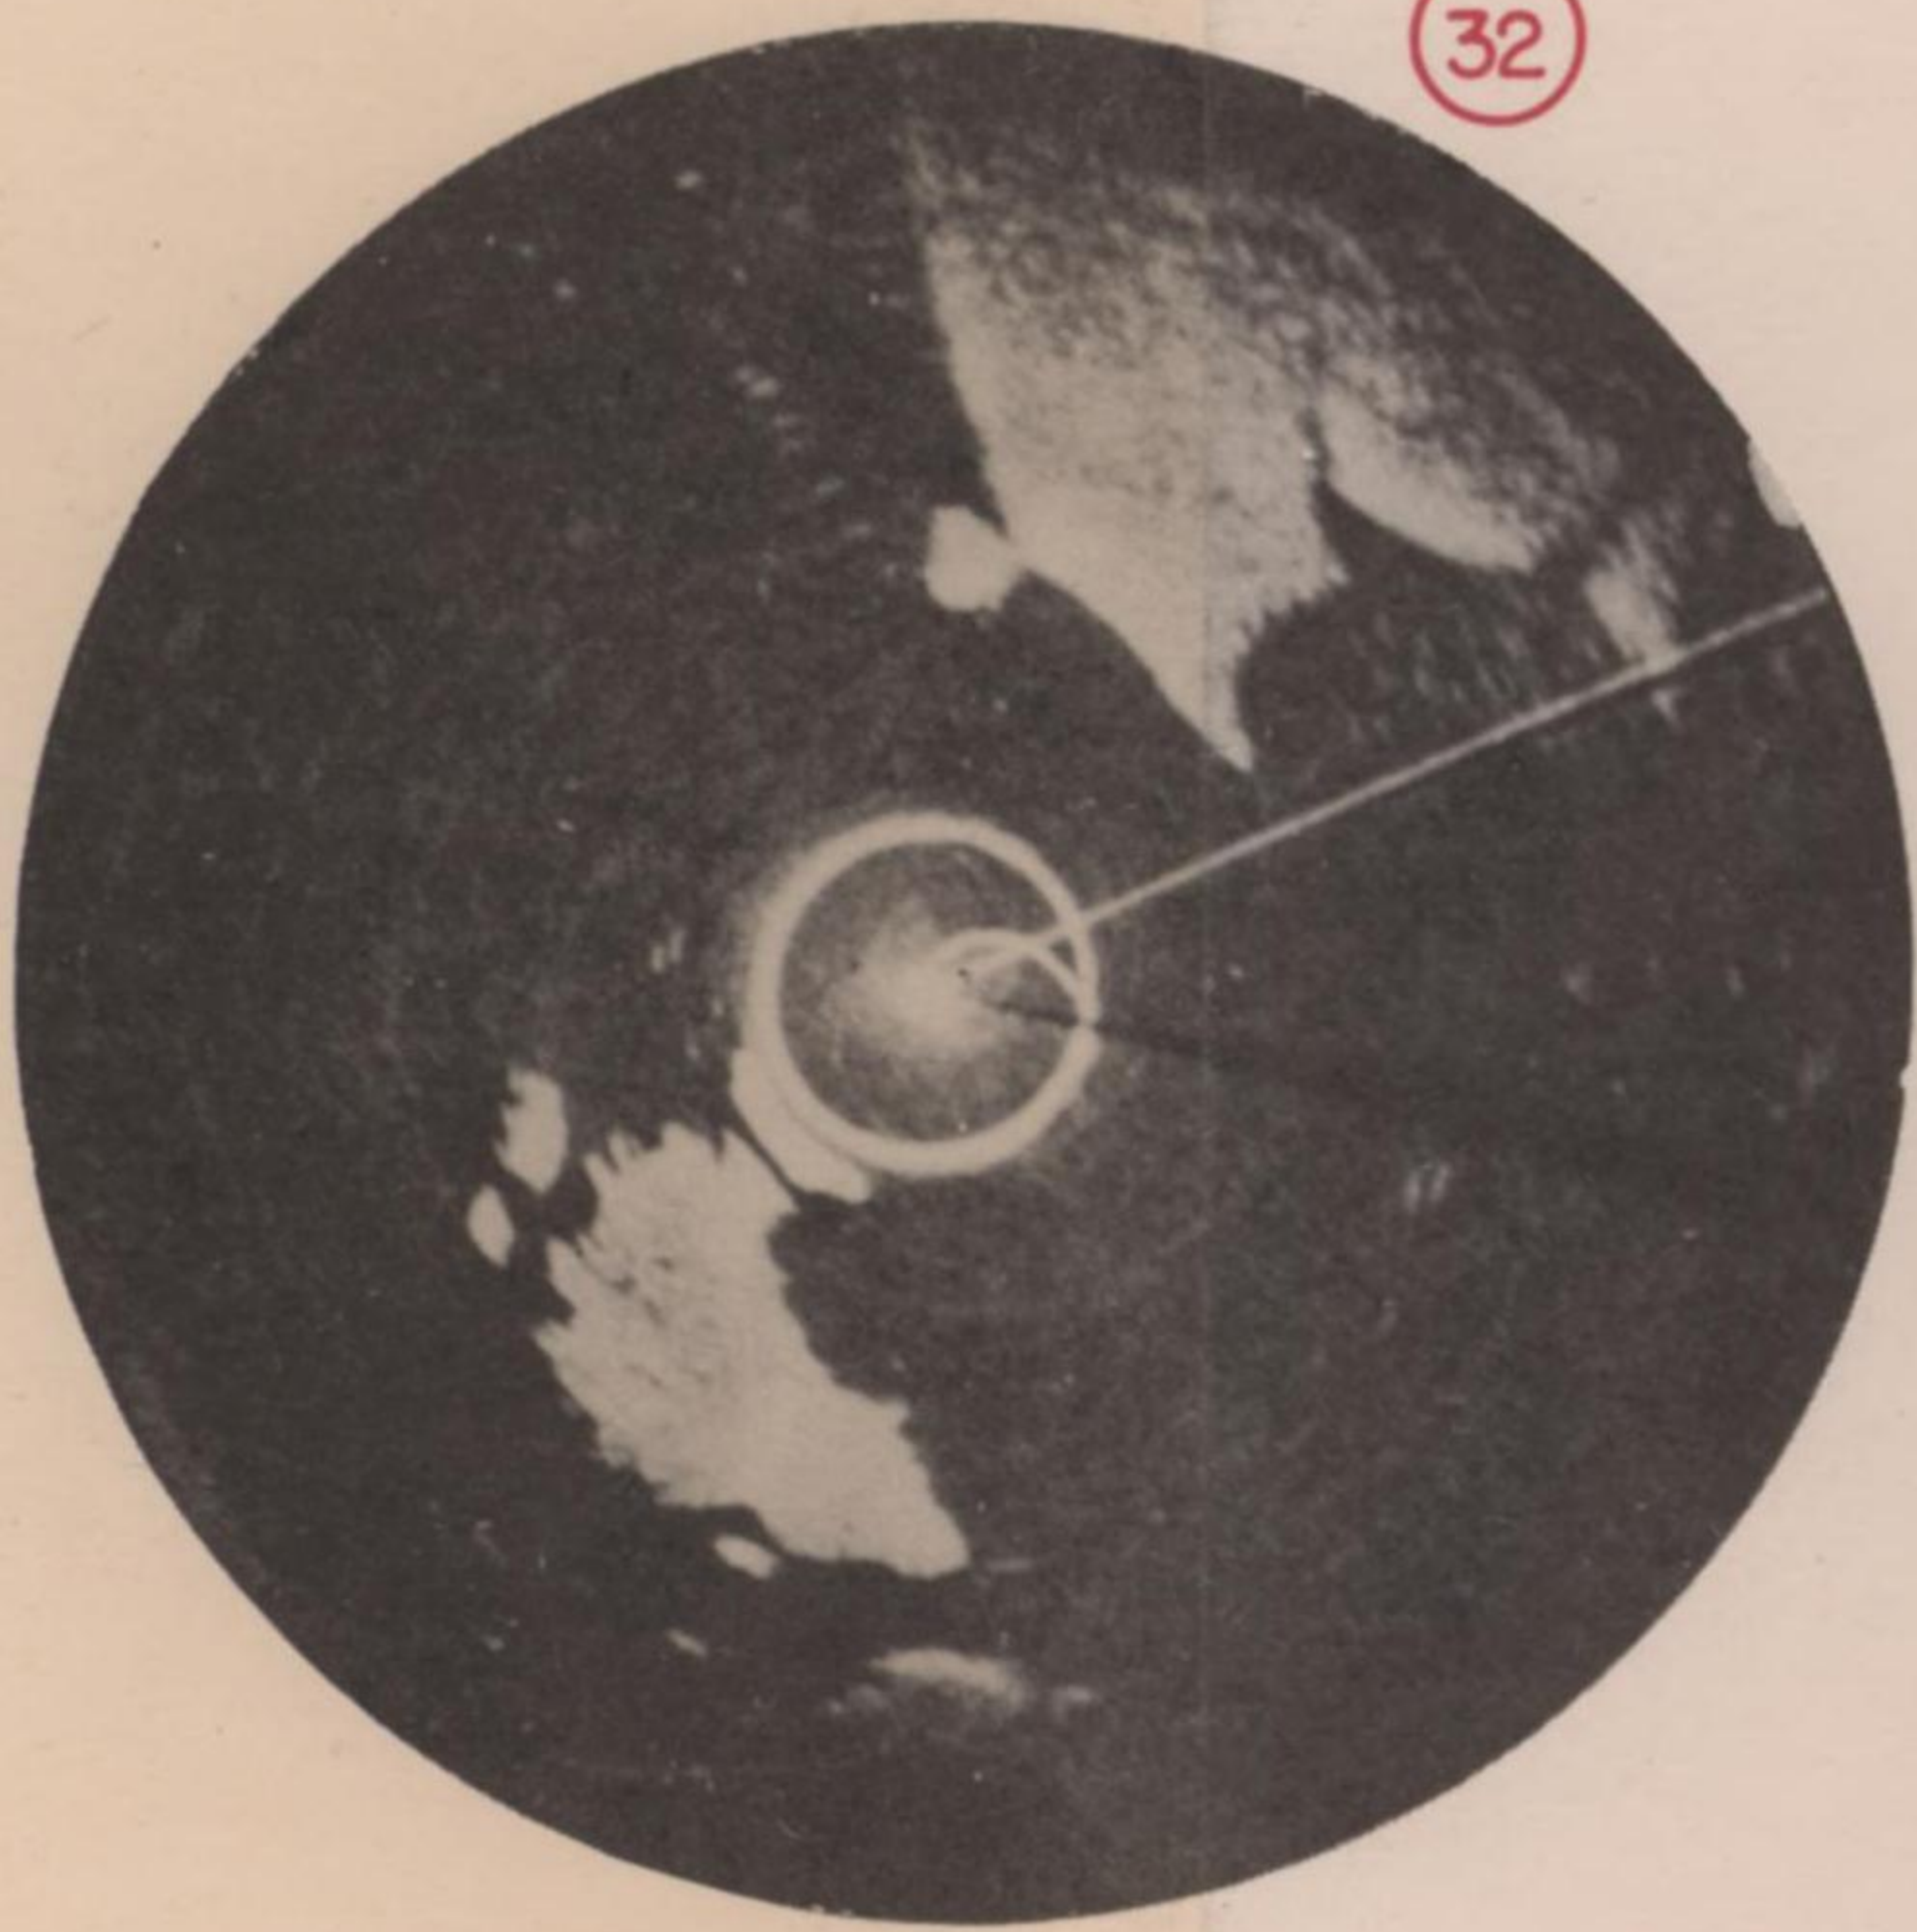
32

66° MAG.

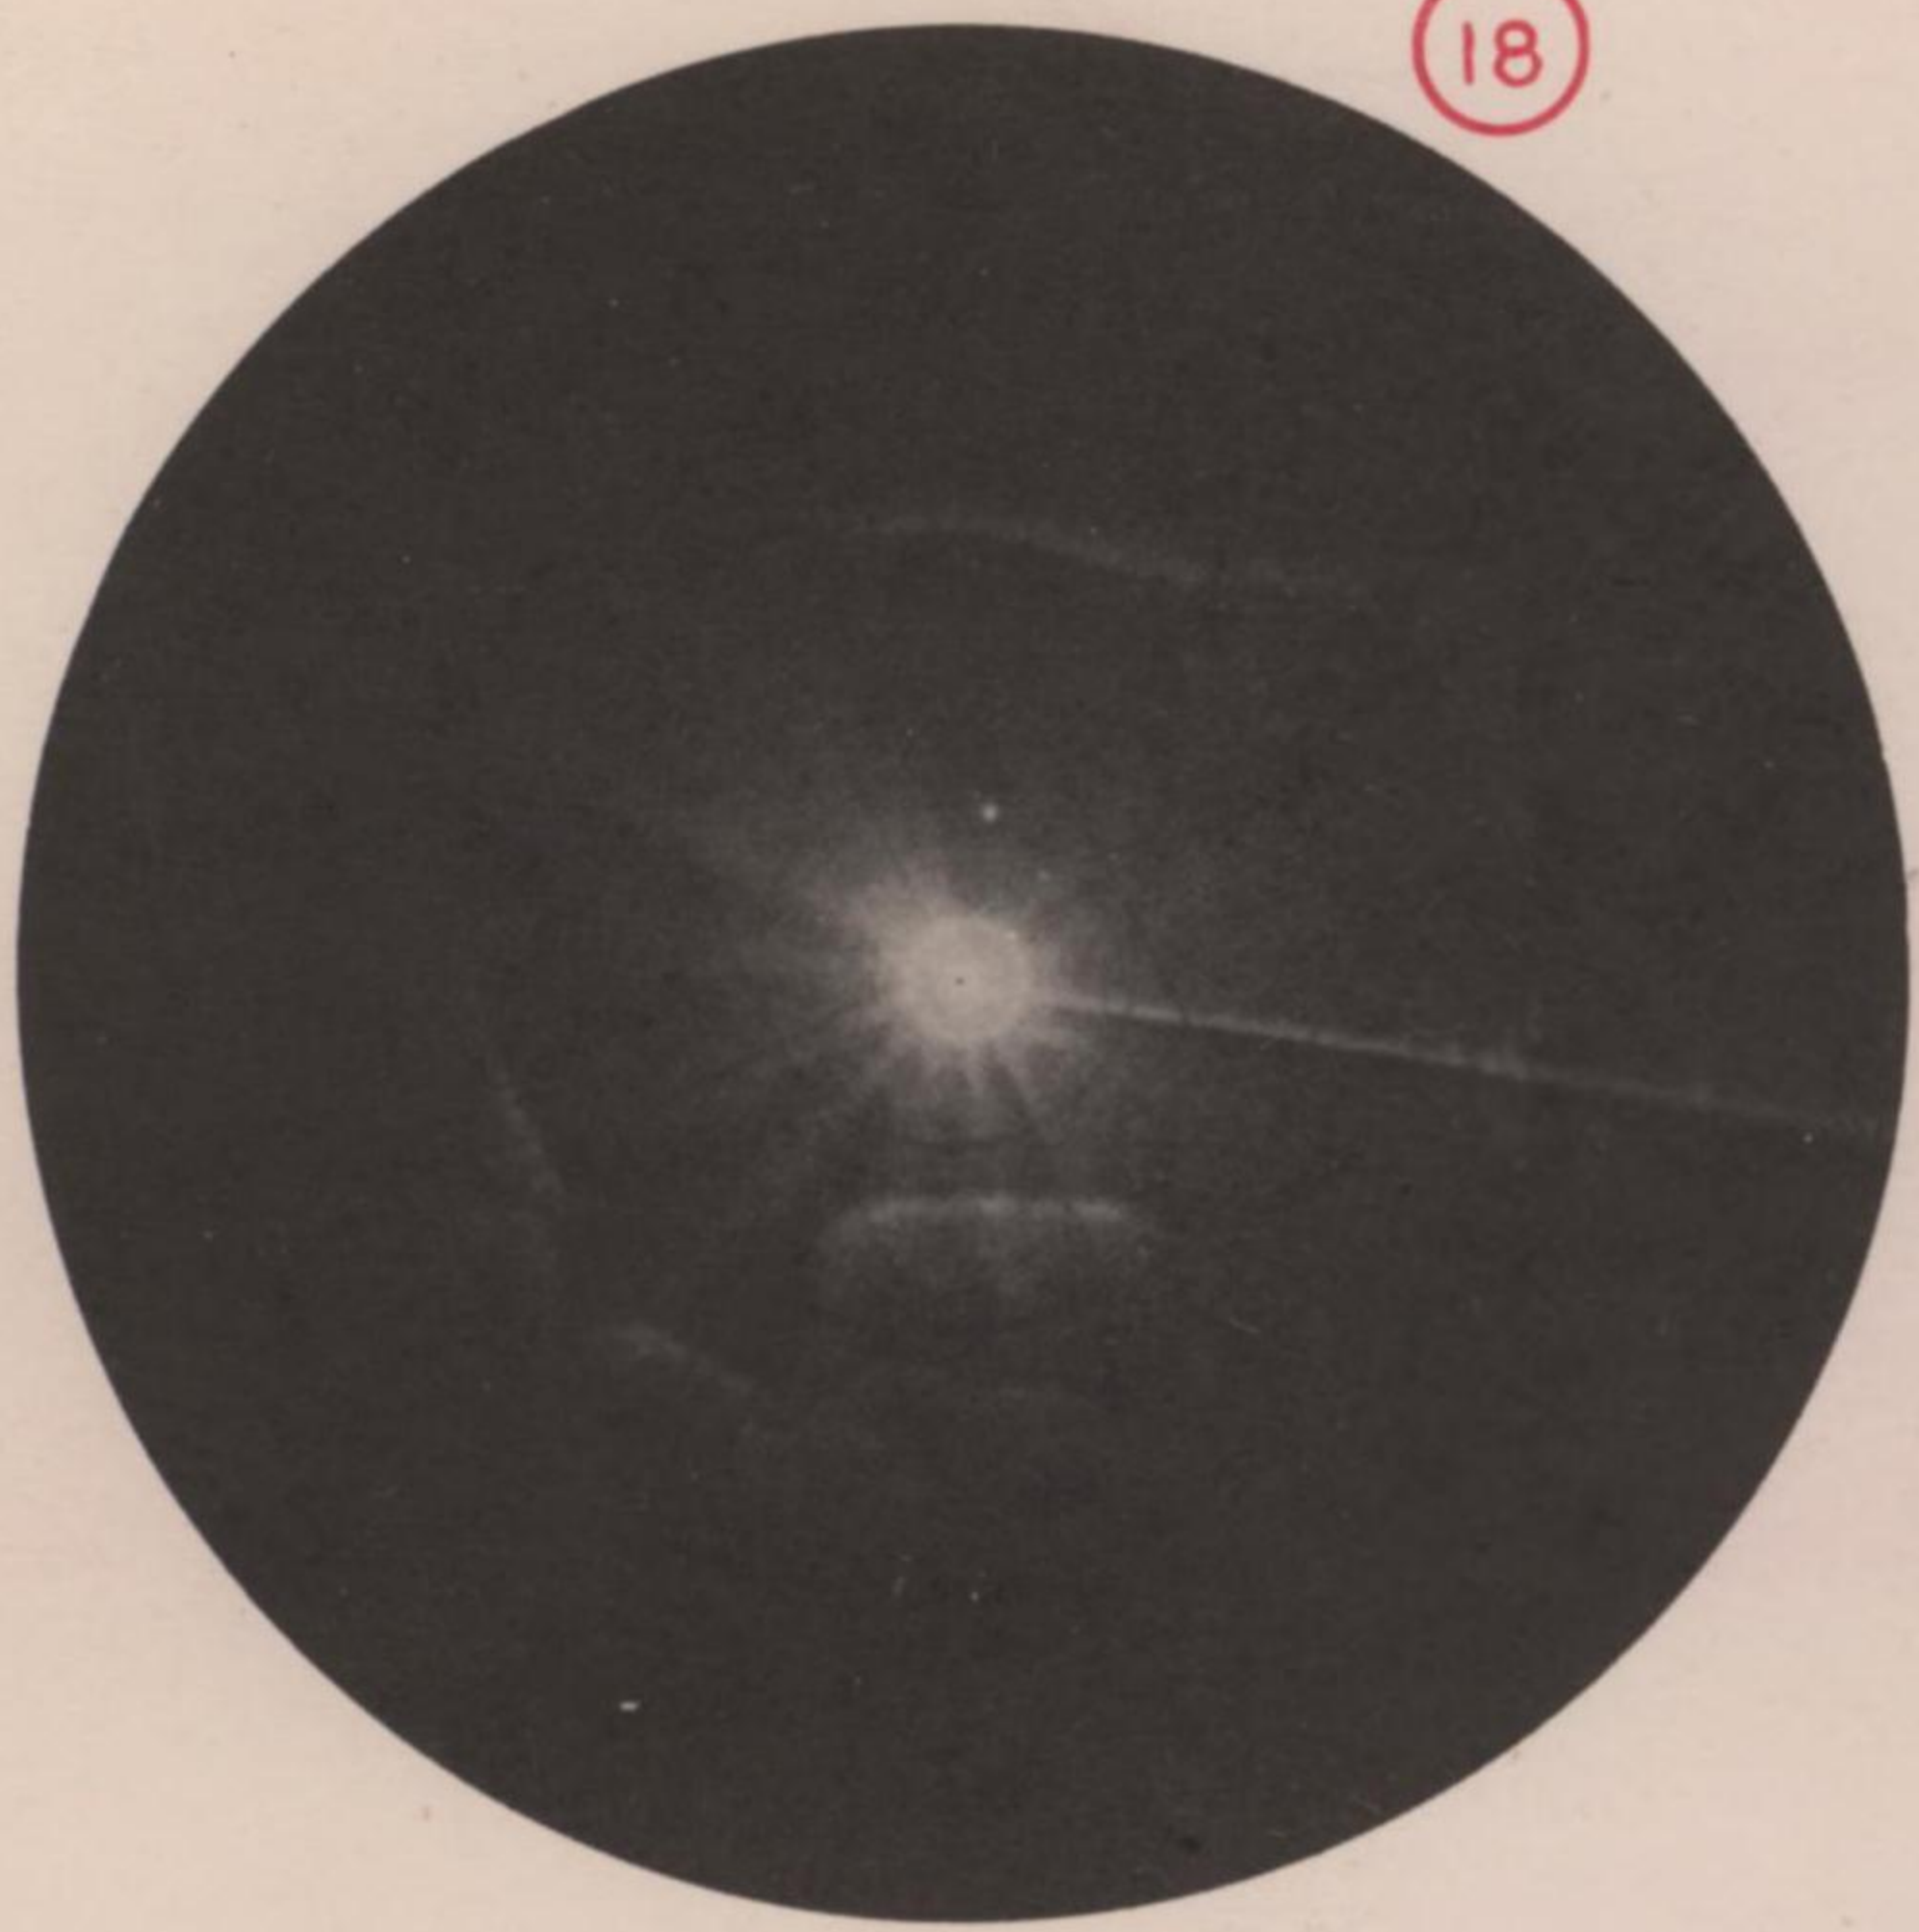
18

ALL ALTITUDES 20,000'

HEADING 98° MAG.

50 MILE SWEEP
