MISSION #33 SINGAPORE "PILICAN 3"
1 February 1945

Tactical Mission Report

No. 33

TARGETS: Floating Drydock, Singapore
Drydock in the Naval Base Area, Singapore.

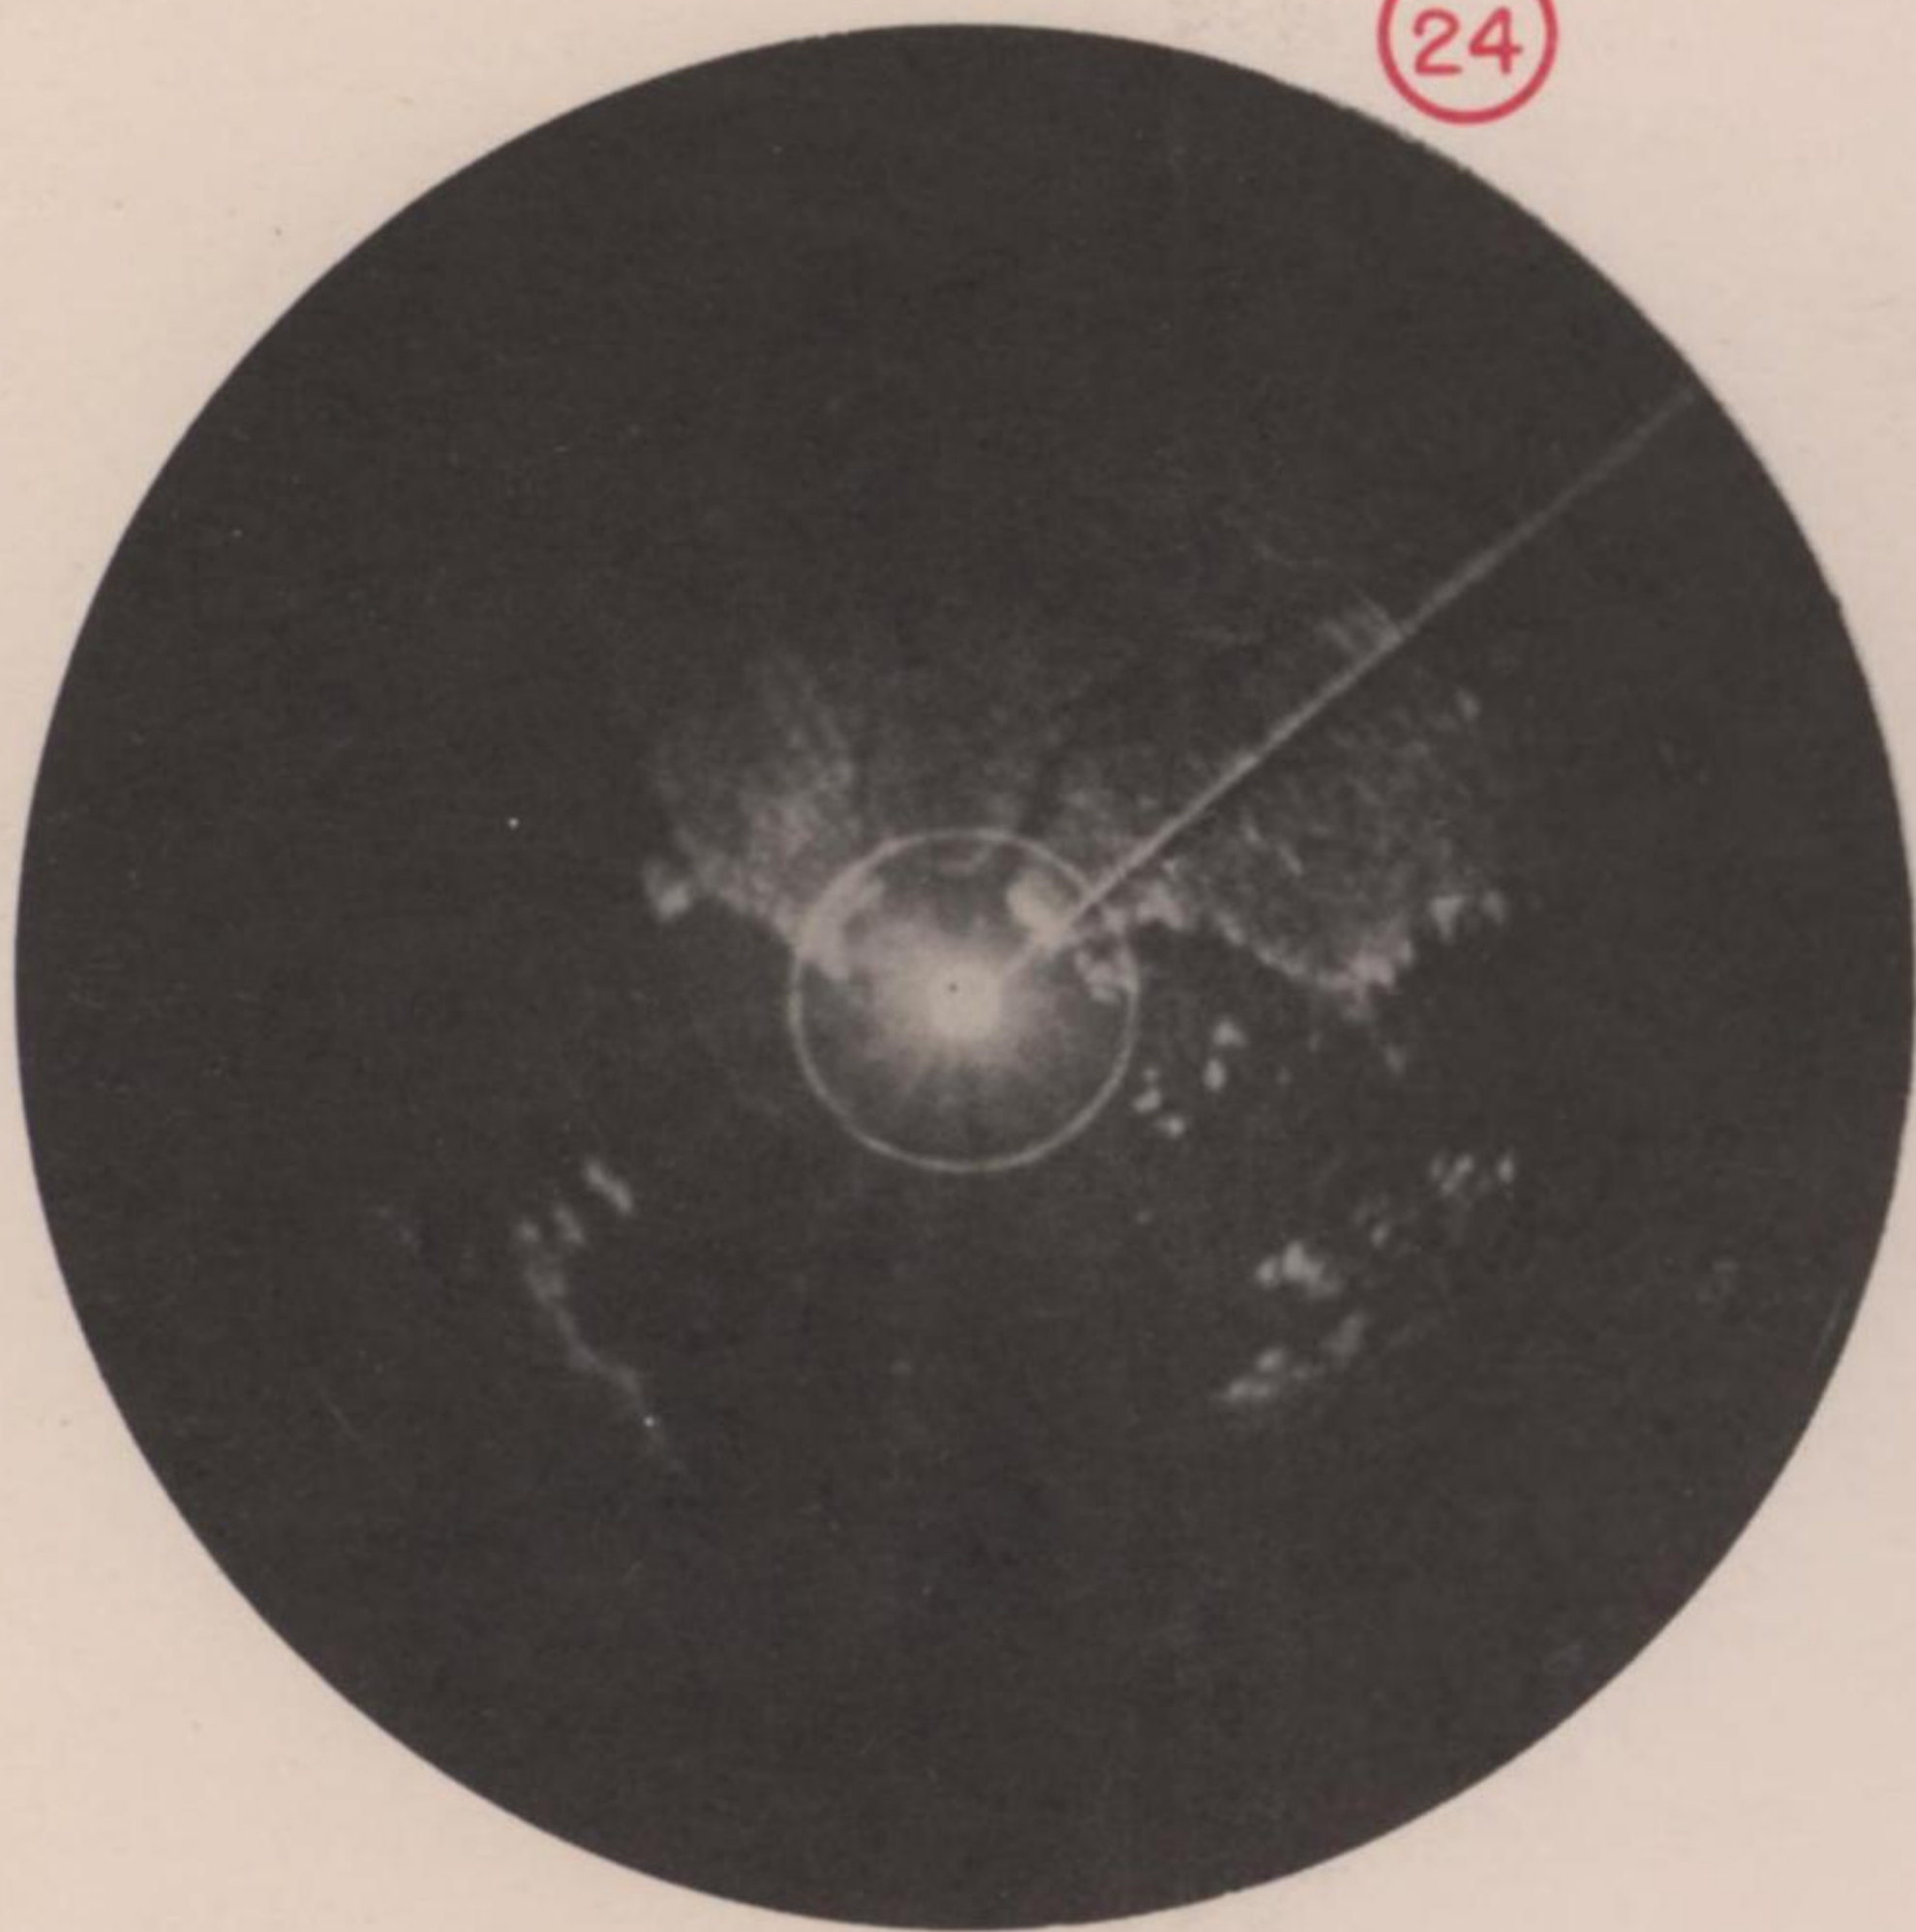
24

HEADING 51° MAG.

50 MILE SWEEP

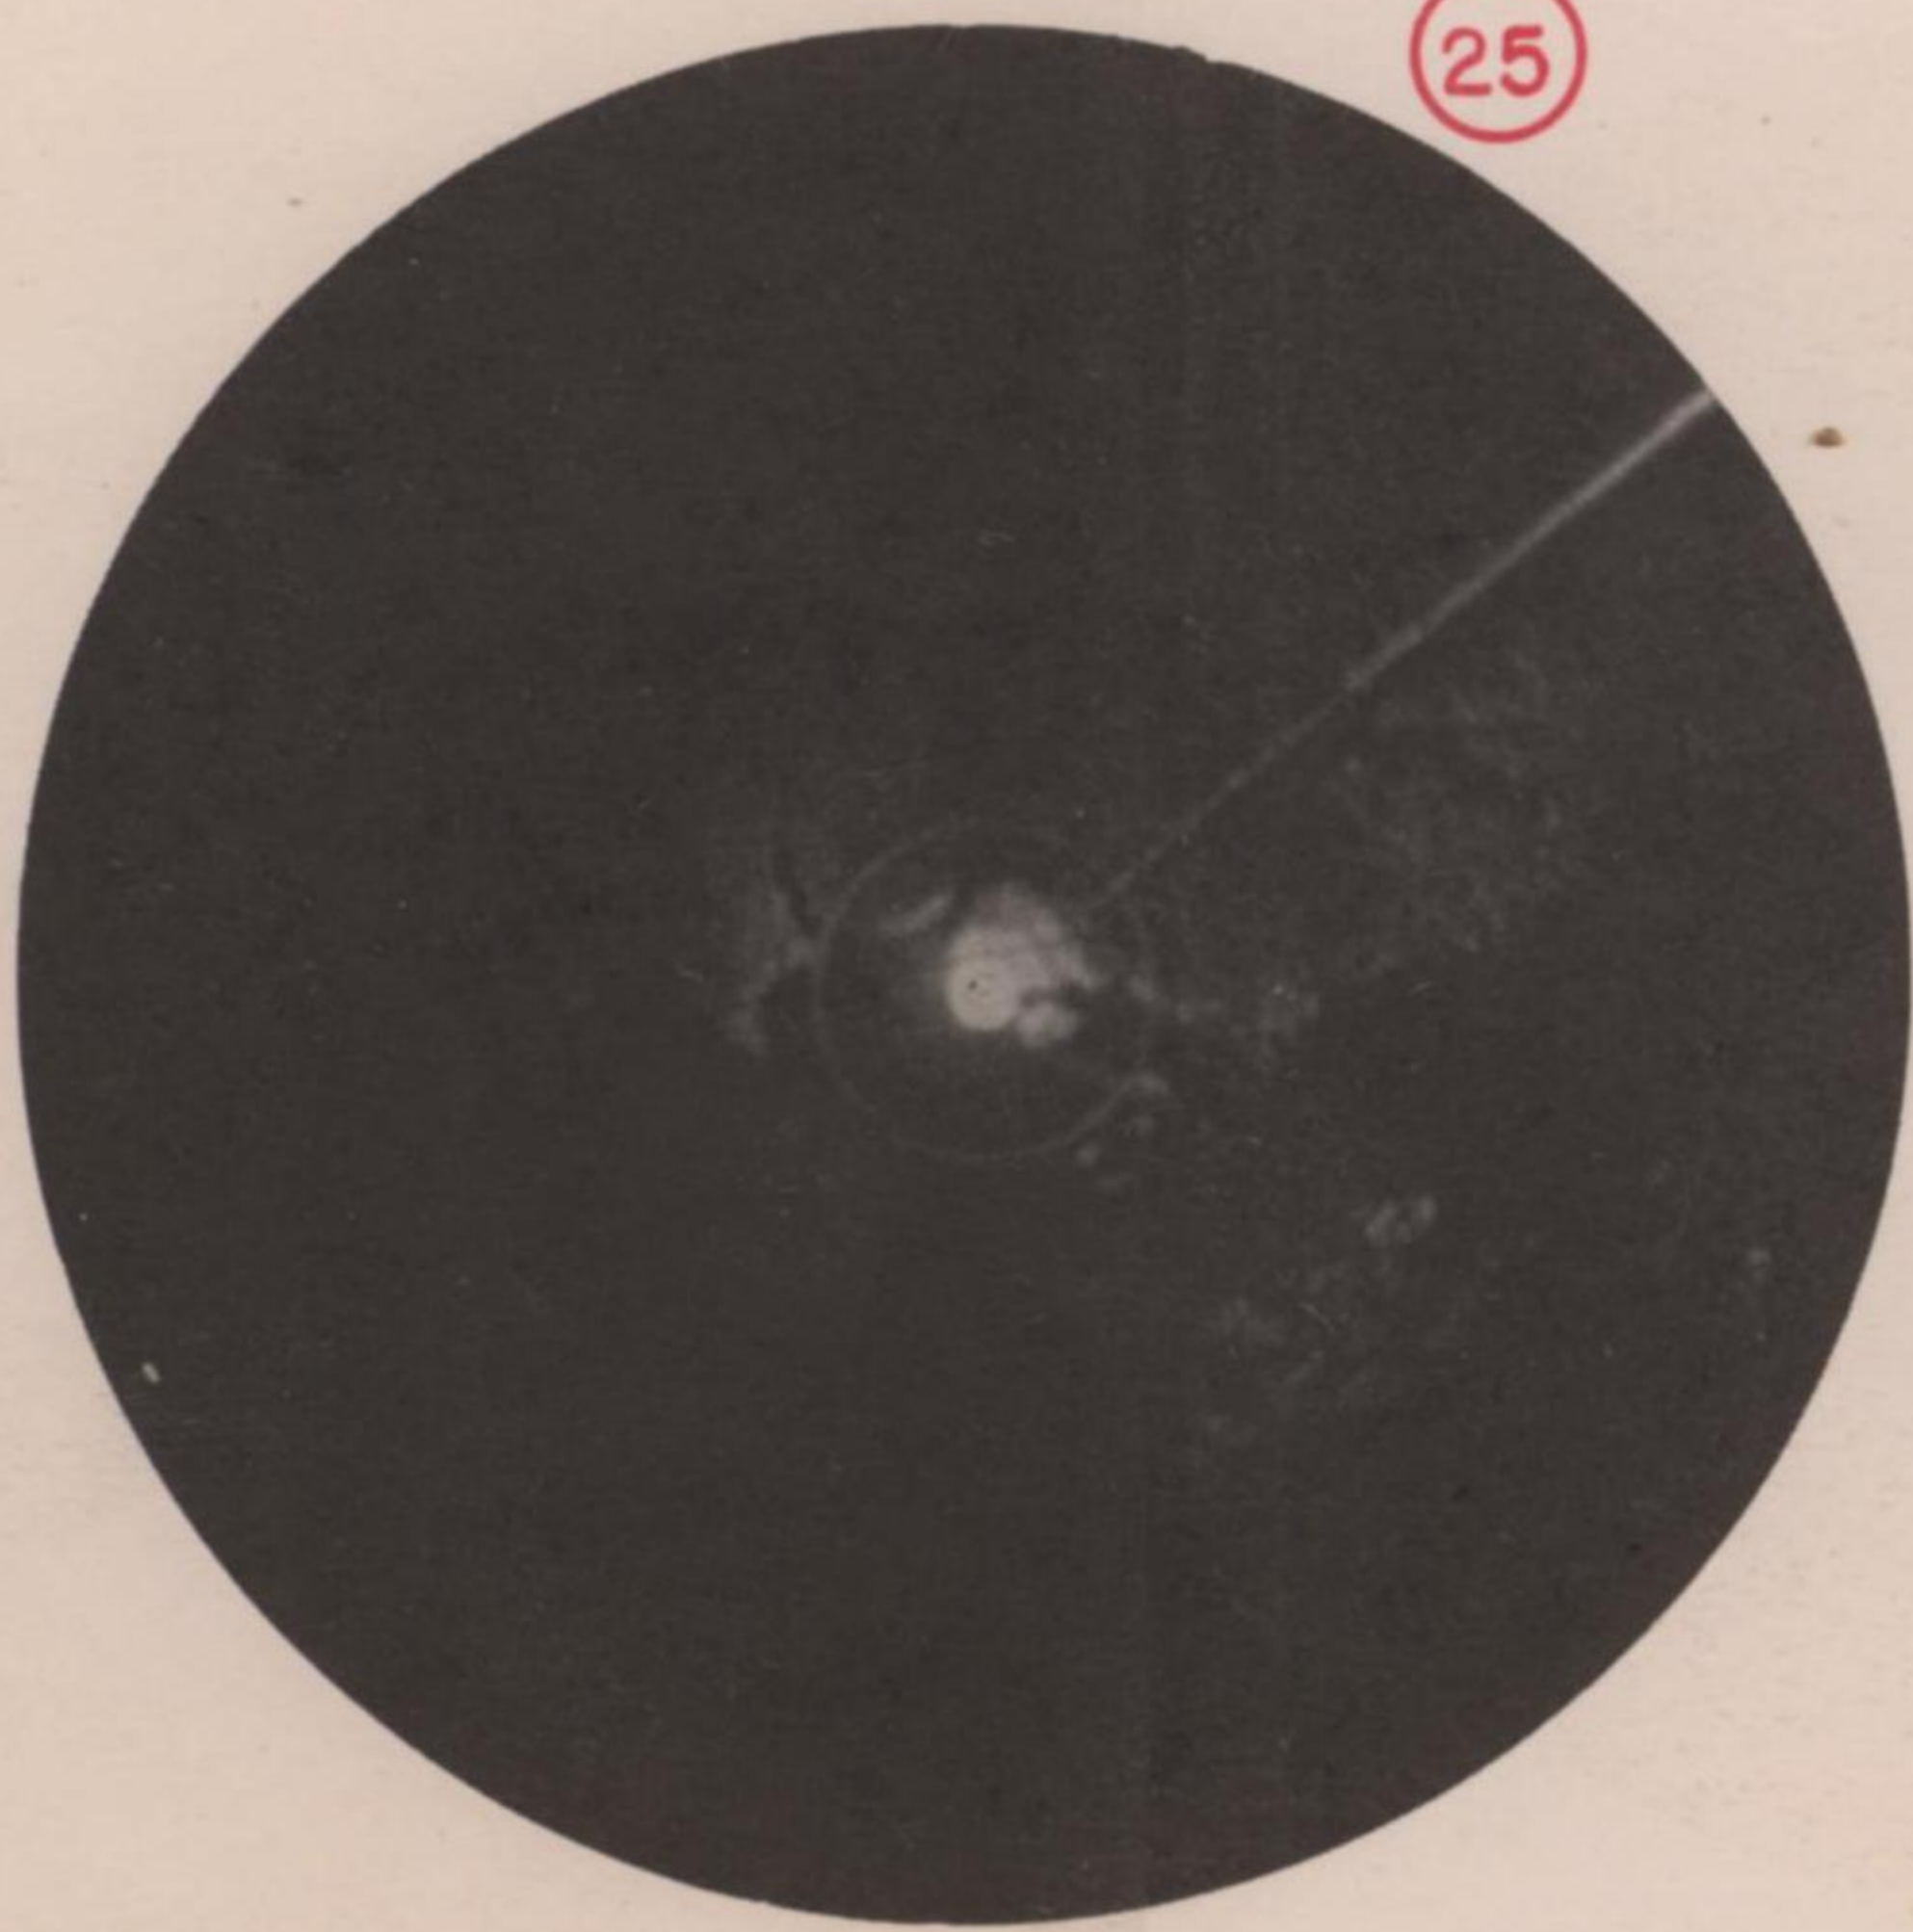
25

HEADING 51° MAG.

50 MILE SWEEP

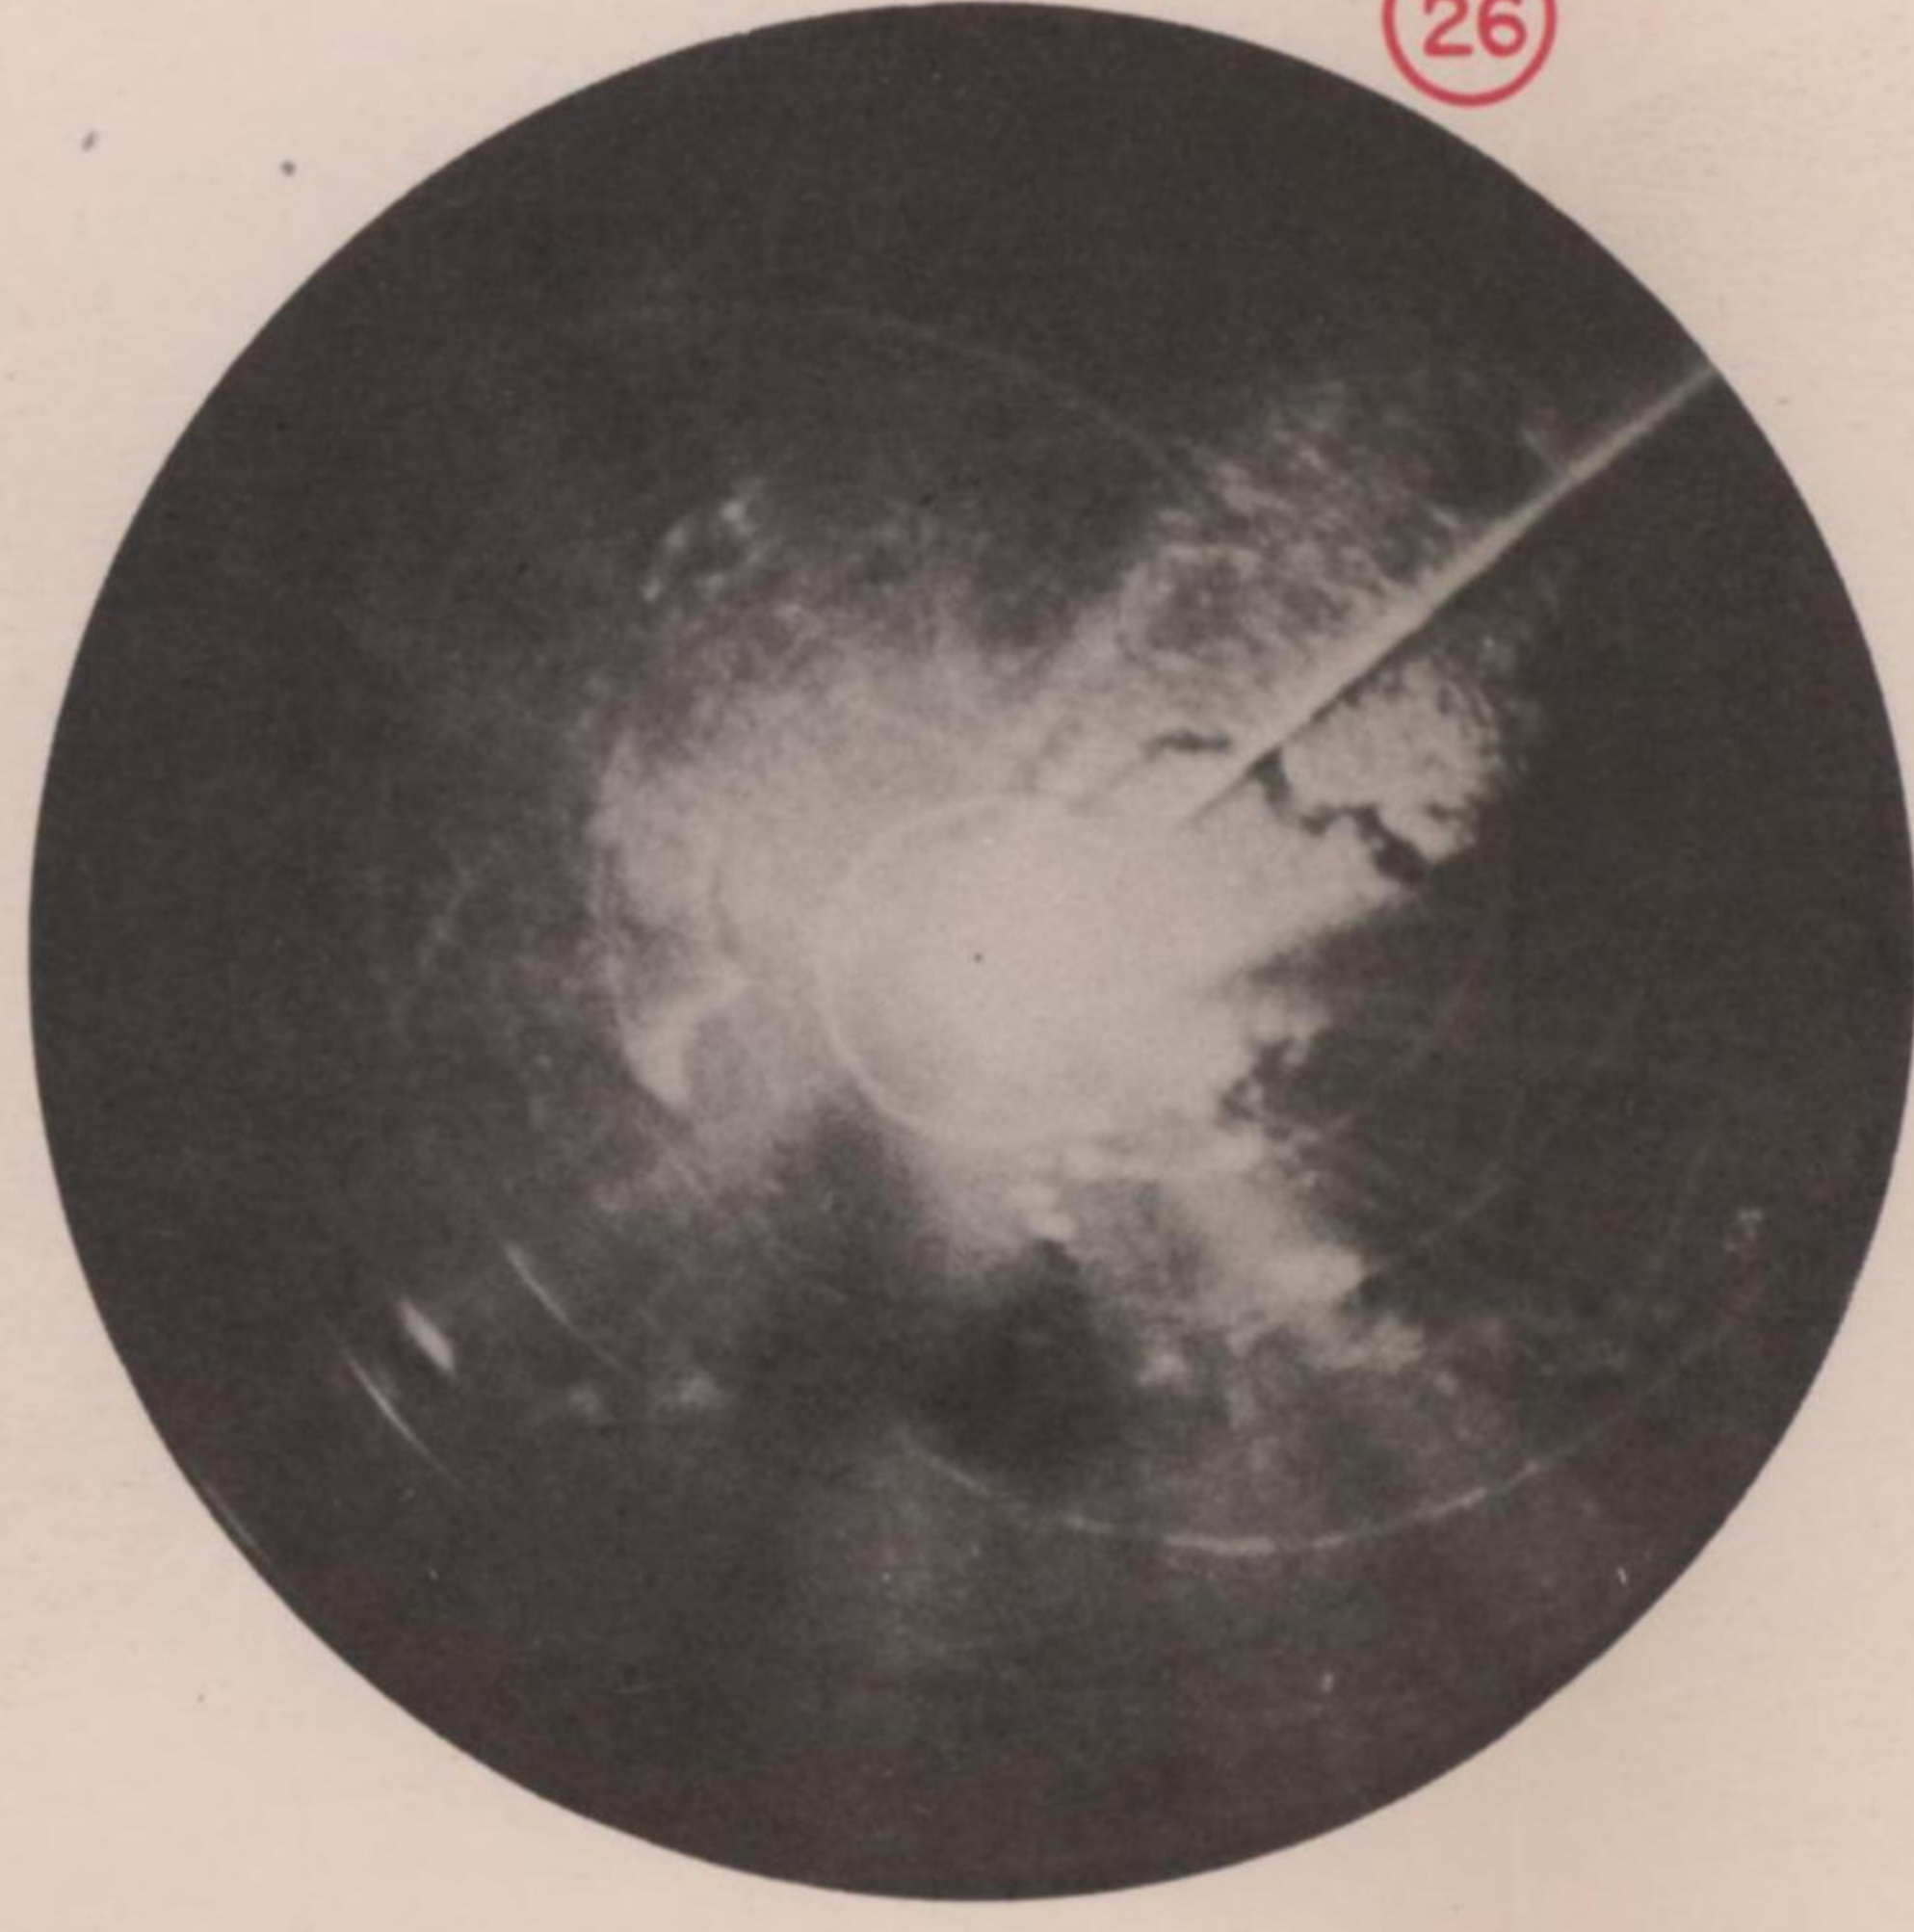
26

HEADING 51° MAG.

50 MILE SWEEP

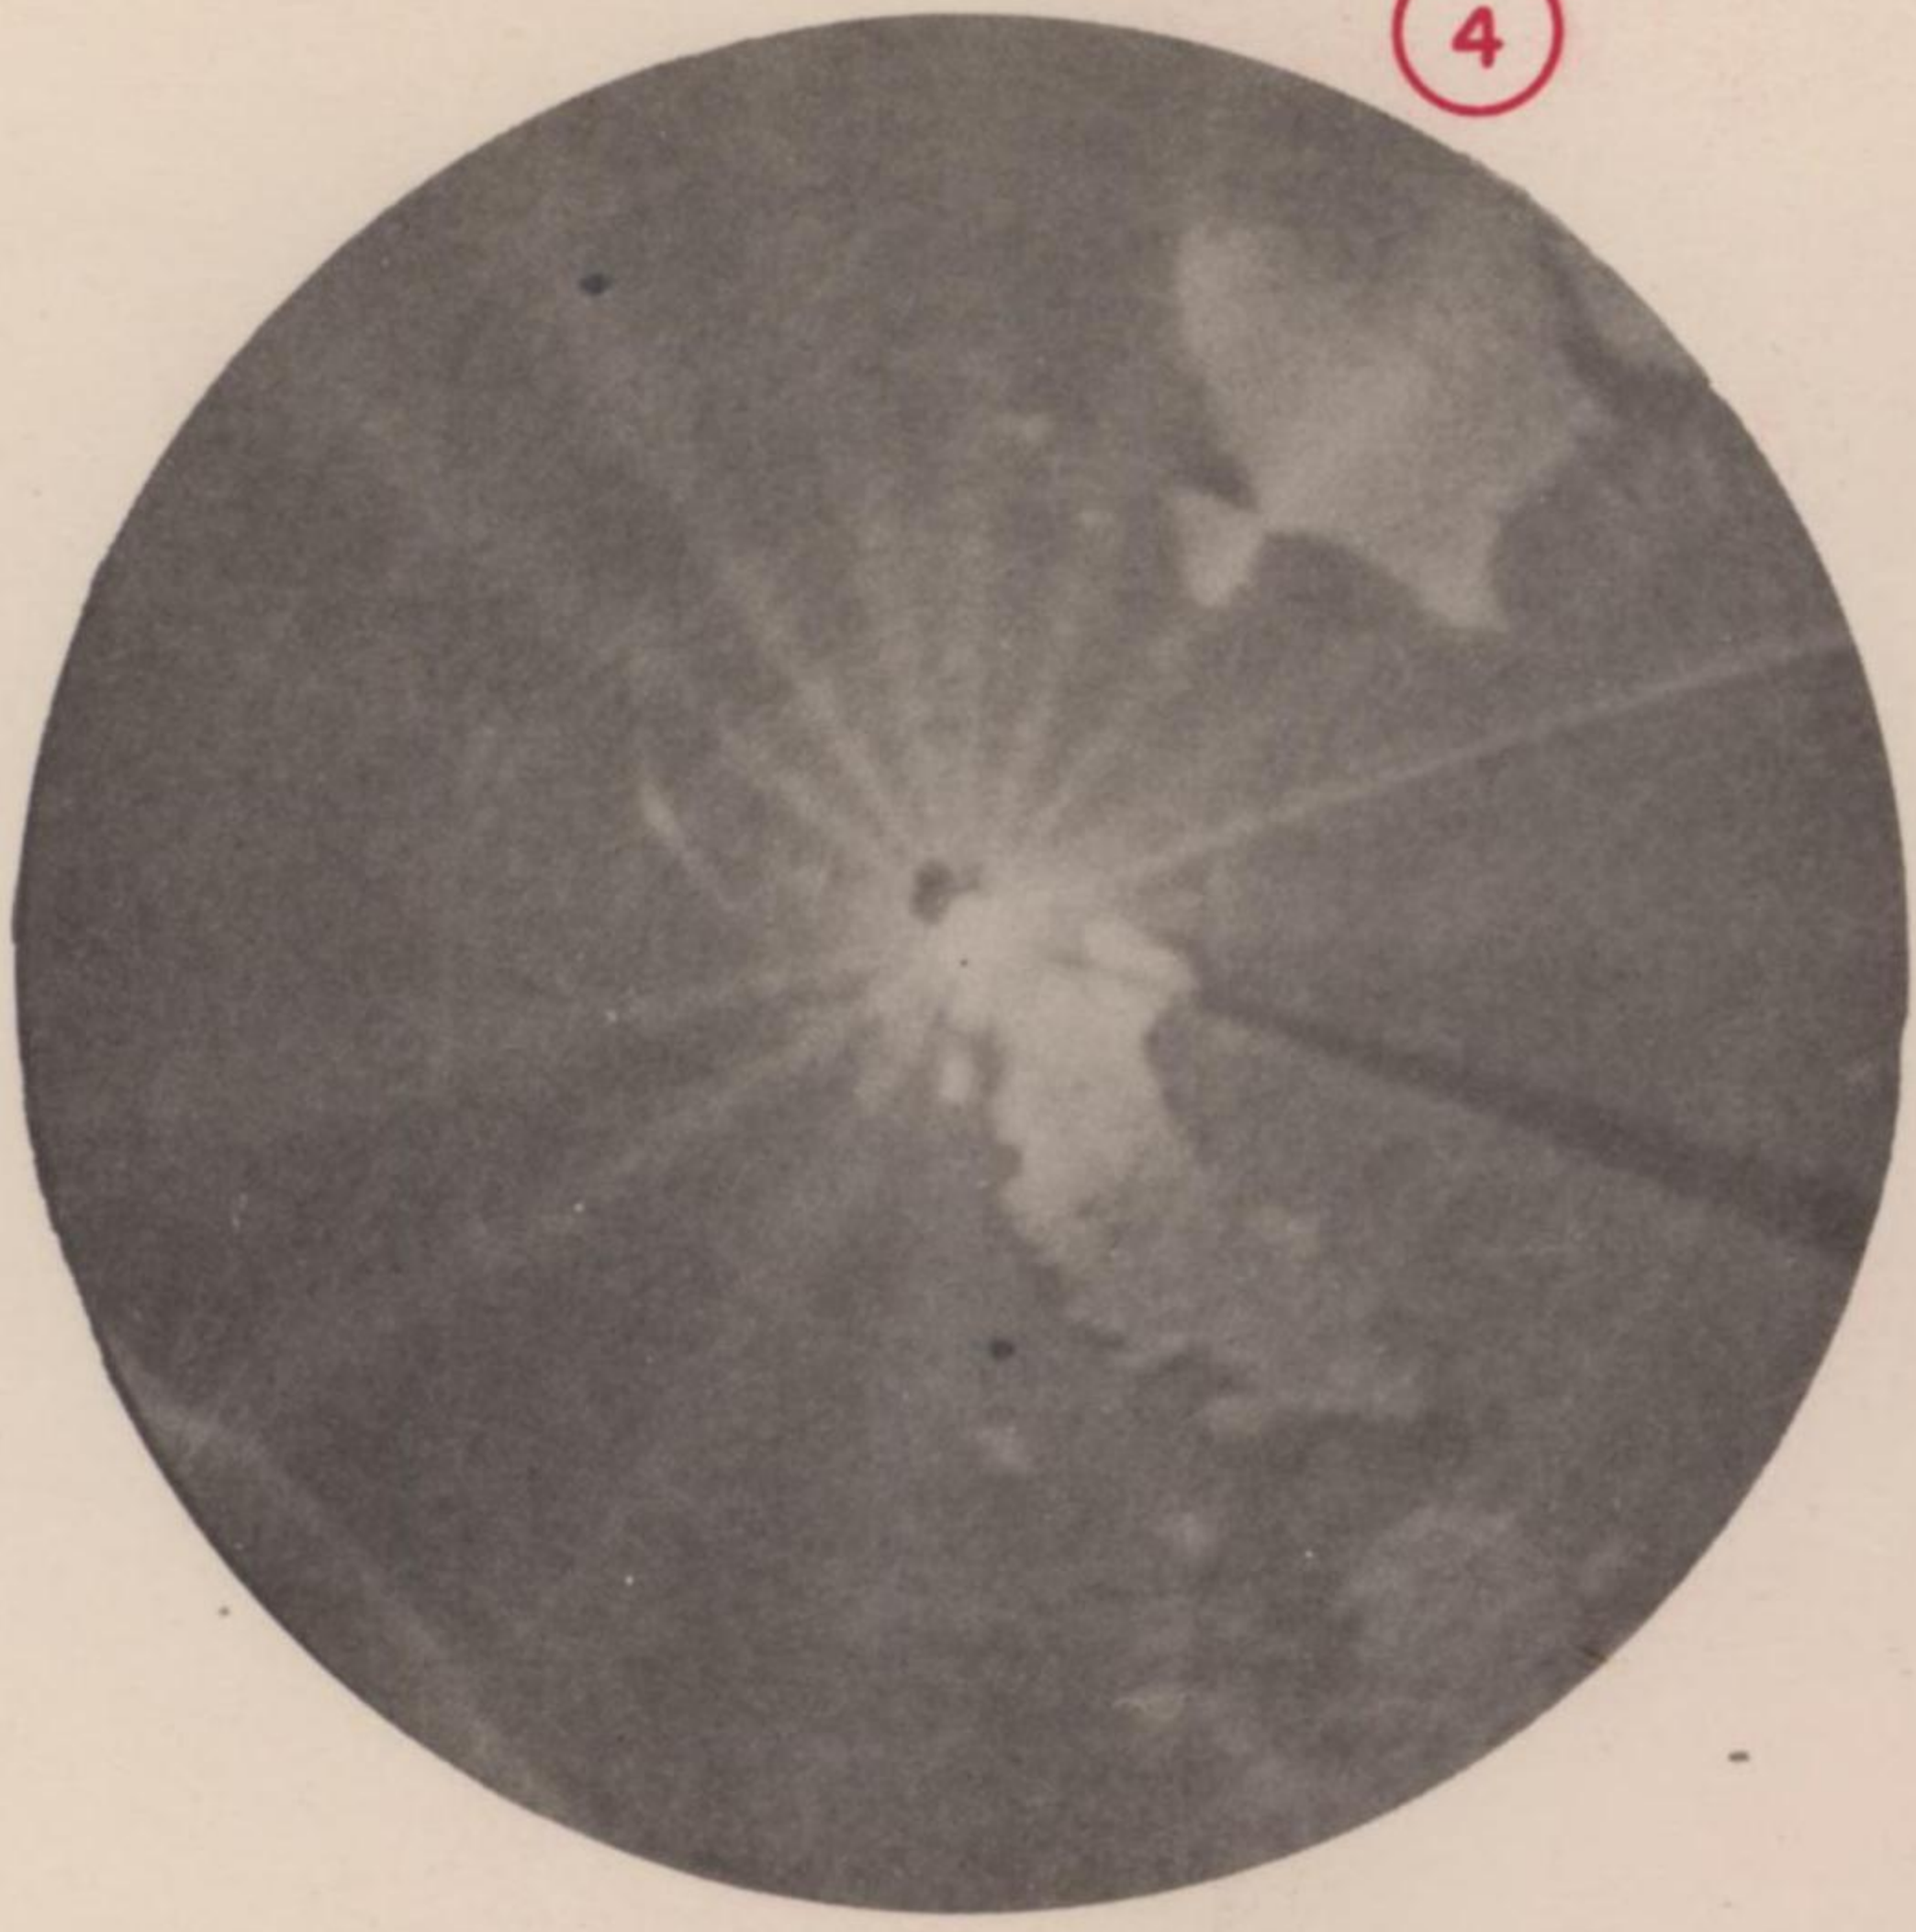
4

HEADING 69° MAG.

ALTITUDE 19,100
