90.25 - 2041 - Sumitomo Propellor Plant - Kanzaki - 22 Oct & 31 Oct '45.

PIC-R-REPORT No. 4.

RX-4 - 90.25-2041 SUMITOMO PROPELLOR PLANT, KANZAKI.

RX-1 90.25-263A Sumitomo Metal Co., Sakurajima Plant

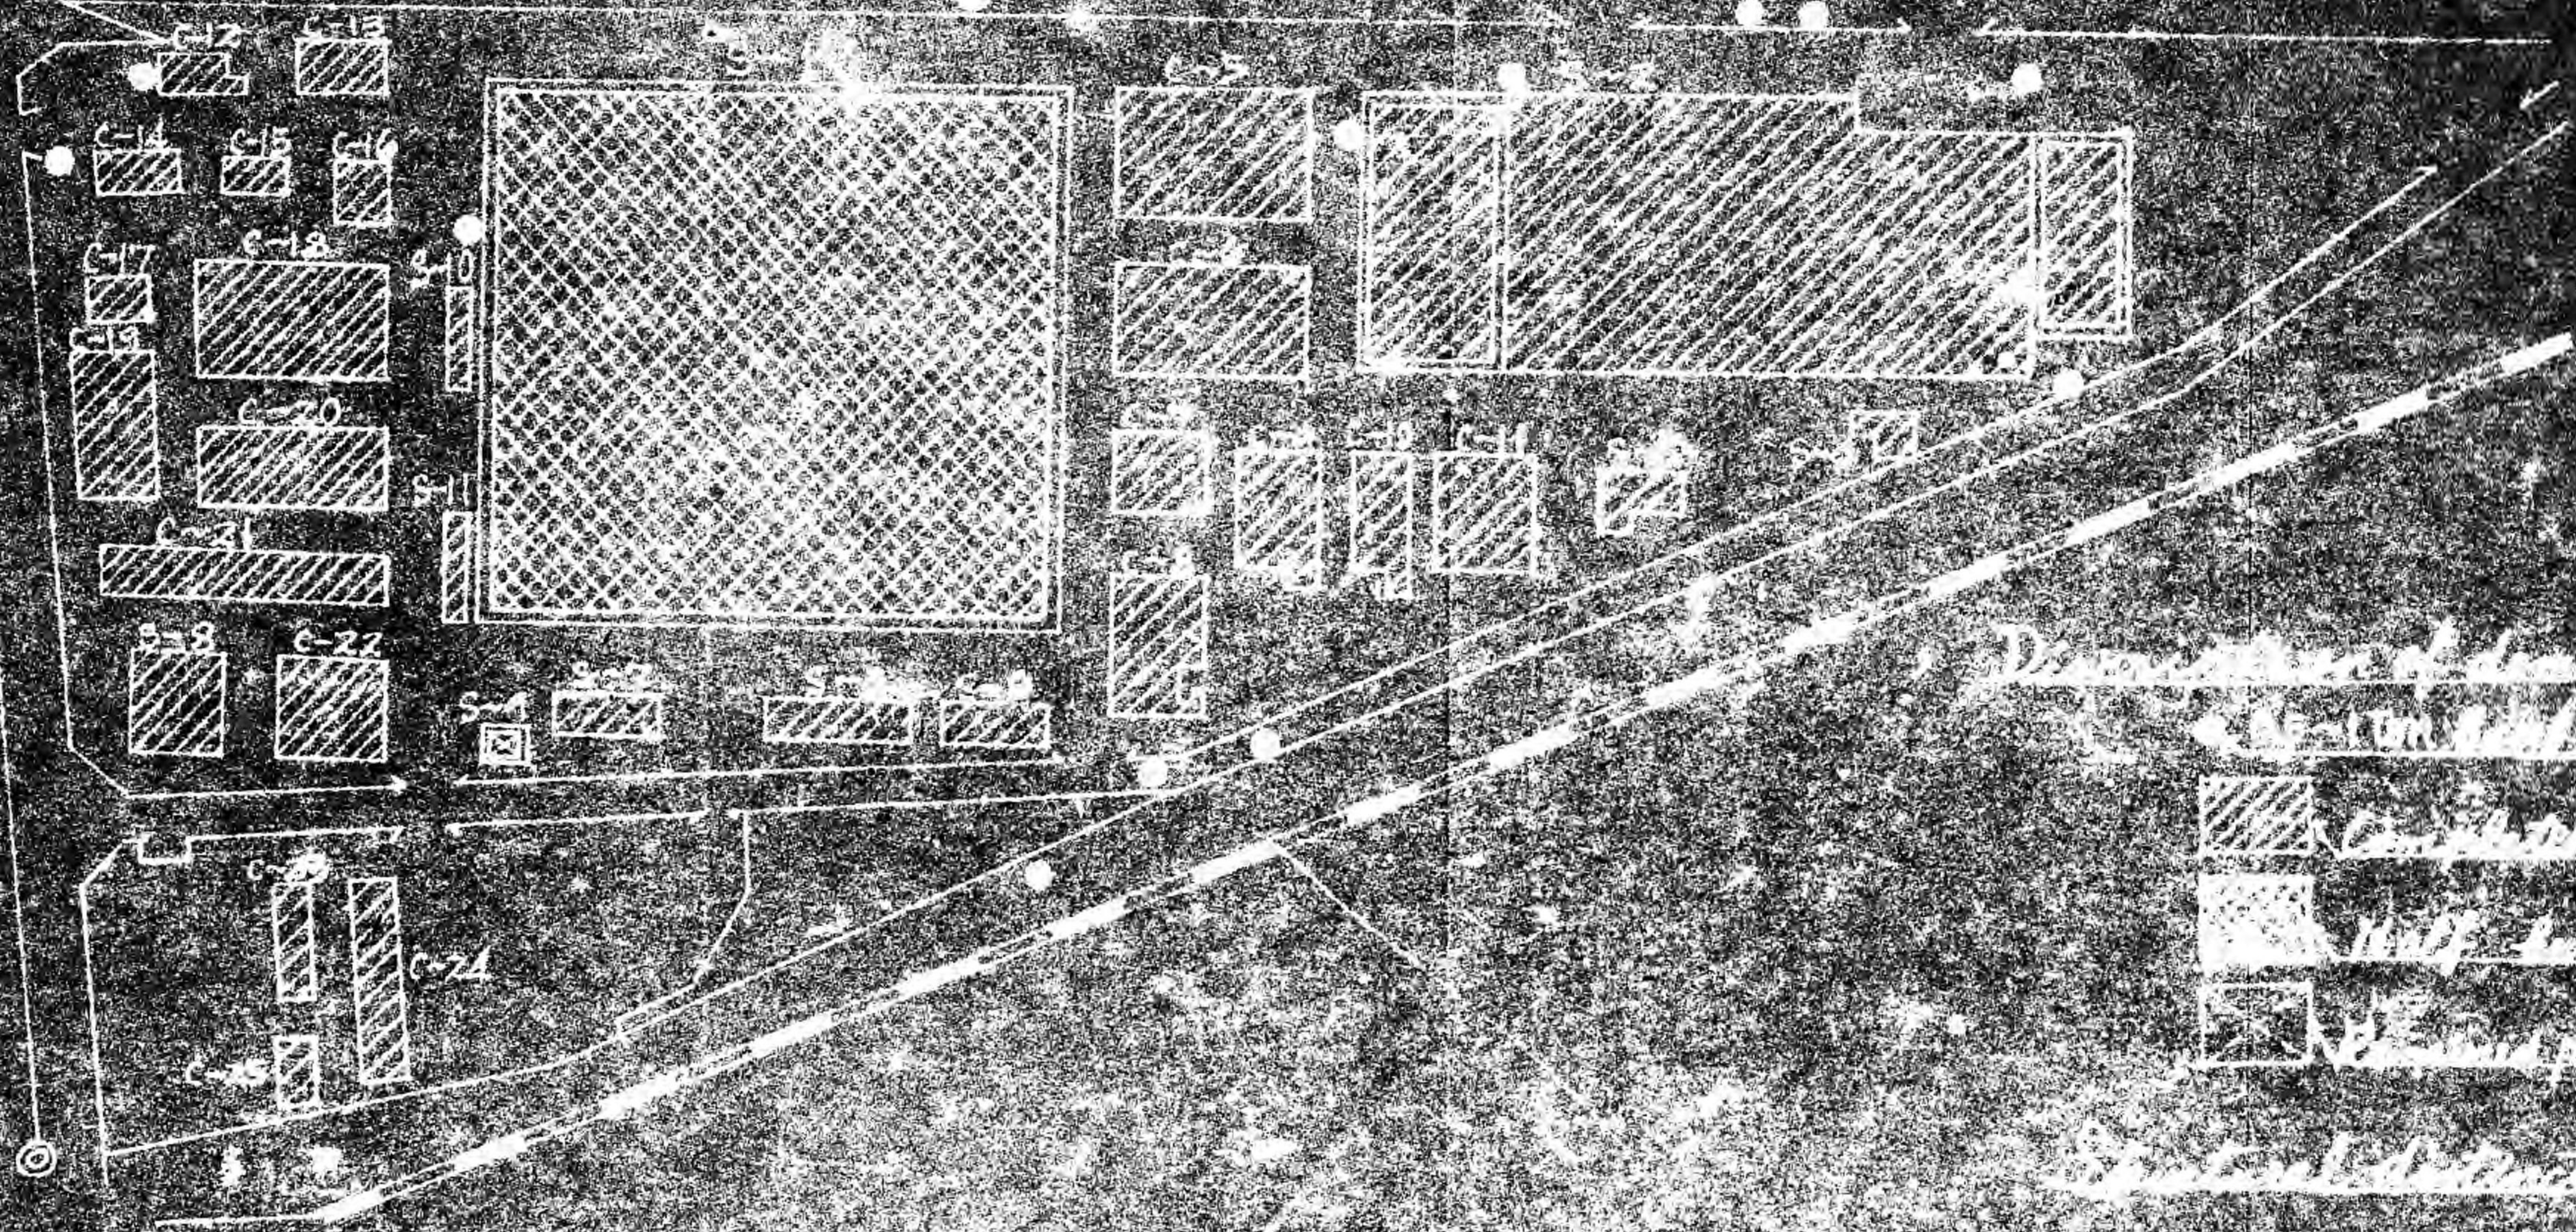
Sakurajima plant

Air raid in 24th July

Distinction of damage

- Completely burned
- Half-burned
- Remained perfectly

Distinction of building

- Iron frame bldg.
- Wooden bldg.

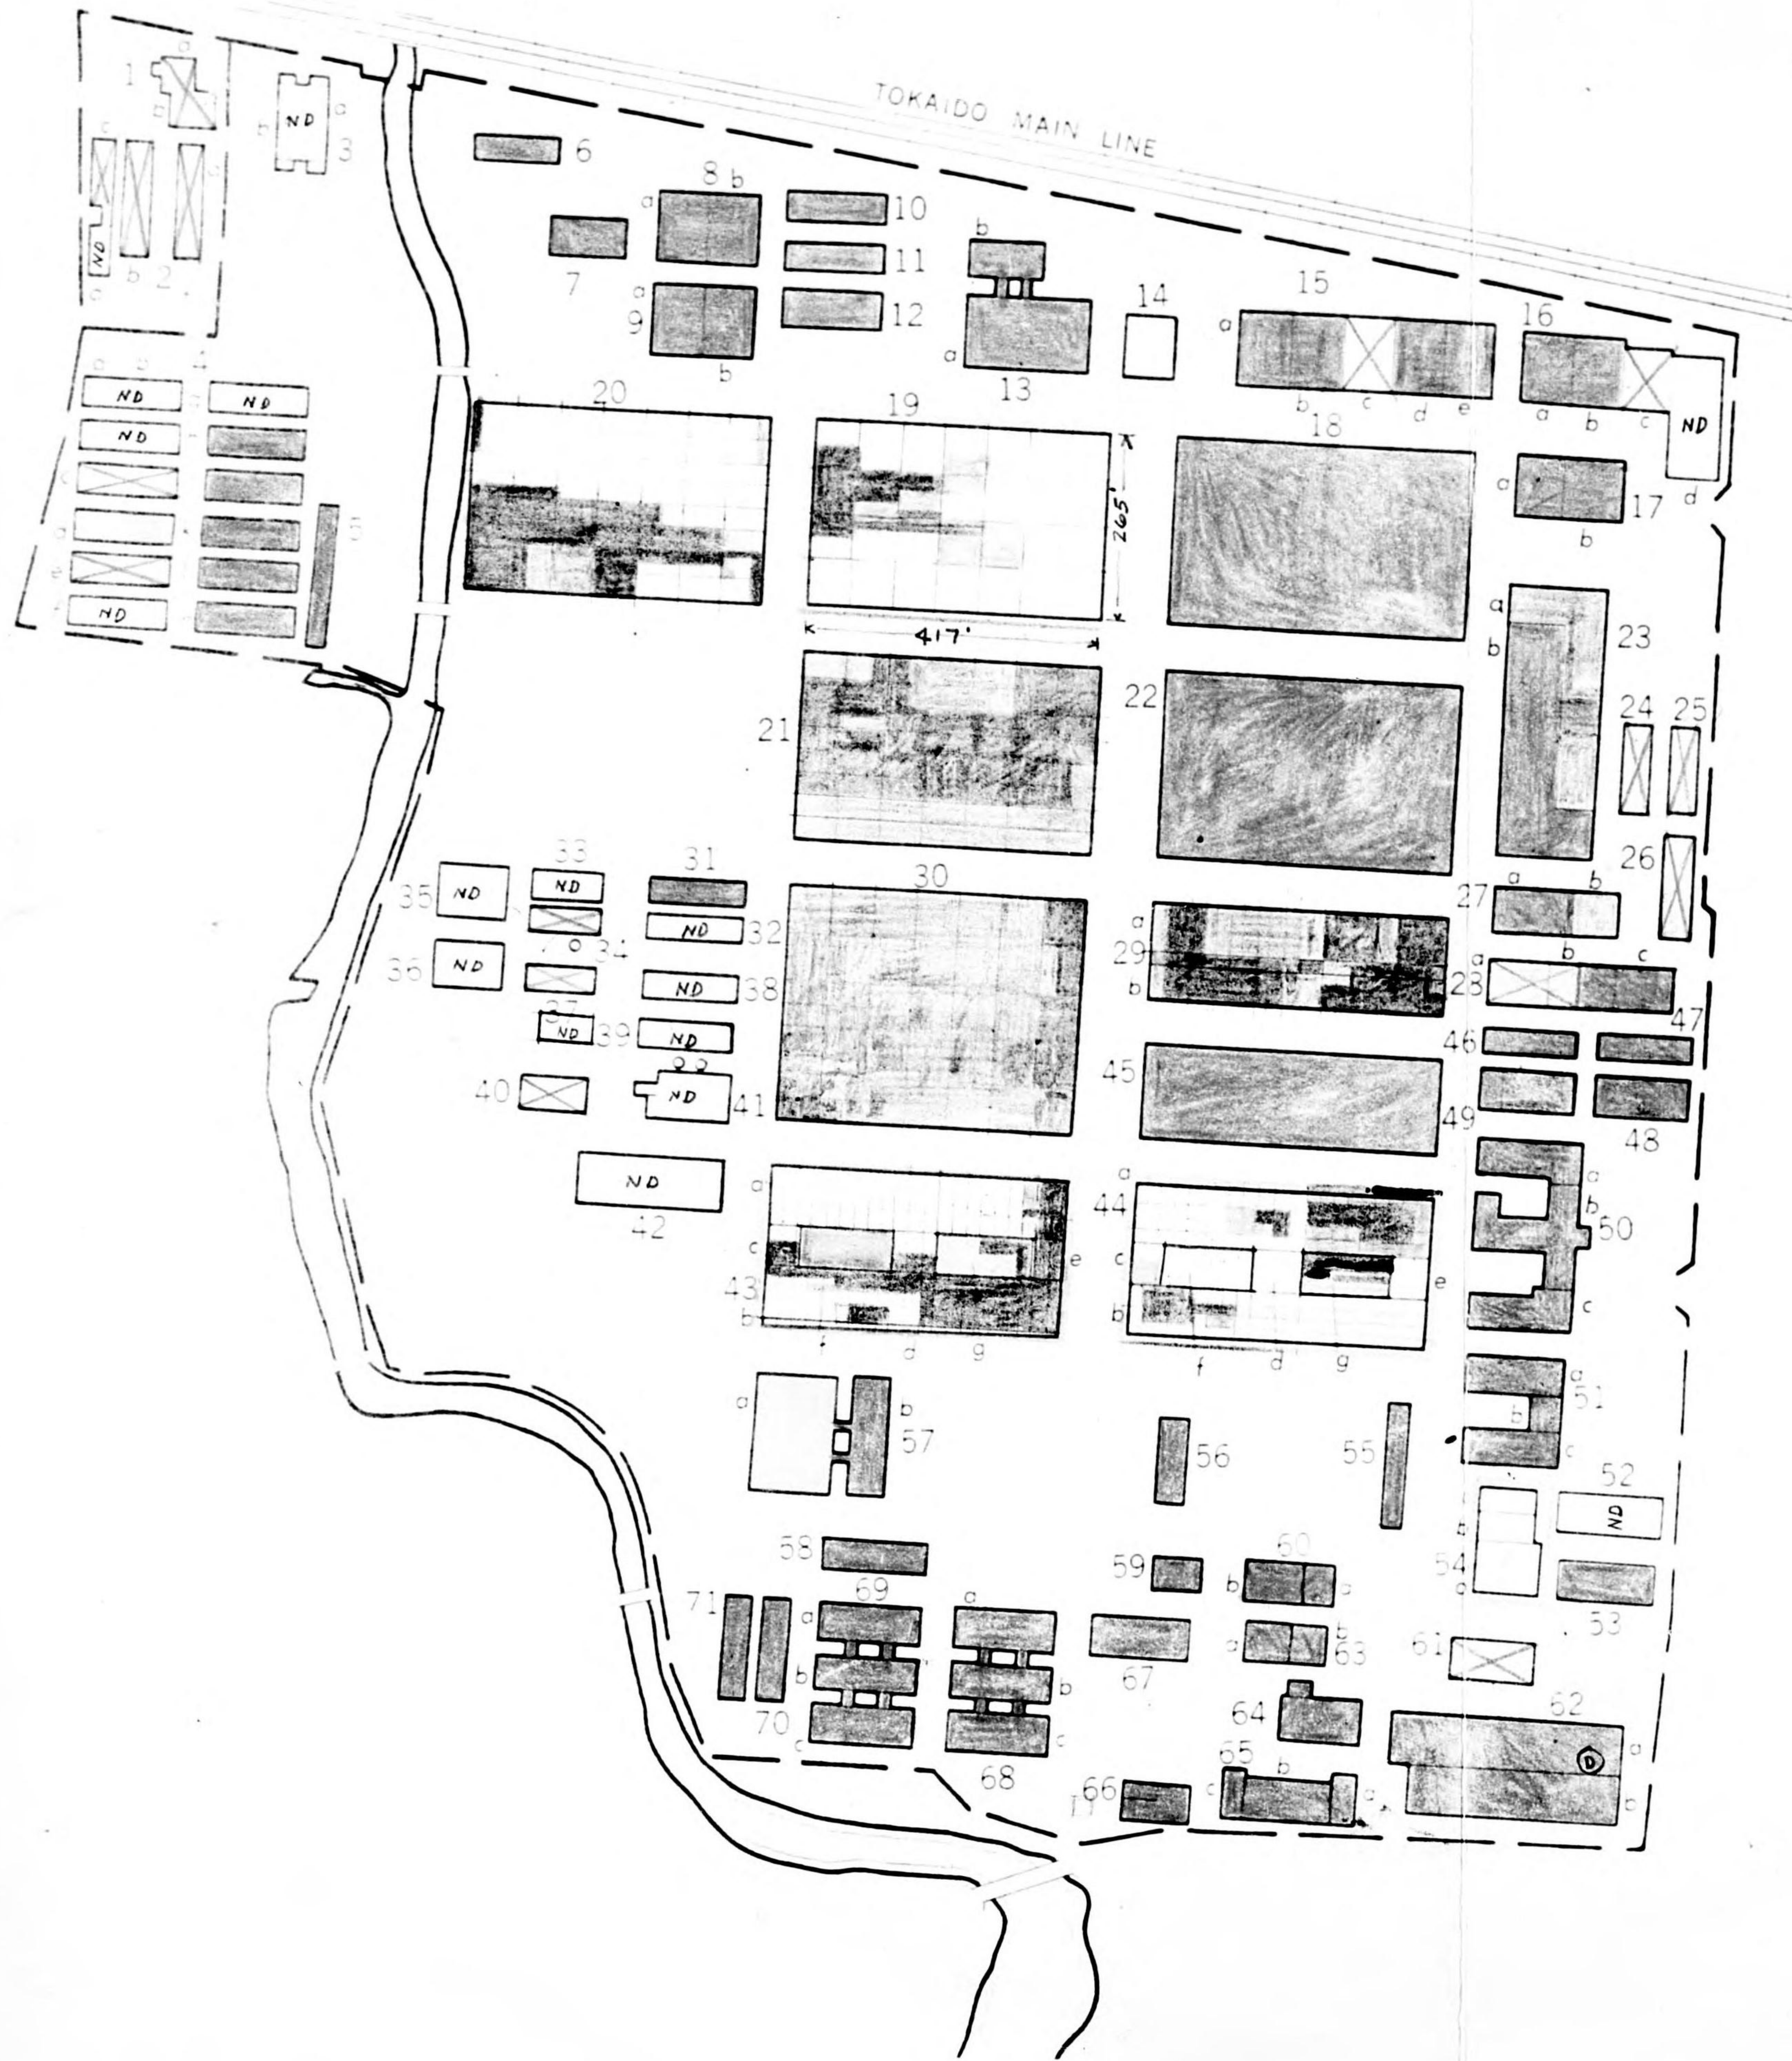
**SUMITOMO PROPELLER
PLANT,
AMAGASAKI, JAPAN**

TARGET NO.
90.25/2041

PHOTOGRAPHY OF
28 JAN 1945
