# THE SERVICE OF REFRACTORY BLOCKS IN A SMALL EXPERIMENTAL GLASS TANK

By W. L. Pendergast and Herbert Insley<sup>1</sup>

Tests to determine the relative resistance of various types of refractories to the action of flowing molten glass were made in a small laboratory glass-melting furnace similar in shape and in operation to commercial scale continuous glass tanks. The results of tests made in nine runs of the furnace, each run continuing for approximately 30 days, are given. Clay tank block of commercial manufacture as well as blocks made of unusual compositions and by unusual processes were tested.

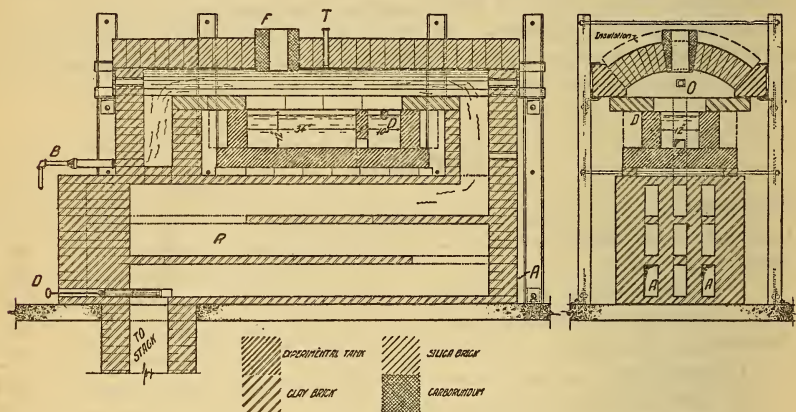
FIG. 1.—Drawing of furnace showing position of tank and batch-feeding tube and the direction of gas flow

In its final form the furnace was a modified down-draft kiln, the gases burning while they passed horizontally over the tank. The furnace operated quite satisfactorily, considering that the fuel used was a carburetted water gas supplied for domestic use, averaging about 600 B. t. u. per cubic foot. Two burners with one-half-inch orifices were sufficient to maintain the required temperature. The tank itself was 12 inches high, 12 inches wide, and 4 feet long, the glass level being maintained about 2 inches from the top of the tank B. Batch was fed in at *F* (fig. 1); the molten glass passed through the opening in the bridge wall and was drawn off at *D*. The crown was of silica brick with the exception of the carborundum block which

contained the batch-feeding hole *F* (fig. 1). The bottom blocks and tuck stones were made of a modified glass-pot body developed at the Bureau of Standards and composed of 50 per cent fire-brick grog burned to cone 16 and 50 per cent of unburned material. The unburned material was composed largely of Tennessee and Kentucky ball clays and North Carolina kaolin with minor amounts of Georgia and Delaware kaolins and feldspar.

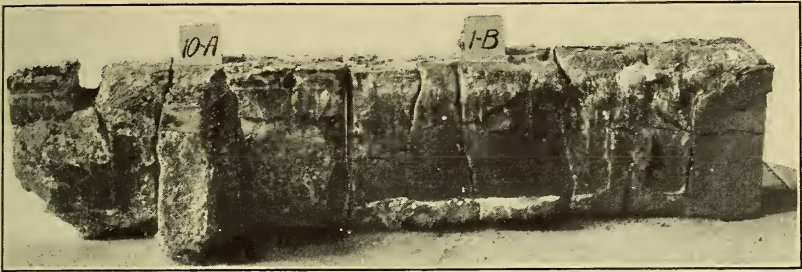
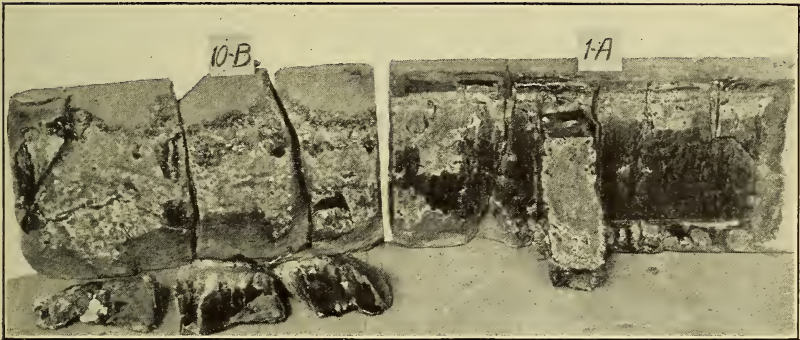
FIG. 2

The side walls of the first tank were built of six blocks furnished by three manufacturers. The blocks marked 1-A (fig. 3) and 1-B (fig. 2) were from the same manufacturer and were alike in composition and treatment except that 1-B was reburned to cone 15 at the Bureau of Standards. All the blocks were 6 inches thick.

Since this was a first run, various unforeseen troubles arose which necessitated shutting down the furnace three times. Consequently, the time during which batch was melted was only 13 days. The average temperature during the melting period was 1,420°, and 3,800 pounds of batch were melted. The severity of service in this tank was considerably less than in any other tank in the series. Nevertheless, the blocks showed fairly severe corrosion. Figures 2 and 3 are photographs of the side-wall blocks arranged after dismantling the tank in the relative position which they occupied during the run. The bridge wall is toward the left in Figure 2 and toward the right in Figure 3. The end wall blocks are shown in Figure 4, the melting chamber end wall on the right and the refining chamber end wall on the left. All of the blocks showed serious spalling at the upper inside edges, probably because the furnace was shut down several times during the first three days of the test.

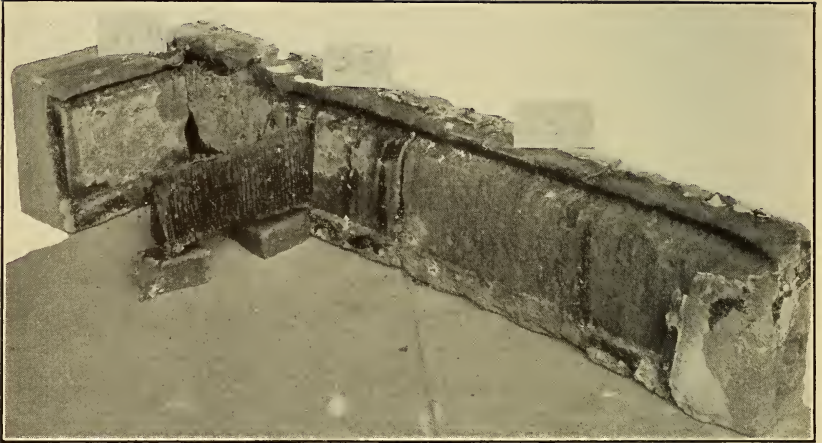
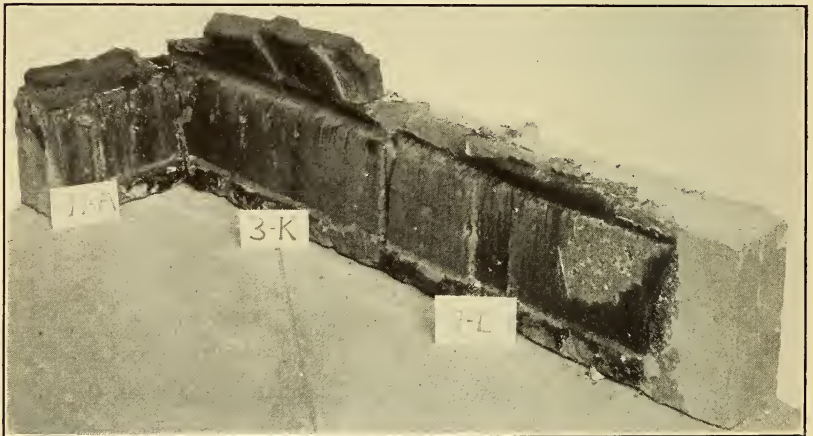
FIG. 5

The side walls of tank 2 were built of six commercial blocks, all 6 inches thick, furnished by three manufacturers. Block 1-I is the same as 1-L, except that the former was reburned to cone 15. (Figs. 5 and 6.) Batch was melted in this tank for 34 days at an average temperature of about 1,450° C. Nine thousand pounds of batch were used. Although this average temperature was slightly higher (25°) than that of tank 9, the melting period was 10 per cent shorter and the amount of batch used 25 per cent less. (Table 1.) As affecting the amount of corrosion on tank walls, therefore, service conditions in tank 2 were probably slightly less severe than in tank 9. Figure 5 is a photograph of one side wall, a portion of the bridge, and the refining end wall, and Figure 6 shows the other side wall and the melting end wall. The bridge-wall block, which was a commercial refractory, was partially destroyed, but all the side-wall blocks were quite free from pits and corrugation and showed little evidence of corrosion except at the glass line. Even at the glass line the depth of corrosion was not great as compared with that in most of the other tanks in the series. The commercial block reburned to cone 15 showed 9.2 per cent absorption as compared with 13.0 per cent absorp-

tion for the block of the same manufacture not reburned. The reburned block also showed a slightly greater resistance to glass attack.

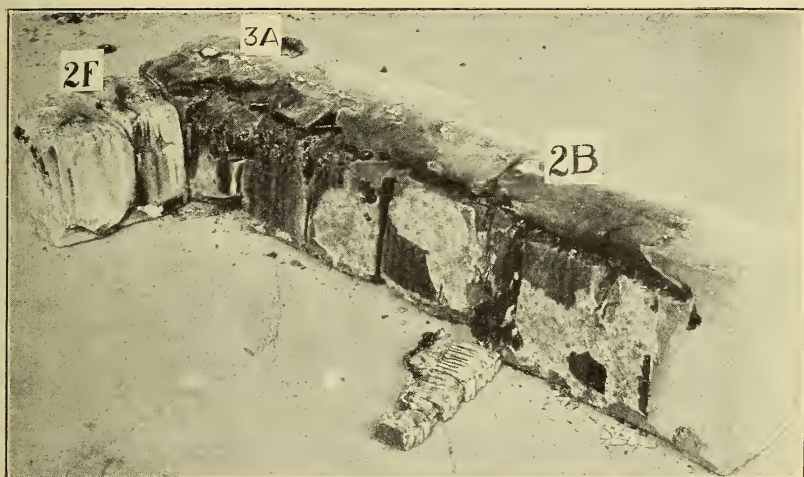
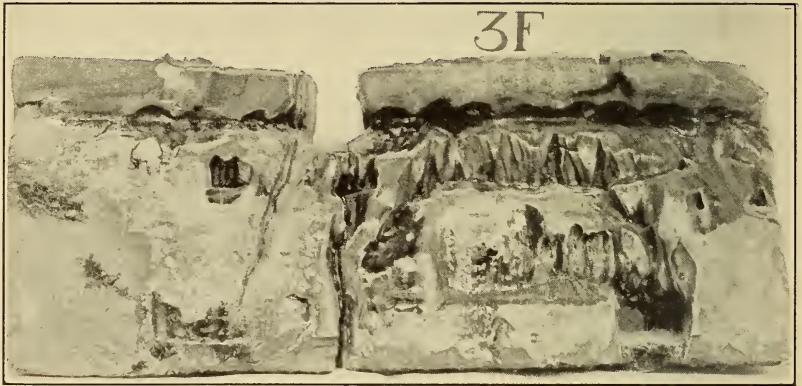
FIG. 7

Corrosion upward from horizontal cracks, so characteristic of the action in many commercial tanks,<sup>2</sup> is well exemplified in blocks 3F (fig. 9), 3A (fig. 7), and 2F (fig. 7). Block 2F was also worn back greatly above the glass line. It should be noted that this block contained more silica (73 per cent) than any other wall block used in this series of experiments.

The six blocks making up the side walls of tank 3 were from three manufacturers, and the bridge wall also was a piece of a commercial block. During a melting period of 26 days the tank was operated at an average temperature of 1,525° C., and approximately 9,000 pounds of batch were used. Although the average operating temperature was about as high as for any tank in the series, the melting period was unusually short. Consequently, the severity of service was less than for tanks 4, 5, and 6, and may be considered as about equal to tank 7. Figure 7, a photograph of one side wall, the melting-chamber end wall, and a detached piece of the bridge, shows the marked effects of glass attack on the end wall and the blocks in the melting end of the tank. Figure 8 is a photograph of the other side of the tank with the refining-chamber end wall. The bridge was eaten through and broken away from the side walls, and the indentation at the glass line was greater than 2 inches on all the blocks in the melting end of the tank and reached a maximum of  $3\frac{3}{4}$  inches on block 2J. (Fig. 8.) Block 2J showed more attack than any other block in the tank. This was in large part due to the presence of vertical and horizontal cracks or laminations which provided starting places.

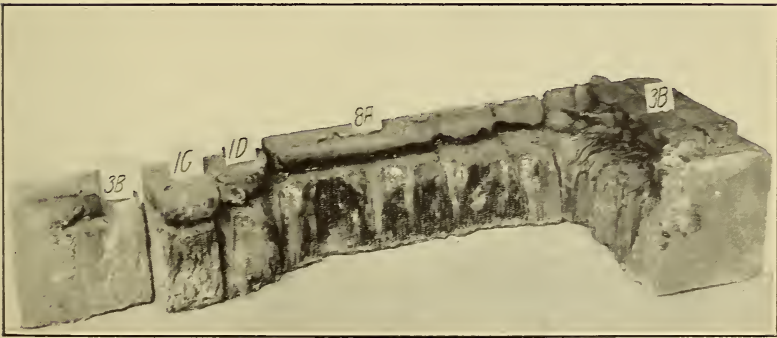
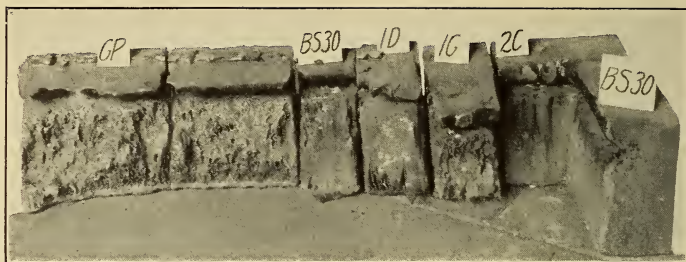
FIG. 14

The blocks in the melting chamber (on the right in fig. 14 and on the left in fig. 15) showed marked effects of glass action. Block 8A is unusual in that it shows numerous, repeated, vertical flutings or corrugations. The deeper channels due to pronounced vertical cracks or laminations can also be observed. Block GP was worn to a depth of 5 inches at the glass line. Below the glass line the surface in contact with the glass was honeycombed with pits. (Figs. 15 and 16.) In places these pits extended to within 2 inches of the cool surface. The pitting may be ascribed to a combination of rather high porosity and to easy solubility in the glass. Although the blocks contain only about 56 per cent of silica, the percentage of fluxes present is rather high, about 3 per cent. One of the blocks made at the Bureau of Standards from a manufacturer's batch was used in

the melting chamber. (BS30 in fig. 15.) It withstood corrosion very well, but its position next to the bridge wall was particularly favorable.

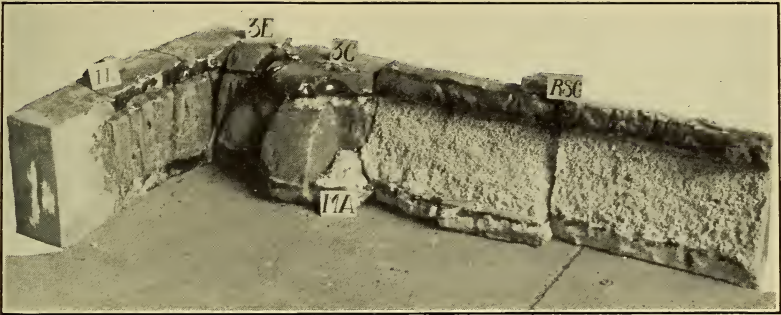
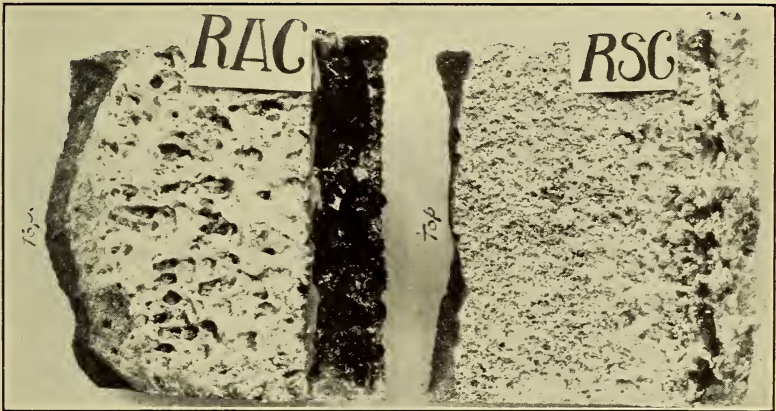
FIG. 18

The walls and bridge of tank 6 were built of 5 commercial and 5 experimental blocks. All the blocks were 6 inches thick except the bridge block, which was 10 inches. The tank was operated for 36 days at an average temperature of 1,500° C., and 12,000 pounds of batch were melted. While the average temperature was 25° lower than in tank 5, the amount of batch used was slightly greater. Of particular interest were the tests on the experimental blocks. The blocks marked RAC (fig. 17) were composed of artificial corundum (made by electric furnace fusion) of 14 mesh or finer. The alumina grains were bonded with 10 per cent clay and burned. As Figure 17 shows, these blocks were badly honeycombed and eaten away. The depth of indentation at the glass line was about 3 inches. The blocks marked RSC (fig. 18) were composed of crystalline mullite (made by electric furnace fusion) of 14 mesh or finer. The mullite grains were bonded with kaolin and alumina in the proportions to give mullite and fired. The mullite blocks were also badly corroded and honeycombed, although the pits were much smaller than in the alumina blocks. (Fig. 19.)

An experimental block 3 inches thick composed largely of spinel ( $MgO \cdot Al_2O_3$ ) was placed in the tank as a part of the bridge wall. It formed the portion of the bridge wall in the melting chamber and was backed by a clay block 7 inches thick. The only remaining fragment of this block is marked MA. (Fig. 18.) It seems probable from this evidence that spinel is readily attacked by molten soda-lime glass. Although the clay portion of the bridge (3C, fig. 18) was eaten through, it withstood glass attack far better than the spinel.

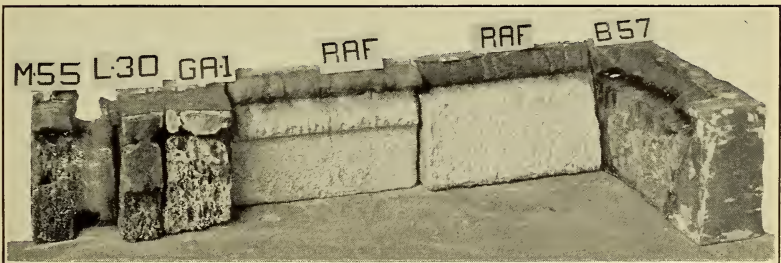
FIG. 20

The blocks marked RAF (fig. 20) were of the same composition (90 per cent artificial corundum, 10 per cent clay) as the blocks RAC in tank 6, but the alumina was much finer grained. Of this pair the block on the right was originally 6 inches thick from the bottom to a horizontal line about 4 inches from the top. Above the line the inside face was beveled off, so that the glass surface made an oblique angle with the face of the block. The block on the left was 4 inches thick below the horizontal line shown in the photograph and 6 inches above. The latter block was made in this way to furnish a ready-made horizontal downward facing surface where the characteristic "upward eating" could take place if the block were susceptible to it. Figure 20 shows some evidence of this action. The fine-grained alumina blocks offered much greater resistance to glass action than did the coarser-grained blocks. (Figs. 17 and 19.) The alumina blocks in tank 7 were eaten back about 1 inch at the glass line. No pitting was visible on the surface exposed to glass action.

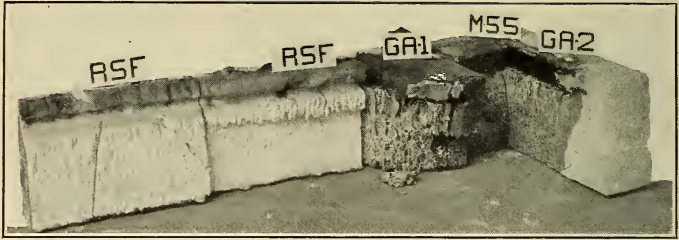
FIG. 21

The mullite blocks (RSF in fig. 21) were the same as the mullite blocks in tank 6 except for increased fineness of grain. Here, again, the finer-grained blocks showed a marked improvement in resistance to glass action. The left-hand block in Figure 21 was corroded to a depth of 1 inch at the glass line, the right-hand block to a depth of 2 inches. In general, there was little wearing away below the glass line, although in the left-hand block there are two cracks along which marked corrosion had taken place. These cracks may have formed during the heating period in the tank before glass melting began. The Georgia kaolin blocks forming the end wall in the refining chamber and a part of the bridge wall are seen in Figure 21 (GA-1 and GA-2). The end wall was corroded at the glass line to a depth of  $2\frac{1}{2}$  inches and was very badly pitted below the glass line. The portion of the bridge wall composed of the kaolin block was eaten through from bottom to top and was also badly pitted. Needless to say, such a test does not give a fair idea of the solubility of burned kaolin in molten glass. The structure was necessarily very open, and apparently disintegration of the block was caused primarily by entrance of molten glass into the pores.

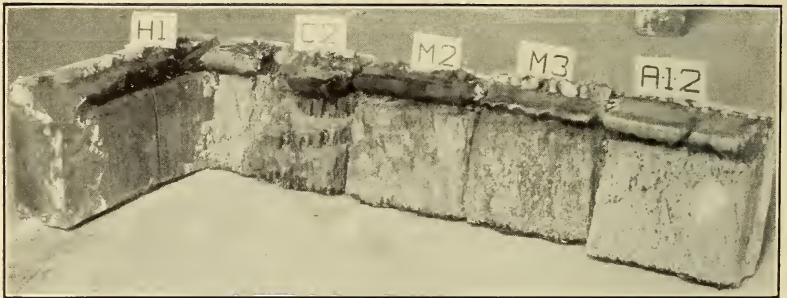
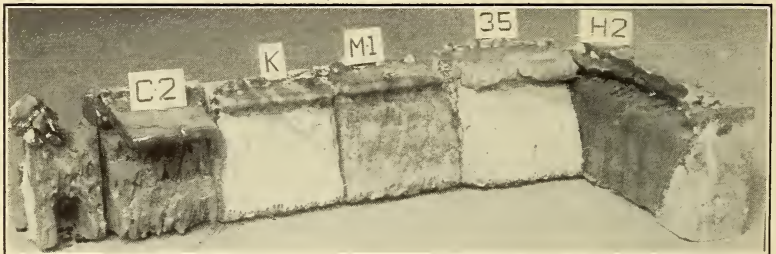
FIG. 22

The blocks in the side walls of the melting chamber (figs. 22 and 23) resisted glass action unusually well, probably in part because the operating conditions were not as severe as in some of the runs. The commercial block in the end wall of the melting chamber (H2), however, showed as much wear as end blocks in runs where operating conditions were more severe.

Blocks M-2 (fig. 22) and M-1 (fig. 23) were dry-pressed blocks made wholly of Missouri flint clay. The grog, composing 45 per cent of the block, was burned to cone 14 at a plant manufacturing tank block, shipped to the bureau, where the raw clay was added, dry pressed at 1,500 lbs./in.<sup>2</sup>, and burned to cone 16. These blocks were worn 1½ inches at the glass line and were in comparatively good condition at the end of the run. Block M-3 (fig. 22) was a handmade diaspore block, burned to cone 16. It was worn to a depth of 1½ inches at the glass line and apparently was similar to M-2 in resistance to glass action. Block A-1-2 (fig. 22) was an experimental hand-rammed block made of calcined cyanite. Although it showed fair resistance to glass action and was worn only 1½ inches at the glass line, it was badly pitted and contained one long curved crack along which marked corrosion took place. Block 35 (fig. 23) was made of the same material as block A-1-2 but was dry-pressed to 3,500 lbs./in.<sup>2</sup> instead of hand rammed. As the photograph indicates, this block withstood glass action much better than A-1-2, the pits were few and small, and there were no cracks. Block K was made of the glass pot batch used in the bottom blocks and tuck stones in all the experimental tanks, but was dry pressed to 850 lbs./in.<sup>2</sup> instead of being hand rammed. The block was in good condition after the run except for a large crevice probably formed during the burning of the block or the heating up of the tank.

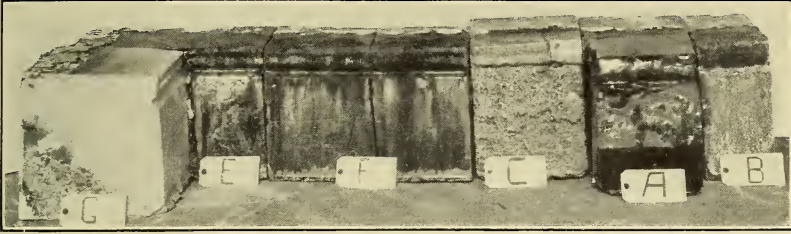
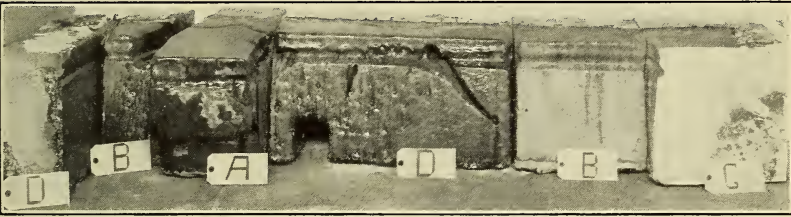
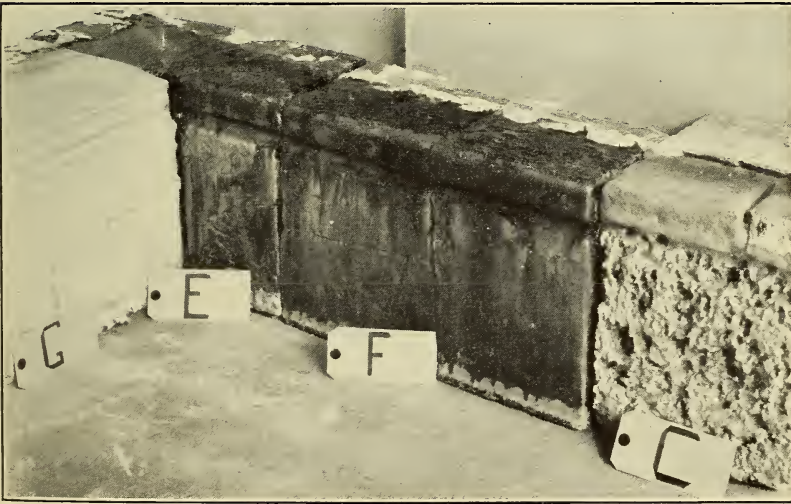
FIG. 24

The effect on the wall blocks is seen in Figures 24, 25, and 26. Block A, the bridge wall, is a commercial clay block. It shows severe corrosion, but considering that the bridge wall in many runs was almost wholly eaten away, it resisted glass action remarkably well.

Block C (figs. 24 and 26) was a special refractory. Petrographic examination showed that it was composed largely of very minute crystals of mullite in glass with a little granular corundum. Apparently a large part of the mullite and glass had been formed by the dissociation of cyanite, since large aggregates of minute needles of mullite and glass contained remnants of undissolved cyanite grains at their centers. This block was badly pitted after service and showed the least resistance to corrosion of any block in the tank. Disintegration probably resulted more from porous structure or from lack of homogeneity than from chemical composition. Blocks E and F (figs. 24 and 26) were from the same manufacturer and were made, it is understood, of an electrically fused mixture containing alumina and silica in the proper proportions to form mullite.

These two blocks showed greater resistance to glass attack than any of the other blocks in this series of tests. The indentation at the glass line was only one-half to five-eighths of an inch with a maximum corrosion at the center of the block of about one-fourth inch. Block E cracked some time after installation. The surface also shows some checking. Block F was partially cracked when received, and the cracks continued through the block during test. Glass attack at the cracks in these blocks was not appreciably more than at any other part of the surface of the block below the glass line. (Fig. 26.)

After use in the furnace the blocks were broken in half and specimens chipped from several places on the fractured faces. Petrographic examinations of these chips gave the following results: Block E was found to be composed of mullite ( $3\text{Al}_2\text{O}_3 \cdot 2\text{SiO}_2$ ), corundum ( $\text{Al}_2\text{O}_3$ ), glass and opaque material. In all the chips examined mullite was the most abundant constituent, although the relative amount present varied from place to place in the block. Corundum varied from 10 to 30 per cent. Glass in small amounts was observed in channels between the mullite crystals. The opaque material occurred as lenticular masses and dendritic growths included in both mullite and glass. Chips from block F were composed largely of corundum with small amounts of glass, mullite, and an unidentified compound with very high index of refraction and high double refraction. Corundum occurred in large, well-formed crystals and was evidently the first compound to crystallize. The mullite crystals, although very small, were well developed and were inclosed in glass. In all probability crystallization of the mullite took place after the corundum.

Block G used as the end wall of the melting chamber was a special refractory. Petrographic examination showed that it was composed of fairly coarse grains of corundum and mullite with interstitial glass. The interstitial glass often contained well-developed needles of mullite. The structure suggests that the block is composed of mullite and corundum formed by electrical fusion afterwards bonded with an aluminum silicate (perhaps clay) and fired to a rather high temperature. Although the block was in a position in the furnace where corrosive action of the melt was pronounced, it showed excellent resistance to such action. There was an indentation at the glass line of about an inch, while the center of the exposed face was corroded only about one-half inch. Four cracks developed in the same block some time after installation, but glass attack along these cracks was not excessive.

Block B was a special refractory composed, according to petrographic examination, of corundum, andalusite and quartz in fairly coarse grains, corundum and andalusite being the most abundant constituents. The edges of the andalusite grains were converted to a mixture of mullite and glass. This block also withstood glass attack exceptionally well. A few very small pits were found in the face of the block, and the indentation at the glass line was only about an inch.

Block D is a clay block which, it is understood, received a somewhat unusual treatment before burning. This block compared favorably with the best clay blocks previously tested. The block was eaten away at the glass line to a depth of  $1\frac{1}{4}$  inches. A few small pits developed in the face and one fairly large oblique crack, which was further enlarged by glass attack.
