MITSUBISHI OIL REFINERY

**MITSUBISHI OIL
REFINERY**
KAWASAKI

DAMAGE ASSESSMENT REPORT 173

PO . STRIKE
TARGET 90.17-116/127
20AF- MISSIONS 291, 310
25-26 JULY & 1-2 AUG. '45
D.A. REPORT 173
C.I.U.- 20 AF

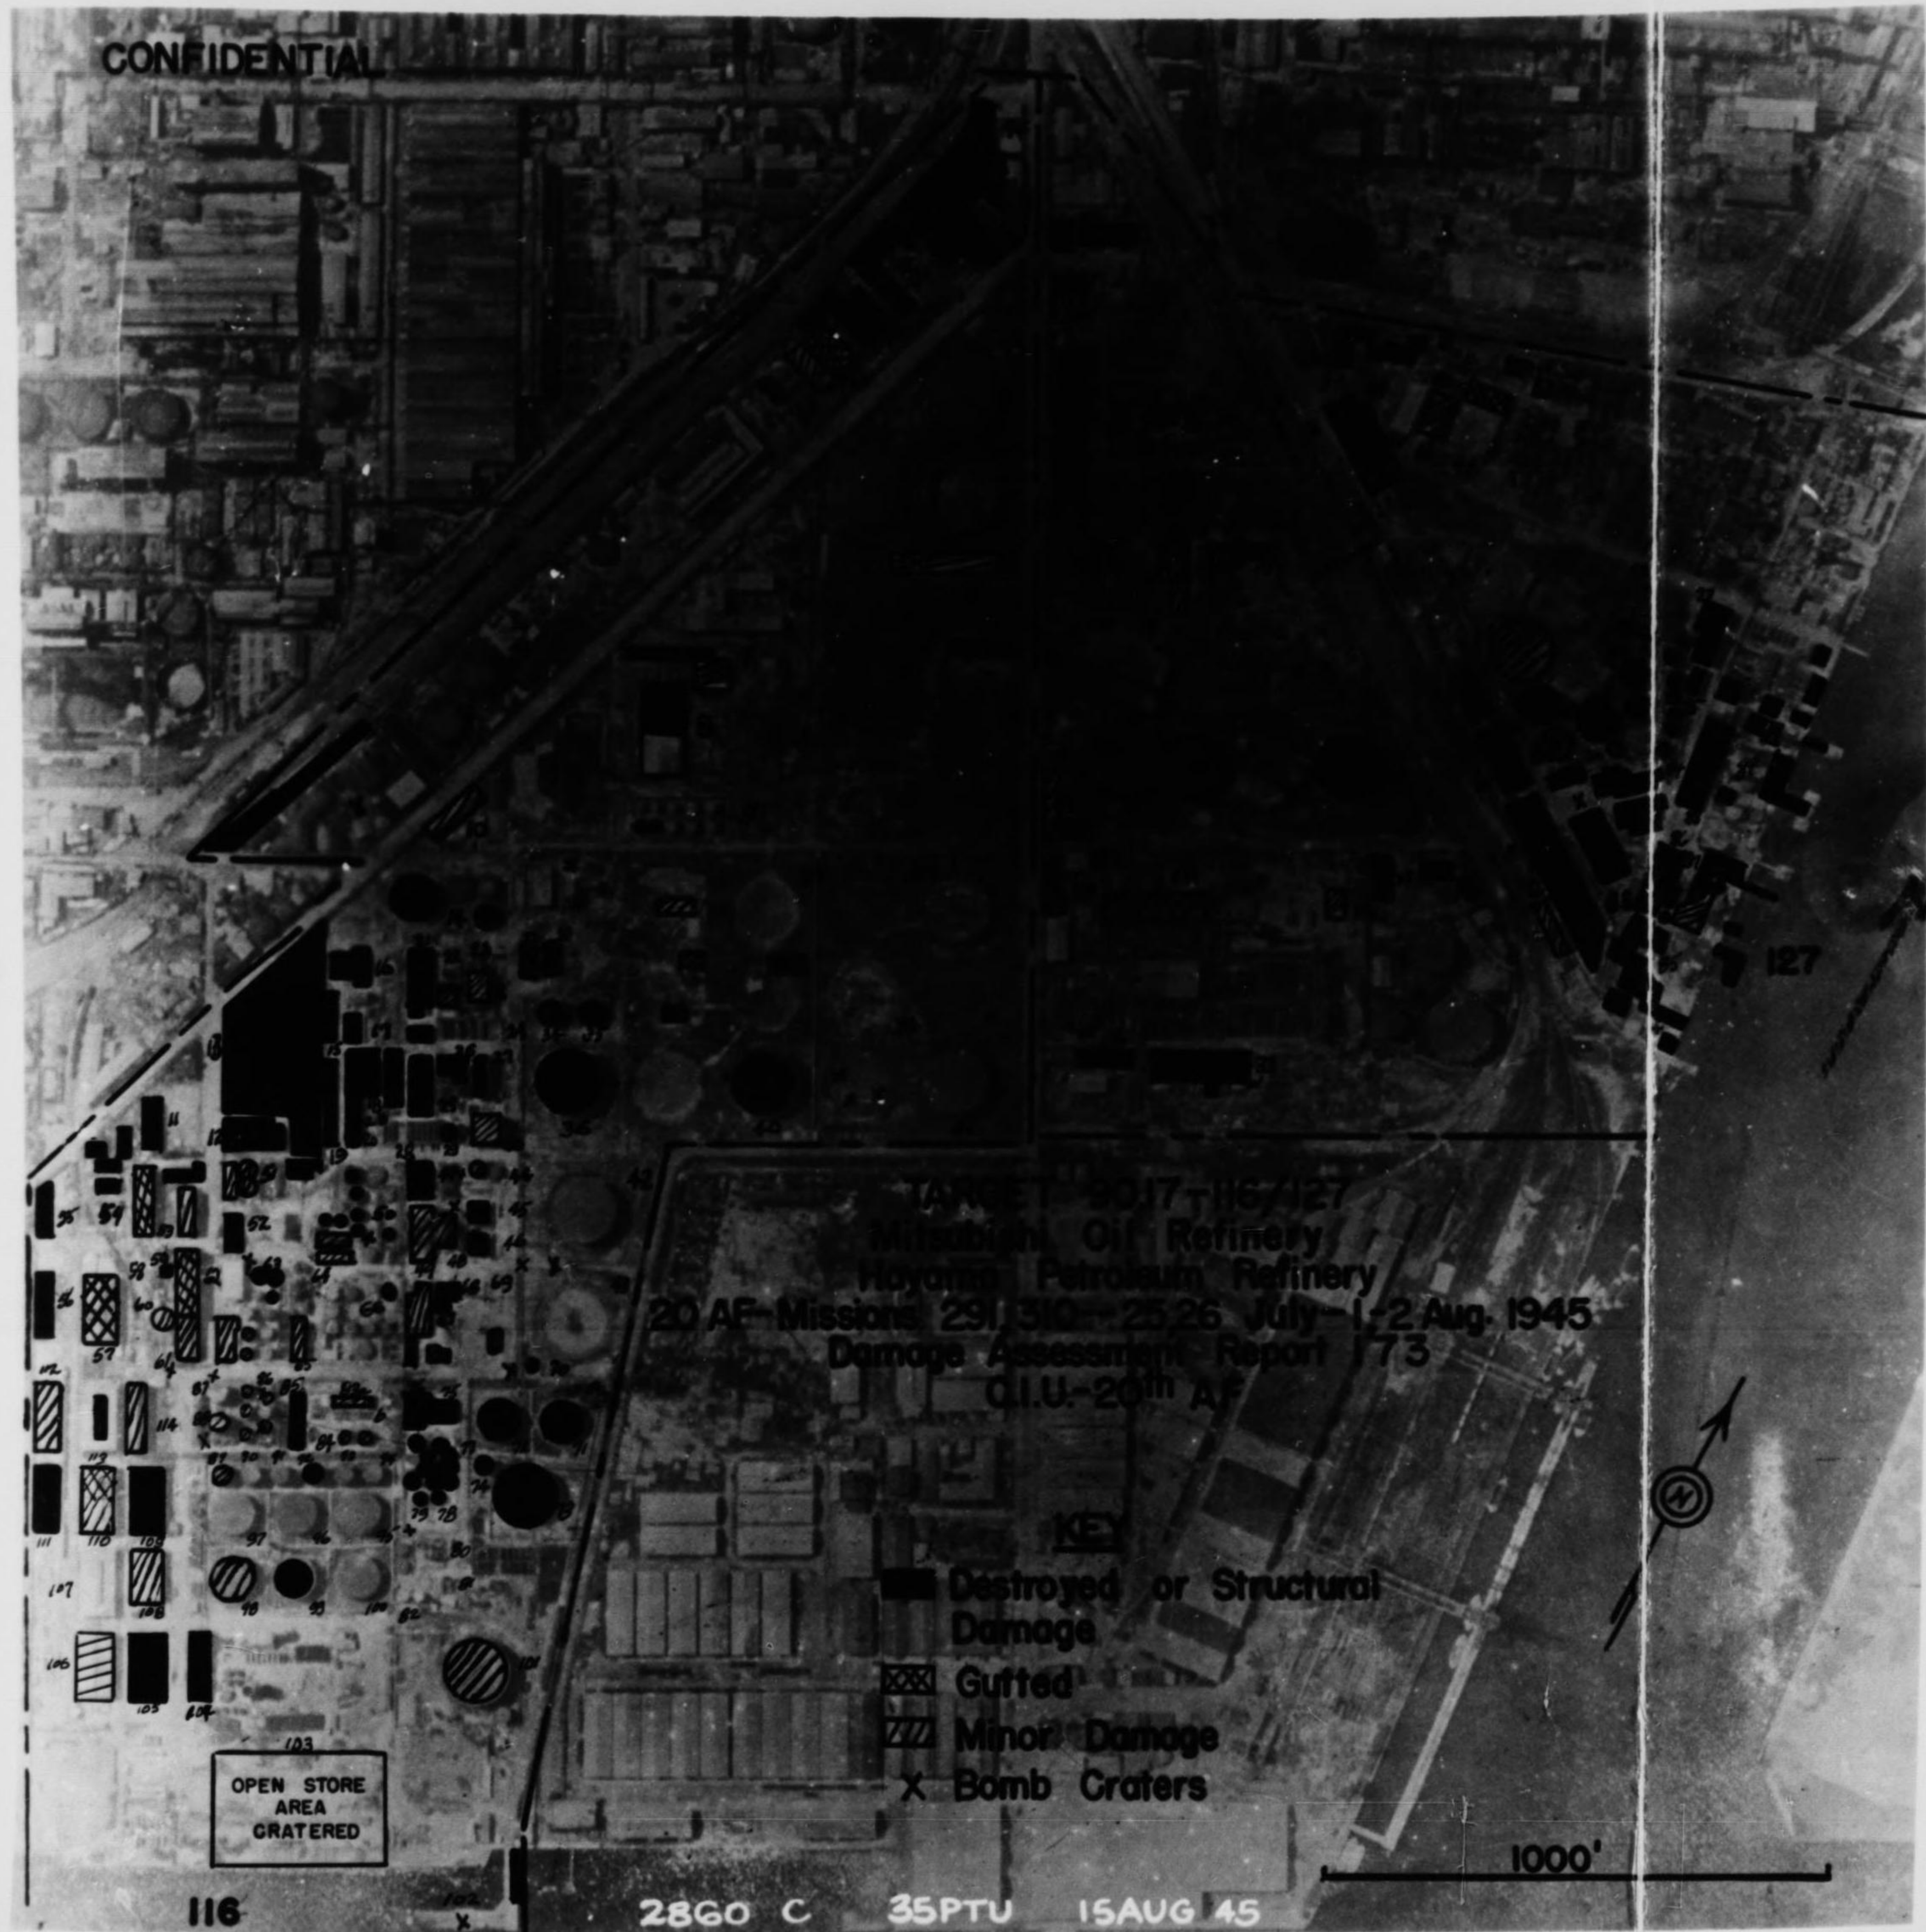
Photos show the Mitsubishi Oil Refinery to be practically inoperative. Twelve of 14 primary buildings, as outlined by Ref. A, are destroyed. The Hayama Petroleum Refinery sustained crippling damage, 40% of its primary structures being destroyed.

Damage and destruction encompasses practically all of Target 116, particularly the central, western and central sections of the plant.

Most of the destruction at Target 127 is located in the southern half of the plant area. Residential and office areas in the NW part of the target received extensive damage. A refinery unit and tank section, located in the NE part of the plant, remains apparently undamaged. Four piers were destroyed. A RR yard received several direct hits.

A total of 537,400 barrels or 38% of the storage tank capacity (1,404,400 bbls.) were destroyed or damaged at the Mitsubishi Oil Refinery. In addition, 13,625 barrels or 30.4% of the intermediate tank capacity (44,750 bbls.) were destroyed or damaged.

At the Hayama Refinery 334,000 barrels or about 44% of the storage tank capacity (761,600 bbls.), and 26,100 barrels or about 26% of the intermediate tank capacity (100,800 bbls) were damaged or destroyed.

<u>ANNOT. NO.</u>	<u>IDENTIFICATION</u>	<u>DESCRIPTION OF DAMAGE</u>
4	Warehouse - 8400 sq. ft.	25% structural damage, 25% gutted and 50% minor roof damage.
5	Warehouse	Completely destroyed
7	Unidentified	Square portion of this small building received minor roof damage. An adjoining long, narrow building was destroyed.
8	Unidentified 13,800 sq. ft.	Half of this building was structurally damaged.
9	Two 18' diameter storage tanks 3000 bbls.	Both tanks are distorted. There is a bomb crater about 50' S/W of these tanks.
10	Warehouse	Roof damaged
11	Workers building	Destroyed
12	Office type building	Destroyed
13	Workers residences - numerous homes occupying a roughly rectangular area of approx. 20,000 sq. ft.	Devastated
14	1 storage tank 75' diameter - 25,000 bbls. 1 storage tank 15,500 bbls	Large tank structurally damaged. Smaller tank " "
15	Warehouse	Destroyed
16	Unidentified	Destroyed
17	Unidentified	Destroyed

18a	Poss. processing building	Destroyed
19	Warehouse	Destroyed
20	Unidentified	Destroyed
*21	Iso-octane unit	Destroyed
*22	Iso-octane unit	Probably received some damage when No. 21 was destroyed.
23	Furnace	Minor damage
*25	Iso-octane unit	Destroyed
*26	Iso-octane unit	Destroyed
27	Poss. processing building	Destroyed
29	Intermediate tank 1,300 bbl	Structurally damaged
30	Furnace	Minor roof damage
32	Horizontal tanks - 1725 bbls	Destroyed
33	Storage tank - 2600 bbls	Structurally damaged
34	" " 8000 bbls	Destroyed
35	Storage tank 12500 bbls	Destroyed
36	Storage tank 80000 bbls	Destroyed
40	Storage tank 80000 bbls	Destroyed
44	Unidentified - near a storage tank - 1600 bbls	Minor damage
*45	Furnace	Structurally damaged
*46	"	Structurally damaged
*47	Cracking unit	Structurally damaged. A crater is visible in the immediate vicinity.
48	Cracking unit	Structural damage caused by near misses.

ANNOT. NO.	IDENTIFICATION	DESCRIPTION OF DAMAGE
49	Cracking Unit	Same as No. 48
50	Intermediate tanks (1) 2200 bbls (5) 3000 bbls (1) 800 bbls	Structural damage - 3 or 4 near misses visible.
51	Storage tanks - (2) 4400 bbls	Minor damage - crater visible - approx 50' S of these tanks
52	Research laboratory	Structurally damaged
53	Offices	Minor roof damage
54	Personnel bldg	Destroyed
55	Probable shipping offices	Destroyed - 3 craters visible in the immediate vicinity
56	Warehouse	Destroyed
57	Warehouse	Gutted
58	Office	Destroyed
59	Boiler house	Destroyed, chimney remaining
60	Storage tank - 4000 bbls	Top apparently destroyed
61	Possible pump house	Minor roof damage
62	Chemical laboratory	Gutted
63	2 inter. tanks - 2200 bbls 3 " " 1500 bbls	Structurally damaged Destroyed
64	Possible treating plant	Damaged - crater close by
65	Possible treating plant	Damaged roof
66	Inter. tank - 900 bbls	Destroyed
*67	Primary distilling unit	(Structurally damaged. Two craters 100'-110' S of units.)

*68	" " "	
70	1 storage tank - 4000 bbls	Destroyed
71	1 " " 28000 bbls	"
72	1 " " 25000 bbls	"
73	1 " " 80000 bbls	"
74	1 " " 3600 bbls	"
*75	Furnace	"
*76	Vacuum distillation unit	"
77	11 storage tanks - 4,800 bbls	Destroyed
78	1 storage tank - 1700 bbls	Structural damage
79	1 storage tank - 1700 bbls	Structural damage
83a	Pump house	Minor roof damage
84	2 storage tanks	Minor damage
85	Pump house	Structural damage
86	5 storage tanks - 10,000 bbls	Possibly structurally damaged. Craters in immediate vicinity.
88	1 storage tank - 7000 bbls	Same as No. 86
89	1 " " 5500 bbls	Damaged, crater immediately N of tank
92	1 " " 5500 bbls	Destroyed
99	1 " " 25000 bbls	Structurally damaged.
98	1 " " 25000 bbls	Minor damage on top cover
101	1 " " 80000 bbls	Damage to top
102	Oil bunkering pier	Pipe line from wharf destroyed. Pier shows a crater.
103	Open storage area	Cratered
104	Warehouse	Structural damage
105	" (drum storage)	Structural damage

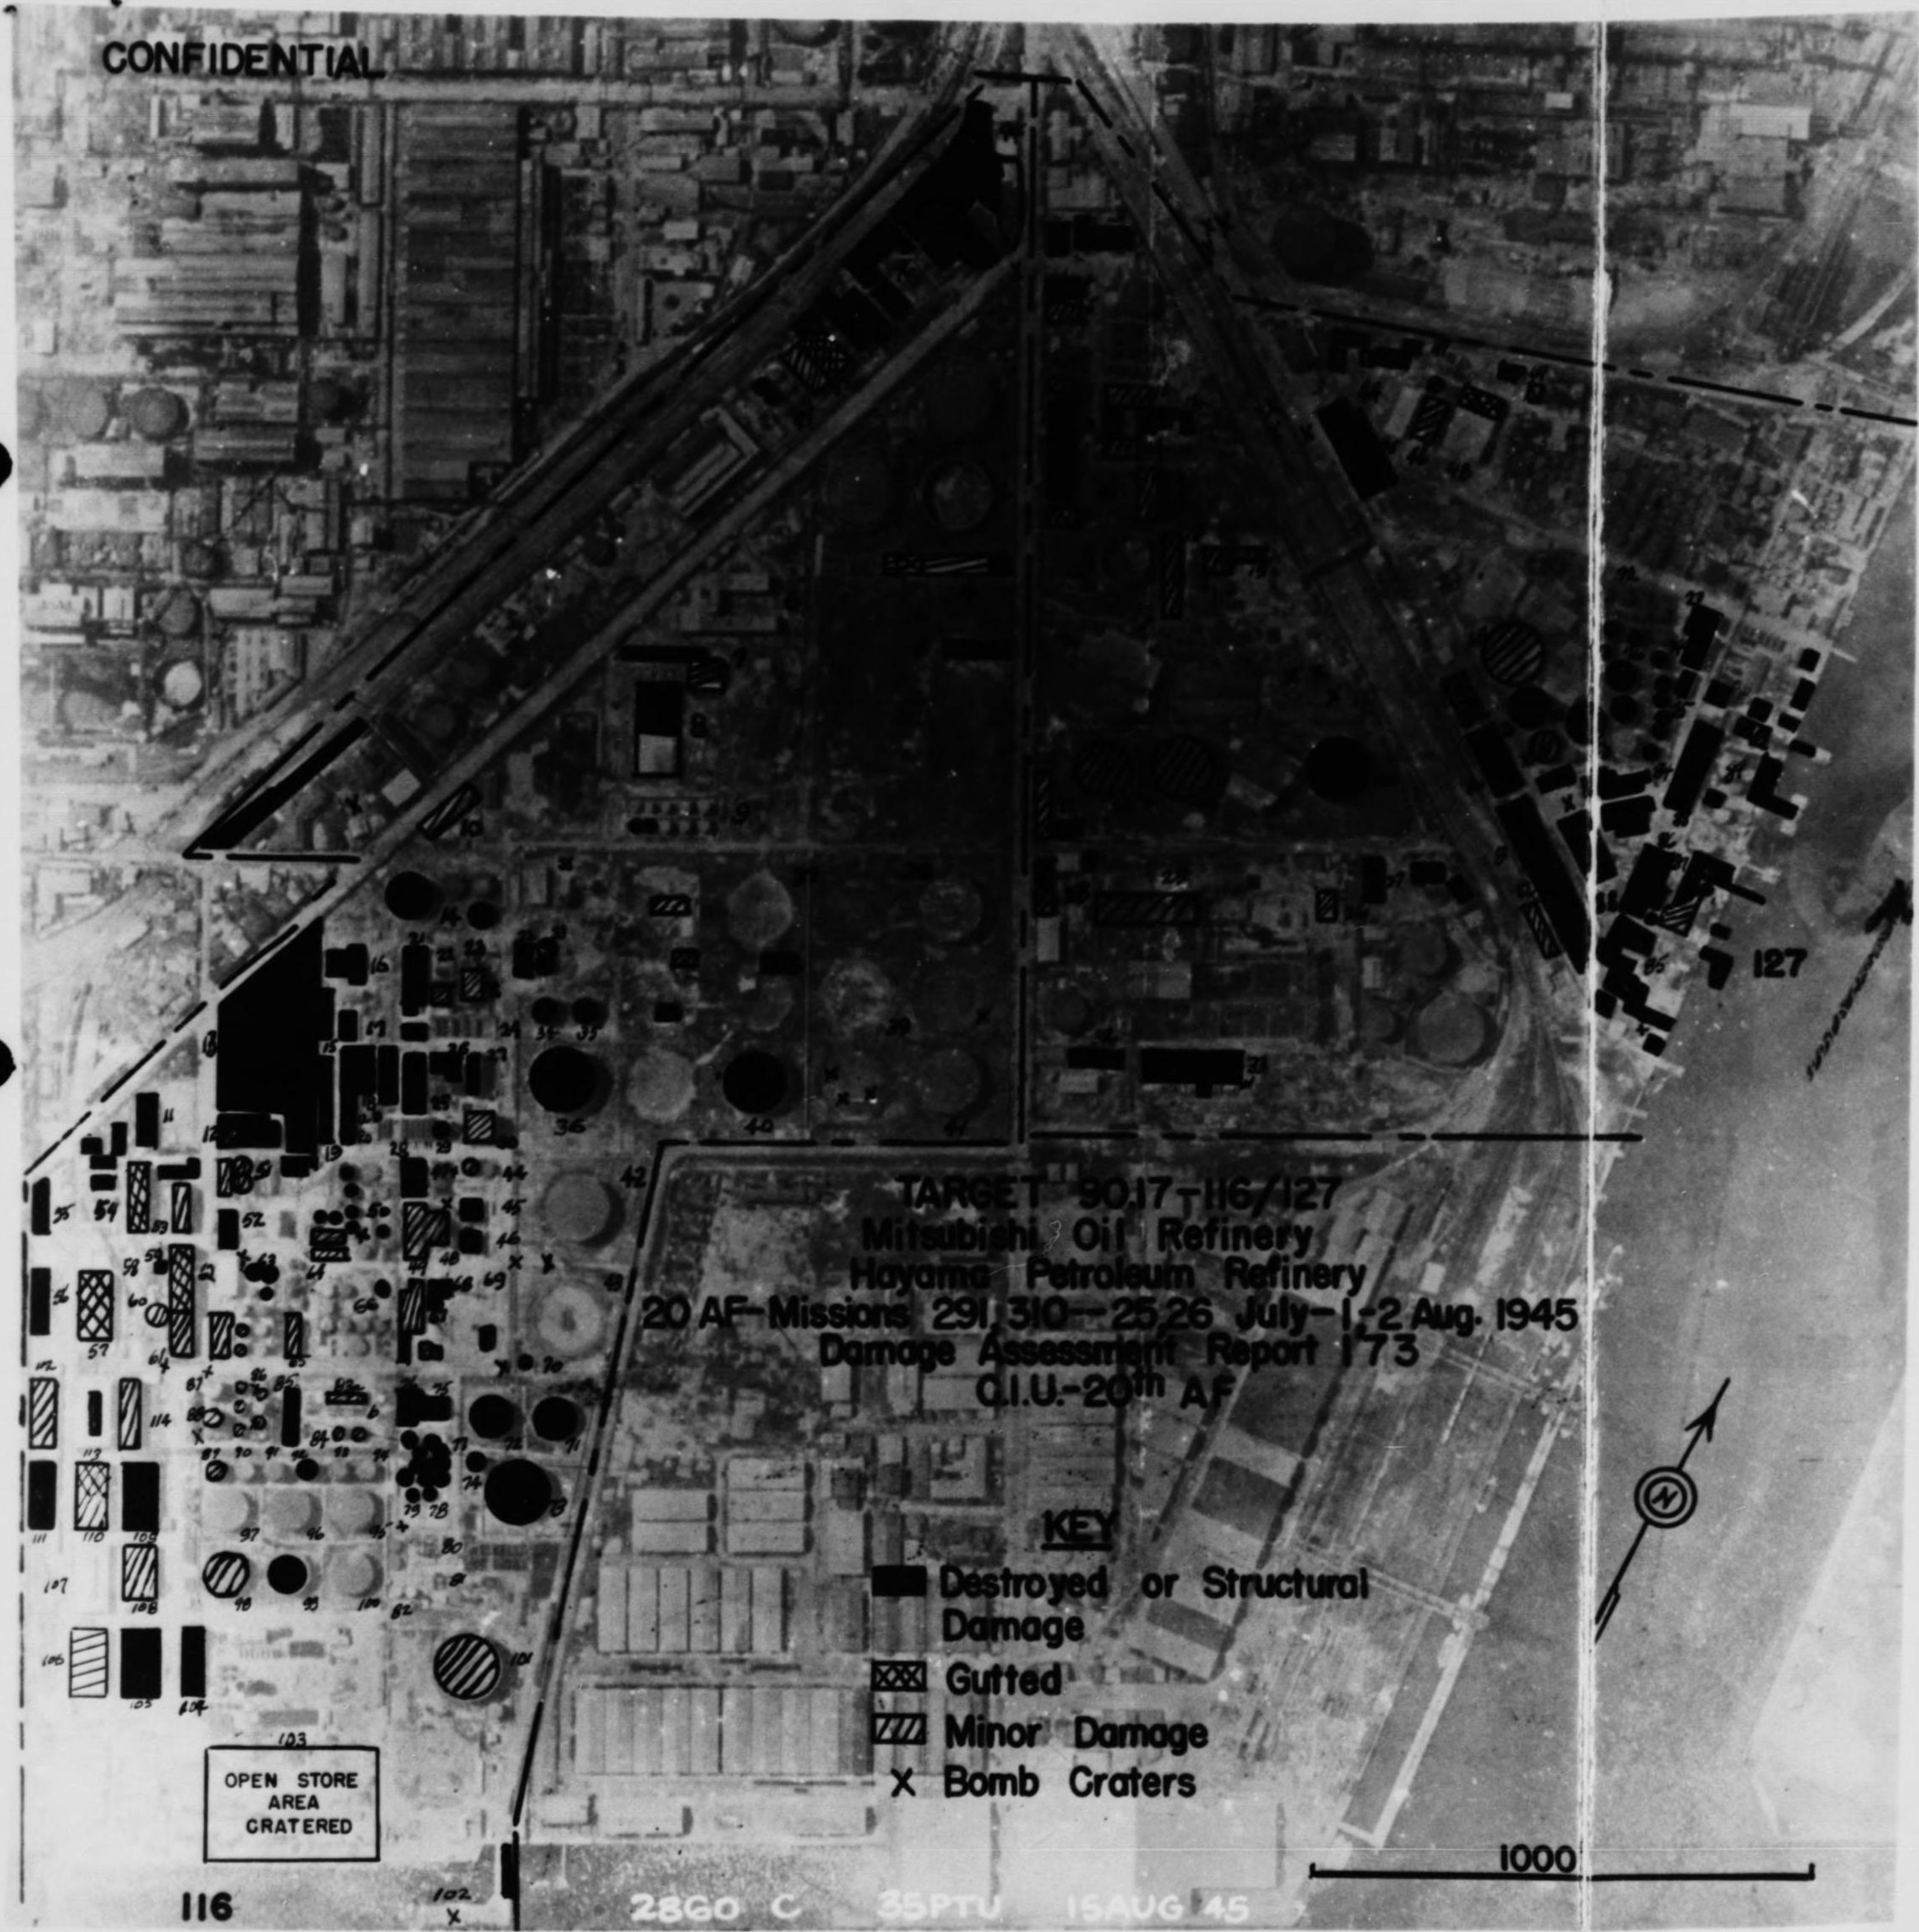
TARGET 9017-116/127
Mitsubishi Oil Refinery
Hayama Petroleum Refinery
20 AF Missions 291, 310 - 25, 26 July - 1, 2 Aug. 1945
Damage Assessment Report 173
C.I.U.-20th AF

Photos show the Mitsubishi Oil Refinery to be practically inoperative. Twelve of 14 primary buildings, as outlined by Ref. A, are destroyed. The Hayama Petroleum Refinery sustained crippling damage, 40% of its primary structures being destroyed.

Damage and destruction encompasses practically all of Target 116, particularly the central, western and central sections of the plant.

Most of the destruction at Target 127 is located in the southern half of the plant area. Residential and office areas in the NW part of the target received extensive damage. A refinery unit and tank section, located in the NE part of the plant, remains apparently undamaged. Four piers were destroyed. A RR yard received several direct hits.

A total of 537,400 barrels or 38% of the storage tank capacity (1,404,400 bbls.) were destroyed or damaged at the Mitsubishi Oil Refinery. In addition, 13,625 barrels or 30.4% of the intermediate tank capacity (44,750 bbls.) were destroyed or damaged.

At the Hayama Refinery 334,000 barrels or about 44% of the storage tank capacity (761,600 bbls.), and 26,100 barrels or about 26% of the intermediate tank capacity (100,300 bbls) were damaged or destroyed.

<u>NO.</u>	<u>IDENTIFICATION</u>	<u>DESCRIPTION OF DAMAGE</u>
4	Warehouse - 8400 sq. ft.	25% structural damage, 25% gutted and 50% minor roof damage.
5	Warehouse	Completely destroyed
7	Unidentified	Square portion of this small building received minor roof damage. An adjoining long, narrow building was destroyed.
8	Unidentified 13,800 sq. ft.	Half of this building was structurally damaged.
9	Two 18' diameter storage tanks 3000 bbls.	Both tanks are distorted. There is a bomb crater about 50' S/W of these tanks.
10	Warehouse	Roof damaged
11	Workers building	Destroyed
12	Office type building	Destroyed
13	Workers residences - numerous homes occupying a roughly rectangular area of approx. 20,000 sq. ft.	Devastated
14	1 storage tank 75' diameter - 25,000 bbls. 1 storage tank 15,500 bbls	Large tank structurally damaged. Smaller tank " "
15	Warehouse	Destroyed
16	Unidentified	Destroyed
17	Unidentified	Destroyed

18a	Poss. processing building	Destroyed
19	Warehouse	Destroyed
20	Unidentified	Destroyed
*21	Iso-octane unit	Destroyed
*22	Iso-octane unit	Probably received some damage when No. 21 was destroyed.
23	Furnace	Minor damage
*25	Iso-octane unit	Destroyed
*26	Iso-octane unit	Destroyed
27	Poss. processing building	Destroyed
29	Intermediate tank 1,300 bbl	Structurally damaged
30	Furnace	Minor roof damage
32	Horizontal tanks - 1725 bbls	Destroyed
33	Storage tank - 2600 bbls	Structurally damaged
34	" " 8000 bbls	Destroyed
35	Storage tank 12500 bbls	Destroyed
36	Storage tank 80000 bbls	Destroyed
40	Storage tank 80000 bbls	Destroyed
44	Unidentified - near a storage tank - 1600 bbls	Minor damage
*45	Furnace	Structurally damaged
*46	"	Structurally damaged
*47	Cracking unit	Structurally damaged. A crater is visible in the immediate vicinity.
48	Cracking unit	Structural damage caused by near misses.

ANNOT. NO.	IDENTIFICATION	DESCRIPTION OF DAMAGE
49	Cracking Unit	Same as No. 48
50	Intermediate tanks (1) 2200 bbls (5) 3000 bbls (1) 800 bbls	Structural damage - 3 or 4 near misses visible.
51	Storage tanks - (2) 4400 bbls	Minor damage - crater visible - approx 50' S of these tanks
52	Research laboratory	Structurally damaged
53	Offices	Minor roof damage
54	Personnel bldg	Destroyed
55	Probable shipping offices	Destroyed - 3 craters visible in the immediate vicinity
56	Warehouse	Destroyed
57	Warehouse	Gutted
58	Office	Destroyed
59	Boiler house	Destroyed, chimney remaining
60	Storage tank - 4000 bbls	Top apparently destroyed
61	Possible pump house	Minor roof damage
62	Chemical laboratory	Gutted
63	2 inter. tanks - 2200 bbls 3 " " 1500 bbls	Structurally damaged Destroyed
64	Possible treating plant	Damaged - crater close by
65	Possible treating plant	Damaged roof
66	Inter. tank - 900 bbls	Destroyed
*67	Primary distilling unit	(Structurally damaged. Two craters

*68	" " "	100'-110' S of units.)
70	1 storage tank - 4000 bbls	Destroyed
71	1 " " 28000 bbls	"
72	1 " " 28000 bbls	"
73	1 " " 80000 bbls	"
74	1 " " 3600 bbls	"
*75	Furnace	"
*76	Vacuum distillation unit	"
77	11 storage tanks - 4,800 bbls	Destroyed
78	1 storage tank - 1700 bbls	Structural damage
79	1 storage tank - 1700 bbls	Structural damage
83a	Pump house	Minor roof damage
84	2 storage tanks	Minor damage
85	Pump house	Structural damage
86	5 storage tanks - 10,000 bbls	Possibly structurally damaged. Craters in immediate vicinity.
88	1 storage tank - 7000 bbls	Same as No. 86
89	1 " " 5500 bbls	Damaged, crater immediately N of tank
92	1 " " 5500 bbls	Destroyed
99	1 " " 25000 bbls	Structurally damaged.
98	1 " " 25000 bbls	Minor damage on top cover
101	1 " " 80000 bbls	Damage to top
102	Oil bunkering pier	Pipe line from wharf destroyed. Pier shows a crater.
103	Open storage area	Cratered
104	Warehouse	Structural damage

<u>ANNOT.</u> <u>NO.</u>	<u>IDENTIFICATION</u>	<u>DESCRIPTION OF DAMAGE</u>
3	Probable office	Destroyed
4	Unidentified	Destroyed
5	Unidentified	Minor roof damage
10	Warehouse	Destroyed
11	Unidentified	Roof damage
12	Still	Destroyed - crater visible about 40' E of unit.
13	Unidentified	Roof damage
15	Unidentified	Roof damage
18	Probable storage	Roof damage
19	Not identified	Roof damage
23	Storage tank - 80,000 bbls	Minor damage - crater between tanks
24	" " " "	Minor damage - hole on top
26	" " " "	Structurally damaged
27	Unidentified	Destroyed
28	"	2 small bldgs. destroyed. One small bldg. sustained minor damage to roof.
29	Unidentified	Minor damage
32	Unidentified	Destroyed
33	2 horizontal tanks - 500 bbls, one building	Destroyed
36	Not identified	Minor roof damage
37	" "	Destroyed
44	Warehouse (16,600 sq. ft.)	Destroyed
46	Possible drum plant	Minor roof damage
48	Possible drum plant	30% gutted
*49	Stills and fractioning columns	Minor damage

68	Storage tank - 25,000 bbls	Minor damage to top
70	Storage tank - 25,000 bbls	Structural damage
76	Tanks - storage - 13,000 bbls	" "
77	Storage tank - 20,000 bbls	" "
75	Inter. tanks - 24,400 bbls	" "
78	Storage tank - 15,000 bbls	Minor damage to top
79	" " - 10,000 bbls	Minor damage
80	Warehouse	Structural damage
81	"	Destroyed
82	"	"
83	Unidentified miscellaneous store and maintenance sheds	"
84	Same as No. 83	Destroyed
85	" " " "	Destroyed
86	" " " "	Destroyed
87	Prob. warehouse and oil pier	Structural damage
*88	Still	Destroyed
*90	"	"
94	Office group	Rough triangular built-up area (22,000 sq. ft.) destroyed.
*95	Still	Destroyed
96	Unidentified	"
97	Unidentified	"
98	Unidentified	Gutted

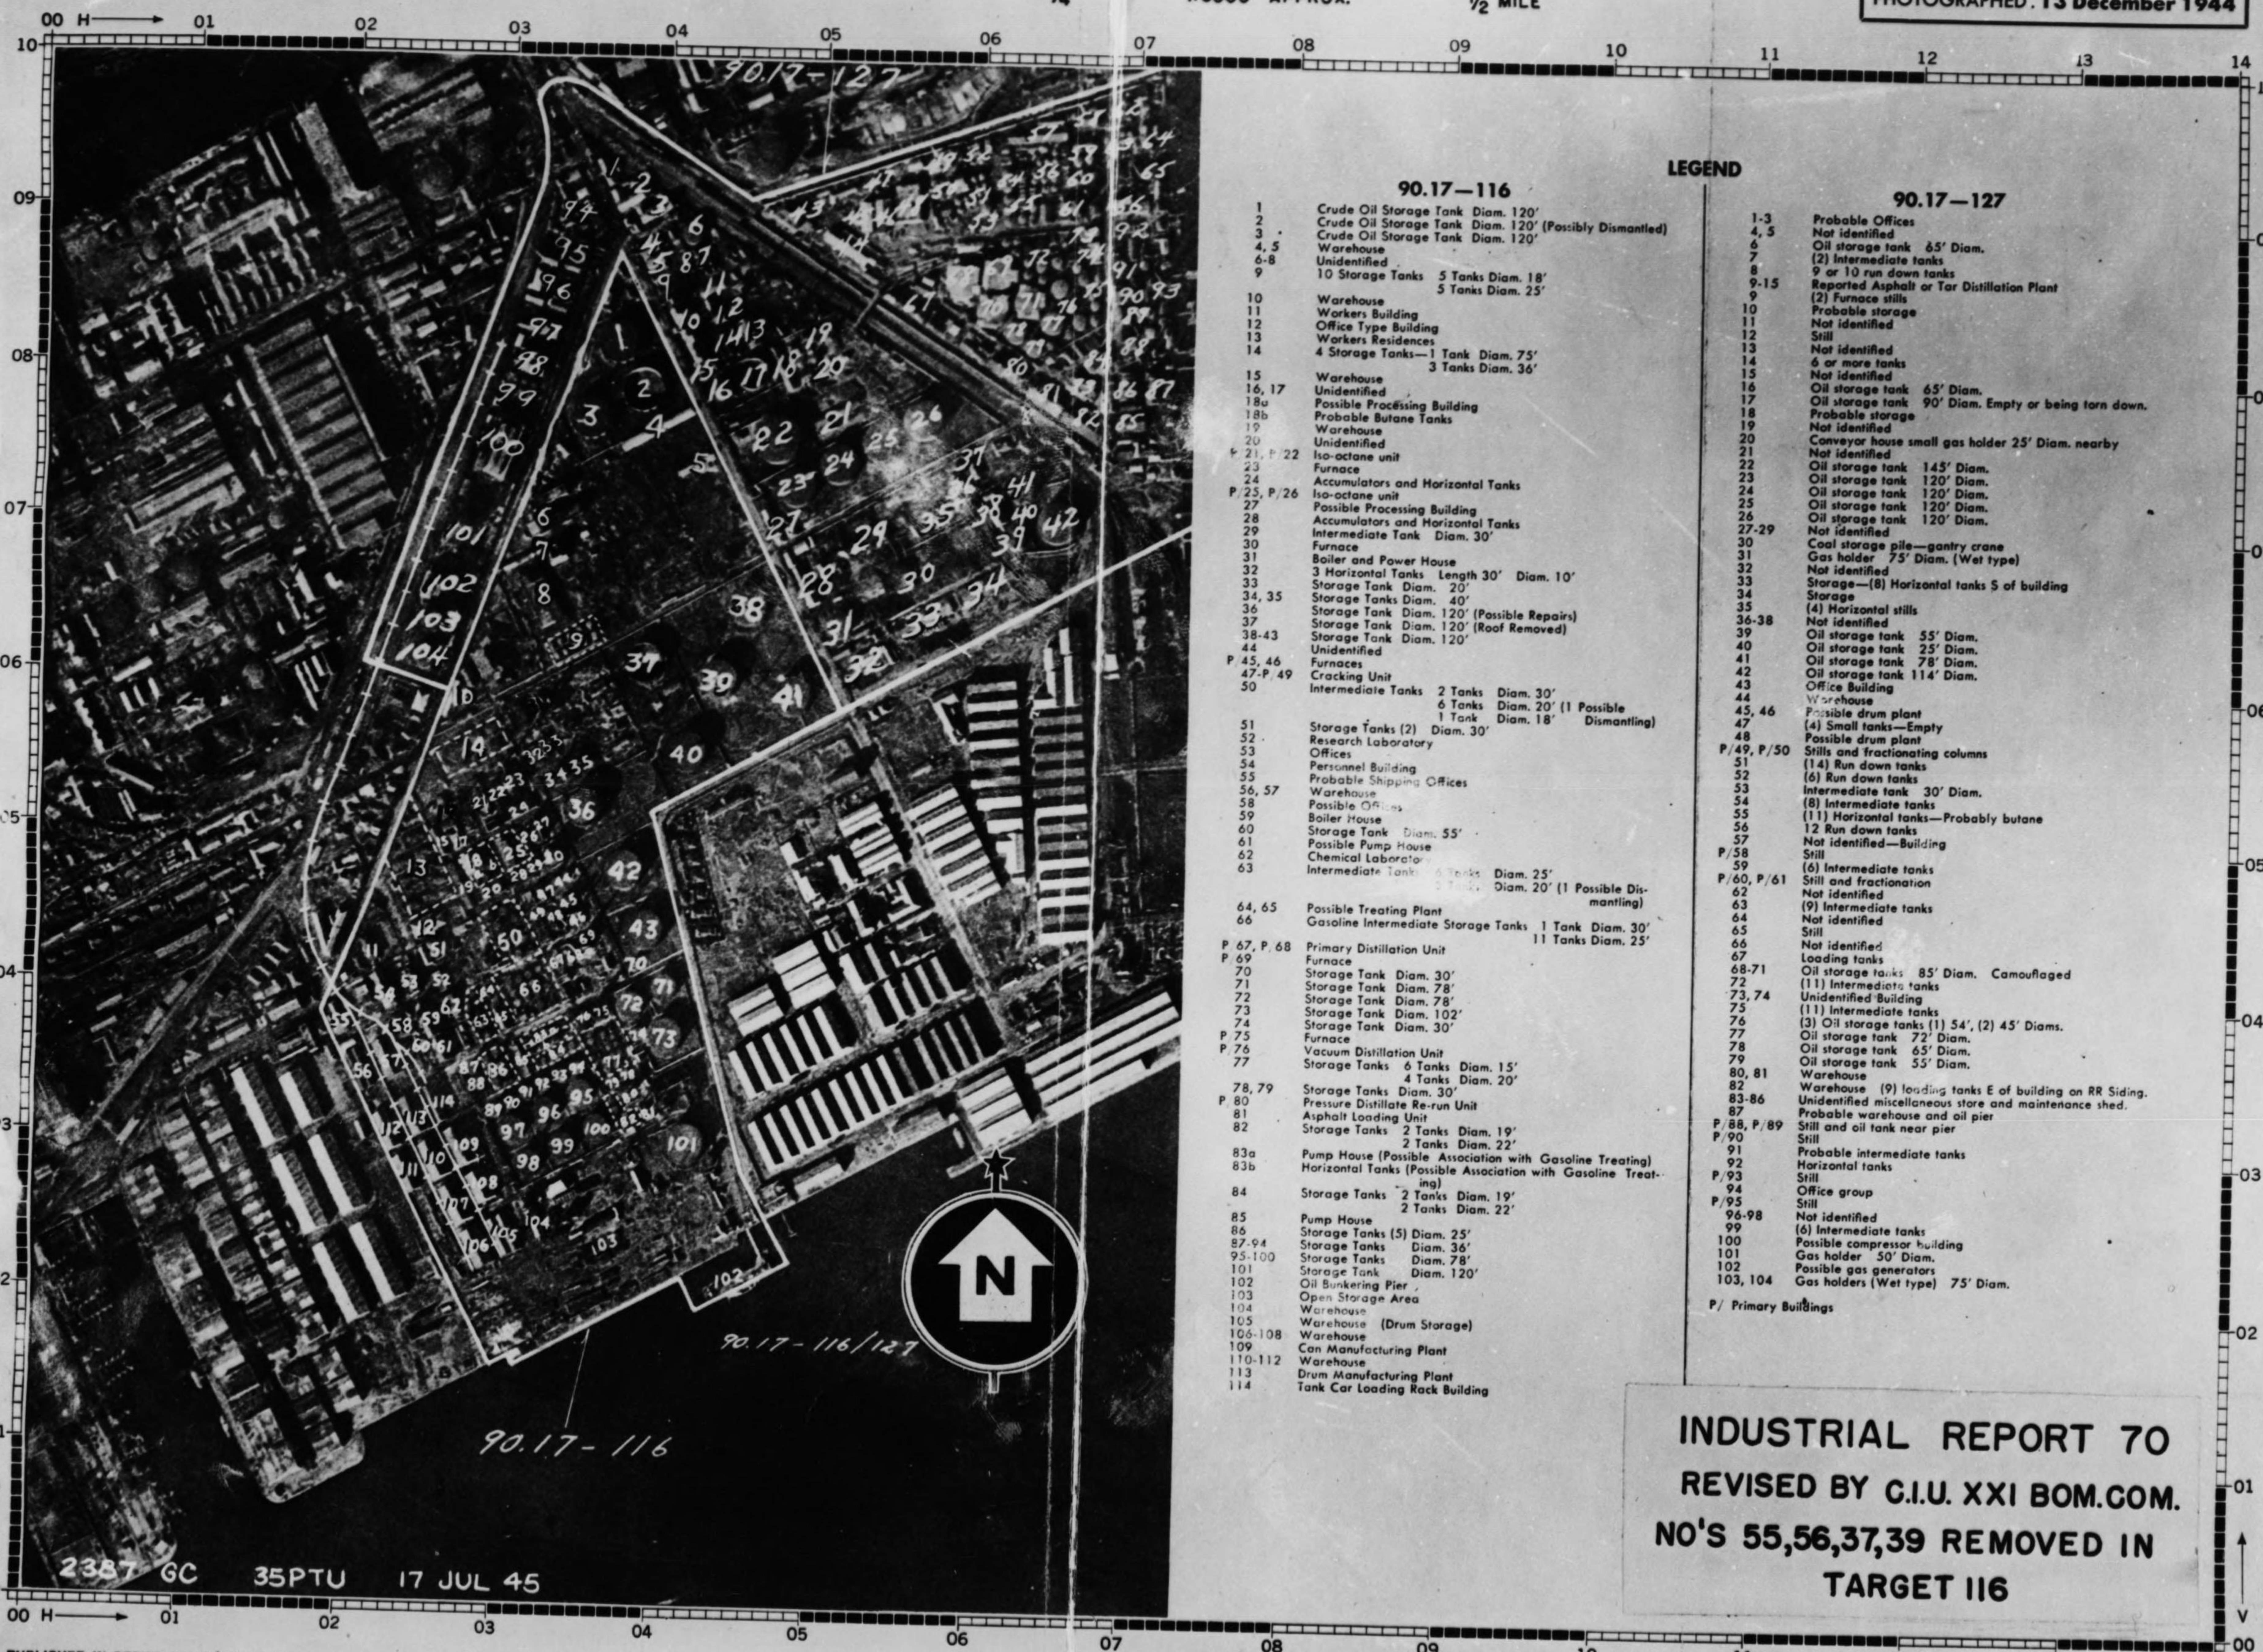
ILLUSTRATION No. 9017-116/127 P4
DATE 29 April 1945
TARGET No. 90.17-116/127
COORDINATES . . . 35°30'N 139°44'E
PHOTOGRAPHED . 13 December 1944

- 90.17-116**
- 1 Crude Oil Storage Tank Diam. 120'
 - 2 Crude Oil Storage Tank Diam. 120' (Possibly Dismantled)
 - 3 Crude Oil Storage Tank Diam. 120'
 - 4, 5 Warehouse
