# PHYSICAL PROTECTION WORKBOOK

### CASAMERO SITE-PHASE III

(AR-NM-01-144) ALBUQUERQUE DISTRICT

PHYSICAL PROTECTION WORKBOOK

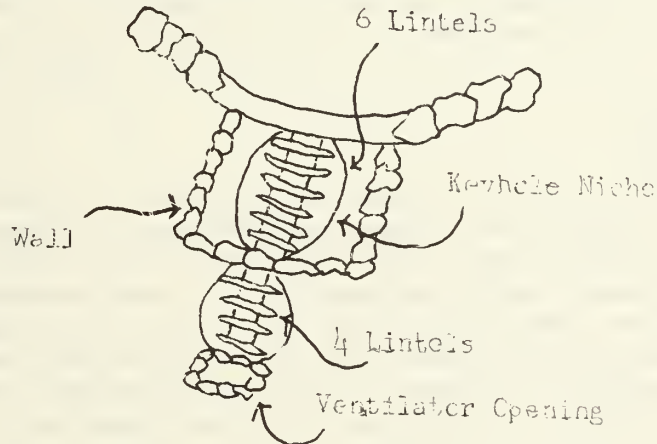
have been a secret entryway or a careless trowel. Along the southern part of the wall was a closet, measuring 5' long and 2½' wide, used to store ceremonial paraphernalia. The wall between the closet and the kiva was 7" wide with a doorway 11" wide x 2'5" high. Below the right side of the above mentioned doorway was a square plastered hole (niche) measuring 4" x 4". Another hole located 2' north of the ventilator opening was 17" long x 9" high x 16" deep, just above the floor. During stabilization procedures the kiva was exposed to a depth of 72" SD3 and the bench was at 57½" SD3. During the minimal excavation in order to define walls, the northwest quadrant immediately outside the kiva wall was dug to a depth of 31" SD3, where a shaped rock layer was found. A second ventilator shaft was discovered just south of the chamber on the south side of the kiva. The shaft is between Room 23 and Room 15 and is 1.3' x 1.3' square. The shaft is made of red sandstone blocks and thin limestone chinking, probably close to the Type B masonry. The collapsed surface of the keyhole niche in the southeast wall was rebuilt. Ten juniper lintels (round) were placed over the short axis of the ventilator shaft, then flat limestone slabs, then dirt was placed over that (See illustration).

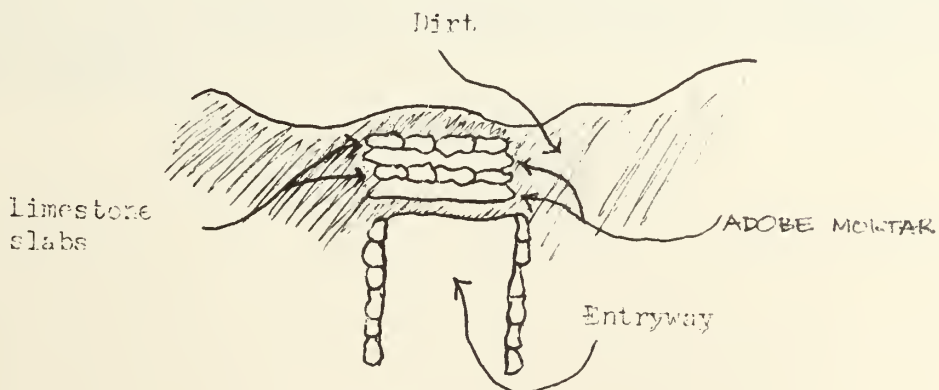
During stabilization, a flat sandstone slab was replaced over a tiny niche in the west portion of the bench. The kiva was remodeled where the wall of Room 22 forms a portion of the kiva wall. The diagonal entryway (tunnel) in the southeast portion of the kiva (just south of the keyhole niche) was stabilized thusly:

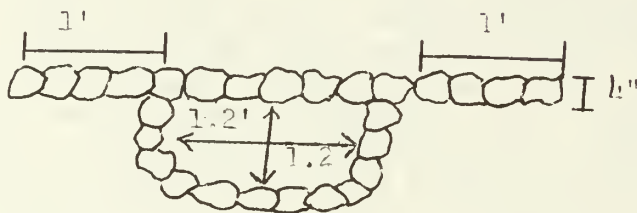
During stabilization of the eastern ventilator shaft, a row of sandstone blocks (thin and flat) was discovered formed in the wall. Looks thus:

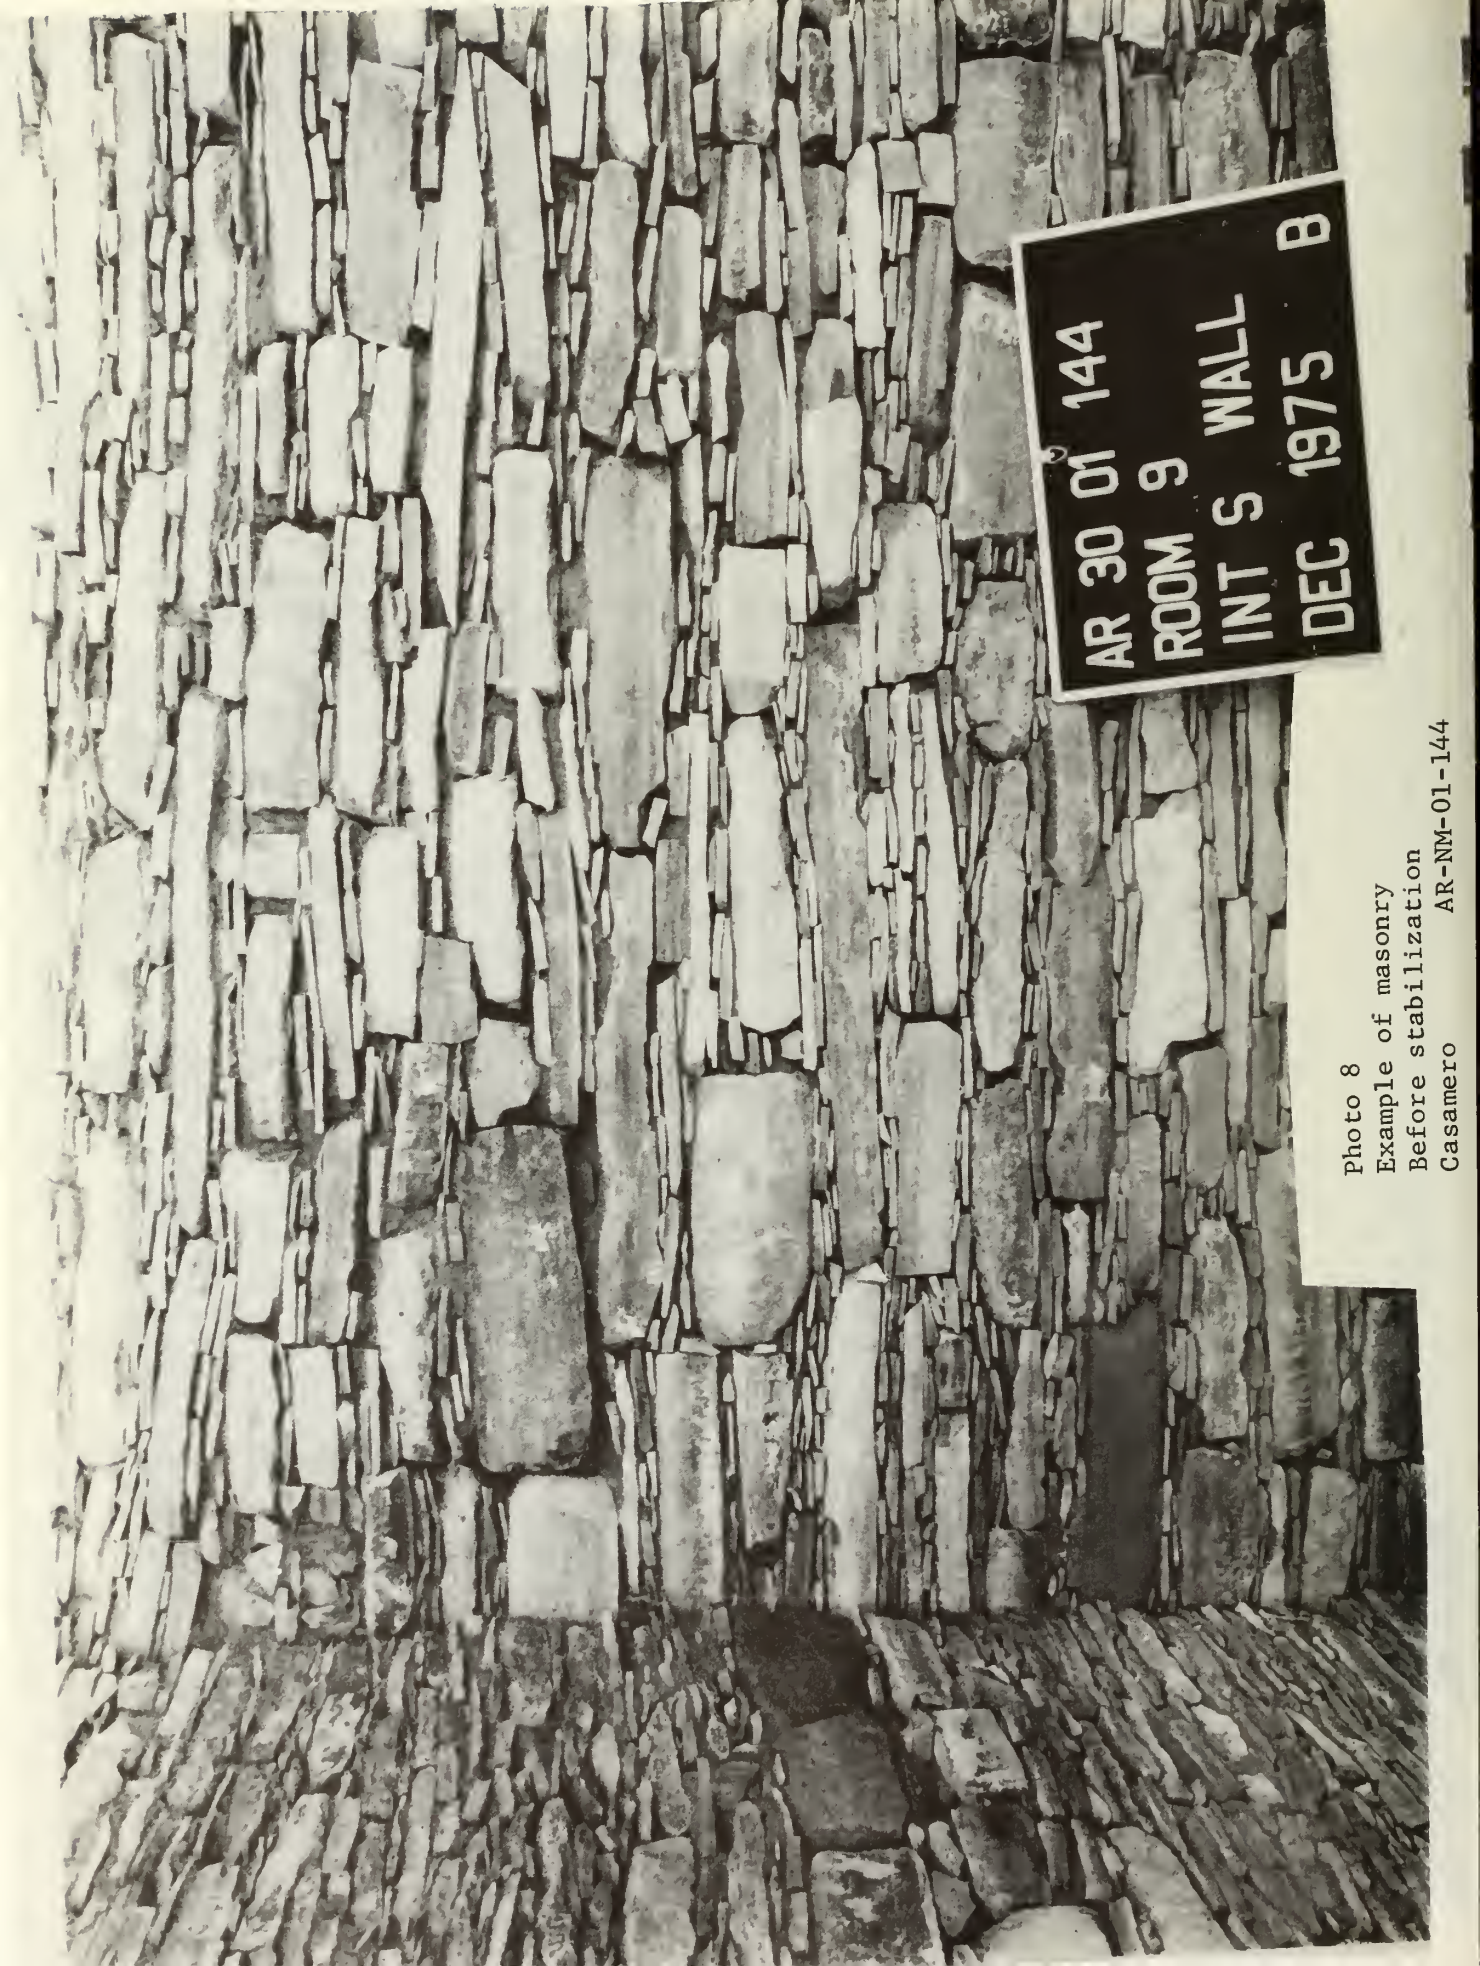
AR 30 01 144  
ROOM 9  
INT S WALL  
DEC 1975 B

Photo 8  
Example of masonry  
Before stabilization  
Casamero AR-NM-01-144

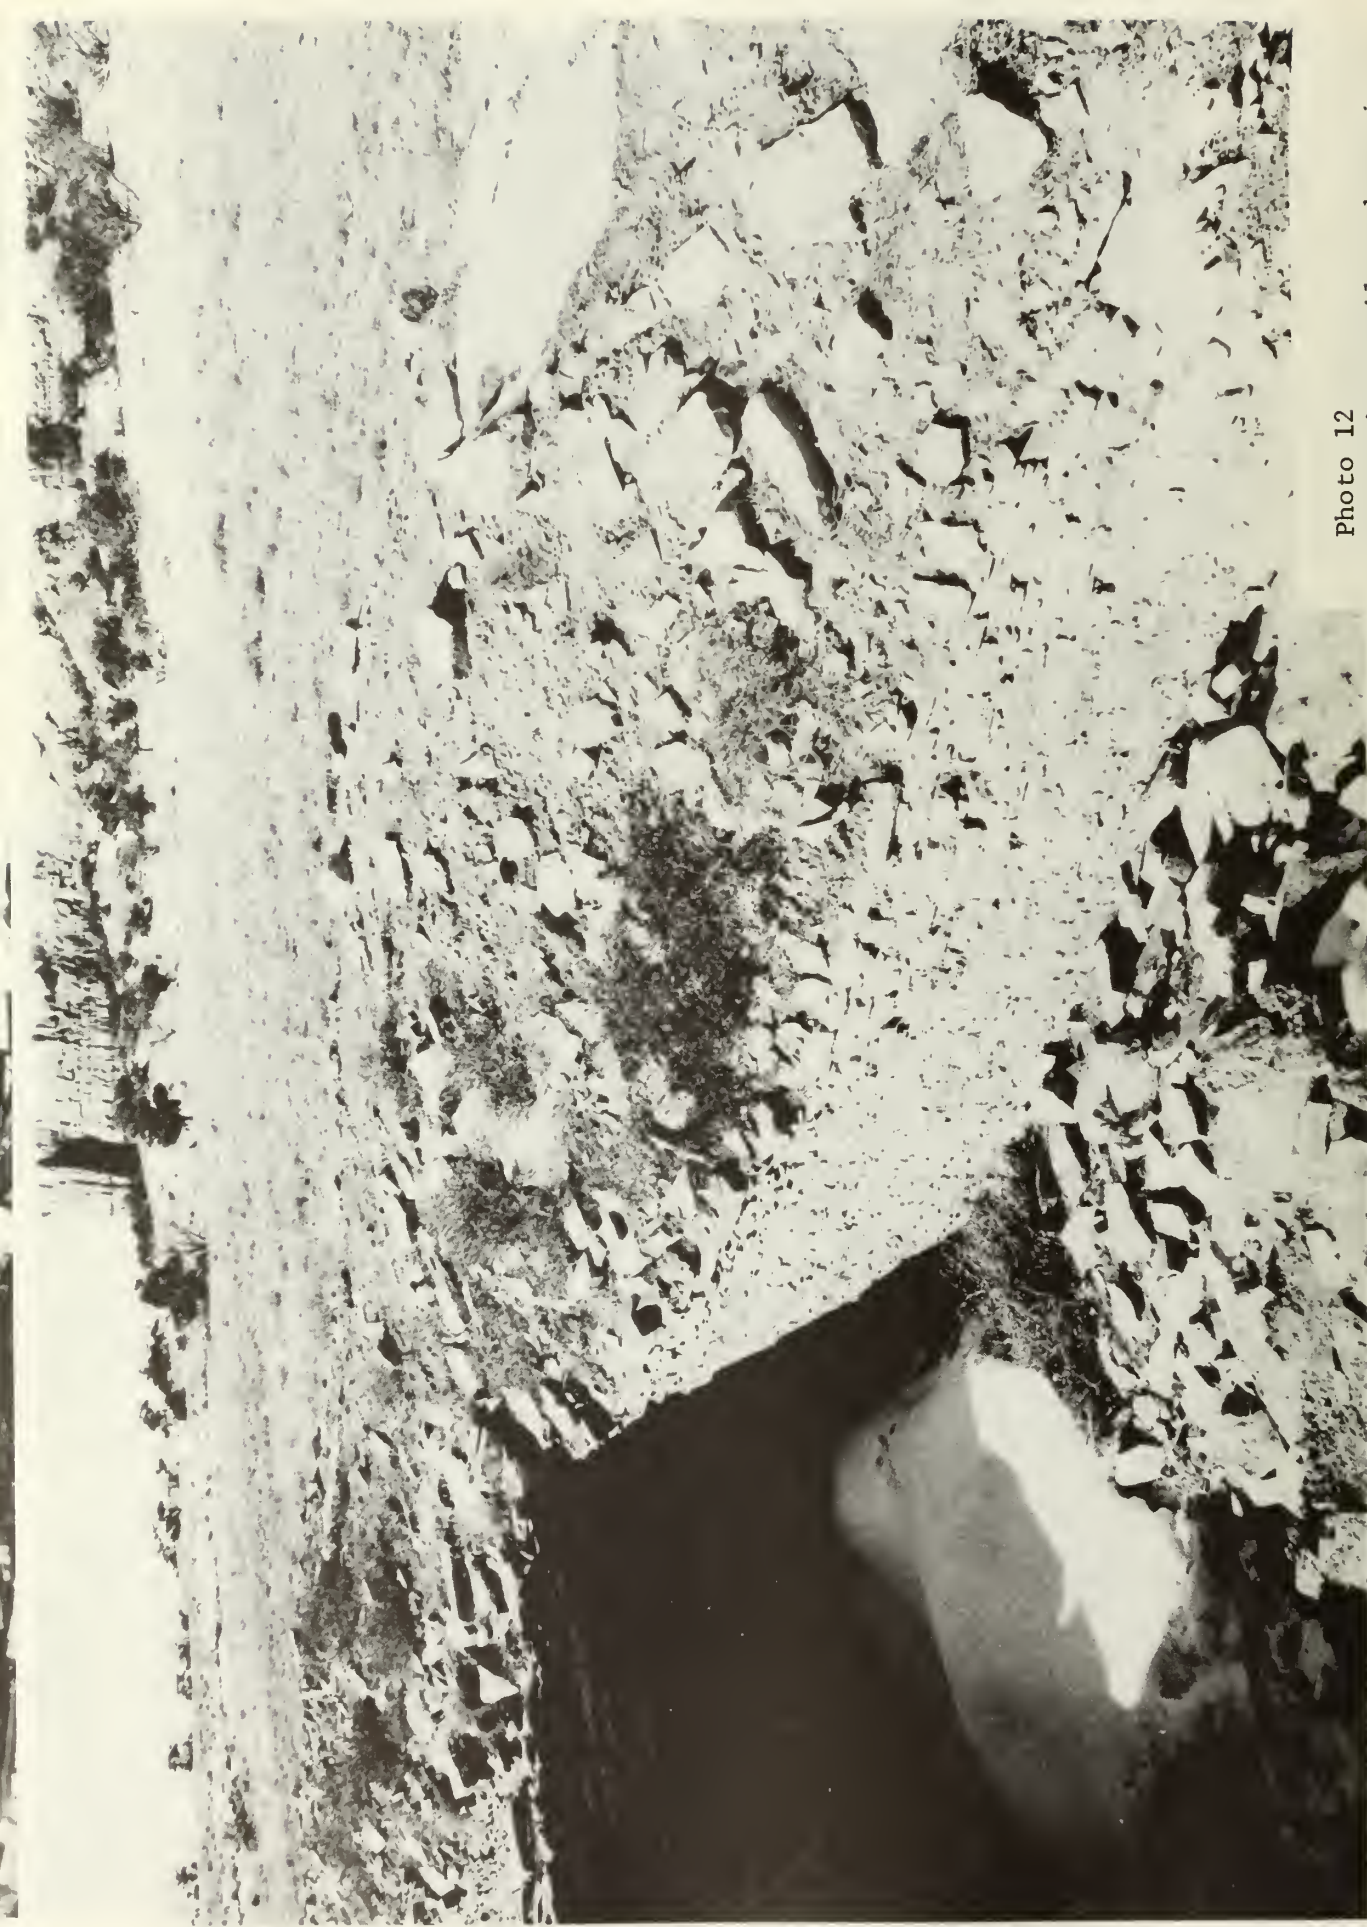
Photo 12

Excavation spoil, endangering

2.3 RECONSTRUCTION Reconstruction must be kept to a minimum, and will include only those areas that have a degrading effect on the structural integrity. Specific examples include: (1) the terminus of Trench "A", which is located in the east wall of room 4 (Photo 21); (2) the terminus of Trench "B", which is located in the west wall of room 1 (Photo 22); (3) sluffing of the west wall in rooms 3 and 5 (Photos 12, 13, 15);

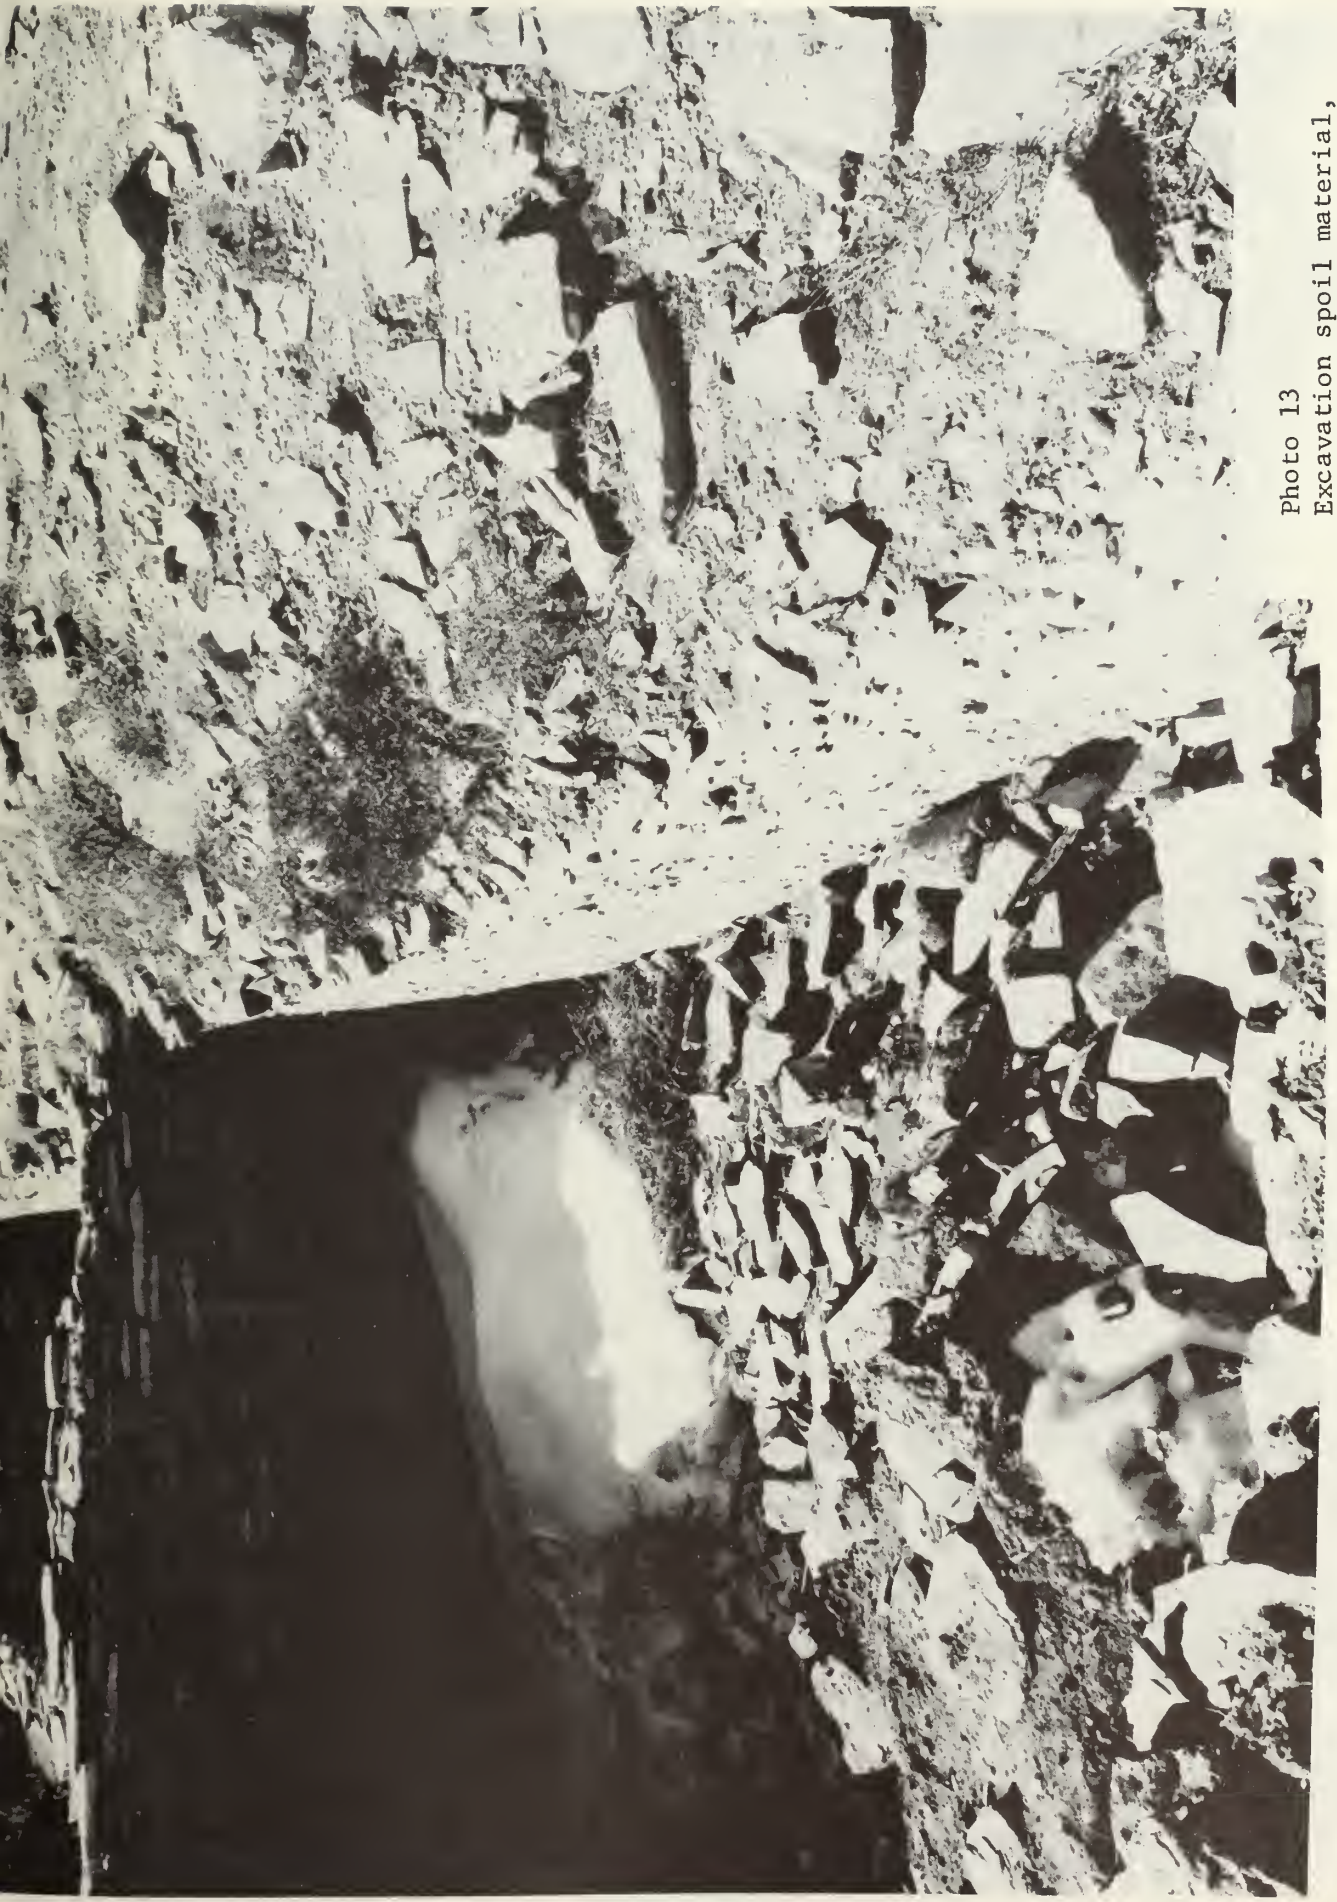
Photo 13

Excavation spoil material,

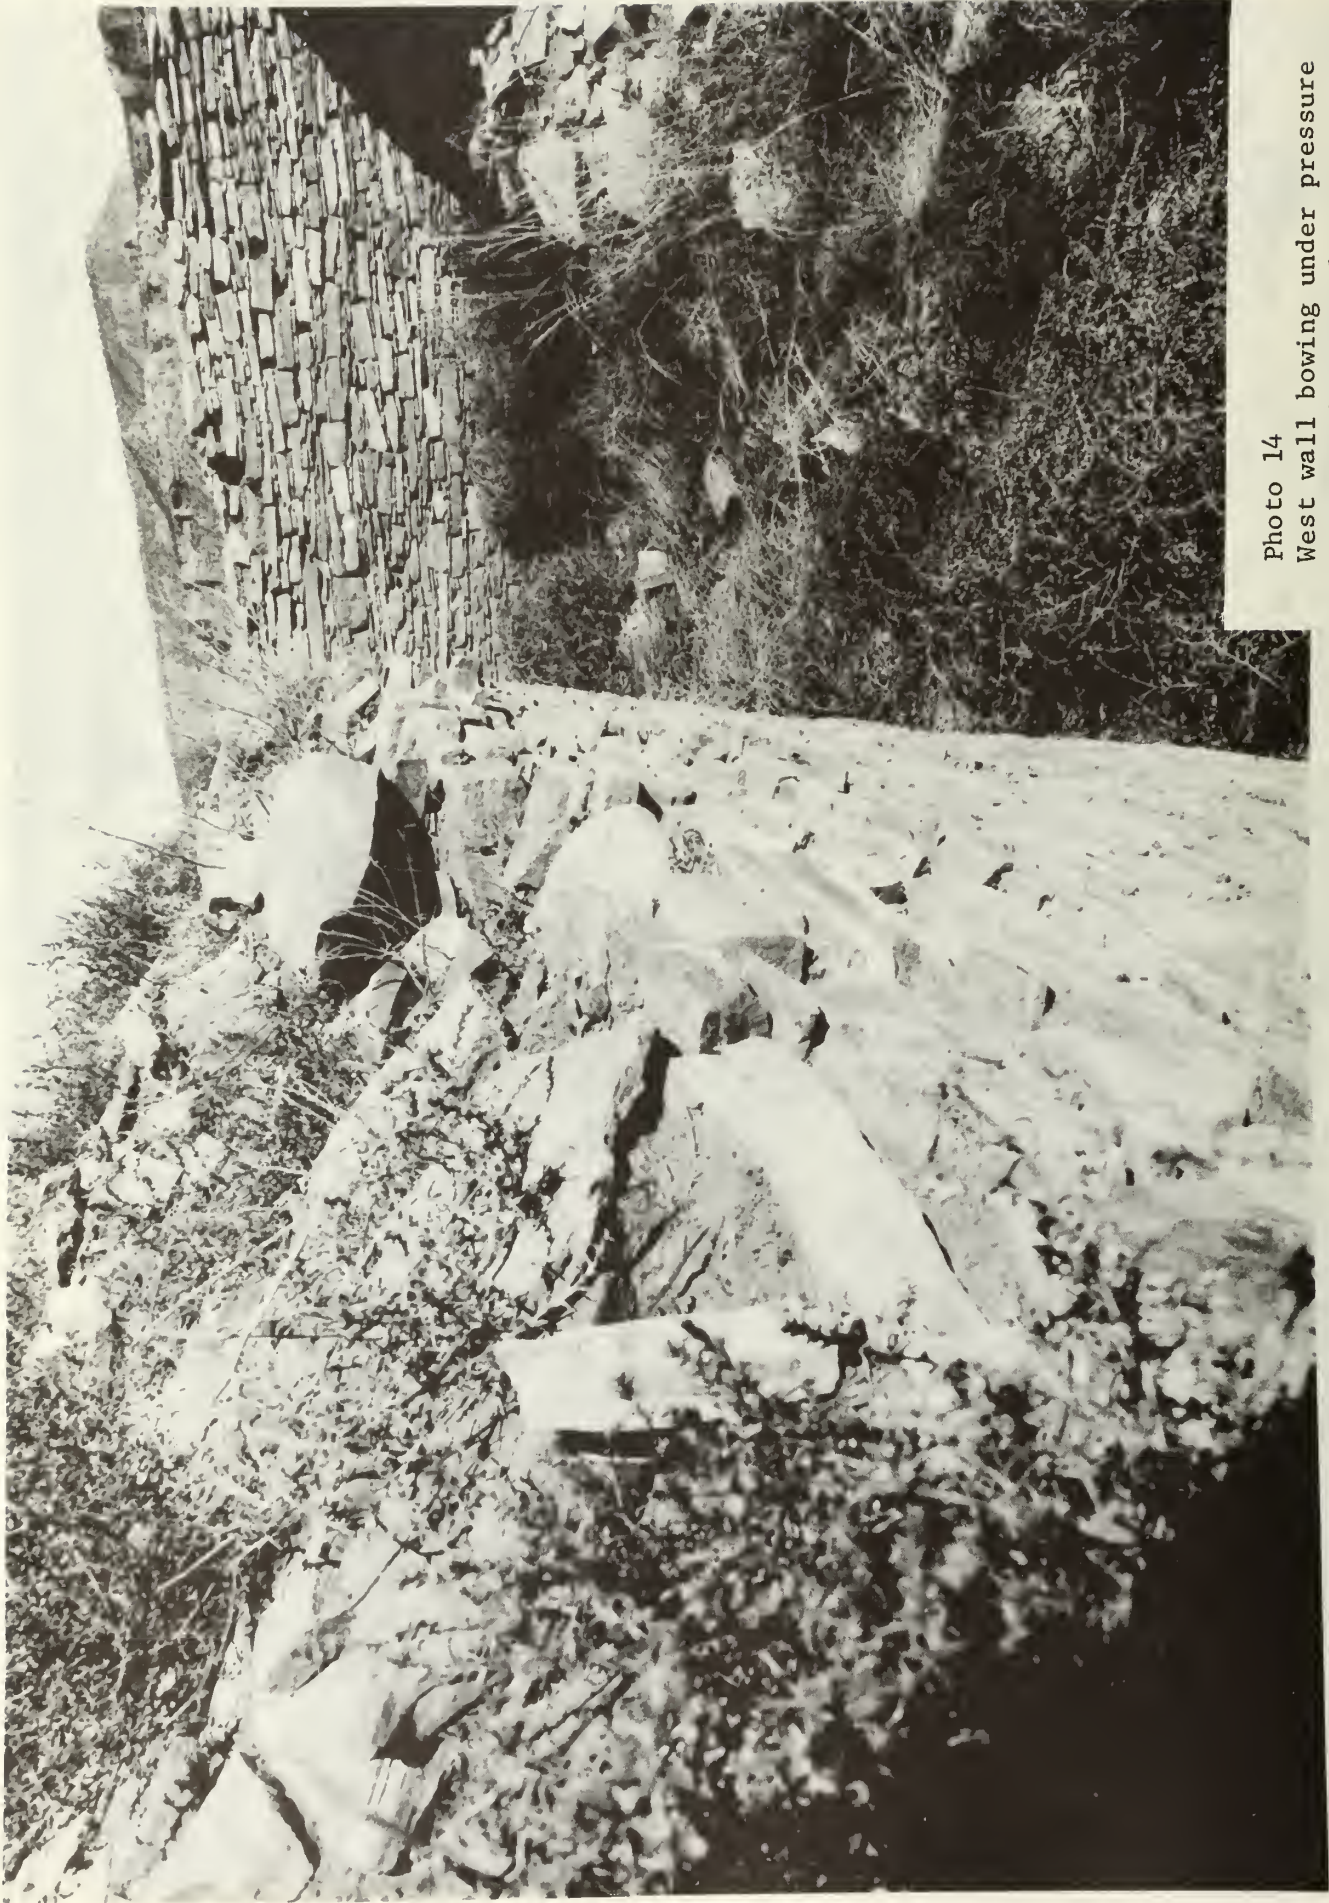
Photo 14

West wall bowing under pressure  
from spoil material  
Before stabilization  
Casamero AR-NM-01-144

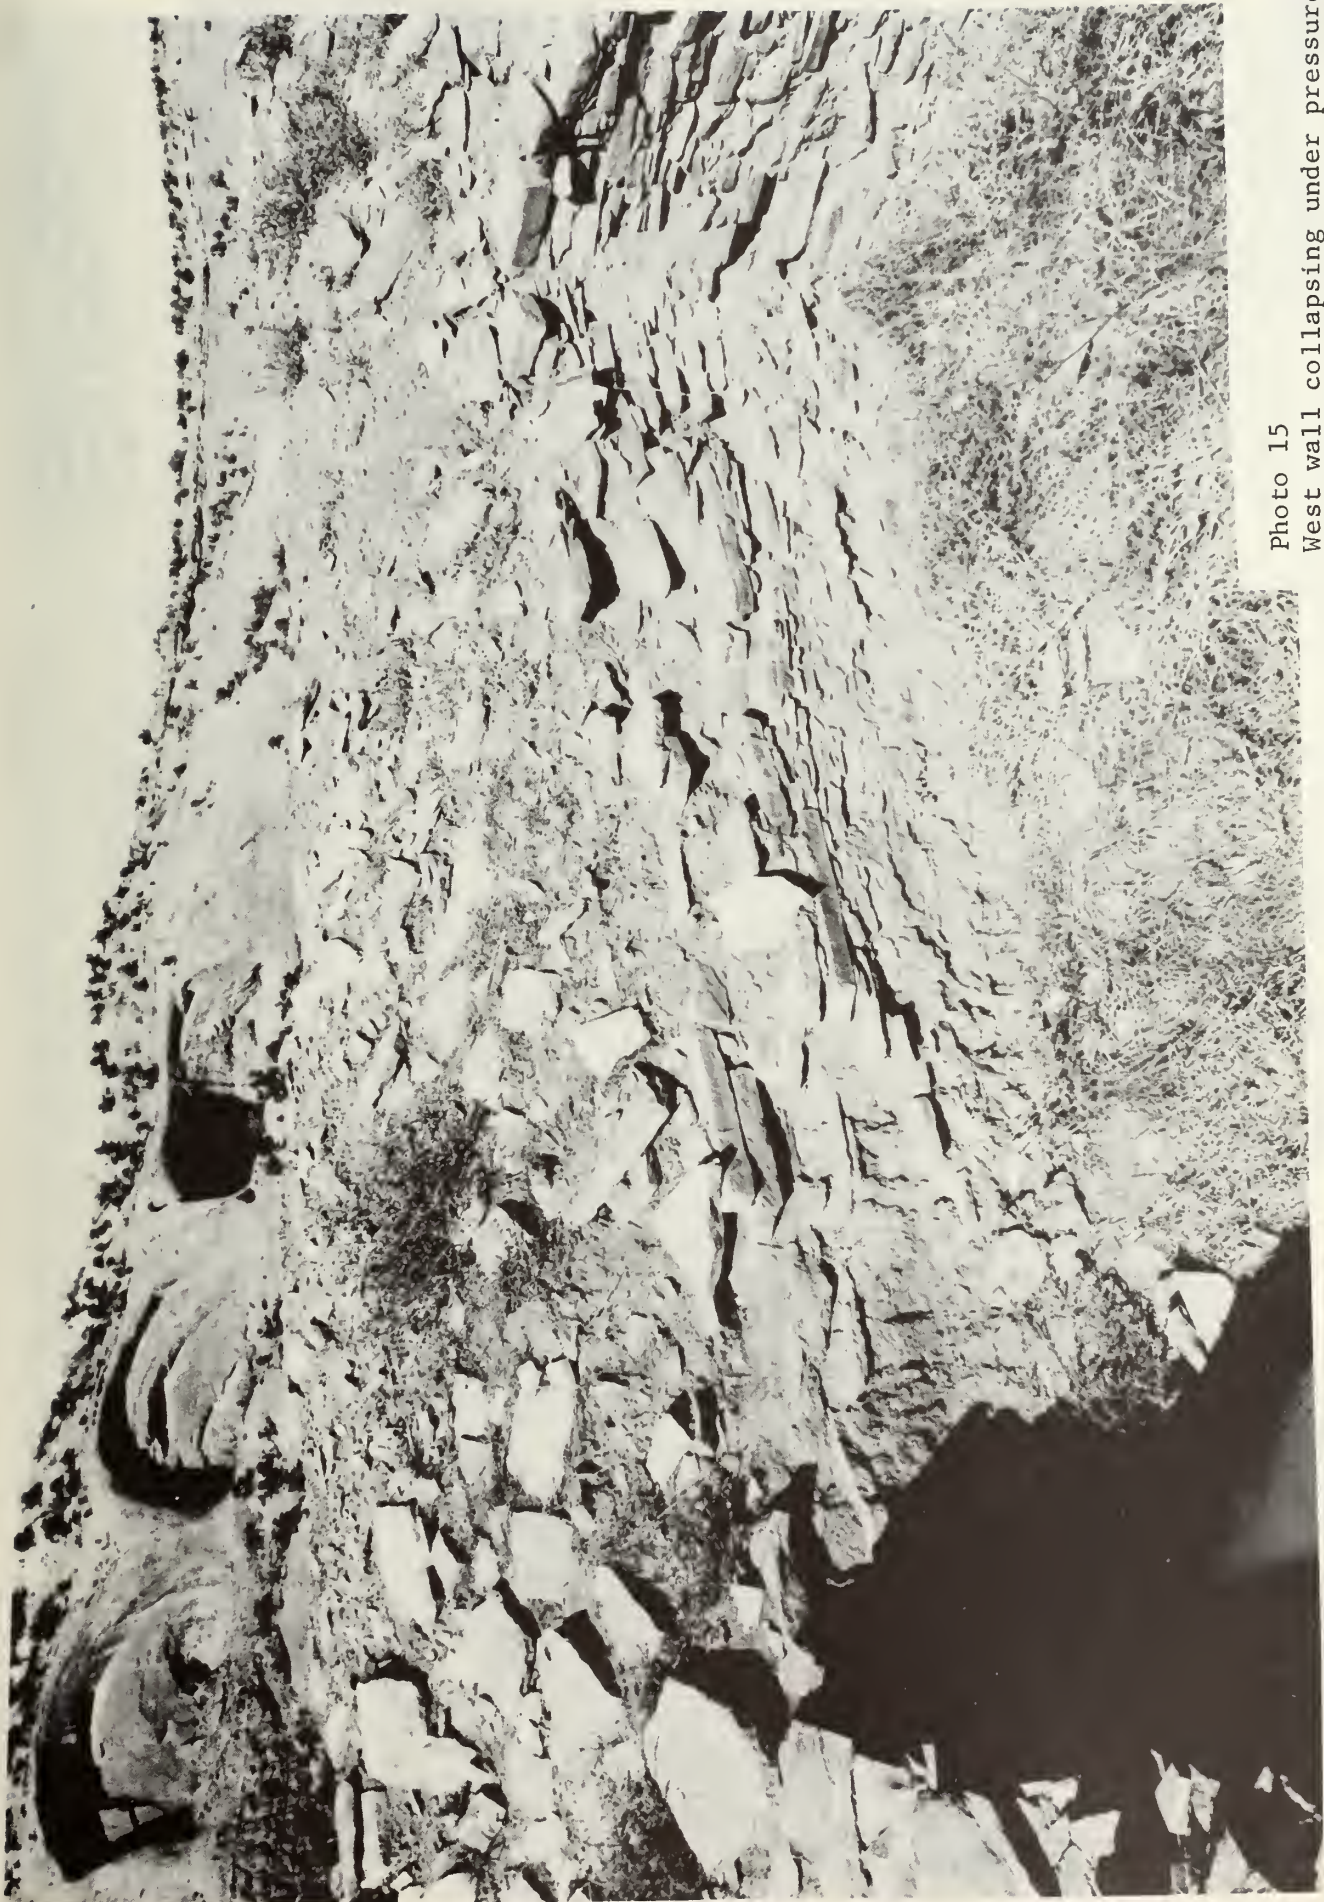
Photo 15

West wall collapsing under pressure  
from spoil material  
Before stabilization  
Casamero AR-NM-01-144

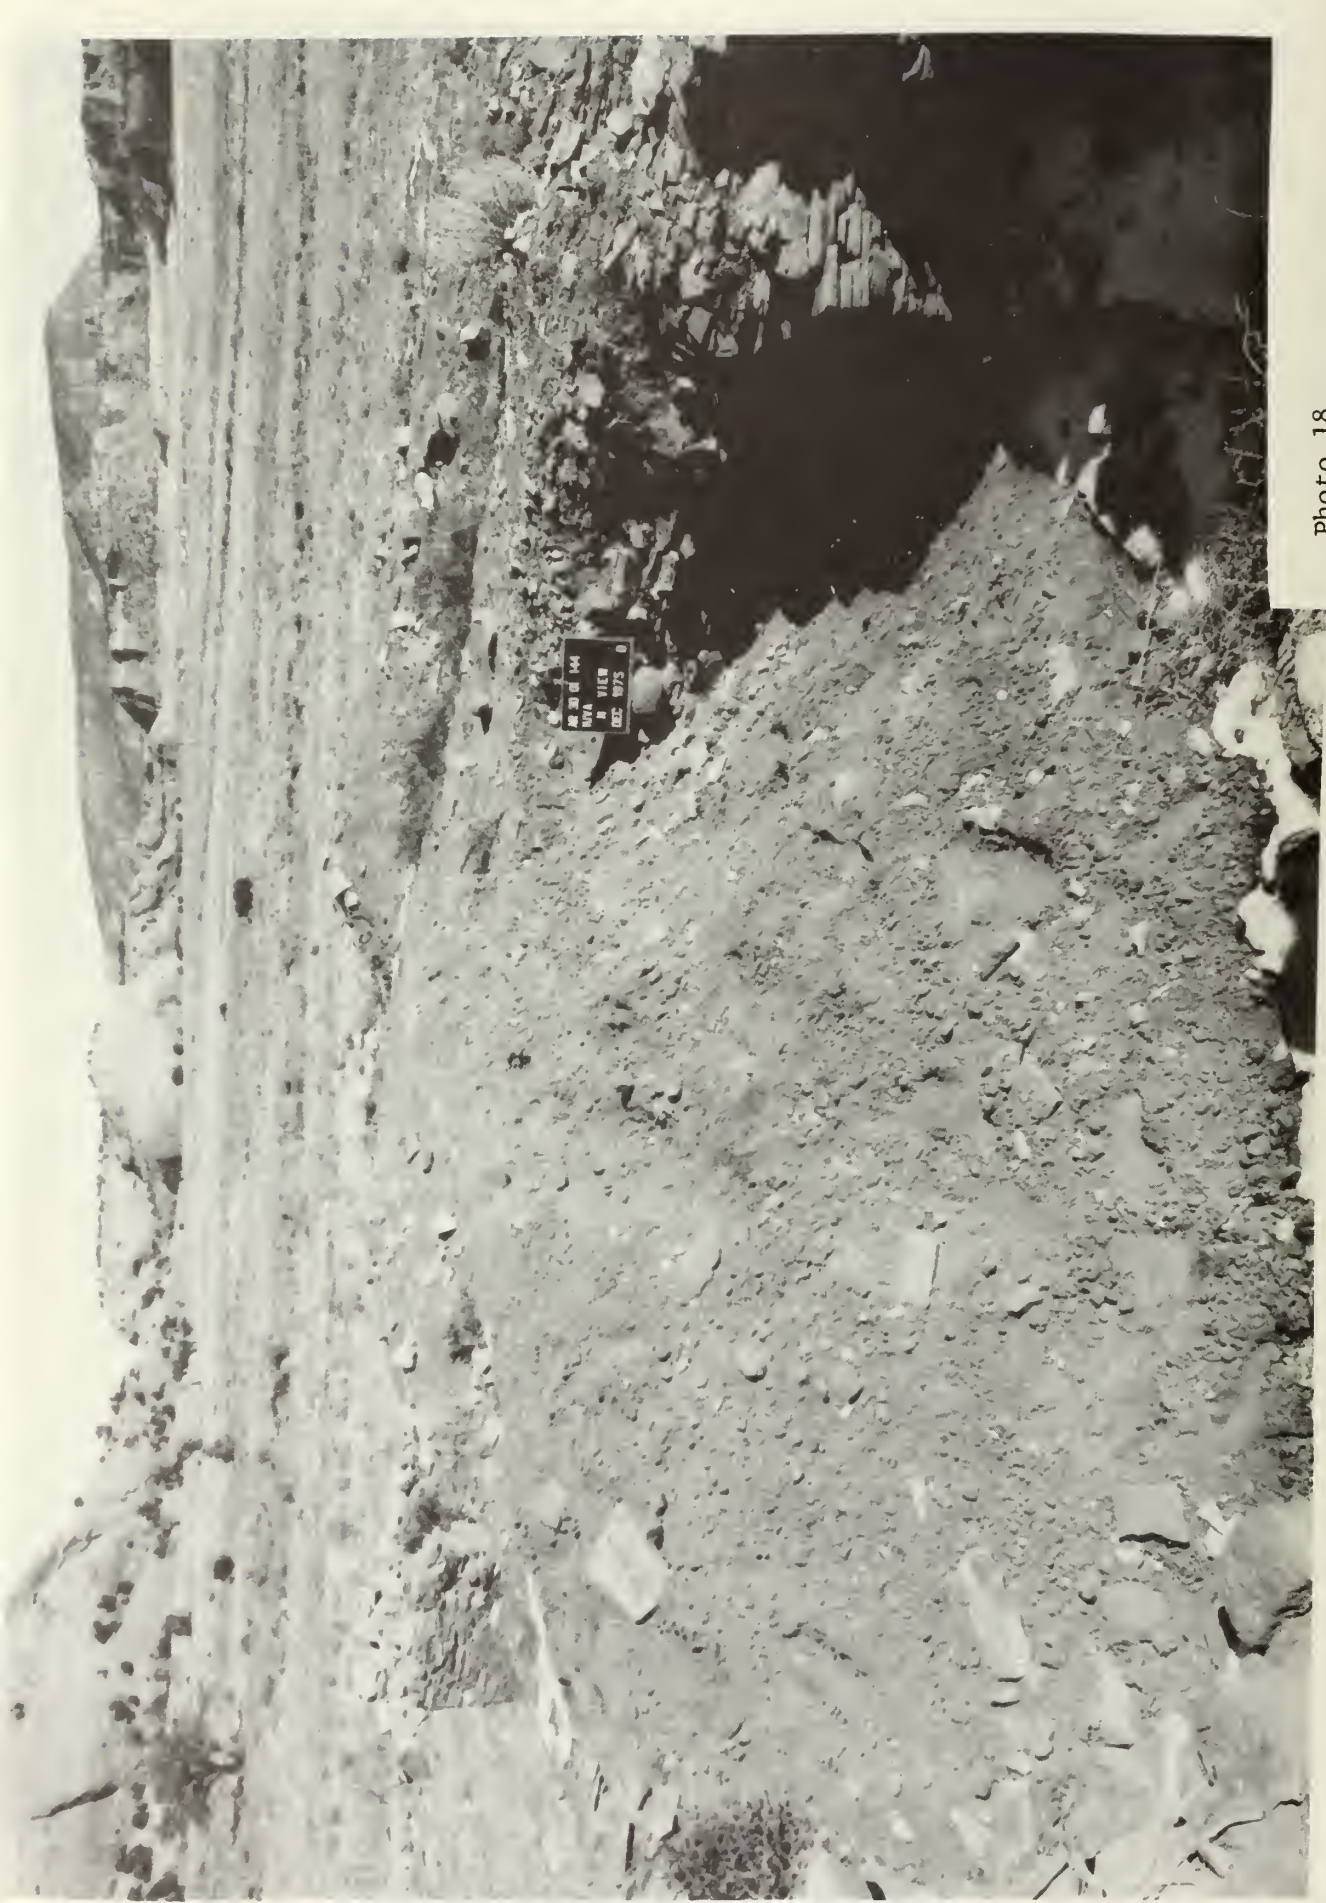
Photo 18

Excavation spoil material causing  
unequal pressure in kiva  
Before stabilization  
Casamero AR-NM-01-144

Each room will require attention. This will vary from simple debris removal to considerable effort in the Kiva (Photos 18, 19). Particular attention is needed for the sub-floor excavation in rooms 1, 3, & 6. These excavations exposed the wall foundations, thus placing the structural integrity of the walls in jeopardy. The holes must be cleaned, the wall foundations stabilized, and the hole backfilled with a densely compacted material.

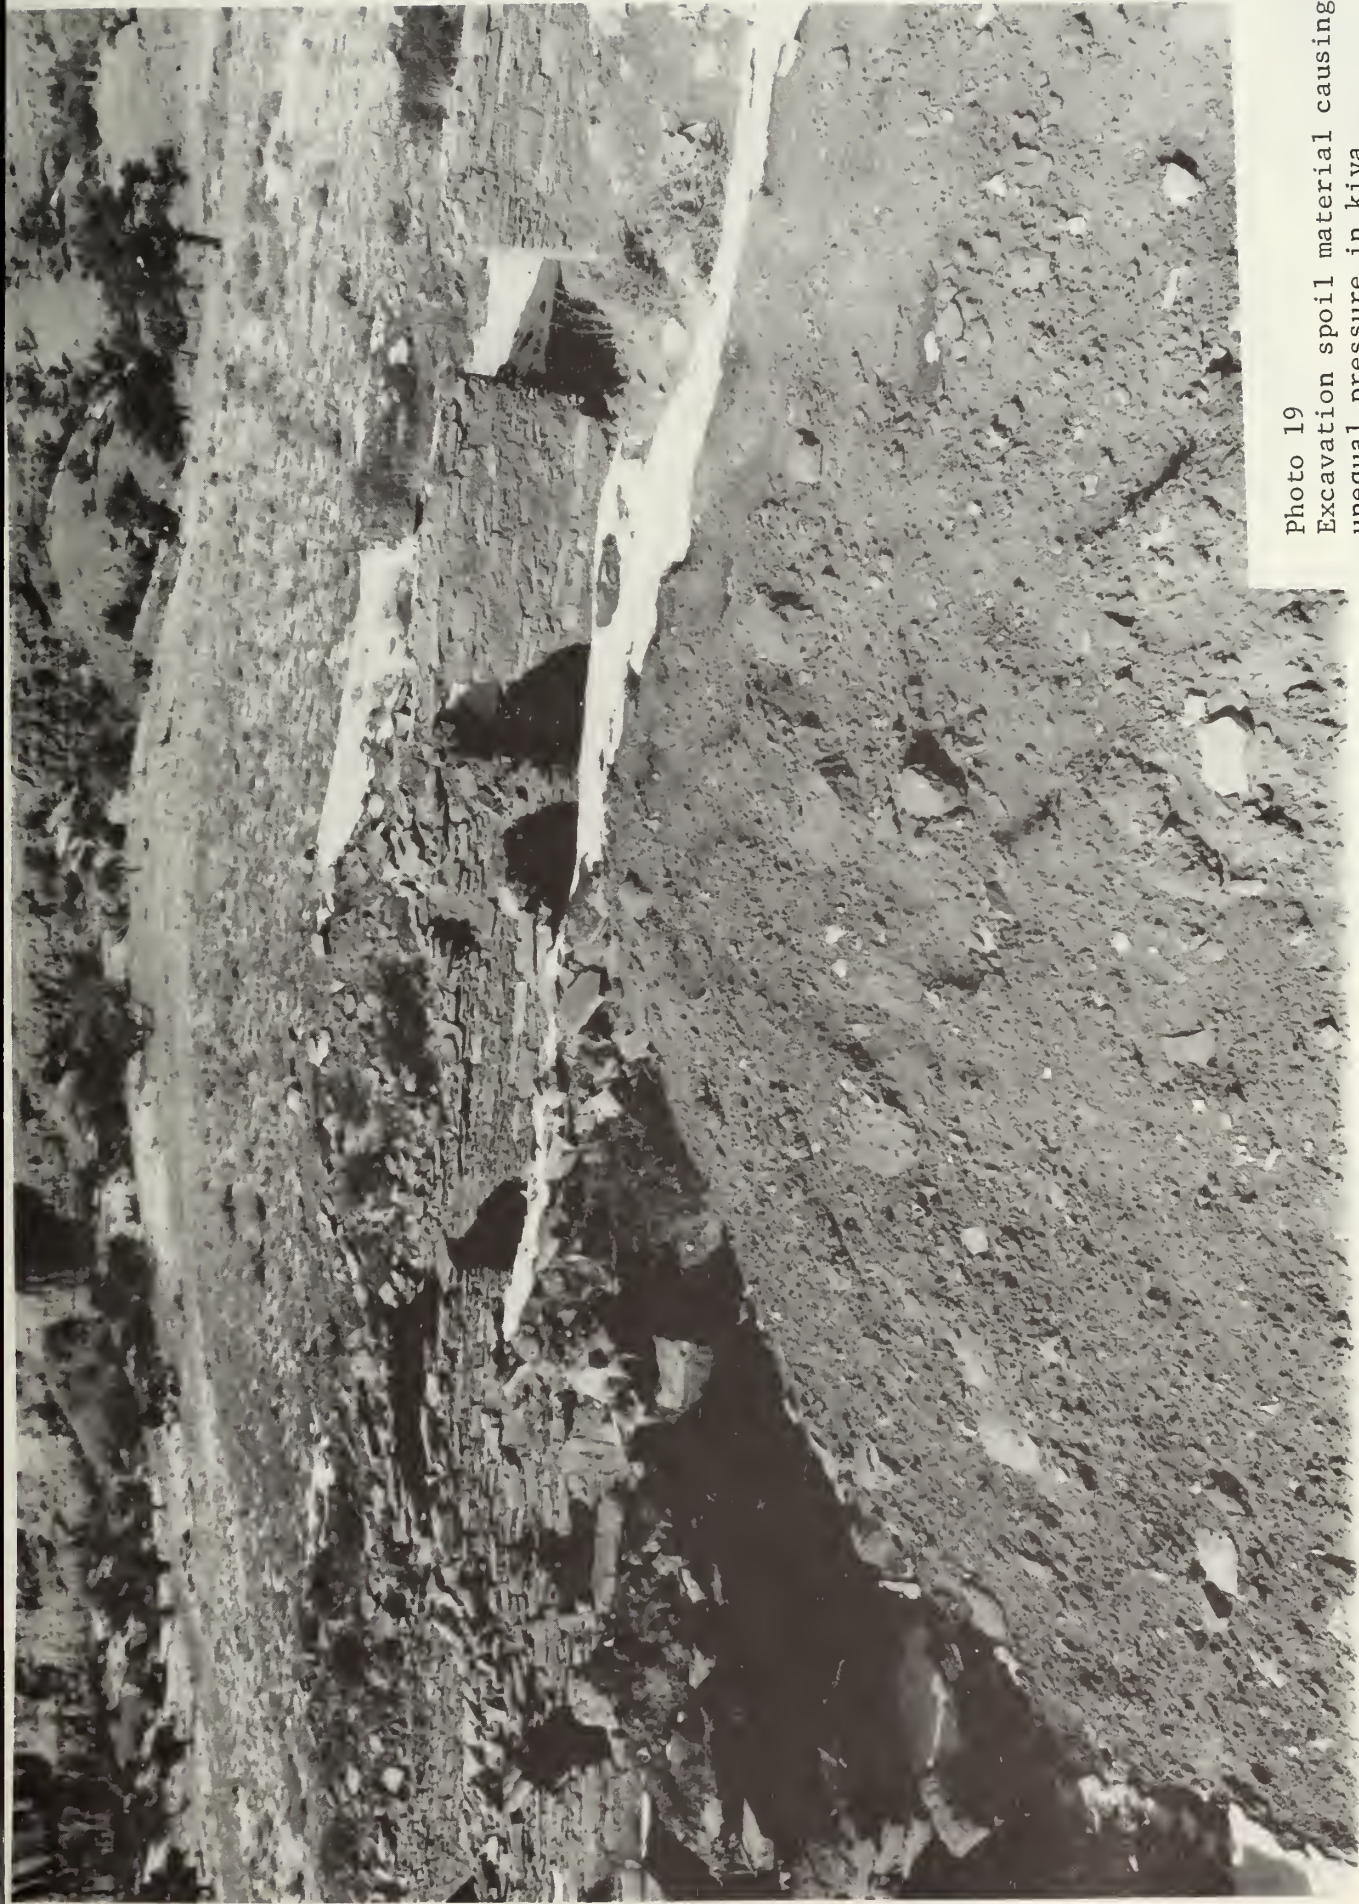
Photo 19  
Excavation spoil material causing  
unequal pressure in kiva  
Before stabilization  
Casamero AR-NM-01-144

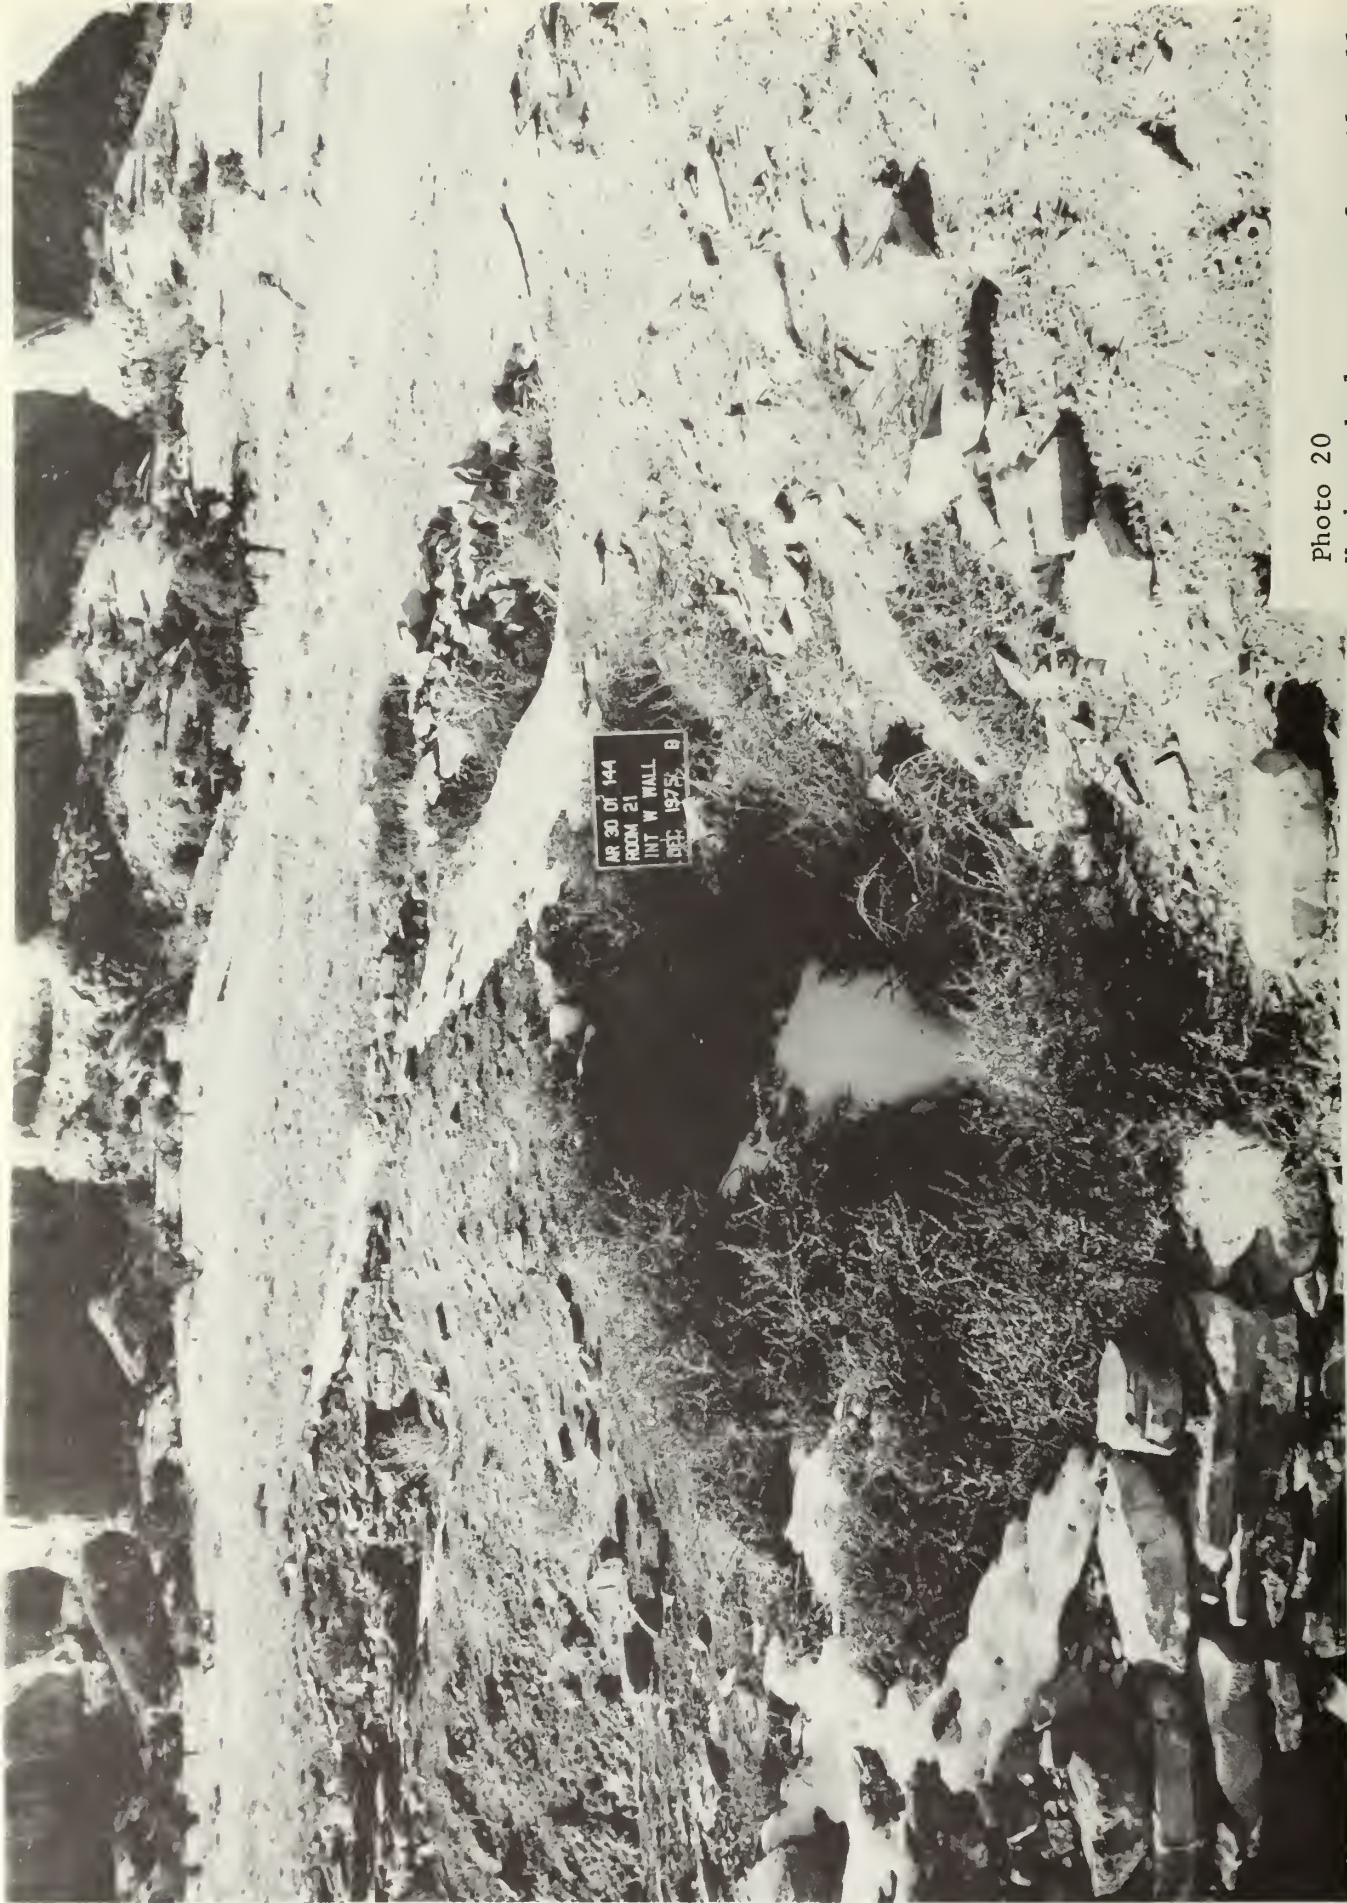
Photo 20

Haphazard placement of spoil, wall  
definition difficult  
Before stabilization  
Casamero AR-NM-01-144

2.2 ESTABLISHMENT OF WALL ALIGNMENTS- Because of the haphazard placement of spoils material, wall identification was extremely difficult. Trenches were dug on both interior and exterior sides of all walls that were reported to have been dug in 1963 and 1966-1967. Minimal excavation took place, but in most cases, the trenches were 18"-24" wide, exposing enough of the wall so that repairs and reconstruction could be made with minimal destruction. While excavations were being performed, the Team Archaeologist was on hand for careful supervision of exact location of walls.
