# PHYSICAL PROTECTION WORKBOOK

### CASAMERO SITE-PHASE III

(AR-NM-01-144) ALBUQUERQUE DISTRICT

PHYSICAL PROTECTION WORKBOOK

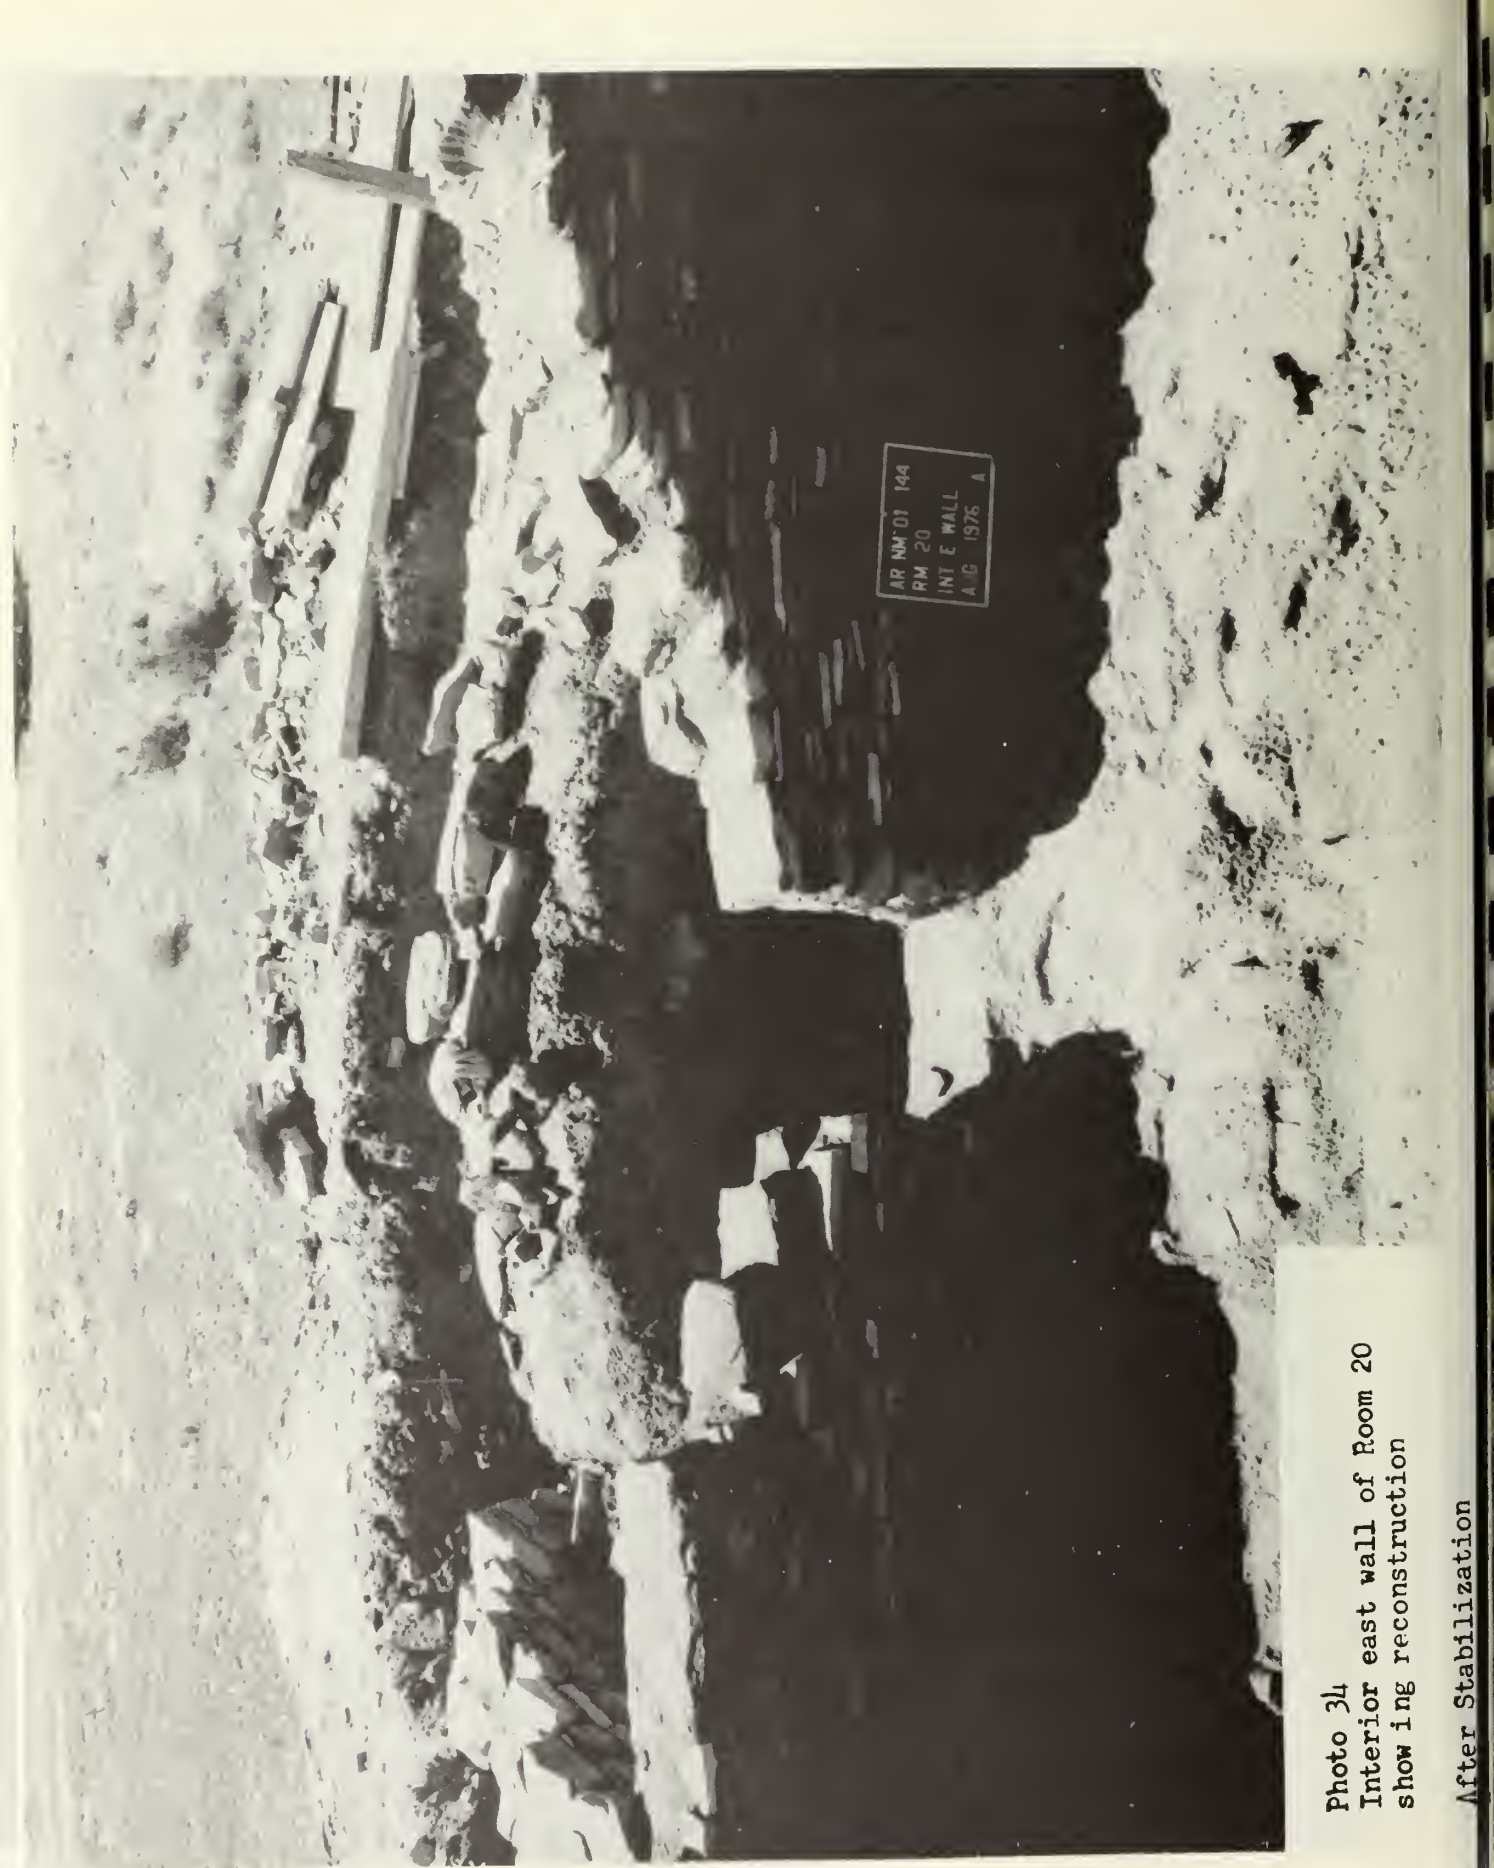
Photo 34  
Interior east wall of Room 20  
showing reconstruction

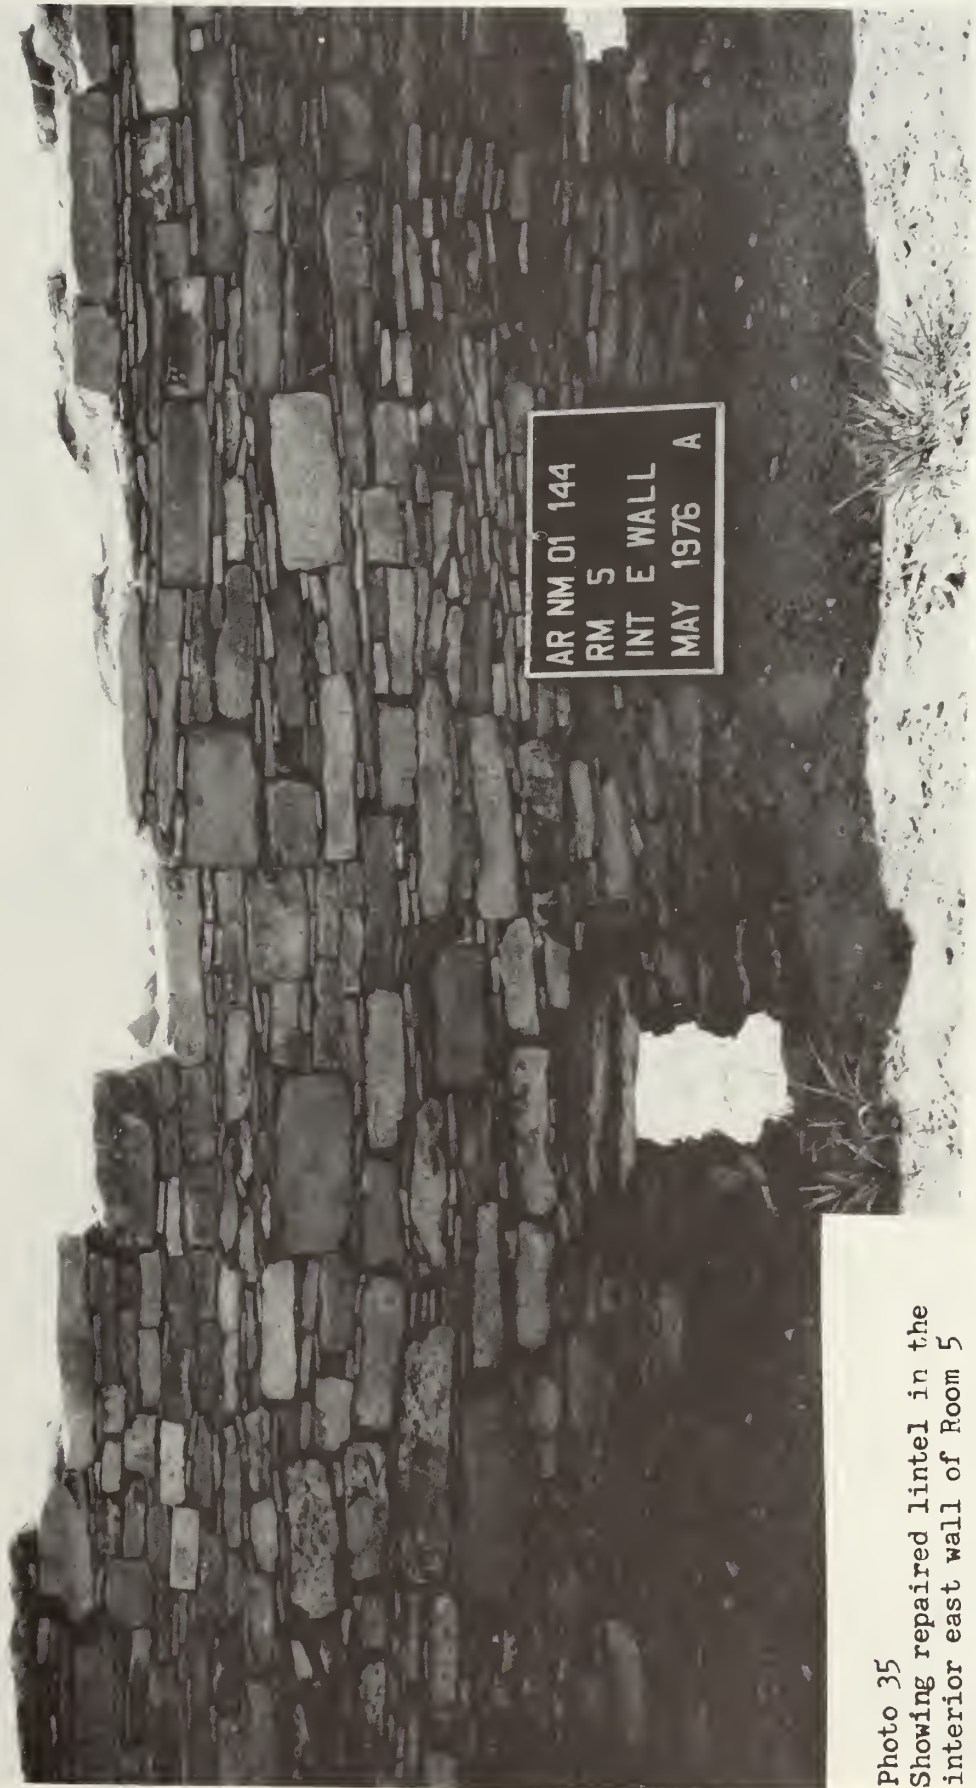
Photo 35  
Showing repaired lintel in the  
interior east wall of Room 5

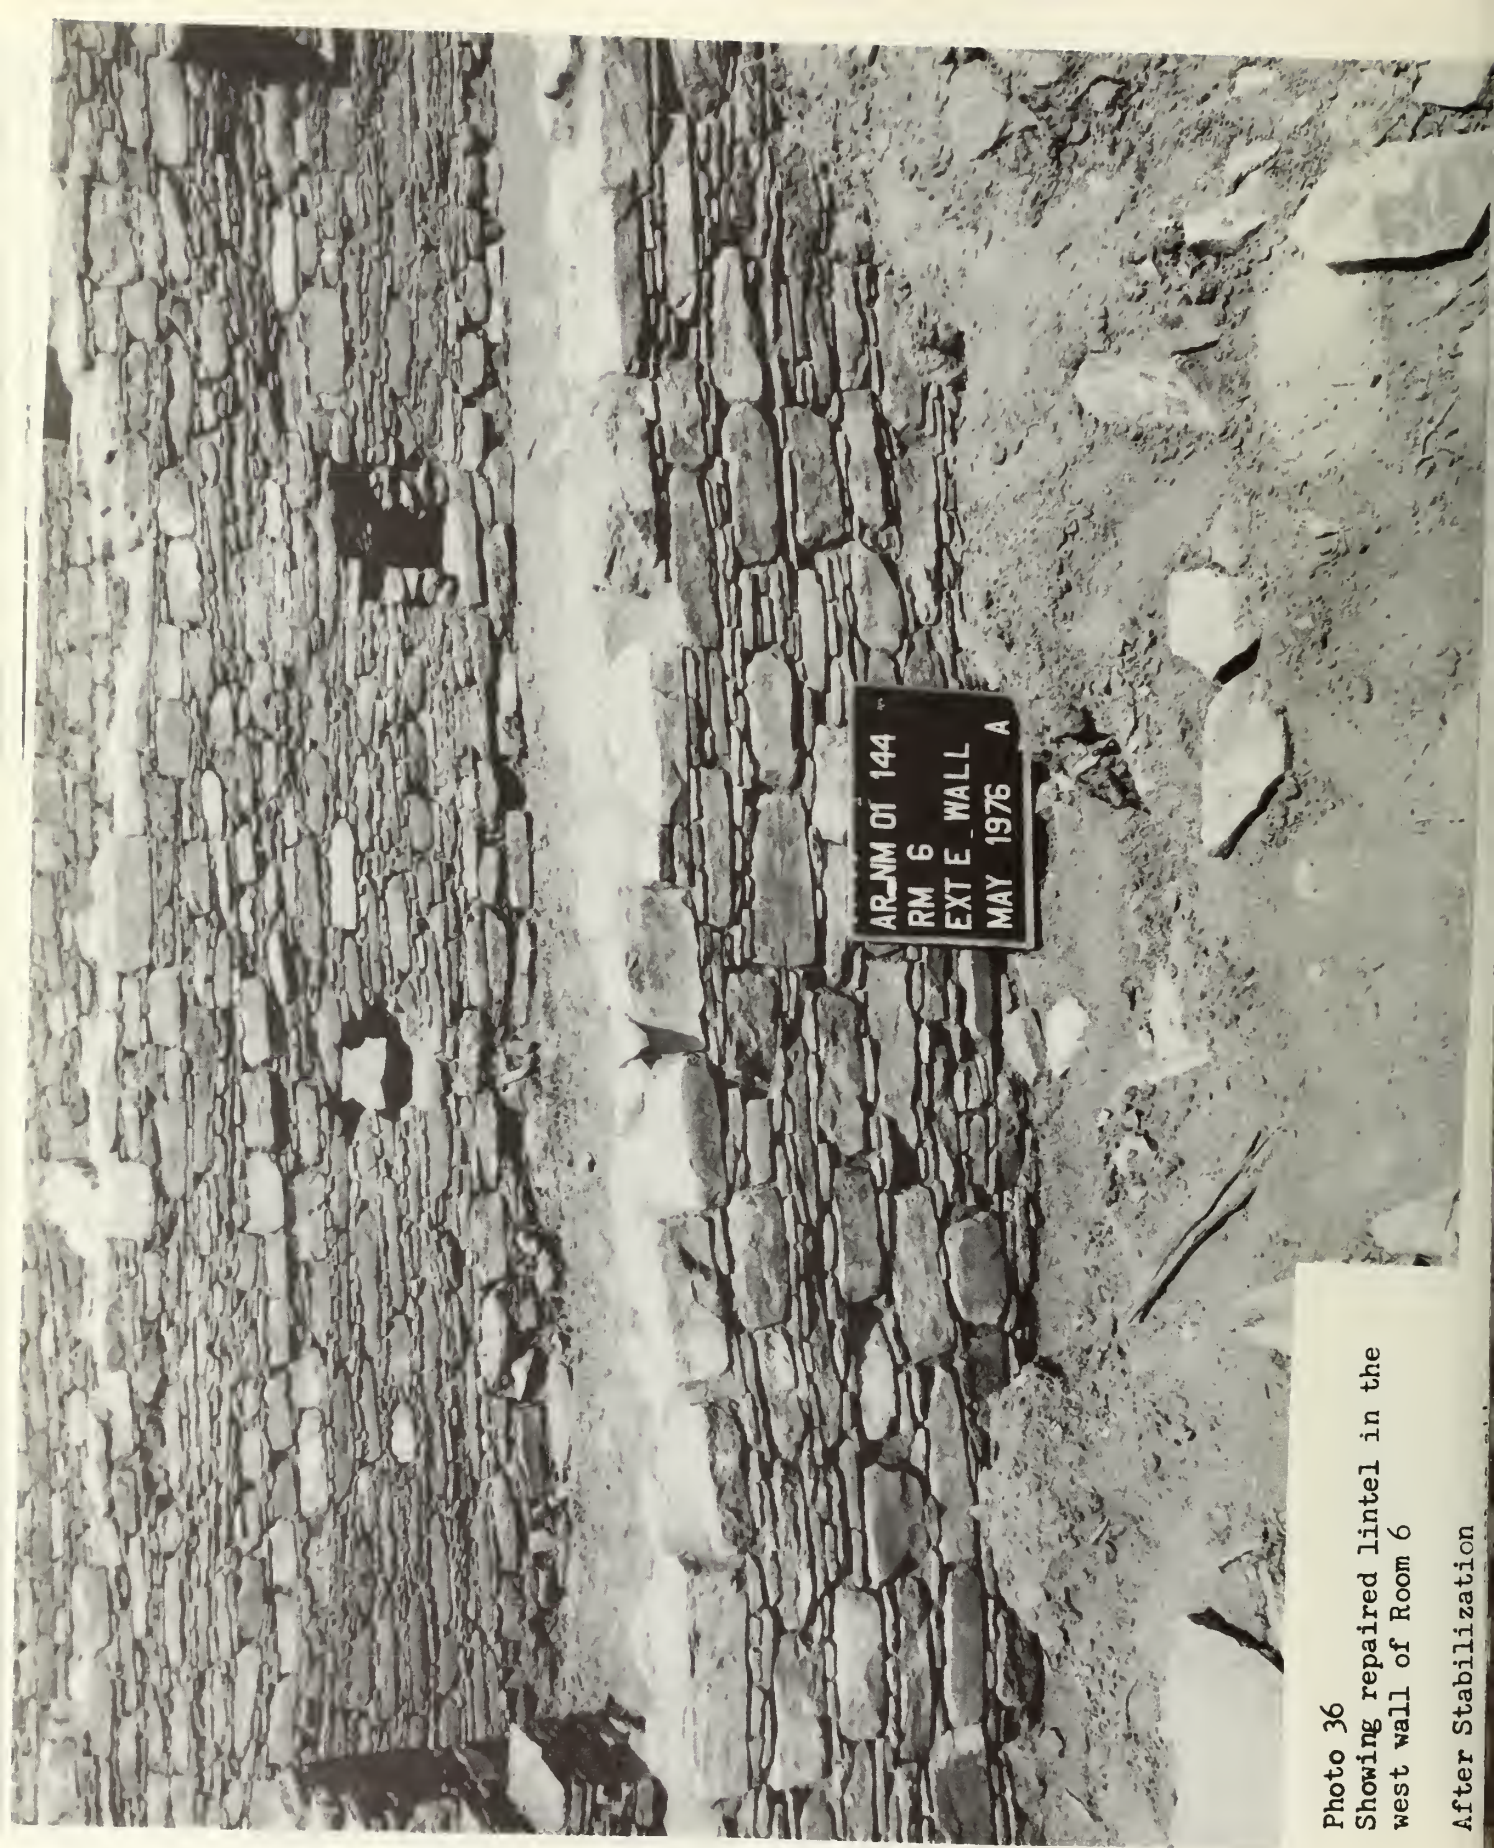
Photo 36  
Showing repaired lintel in the  
west wall of Room 6  
After Stabilization

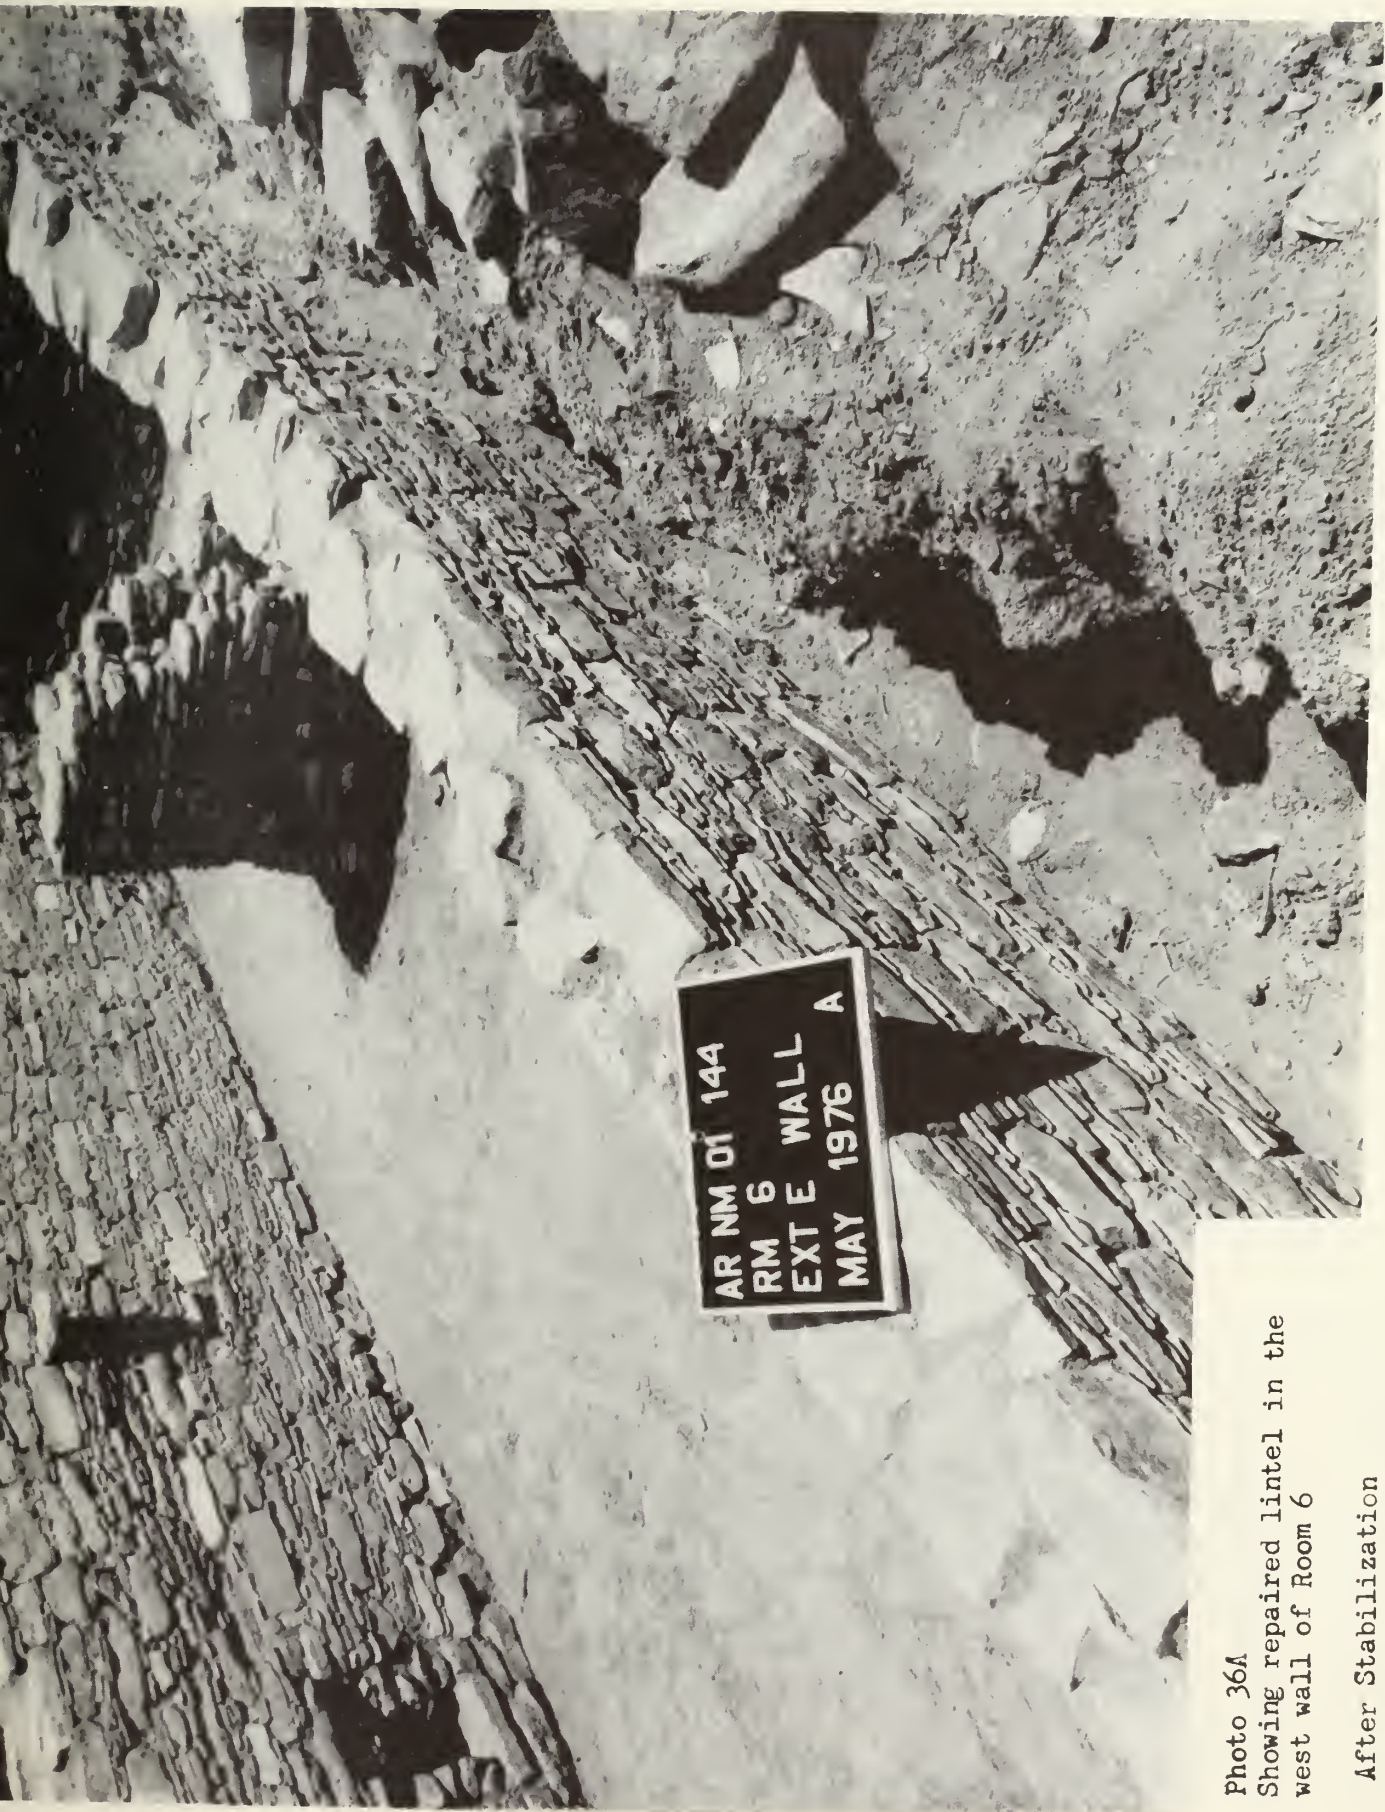
Photo 36A  
Showing repaired lintel in the  
west wall of Room 6

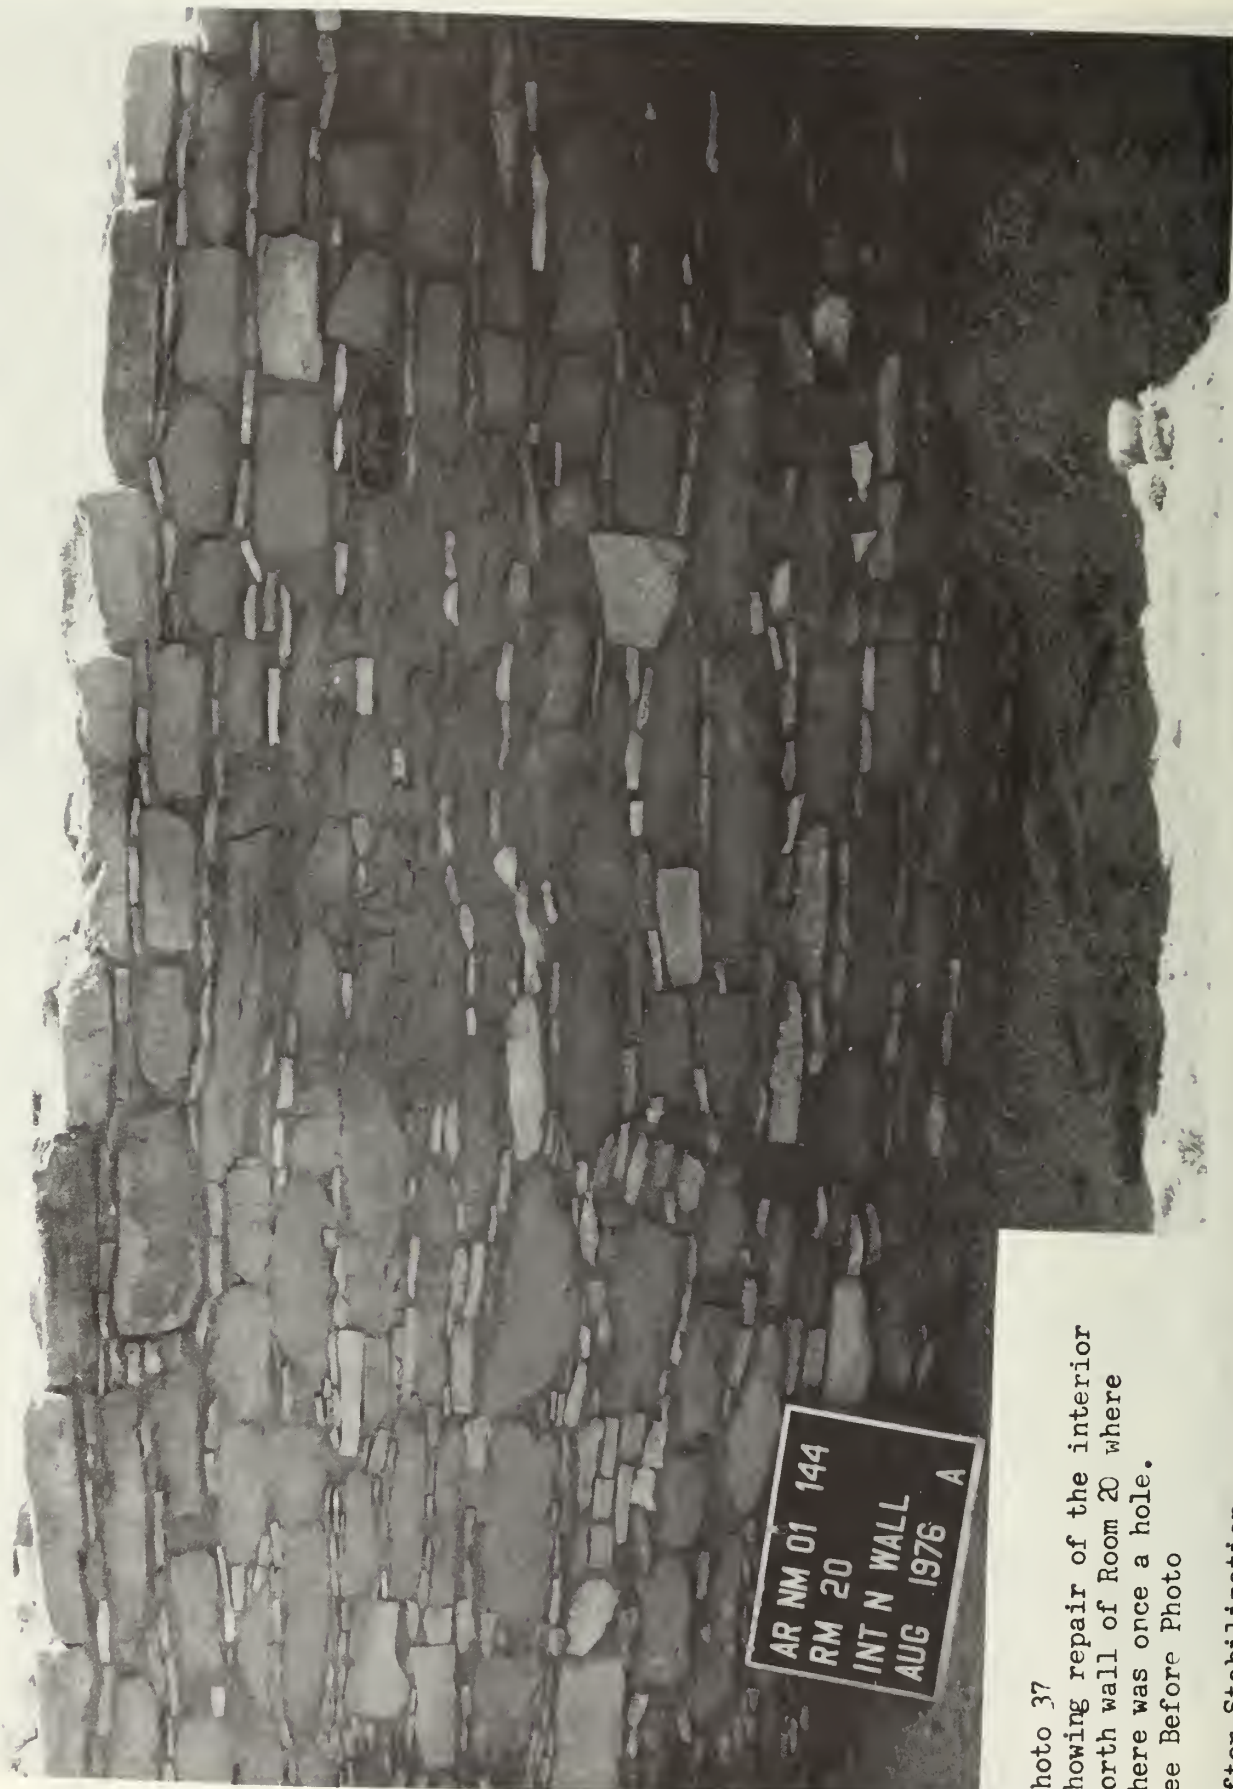
AR NM 01 144  
RM 20  
INT N WALL  
AUG 1976 A

Photo 37  
Showing repair of the interior  
north wall of Room 20 where  
there was once a hole.  
See Before Photo

2.3 RECONSTRUCTION- Reconstruction was kept to a minimum and included only those areas that had a degrading effect on the structural integrity and stability of the site. Specific examples include: (1) In Trench A and Trench B, that were dug during the excavation in 1966 by Anne Sigleo, were placed some perforated plastic to show the present level, then was backfilled. (2) The west walls of Rooms 3 and 5 were in dire need of reconstruction because of back dirt pressure causing cave-ins. After establishment of exact wall locations, all loose material was removed from the areas and grouting and capping procedures began. The original west wall of Rooms 3 and 5 leaned too much to repair, so it was reconstructed (See Photos 31 and 32). The walls were reconstructed with limestone fall rock located on the site, and stabilized adobe. The walls were then capped and grouted with a minimum of two courses of masonry to the existing horizontal walls. (3) The east walls of Rooms 6 and 20 also were in need of repair and reconstruction because of back dirt pressure and continued visitor use causing the walls to collapse and cave in. The walls, as in Rooms 3 and 5, were reconstructed of limestone fall material located in and around the site, and securely stabilized with stabilized adobe. The walls were then capped and grouted with a minimum of two courses of masonry to the existing horizontal walls (See Photos 33 and 34). (4) The lintel located in the ventilator ports of the wall between Rooms 5 and 6 was repaired (See Photos 35, 36 and 36A). (5) Above the doorway located in the east wall of Room 12, there was lintel failure. This was repaired. (6) Before repairs could be made on the hole in the base of the north wall of Room 20, a pit was dug on the inside of the wall to expose the hole. The area was cleaned of all loose material and was repaired with fall rock located on the site (See Photo 37).

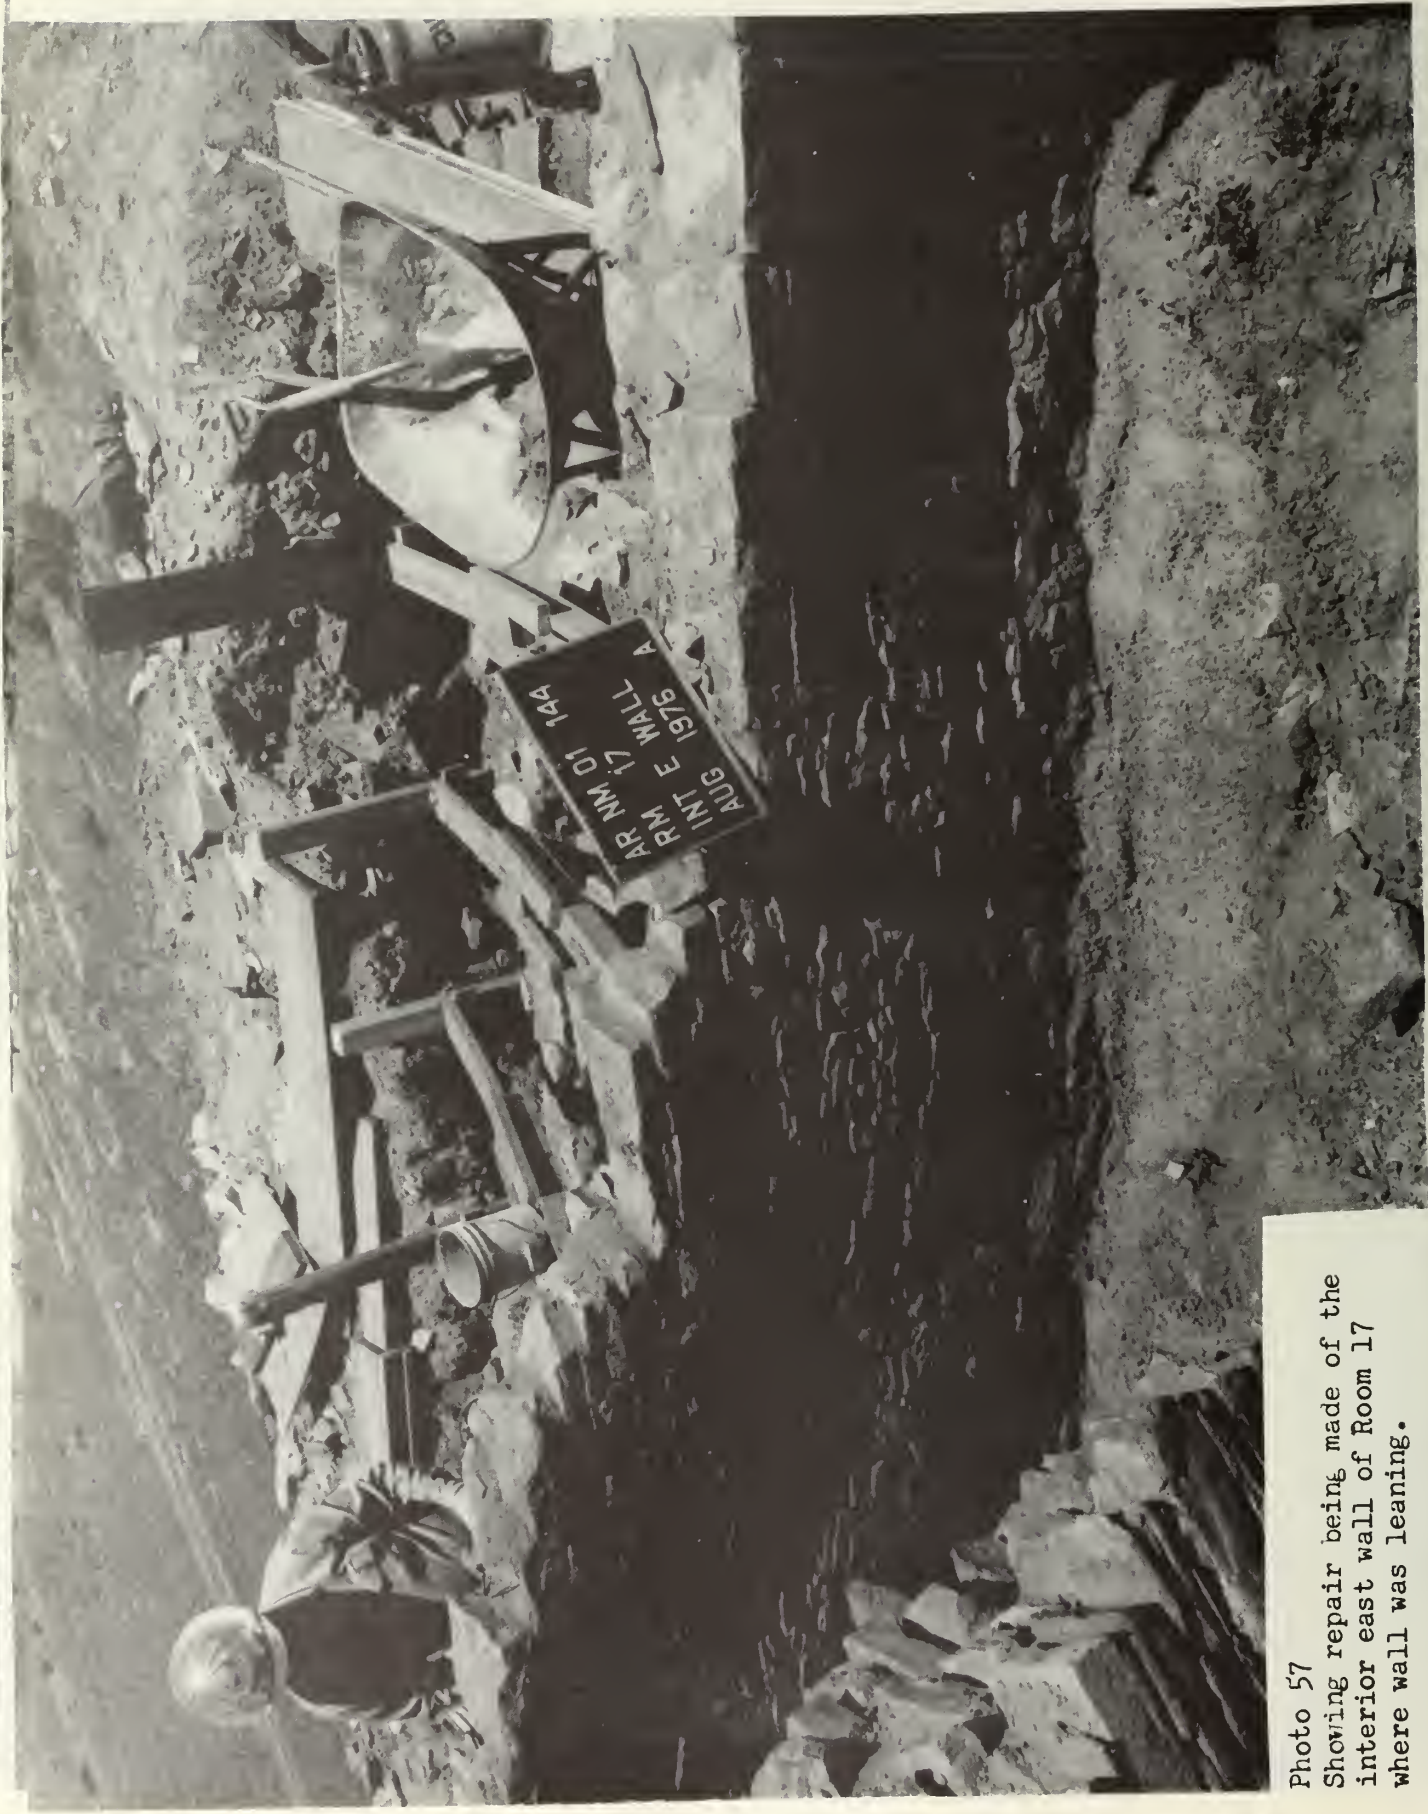
Photo 57  
Showing repair being made of the  
interior east wall of Room 17  
where wall was leaning.

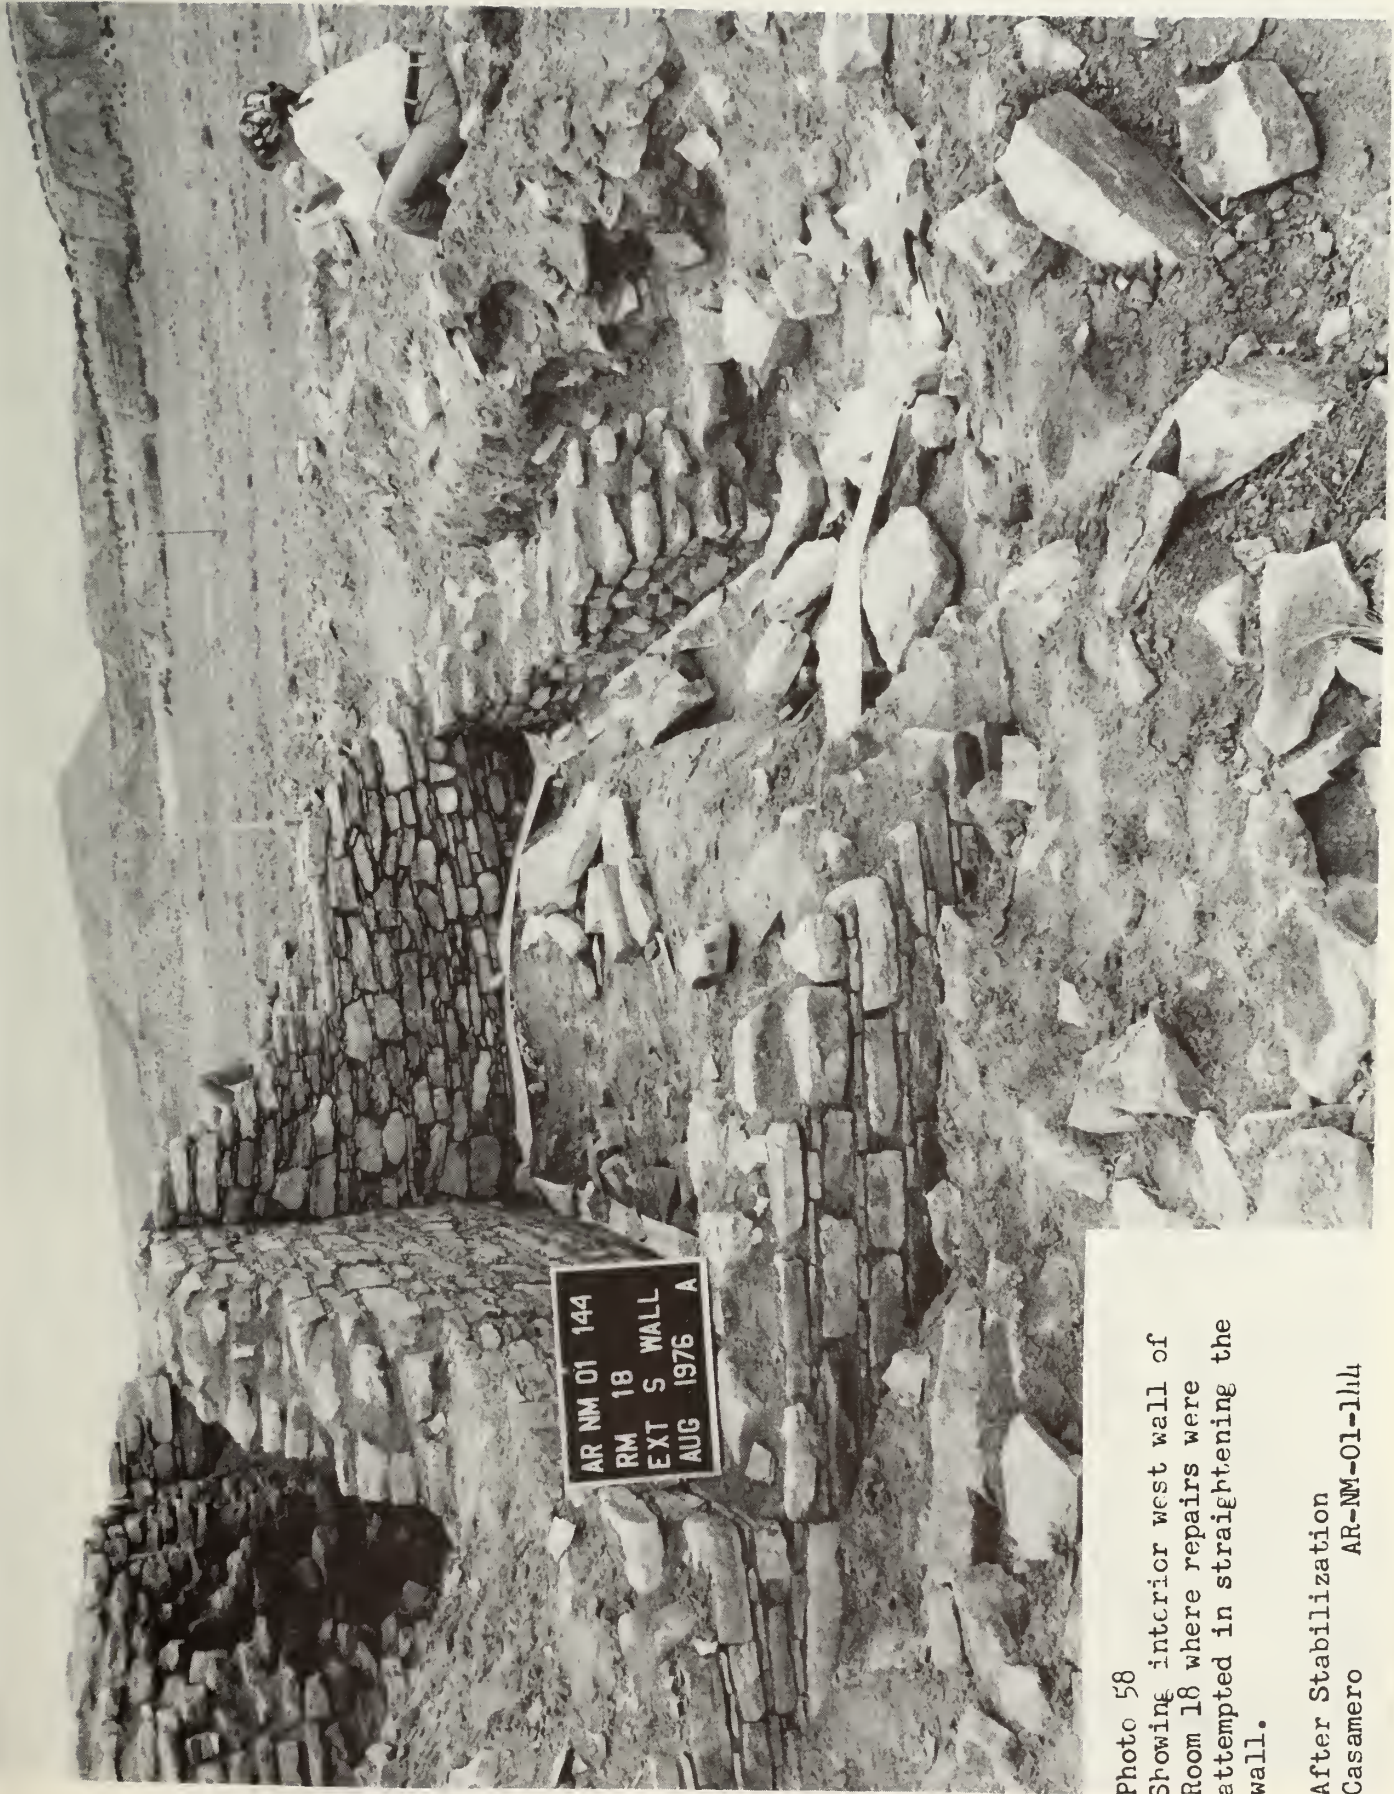
Photo 58  
Showing interior west wall of  
Room 18 where repairs were  
attempted in straightening the  
wall.

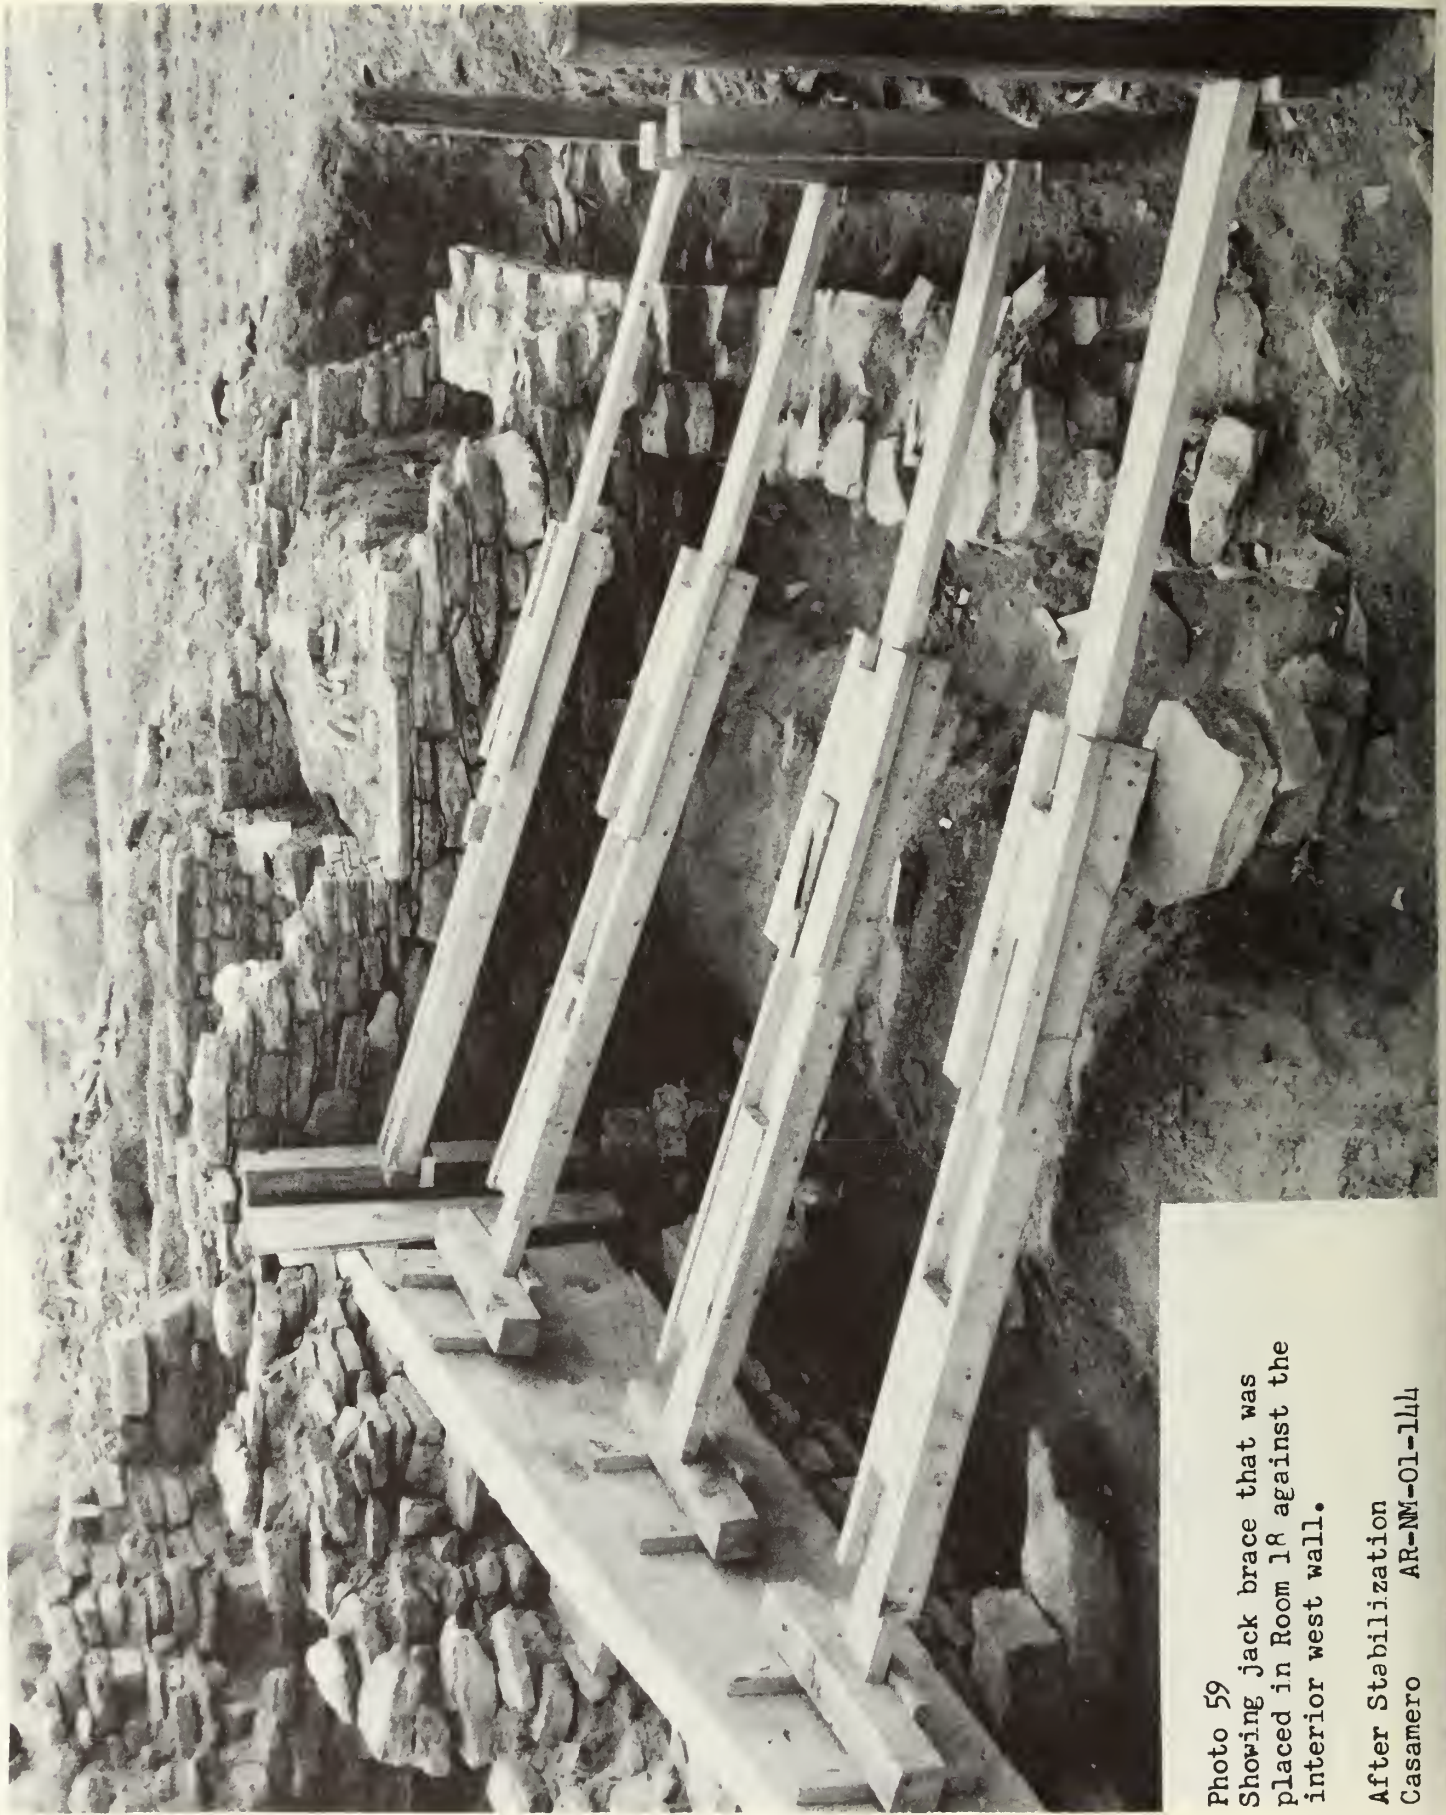
Photo 59  
Showing jack brace that was  
placed in Room 18 against the  
interior west wall.

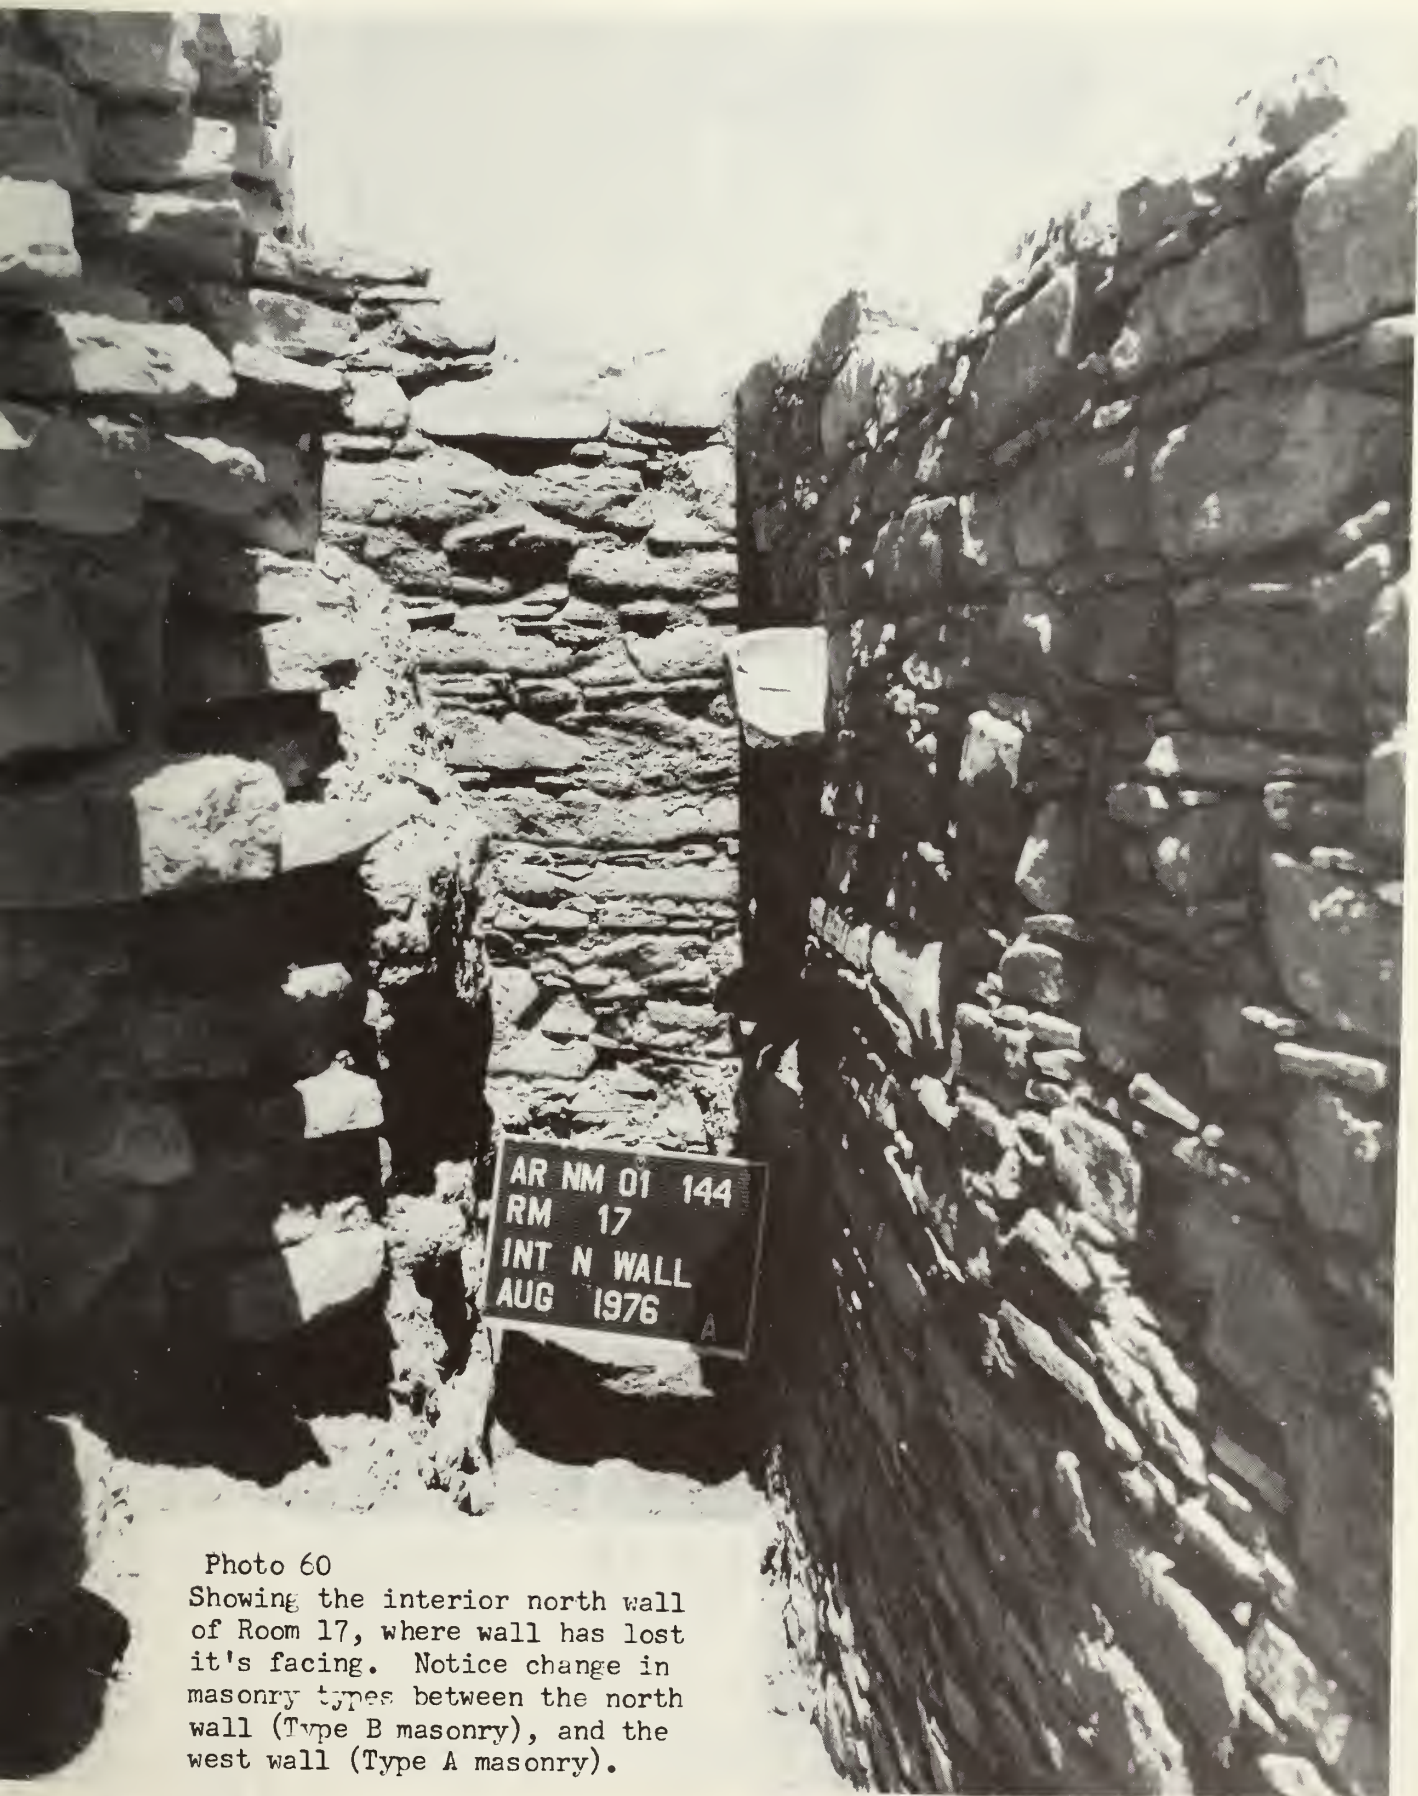
Photo 60  
Showing the interior north wall  
of Room 17, where wall has lost  
it's facing. Notice change in  
masonry types between the north  
wall (Type B masonry), and the  
west wall (Type A masonry).
