# PHYSICAL PROTECTION WORKBOOK

### CASAMERO SITE-PHASE III

(AR-NM-01-144) ALBUQUERQUE DISTRICT

PHYSICAL PROTECTION WORKBOOK

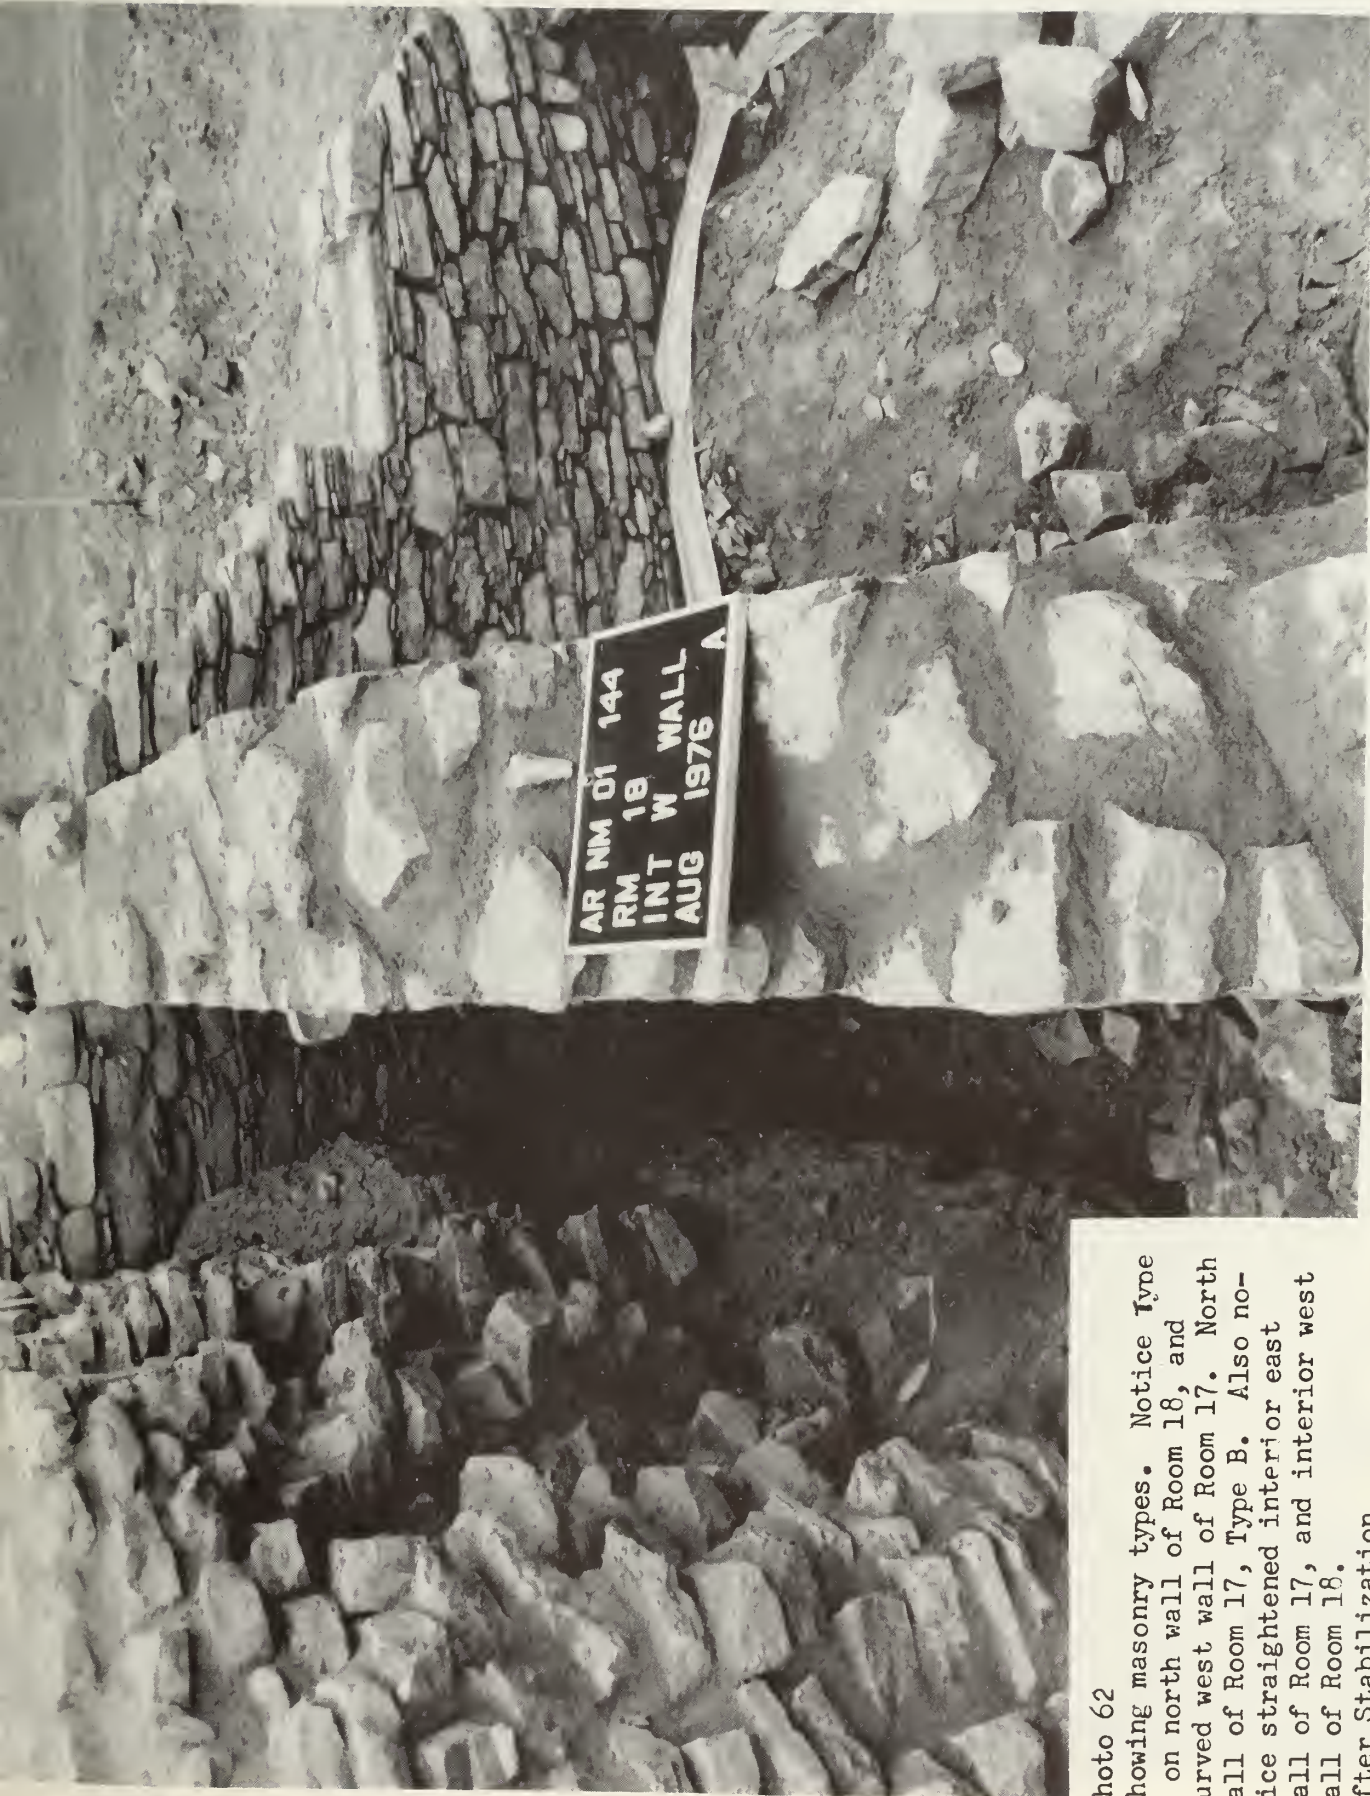
Photo 62  
Showing masonry types. Notice Type A on north wall of Room 18, and curved west wall of Room 17. North wall of Room 17, Type B. Also notice straightened interior east wall of Room 17, and interior west wall of Room 18.

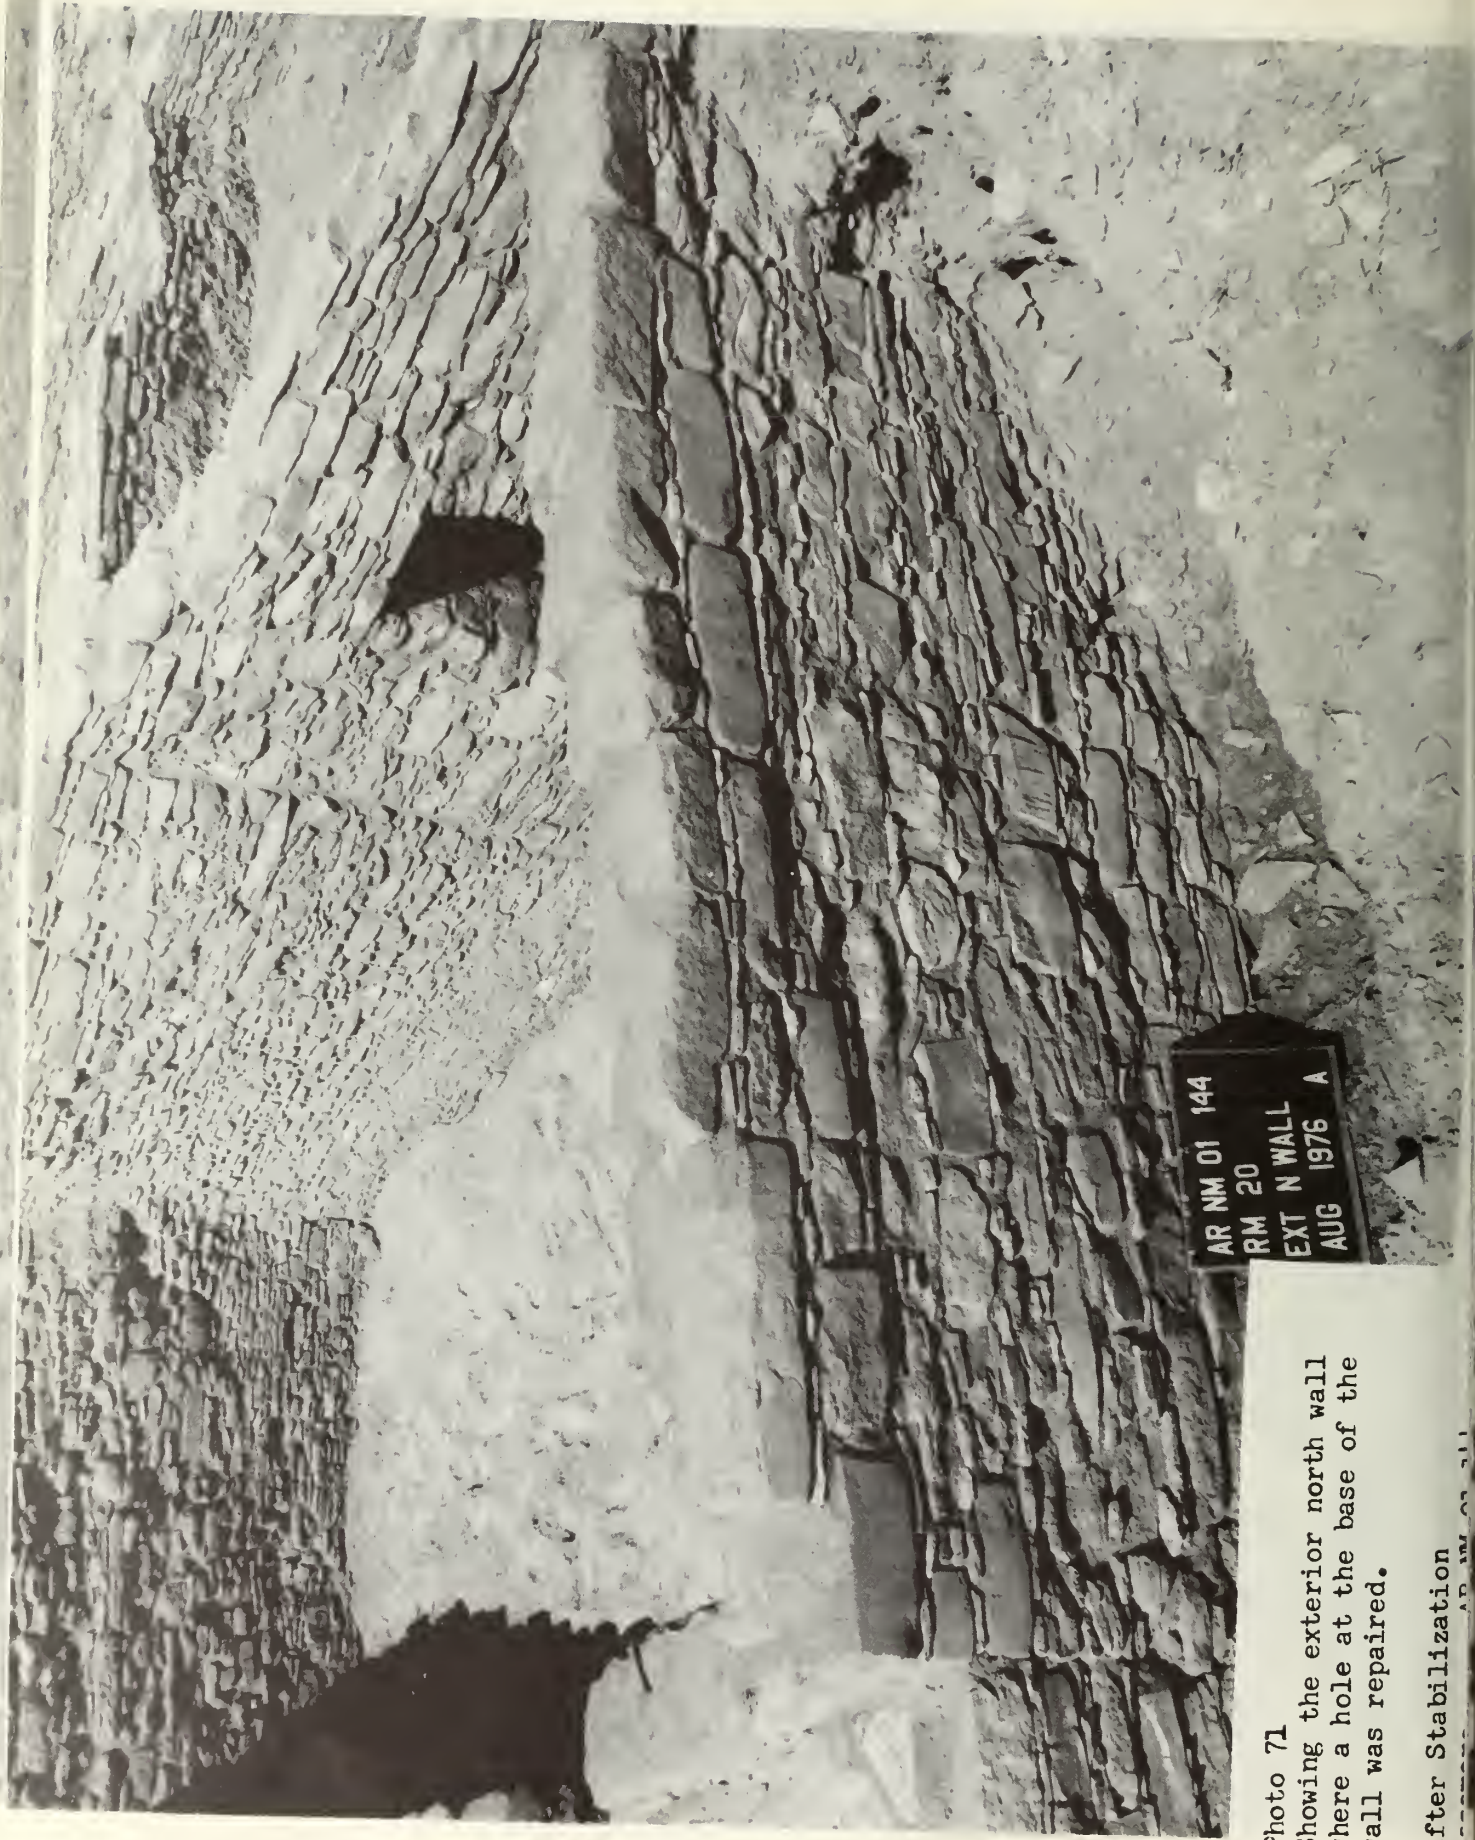
Photo 71  
Showing the exterior north wall  
where a hole at the base of the  
wall was repaired.

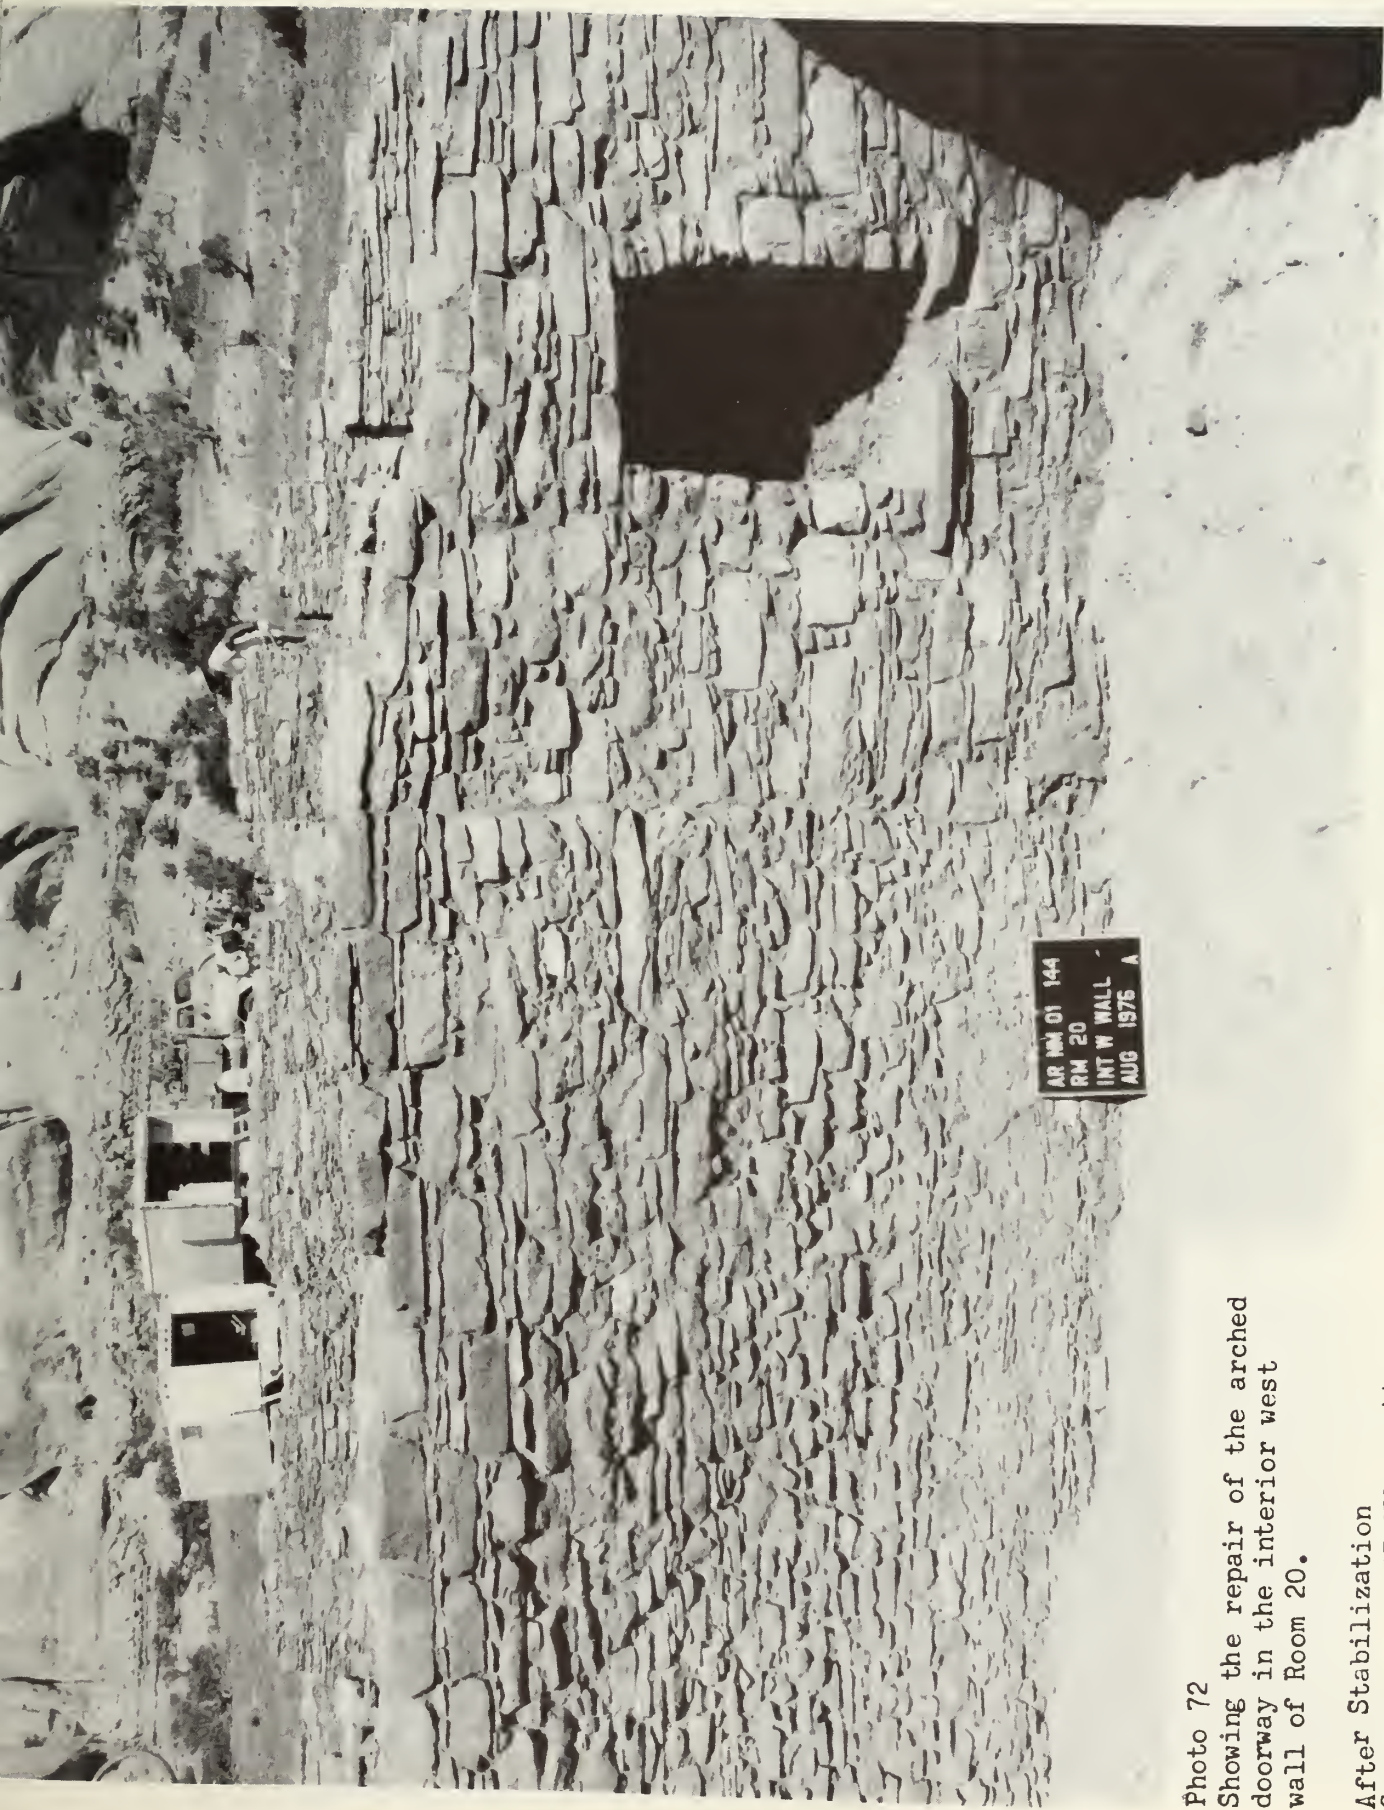
Photo 72  
Showing the repair of the arched  
doorway in the interior west  
wall of Room 20.

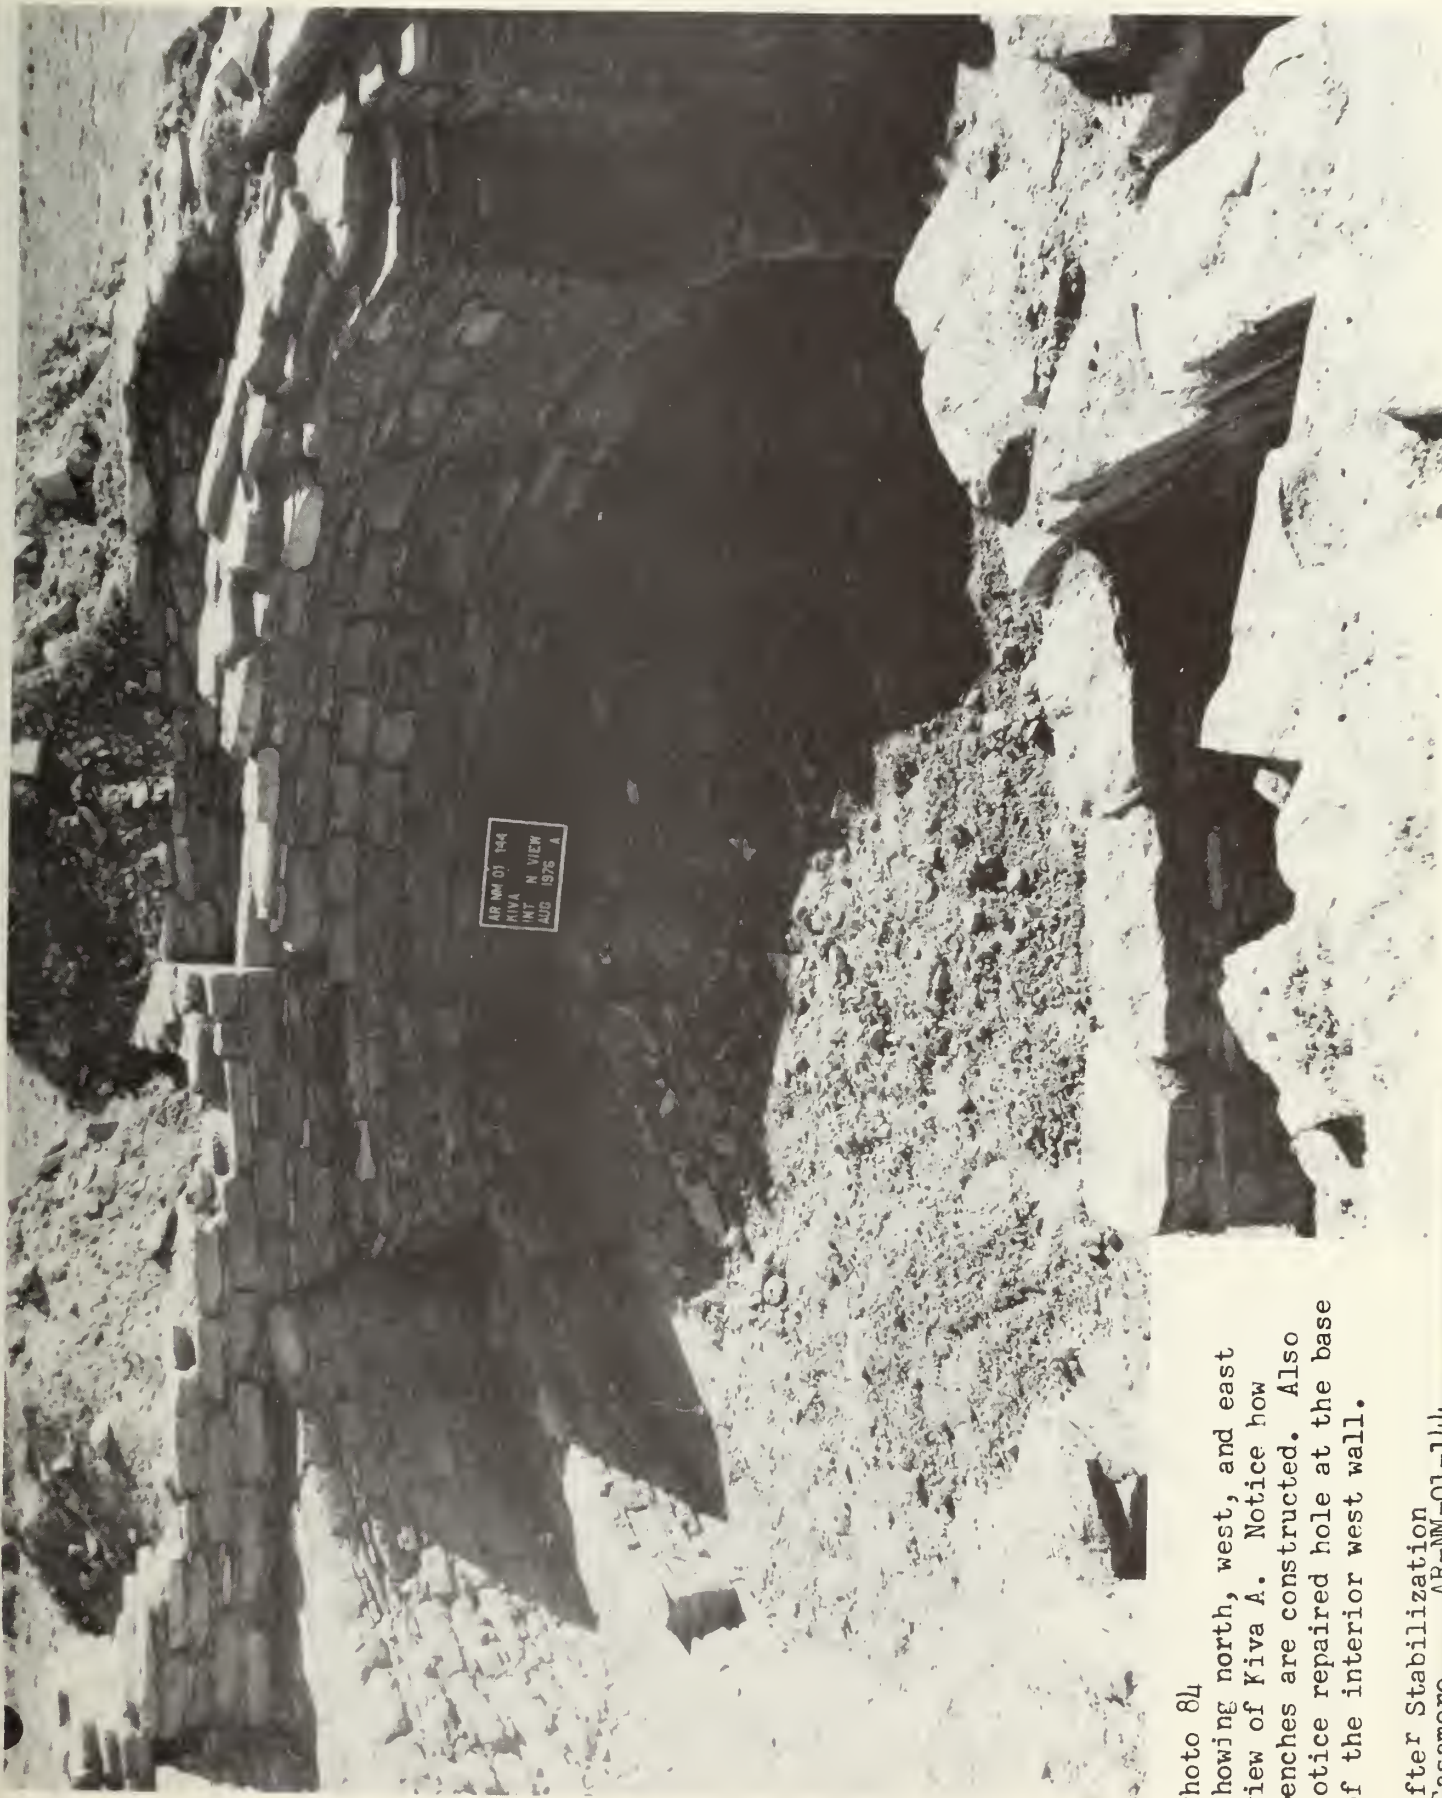
Photo 84  
Showing north, west, and east  
view of Kiva A. Notice how  
benches are constructed. Also  
notice repaired hole at the base  
of the interior west wall.

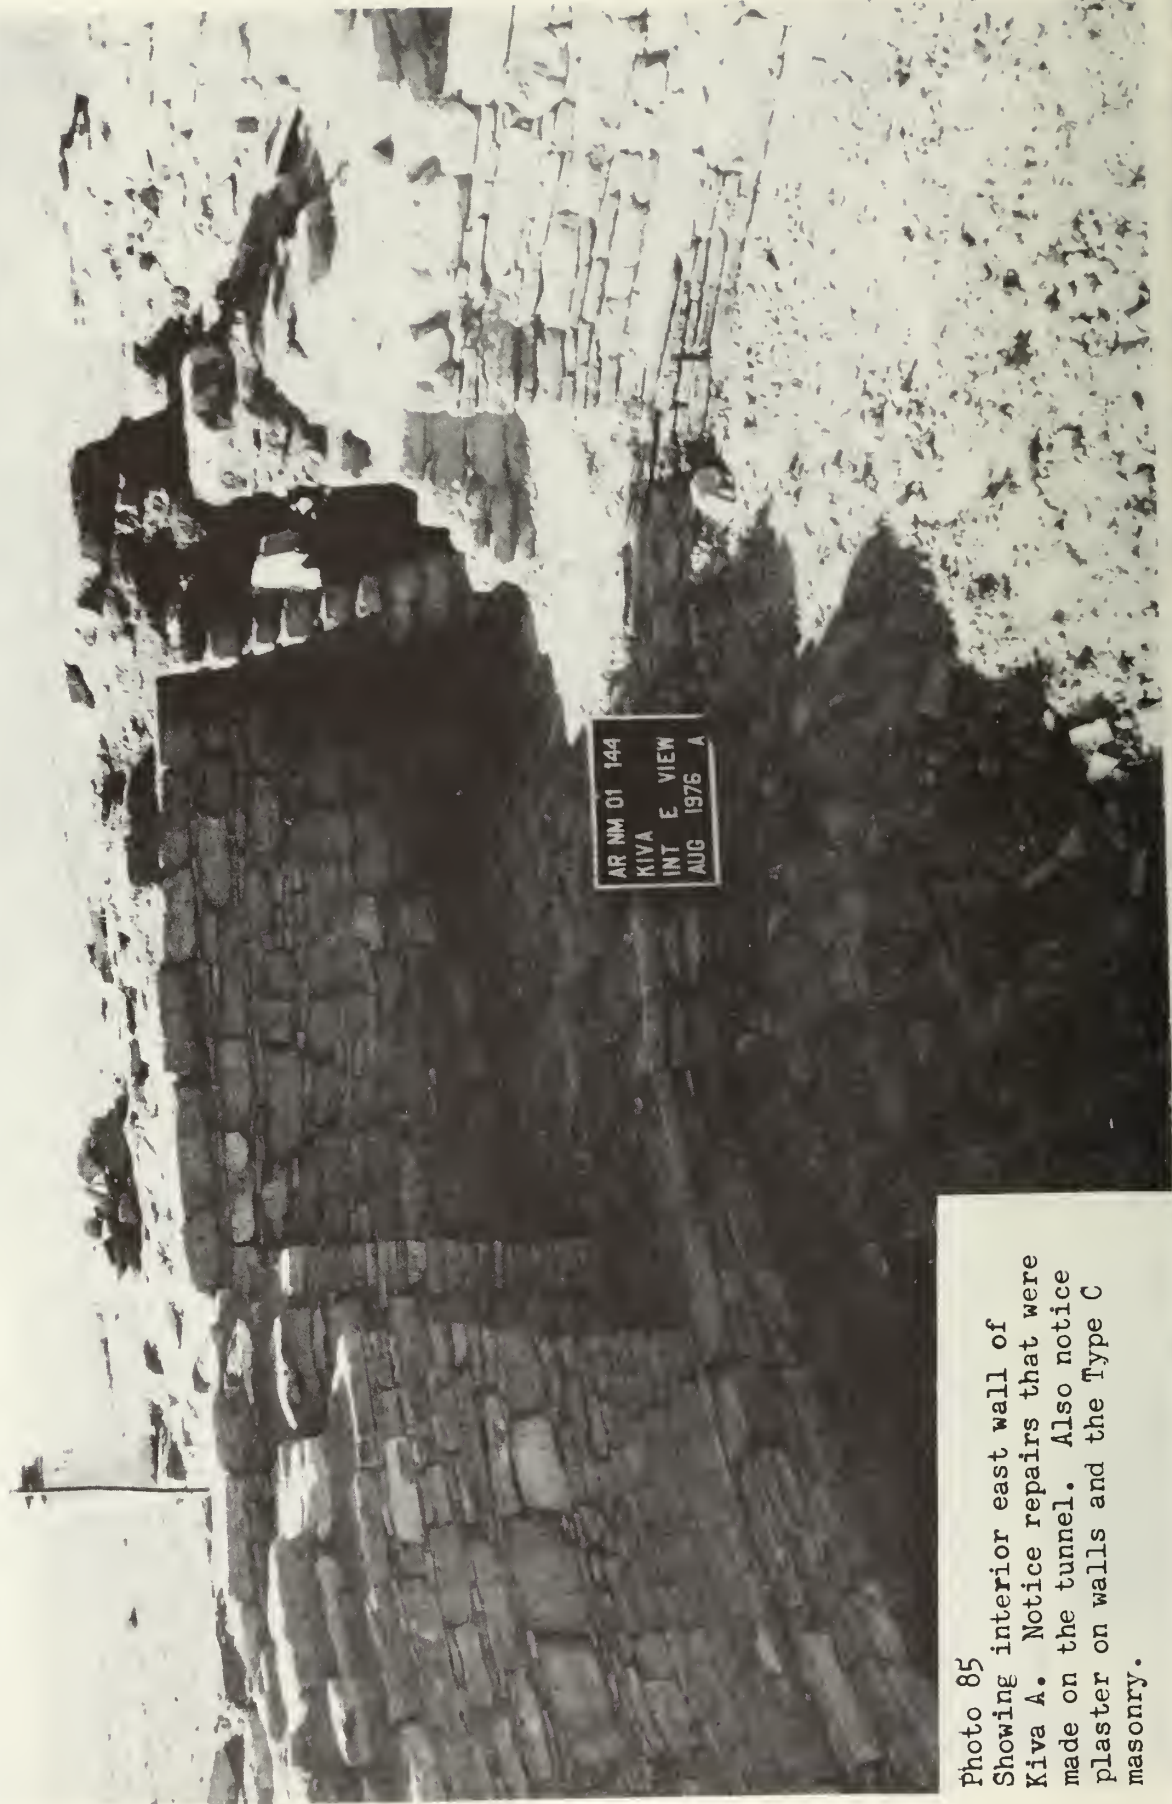
Photo 85  
Showing interior east wall of  
Kiva A. Notice repairs that were  
made on the tunnel. Also notice  
plaster on walls and the Type C  
masonry.

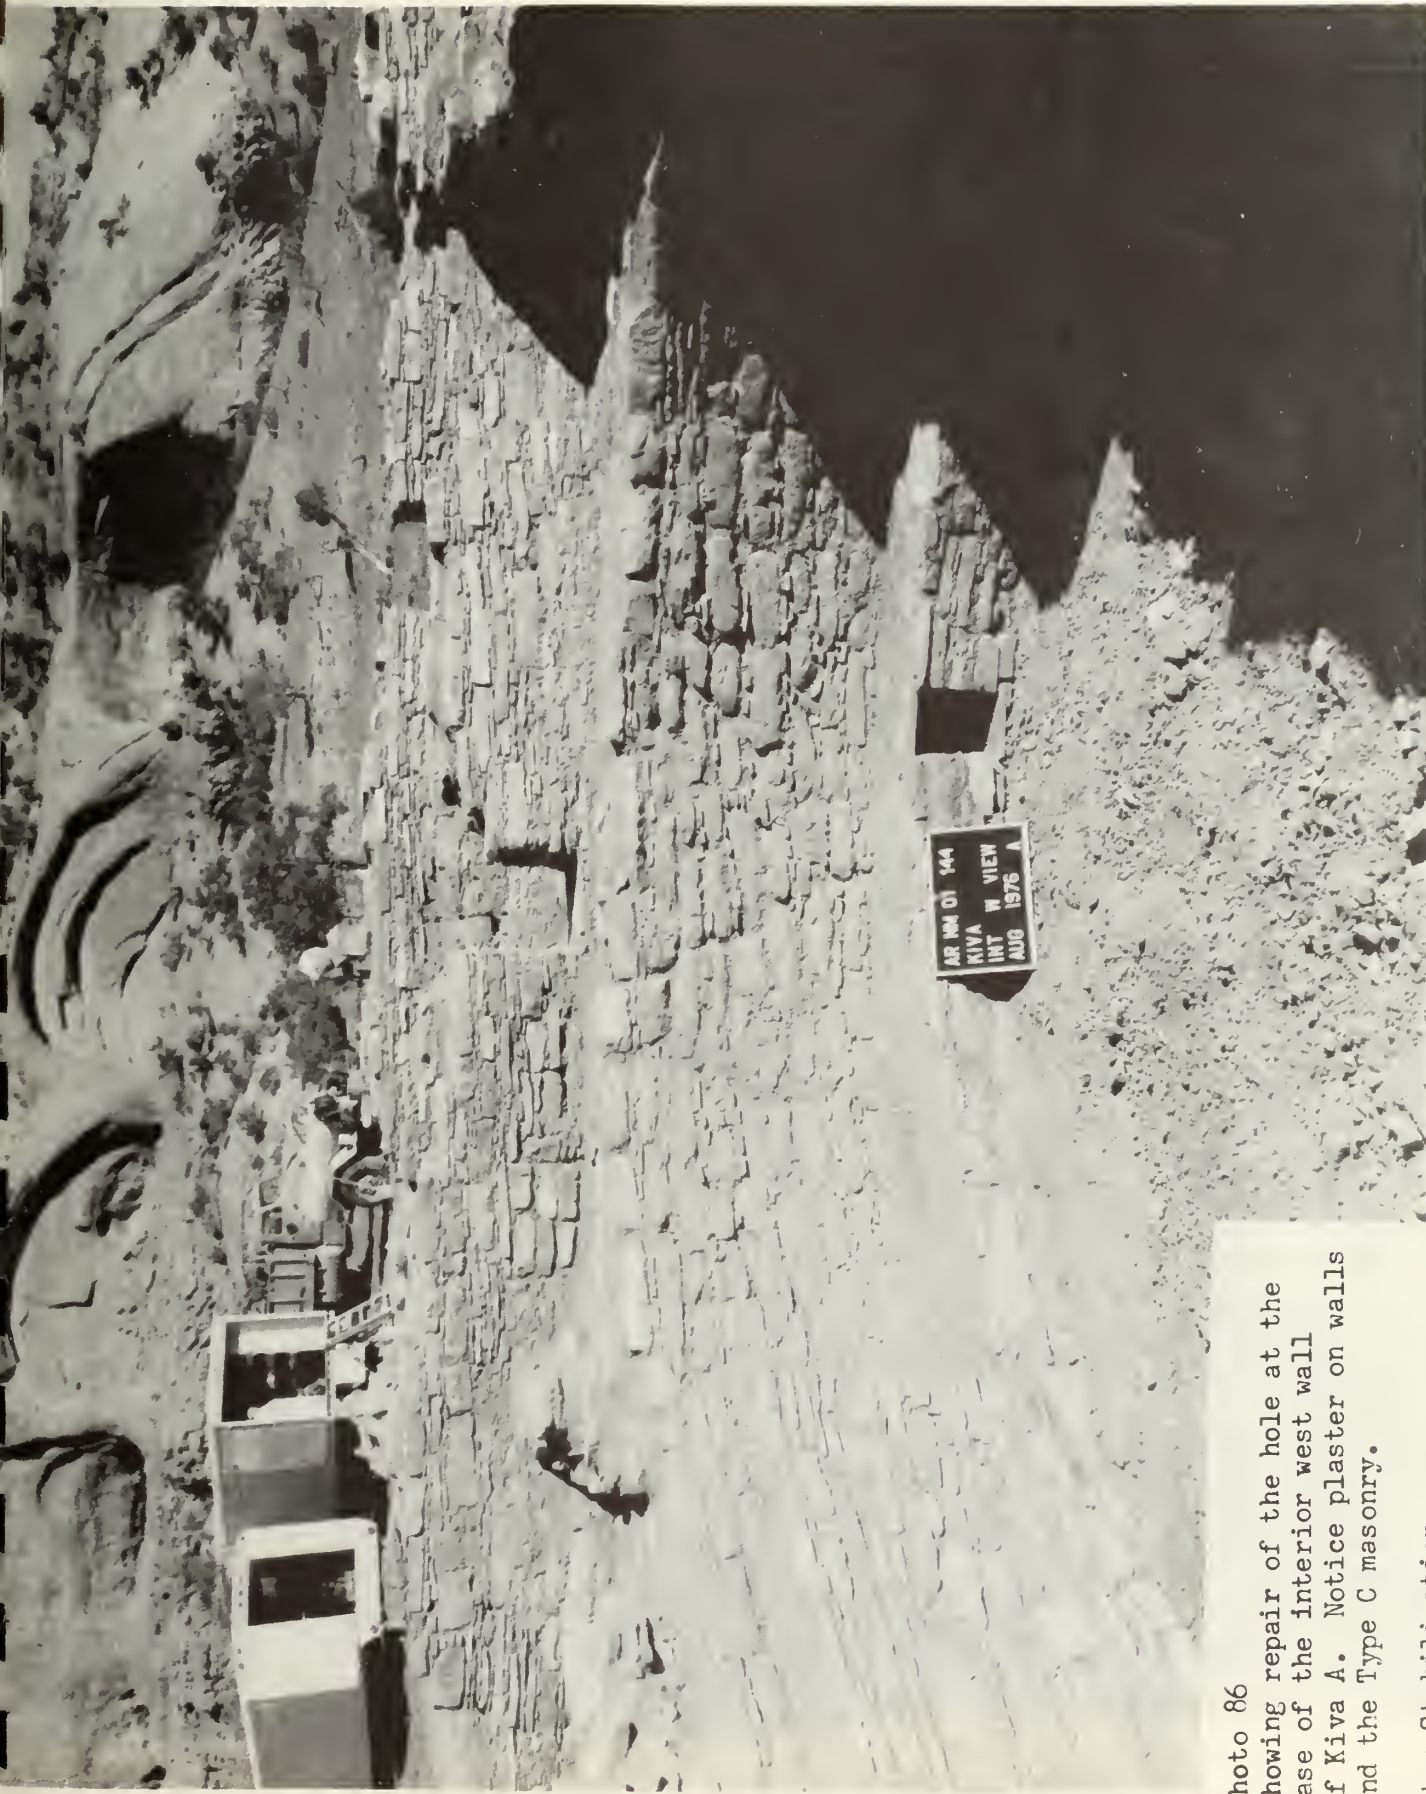
Photo 86  
Showing repair of the hole at the base of the interior west wall of Kiva A. Notice plaster on walls and the Type C masonry.

East of this wall are larger, irregular sandstone blocks forming a rather haphazard fill. The "hole along the northwest part of the kiva wall" mentioned by Sigleo appears to be a niche. Its sides are straight and well-faced, and it was partially covered by a fragment of thin sandstone slabs. During stabilization, the sandstone slab was replaced (See Photo 86).
