KASUMIGAURA NAVAL AIR STATION

**KASUMIGAURA**  
SEAPLANE BASE

DAMAGE ASSESSMENT REPORT NO. 103

90.14-1491  
KISUMIGIURA SEAPLANE STATION  
(36/03 N--140/14 E)

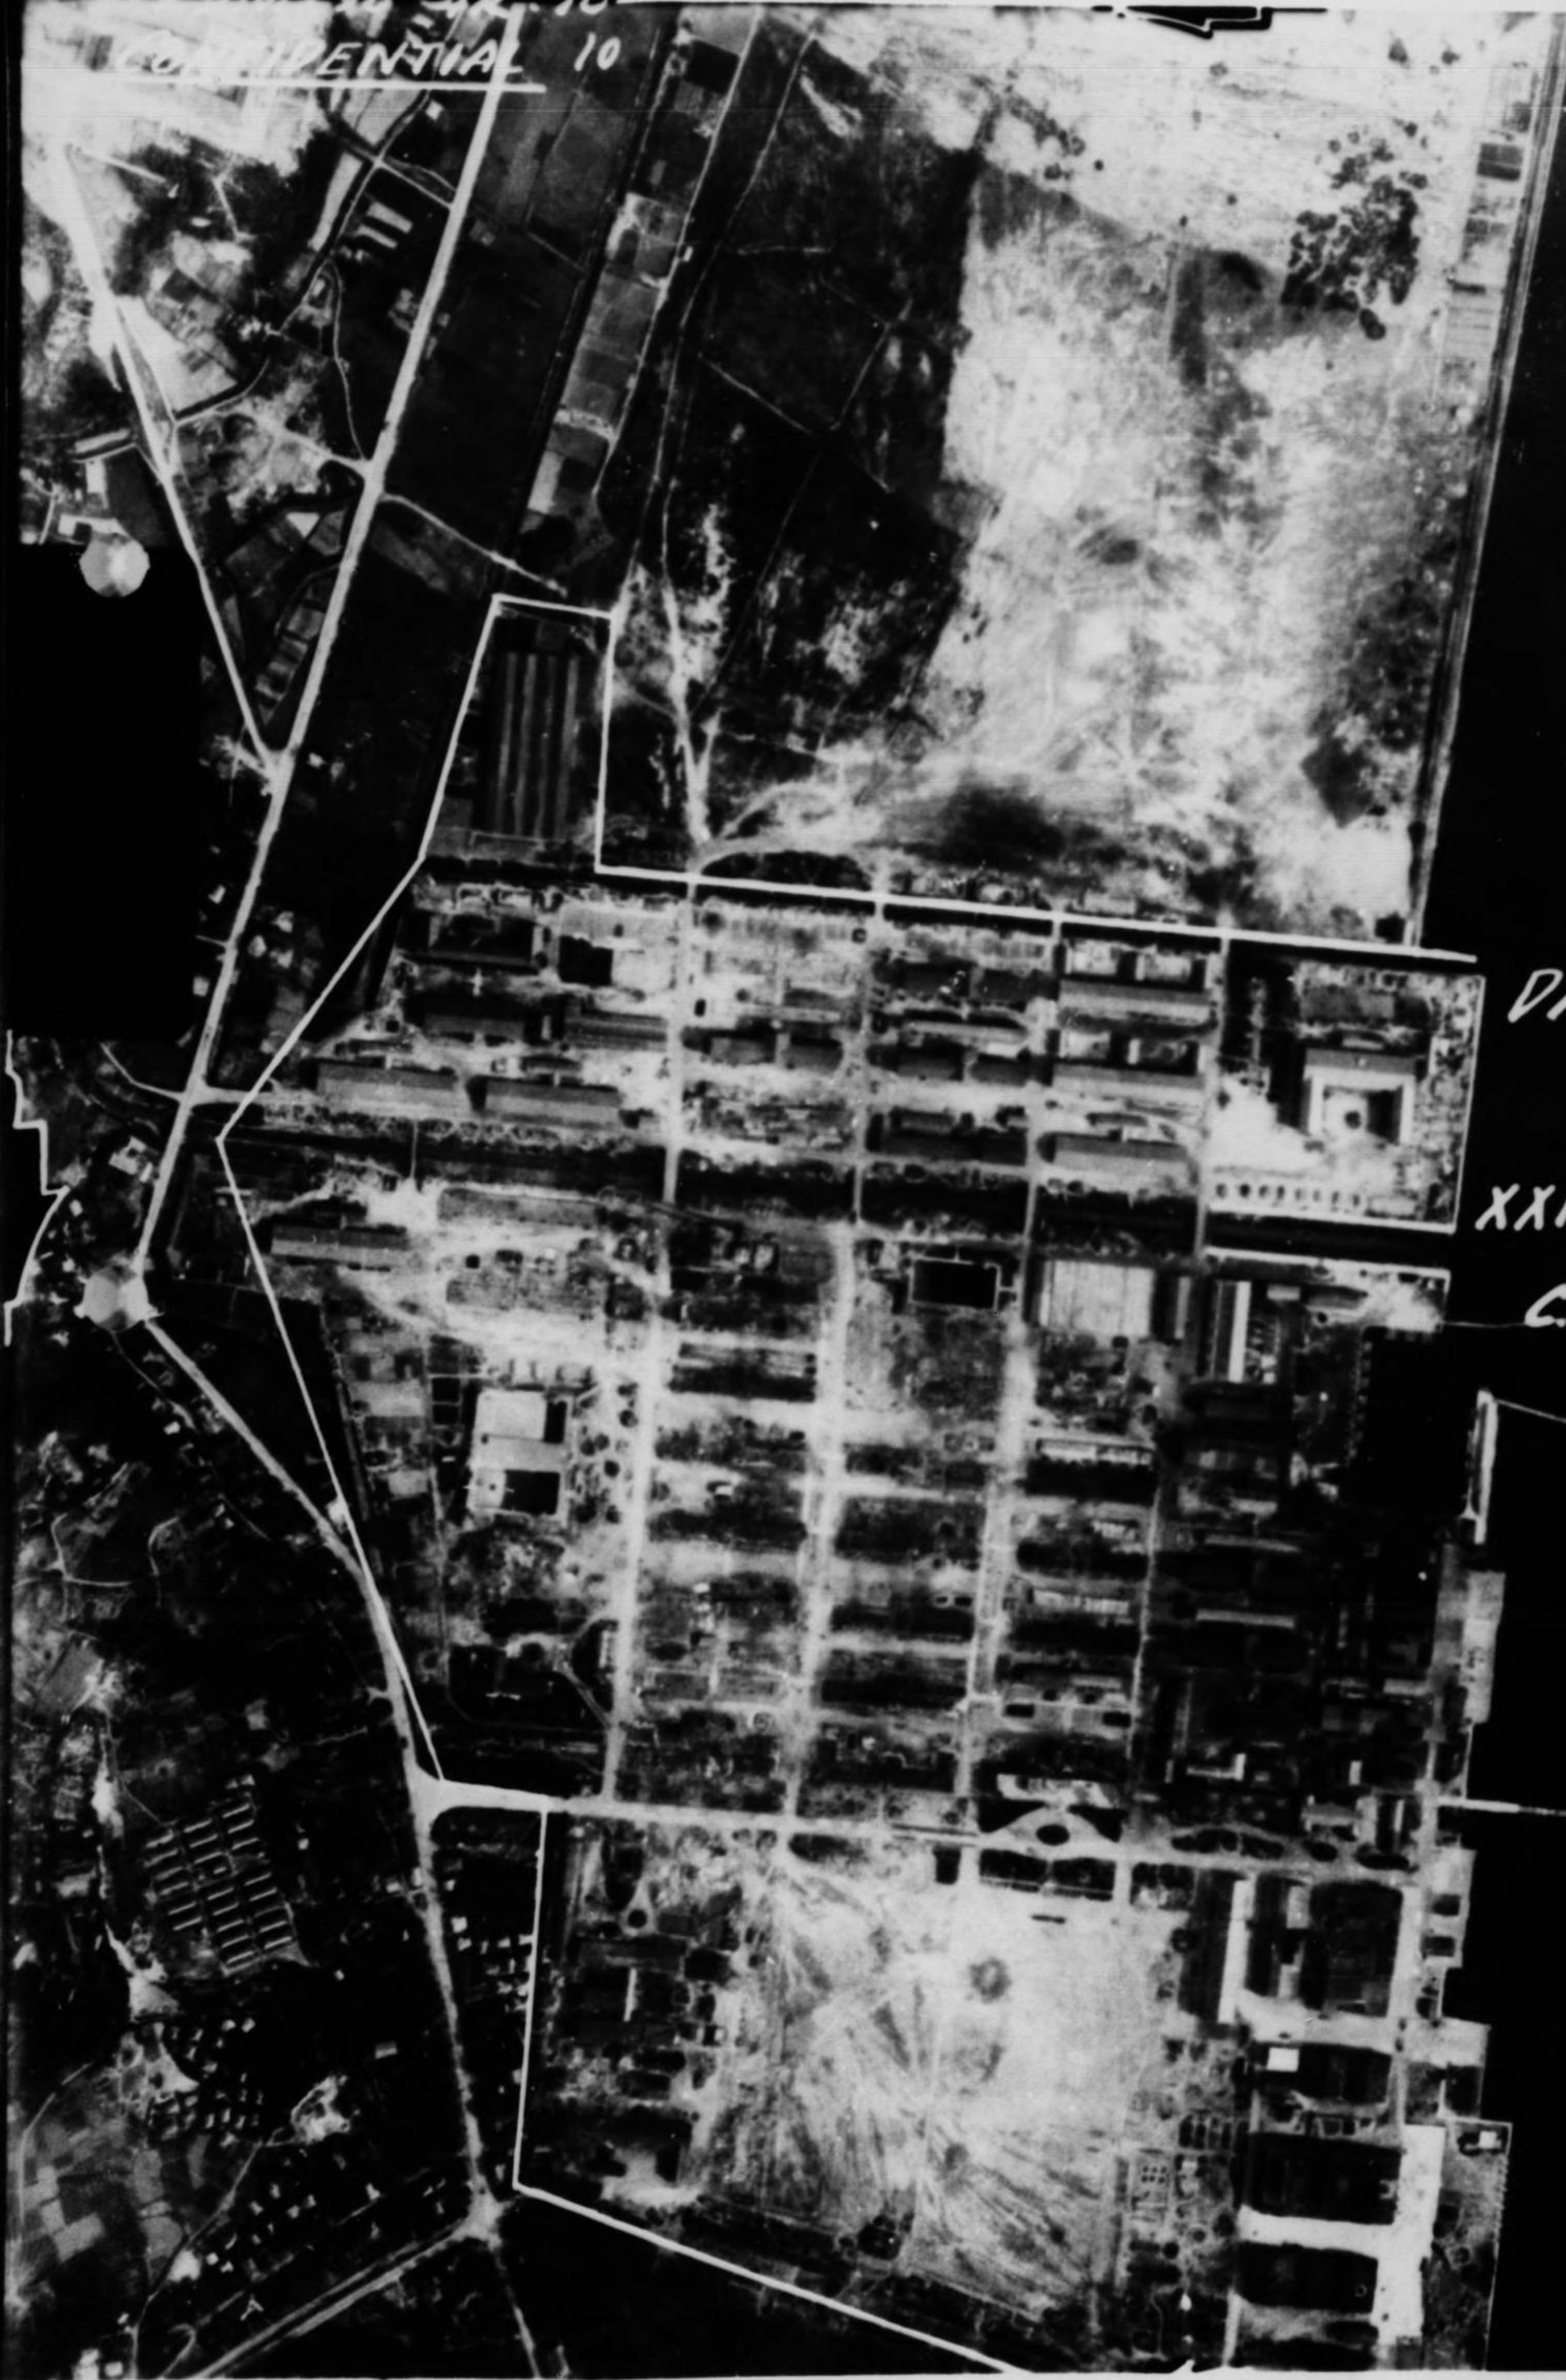
90.14-1491  
KASUMIGAURA S.S.  
DAMAGE ASSESSMENT  
REPORT 103  
XXI. B.C. MISSIONS 195, 199  
C.I.U. - XXI BOM. COM.  
SCALE 1:15,550

About 39.5 percent or 275,300 sq. ft. of the total roof area in Target 1491 was destroyed by XXI Bomber Command Missions 195 and 199 on 10 June 1945.

Approximately 199,100 sq. ft. of damage (or about 28.3 percent of the total roof area) is in the barracks area (area D on the attached print). Remaining damage is distributed over the whole target.

The areas outlined on the accompanying photo are listed as follows:

Area A: hangar area.  
Area B: barracks area.  
Area C: warehouse area.  
Area D: probable school.

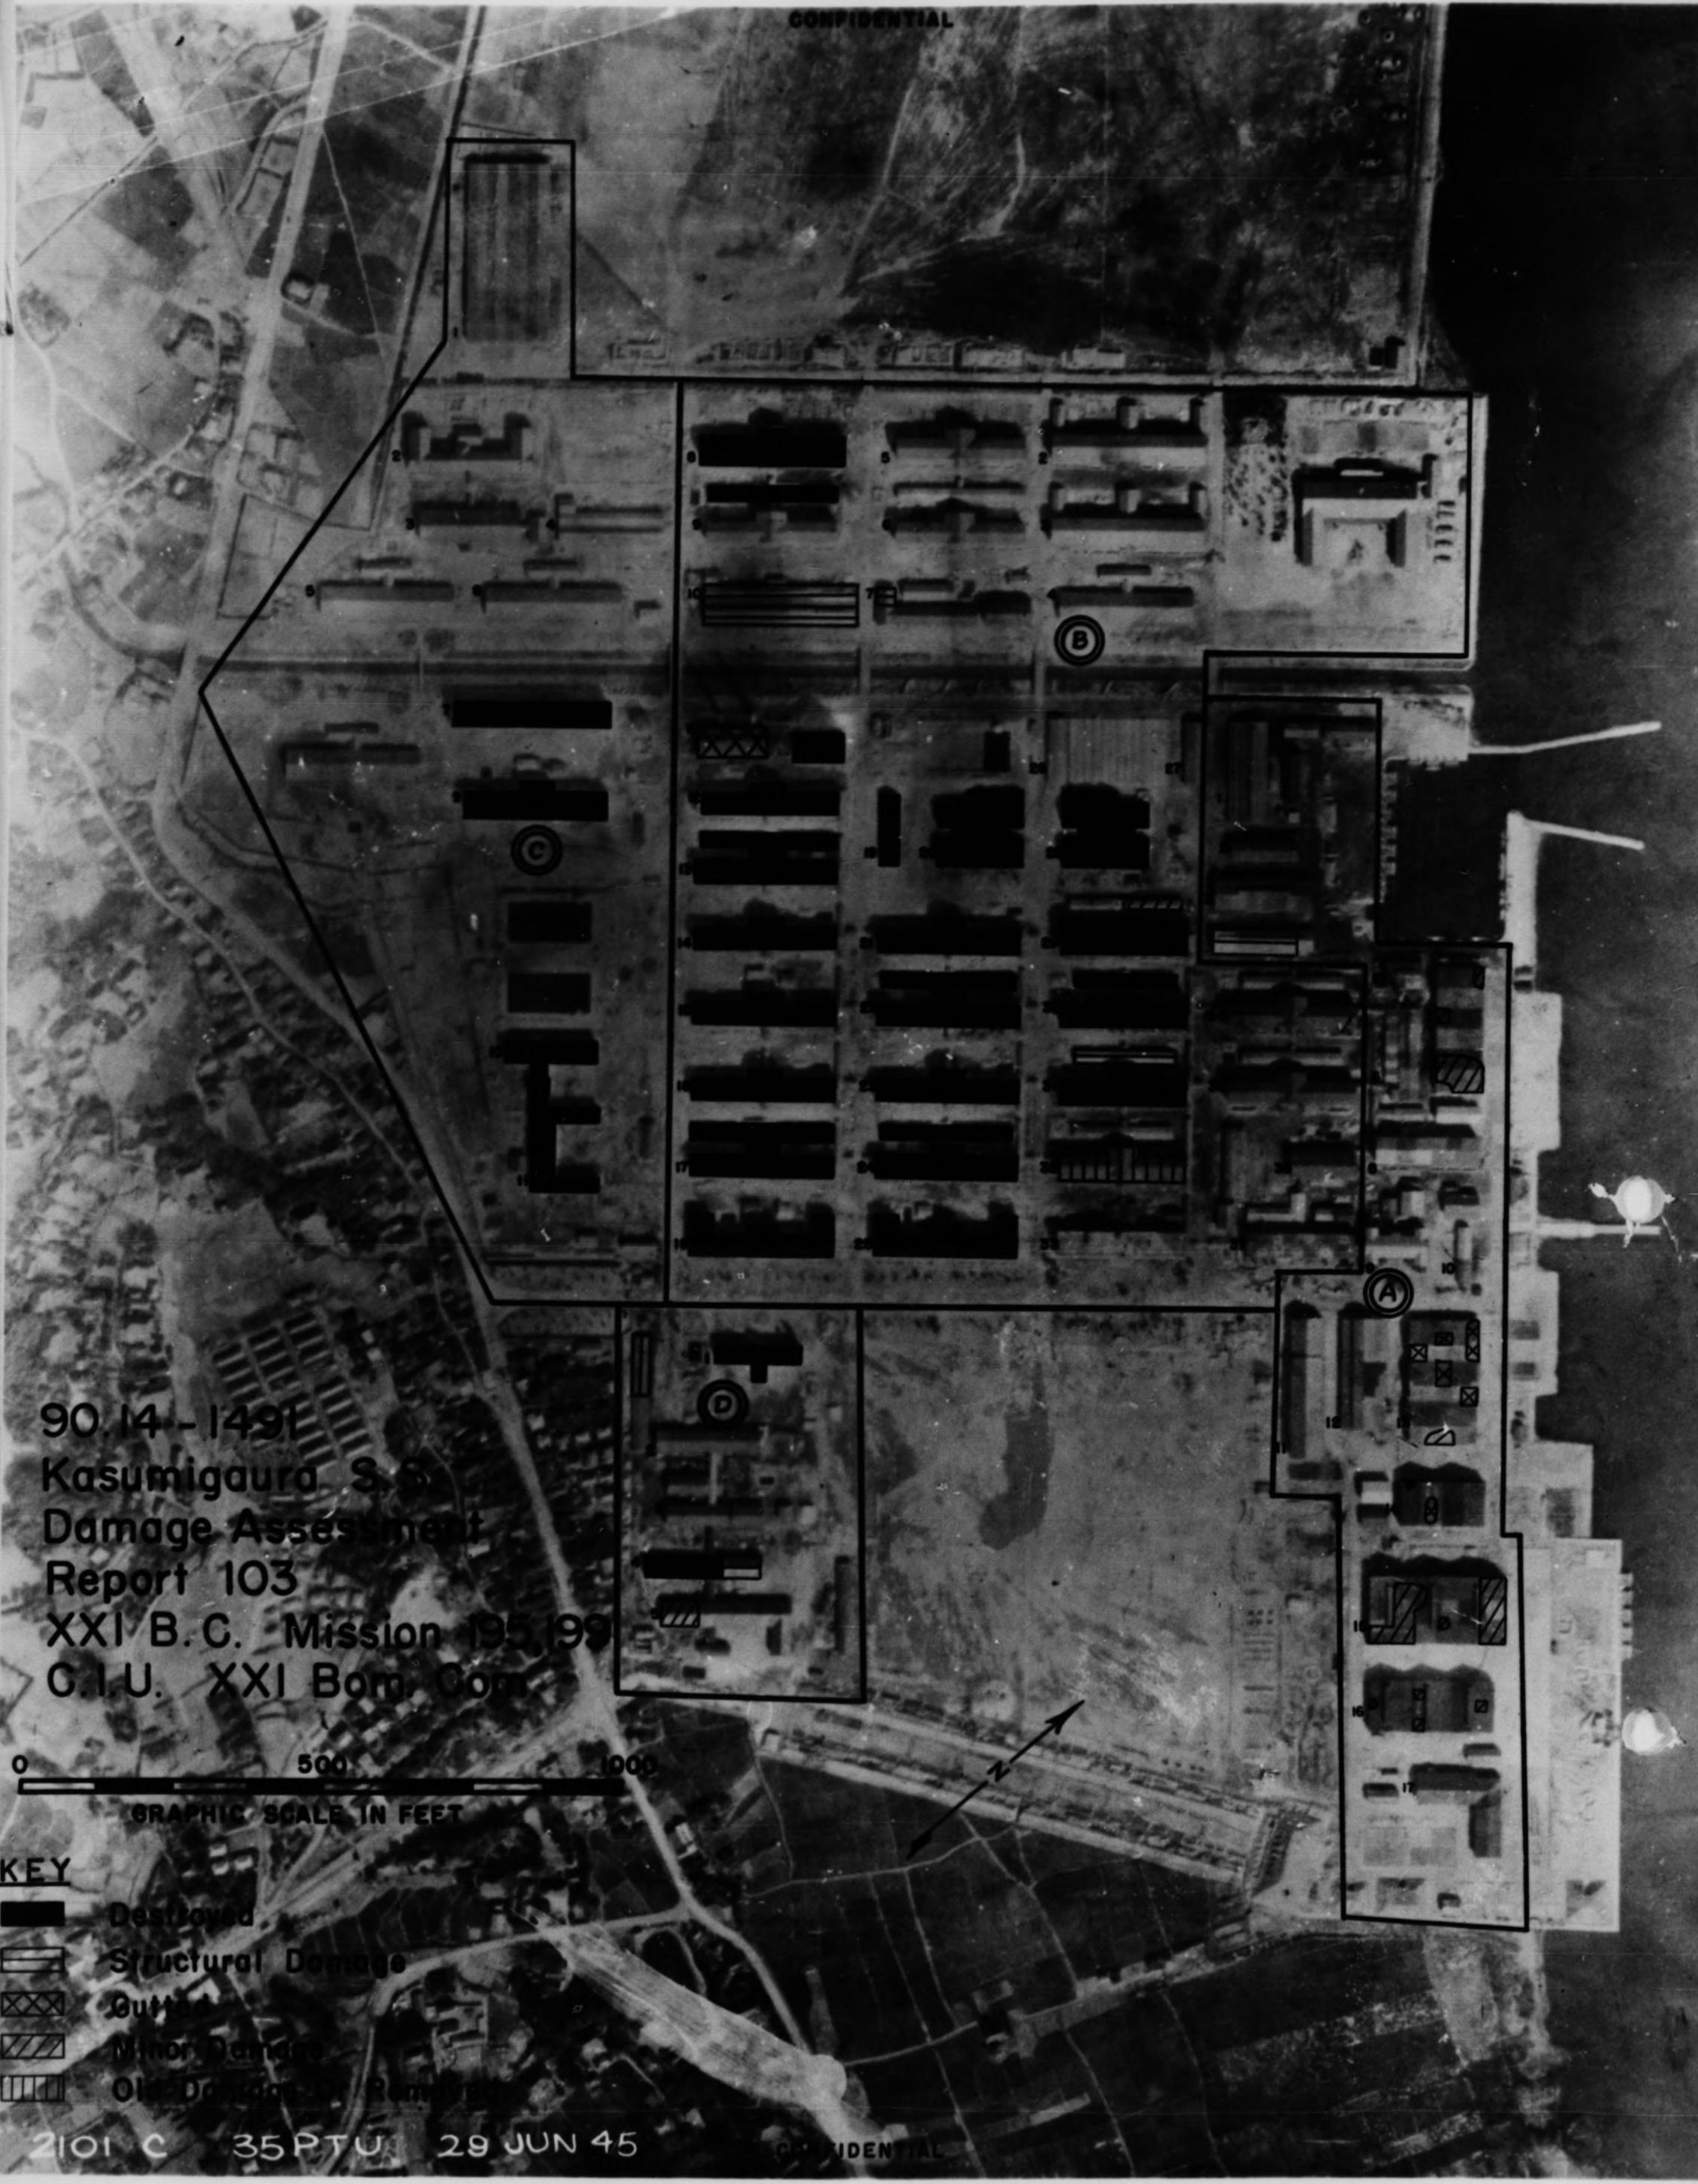
90.14 - 1491  
Kasumigaura, S. S.  
Damage Assessment  
Report 103  
XXI B.C. Mission 195, 199  
C.I.U. XXI Bom. Com.

- Destroyed
- ▨ Structural Damage
- ⊗ Gutter
- ▧ Minor Damage
- ▤ Old Foundations Remnants
