OFFICE OF EXPERIMENT STATIONS—BULLETIN 240.

TIDAL MARSHES AND THEIR RECLAMATION.

GEORGE M. WARREN,

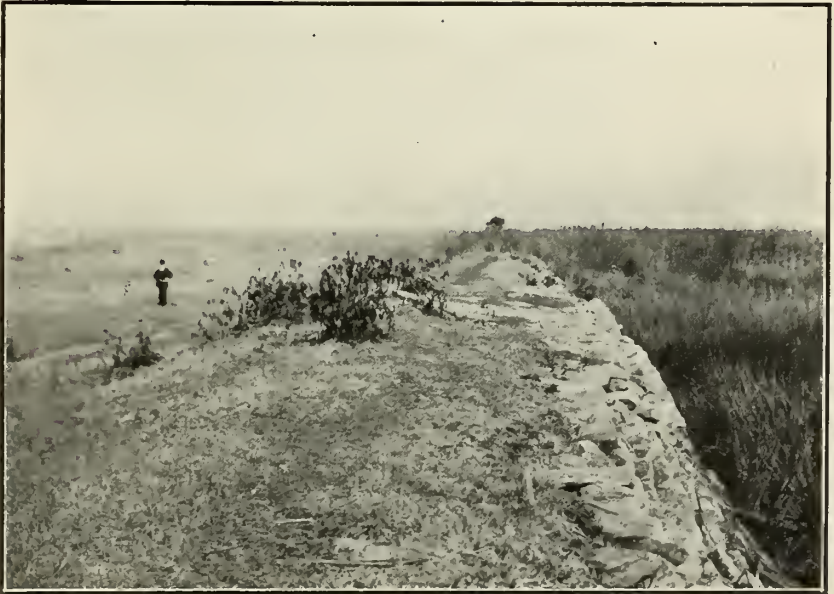
FIG. 2.—LEVEE, FIELD, AND FORESHORE.

COLBURN MARSH LANDS, DELAWARE CITY, DEL., NOVEMBER 1 1909.

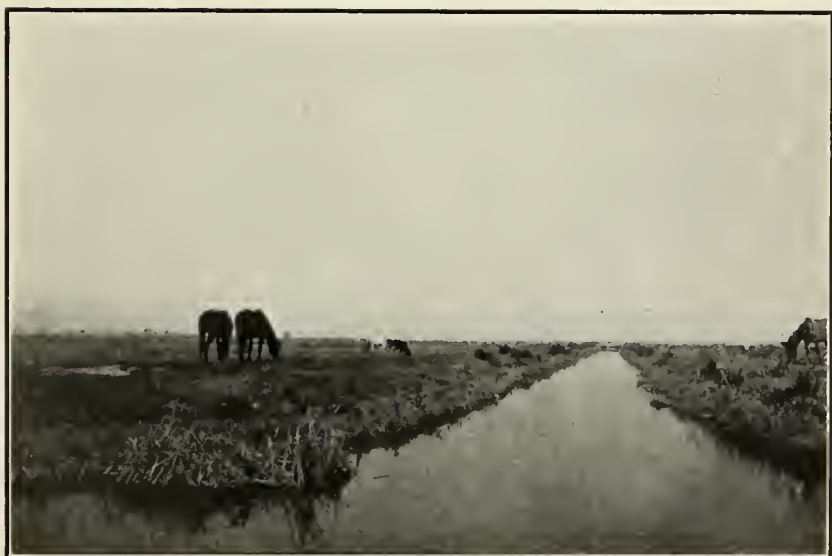
FIG. 2.—EXAMPLE OF A LATERAL DRAINAGE DITCH.

COLBURN MARSH LANDS, DELAWARE CITY, DEL., NOVEMBER 1, 1909.

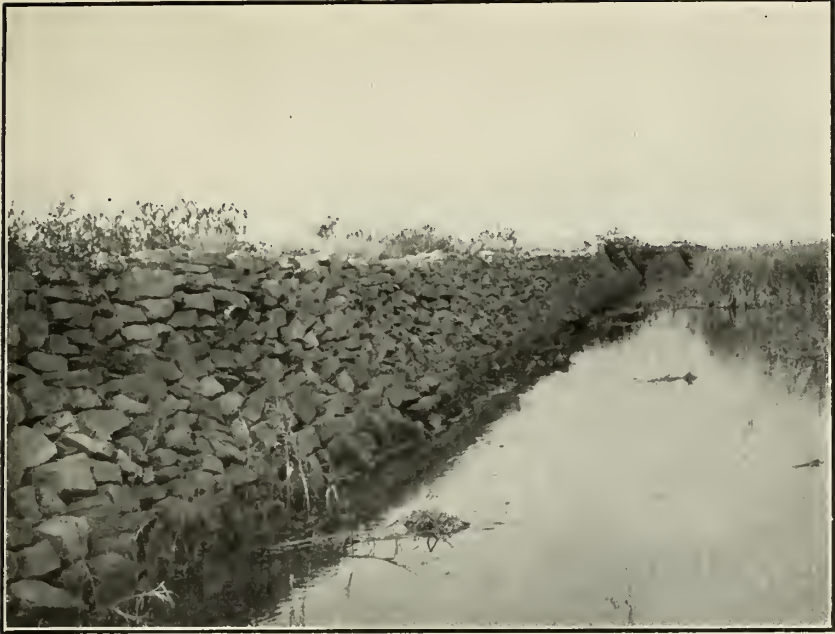
FIG. 1.—ROCK-FACING FOR PROTECTION OF LEVEE AND FORESHORE AT HALF-TIDE LEVEL, ST. GEORGES MARSH CO., NEW CASTLE COUNTY, DEL., NOVEMBER 1, 1909.

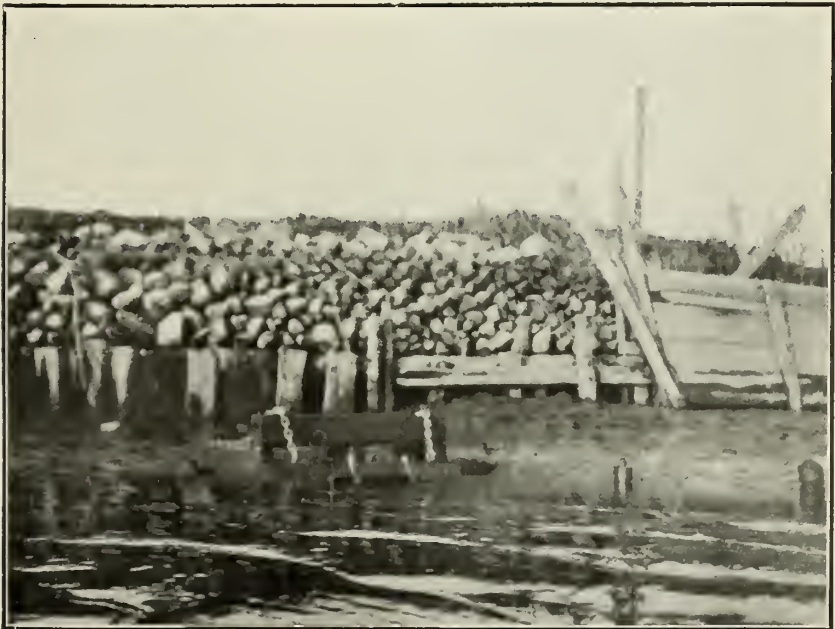
FIG. 2.—METHODS OF LEVEE PROTECTION AND SLUICE 4 AT LOW TIDE IN MAURICE RIVER, DORCHESTER, N. J., NOVEMBER 12, 1909.

[Cord-wood protection is on lands of Alfred H. Lupton; plank bulkhead is on lands of Richard Camp.]

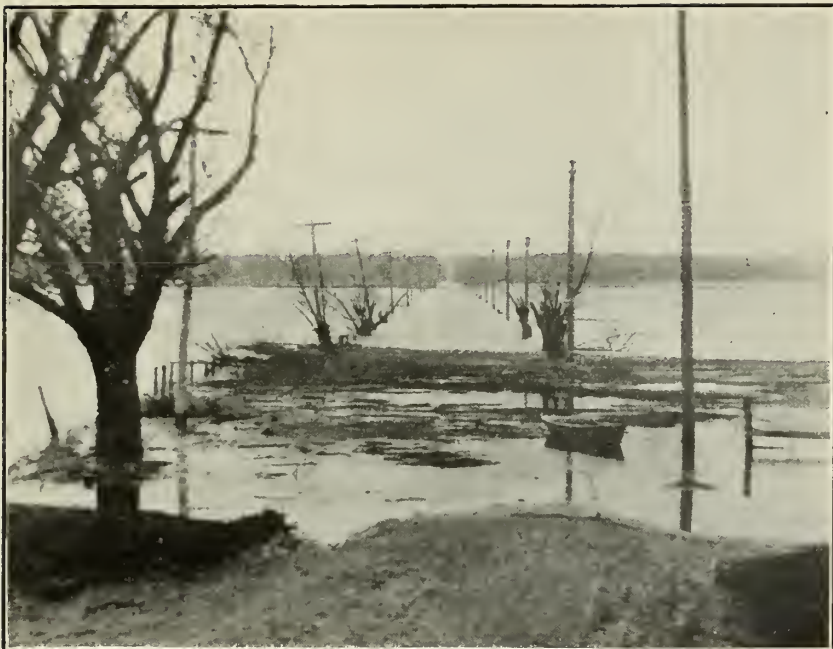
FIG. 1.—AT ORDINARY HIGH TIDE (TWICE DAILY) JULY, 1903.

[Note the lean of the telegraph poles along the old marsh road.]

VIEWS FROM MAURICETOWN BRIDGE, EASTERLY ALONG HIGHWAY, DORCHESTER, N. J. MARSH LAND OF ALFRED H. LUPTON IS IN THE FOREGROUND ON THE RIGHT; HOWARD COMPTON'S IN THE BACKGROUND.

The present levee was built in part by dredge in 1903, and the highway forming the northern boundary of the tract was built the same year. (See Pl. IV, fig. 2.) The transformation which has been wrought by this reclamation is well depicted by the series of views shown in Plates IV, V, VI, and VII, figure 1. The contributing drainage area contains about 2,180 acres, has a frontage on the river of 1.2 miles, and extends easterly therefrom about $2\frac{1}{2}$ miles. Only about 176.5 acres near the river have been put to agricultural purposes; the remaining area consists largely of woodland, varying from wet and swampy at elevation 3 to hills having summits upwards of 50 feet above mean low water.

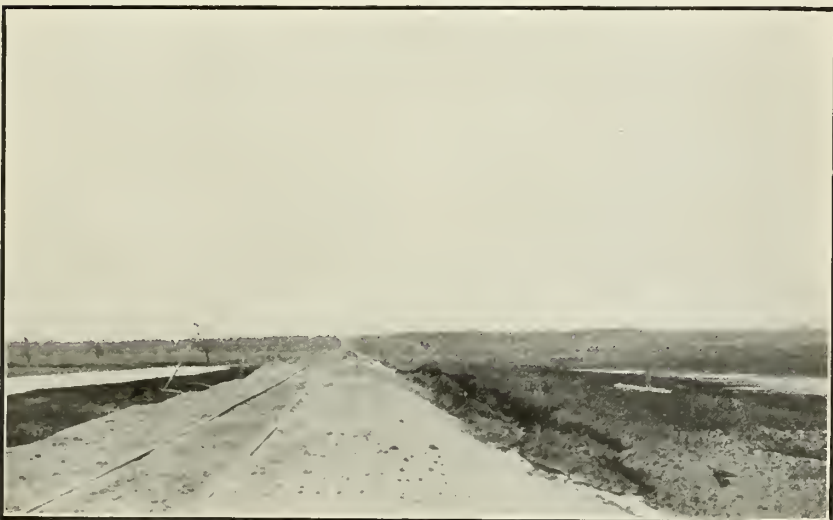
FIG. 2.—DURING NEW CONSTRUCTION WORK, DECEMBER, 1903.

[Note the wave or roll of marsh soil along the right toe of embankment and the lean of telegraph poles on the left.]

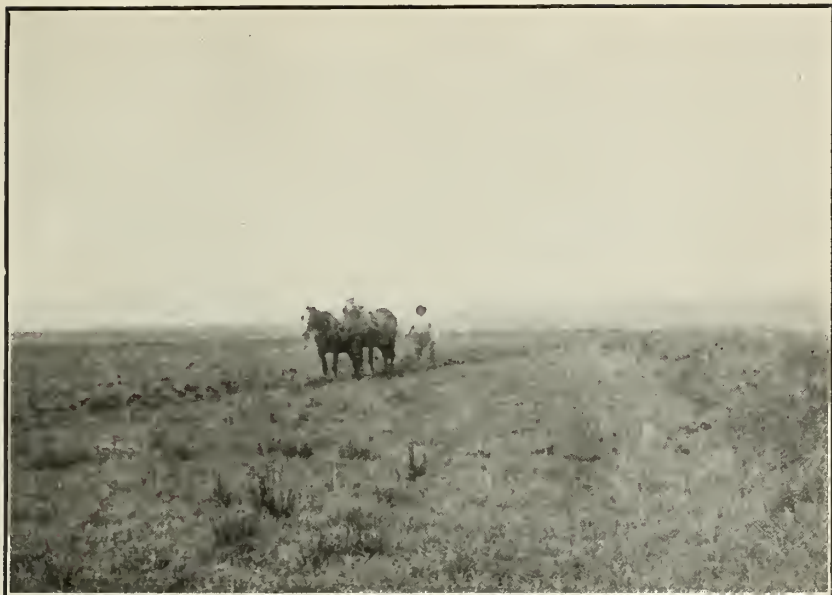
FIG. 1.—PLOWING ON LAND 1.2 FEET ABOVE MEAN LOW TIDE IN MAURICE RIVER, NOVEMBER 12, 1909.

MARSH LANDS OF ALFRED H. LUPTON, DORCHESTER, N. J.

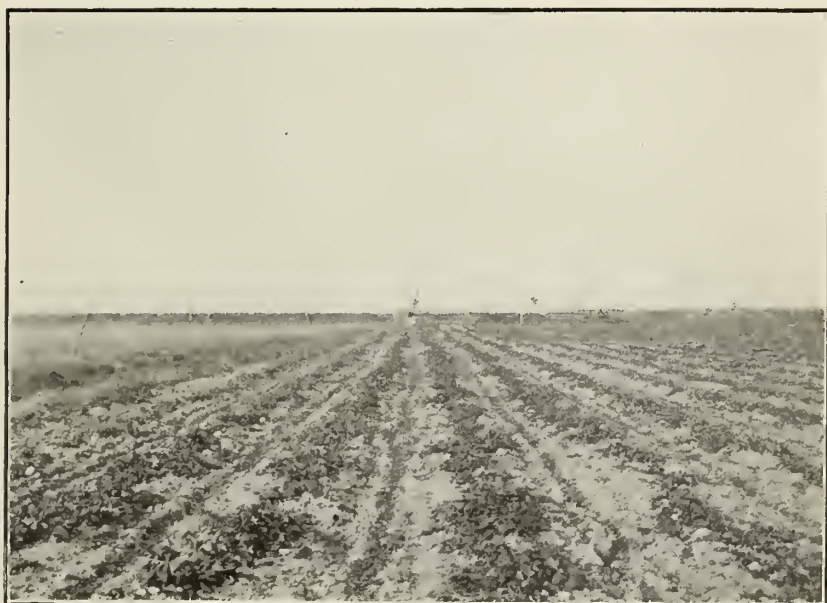
FIG. 2.—STRAWBERRY FIELD 2.2 FEET ABOVE MEAN LOW TIDE IN MAURICE RIVER, NOVEMBER 2, 1909.

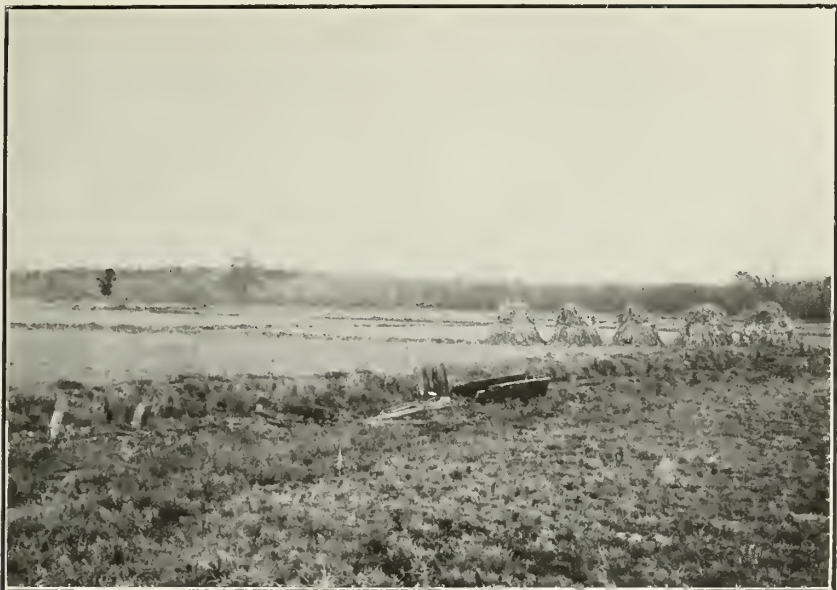
FIG. 1.—DITCH SYSTEM AND PROTECTED FIELDS AND WOODLAND, NOVEMBER 2, 1909.

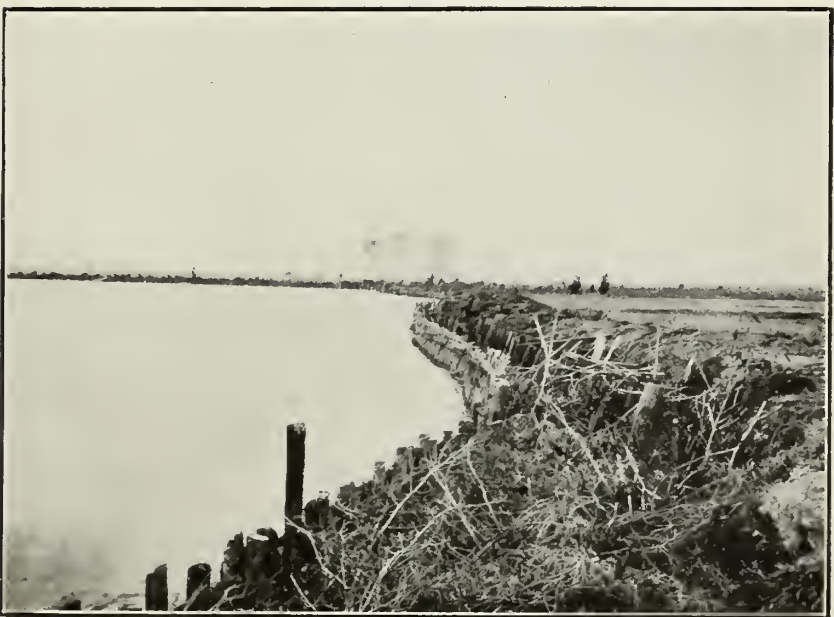
FIG. 2.—LEVEE AND PILE AND BRUSH PROTECTION, MAURICE RIVER, NOVEMBER 2, 1909.
MARSH LANDS OF HOWARD COMPTON, DORCHESTER, N. J.

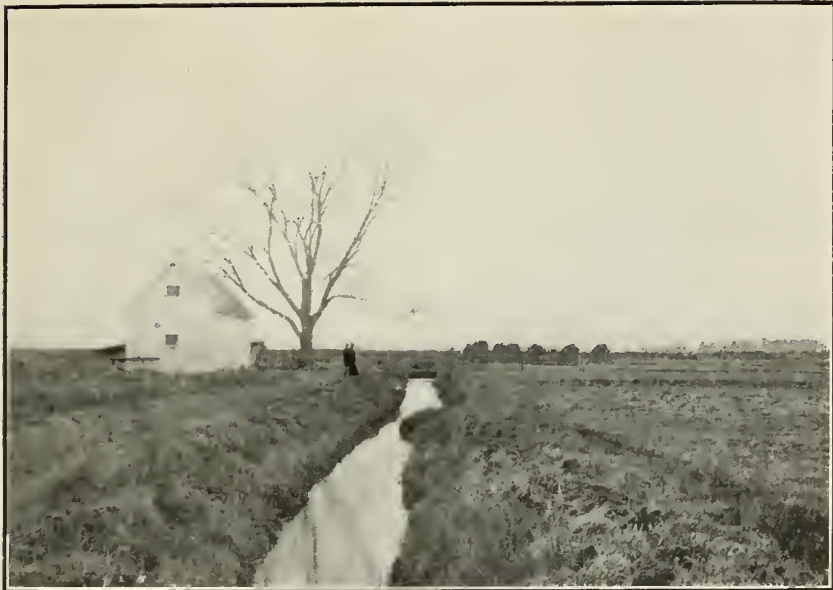
FIG. 1.—MAIN DITCH LEADING TO SLUICE 1, MARSH LANDS OF HOWARD COMPTON, DORCHESTER, N. J., NOVEMBER 2, 1909.

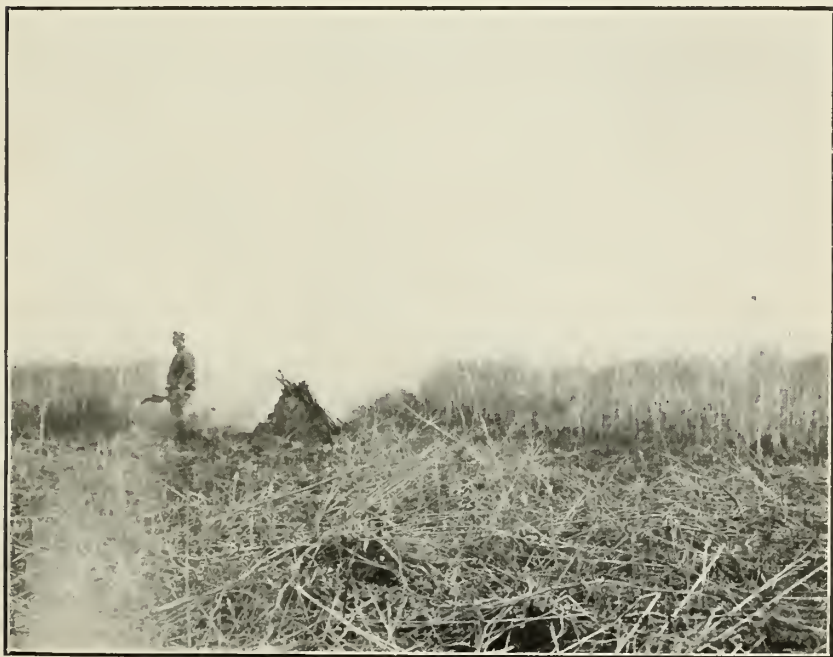
FIG. 2.—CLEARING AND BURNING BRUSH AND STUMPS IN CEDAR SWAMP, MARSH LANDS OF THE MAURICETOWN BANKING CO., MAURICETOWN, N. J., DECEMBER 18, 1909.

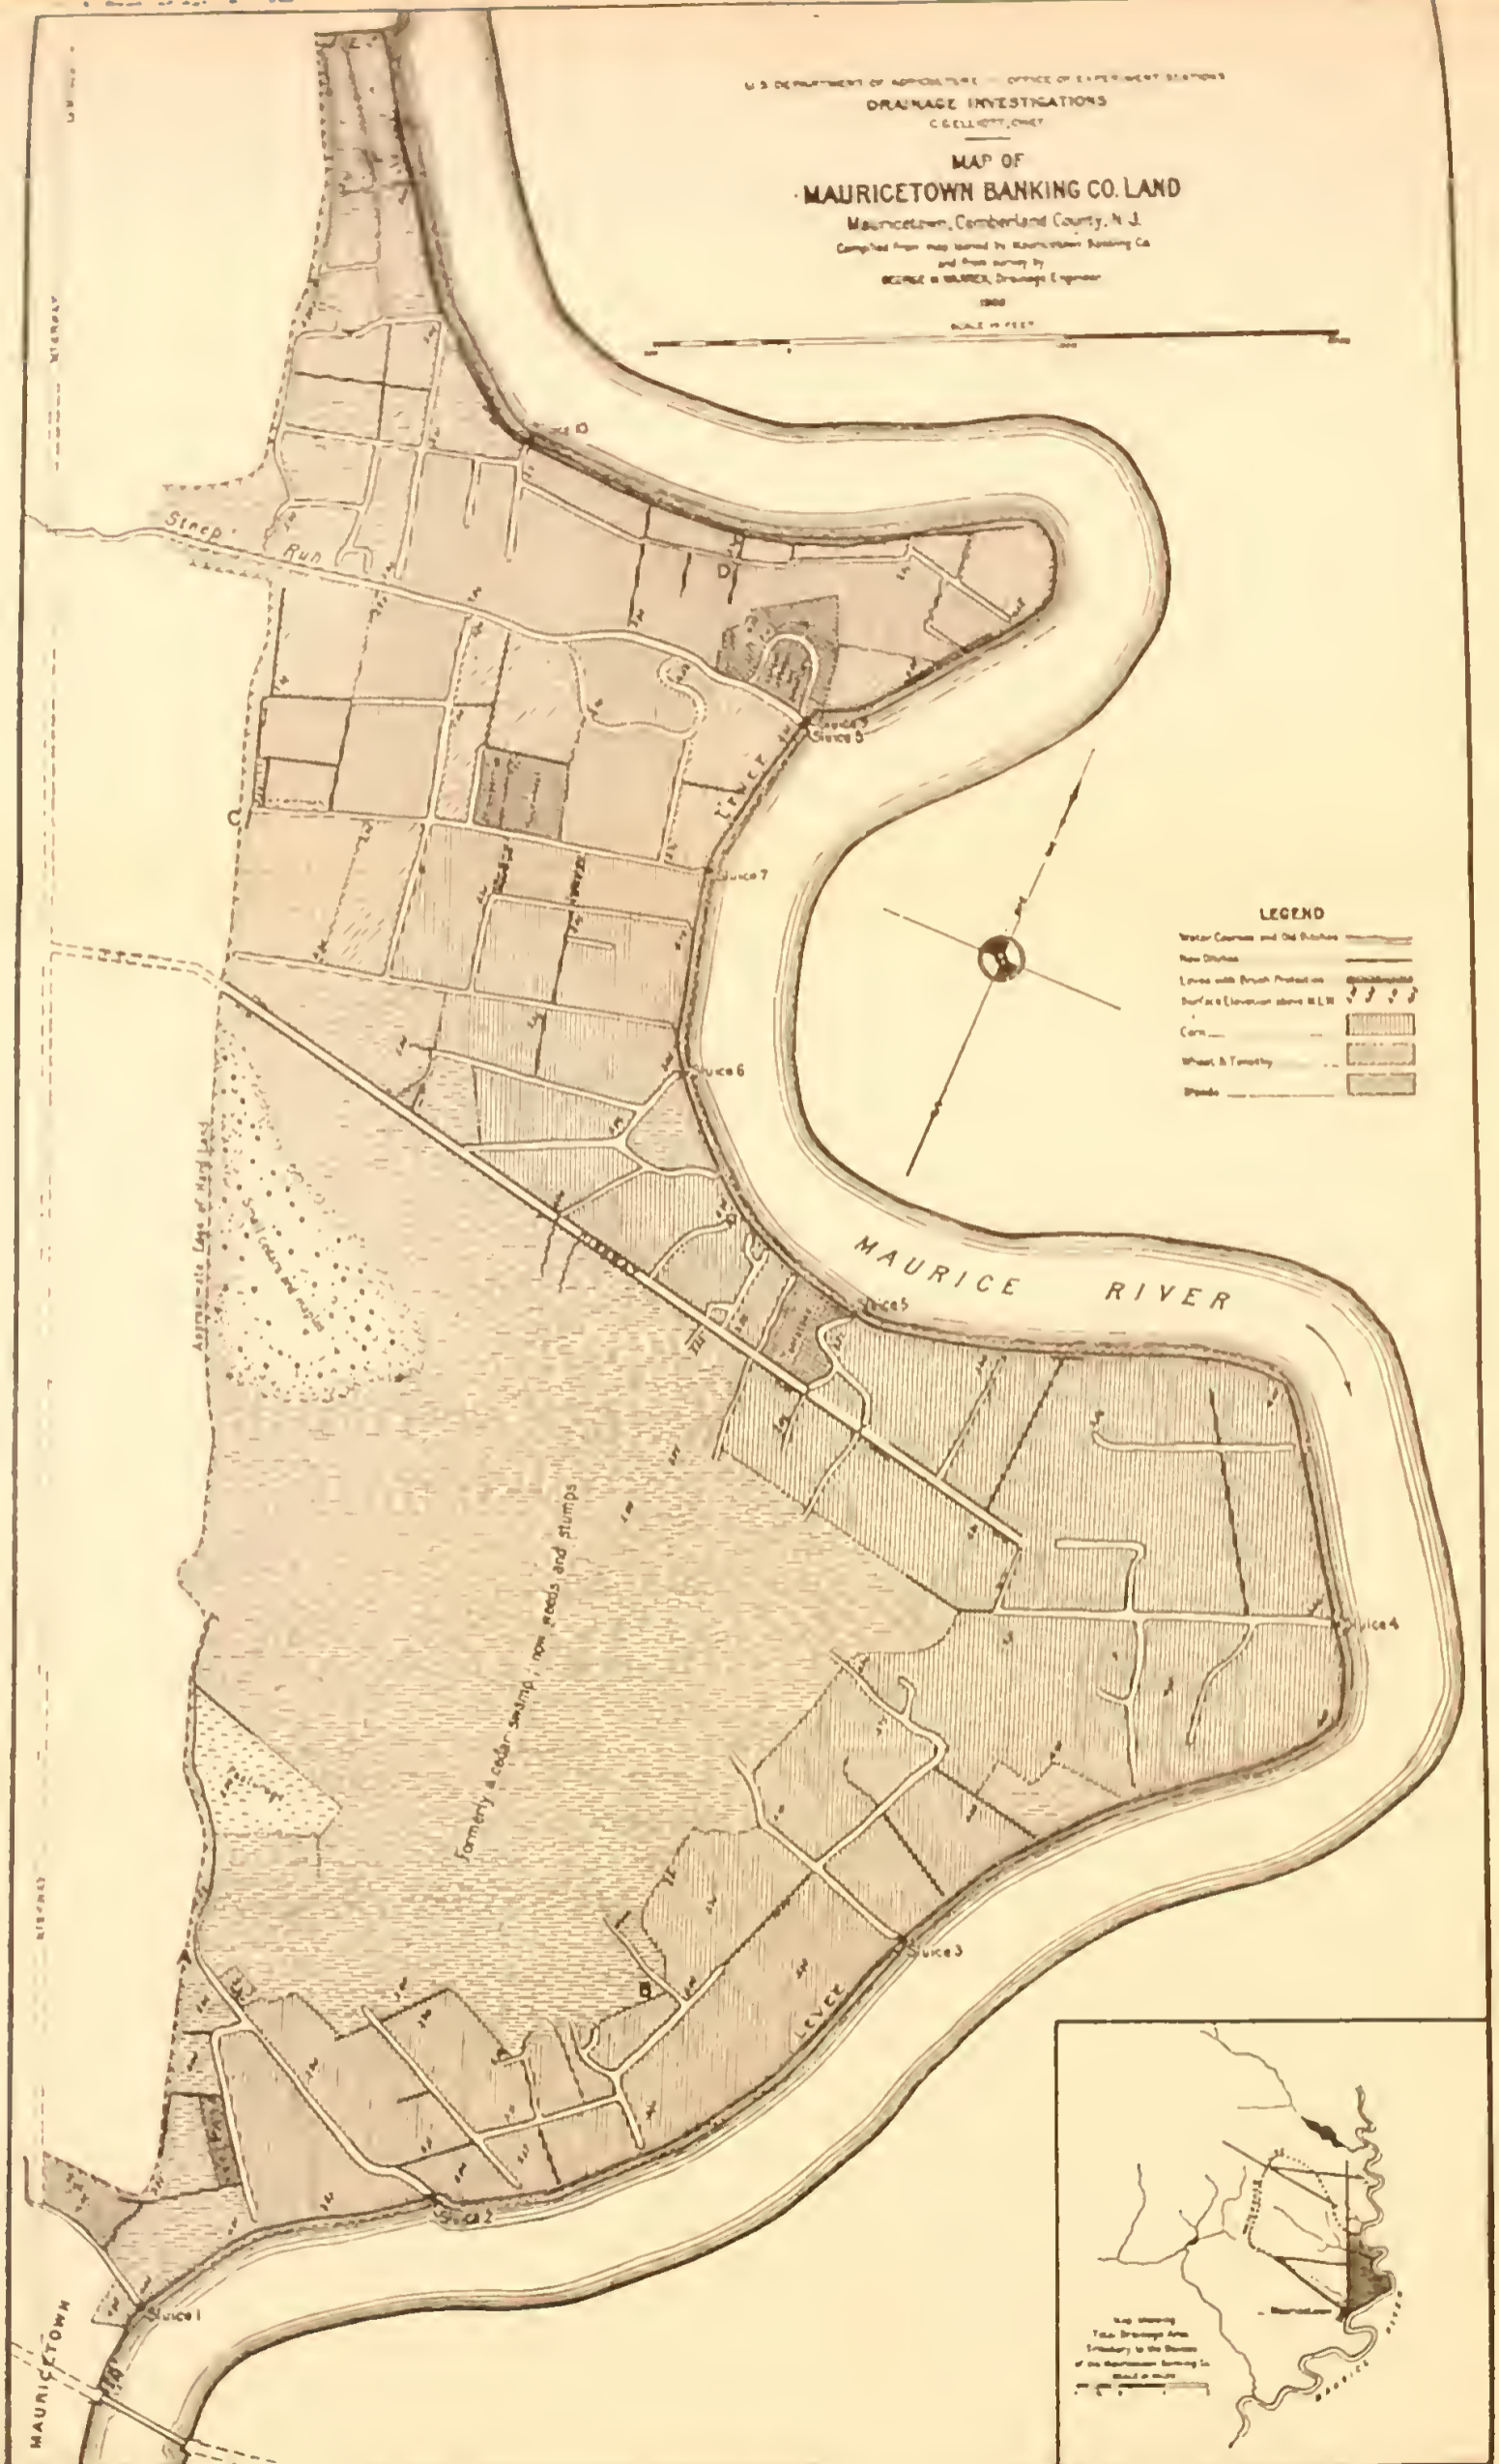
Fig. 15.—Map of Mauricetown Banking Co.'s land, Mauricetown, Cumberland County, N. J.

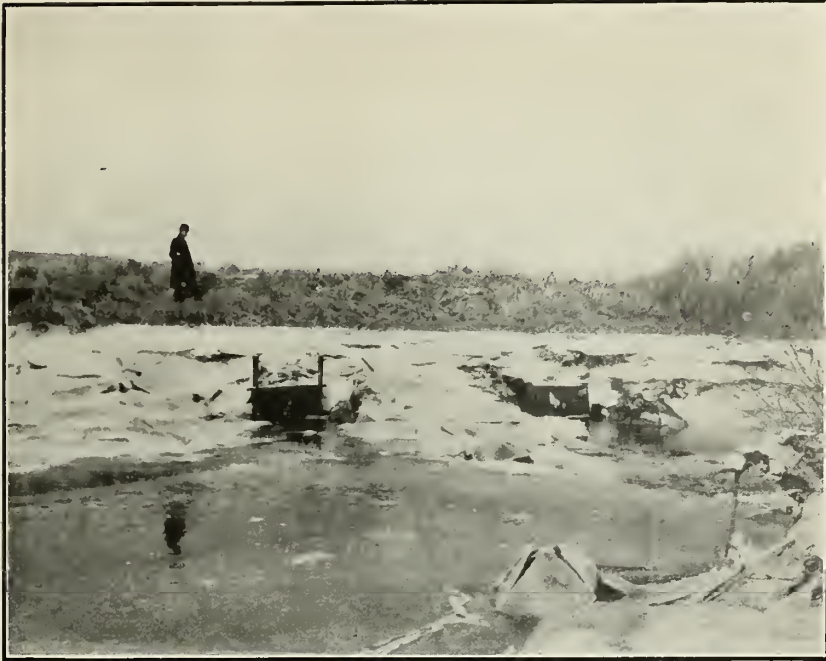
FIG. 1.—SLUICES 8 AND 9, SHOWING FORMATION OF ICE BELOW ORDINARY HIGH WATER MARK.

OUTER END OF SLUICES AT LOW TIDE IN MAURICE RIVER,
MARSH LANDS OF THE MAURICETOWN BANKING CO., MAU-
RICETOWN, N. J., DECEMBER 20, 1909.

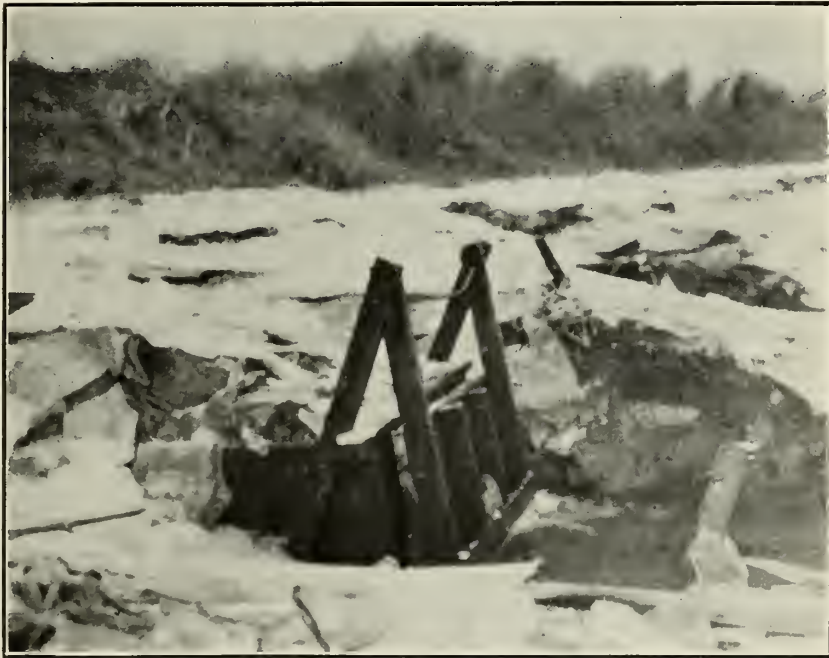
FIG. 2.—SLUICE 8, SHOWING GATE SLIGHTLY OPEN, HOW THE WEIGHT OF THE GATE RETARDS THE DISCHARGE AND THE LIABILITY TO INTERFERENCE FROM ICE.

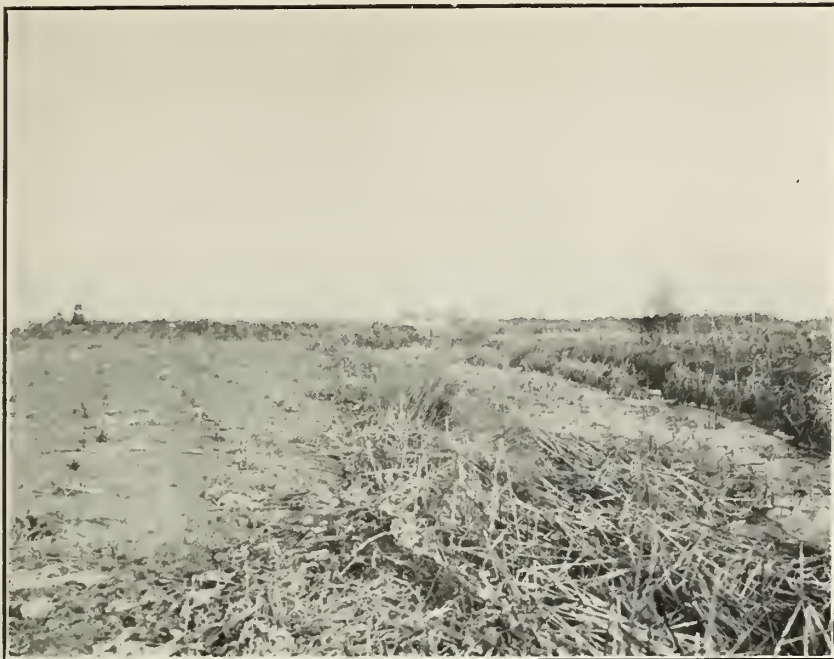
FIG. 1.—MAIN DITCH LEADING TO SLUICE 4.
[Example of a choked ditch.]

DITCHES IN MARSH LANDS OF THE MAURICETOWN BANKING CO.,
MAURICETOWN, N. J., DECEMBER 18, 1909.

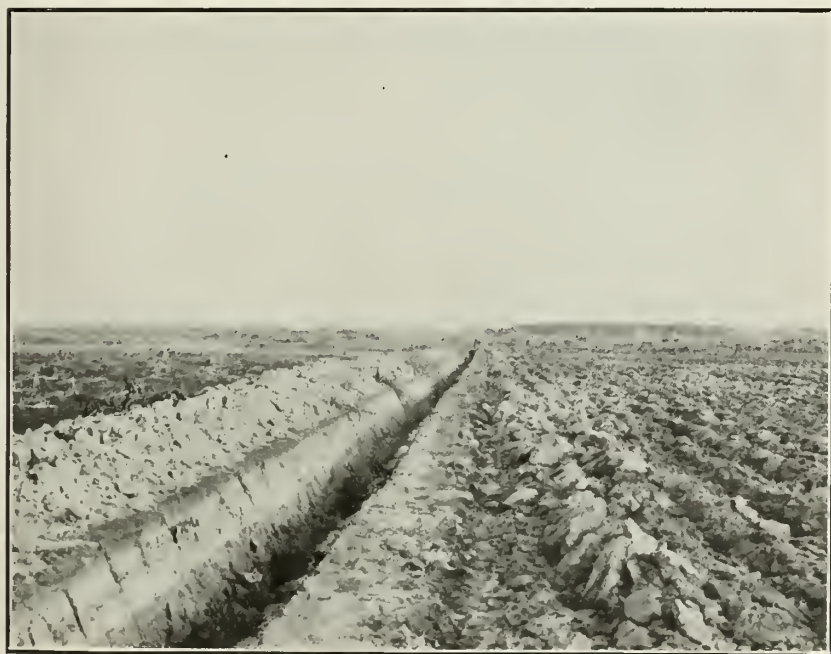
FIG. 2.—LATERAL DITCH NEAR SLUICE 3.
[Example of a clear ditch.]

Such well-aligned ditches (see Pl. X, fig. 2) as have been dug are inadequate for the proper drainage of the land. There are about 3½ miles of these ditches, 4 to 5 feet wide at top, 2 to 3 feet wide at bottom, and about 2½ feet deep. Many are badly choked with wild oats and other grasses. Observations on the ditch water at five different points on the marsh, designated on the plan (see fig. 15) by the letters A, B, C, D, E, showed the ordinary drop during the period of sluice play to be about as follows:

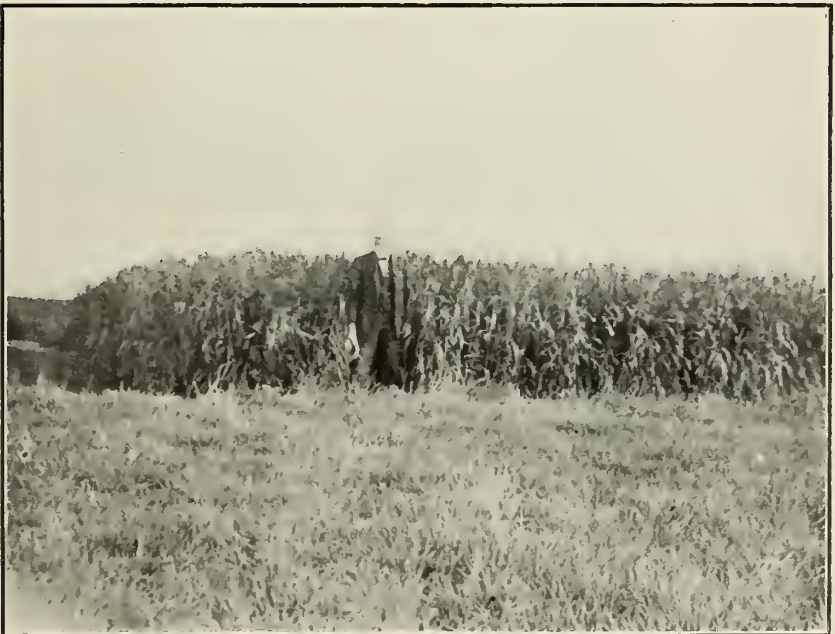
FIG. 2.—JAPANESE MILLET GROWN ON LAND ABOUT 7 FEET ABOVE MEAN LOW WATER.
MARSH LANDS AT GREEN HARBOR, MASS., SEPTEMBER 9, 1910.

large and of excellent quality and for a series of years should net a yearly profit of not less than \$135 per acre. Timothy, redtop, Japanese millet (see Pl. XI, fig. 2), corn, onions, squashes, and rhubarb have all yielded splendidly the present season without fertilizer of any kind. Oats, rye, asparagus, and strawberries have been raised with pronounced success.

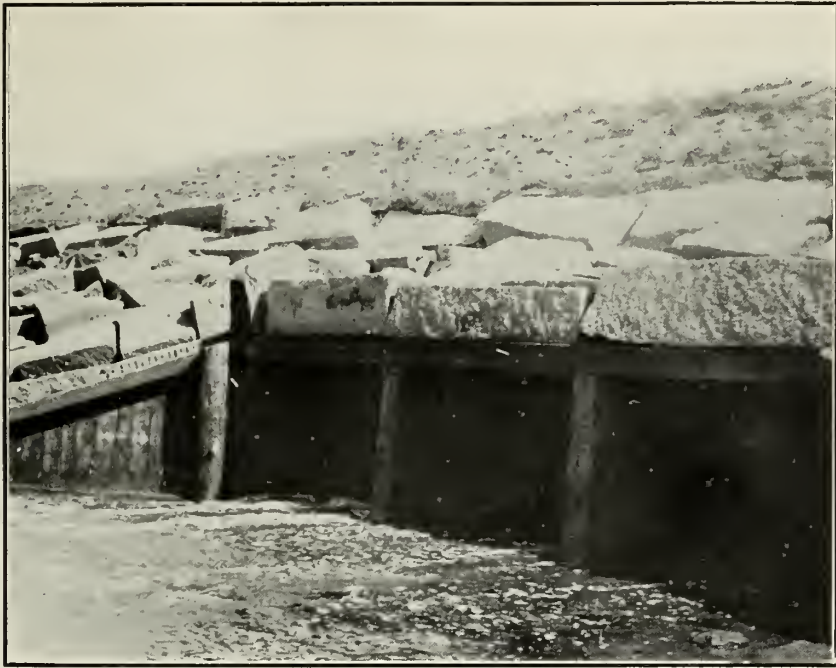
FIG. 1.—OUTER END OF SLUICE AT LOW TIDE, SHOWING GRANITE QUARRY GROUT FACING.

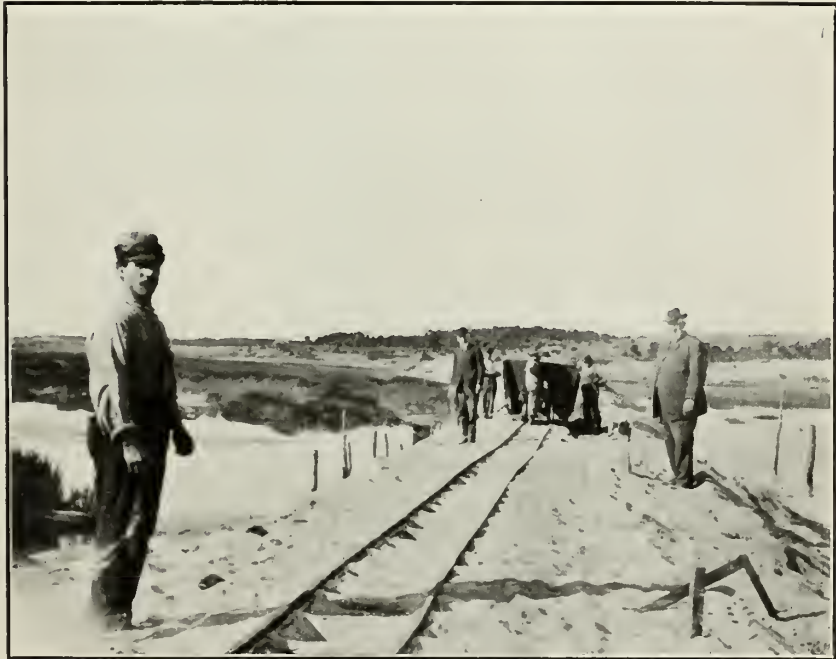
FIG. 2.—DIKING OPERATIONS, SHOWING METHOD OF PLACING MATERIAL.
DIKED LANDS AT WELLFLEET, MASS., SEPTEMBER 22, 1910.

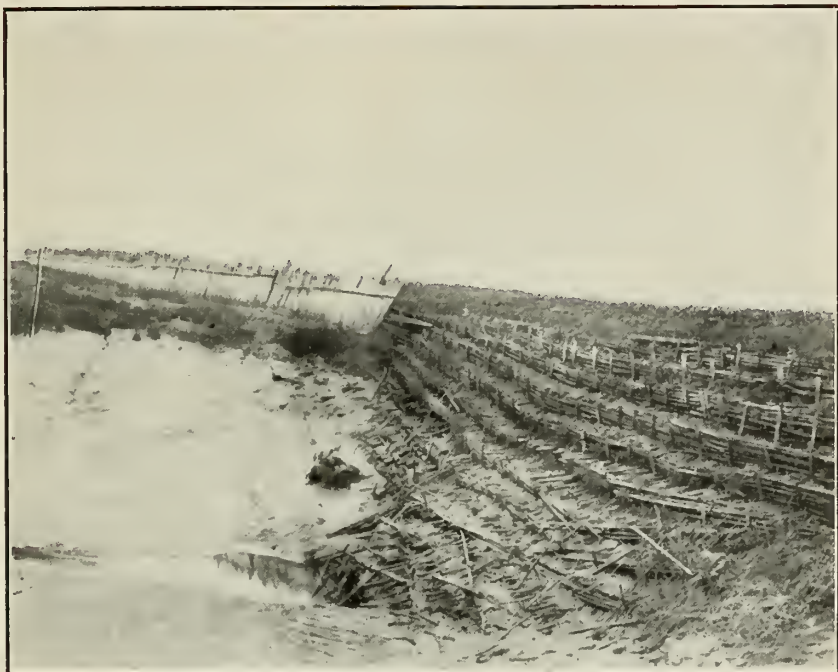
FIG. 1.—WATER SIDE, SHOWING METHOD OF PICKET AND HEADING BRUSH PROTECTION, AND ON THE LEFT, PLANK PROTECTION FOR "RUNNING DIKE."

ABOIDEAU, DISCHARGE CREEK, GRAND PRE, NOVA SCOTIA, TOP 16½ FEET, BASE 55 FEET, HEIGHT 45 FEET. SLUICE BEGINNING TO PLAY, OCTOBER 22, 1910.

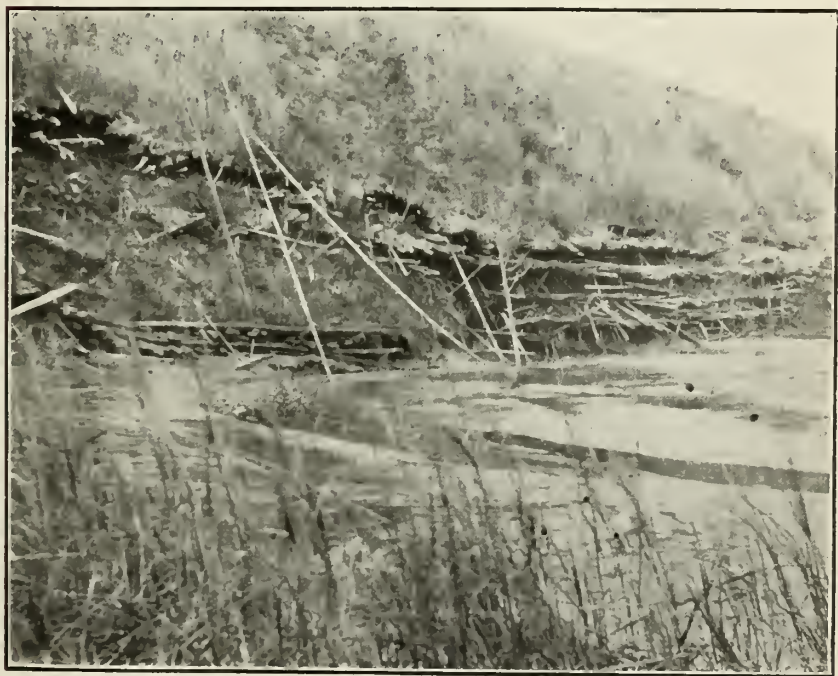
FIG. 2.—LAND SIDE, SHOWING LAYERS OF BRUSH AND ORDINARY HEIGHT OF INTERIOR WATER.

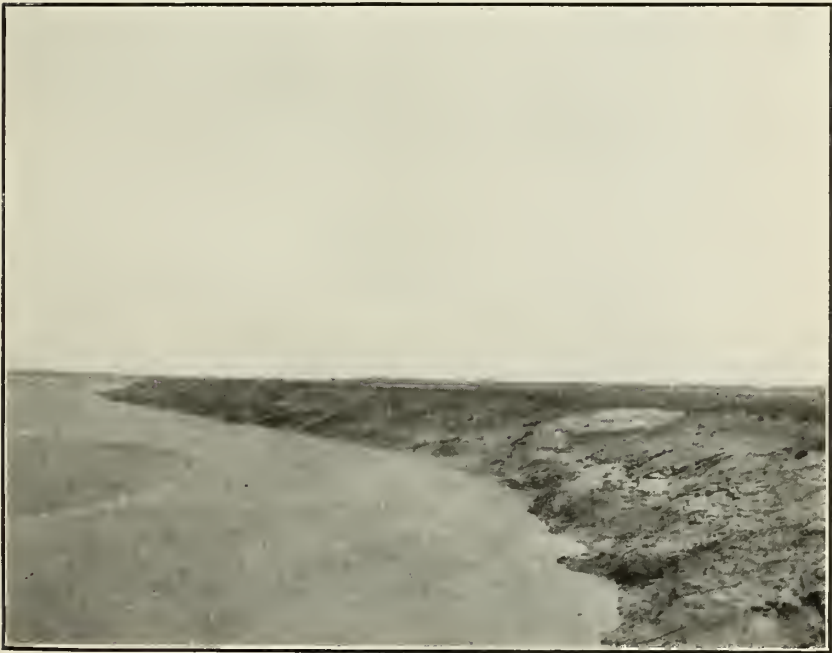
FIG. 2.—TANTRAMAR RIVER, NEW BRUNSWICK, AT HALF TIDE, SHOWING FORESHORE, "RUNNING DIKE," AND HAY BARN IN THE DISTANCE.
[Seventy years ago forded at low tide and now crossed by bridge of 3 spans of 125 feet each, October 31, 1910.]

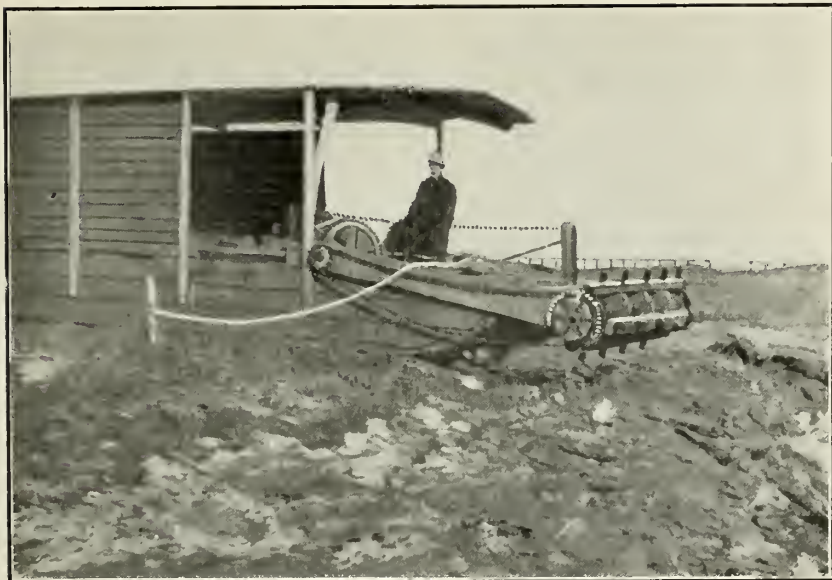
FIG. 1.—POWER-DRIVEN MACHINE FOR FREEING CHANNELS OF SEDGES AND SALT GRASSES, MISSEGUASH MARSH, NEW BRUNSWICK.

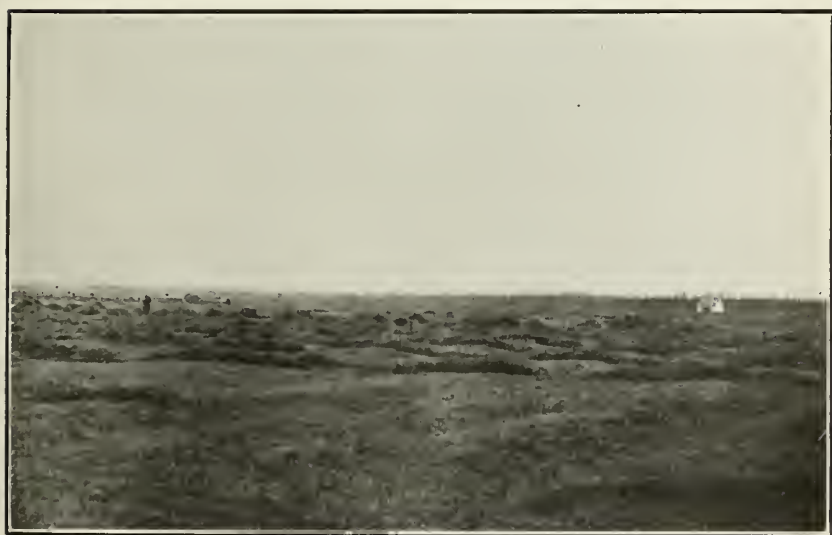
FIG. 2.—HAYING ON WARPED FRESH-WATER BOGS, UPPER REACHES OF MISSEGUASH RIVER, NEW BRUNSWICK.
