MISSION #22 NAGOYA "ERADICATE 3"
23 January 1945

CONSOLIDATED MISSION REPORT

XXI Bomber Command.

HEADQUARTERS
 73RD BOMBARDMENT WING
 APO #297, % POSTMASTER
 SAN FRANCISCO, CALIFORNIA

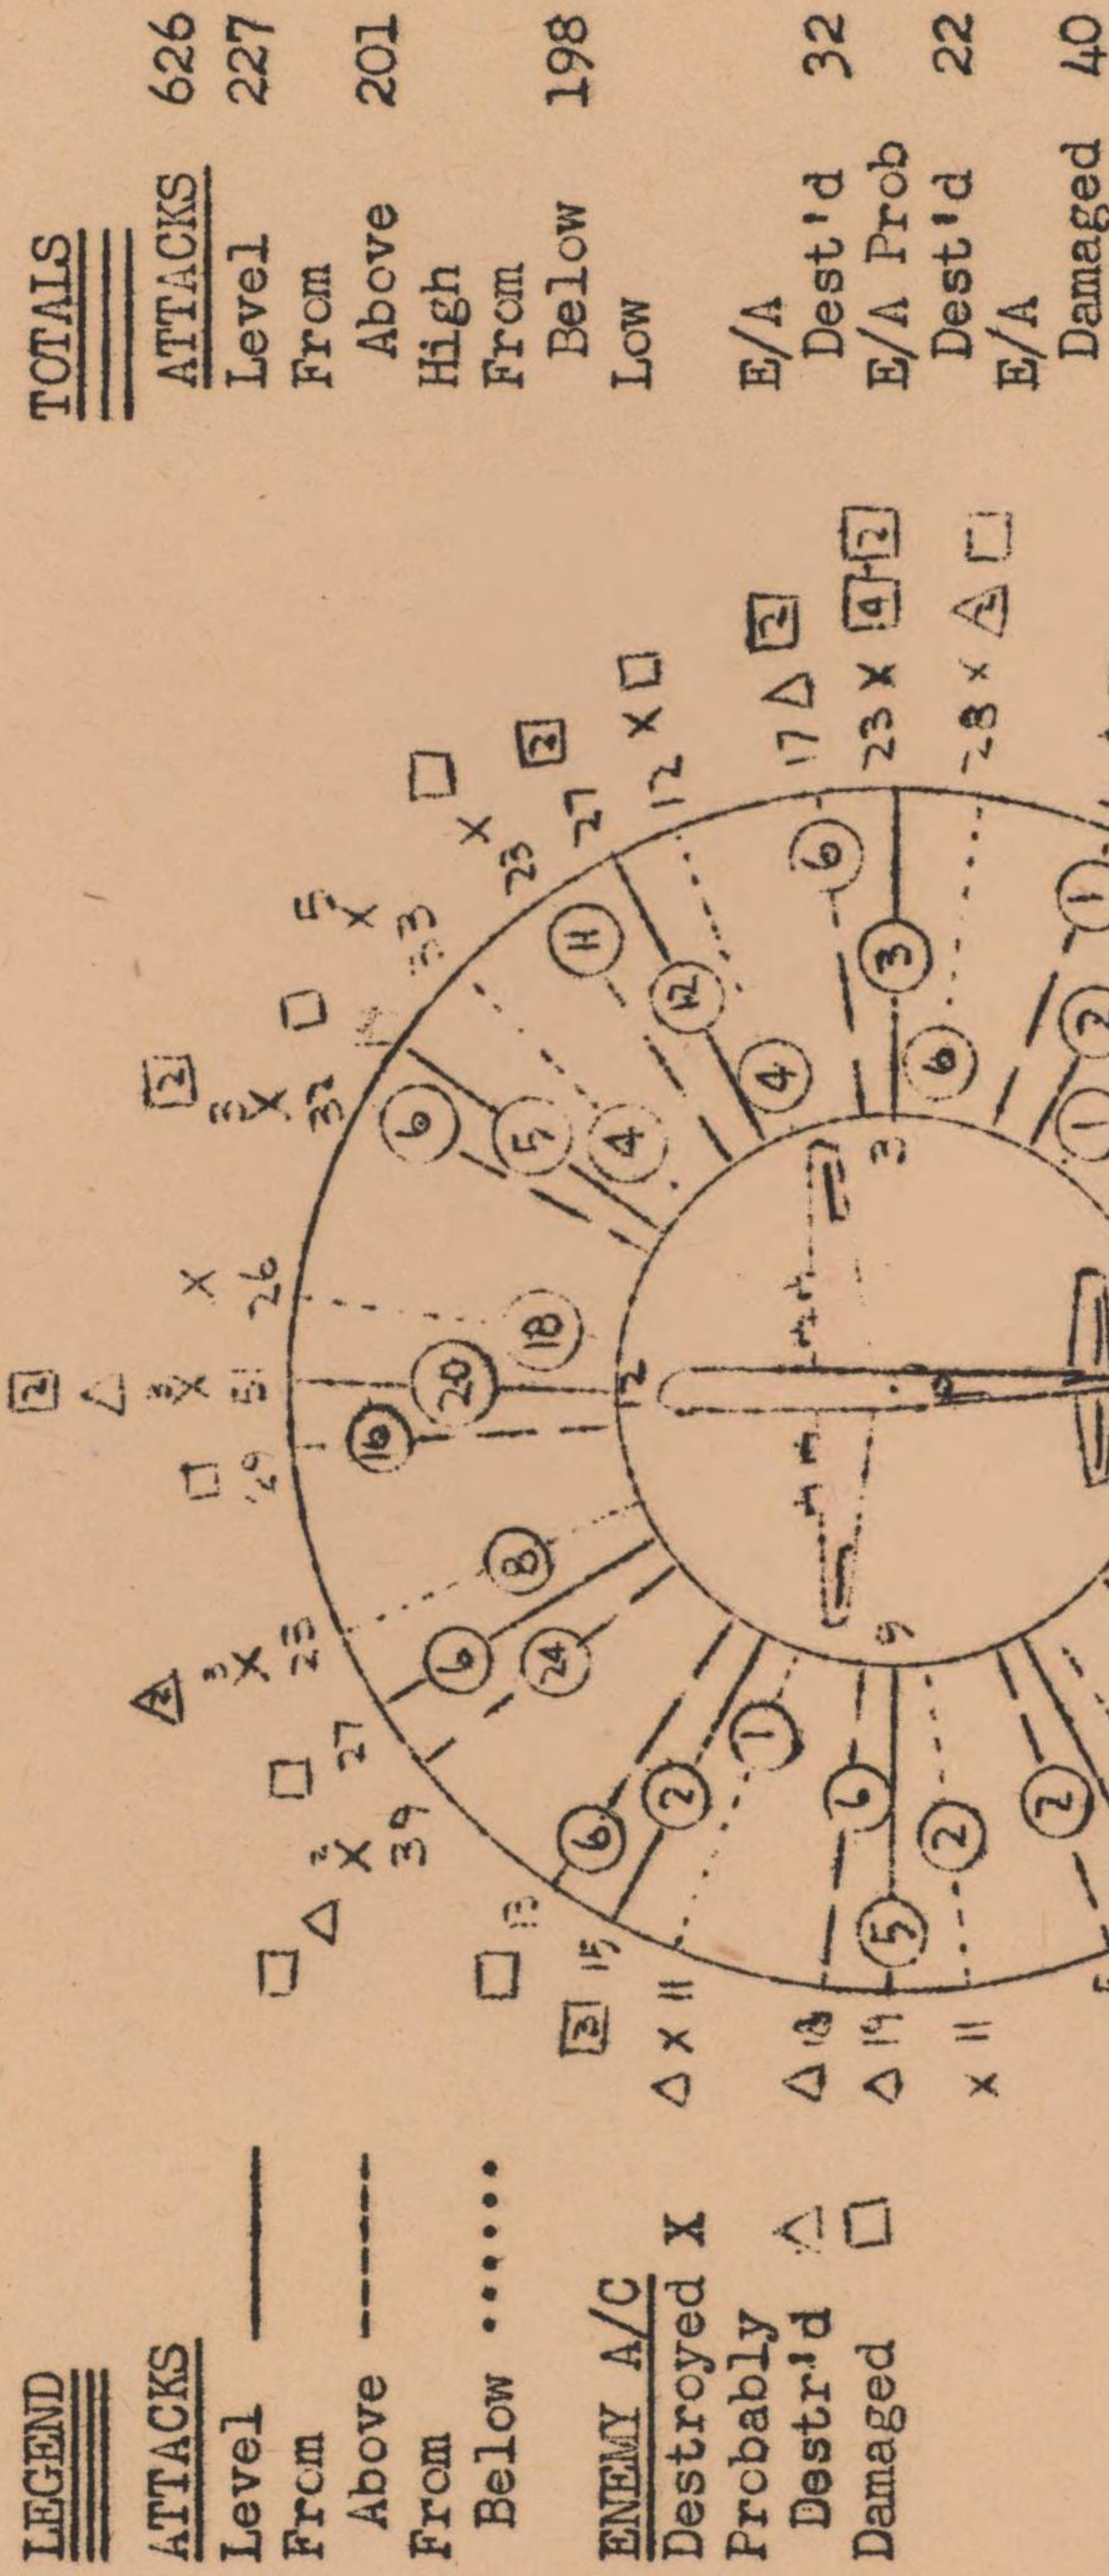
20. ANALYSIS OF ATTACKS BY ENEMY AIRCRAFT:

Note: The number of E/A attacking is shown at the outside end of each line. Attacks made by twin-engine enemy aircraft are indicated by "o" interruption in attack line, and when more than one T/E attack is made, the total is shown inside the "o".
