MISSION #20 KAWASAKI "FRUITCAKE 1"  
19 JANUARY 1945

CONSOLIDATED MISSION REPORT

**XXI Bomber Command,  
 Mission No 20.**

Mission Number 20  
Field Order Number 41  
Date of Mission:  
19 January 1945

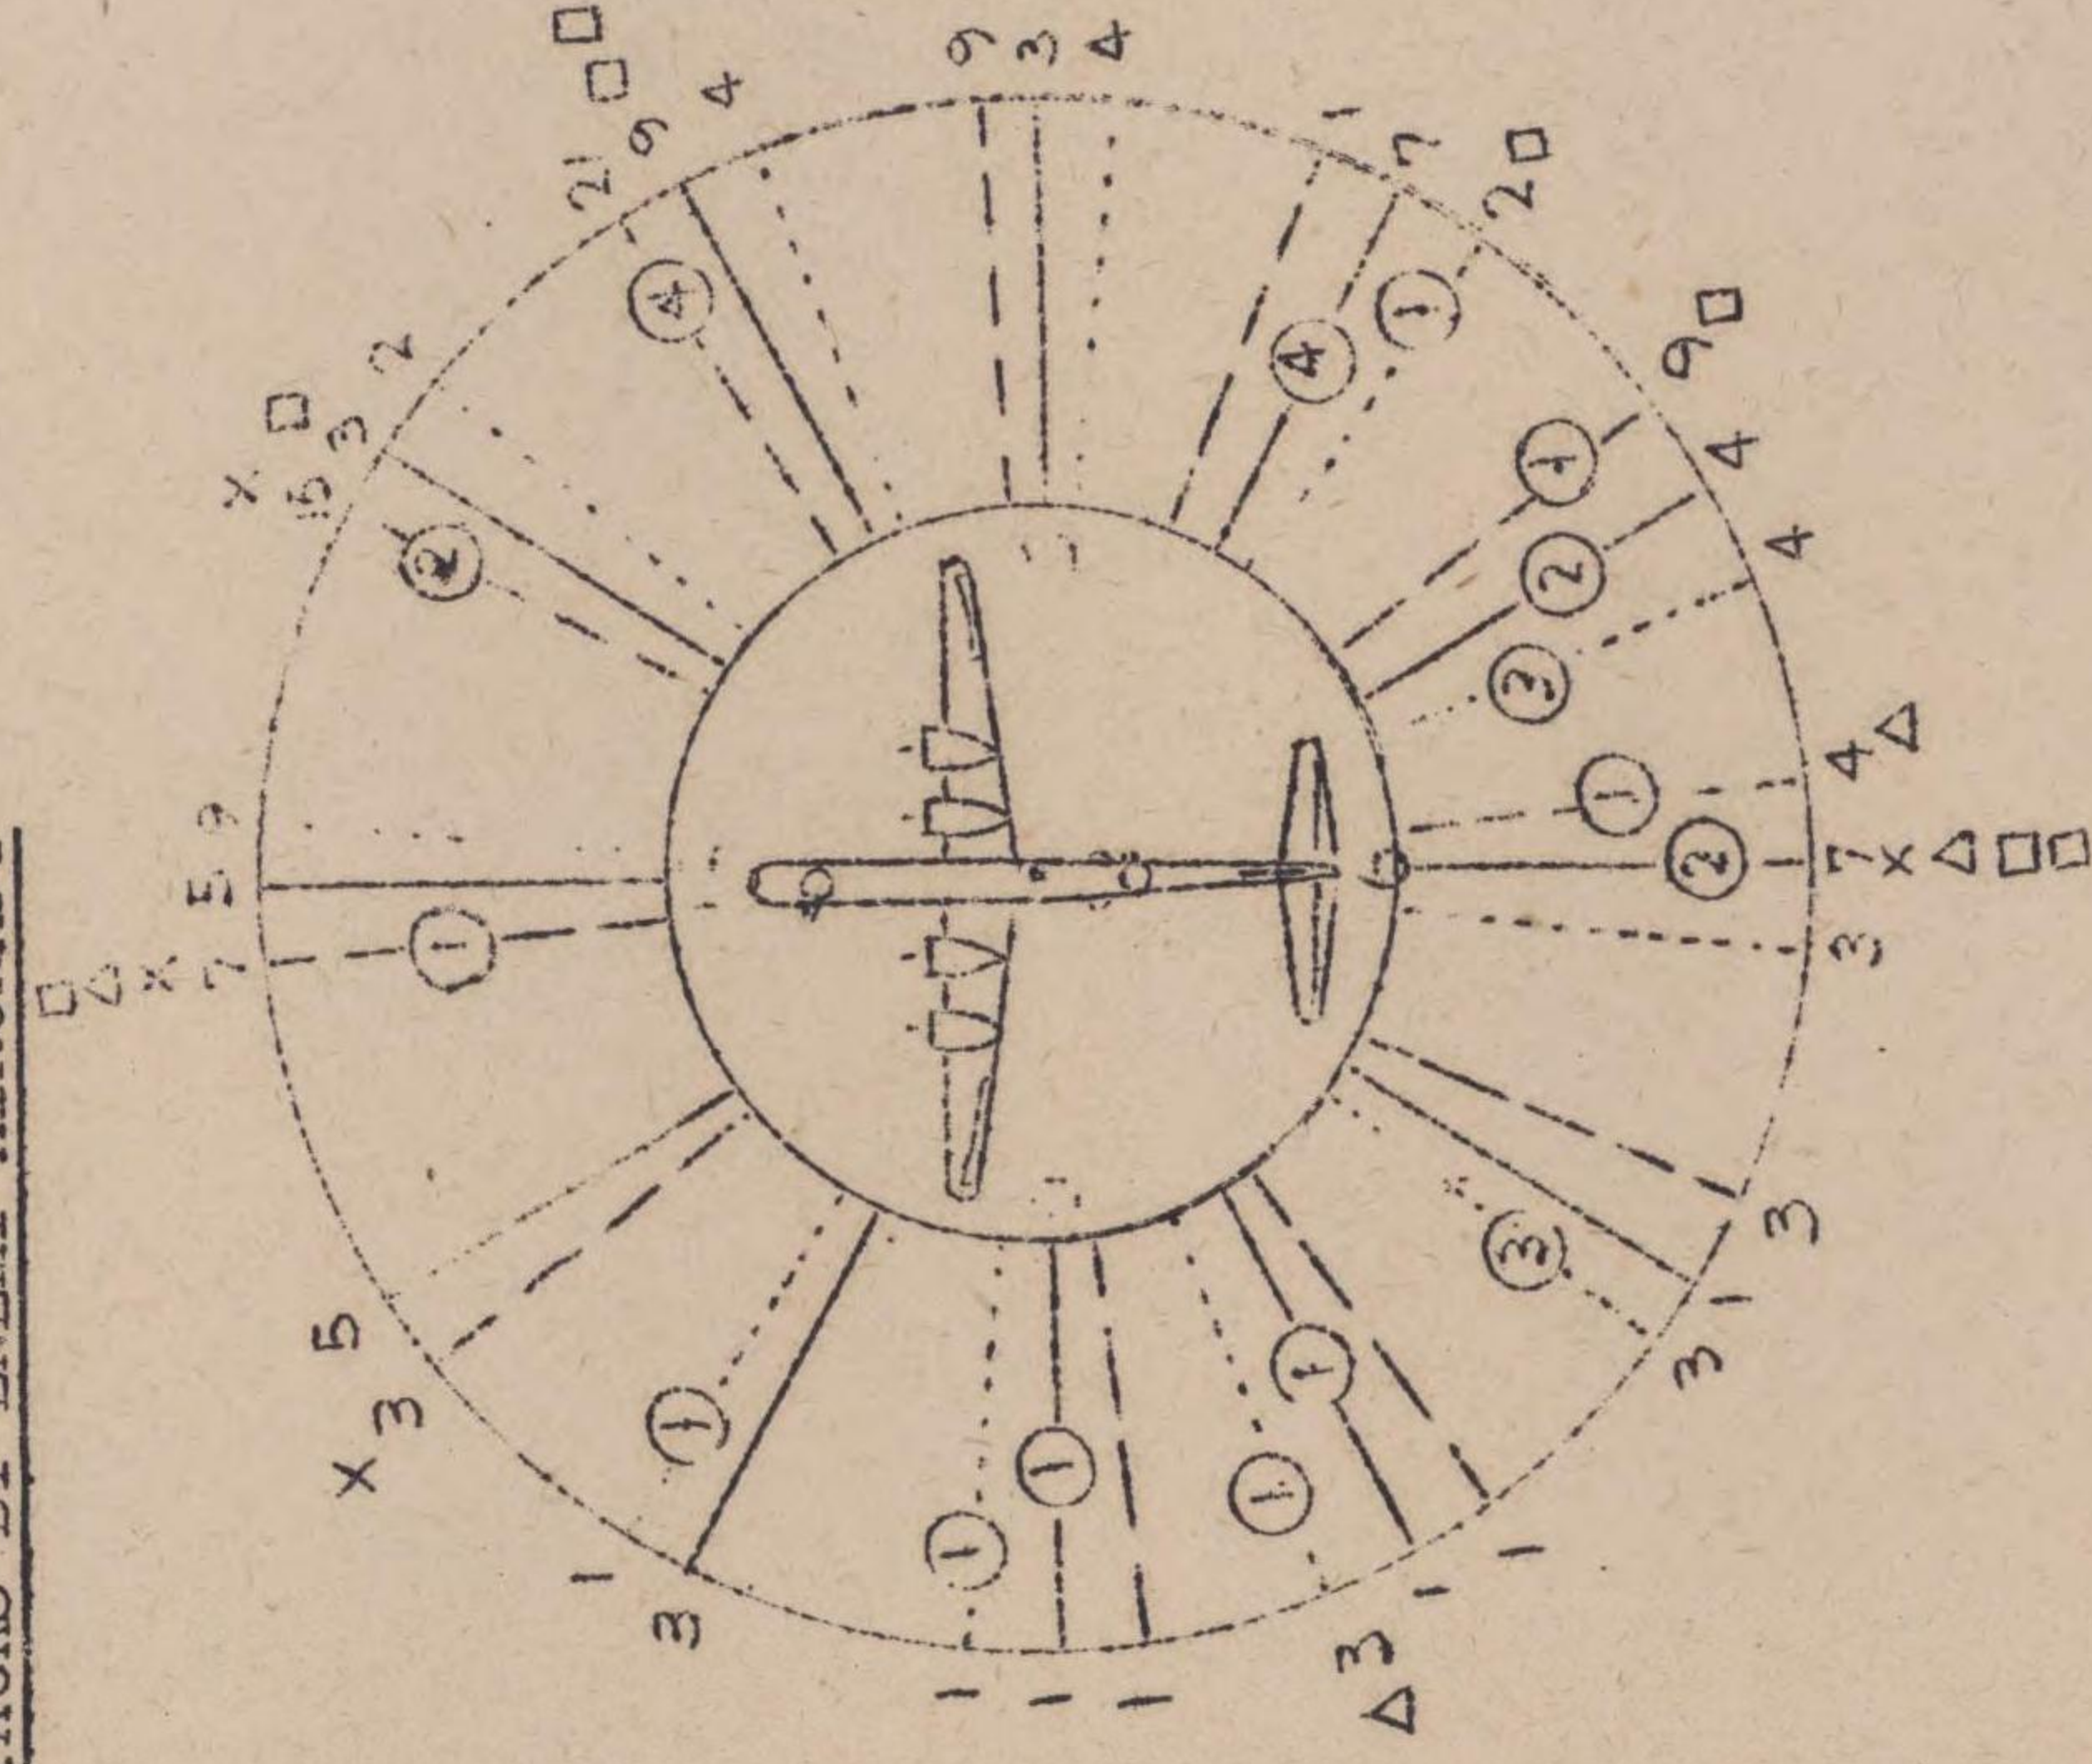
ENEMY A/C

Destroyed x  
Prob x  
Destr'd Δ  
Damaged □

<u>TOTALS</u>	
<u>ATTACKS</u>	159
Level From	49
Above High From	74
Below Low	36
E/A Dest'd	4
E/A Prob Dest'd	4
E/A Damaged	8

NOTE: The number of E/A attacking is shown at the outside end of each line. Attacks made by twin-engine enemy aircraft are indicated by "o" interruption in attack line, and when more than one T/E attack is made, the total is shown inside the "o".

Of the 159 attacks, 74 came from above, predominantly from 12 to 3 o'clock; 49 level attacks from 10 to 6 o'clock; and 36 low attacks from all quarters. Six attacks were coordinated and few were closely pressed. There were no unusual tactics reported on the part of either E/A or B-29's.

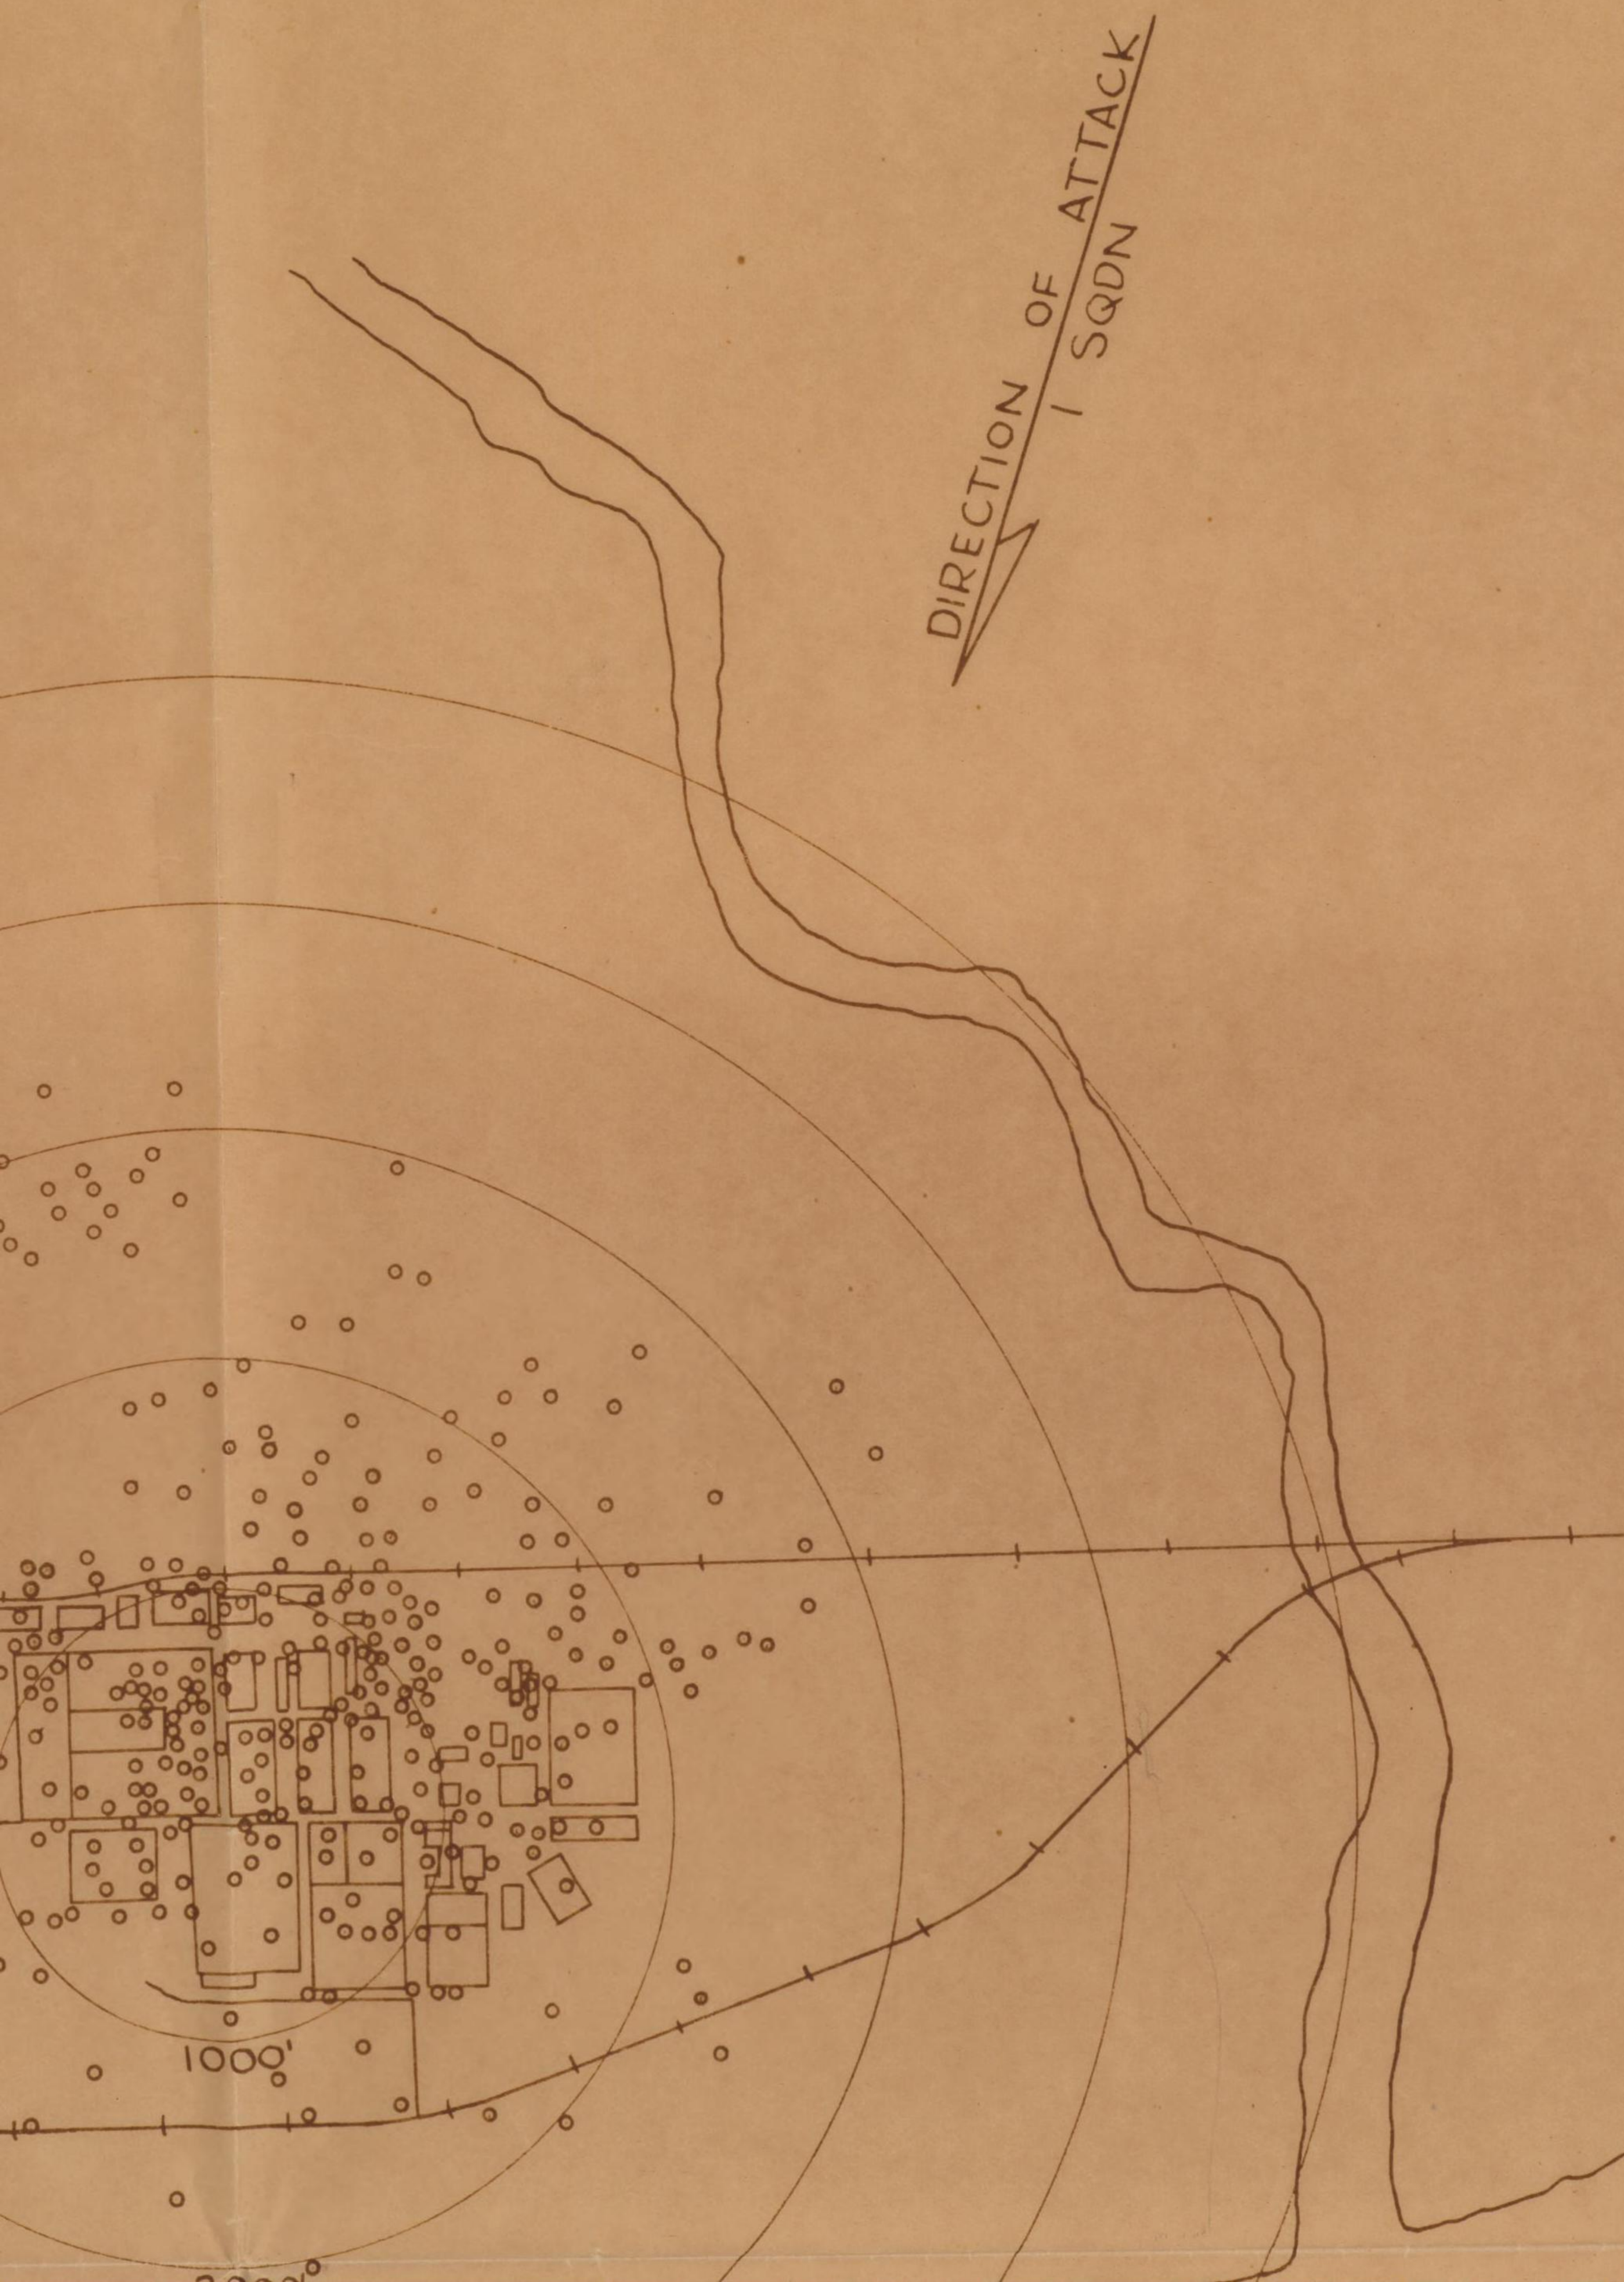
DIRECTION OF ATTACK  
1 SQDN

DIRECTION OF ATTACK  
3 SQDNS

Strike and Post - Strike photography indicates that the Hawaski Aircraft Engine and Assembly Plants at Akashi received major damage. It is estimated that the 129 hits observed on the two plants damaged or destroyed 39% of the total roof area. 31 out of 42 buildings in these plants received one or more direct hits. All main buildings of both the engine plant and the aircraft assembly plant were destroyed or damaged to some extent. The greatest concentration of hits was observed in the engine assembly buildings in the northern half of the target area. These resulted in damage or destruction to 58% of the roof area in the engine plant. The U-shaped building received approximately 35 hits and near misses while 2 buildings were completely gutted and 3 other buildings suffered at least 75% damage or destruction. Several small buildings in the engine plant area were damaged or destroyed.

21 % of the total roof area of the a/c assembly plant was damaged. 8 hits are visible on the largest of the final assembly buildings while 30% of the smaller assembly building immediately to the east was gutted by 6 direct hits. One of the sub assembly buildings was completely gutted. 30% of the other sub assembly building was gutted and an additional 30% damaged. At the eastern edge of the target one of the two large buildings with sawtooth roofs had 9% of its roof damaged. The other building has several clusters of holes. 8 hits destroyed or damaged at least 4 aircraft in the area adjoining the final assembly plant. (Note: dark shadows make final assessment of damaged aircraft impossible) (Note: Percentage of destruction are taken from Hq, XXI BC CIU Damage Assessment Report No. 4.)

39% of the total roof area was damaged or destroyed resulting in severe damage to the target. As 138 (40%) out of 340 bombs scored fell within 1000 feet of the AP results of the bombing are considered to be good.

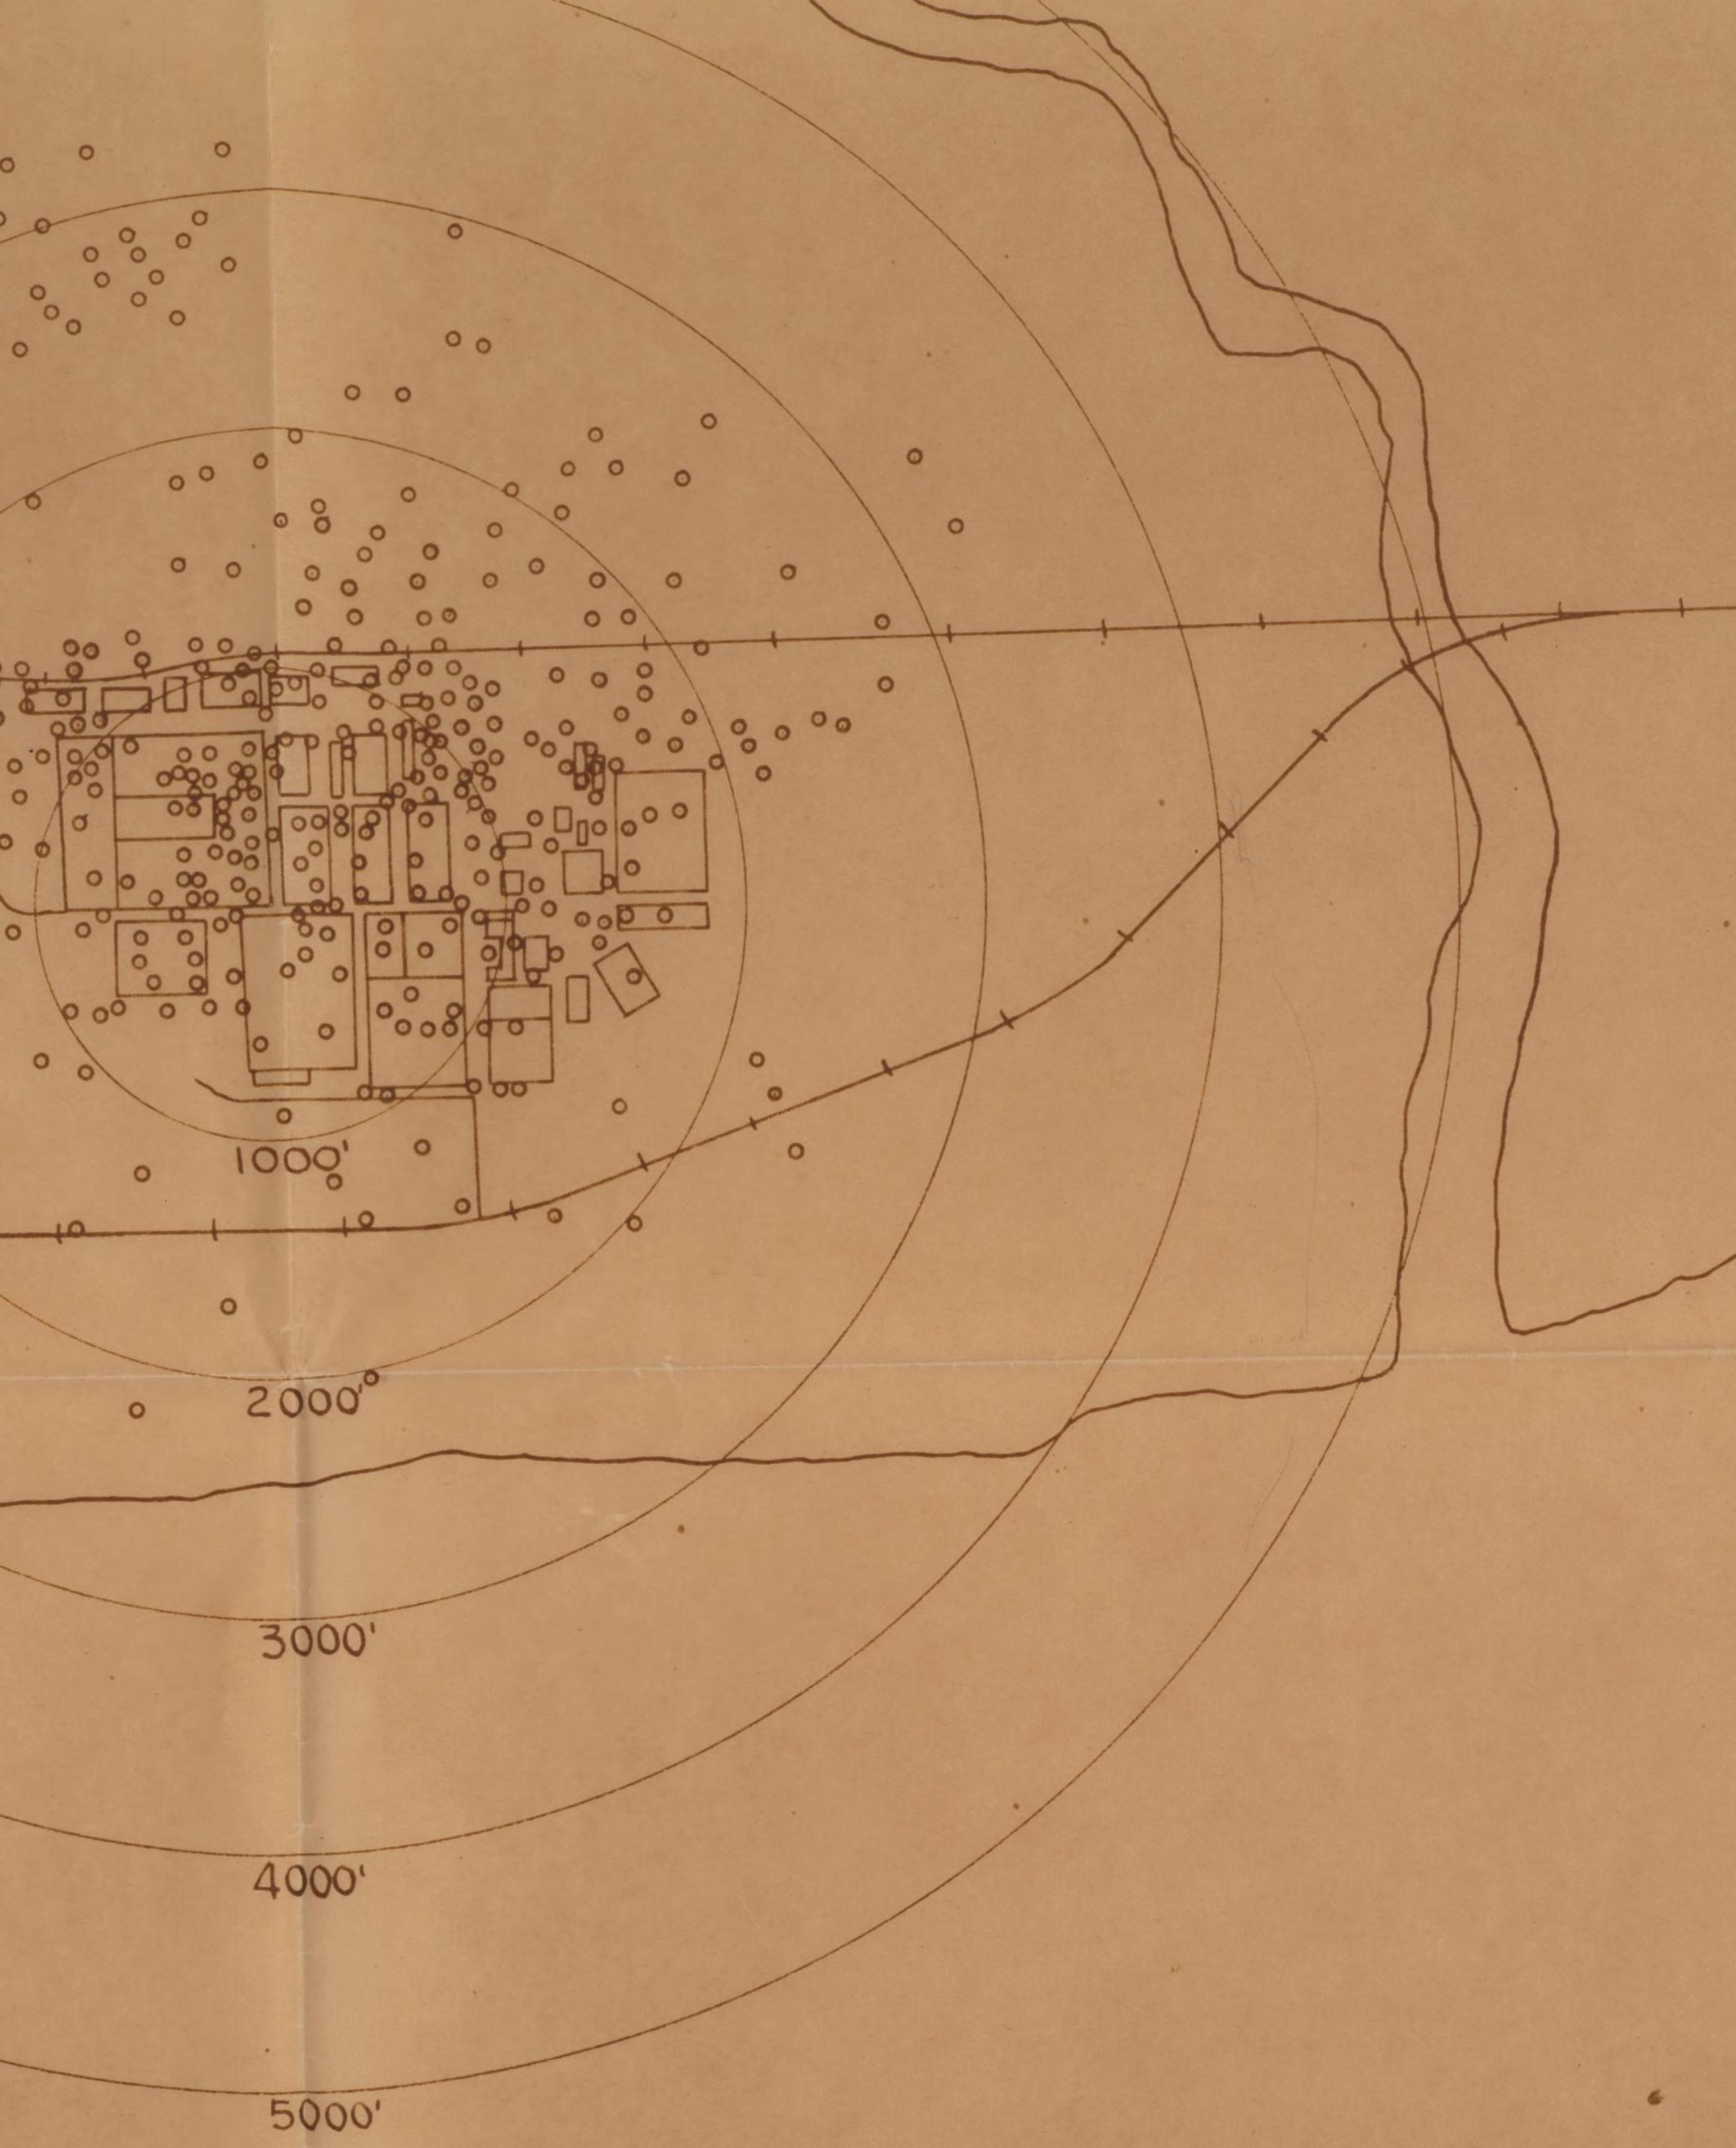
BOMB PLOT -

DIRECTION OF ATTACK  
3 SQDNS

DIRECTION OF ATTACK  
4 SQDNS

TARGET IN  
73 RD

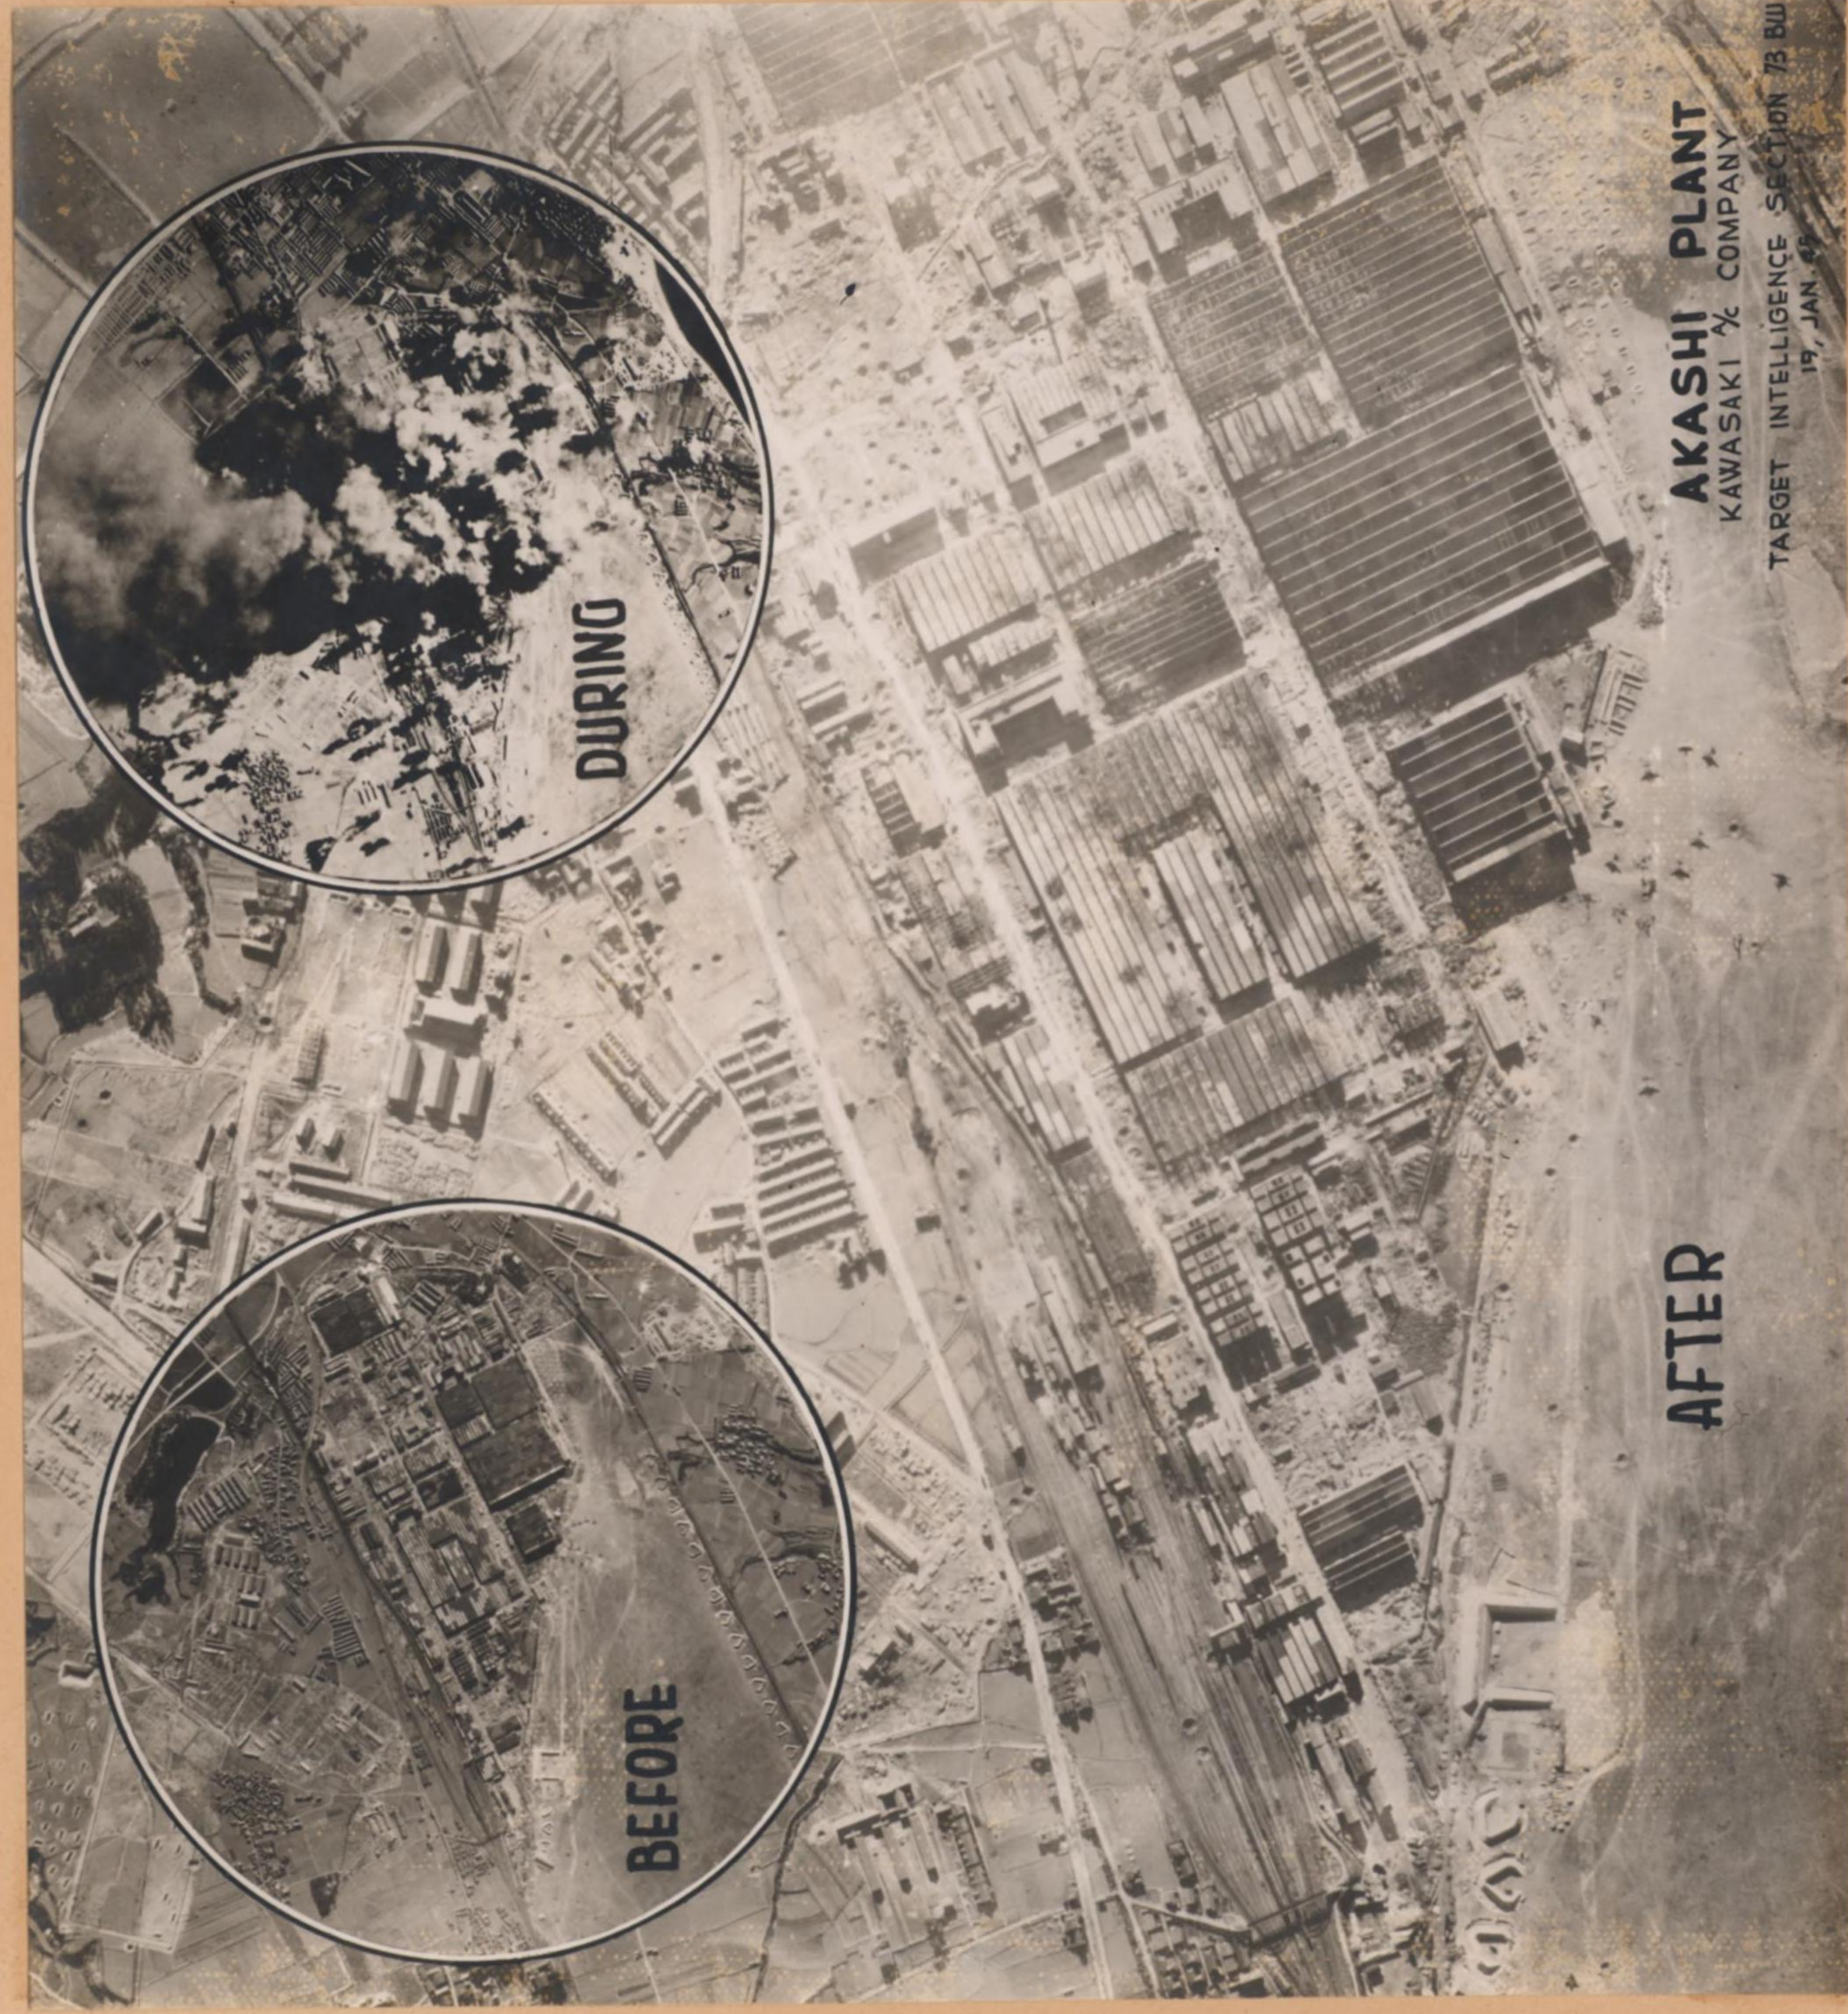
**AKASHI PLANT**  
KAWASAKI CO. COMPANY

TARGET INTELLIGENCE SECTION 73 BU  
19 JAN 45
