**THE UNITED STATES  
STRATEGIC BOMBING SURVEY**

**Evaluation of  
Photographic Intelligence  
in the Japanese Homeland**

**PART SIX  
SHIPPING**

Dates of Survey:  
7 October 1945 through 1 March 1946

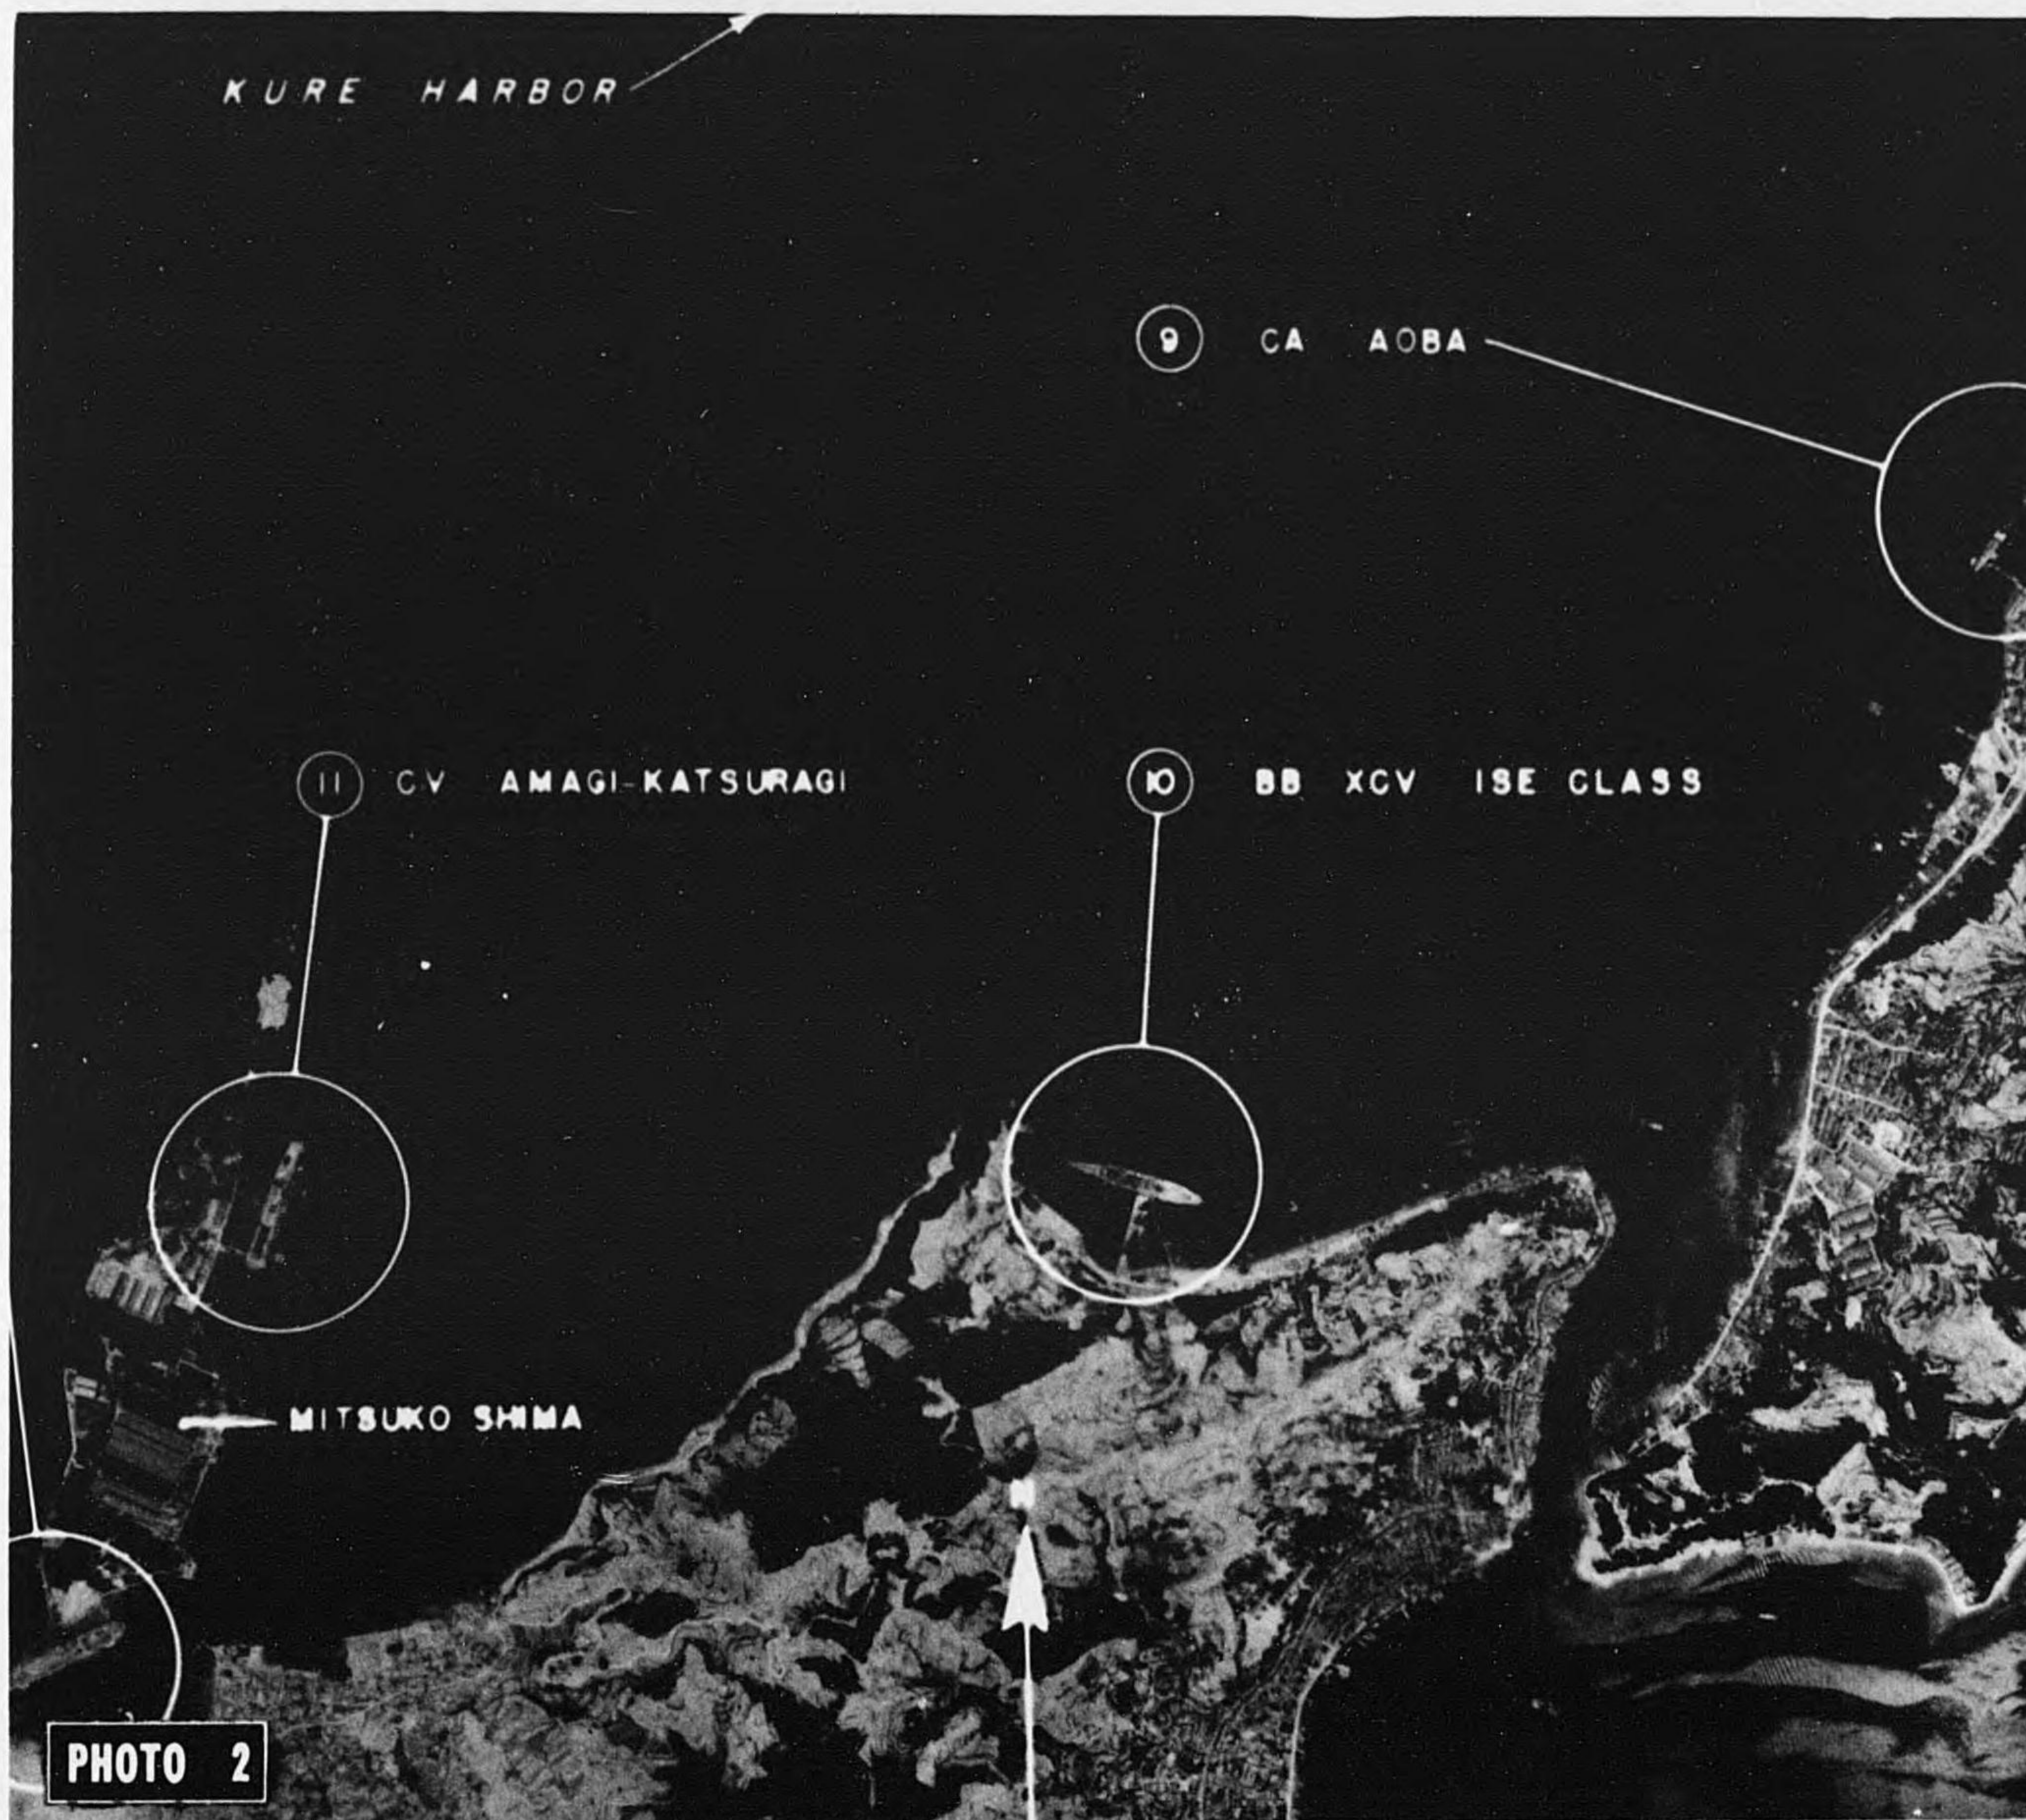
d. Exhibits in the form of vectographs of each of three ships made from photographs taken during the raid have been included in an envelope attached to the last page of this report. It will be readily seen that a three dimensional view is essential in assessing damage. Exhibits are labeled, "A": CA-Aoba, "P": CV-Katsuragi, "C": CV-Amagi.

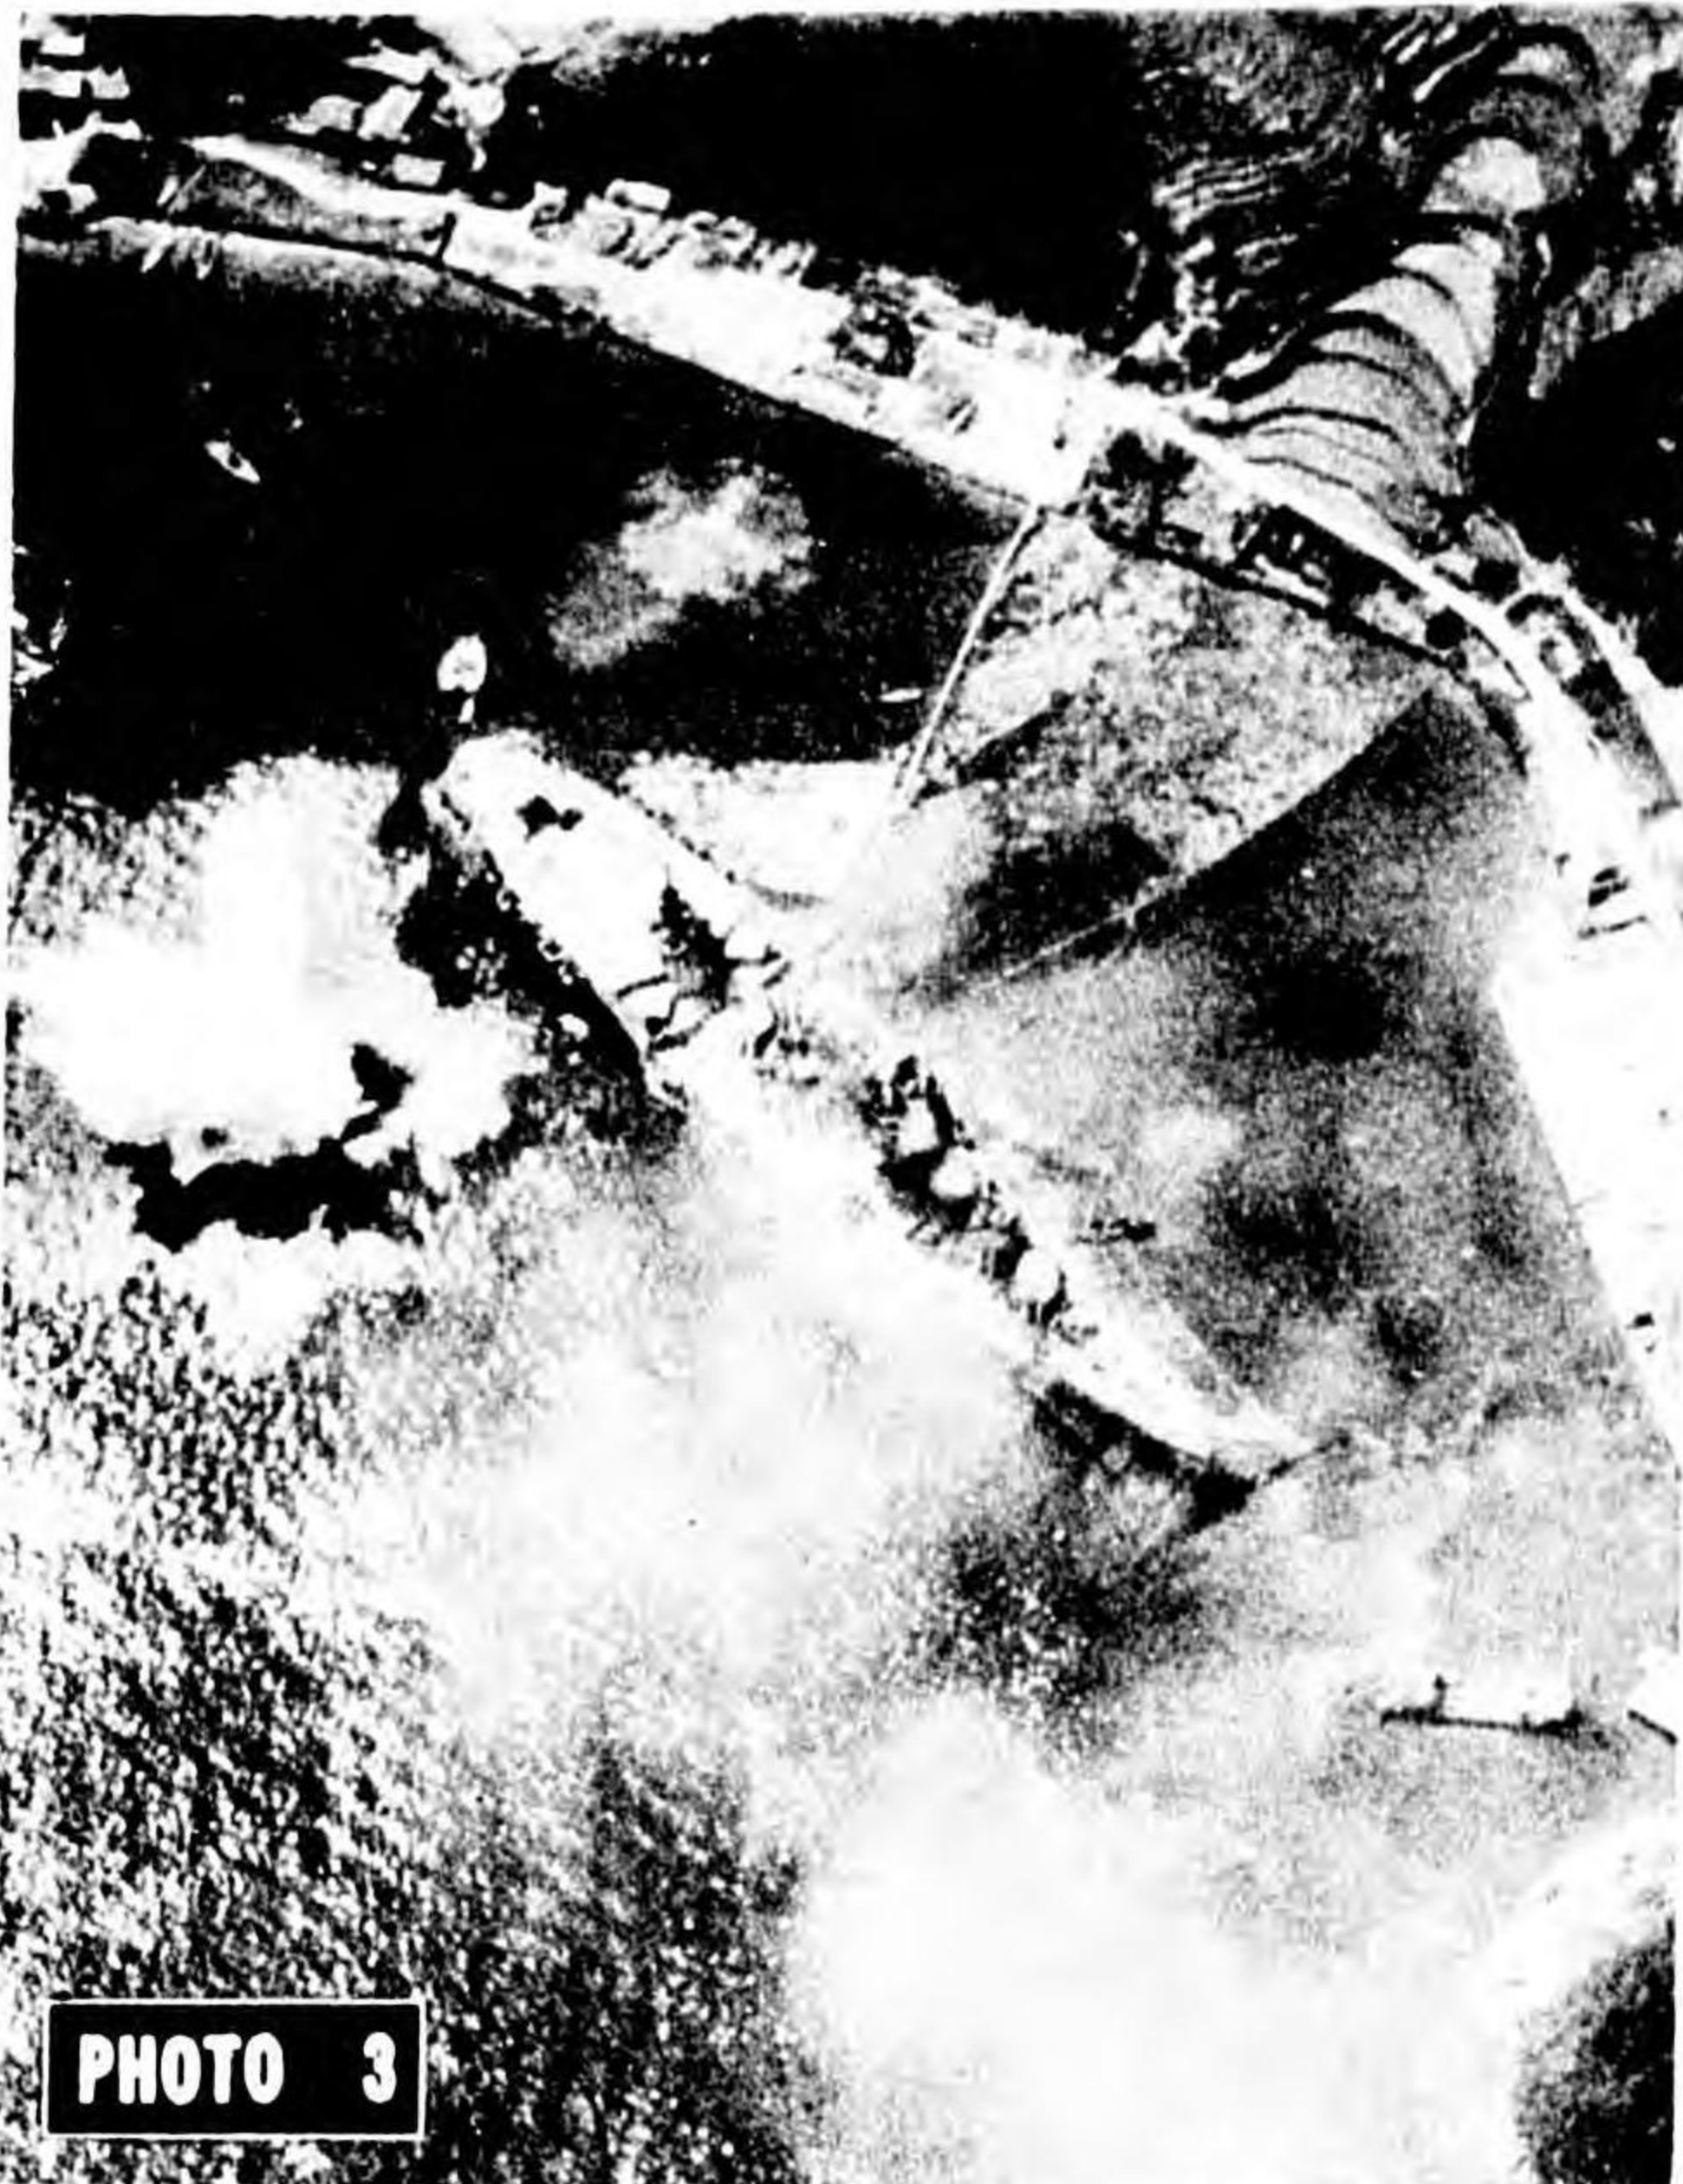
**PHOTO 3**

BB-1SE. Oblique view taken at 1000 on 24 July. See figure 4 for a plan drawing of final damage assessment.

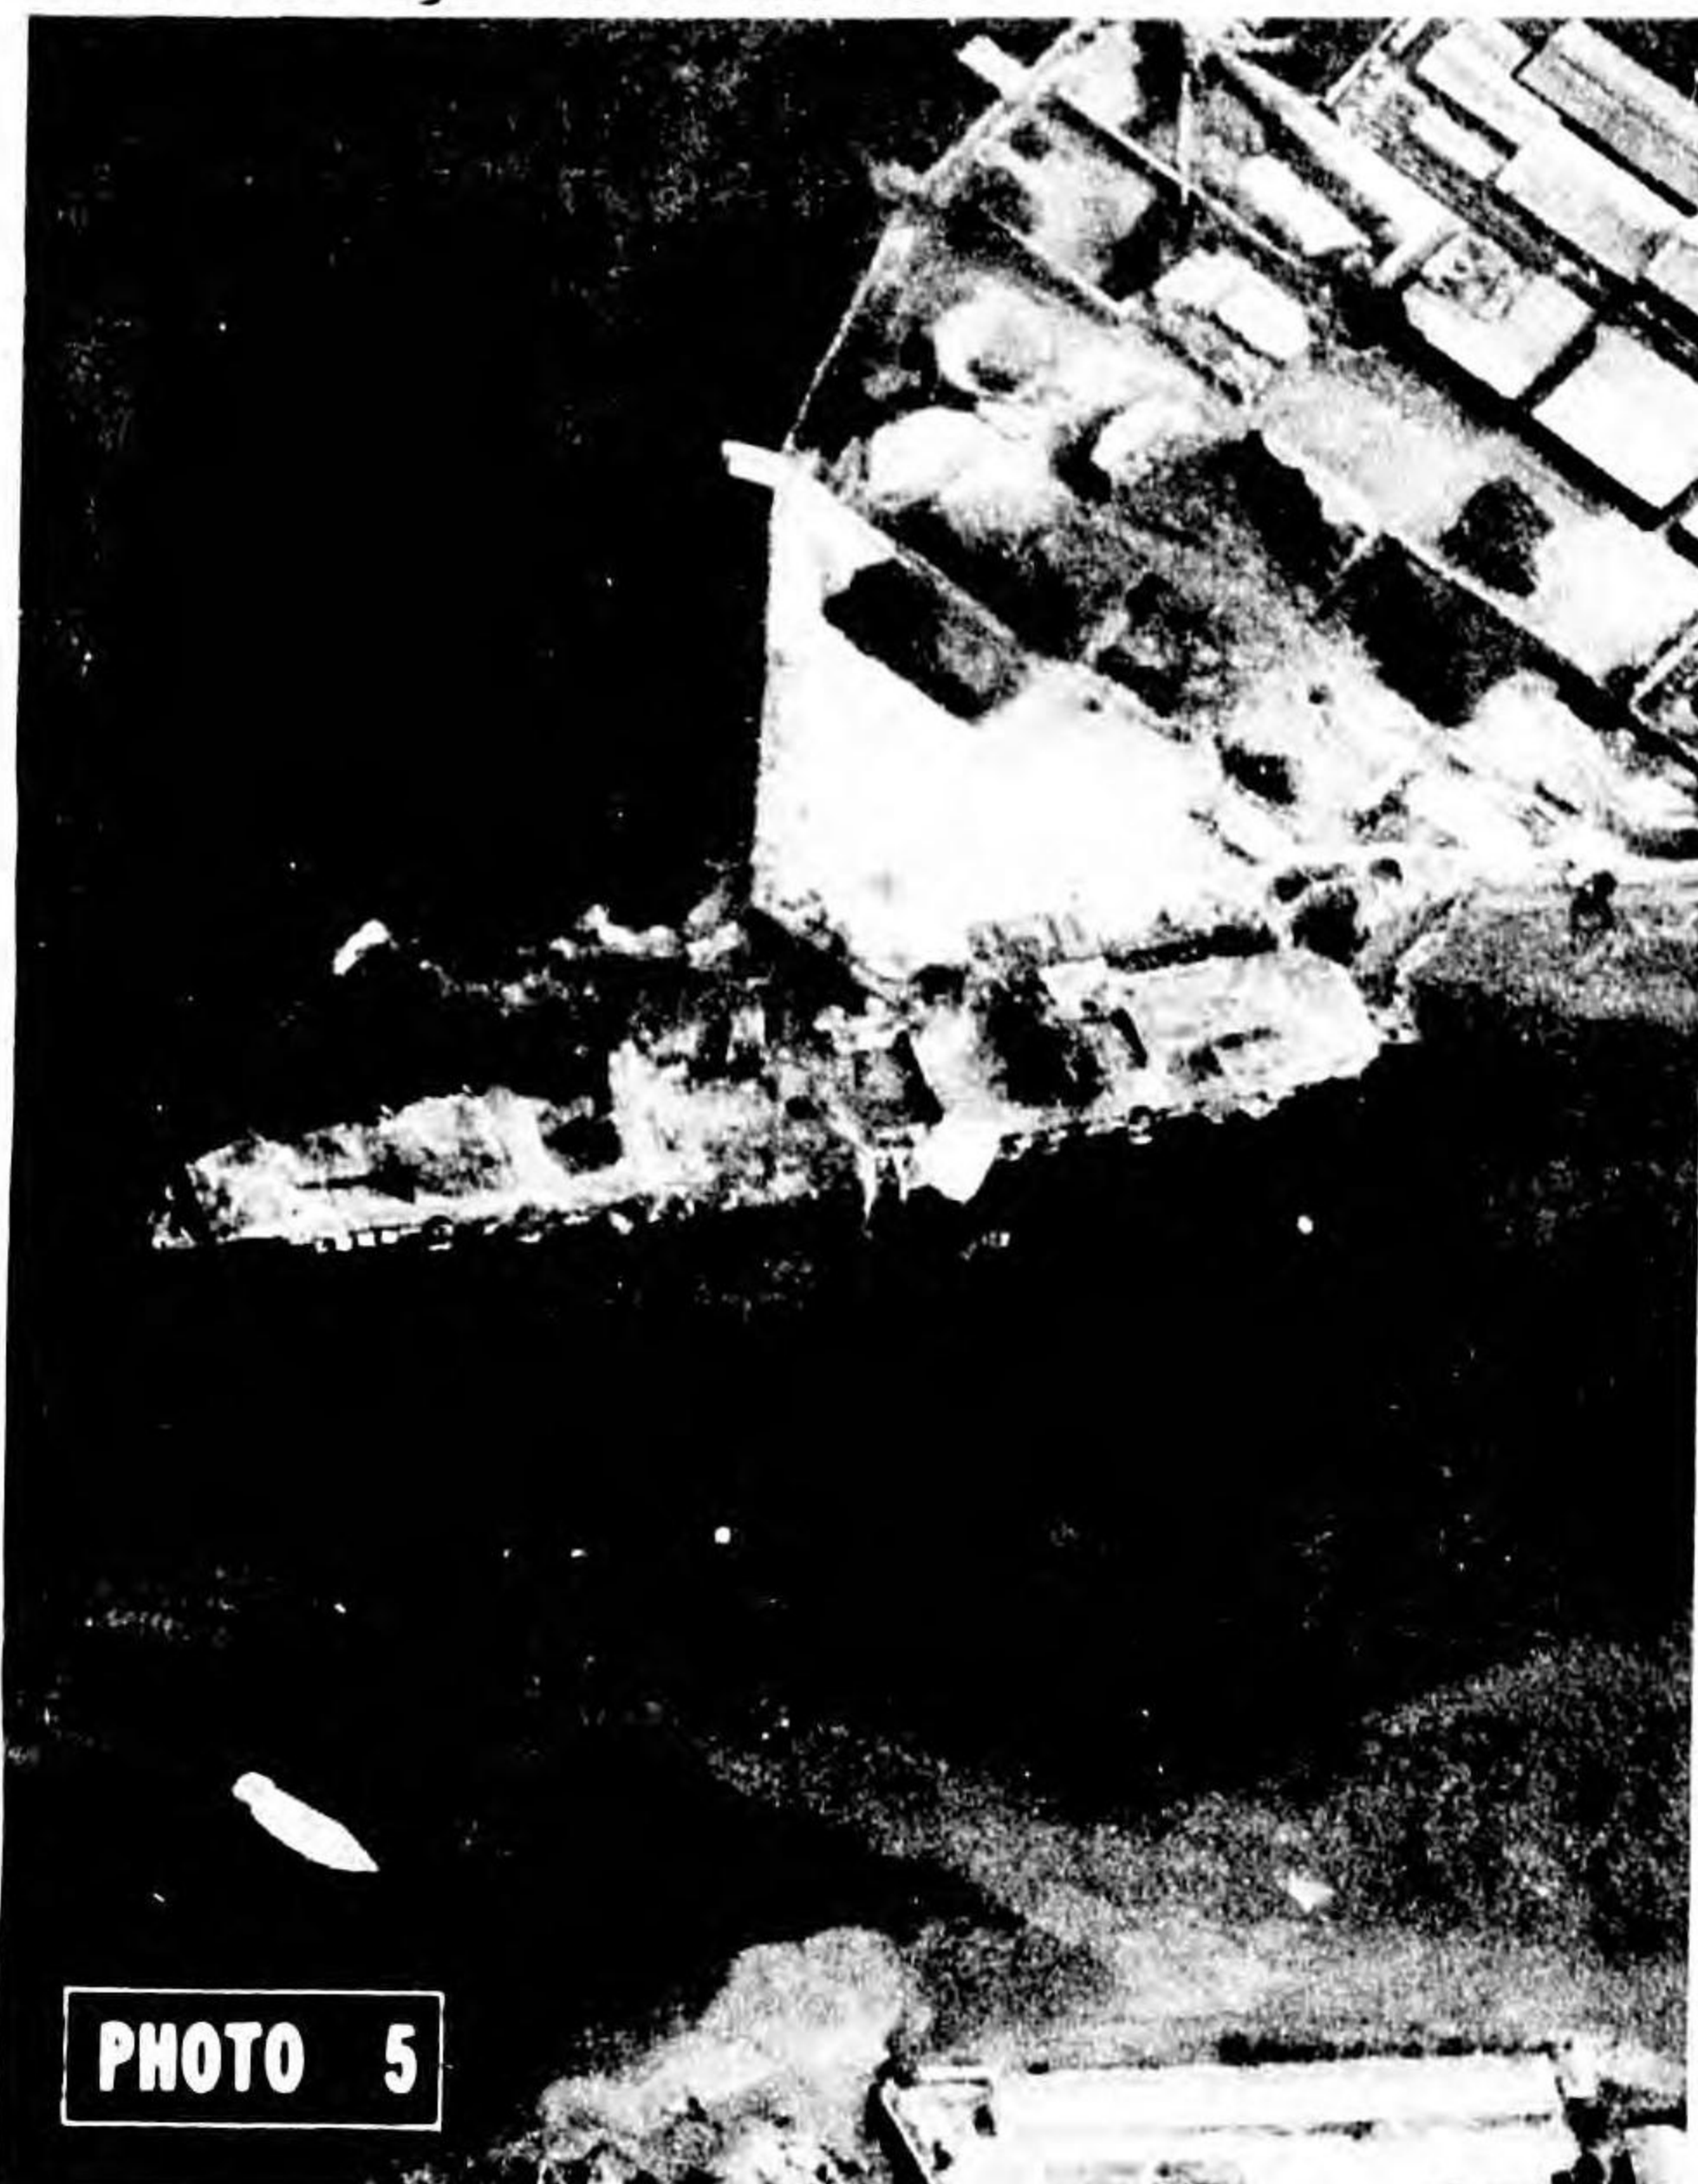
**PHOTO 5**

CV-AMAGI. Taken early in the morning of the second raid, this photograph shows the damage to the flight deck amidships.

Stereoscopic study of the Japanese aircraft carrier "Amagi" revealed the following damage: A hole 180 feet long in the flight deck aft of the island, extending athwartship; A 25 x 10 foot hole through the hangar deck; Two 50 foot sections of side plating on the starboard side blown out down to the hangar deck; 85 feet of flight deck buckled and sagging; An 80 foot section of flight deck hanging over the port side; A portion of flight deck between the after elevator and the starboard side destroyed.

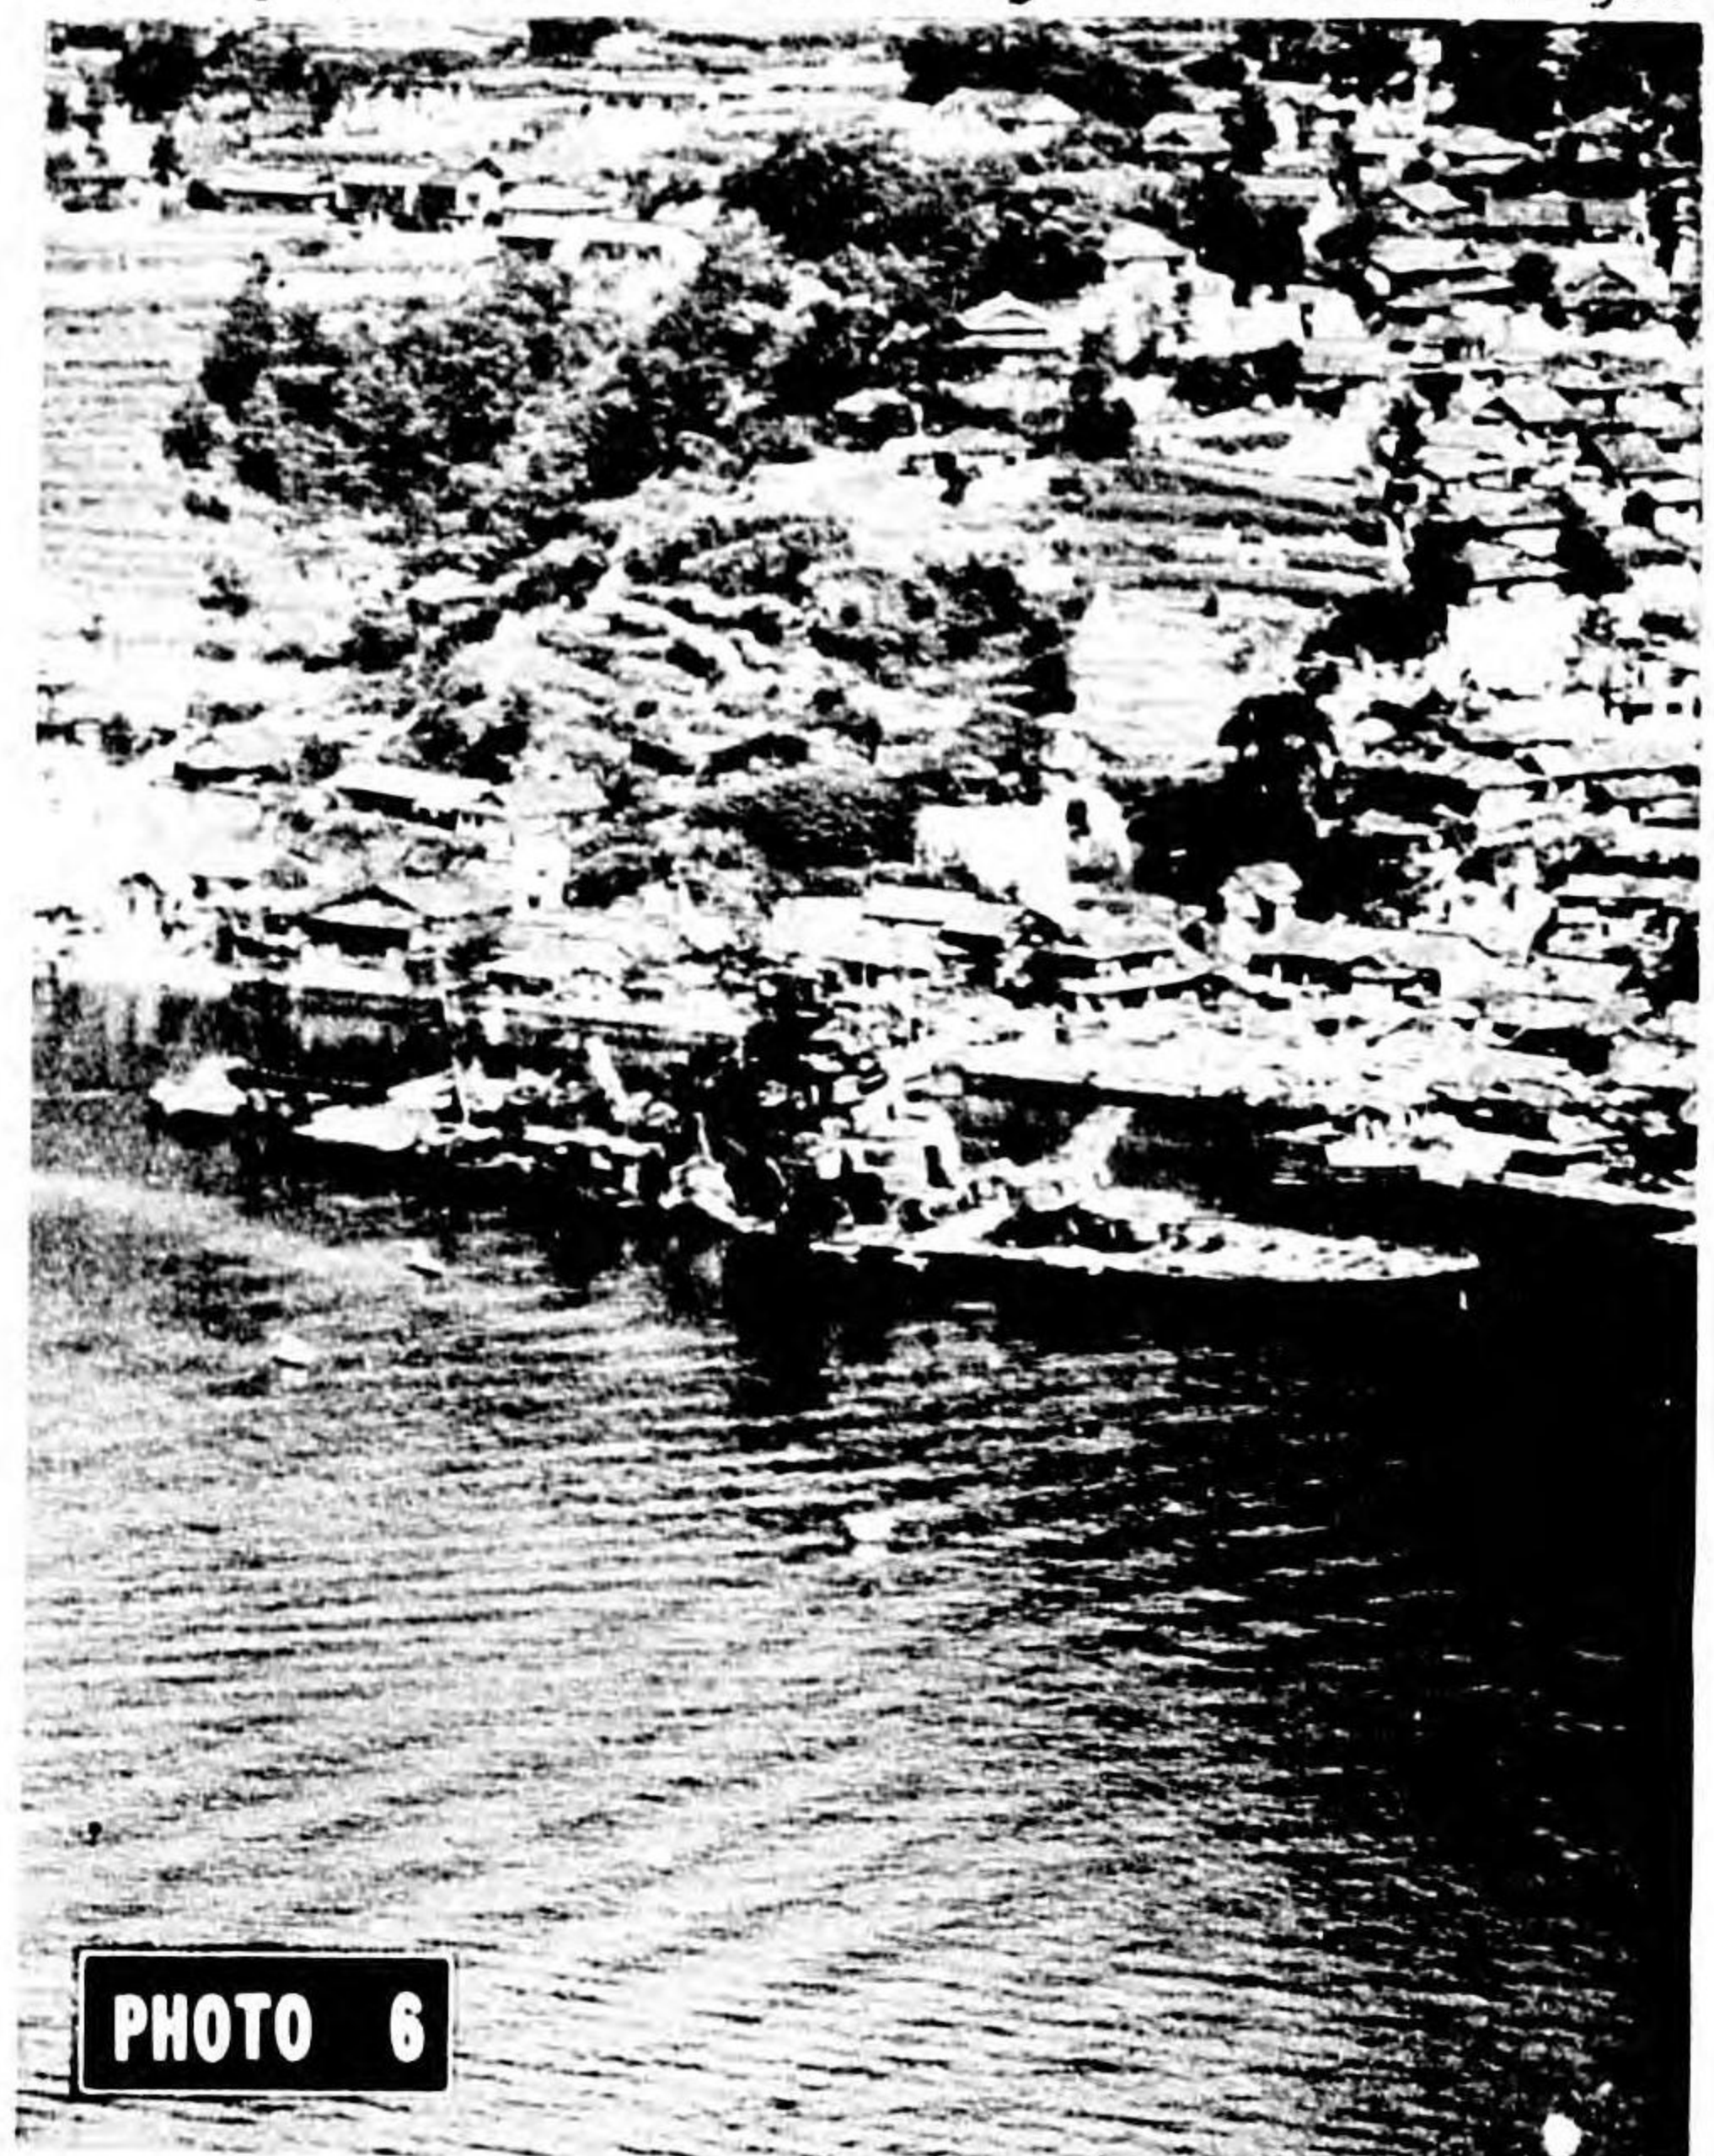
**PHOTO 6**

CA-AOBA. Although photographed on 15 Sept, this oblique view indicates the damage sustained. Note that fantail is broken off.

Careful stereoscopic study of photographs similar to this three dimensional aerial view of the Japanese heavy cruiser "Aoba" revealed that 55 feet of main deck was destroyed aft of the after turret, that side plating on the starboard side in the damaged area was torn down to the water line, and that the ship was resting on the bottom.

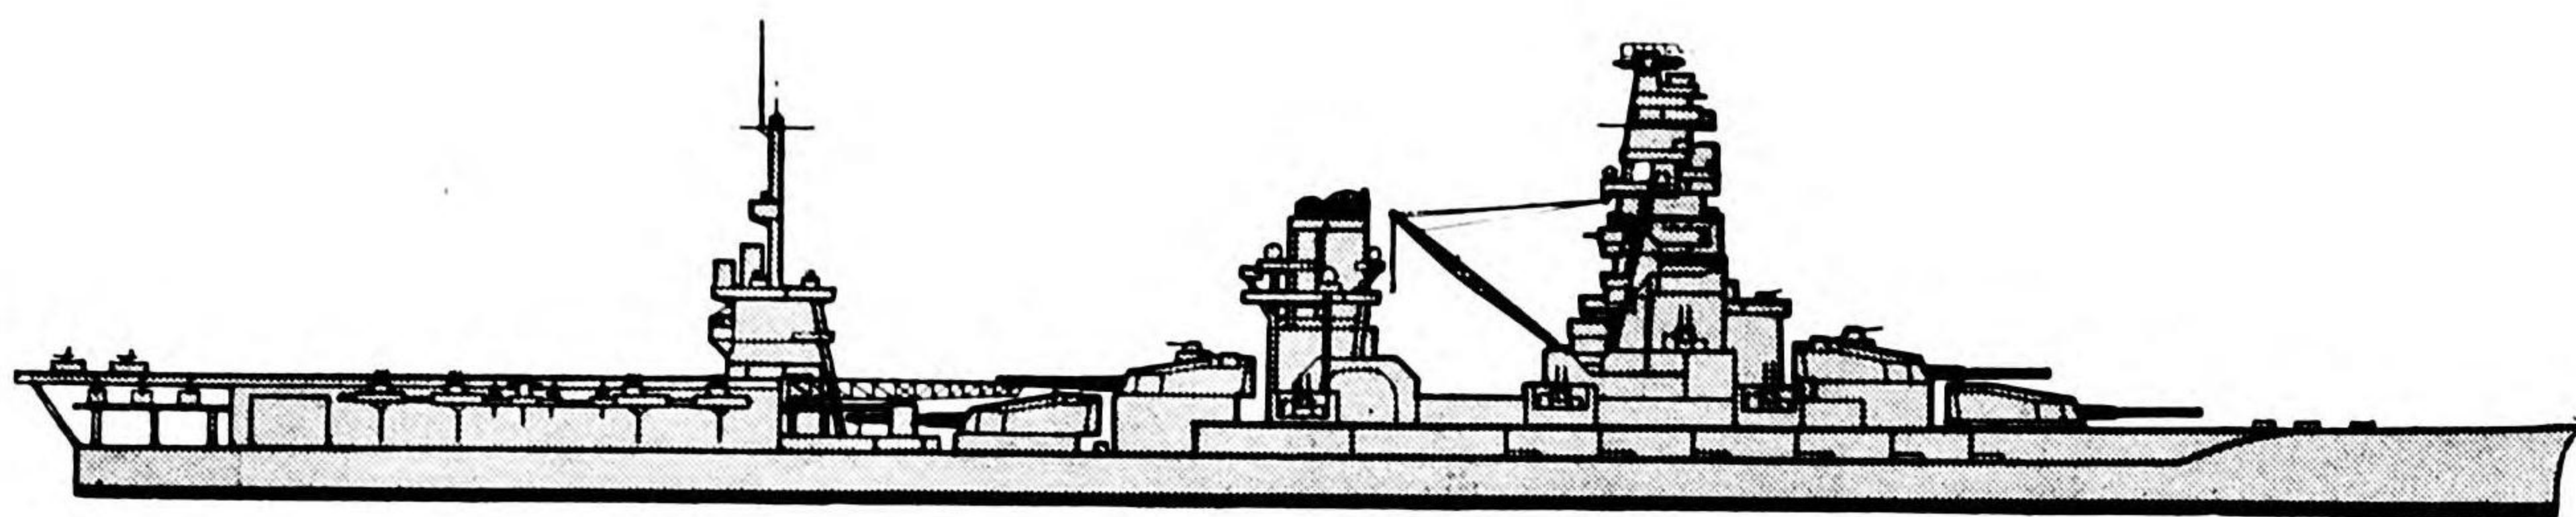
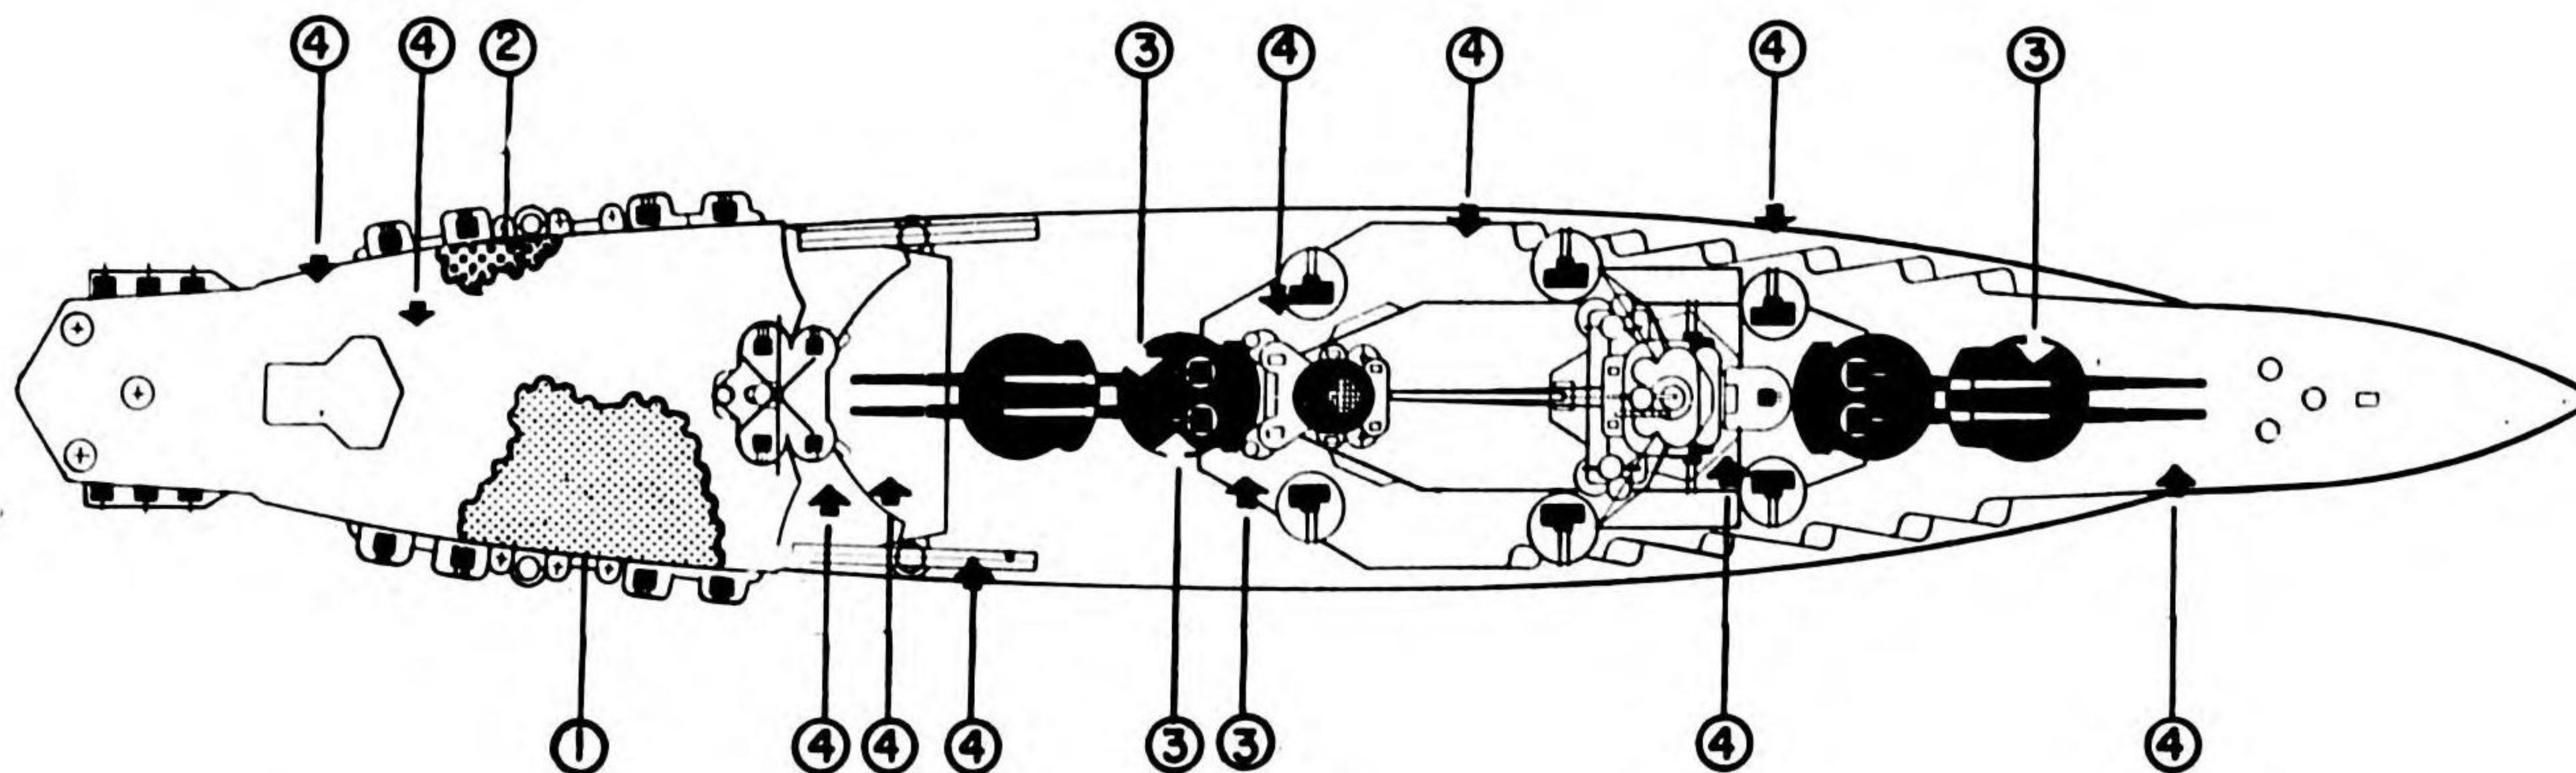
**FIGURE 4**

REPORTED DAMAGE	KEY	ACTUAL DAMAGE
Ship low by the bow probably resting on bottom.		After 24 July attack ship settled by bow. Ship abandoned 1800 28 July after settling on bottom - 15° list to starboard.
Hole in staging deck extending aft of mainmast for 50 feet and from centerline starboard side of ship.	1	Report correct
20 x 20 foot hole on port side at edge of staging deck 130 feet from stern.	2	Report correct
No report	3	Direct hits on #1 & #3 turret roofs failed to penetrate 6 inch armor.
No report	4	Numerous hits on main deck
Maindeck awash		Maindeck awash at high tide
Camouflage destroyed		Report correct
No report		Serious fire below decks around #1 turret caused considerable damage.

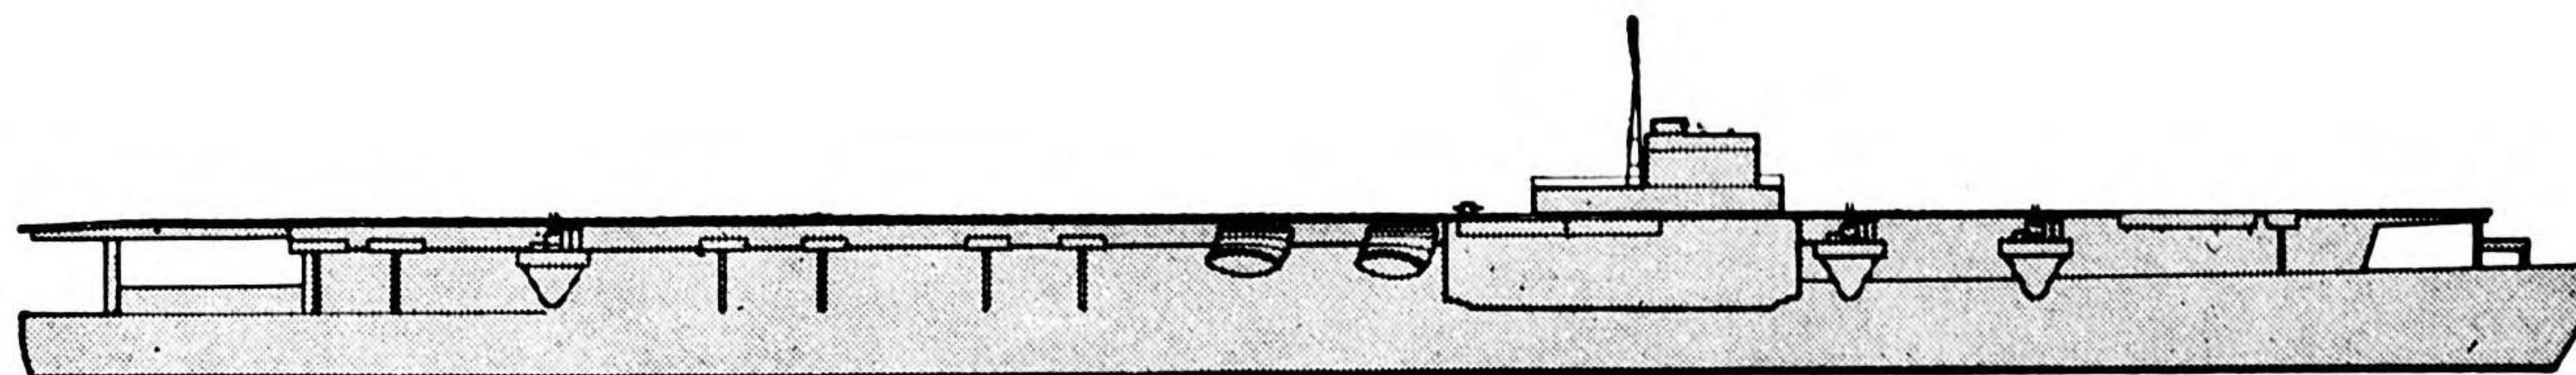
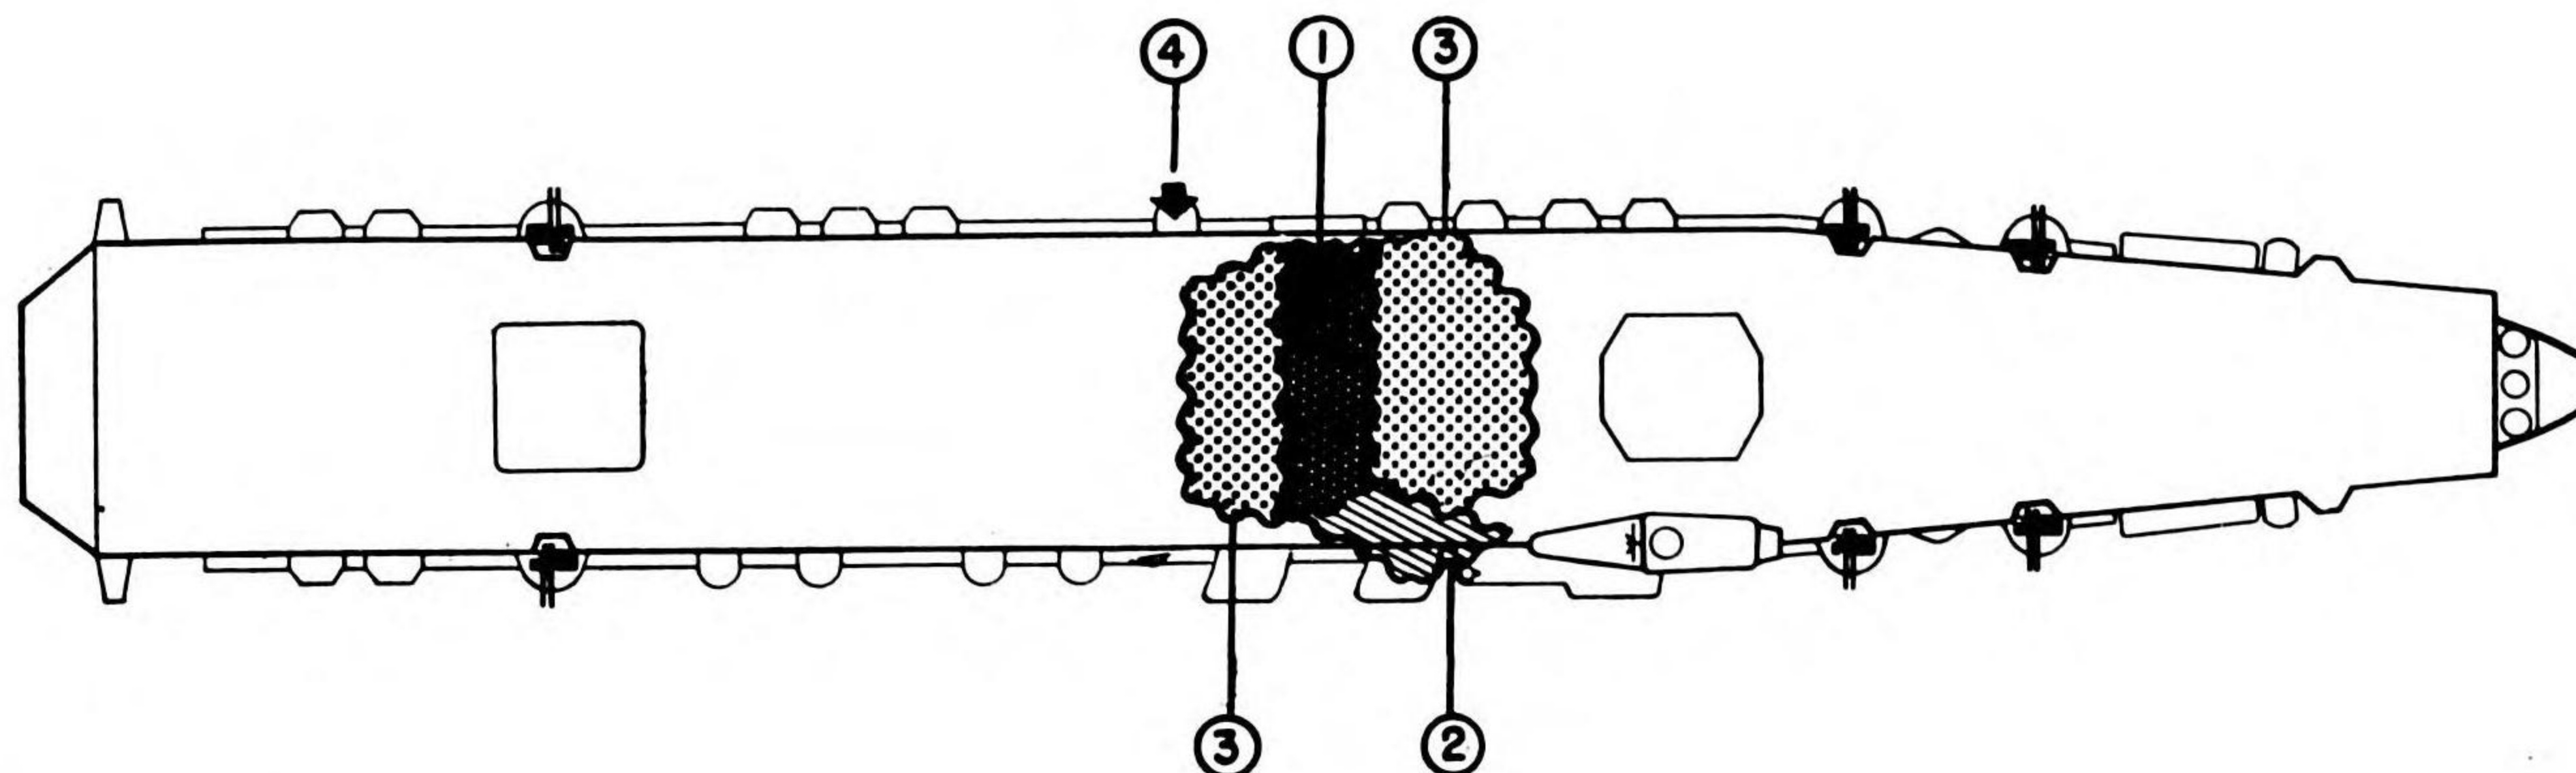
**FIGURE 5**

REPORTED DAMAGE	KEY	ACTUAL DAMAGE
Flight deck destroyed near stacks. Hole extends from side to side and for 35 feet fore and aft with side plating port side blown out down to hangar deck.	1	Report correct; bombs exploded in upper hangar deck.
Destroyed portion of flight deck with framing attached blown out and resting on starboard side.	2	Report correct
Flight deck buckled 50 feet forward and 30 feet aft of hole.	3	Upper deck bulged outward in every direction and much of flight deck and all elevators bent out of line.
80% of ship to shore camouflage destroyed.		Report correct.
Ship pumping water starboard bow.		Not reported.
Not reported	4	One hit on AA gun port, starboard side amidships.

See page 14 of this report for a plan drawing of this ship showing the damaged areas.
