**THE UNITED STATES  
STRATEGIC BOMBING SURVEY**

**Evaluation of  
Photographic Intelligence  
in the Japanese Homeland**

**PART SIX  
SHIPPING**

Dates of Survey:  
7 October 1945 through 1 March 1946

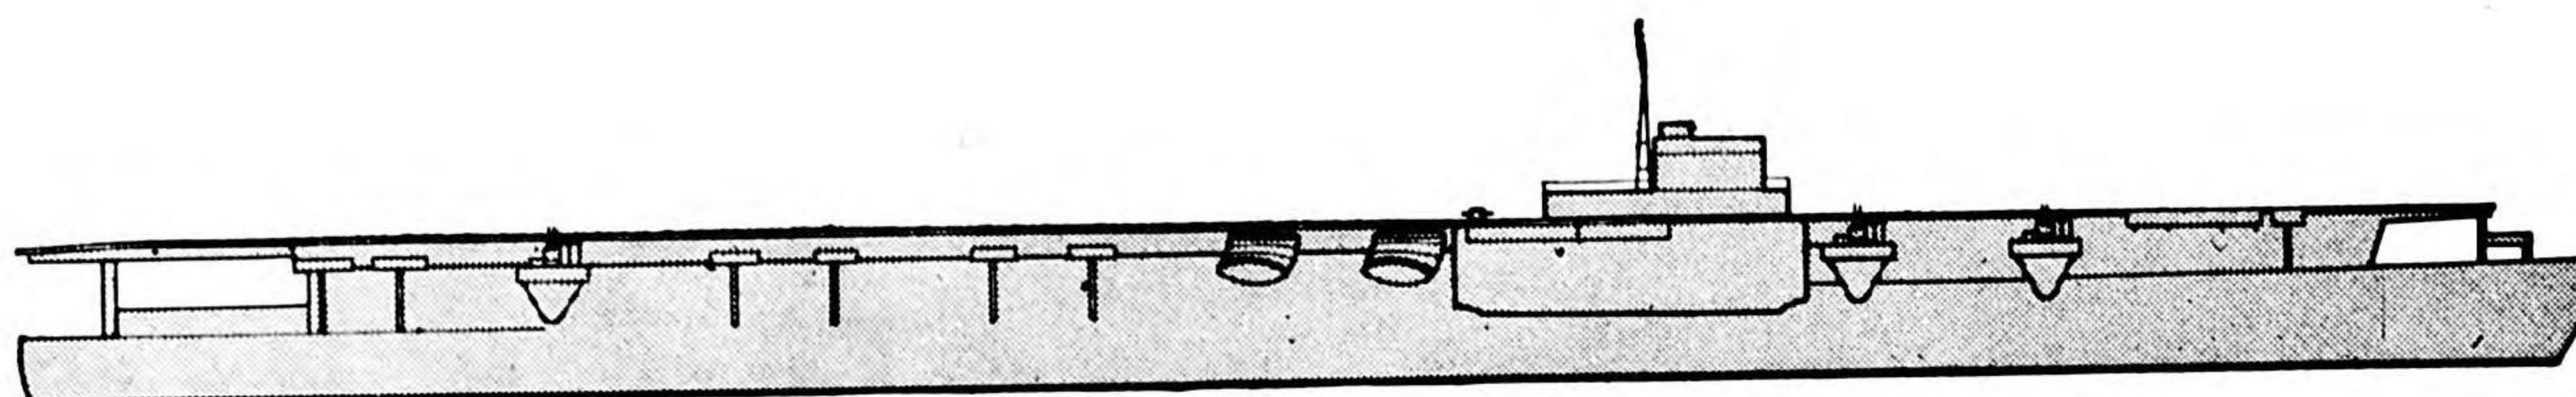
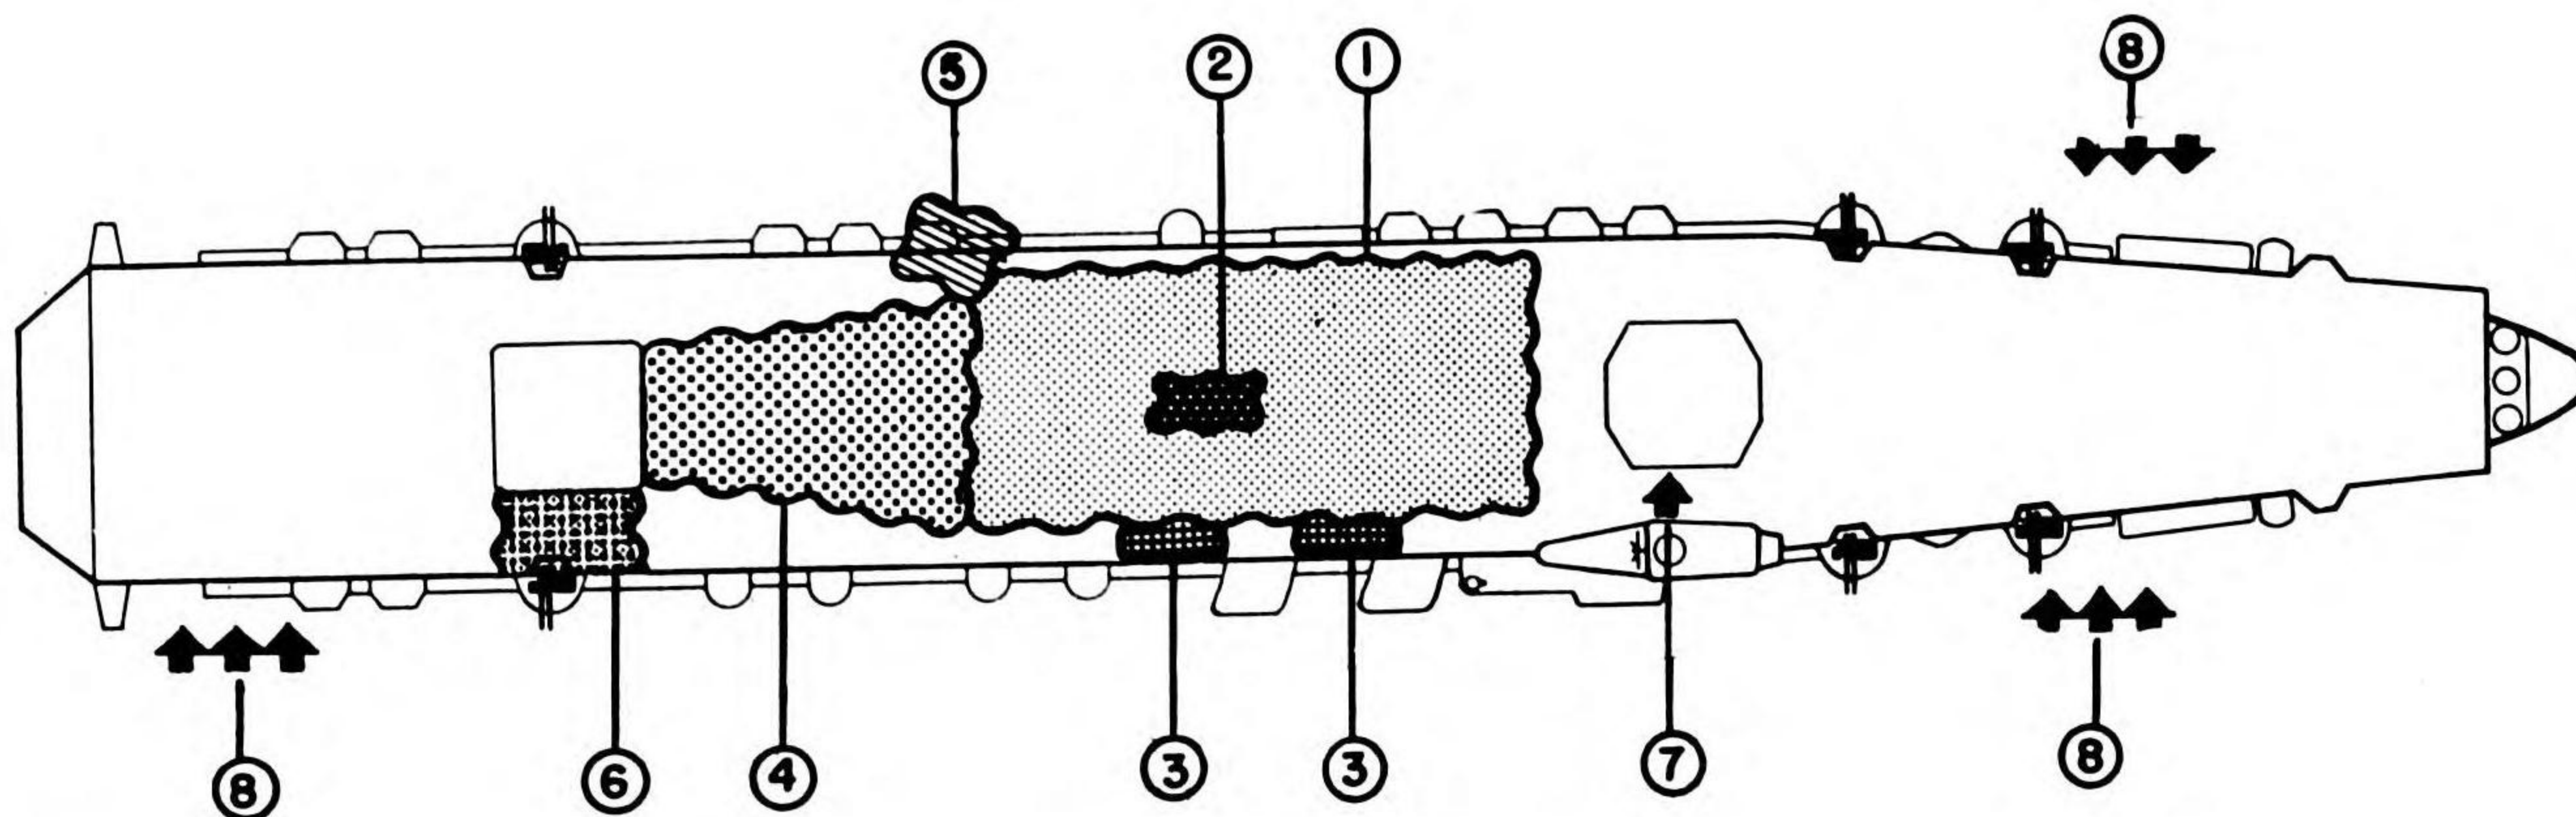
**FIGURE 6**

REPORTED DAMAGE	KEY	ACTUAL DAMAGE
Hole 180 feet long in flight deck aft of island extending across ship	1	Report correct
25 x 10 foot hole through hangar deck	2	Report correct
Two 50 foot sections of side plating starboard side blown out down to hangar deck.	3	Report correct
85 feet of flight deck buckled and sagging.	4	Report correct
30 foot section of flight deck hanging over port side.	5	Report correct
Portion of flight deck between aft elevator and starboard side destroyed.	6	Report correct
Not reported	7	Rocket hit alongside island
Not reported	8	Near misses caused flooding and severe leakage

See page 15 of this report for a plan drawing of this ship showing the damaged areas.

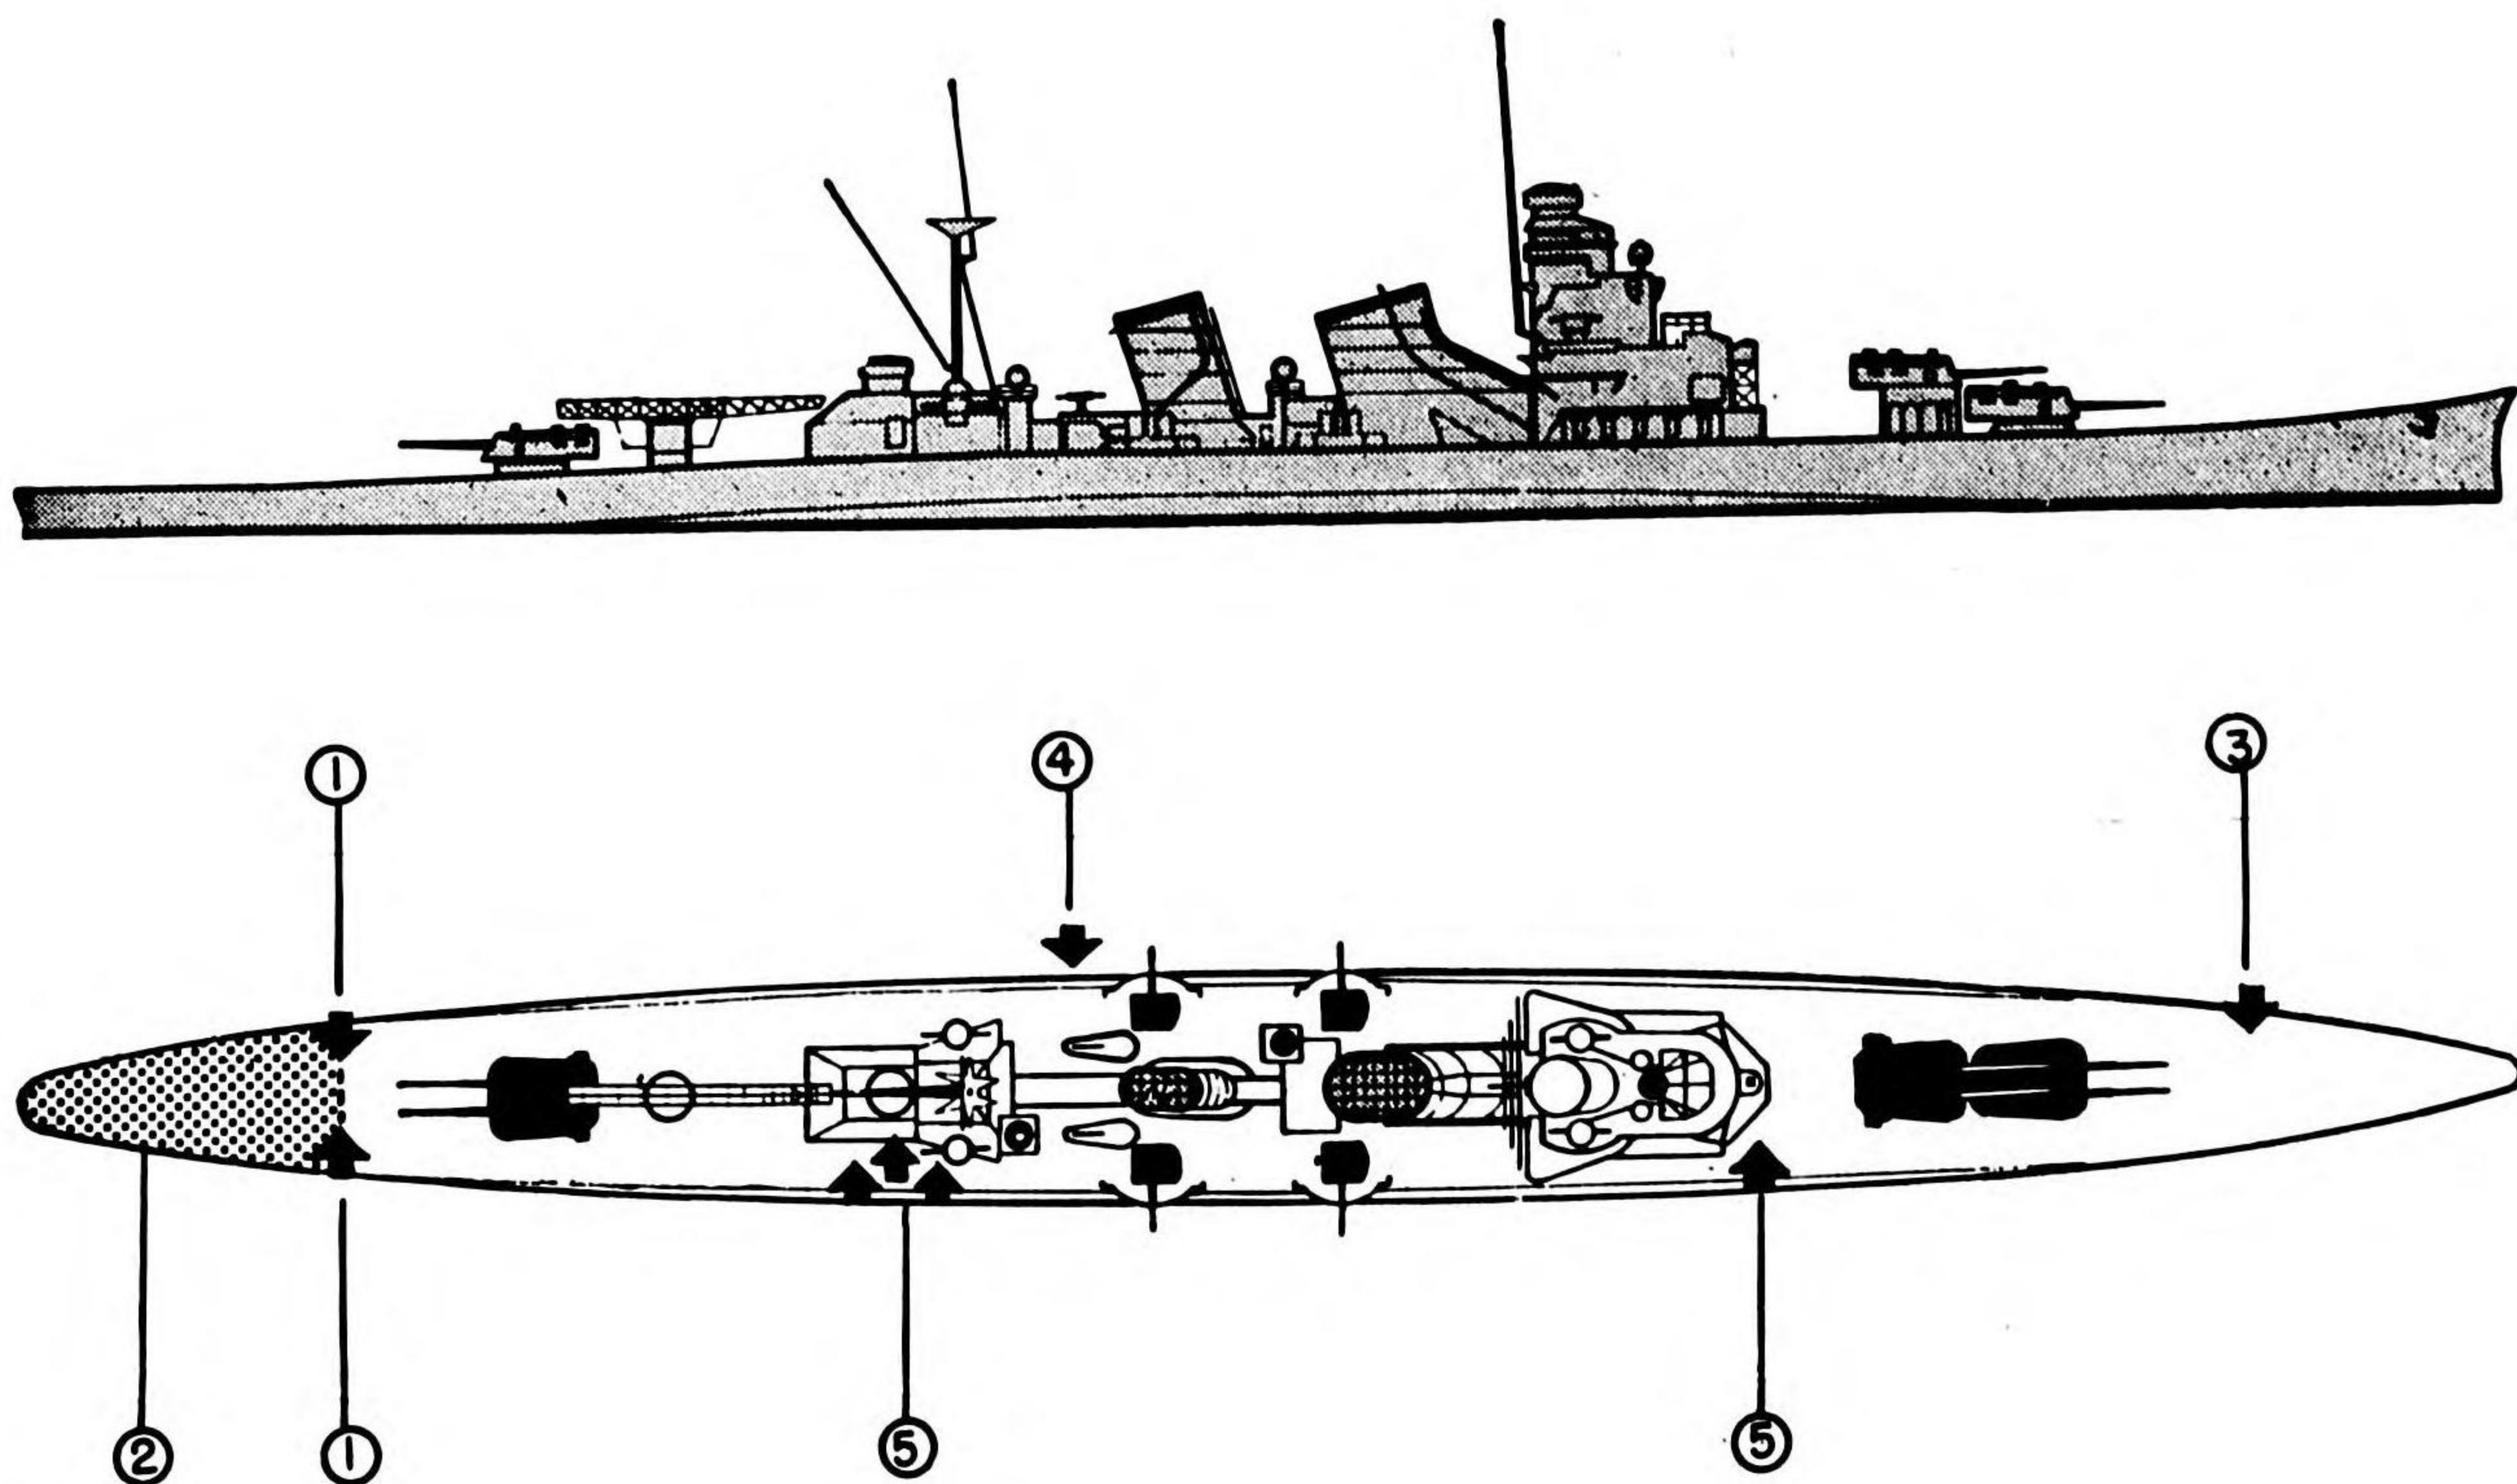
FIGURE 7

REPORTED DAMAGE	KEY	ACTUAL DAMAGE
55 feet of main deck destroyed from side to side aft of #3 turret.	1	Report correct; four or more hits on stern caused it to break off and sink.
Side plating, starboard side in damaged area torn down to waterline.	2	Report correct
Not reported	3	Direct hit on port bow
Not reported	4	Near miss port side aft of #2 stack.
Resting on bottom parallel to and 125 feet off shore.		During 24 July attack ship lost bouyancy and settled to bottom.
Not reported		Near misses caused flooding of all engine rooms.
Evidence of fire, hits not reported.	5	Four direct hits set numerous fires.

See page 16 of this report for a plan drawing of this ship showing the damaged areas.
