HEADQUARTERS XX BOMBER COMMAND
APO 493

B-29 MISSION NO. 3
7-8 JULY 1944

SUBJECT: Report of Operations, 7-8 July 1944.

Herewith submitted is the Tactical Mission Report on
the B-29 strike against targets on the Island of Kyushu, Japan,
on 7-8 July 1944.

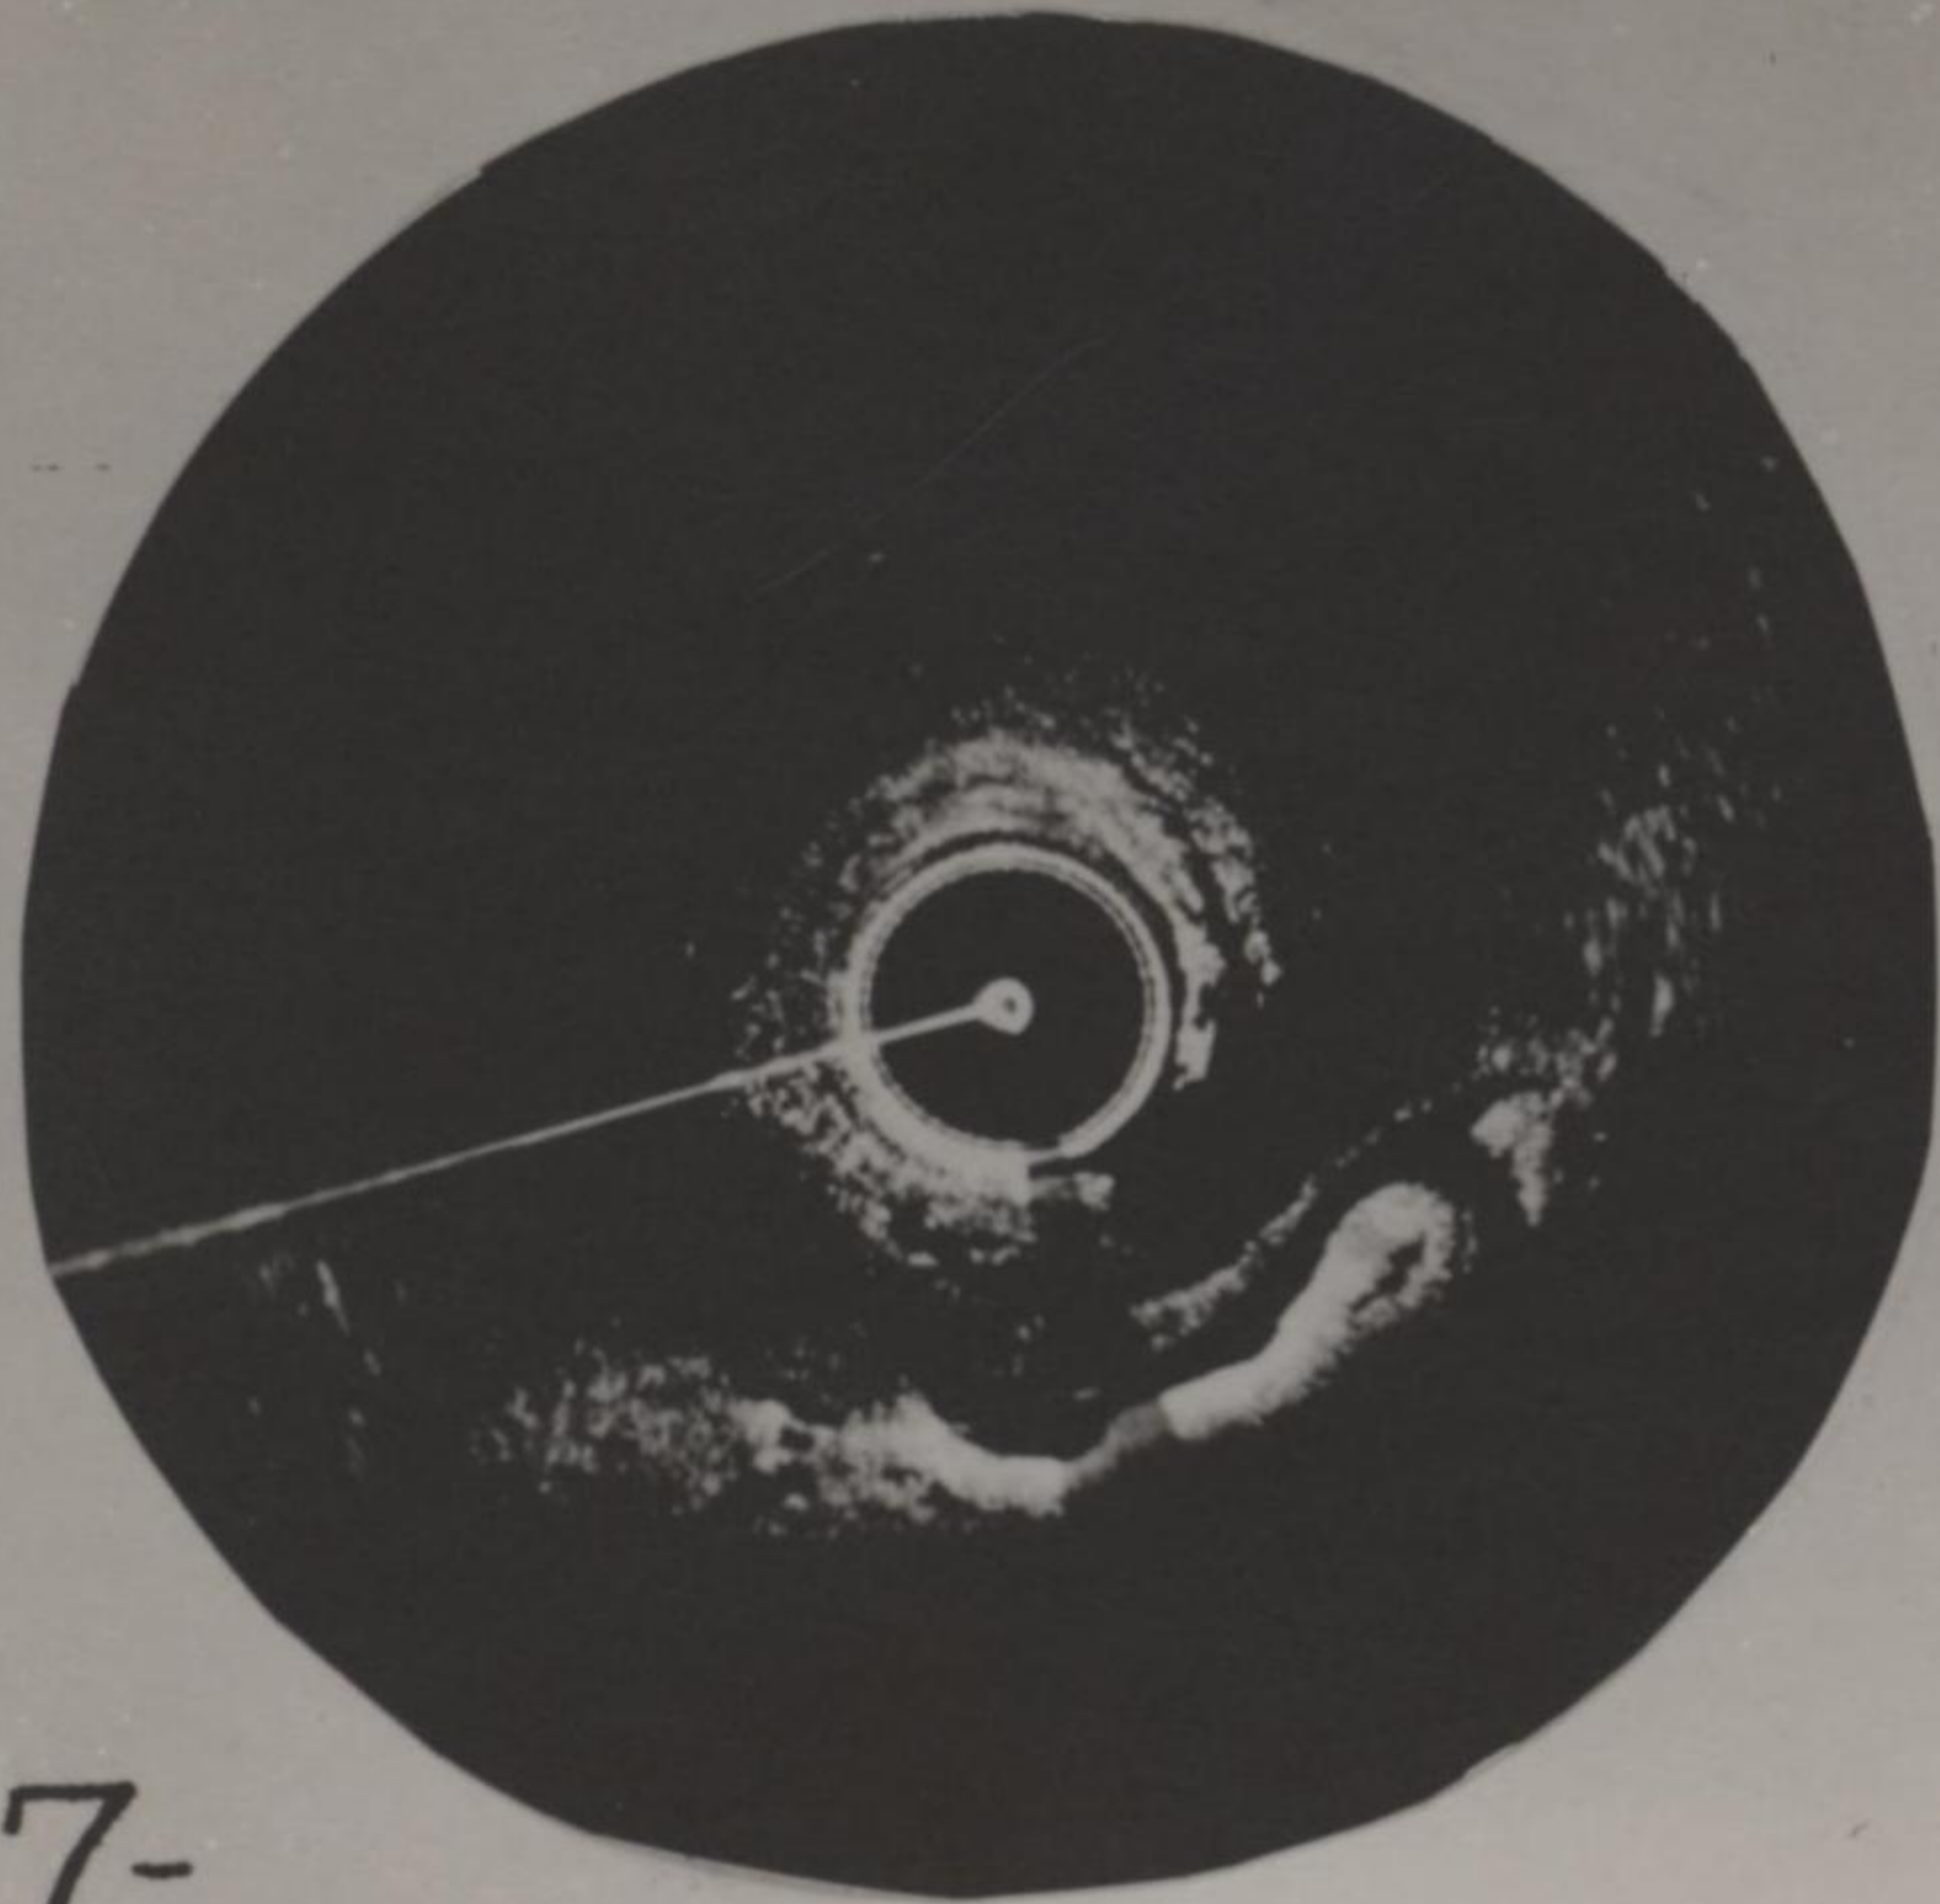
7-
HEADING 260°. SWEEP 20 MILES.
YANGTZE RIVER VISIBLE BETWEEN
4 AND 6 O'CLOCK

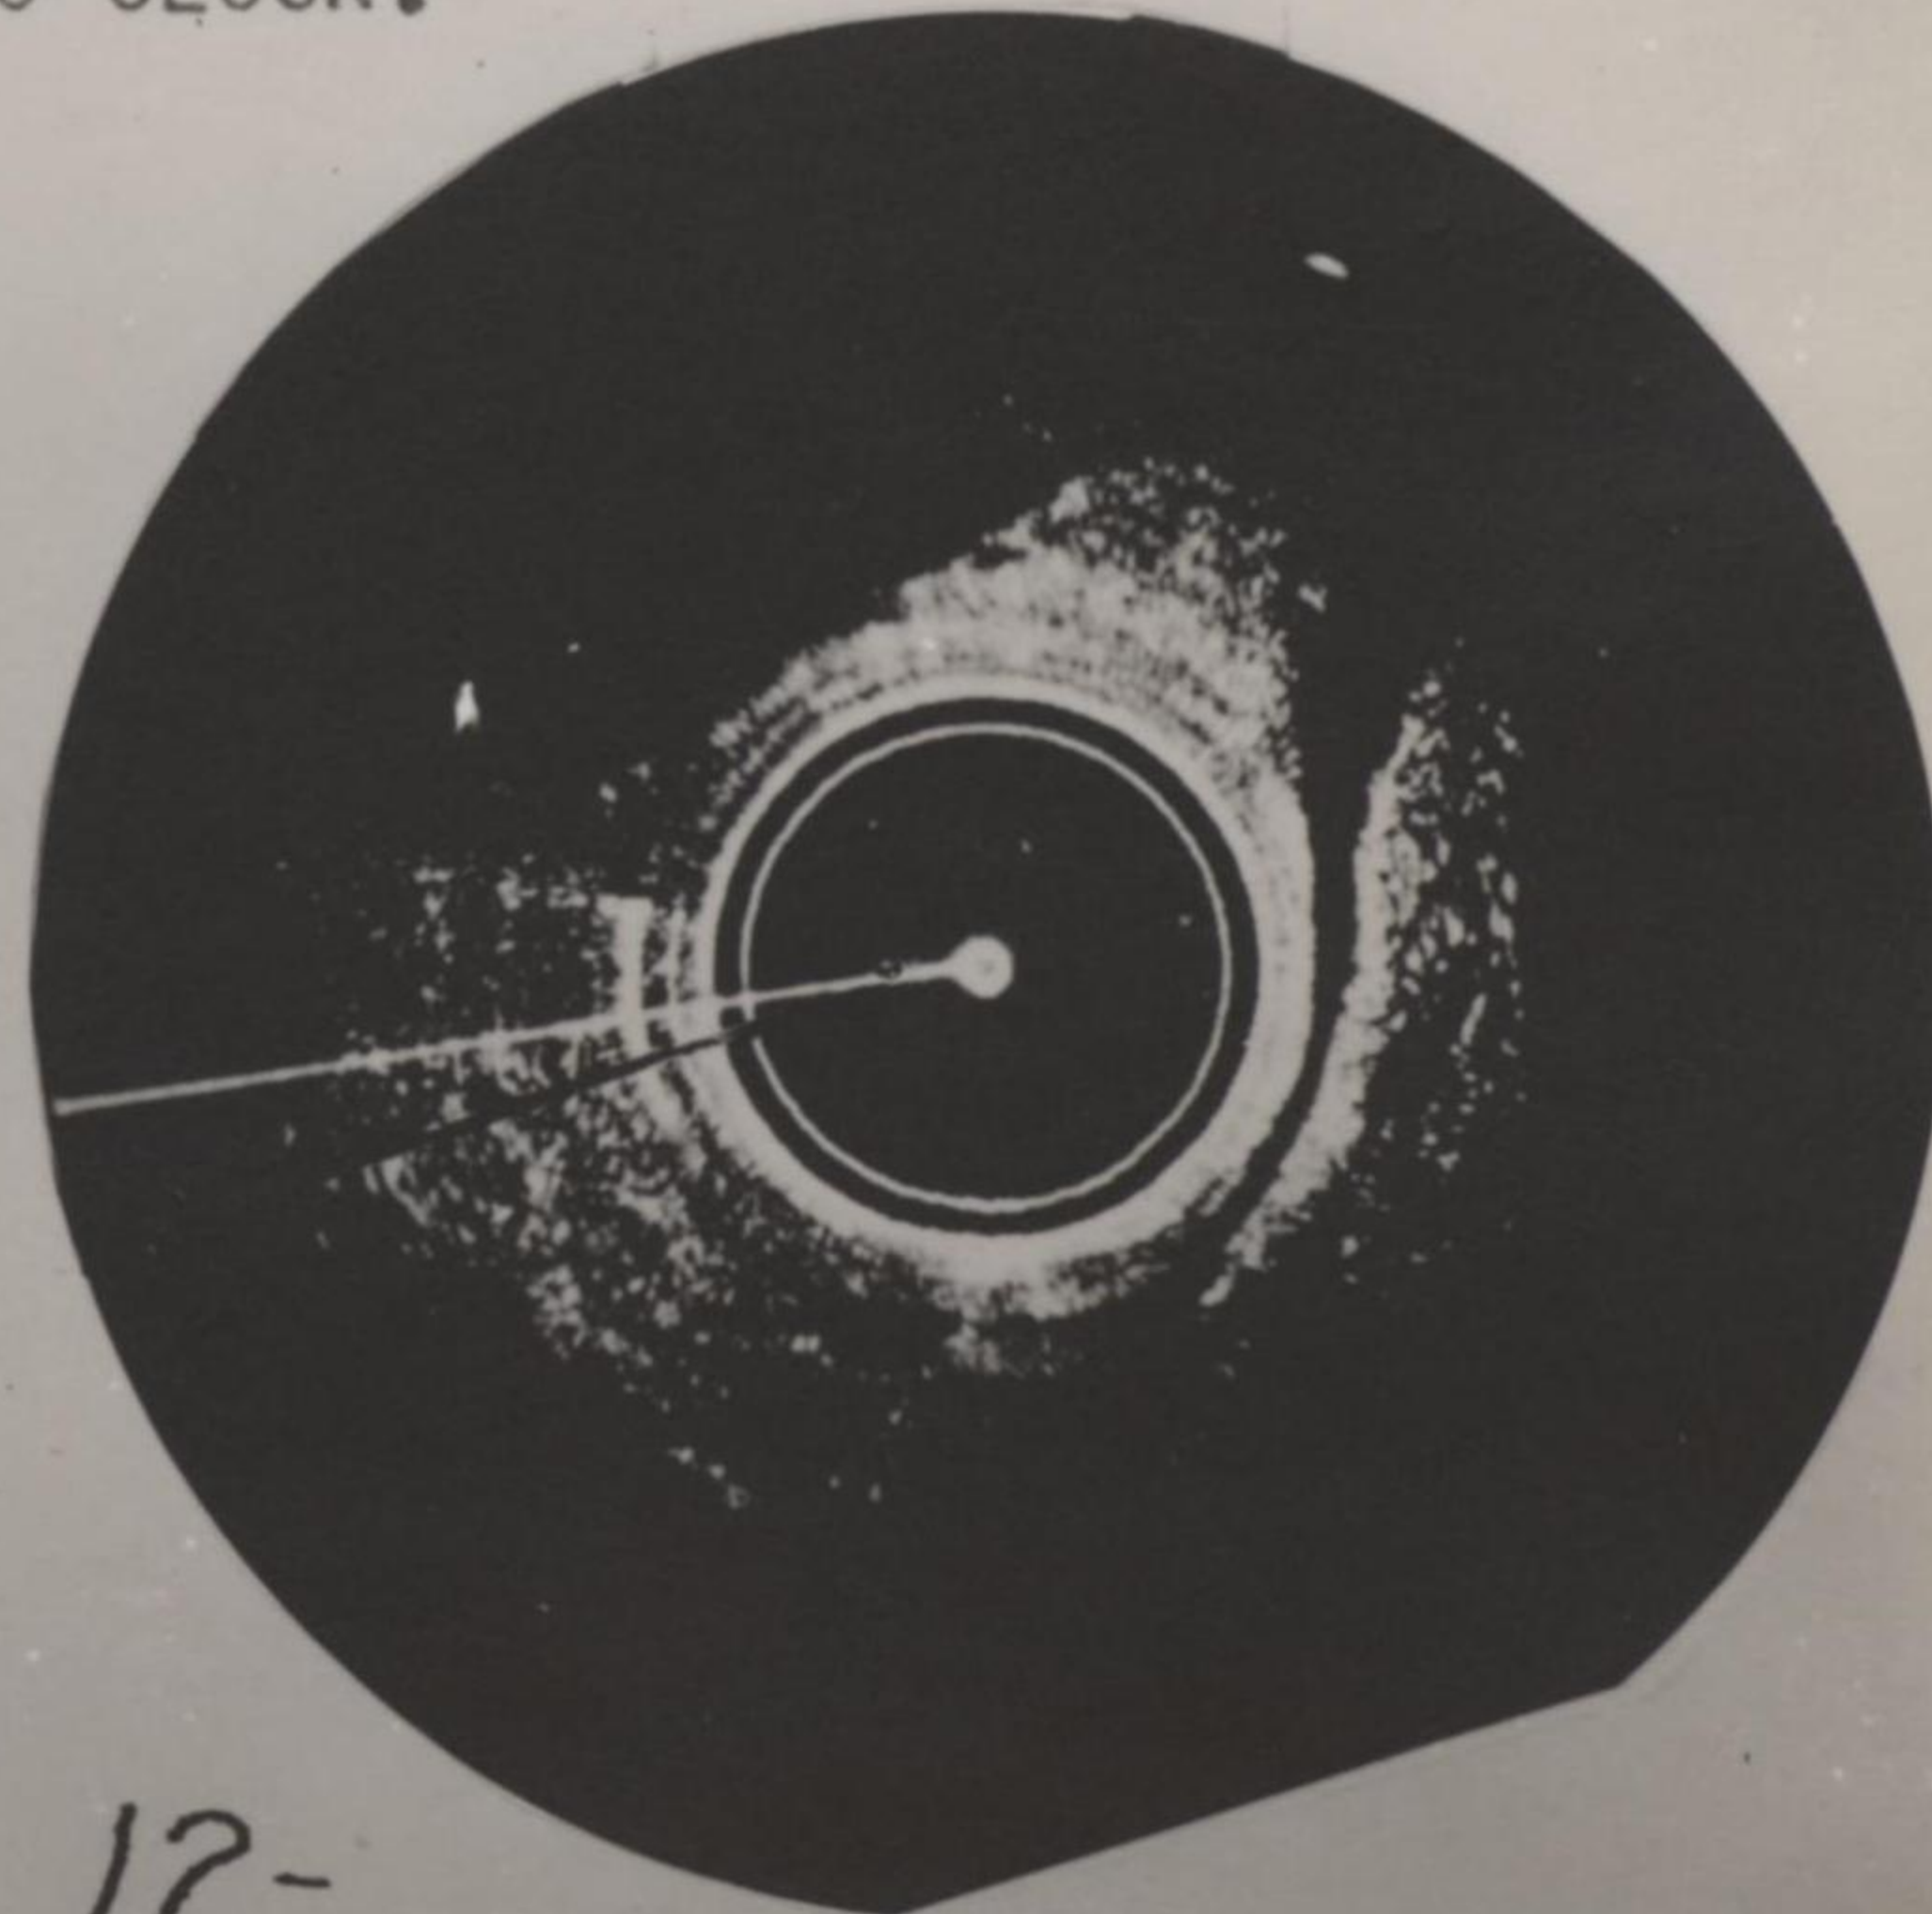
12-
HEADING 260°. SWEEP 10 MILES.
MARSHLAND APPEARS AT 11 O'CLOCK
AND YANGTZE RIVER BETWEEN 2 AND
5 O'CLOCK.
