COMBAT DAMAGE ASSESSMENT TEAM
A-10/GAU-8 LOW ANGLE FIRINGS
VERSUS
INDIVIDUAL SOVIET TANKS
(February - March 1978)

R.H.S. Stolfi

August 1979

Prepared for: A-10 System Program Office
Wright Patterson Air Force Base
Ohio 45433

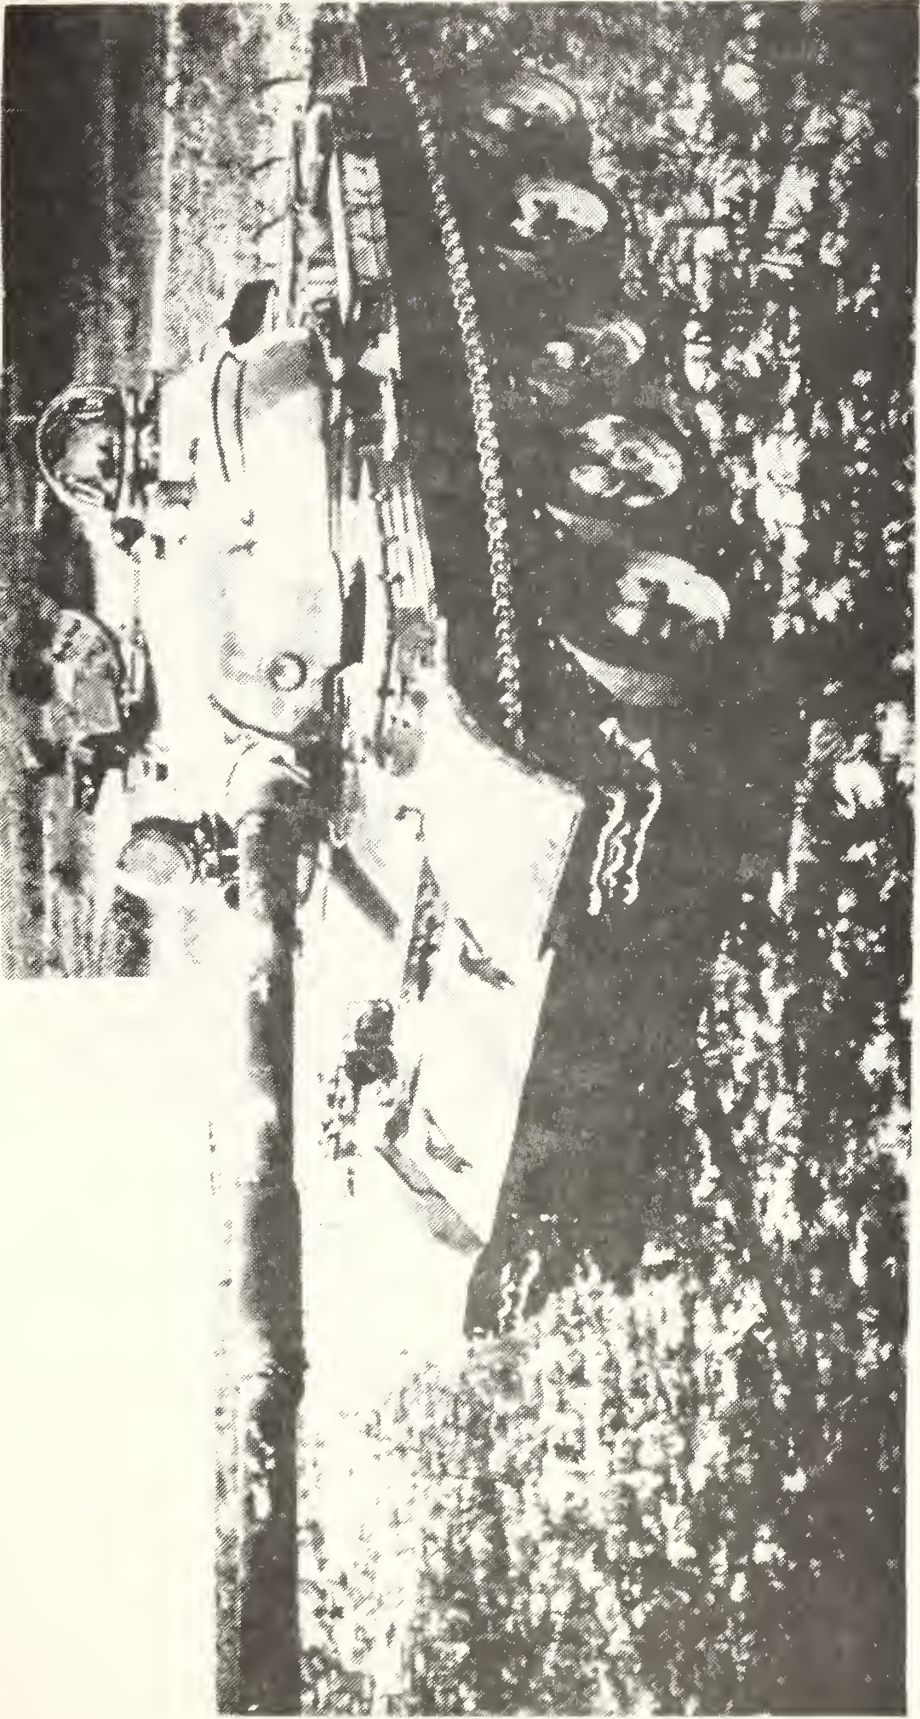
Fig 1. Left Front View of T-62 Tank

The Soviet T-62A tank (Fig. 1) represents the greatest ground threat to U.S. forces in Europe in terms of numbers available to the Soviet units which would initially be committed to combat in a future war in Europe. The performance characteristics of this tank can be found in several classified and unclassified references.

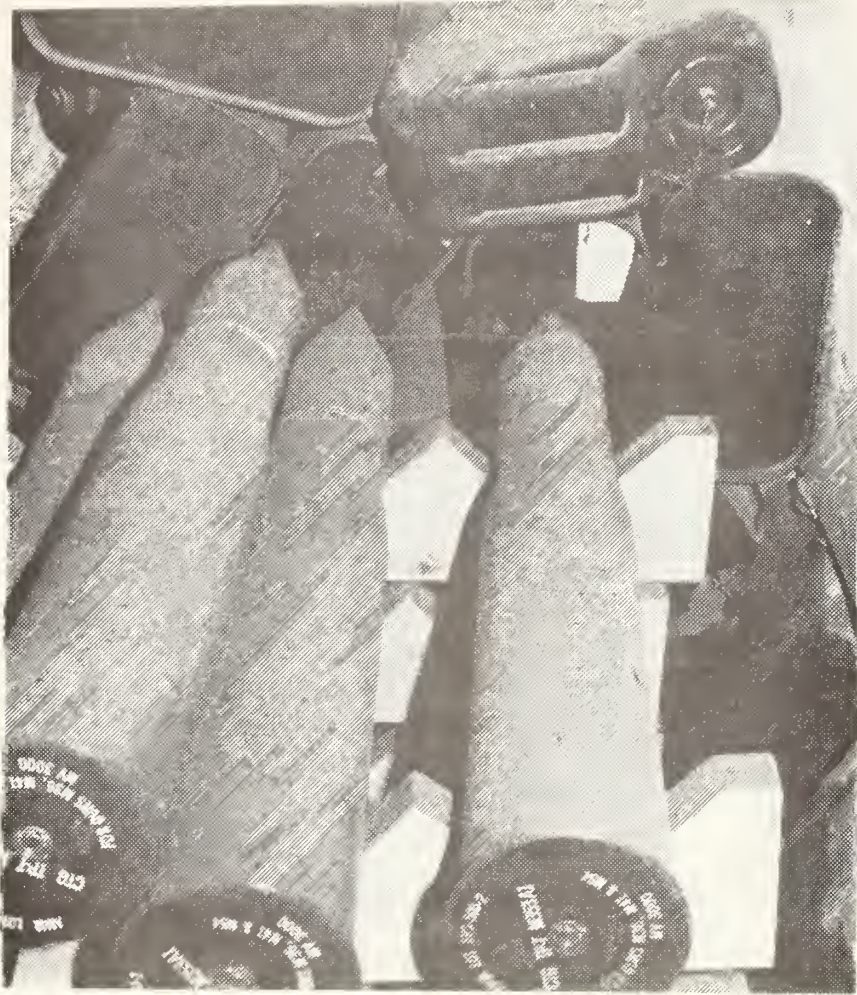
Fig 3. Simulated Bow Racks and Fuel Tank

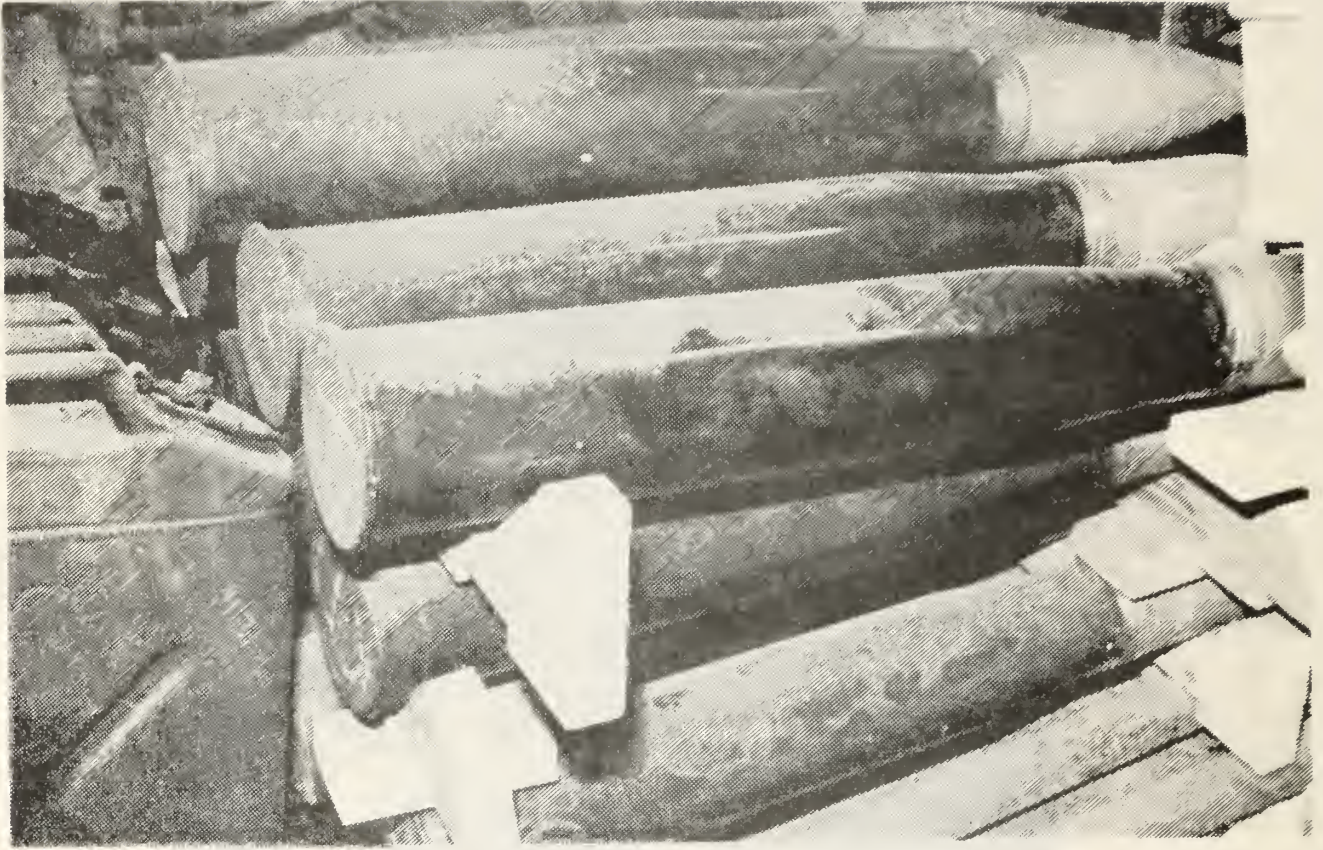
Fig 4. Simulated Fuel Tank and Rear Fighting Compartment Ammunition Stowage

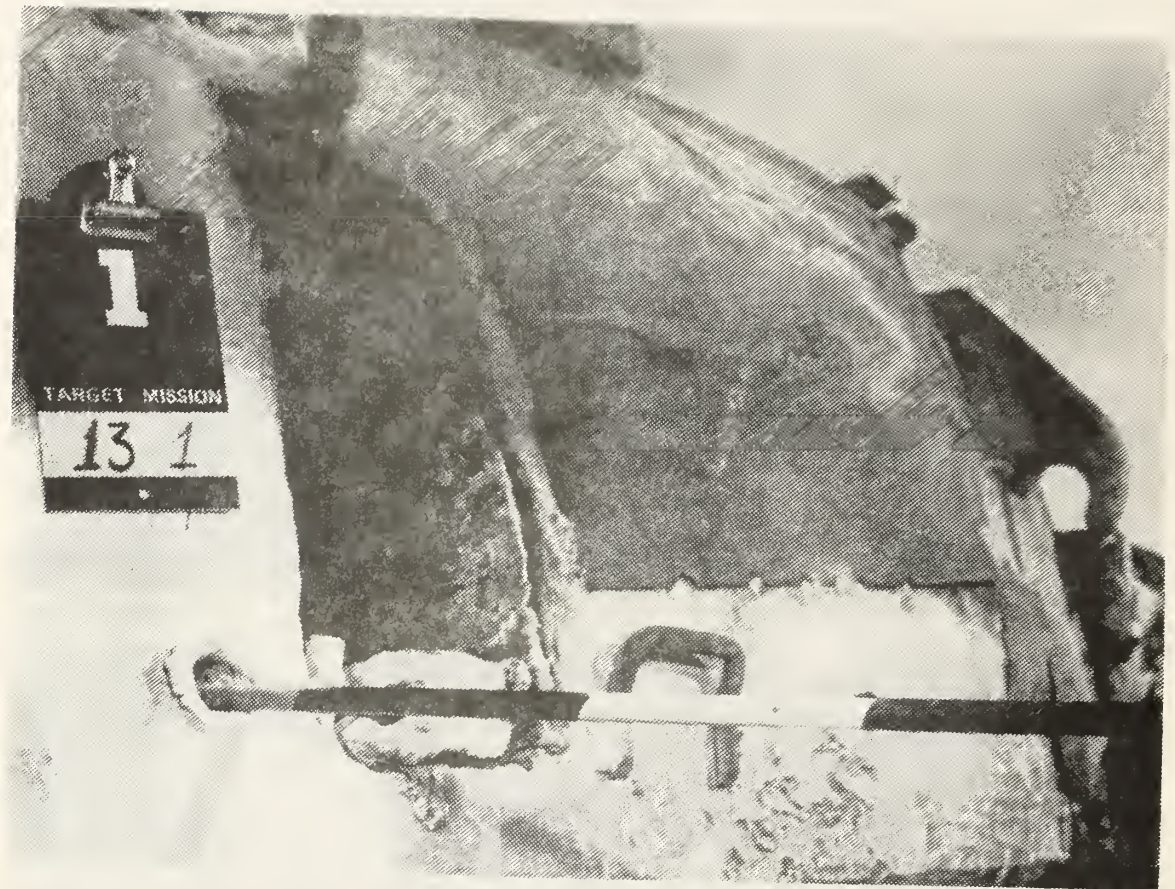
Fig. 6. Close-up view of Impact 1, Mission 1, Target 13 (NOTE: The rectangular hole to the right of the perforation was occasioned by removal of the armor for hardness testing. The patch over the hole was blown outward by the internal explosion and showed no evidence of other impacts.)

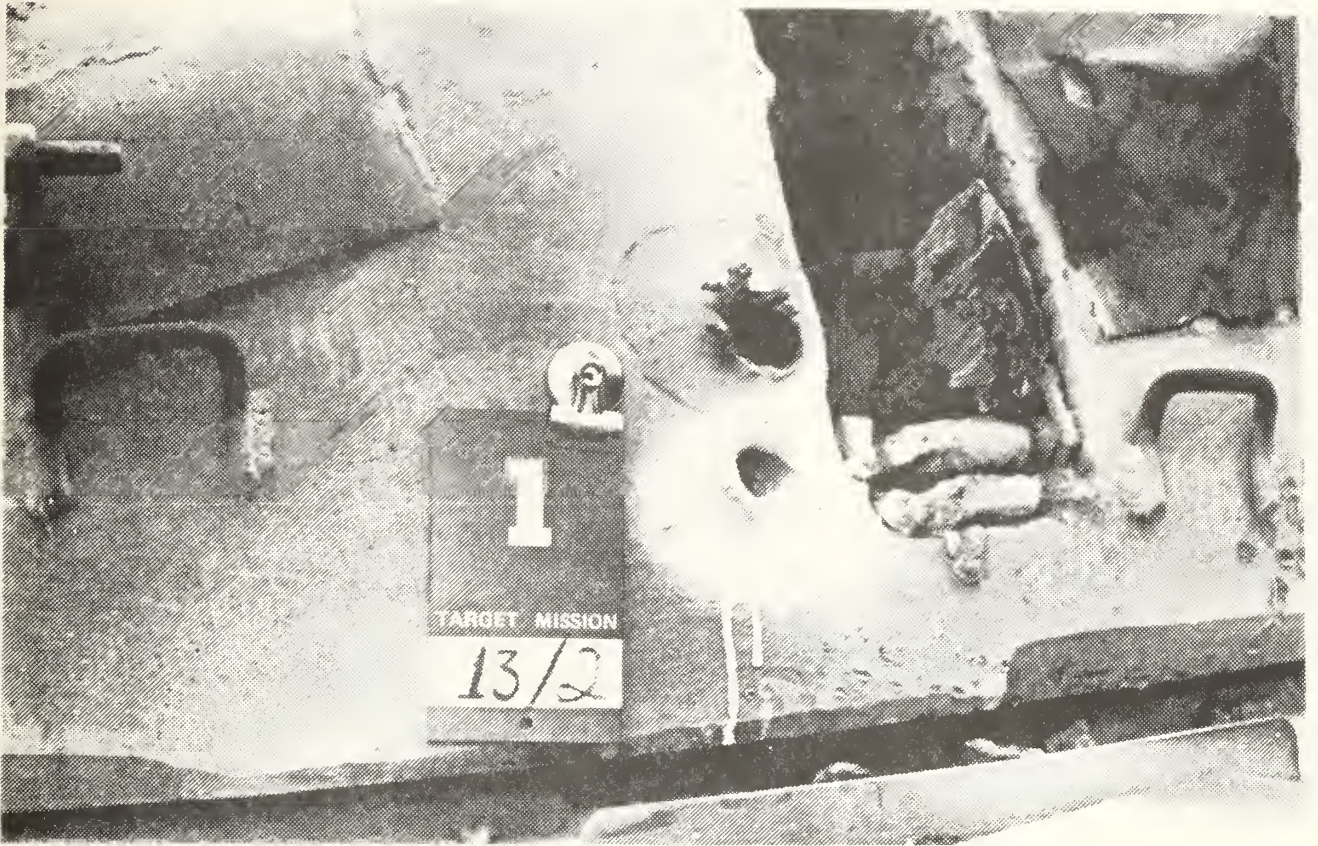
This target was assessed as an immediate K-Kill, resulting from a single perforation of the rear turret armor (Fig. 7). The most likely cause of the kill was an internal explosion which occurred approximately .62 seconds into the burst, probably occasioned by perforation of the armor from impact 1, which occurred .29 seconds into the burst. The location of the strike indicates that the most probable cause of the explosion was impaction of the penetrating projectile, or spall fragments, into a single round of ammunition stowed in the rear of the turret (see Fig. 2). The armored envelope of this target was perforated by two other projectiles, impact 5 (Fig. 8) and impact 6 (Fig. 9).

Fig 7. Location of Strike, Impact 1, Mission 2, Target 13

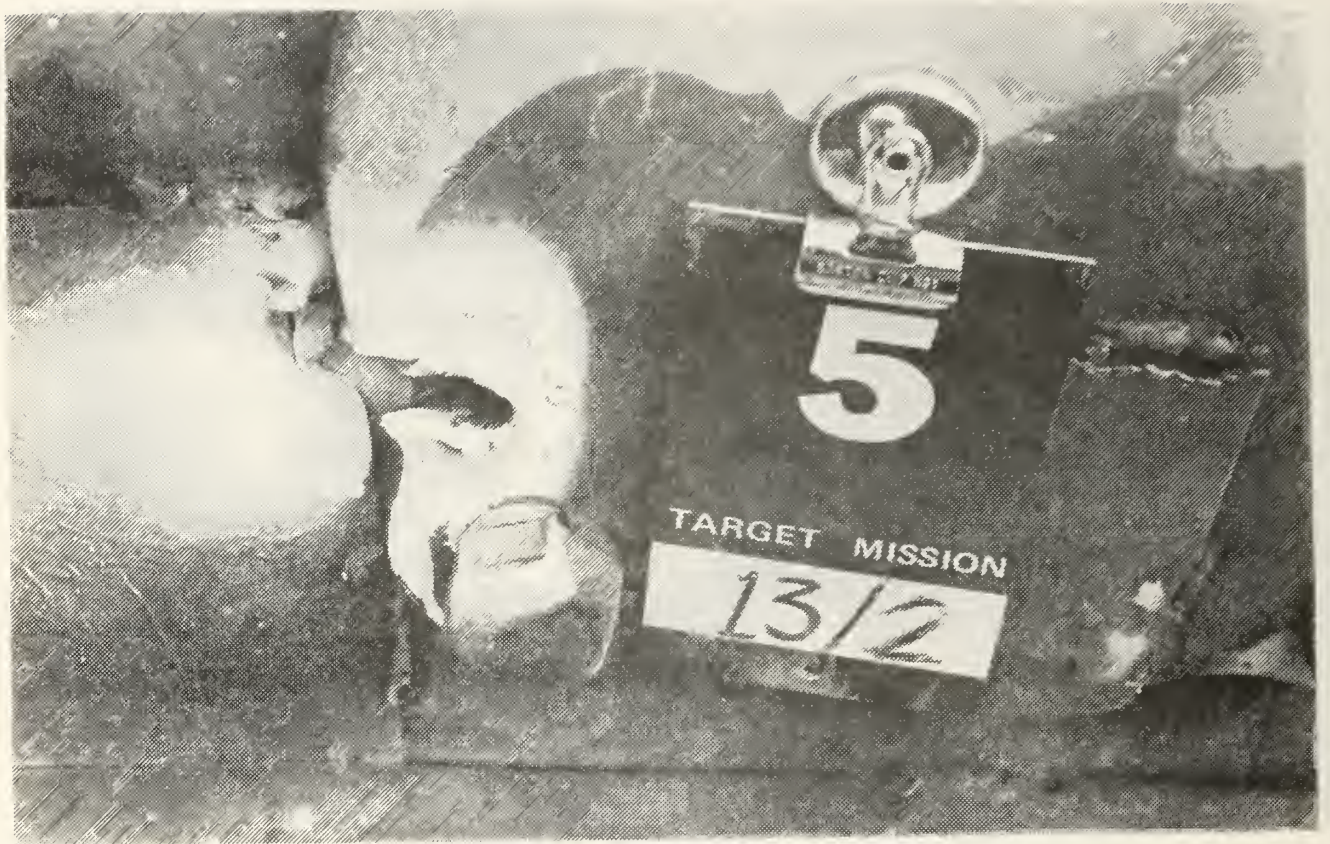
Fig 8. Location of Strike, Impact 5, Mission 2, Target 13

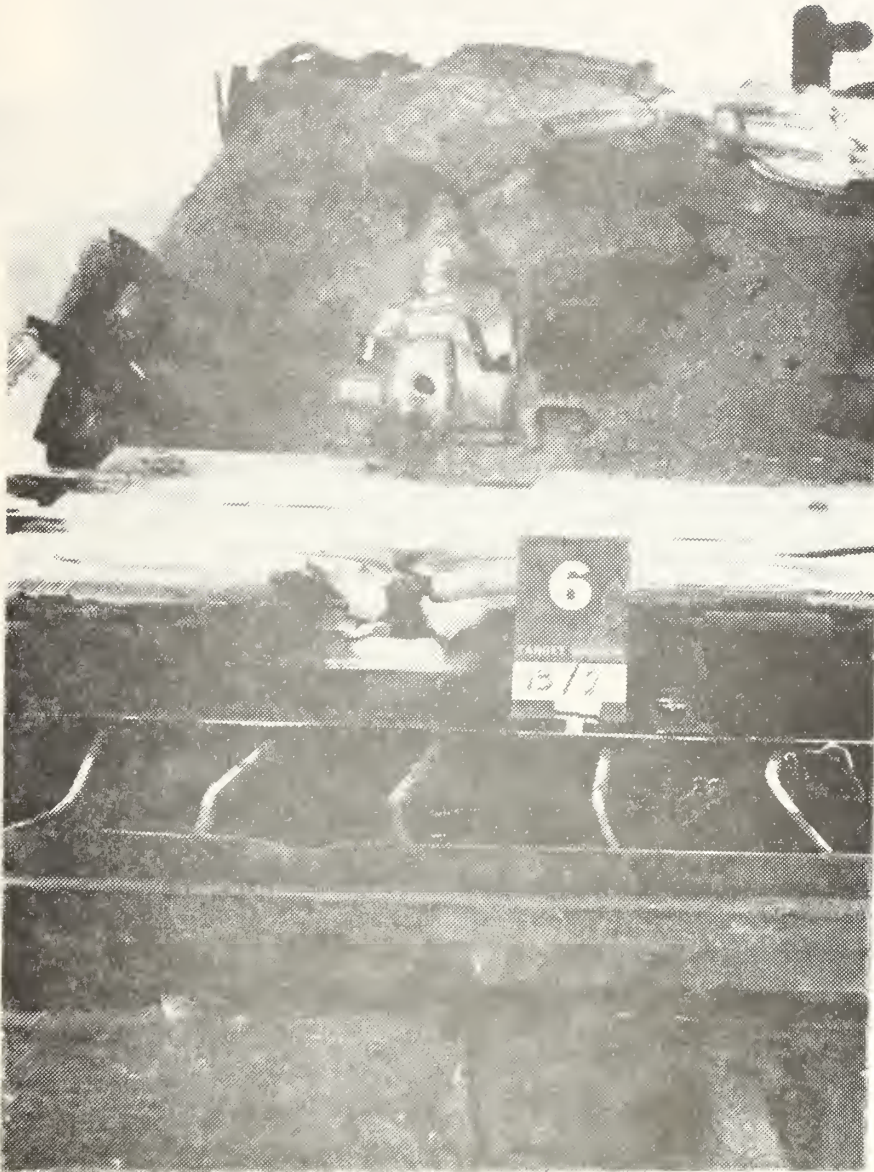
Fig 9. Location of Strike, Impact 6, Mission 2, Target 13

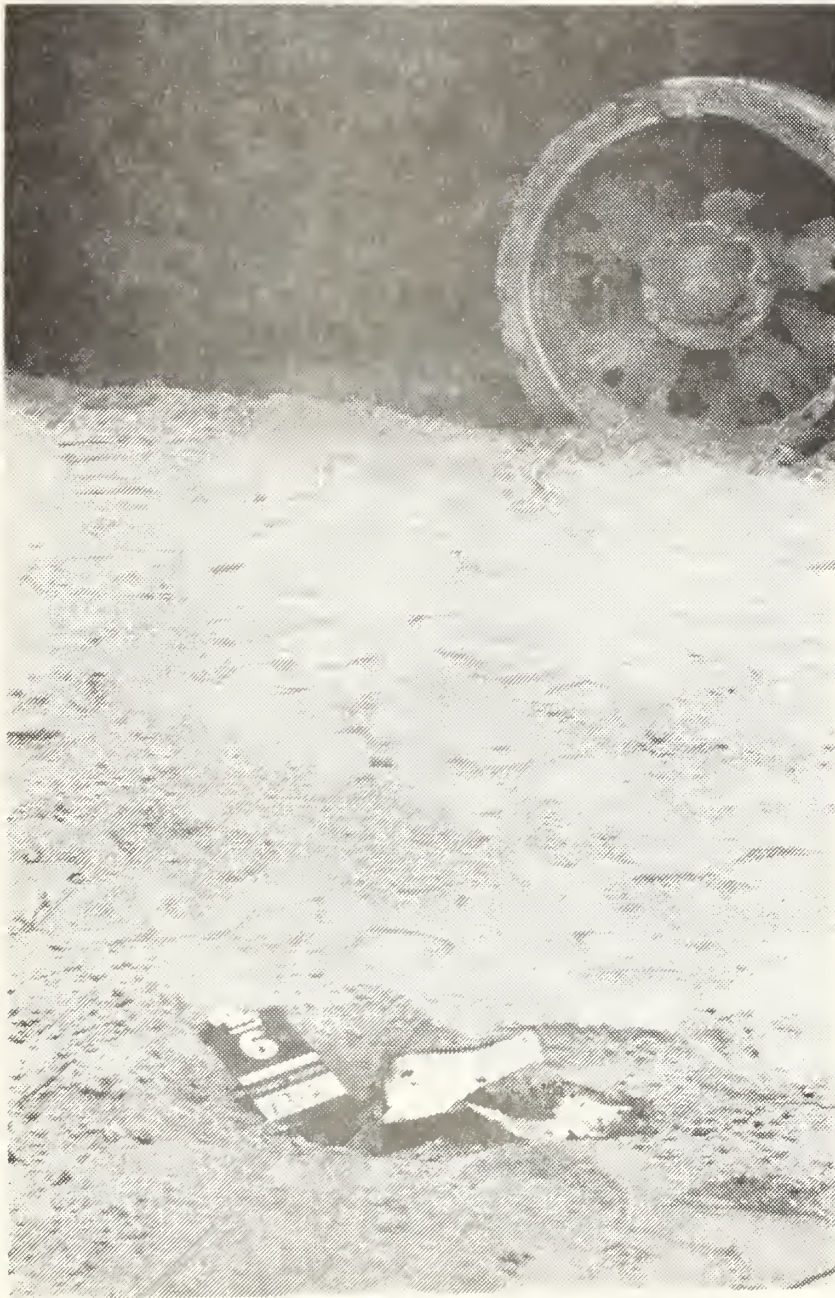
Fig 11. Location of Honeycomb Patch Dislodged by Impact 6

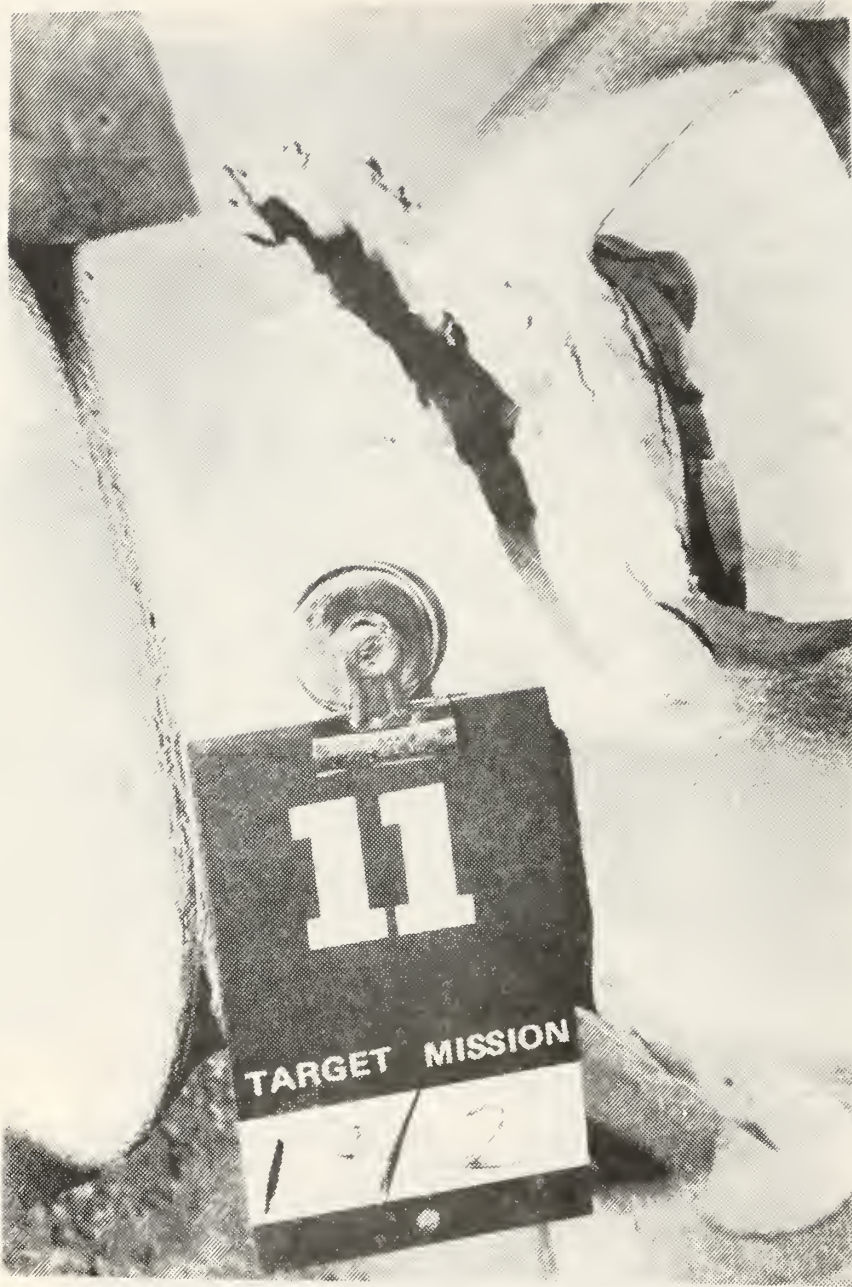
Significant damage was caused by one additional impact (Impact 11, Fig. 12) which penetrated into the right track drive sprocket, cracking the hub and causing loss of oil and severe damage to the bearings. In the absence of a K-Kill, this damage alone was sufficient to cause a 100 percent mobility kill. However, the reader should be cautioned that the track, which would have shielded the sprocket from this impact, was not in place. If it had been, different results may have been recorded.

Fig 12. Damage to Right Track Drive Sprocket
Caused by Impact 11 (Mission 2, Target 13)

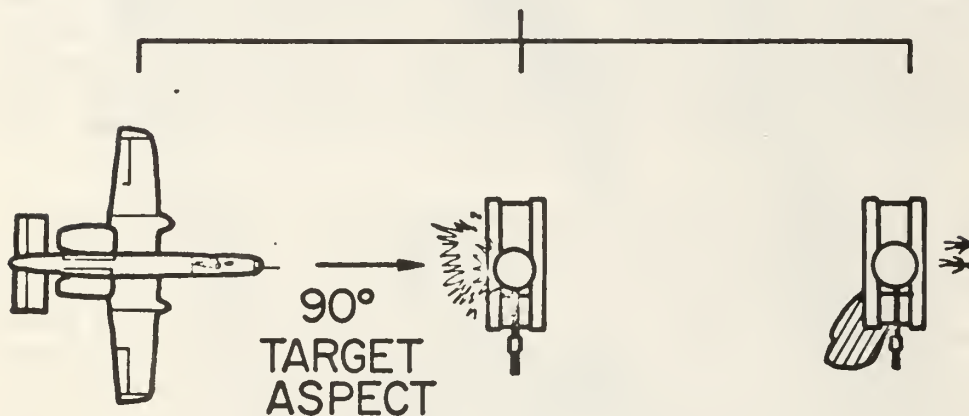
ILLUSTRATION 3

A-10/GAU-8 LOW ANGLE FIRINGS
VERSUS INDIVIDUAL SOVIET TANKS
(MISSION 2, PASS 2 VS TANK 18)
(24 FEB 78)

- 340 KNOTS
- 1.83° DIVE ANGLE
- 3502 FT OPEN FIRE
- 2382 FT CEASE FIRE
- 144 RDS FIRED

③ DAMAGE EFFECTS

- 100% M-KILL
- 0.95 % F-KILL
- RESULTING FROM GUNNER KIA TC WIA AND FUEL TANK DAMAGE

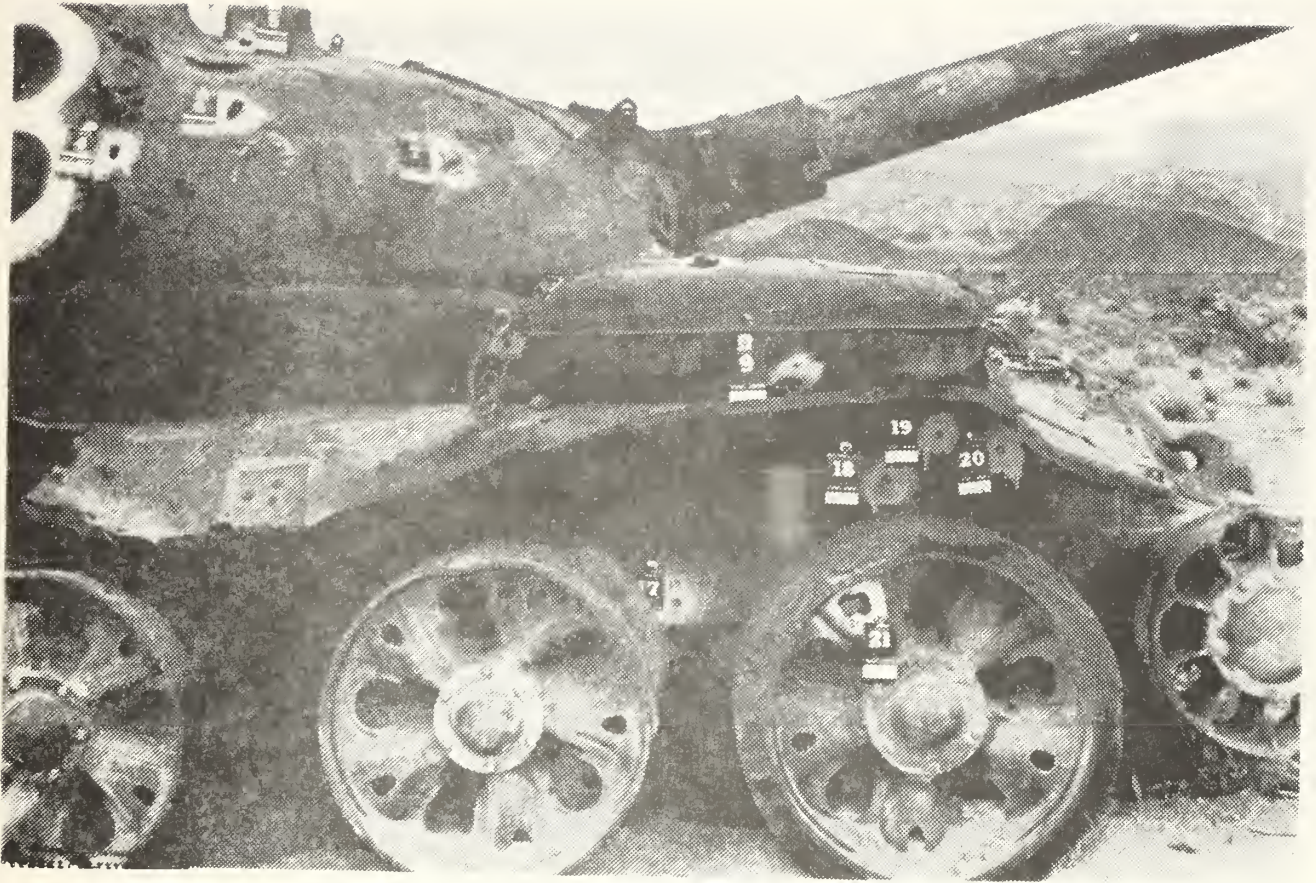
This target was impacted by 21 projectiles of which four caused significant damage. These impacts (numbers 5, 8, 9 and 17) are shown in Fig. 13.

Fig 13. Location of Significant Impacts, Mission 2, Target 18

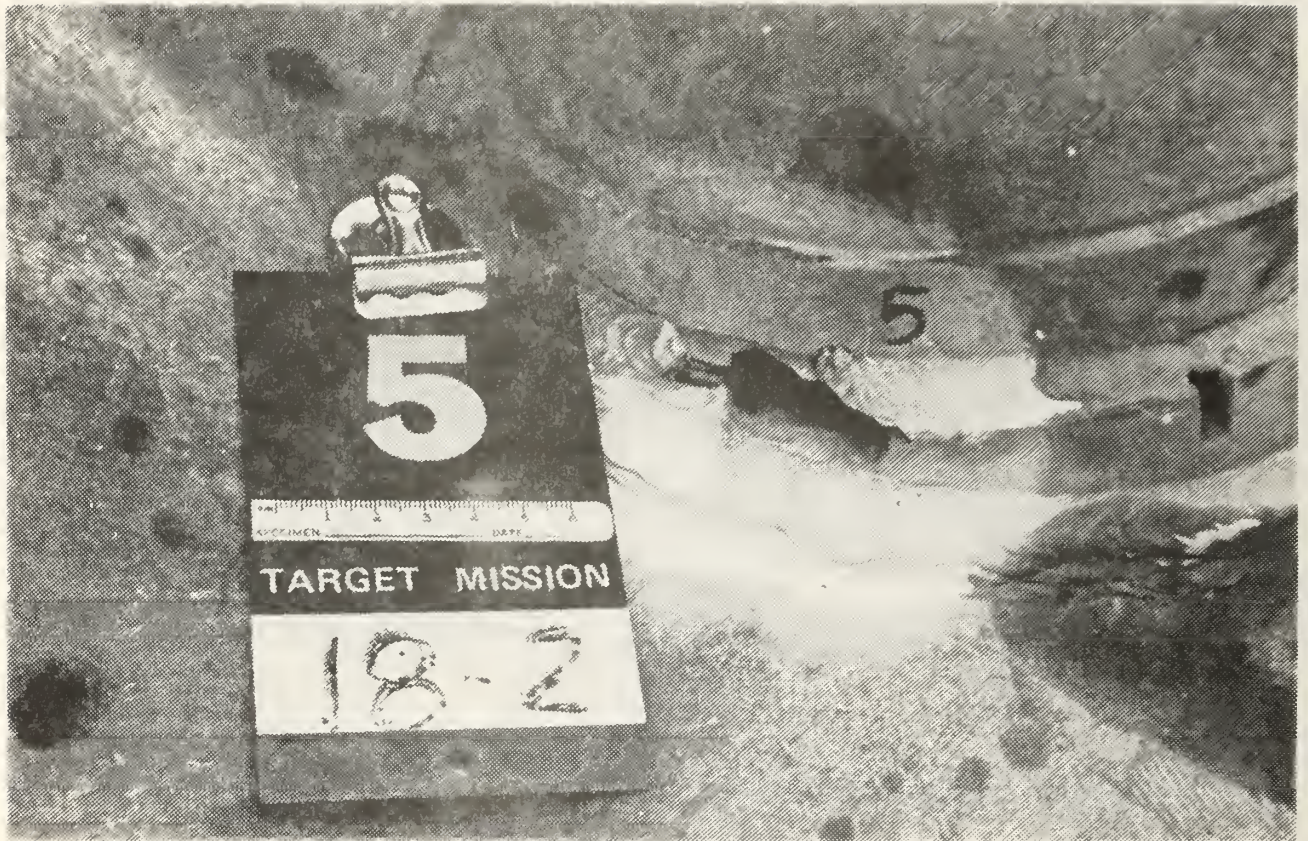
Impact number five perforated the loader's periscope housing (Fig. 14). The projectile and/or spall fragments continued through the fighting compartment to the opposite side of the turret and damaged two mannikins representing the gunner and tank commander. The mannikin at the gunner's station received projectile and/or spall damage in the left shoulder area, and to the right side of the head as shown in Fig. 15 and was assessed as killed in action (KIA). The mannikin representing the tank commander (Fig. 16) was damaged in the left shoulder area and was assessed as wounded in action (WIA). Based on these two casualties, an F-Kill of 95 percent was assessed.

Fig 14. Close-up View of Perforation Through Loader's Periscope Housing, Mission 2, Target 18

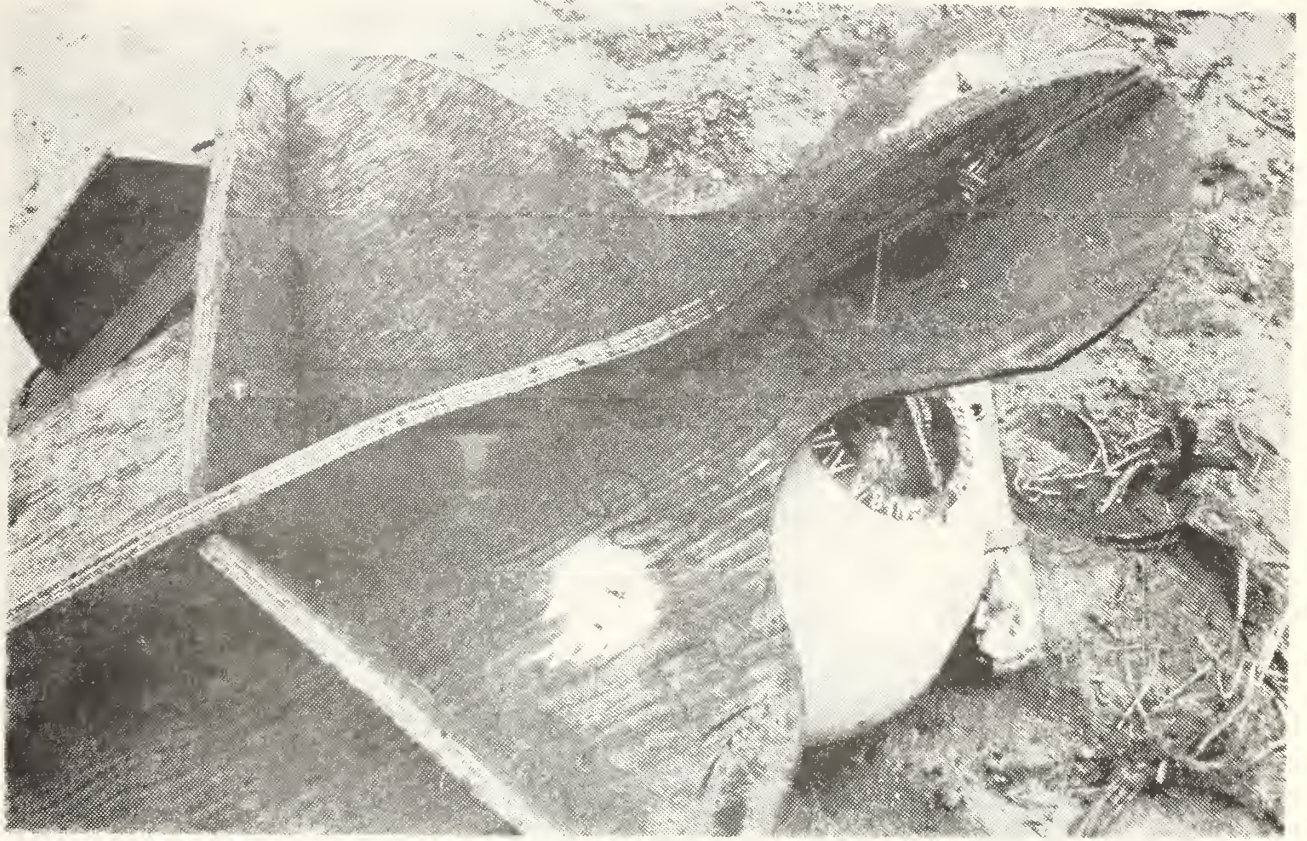
Fig 15. Projectile and/or Spall Damage to Mannikin
at Gunner's Station (Impact 5, Mission 2,
Target 18)

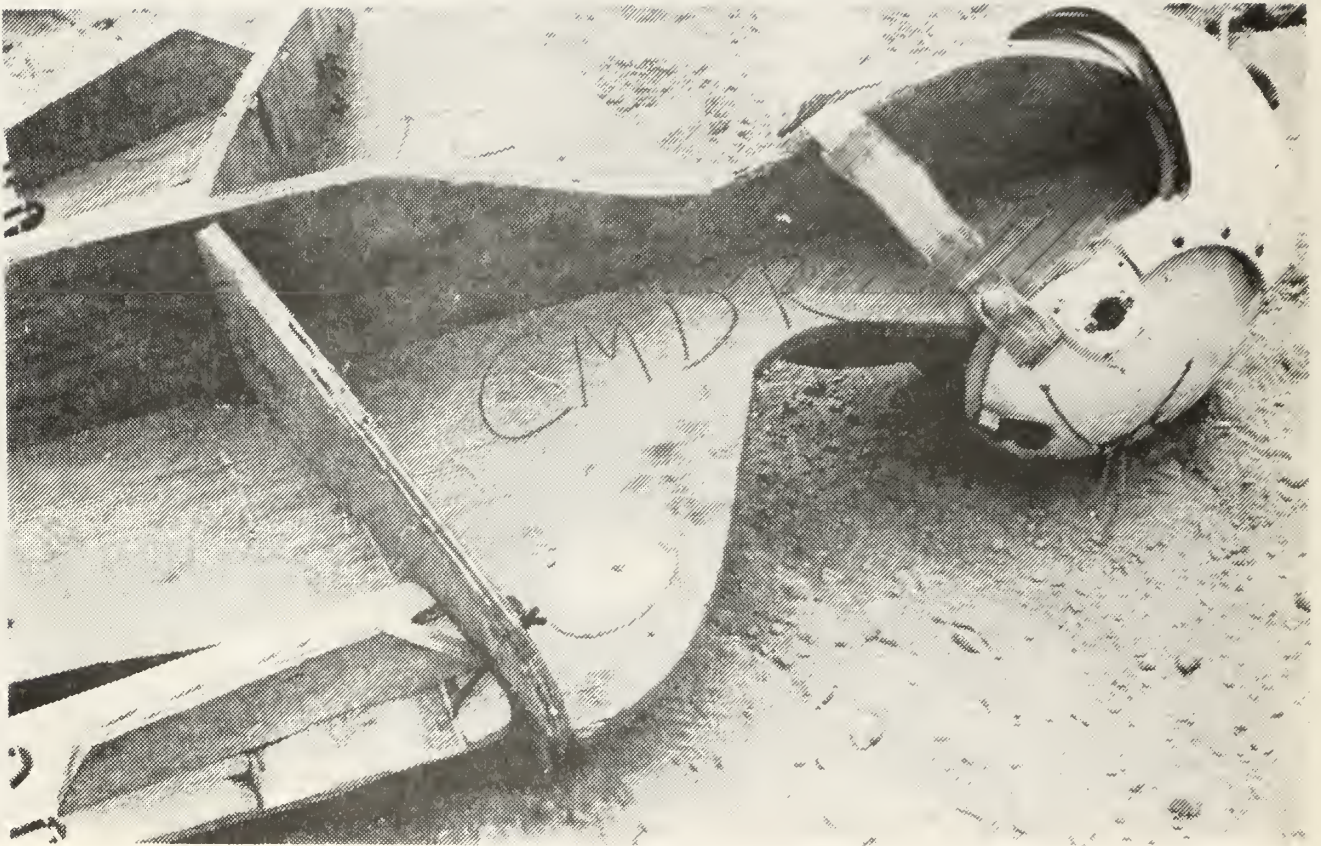
Fig 16. Projectile and/or Spall Damage to Mannikin at Commander's Station (Impact 5, Mission 2, Target 18)

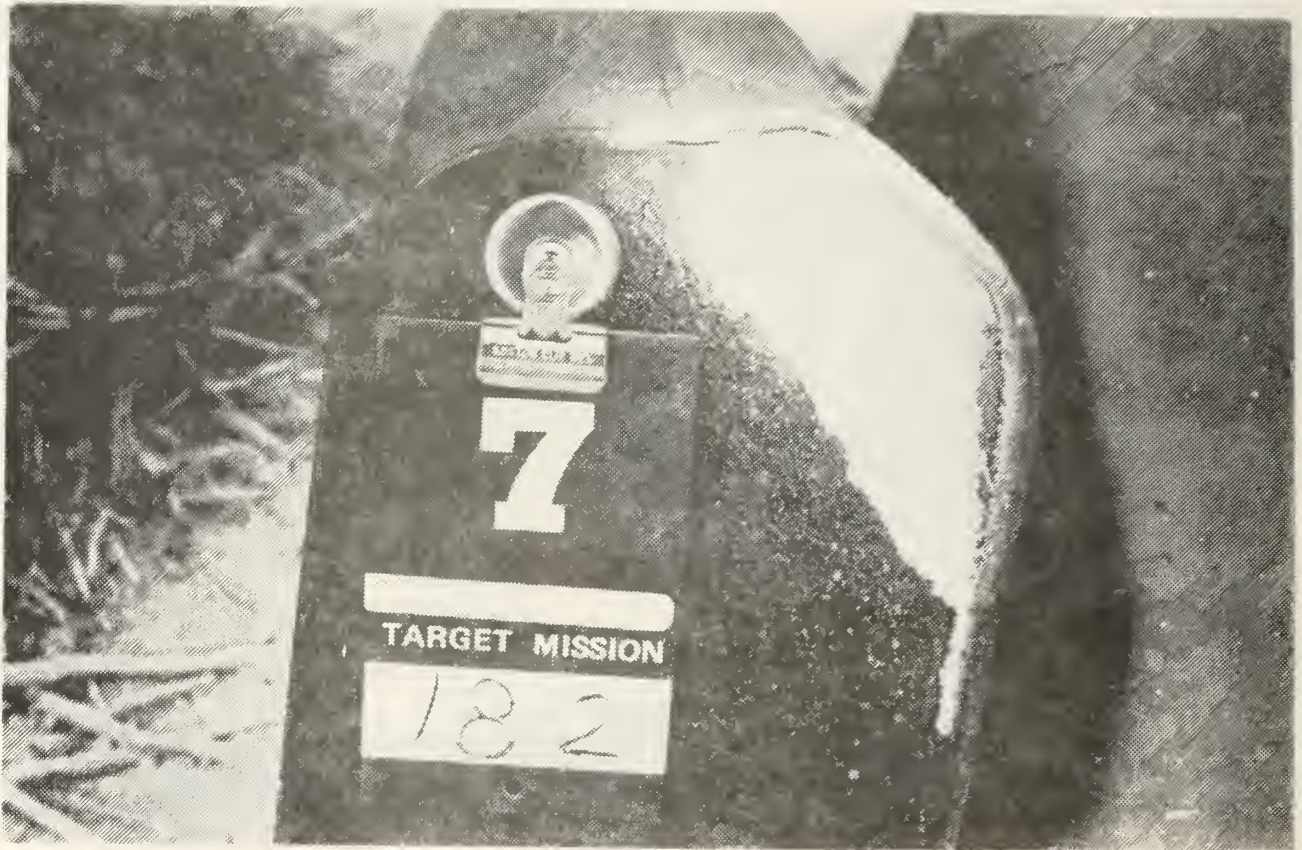
Fig 18. Perforation of Fuel Can Simulating Bow Fuel Tank, Impact 17, Mission 2, Target 18 (NOTE: This impact is mis-numbered and should read 17.)

Fig 19. Perforation of Fuel Can Simulating Bow Fuel Tank, Impact 17, Mission 2, Target 18 (NOTE: This impact is mis-numbered and should read 17.)

Fig 20. Perforation of Fuel Can Simulating Bow Fuel Tank, Impact 17, Mission 2, Target 18 (NOTE: This impact is mis-numbered and should read 17.)

Fig 21. Perforation of Fuel Can Simulating Bow Fuel Tank, Impact 17, Mission 2, Target 18 (NOTE: This impact is mis-numbered and should read 17.)

Fig 22. Perforation of Fuel Can Simulating Bow Fuel Tank, Impact 17, Mission 2, Target 18 (NOTE: This impact is mis-numbered and should read 17.)

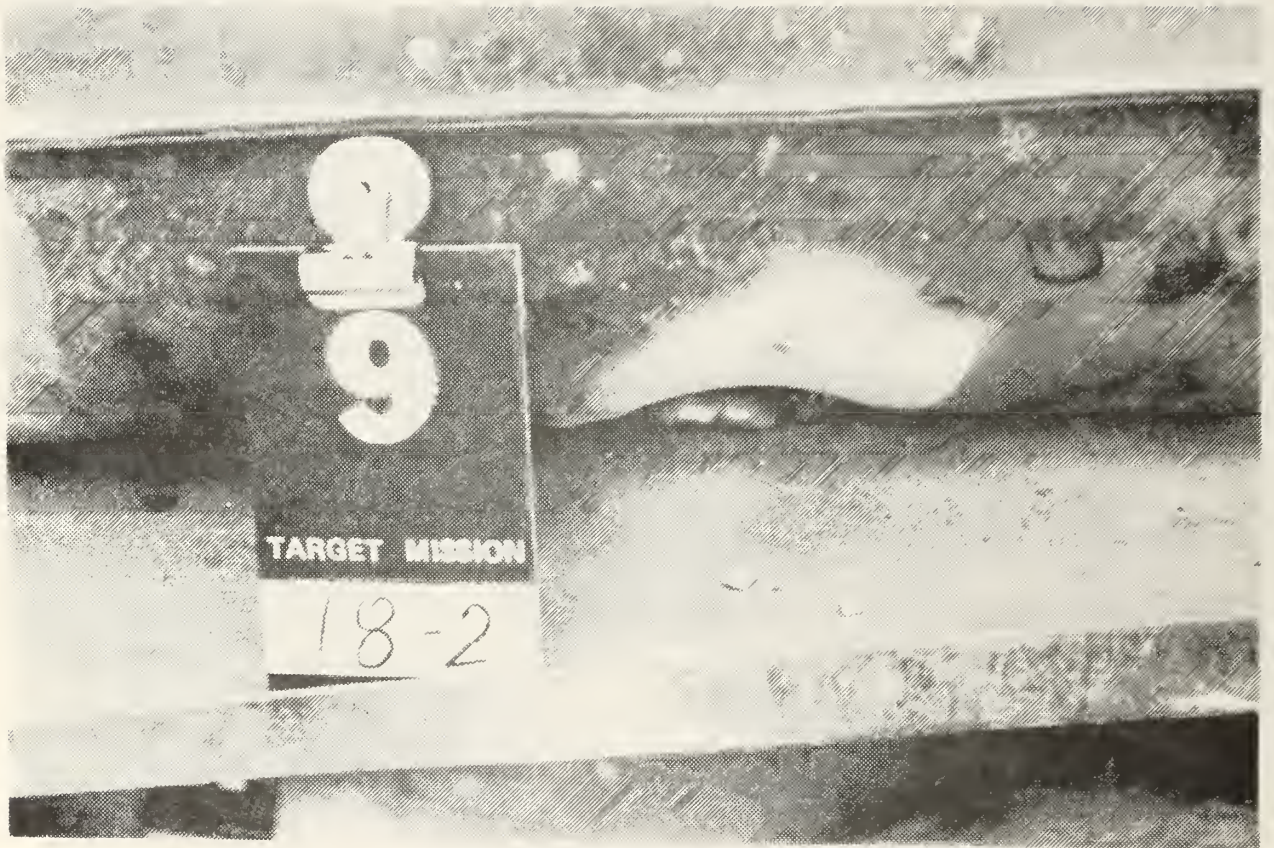
Fig 24. Perforation of External Fuel Tank
by Impact 9, Mission 2, Target 18

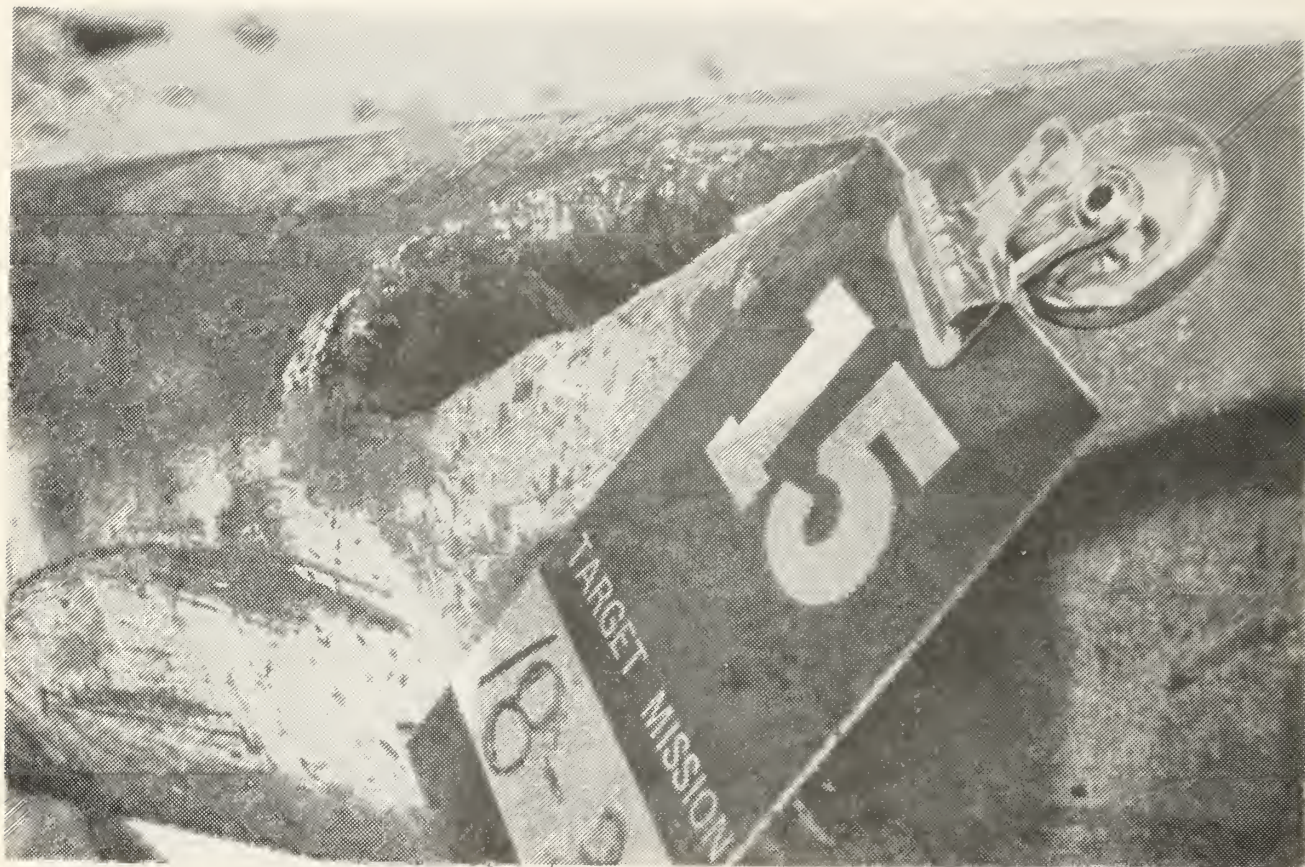
Impact 15 (Fig. 29) penetrated one wall of the gun tube and was assessed as a 10 percent contribution to the F-Kill. This assessment was based on tactical considerations and the CDAT's perceptions of crew attitudes based on damage to the gun tube alone. It was the CDAT's judgment that the crew would avoid firing chemical energy type rounds such as high explosive anti-tank munitions (HEAT) due to the possibility of premature functioning of the projectile due to gun tube damage. However, it was also considered that during an active engagement against ground targets dangerous to tanks they could, and probably would continue to fire kinetic energy (armor piercing) rounds with some loss in accuracy and range which could be compensated for to some extent by gunnery techniques.

Fig 29. Penetrated Wall of Gun Tube
Impact 15, Mission 3, Target 18

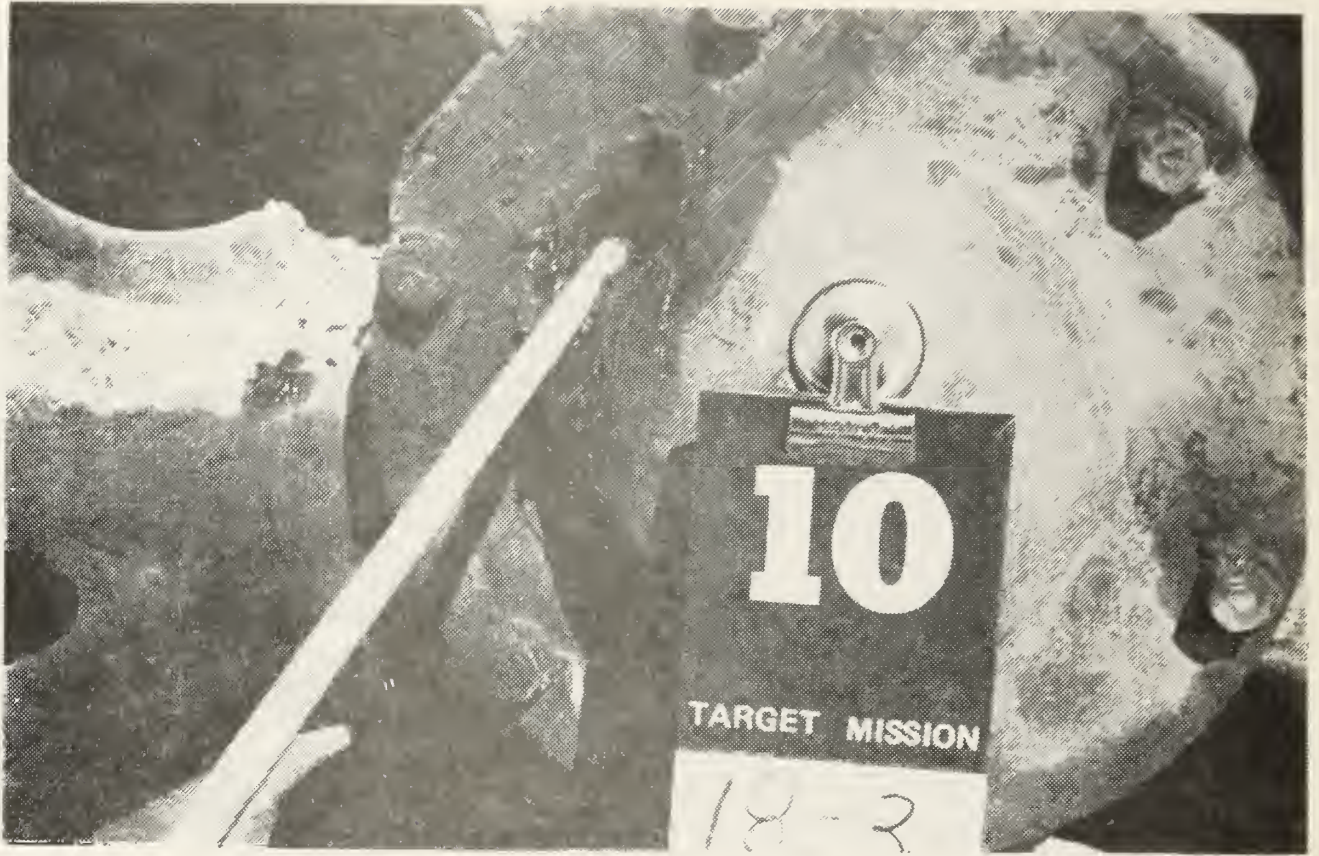
Fig 31. Impact 10, Mission 3, Target 18
Showing Damage to Right No. 1
Road Wheel

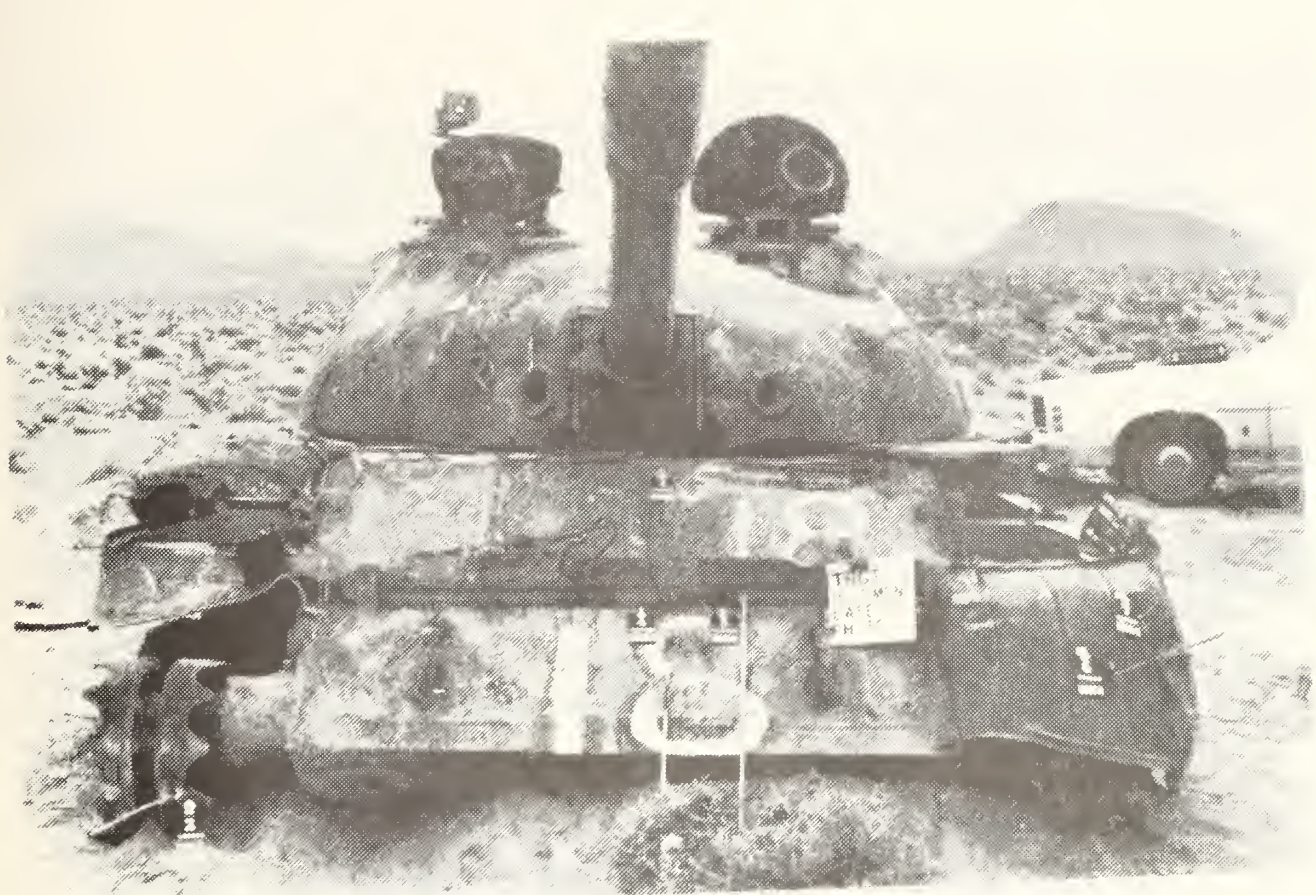
Fig 42. Location of Strikes, Impacts 1 through 7,
Mission 5, Target 18
