COMBAT DAMAGE ASSESSMENT TEAM
A-10/GAU-8 LOW ANGLE FIRINGS
VERSUS
INDIVIDUAL SOVIET TANKS
(February - March 1978)

R.H.S. Stolfi

August 1979

Prepared for: A-10 System Program Office
Wright Patterson Air Force Base
Ohio 45433

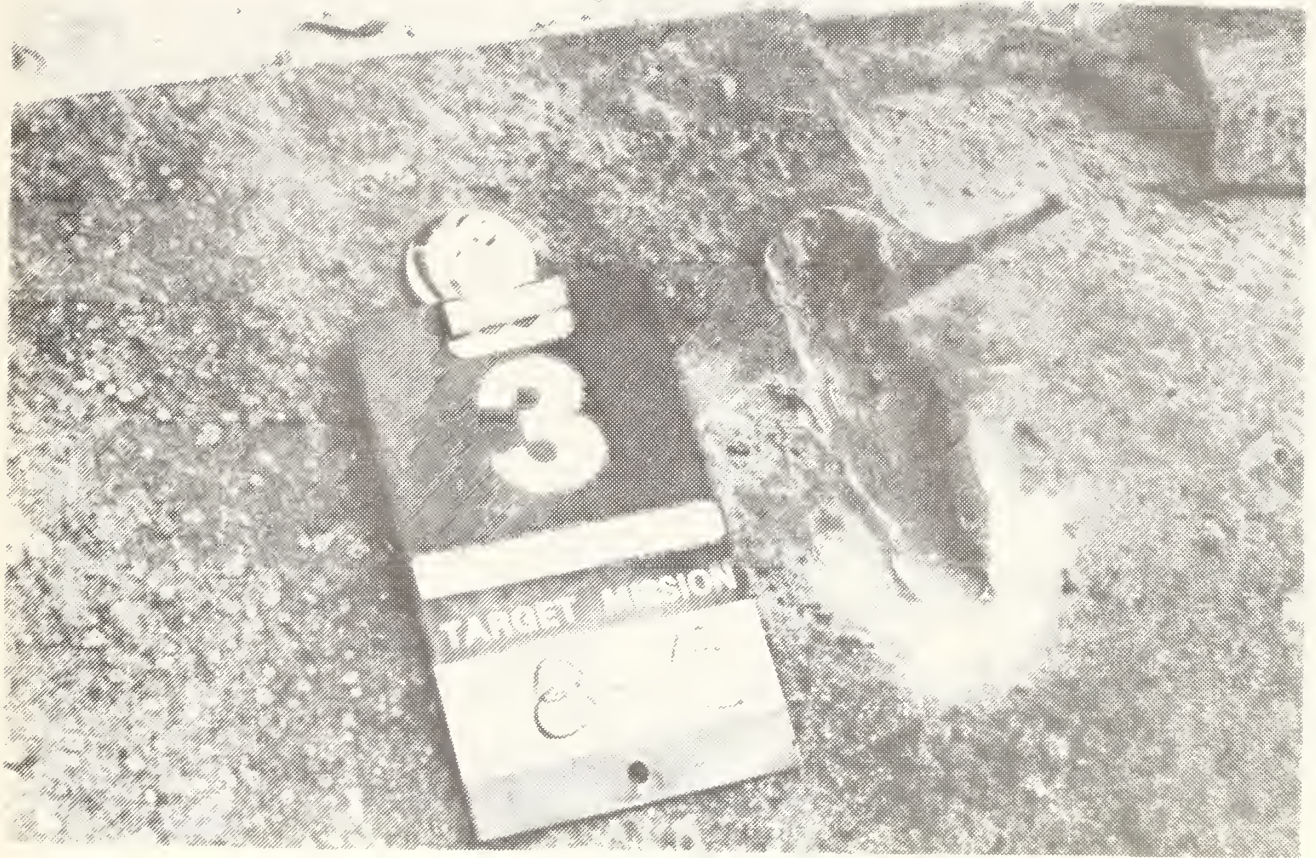
Fig 44. Close-up of Impact 3, Mission 5,
Target 18

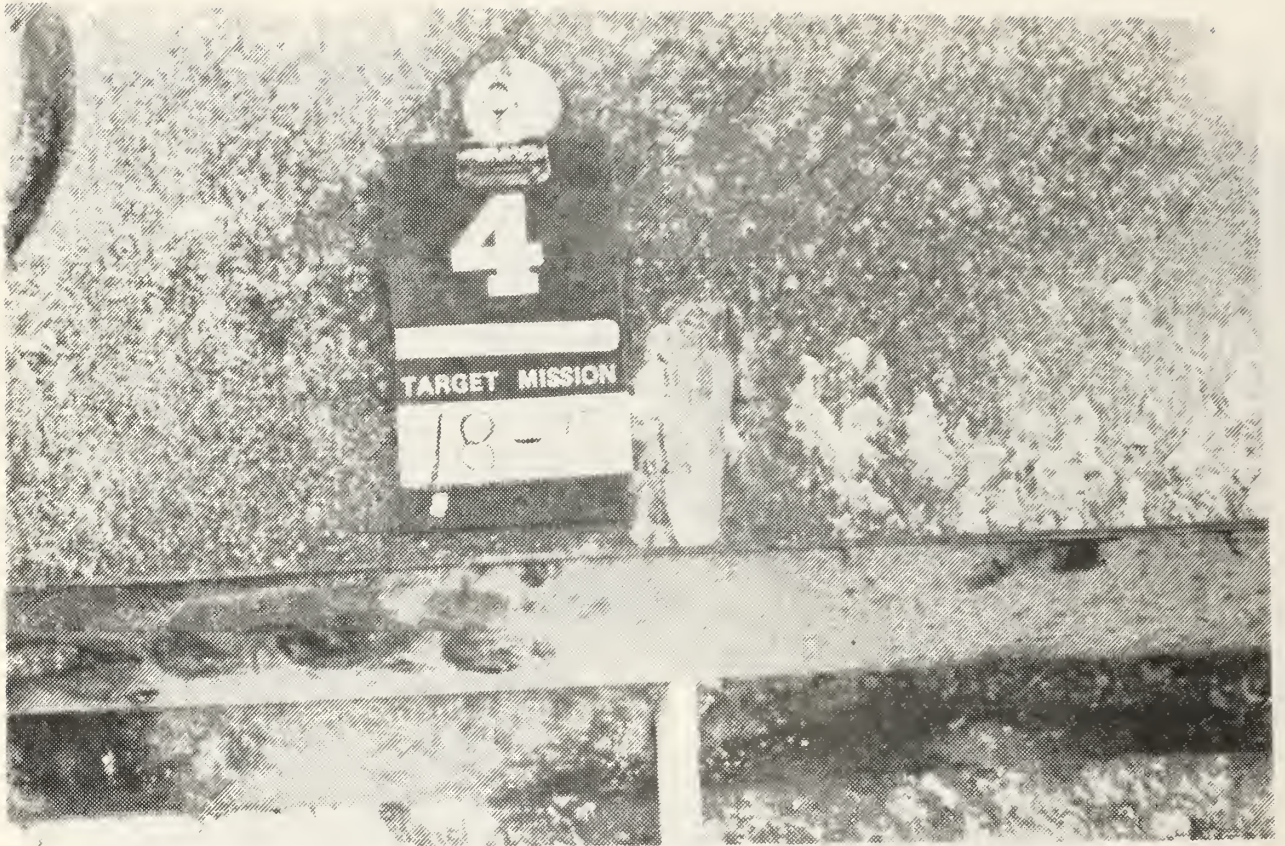
Fig 45. Close-up of Impact 4, Mission 5,
Target 18

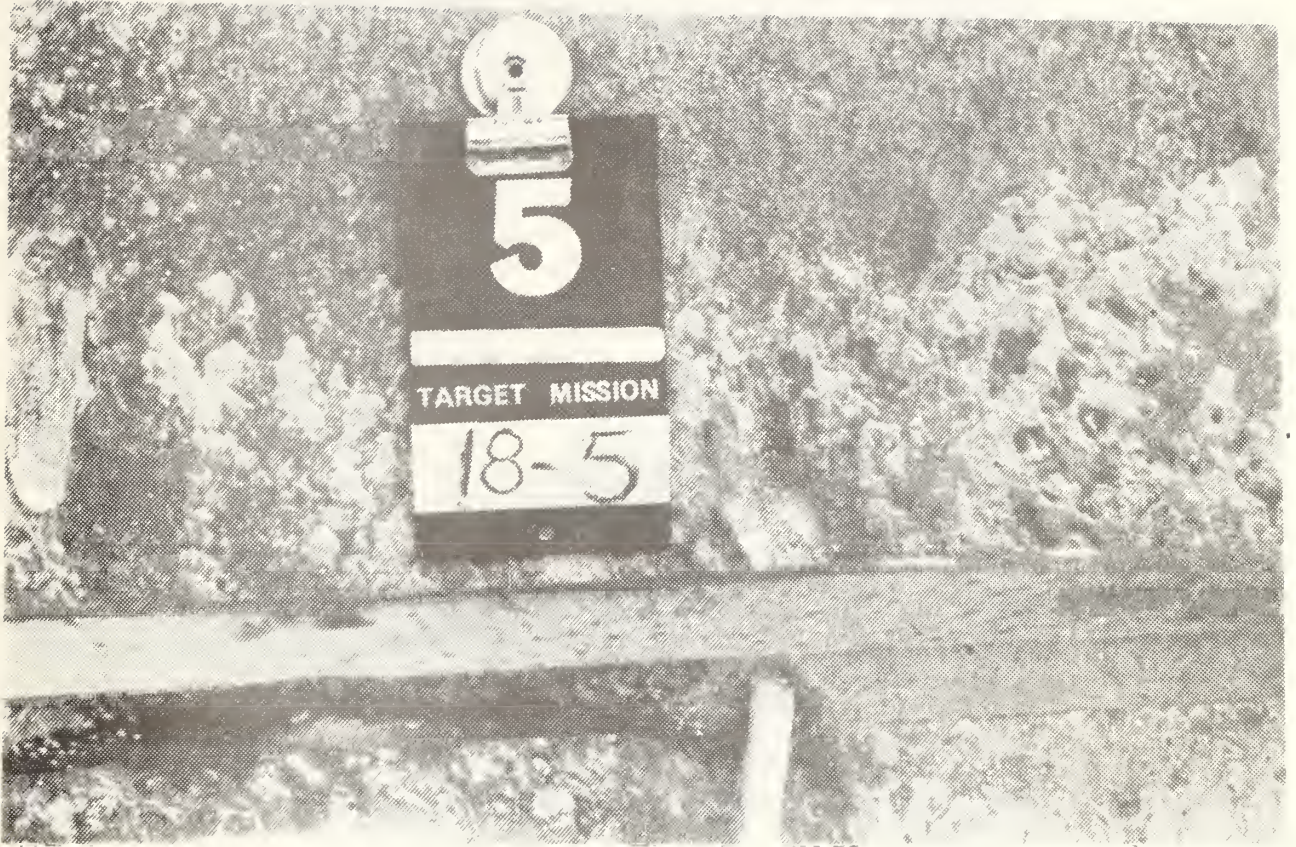
Fig 46. Close-up of Impact 5, Mission 5,
Target 18

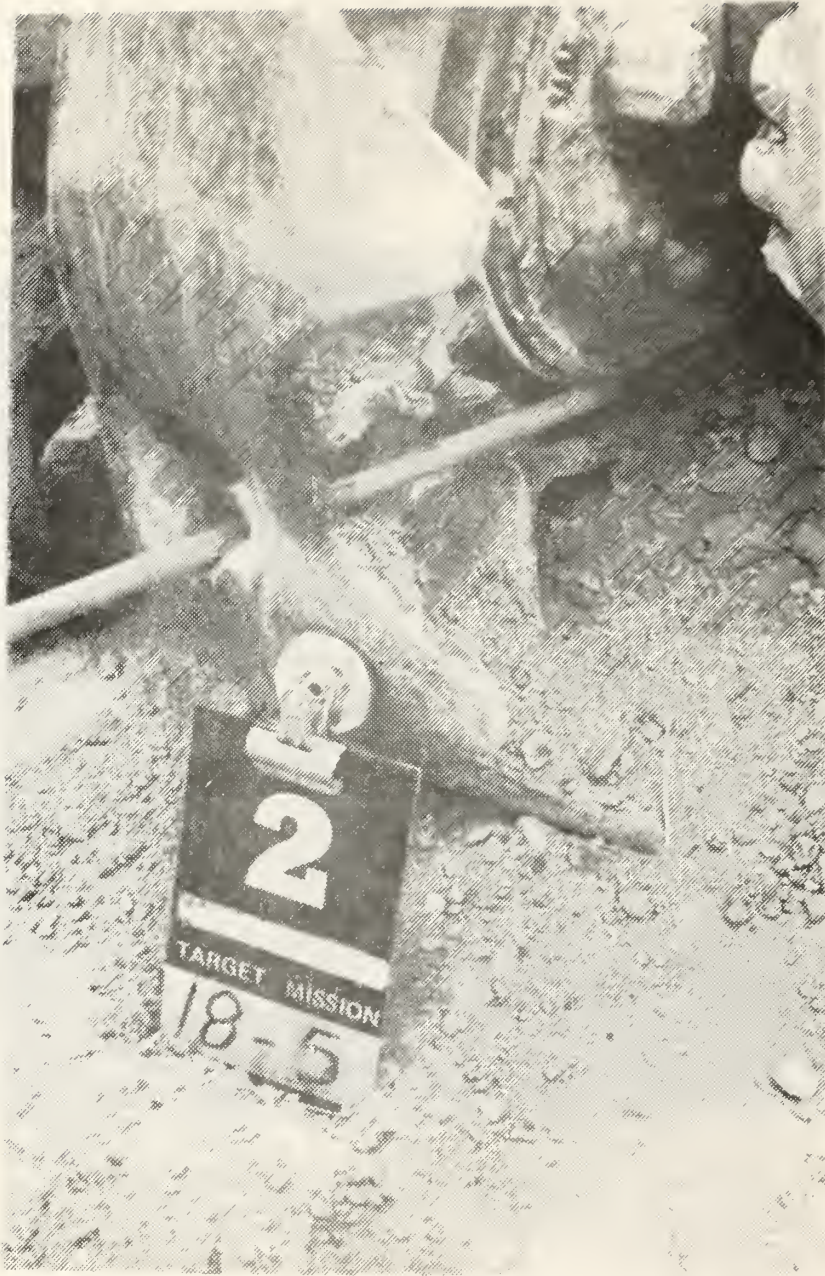
Fig 47. Close-up of Impact 2, Mission 5.
Target 18
