FLOOD PLAIN MANAGEMENT STUDY

CRAWFORD COUNTY, INDIANA

United States Department of Agriculture
Soil Conservation Service
Indianapolis, Indiana

July 1984

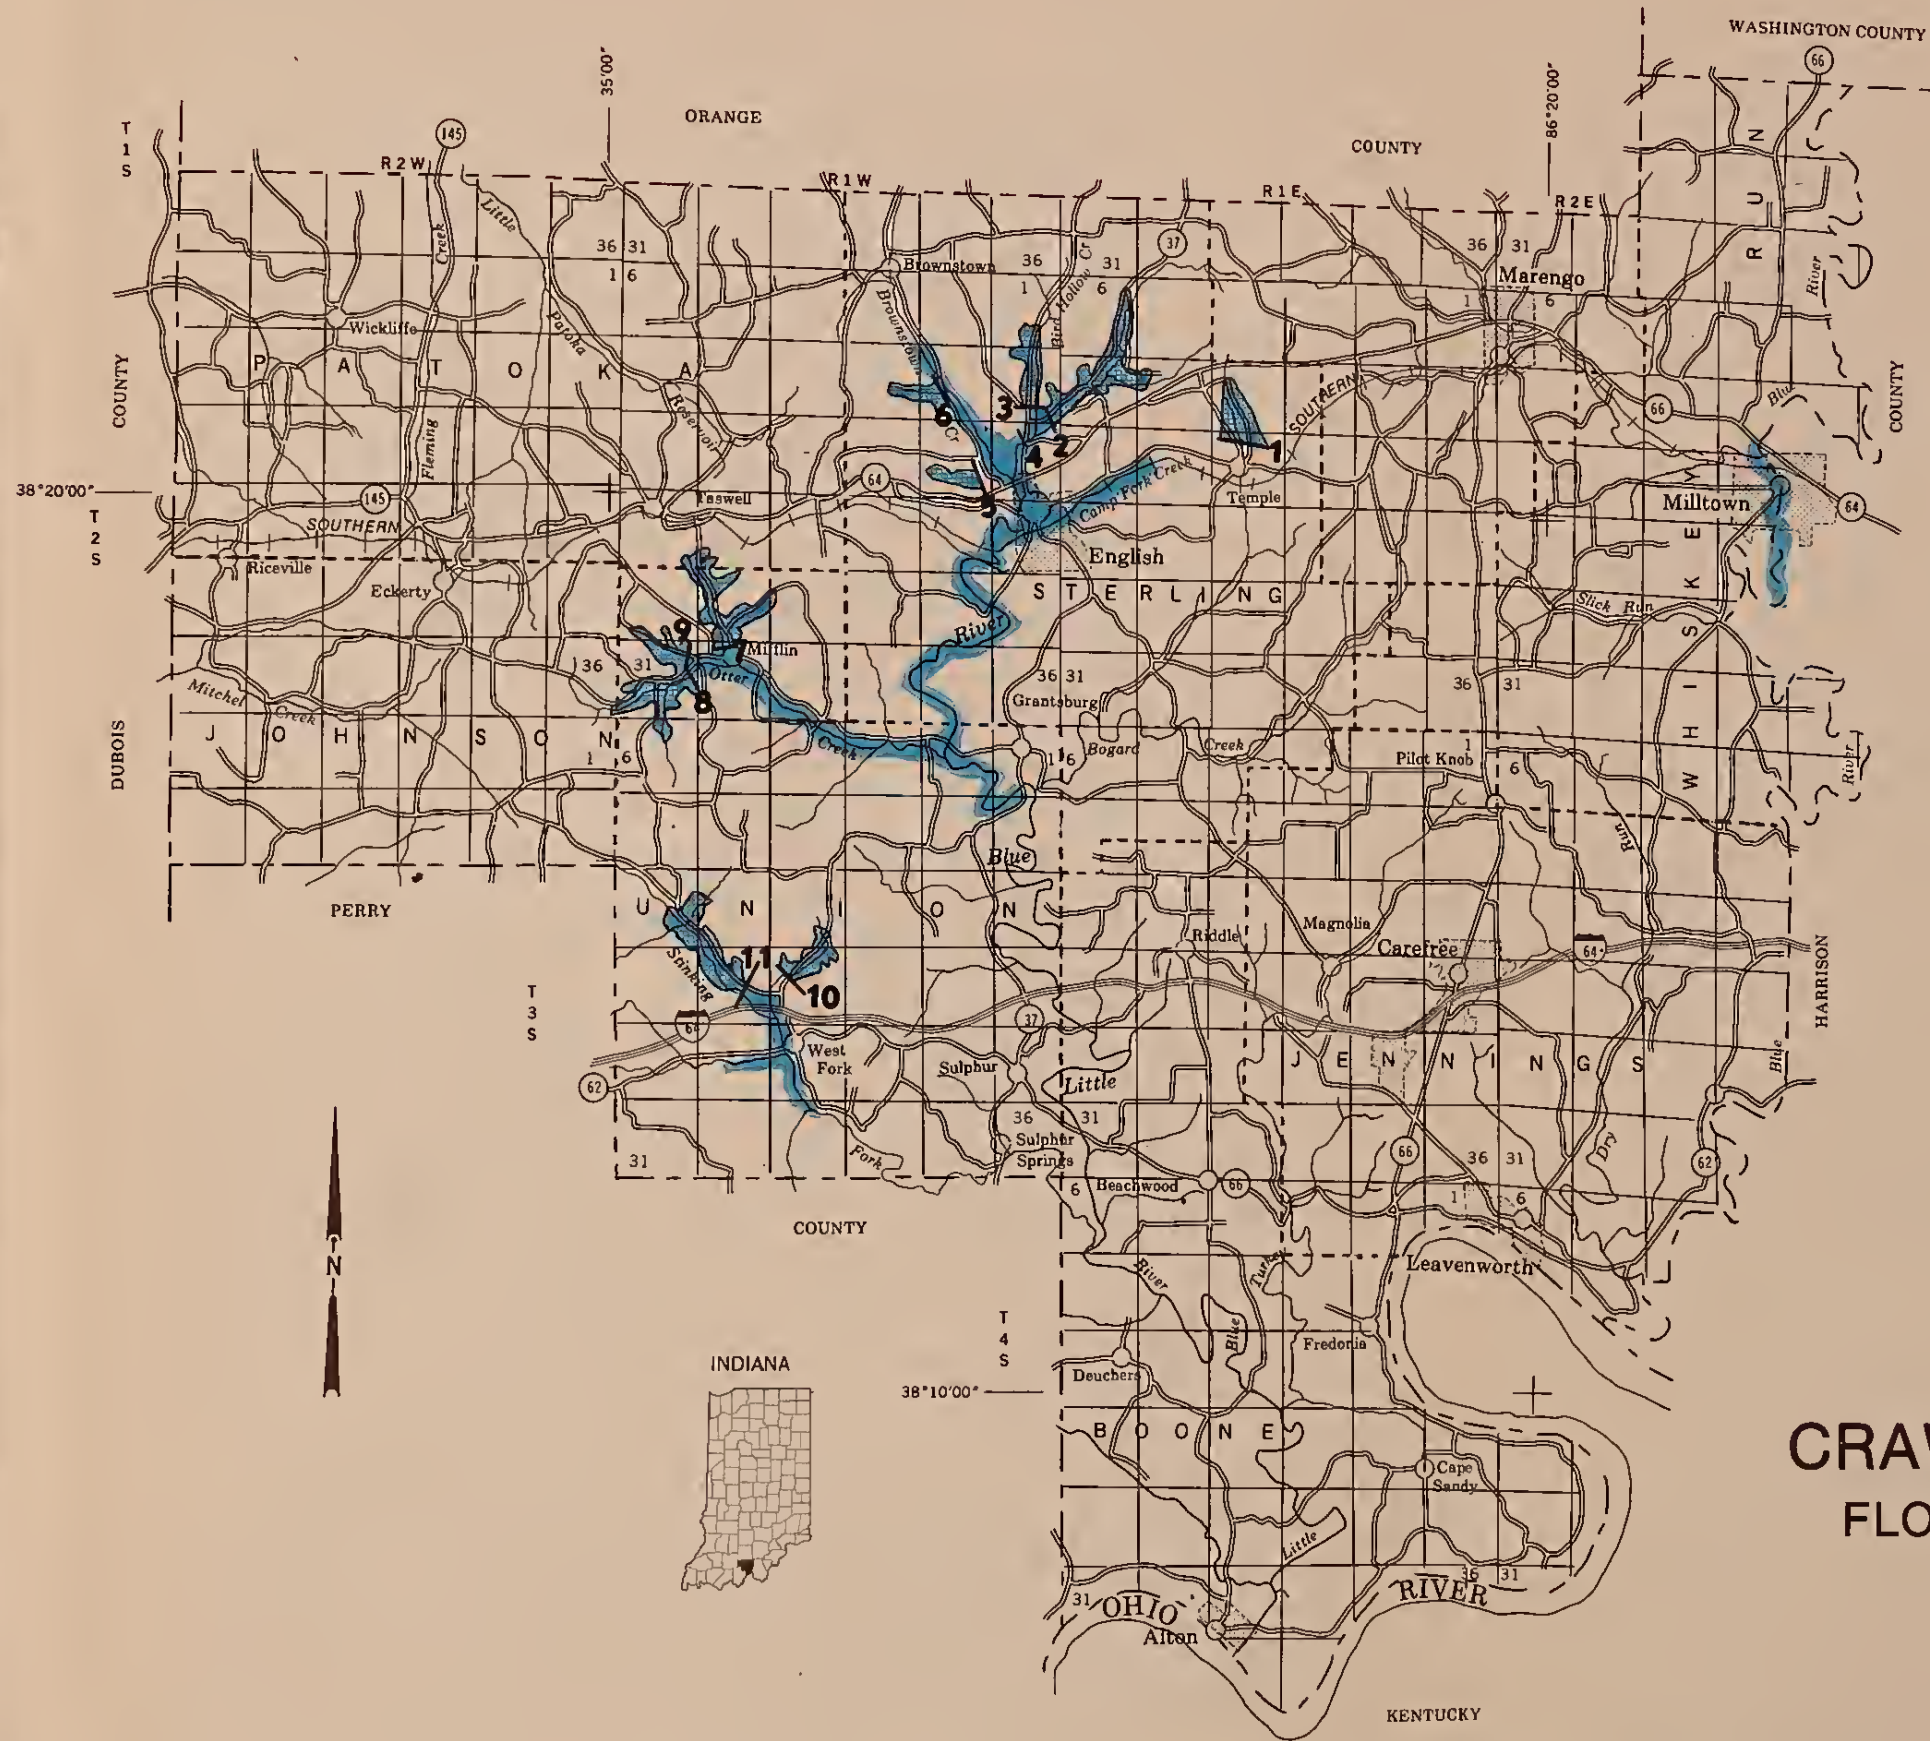
Study Area Map

Index to Flood Hazard Area Photomaps

All streams studied are in hydrologic unit 05140104 (see Index maps, Appendix A). The studied streams are as follows:

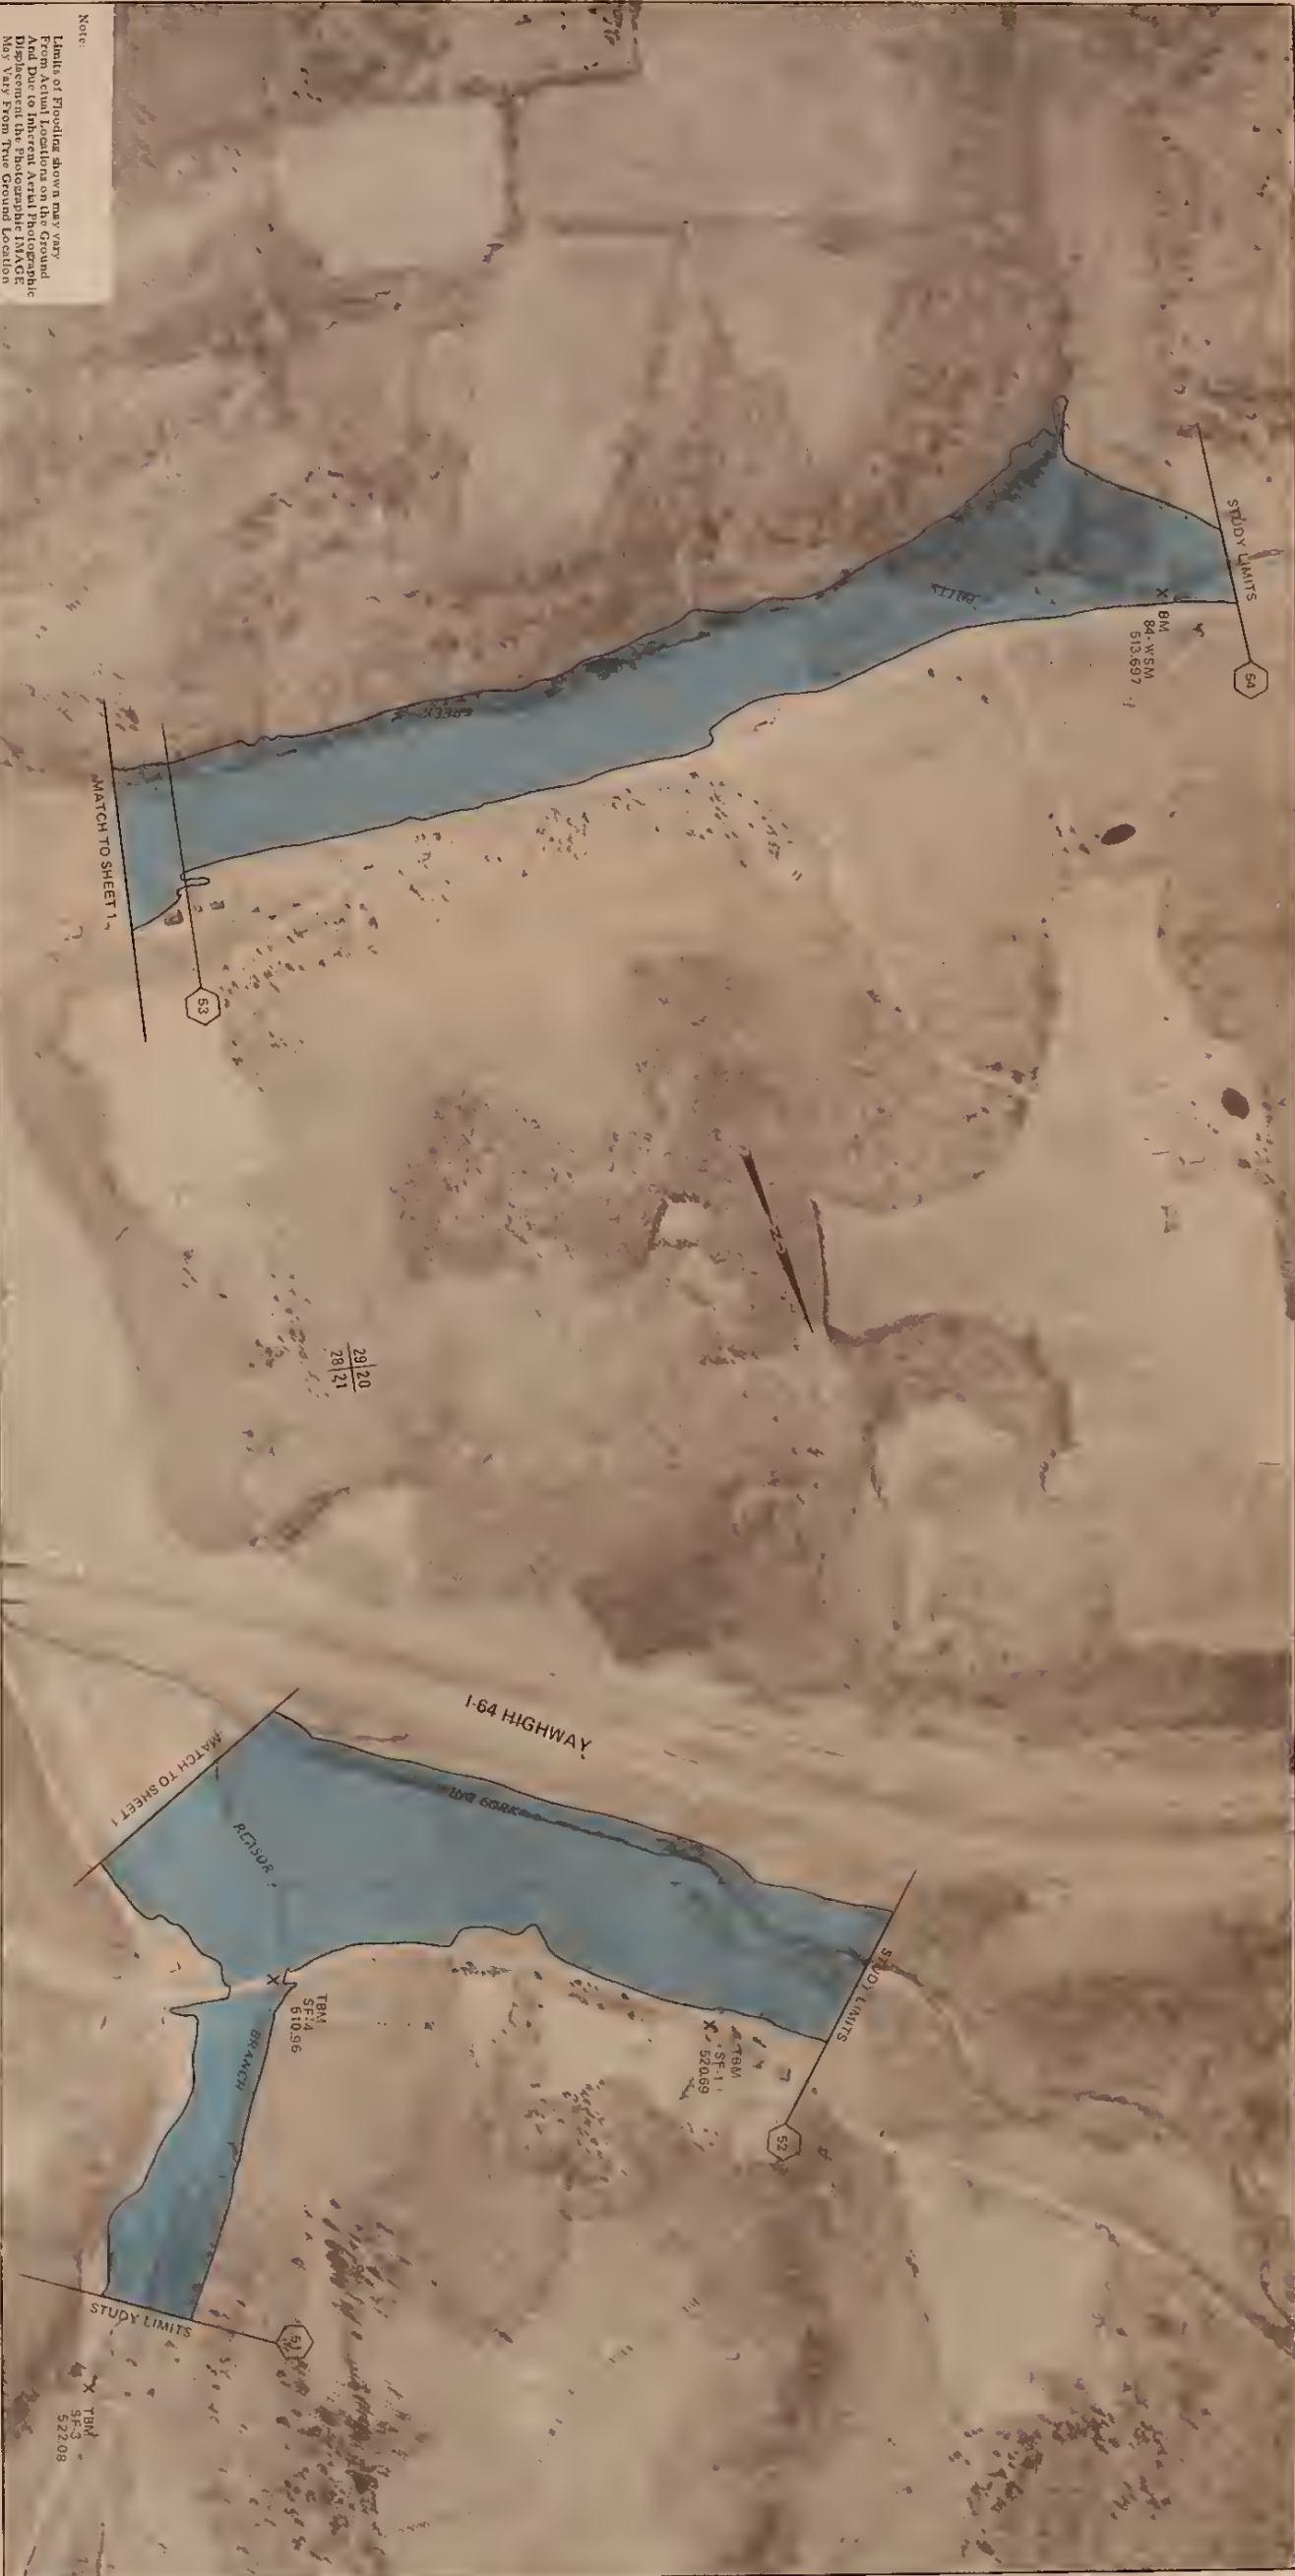
SHEET 2 OF 18

| U.S. DEPARTMENT OF AGRICULTURE SOIL CONSERVATION SERVICE CRAWFORD COUNTY, INDIANA FLOOD PLAIN MANAGEMENT STUDY | FLOOD HAZARD AREA |

The flood hazard maps shown in Appendix B show area inundated by the one percent chance or 100-year frequency flood. The discharges used for all study areas, except Blue River, were determined with the use of the SCS TR-20 computer hydrology model. The 24-hour rainfalls published in the Weather Bureau TP-40 were used. The TR-20 generated discharges were plotted with the corresponding drainage areas on semi-log paper and the best fit straight line determined. These discharges were then coordinated with the various water resource agencies by the Indiana Department of Natural Resources (IDNR). The Blue River discharges were determined from the White Cloud and Fredericksburg stream gage records and coordinated with the water resources agencies by IDNR.

Flood elevations were determined with the aid of the SCS-WSP2 water surface profile program. The flood hazard areas were then determined by drawing the WSP2 flood elevations on 2 foot contour maps for the areas studied in detail.

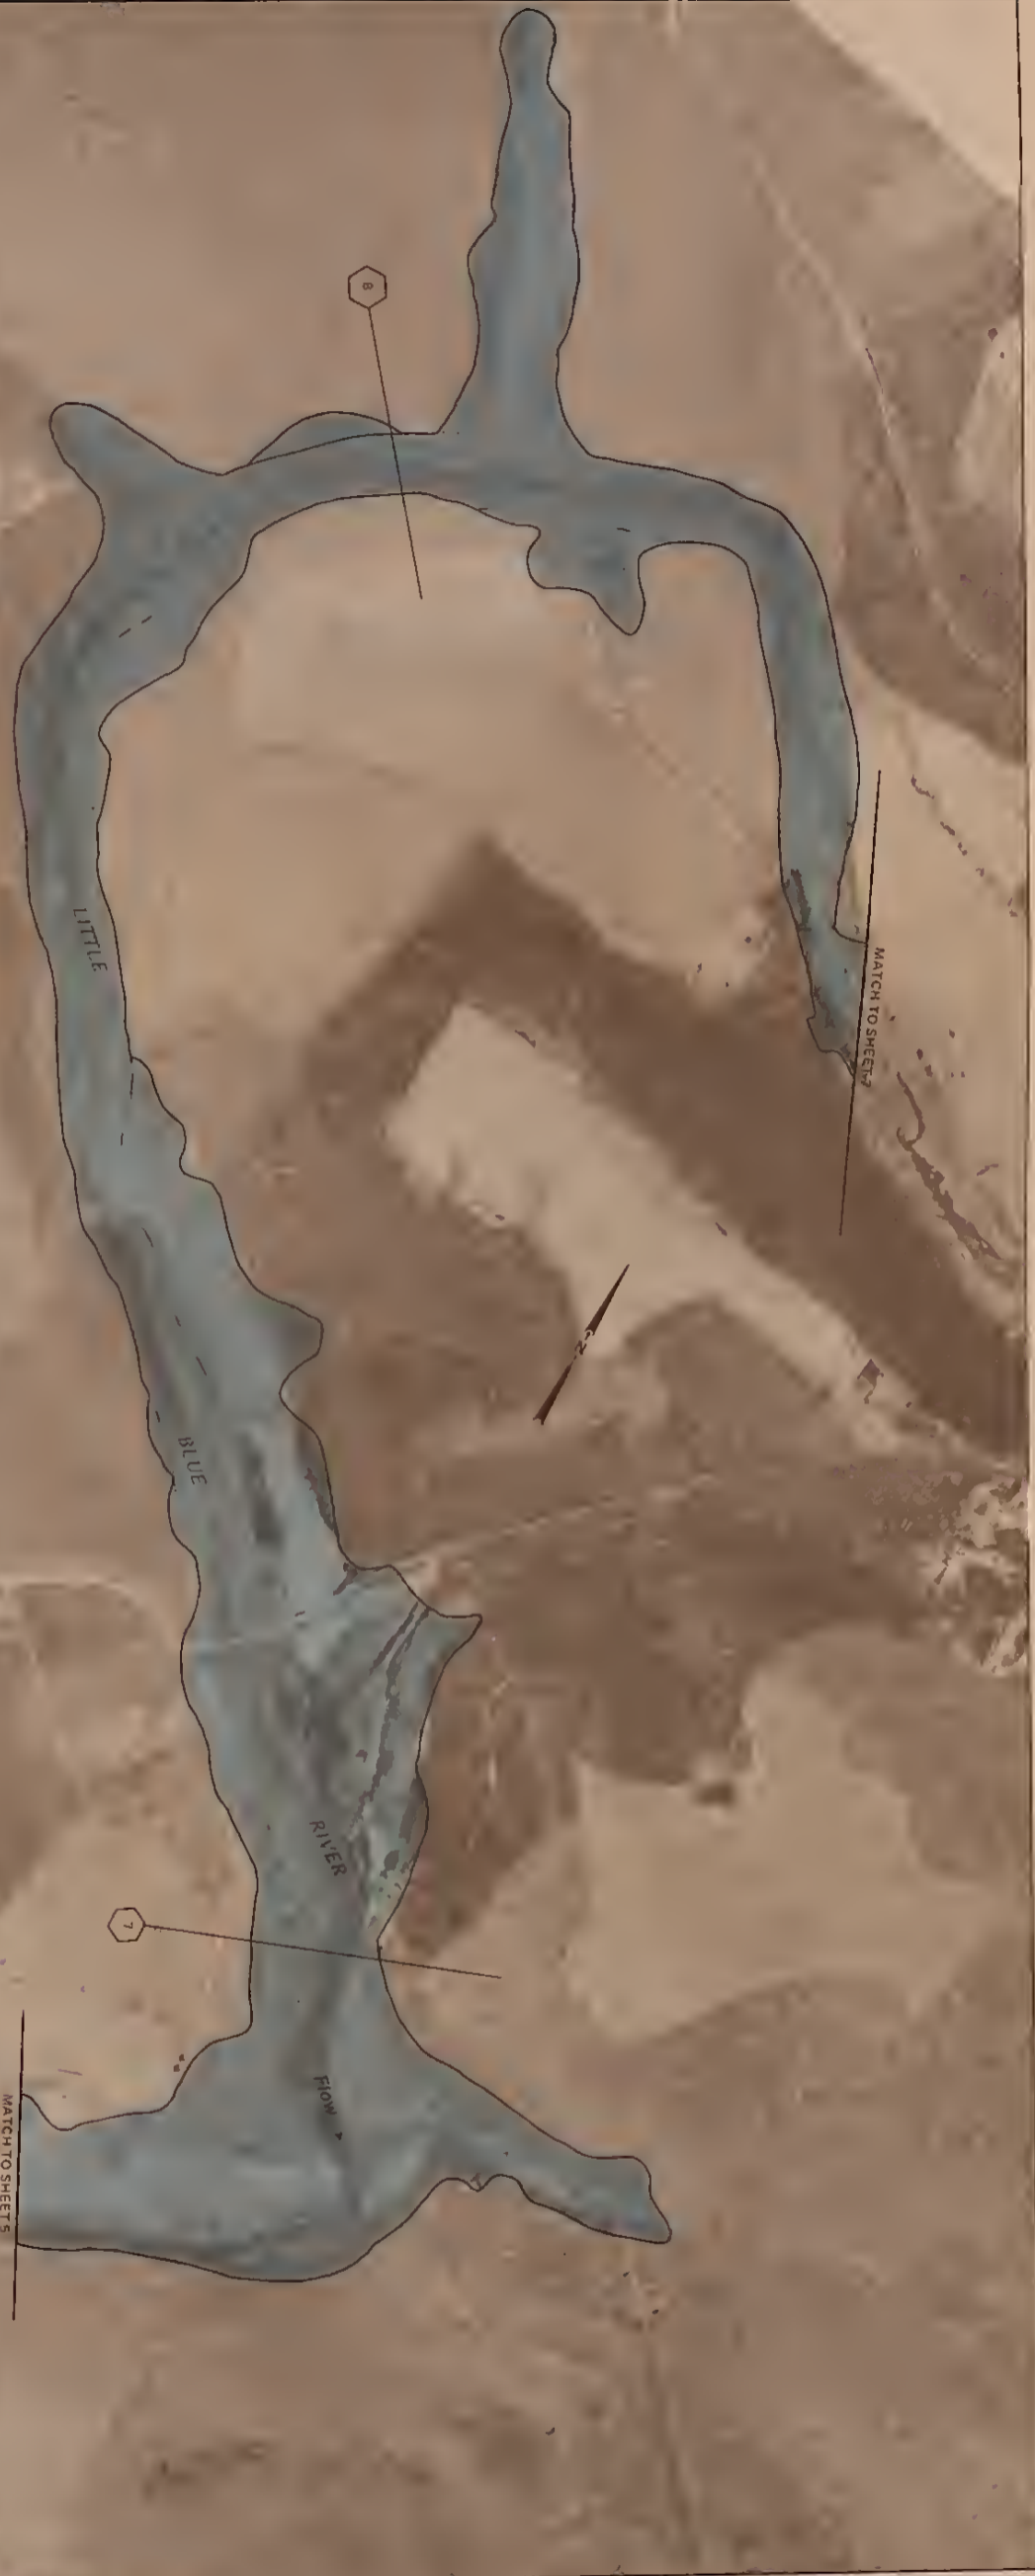
SEPTEMBER 1983 4-R-39460
 SHEET 6 OF 18

FLOOD HAZARD AREA
 Little Blue River
