FLOOD PLAIN MANAGEMENT STUDY

TOCCOA AND EASTANOLLEE CREEKS

STEPHENS COUNTY, GEORGIA

DECEMBER 1981

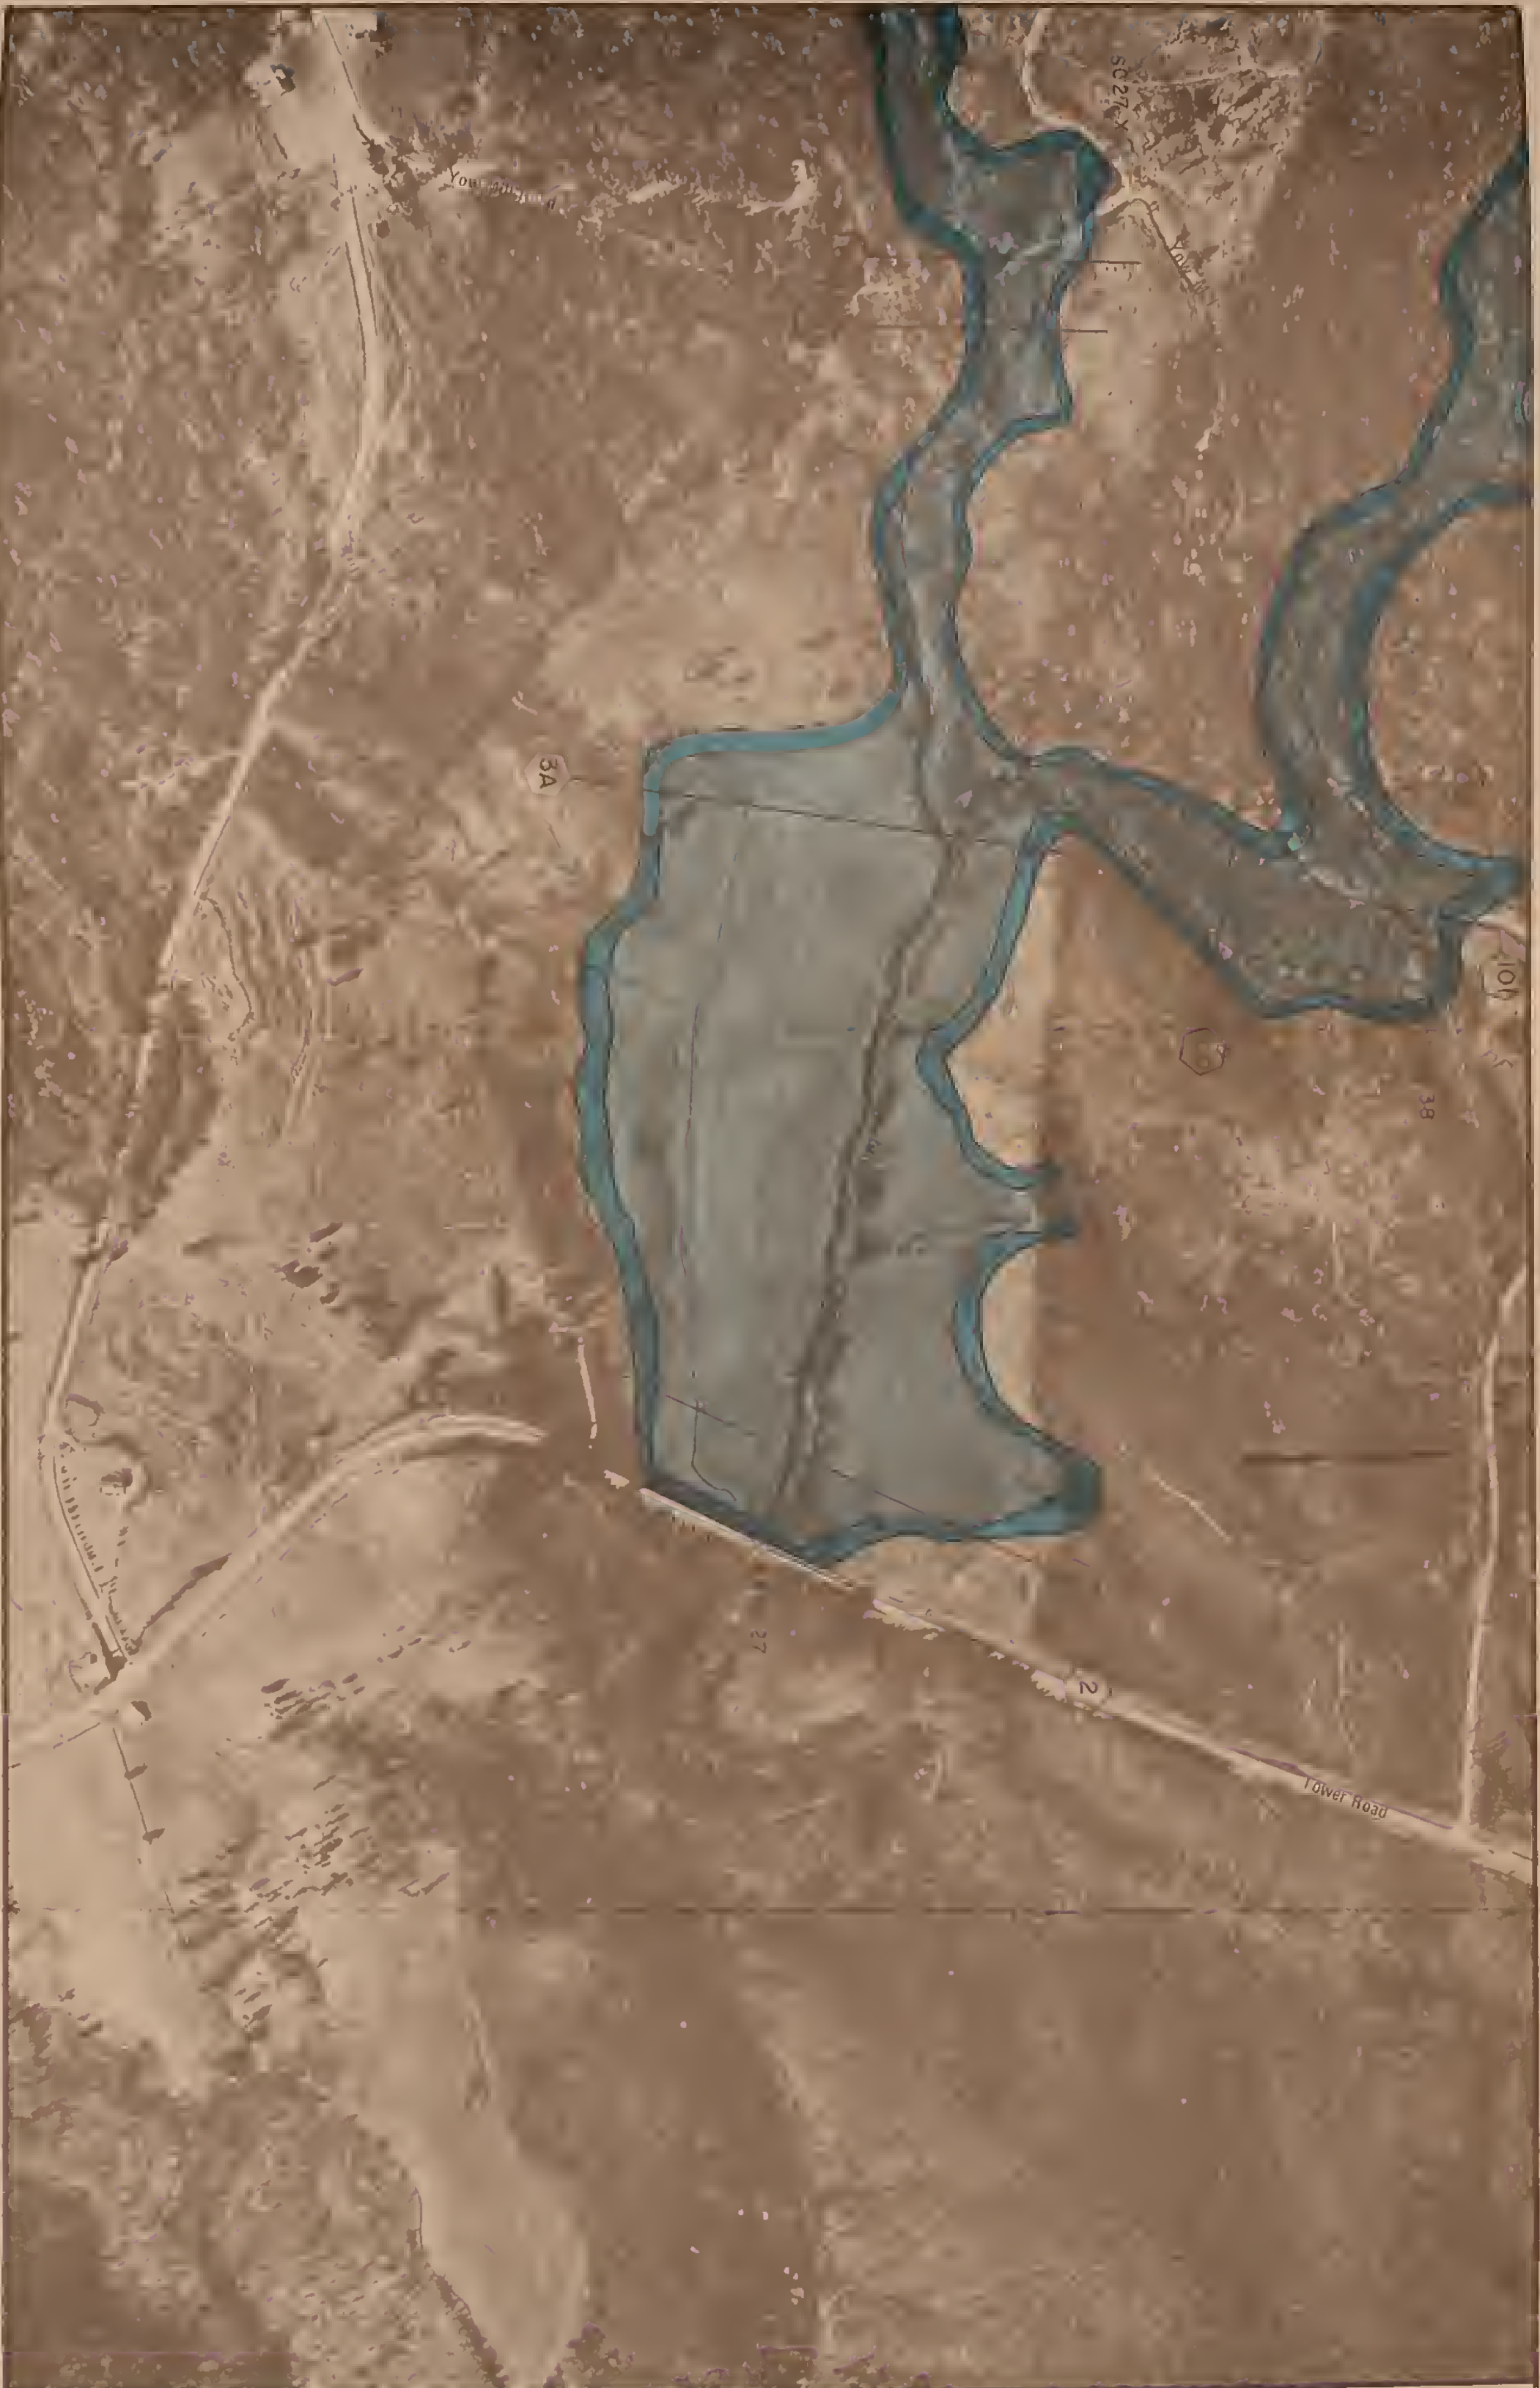
FLOOD HAZARD AREA

EASTANOLLEE CREEK

Flood hazard areas are shown on the photomaps presented in this report. Photographs used for these maps were made in December 1978. The photomaps show the 100-year and 500-year flood hazard areas and the locations of the surveyed cross sections. Flood hazard areas for various frequency floods are given in Table 2. This table reflects current land use.
