AIRCRAFT ACTION REPORT

(a) Unit Reporting VT-45 (b) Based on or at U.S.S. SAN JACINTO (c) Report No. 22
 (d) Take off: Date 18 March 1945 Time (LZT) 0645 (Zone); Lat. 30°-45' Long. 139°-29'
 (e) Mission Strike Kagoshima A/F, Kyushu, Japan (f) Time of Return 1045 (Zone)

REPORT No. **22**

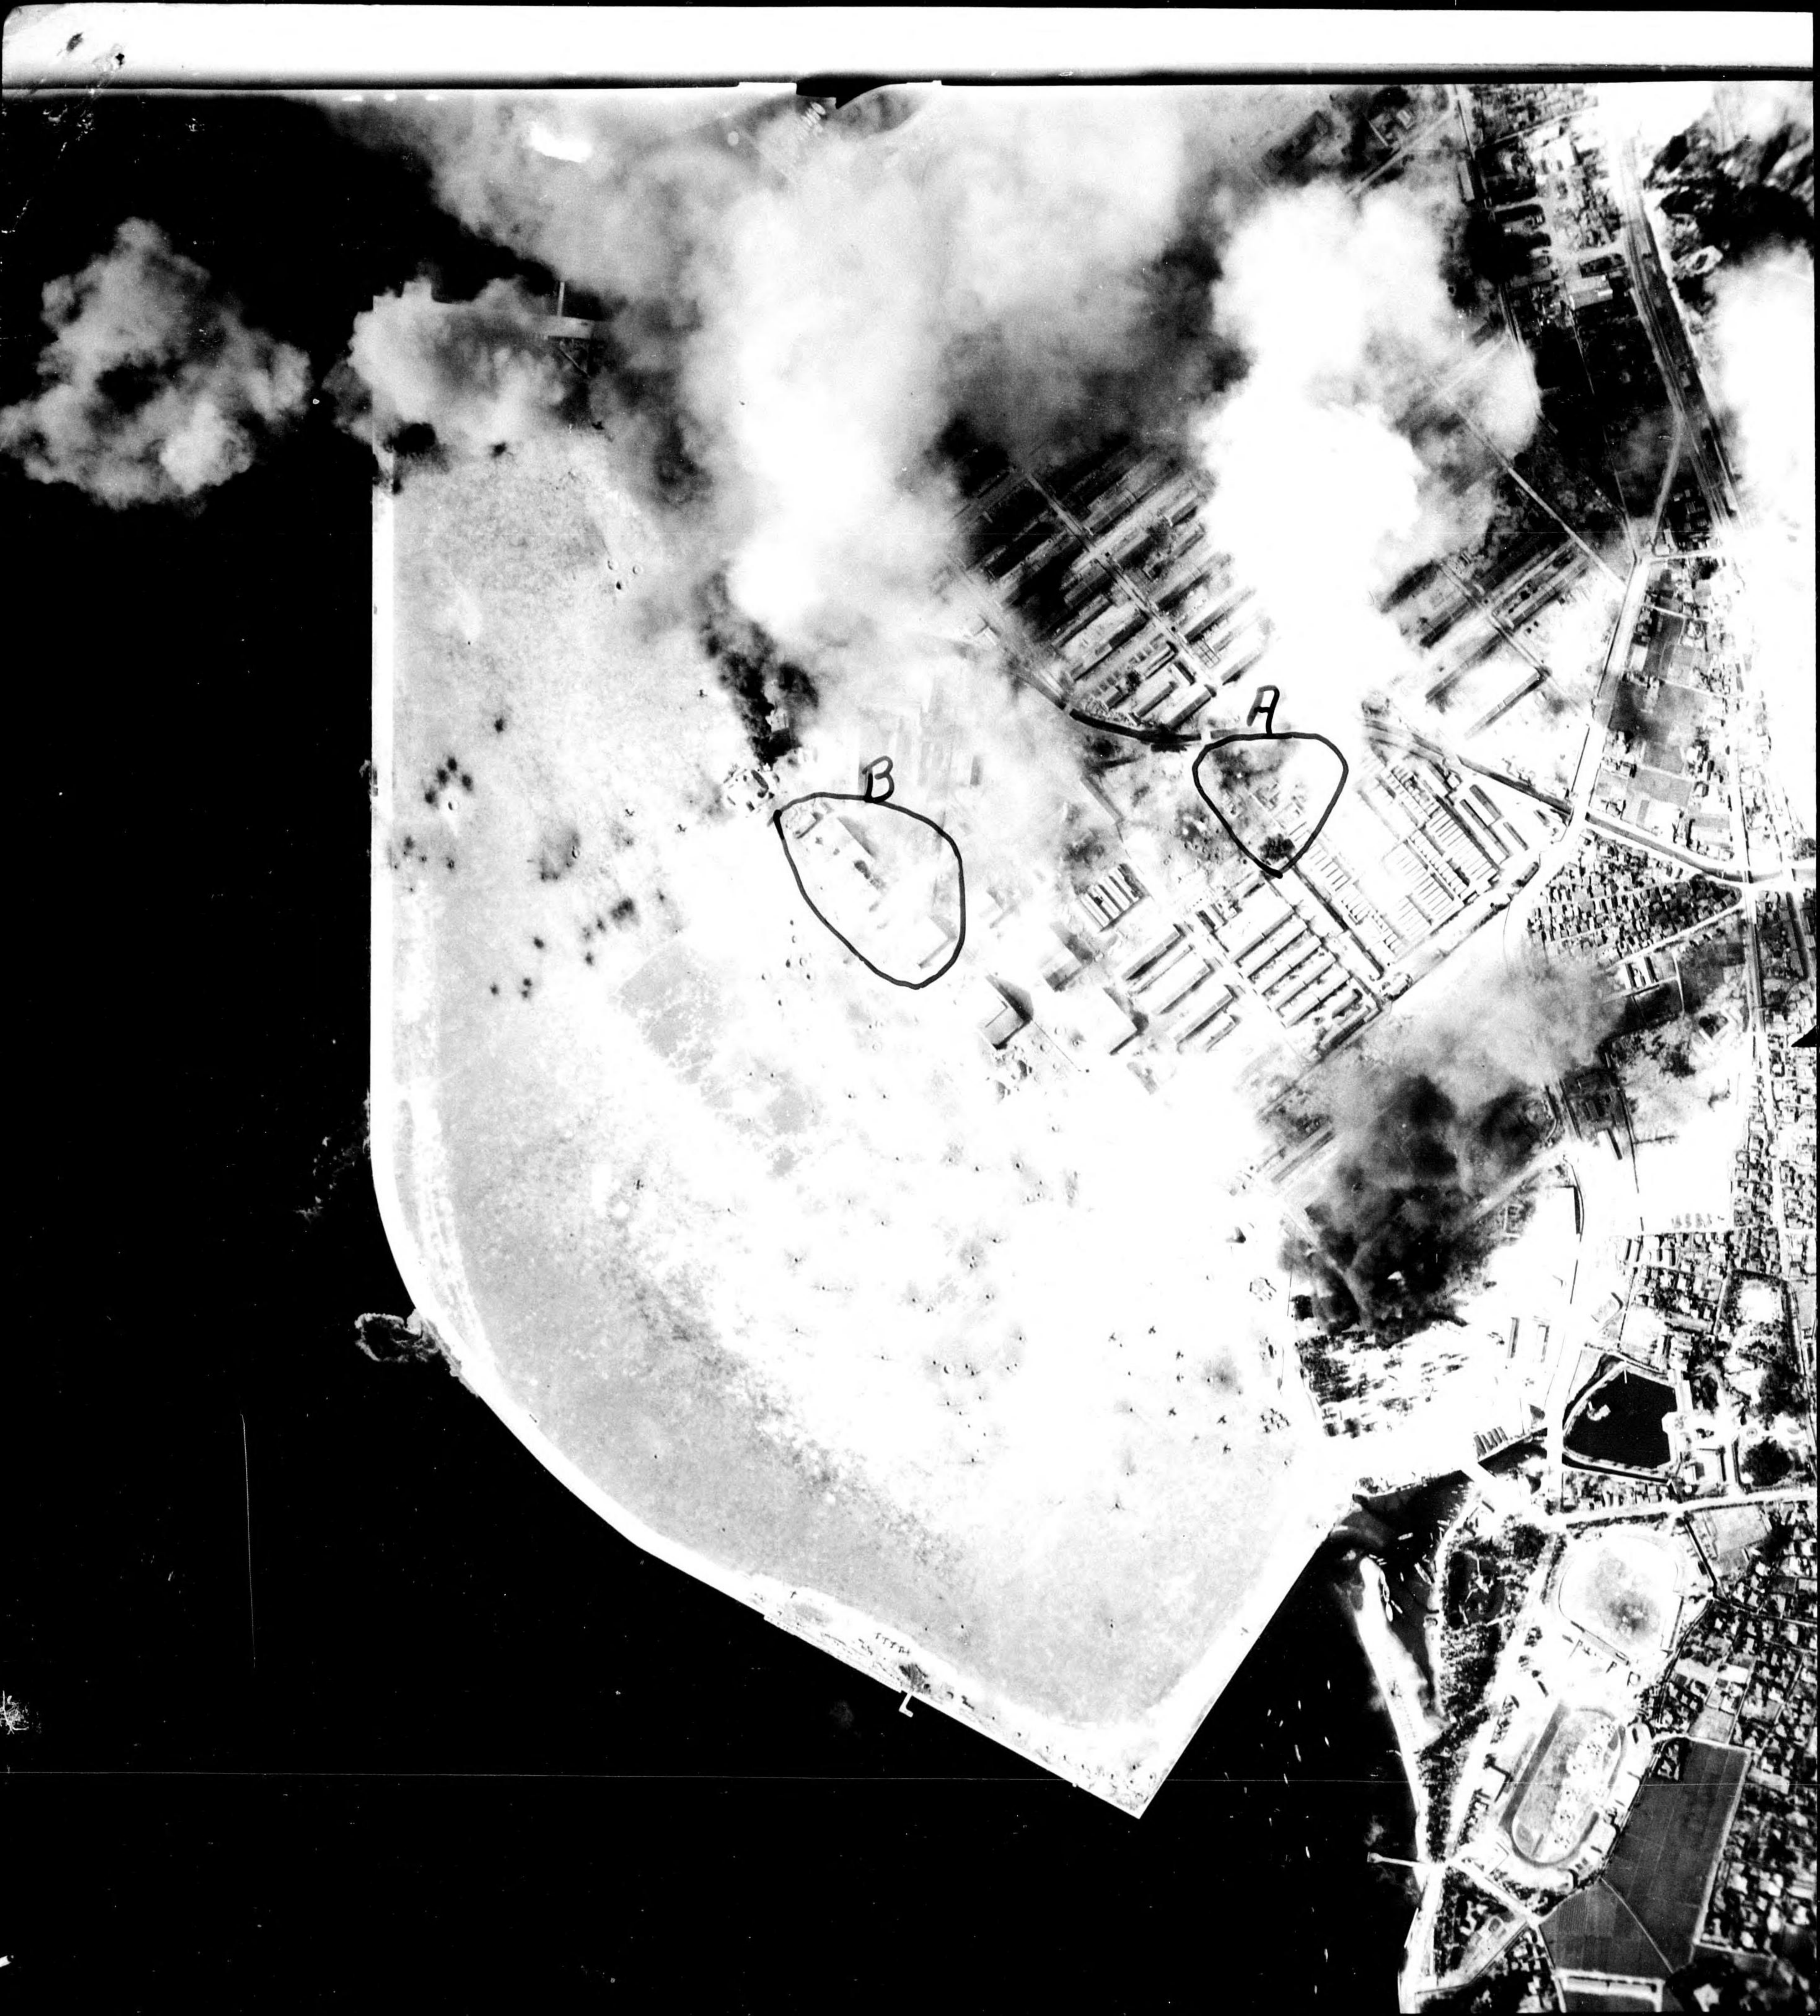
1. The bombing attack by six of the planes was concentrated on the southern half of aircraft assembly plant area about 1500 feet west of the airfield. Majority of bombs dropped were seen to hit on saw tooth roofed assembly plant buildings. Fires resulted. Area "A" on attached photograph is the area destroyed. In it the shattered remains of buildings can be seen.

2. Three planes attacked hangars along west side of field and service buildings immediately west of them. One small building which formerly stood at SE corner of largest hangar was destroyed and four medium sized hangars were hit and fires started. This area is marked "B" in the attached photograph.

The strike approached the target area at 18,000 feet and recognized Kagoshima Airfield without difficulty. The attack was launched from the northeast and push over was at 15,000 feet. Glide angles of 30° to 45° were obtained and bombs were released at altitudes ranging from 5,000 to 7,000 feet. Runs were made from northeast to southwest and the twelve 100/ G.P. bombs in each plane were dropped select. Six pilots chose the aircraft assembly plant 1,500 feet west of the airfield as the target and dropped in rapid succession upon the southern half of it. The attached photograph, which was taken by a VF-45 photo plane immediately after the VF-45 planes attacked, shows that an area of about 32,000 square feet in the southern portion of the plant has been completely destroyed. A few bomb hits can be discerned in the adjoining portions of this plant.

The other three planes chose the hangar area and dropped their bombs select on it. Their runs were directly across four medium hangars at the south end of main paved runway. The attached photograph shows that all of these have been hit by bombs and shows that one is substantially destroyed. A small workshop adjacent to the hangars was exploded by a bomb hit and several other small service buildings were hit.
