CONSOLIDATED MISSION REPORT

FIELD ORDER NUMBER 32  
 MISSION NUMBER 14  
 DATE OF MISSION  
 22 DECEMBER 1944

HEADQUARTERS  
 73RD BOMBARDMENT WING  
 APO #237, % POSTMASTER  
 SAN FRANCISCO, CALIFORNIA

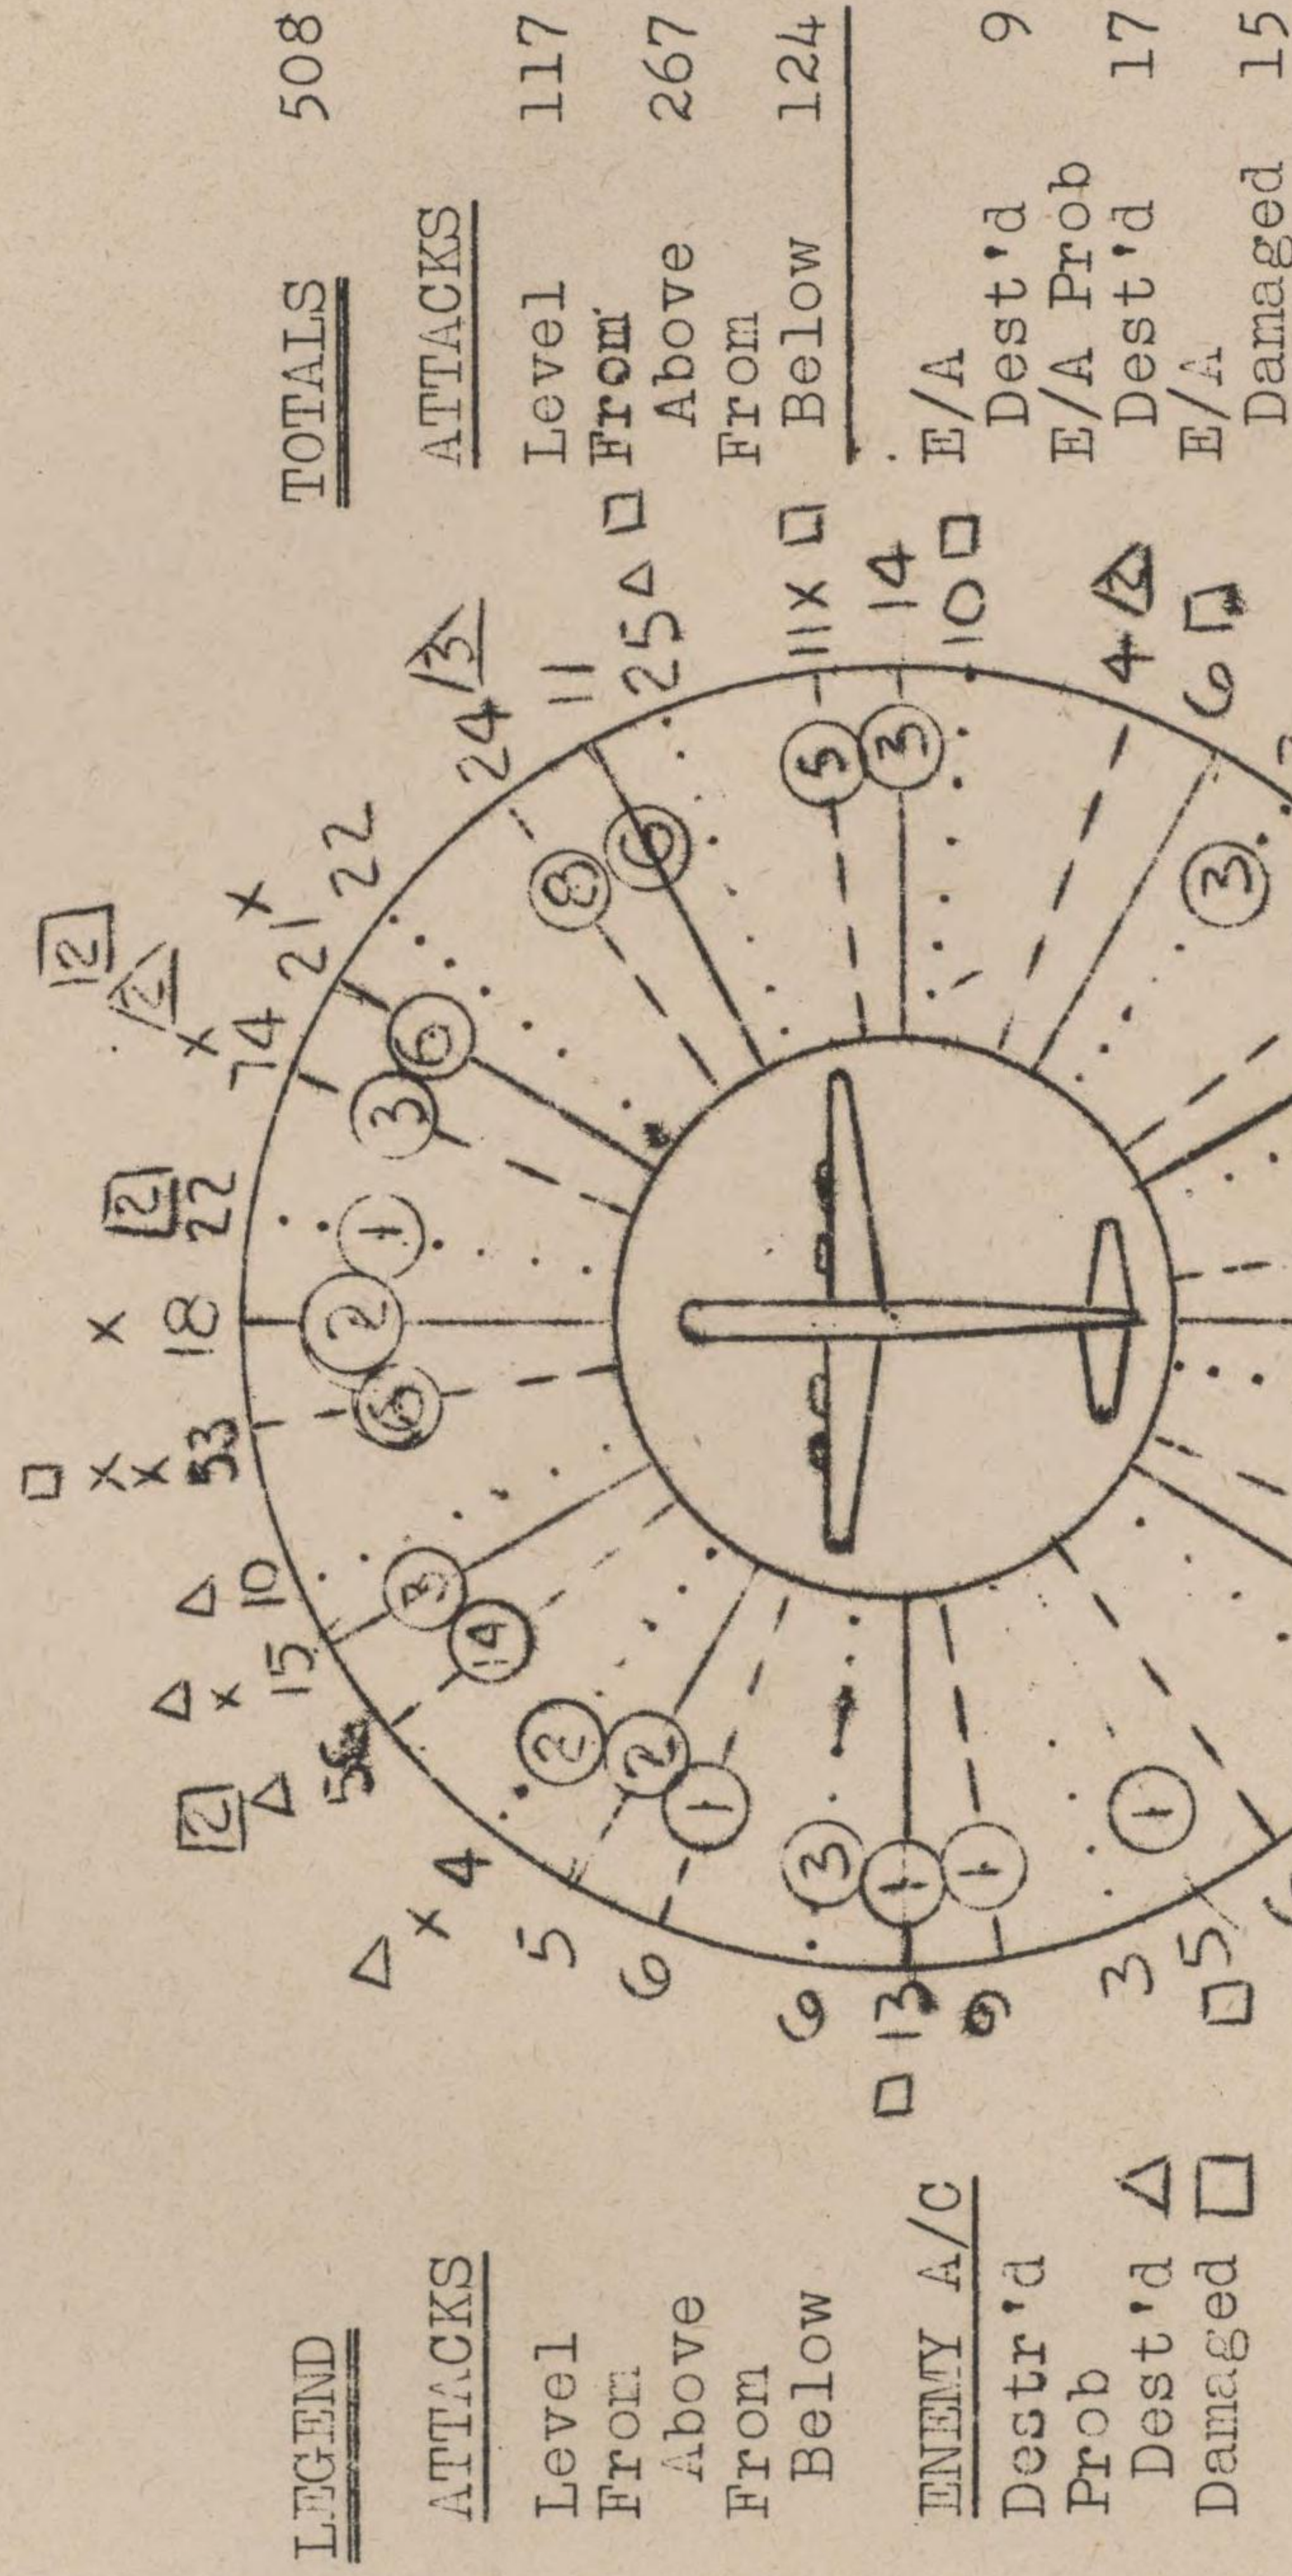
20. ANALYSIS OF ATTACKS BY ENEMY AIRCRAFT

NOTE: The number of E/A attacking is shown at the outside end of each line. Attacks made by twin-engine E/A are indicated by "o" interruption in attack line, and when more than one T/E attack is made, the total is shown inside the "o".

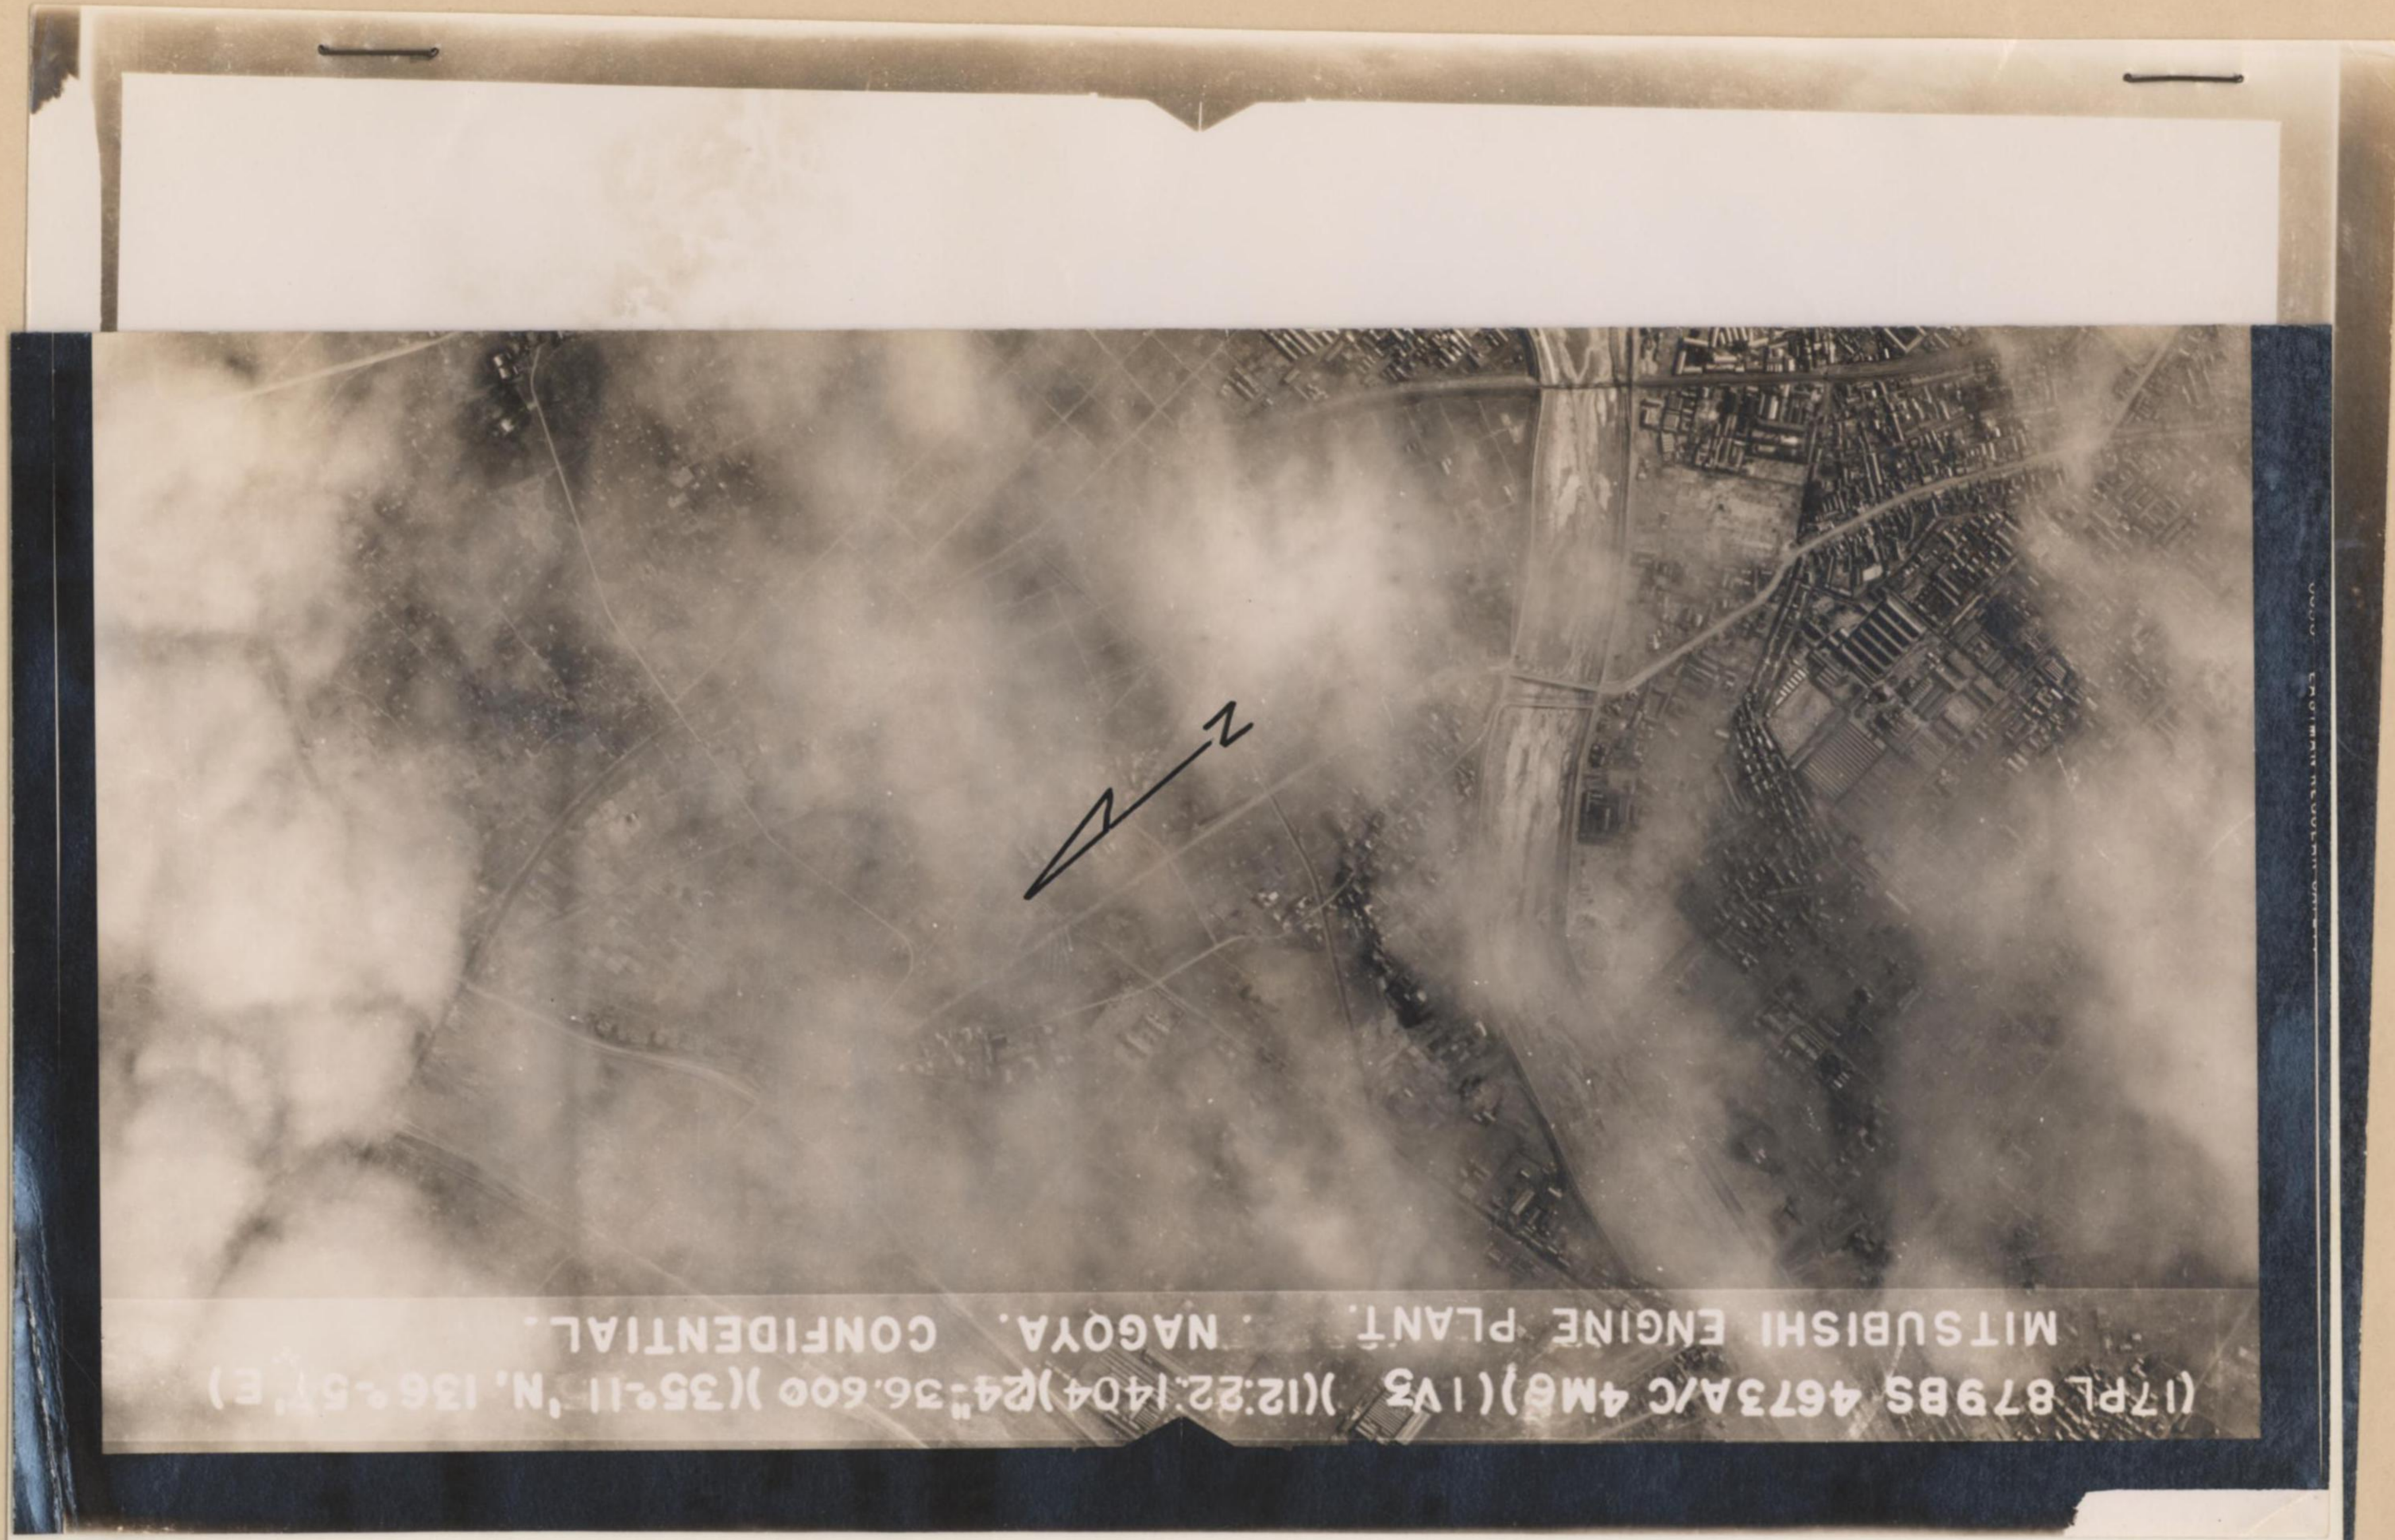
(17FL 879BS 4673A/C 4M6) (1V3) (12:22.1404) (24°36.600) (35°11'N, 136°51'E)  
MITSUBISHI ENGINE PLANT. NAGOYA. CONFIDENTIAL.

Roof areas at Ht.7, V3.5; H7.7, V3.6 (the sub-assembly buildings between the new and old plant areas) and H9.3, V3.8 (SE part of the westernmost final assembly building) are being repaired. Some of the debris is being cleared away in the residential area north of the plant. Print reference 3 PR 4 M17-2-15.

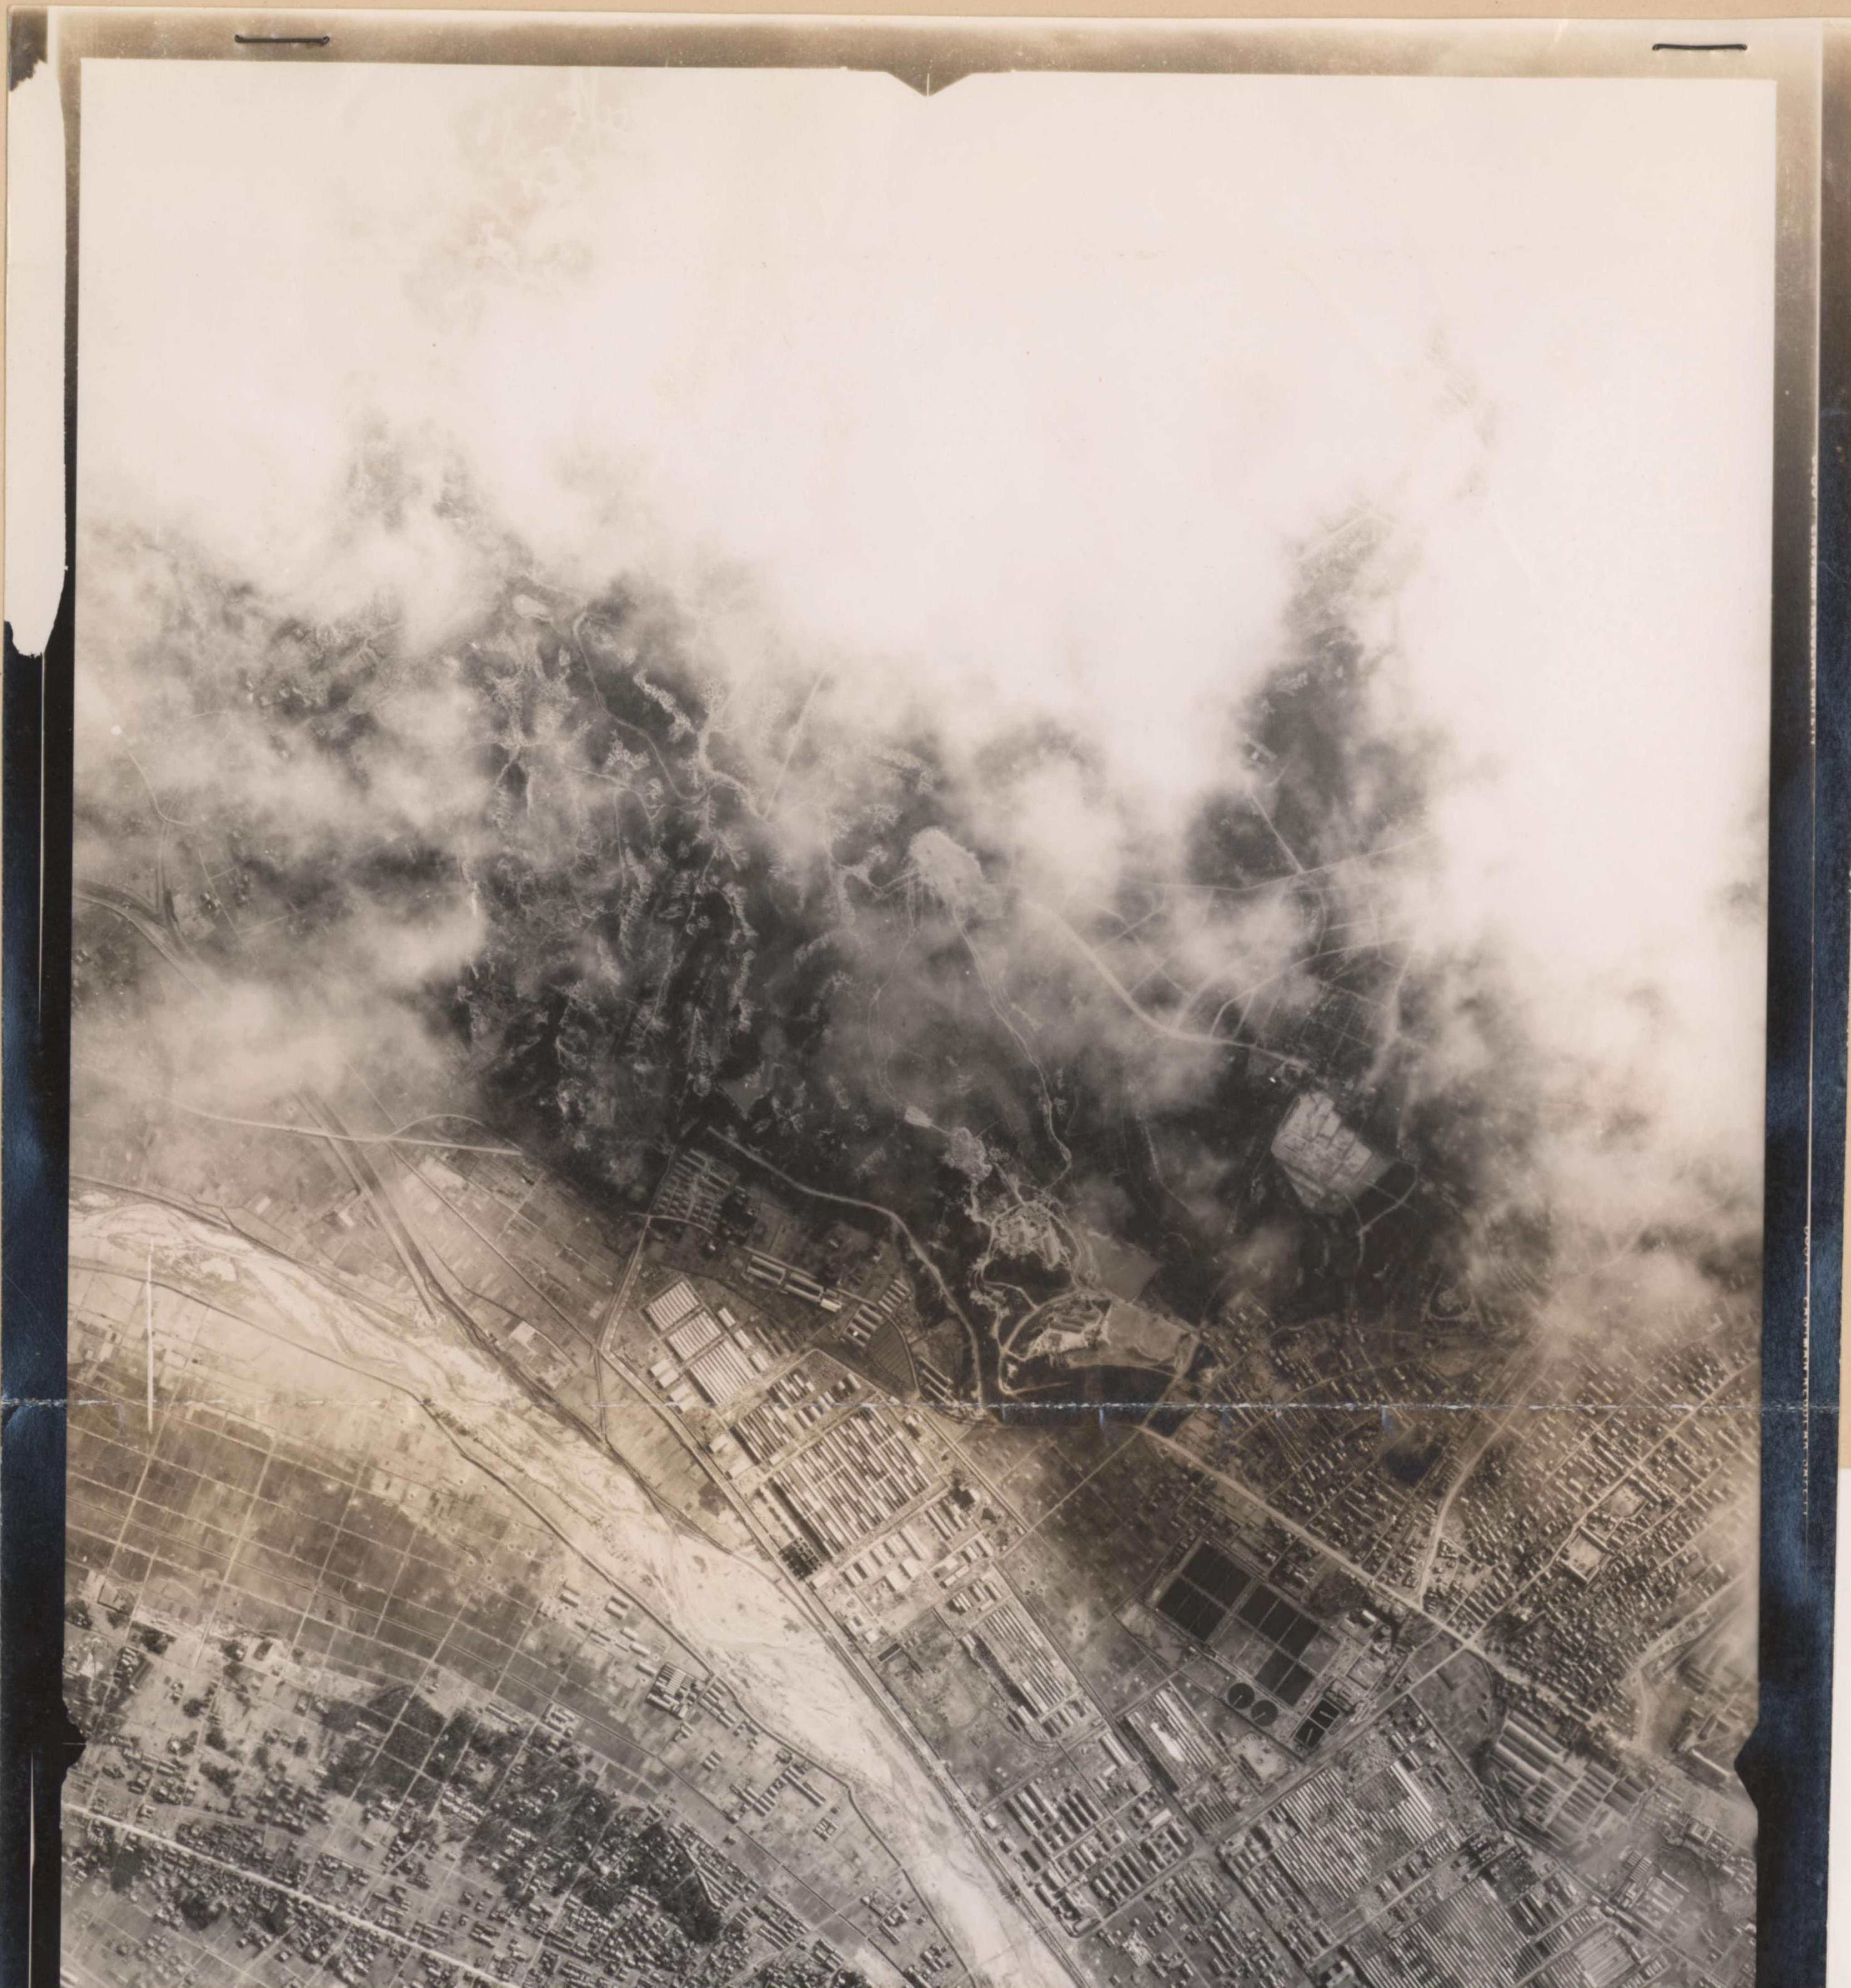
16  
(16PL875BS4606A/C4M4)(IV4)(12.22.1456)(12":23,000)(33°16'N-134°06'E)(MITSUBISHI A/C ENG.  
WORKS,NAGOYA)CONFIDENTIAL

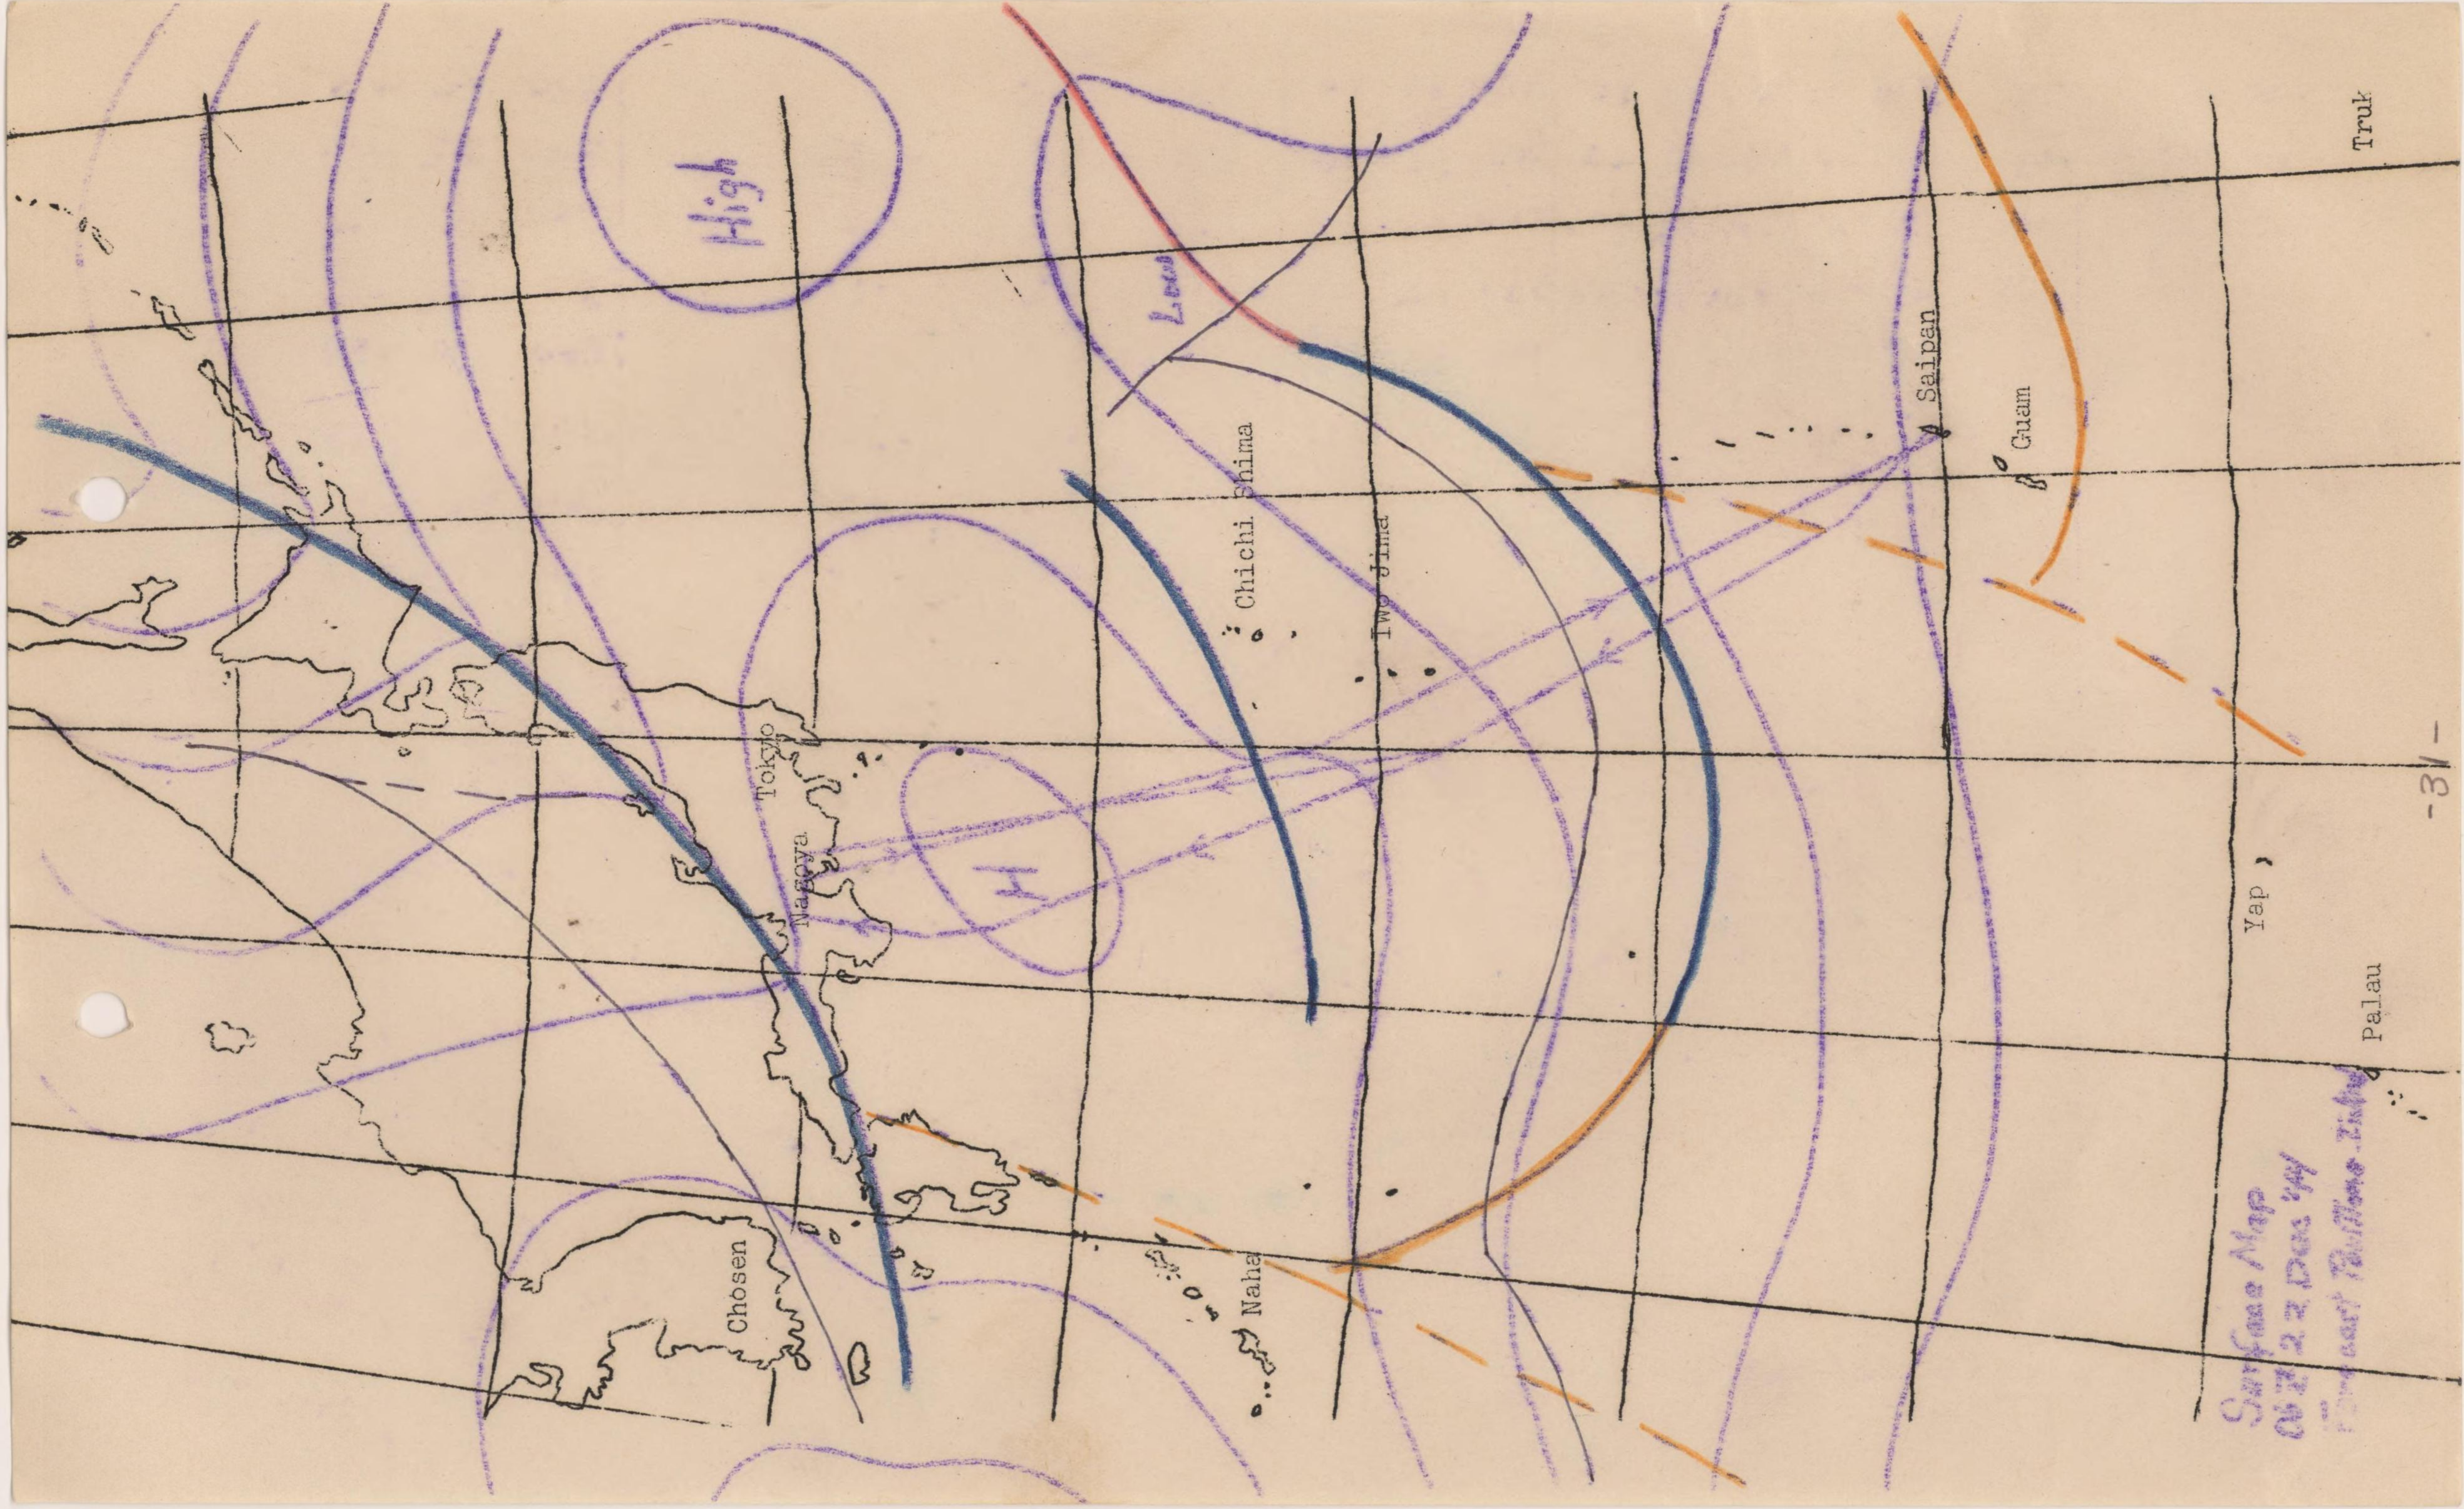
# Forecast 22 Dec '44

The forecast for this mission hinged on the position of the secondary cold front moving down over the empire from the north. The frontal system enroute was not very intense and it was quite certain that the low center would move well to the east of the route so that no trouble was anticipated from it. There was no evidence of anything that would cause poor weather at the base.

The mission encountered the front in approximately the forecast position the winds, however, did not back as far to the north as forecast as the low center to the east did not deepen as much as forecast. The front was not as intense as forecast and few middle clouds were observed as compared with those forecast.
