MISSION #10

OKAYAMA  
(FORMOSAO)

**XXB**OMBER **C**OMMAND  
 MISSION NO **10**  
 DATE **14 October 1944**

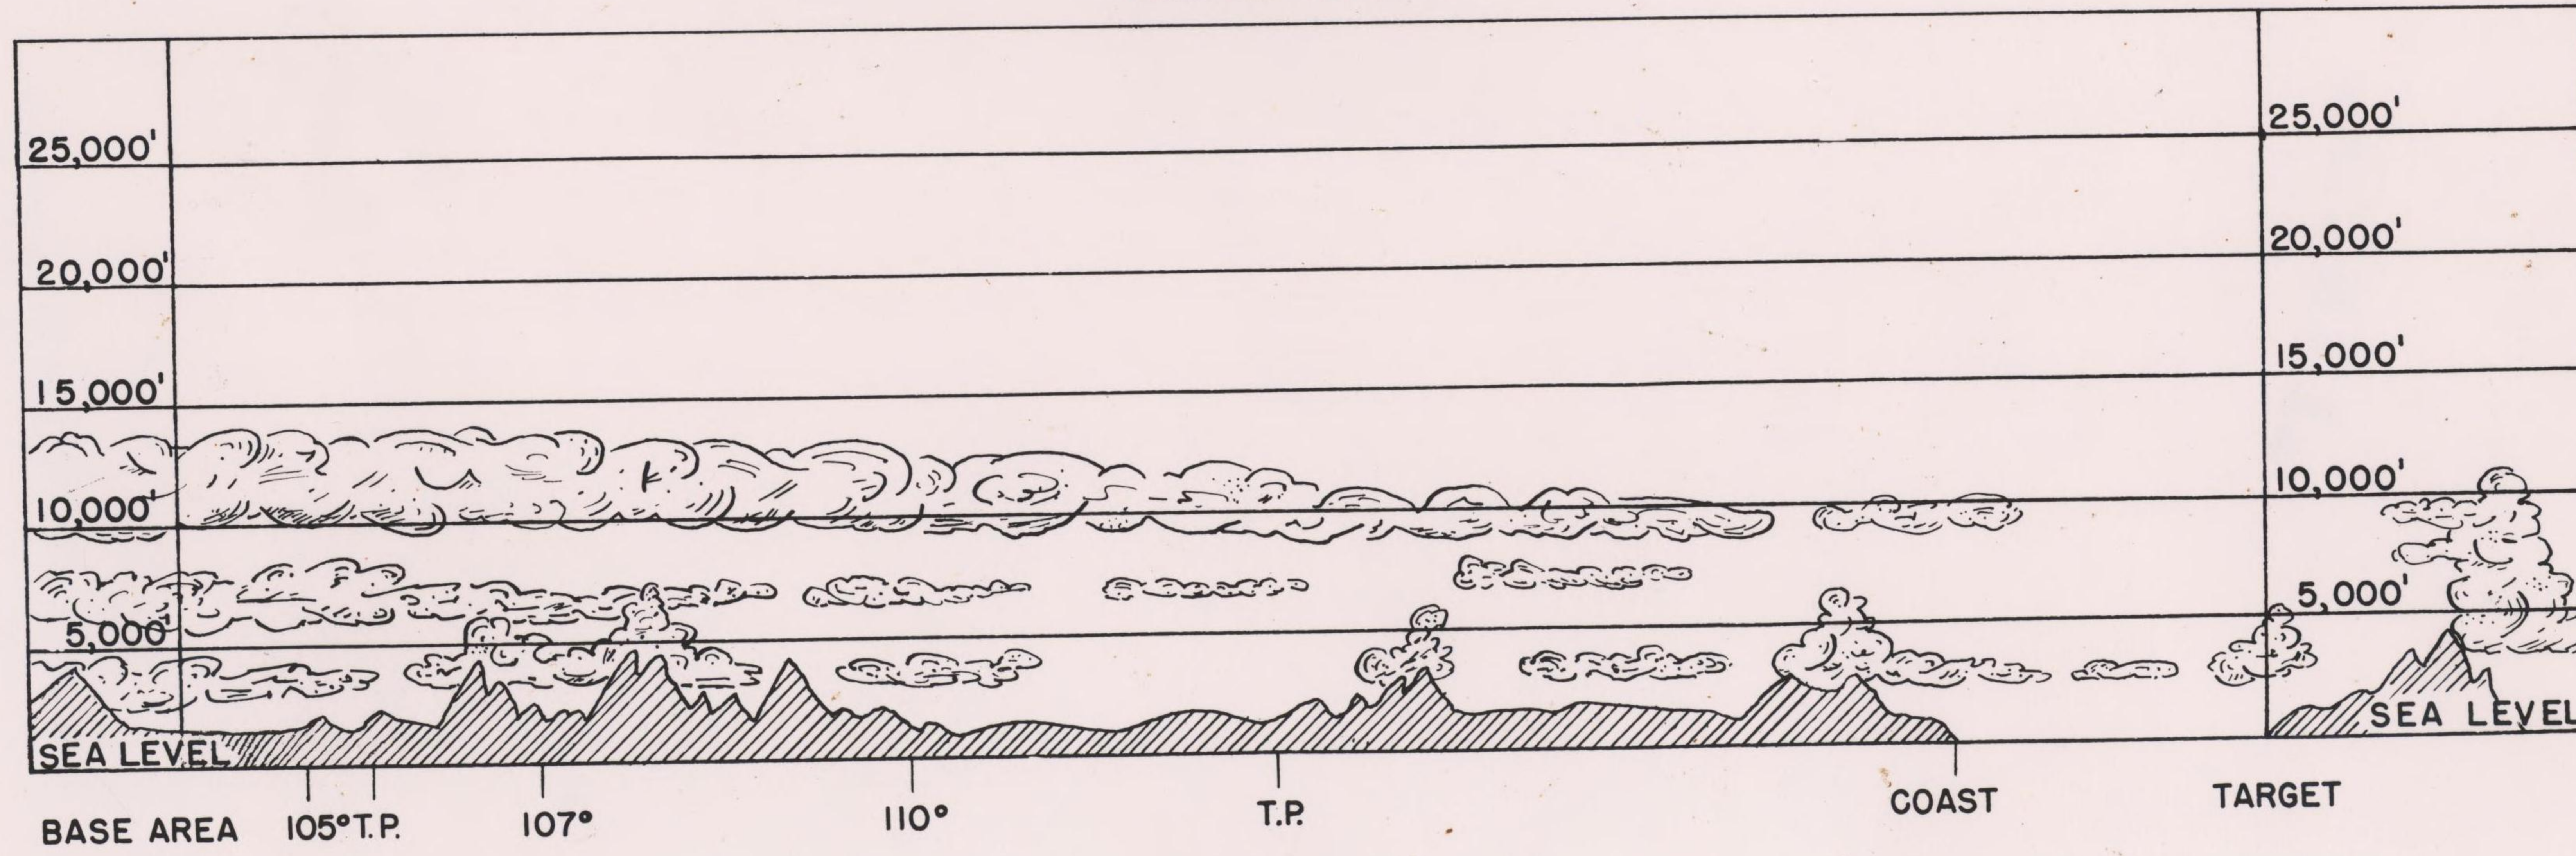
XX BOMBER COMMAND  
MISSION NO. 10  
14th OCTOBER, 1944  
WEATHER FORECAST

As Forecast	As Encountered
Base (Take-off)	3000' overcast top 5000'; 6000' overcast top 8500'; 10,000' overcast top 15,000'. Light drizzle. Vsby 1 1/2 miles in light drizzle and light fog. Moderate to heavy rime icing above 10,000	Hsinching: Broken Strato-cumulus, base 4000', top 5000'. Stratus overcast base 6000', top at 7500'. Altostratus overcast, base 10,000', top 15,000'. Vsby 6 miles. Kwanghan: 3000' broken with thin overcast at 9000'. Vsby 5 miles. <b>Kunglai:</b> Overcast at 2500' with scattered scud at 500'. Breaks in overcast. Vsby 6 miles in haze. Wind light and variable. Pengshan: Overcast at 3500' lifting and breaking rapidly. Vsby 5 miles. Wind N. 5 MPH.
Base To 110° E	Similar cloud and icing conditions except occasional cumuli-form clouds in hills, tops at 9000'. Light intermittent drizzle.	Scattered to broken strato-cumulus 2500', top 3000' locally. Stratus overcast base 3500', top 7500' with occasional breaks and which became nil at 106°E but was replaced by broken cumulus or stratocumulus base 4000' top 7000'-8000'. Beyond 108°E broken stratocumulus base 4000', top 5000' becoming scattered stratus or stratocumulus at coast. Second layer was an altostratus overcast, base 10,000', top 14,000' which persisted to 112°E where it was replaced by a scattered to broken layer of altostratus, base 13,000', top 14,000' which in turn became nil at 116.50°E. Between 108 and 116°E there was a broken layer of altostratus, base 9000', tops frequently merging with layer at 10,000'. Another layer of broken to overcast altostratus base 17,000', top 19,000' between 105°E and 114°E. Another layer of scattered to broken cirrus, base 26,000' between 113°E and target.

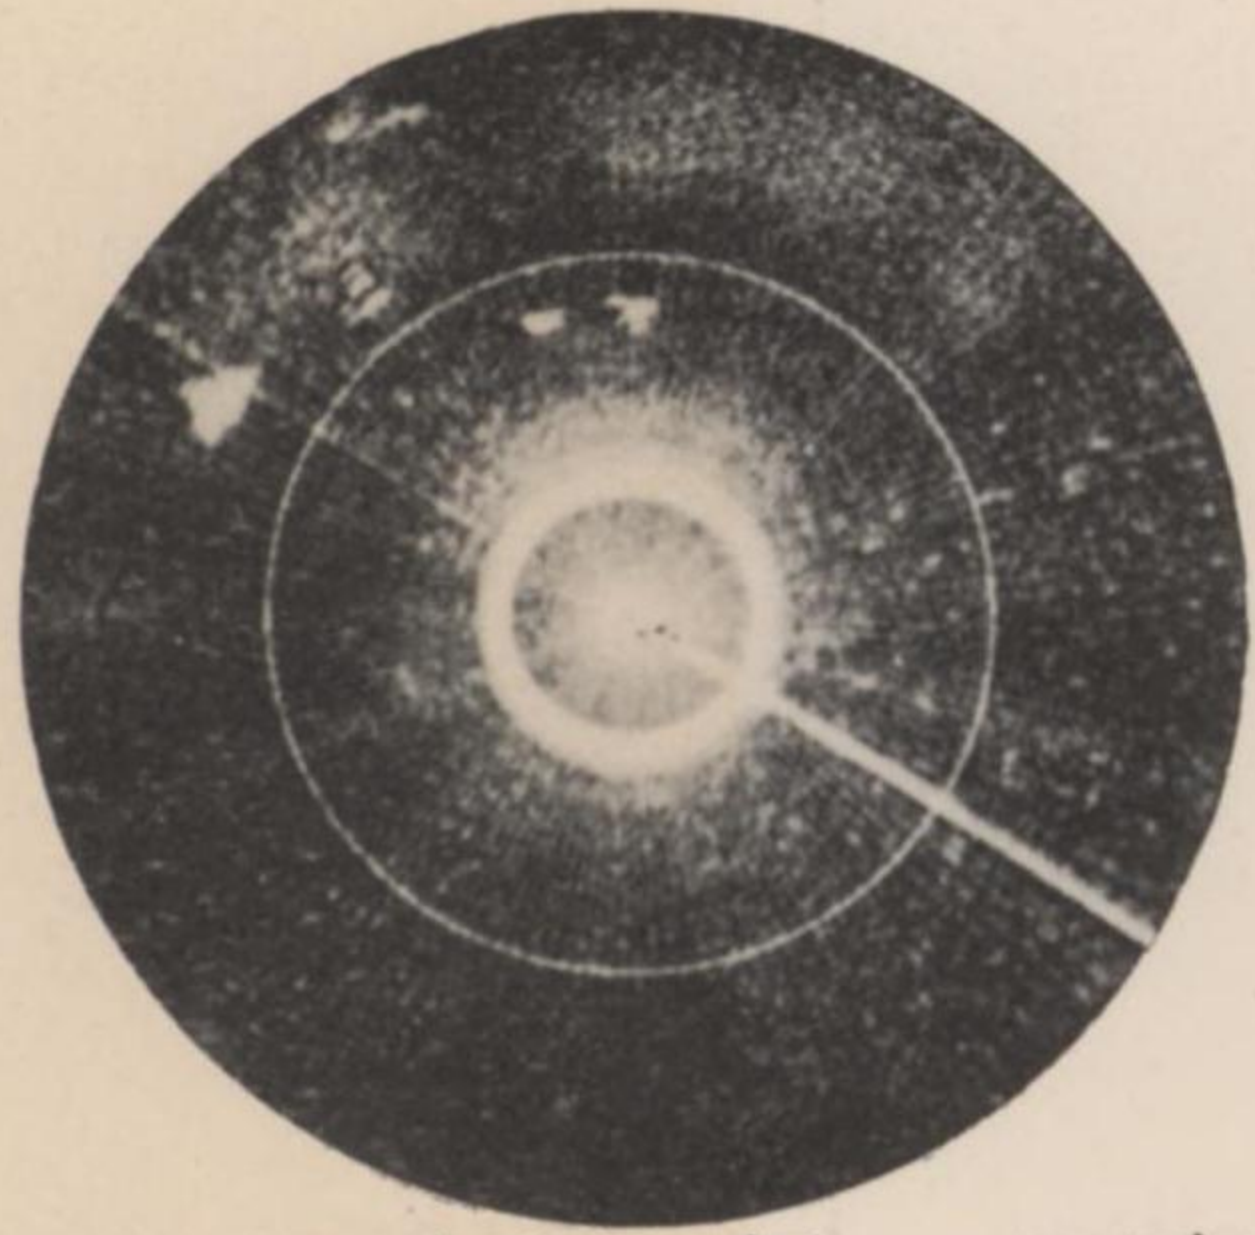
23°06'N  
119°39'E

COURSE 123°11'M (122°00'T)  
SWEEP 20 MILES  
ALTITUDE: 25,400'

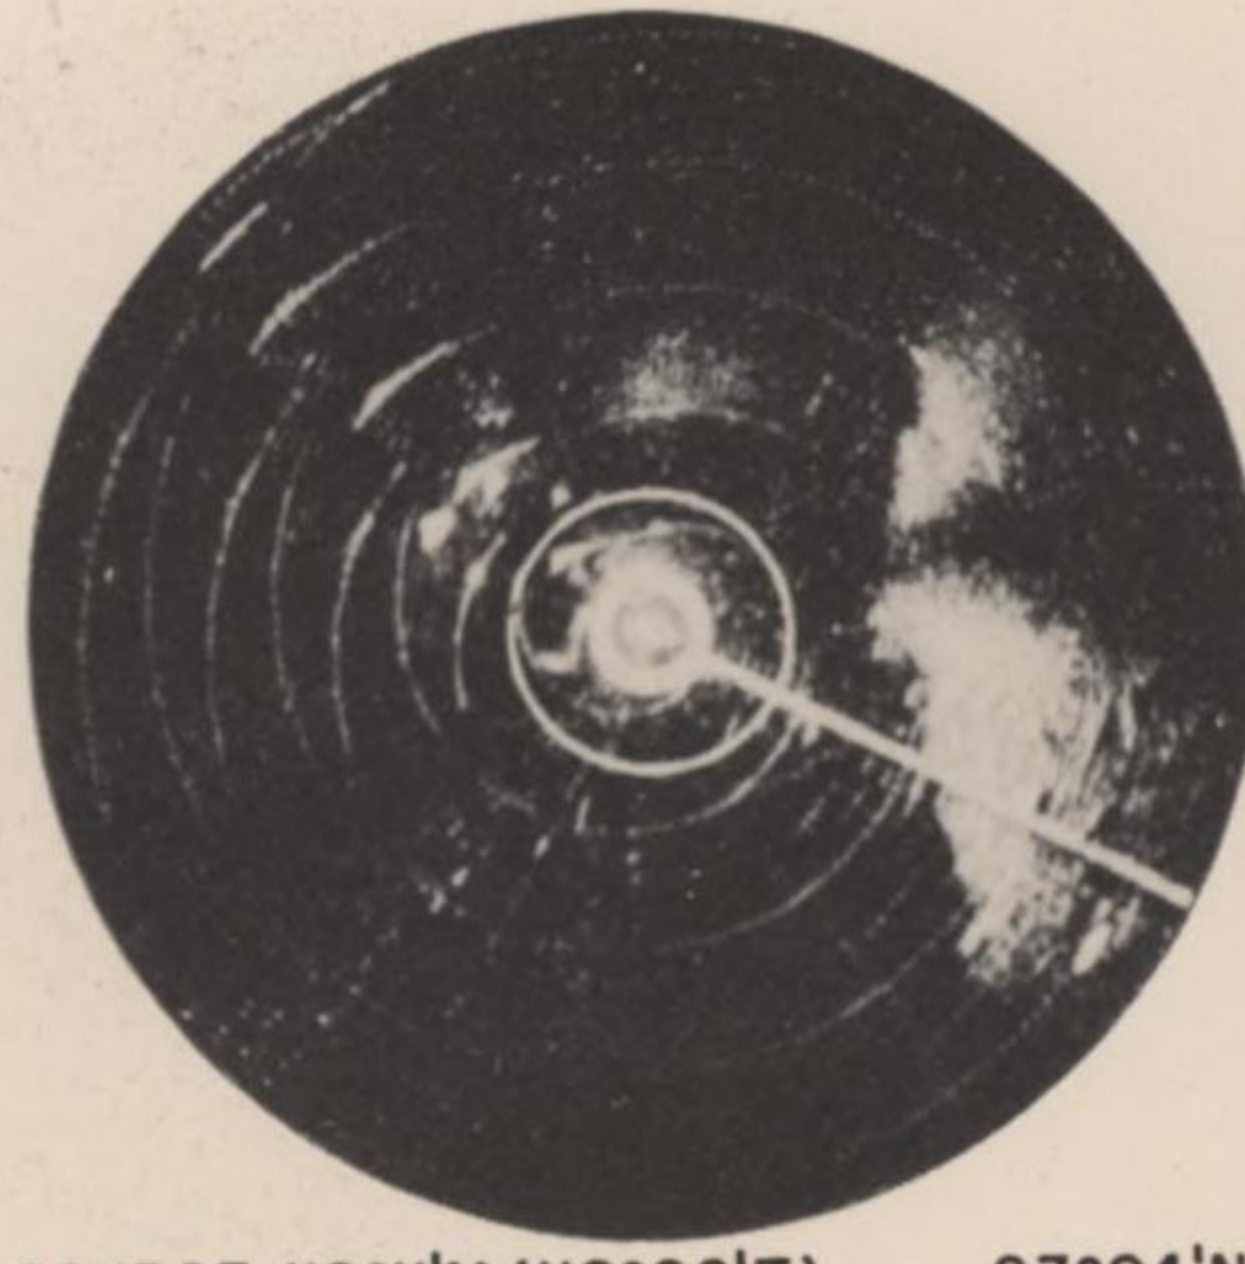
23°04'N  
119°43'E

COURSE 119°11'M (118°00'T)  
SWEEP 50 MILES  
ALTITUDE: 25,400'

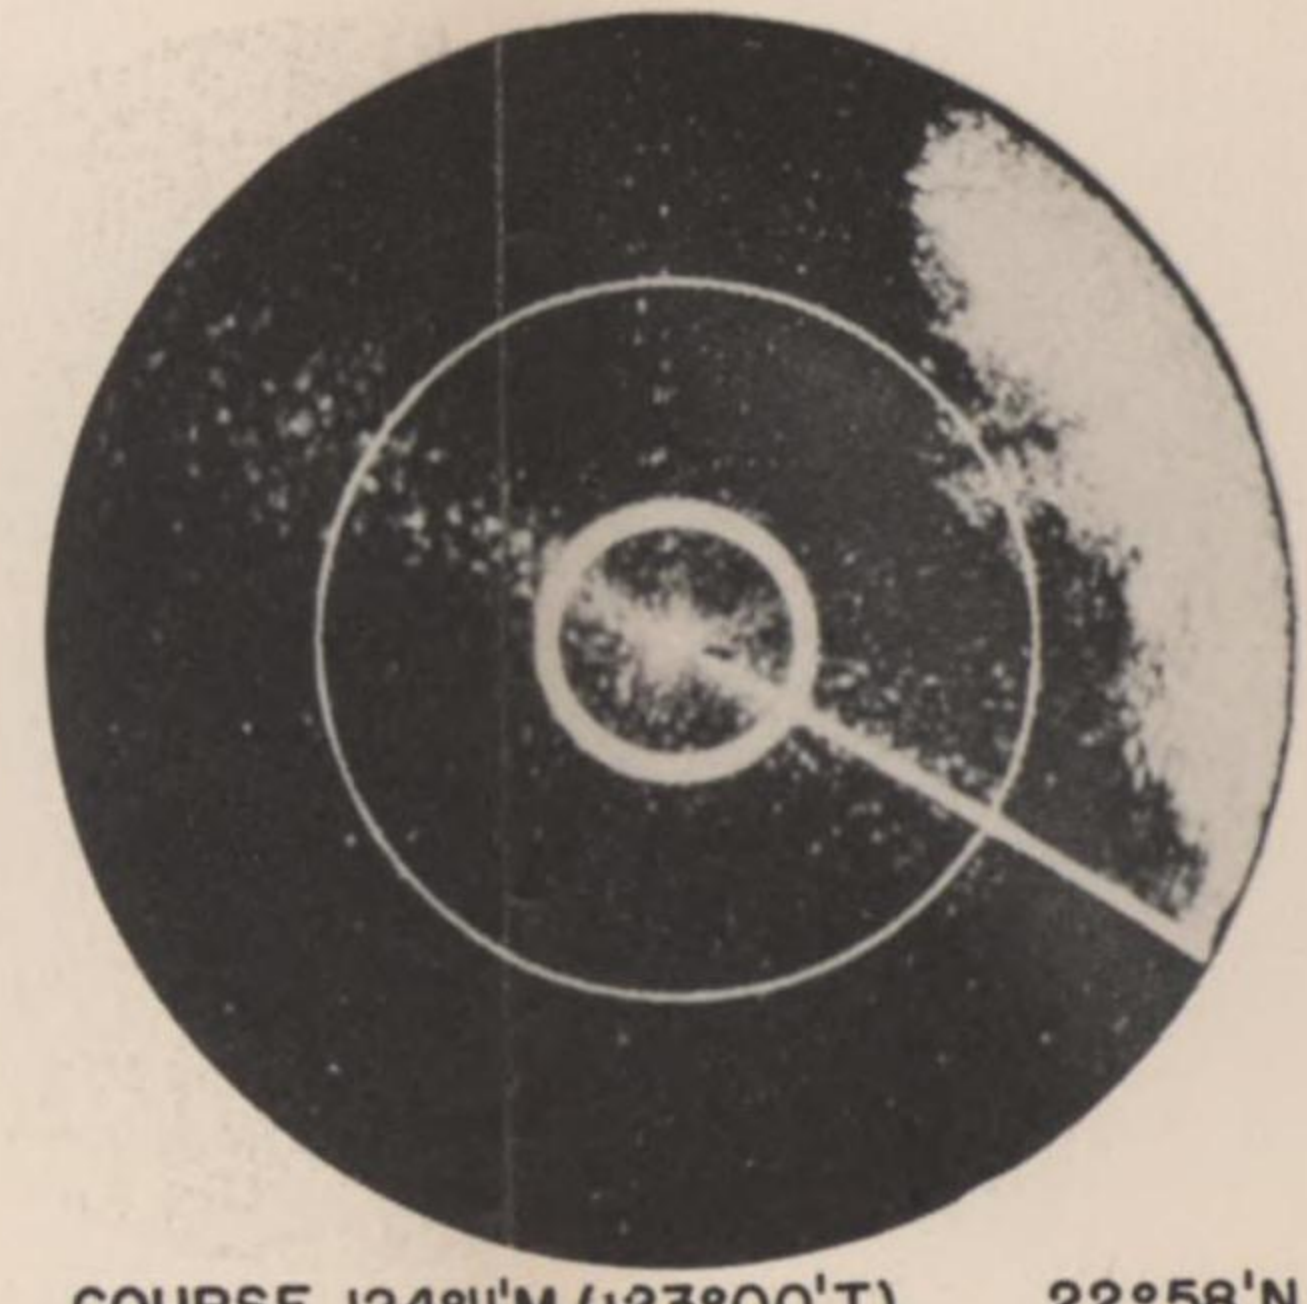
22°58'N  
119°55'E

COURSE 124°11'M (123°00'T)  
SWEEP 20 MILES  
ALTITUDE: 25,400'

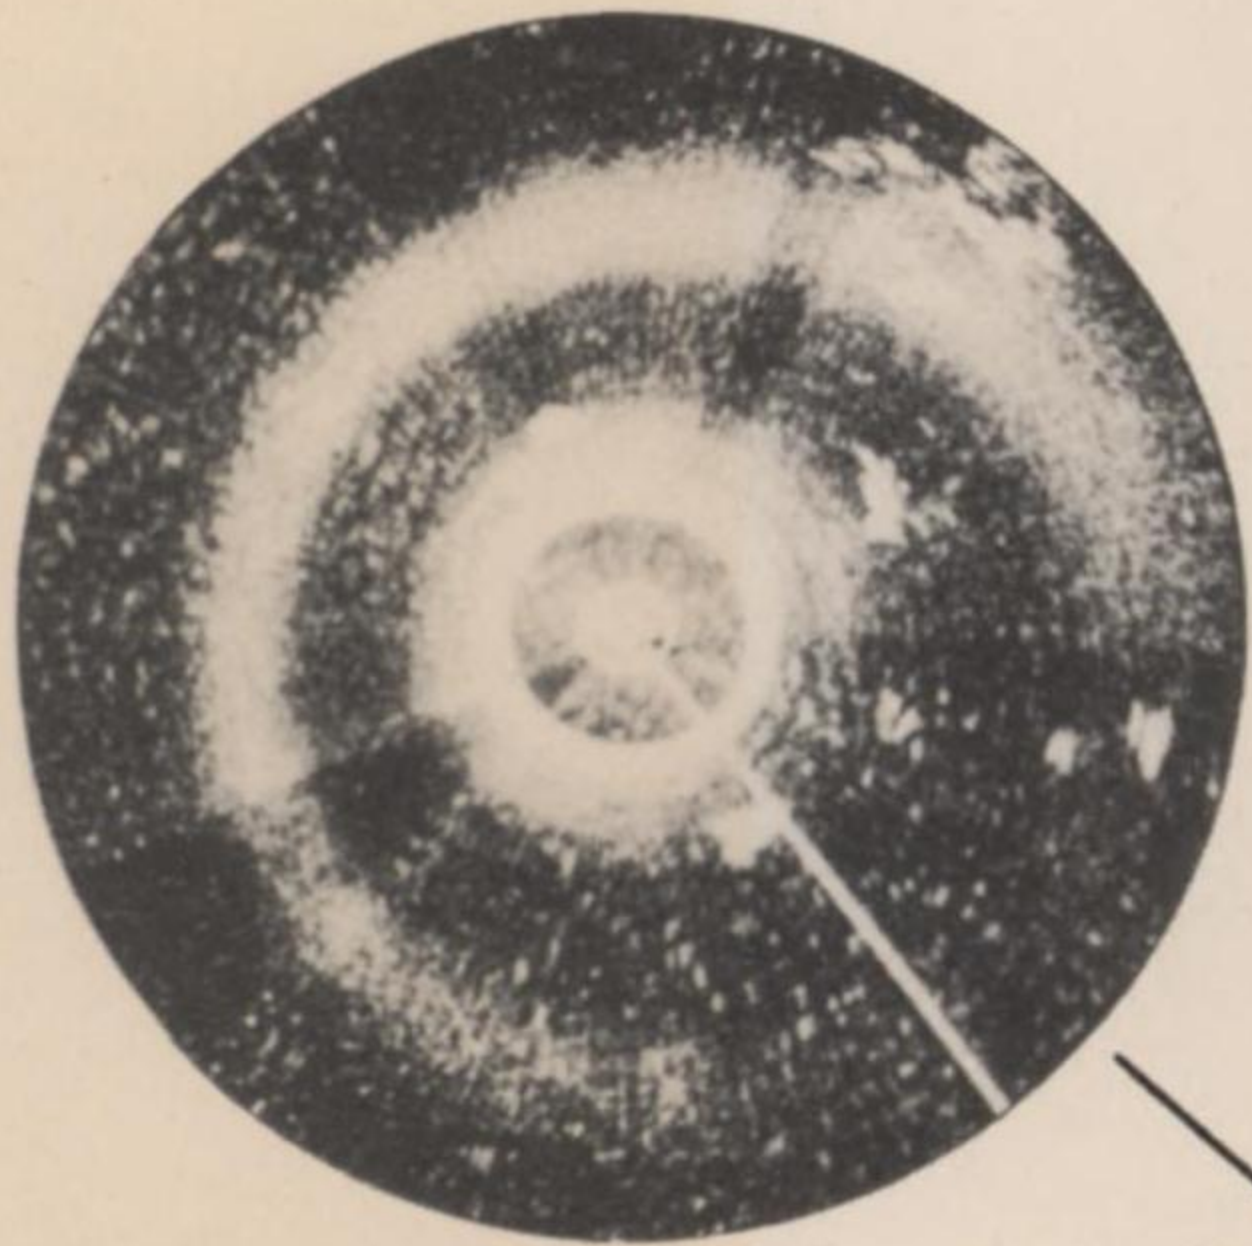
23°18'N  
119°22'E

COURSE 143°11'M (142°00'T)  
SWEEP 20 MILES  
ALTITUDE: 25,400'

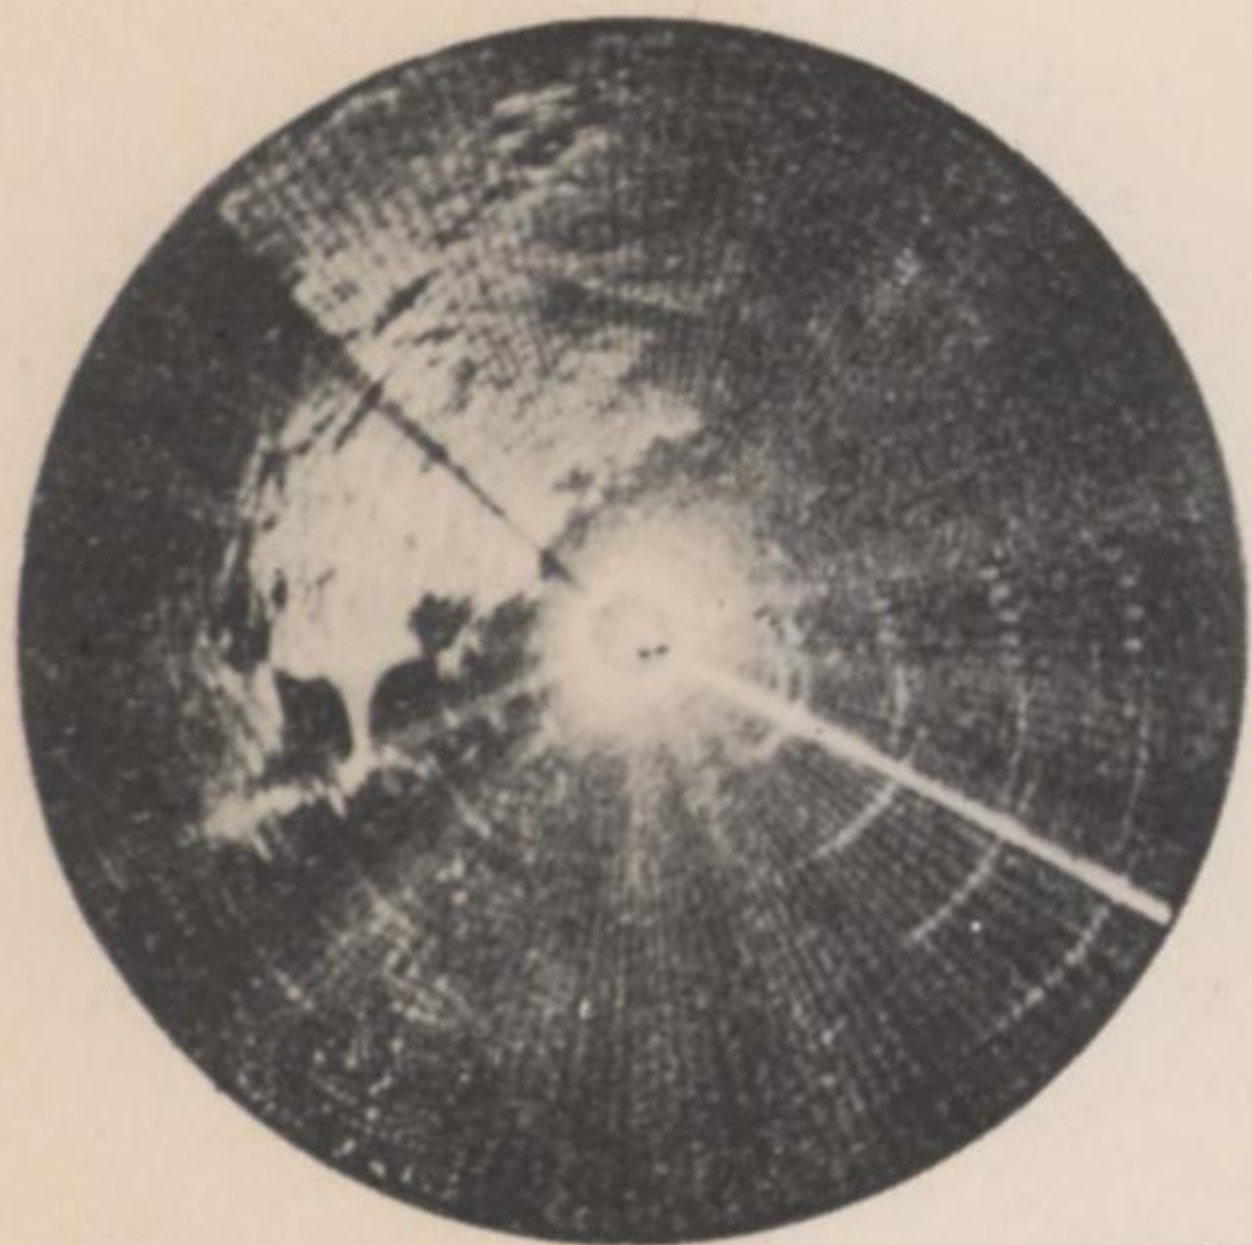
23°57'N  
118°03'E

COURSE 121°11'M (120°00'T)  
SWEEP 50 MILES  
ALTITUDE: 25,000'

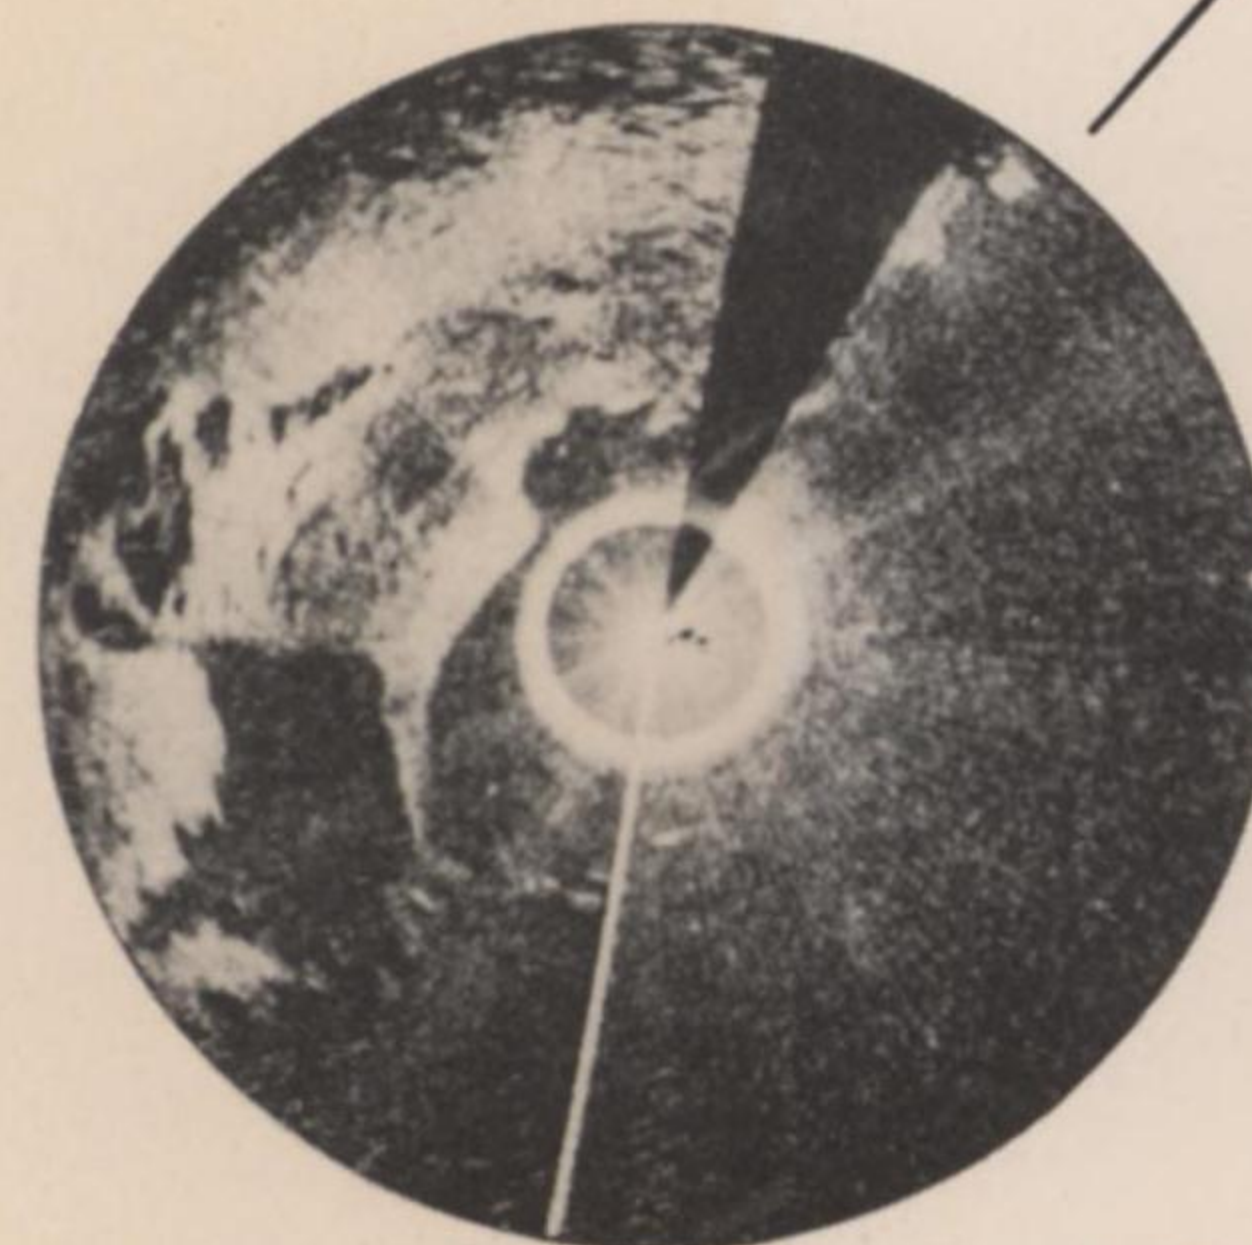
23°55'N  
117°43'E

COURSE 191°11'M (190°00'T)  
SWEEP 20 MILES  
ALTITUDE: 23,500'

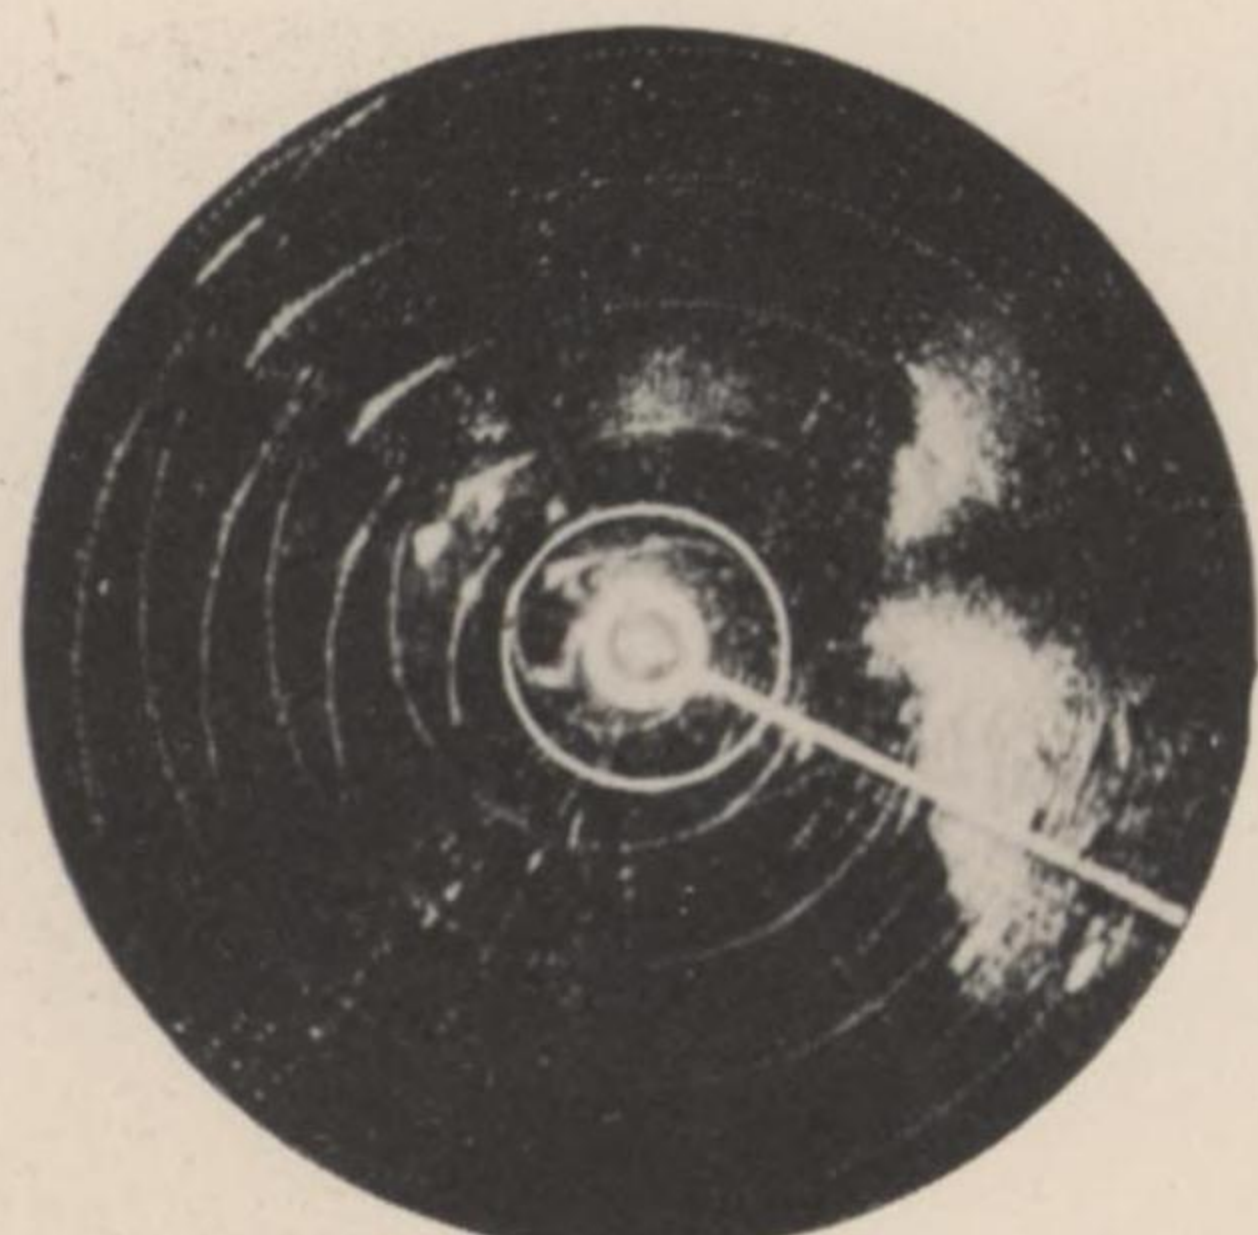
23°04'N  
119°43'E

COURSE 119°11'M (118°00'T)  
SWEEP 50 MILES  
ALTITUDE: 25,400'

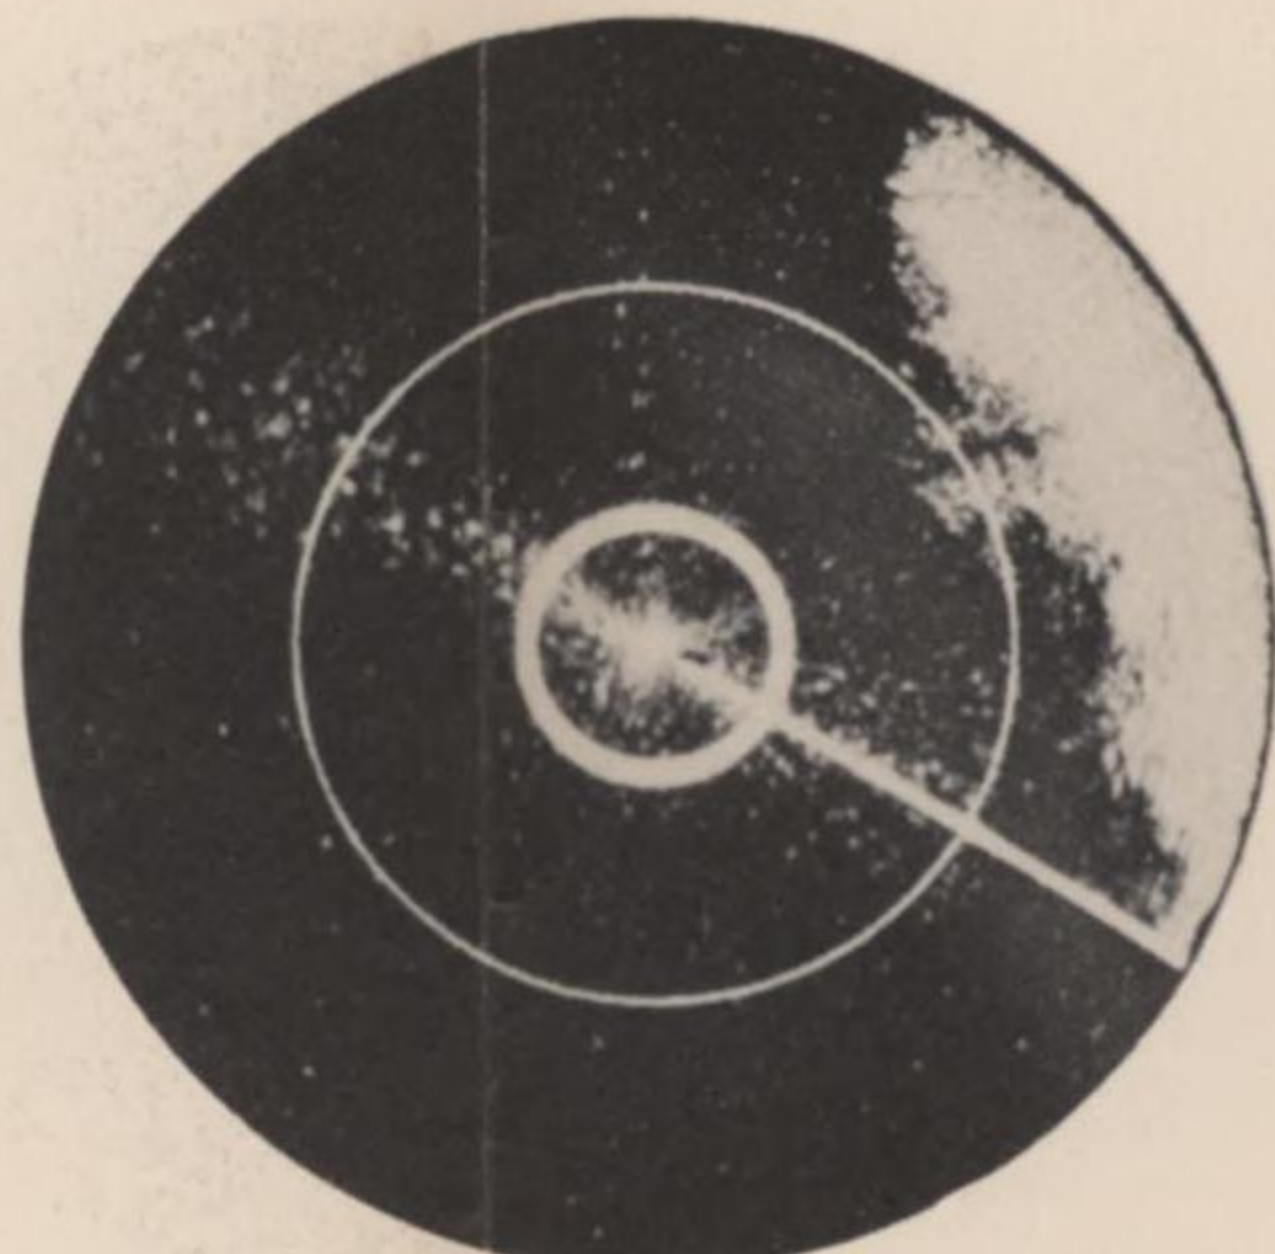
22°58'N  
119°55'E

COURSE 124°11'M (123°00'T)  
SWEEP 20 MILES  
ALTITUDE: 25,400'

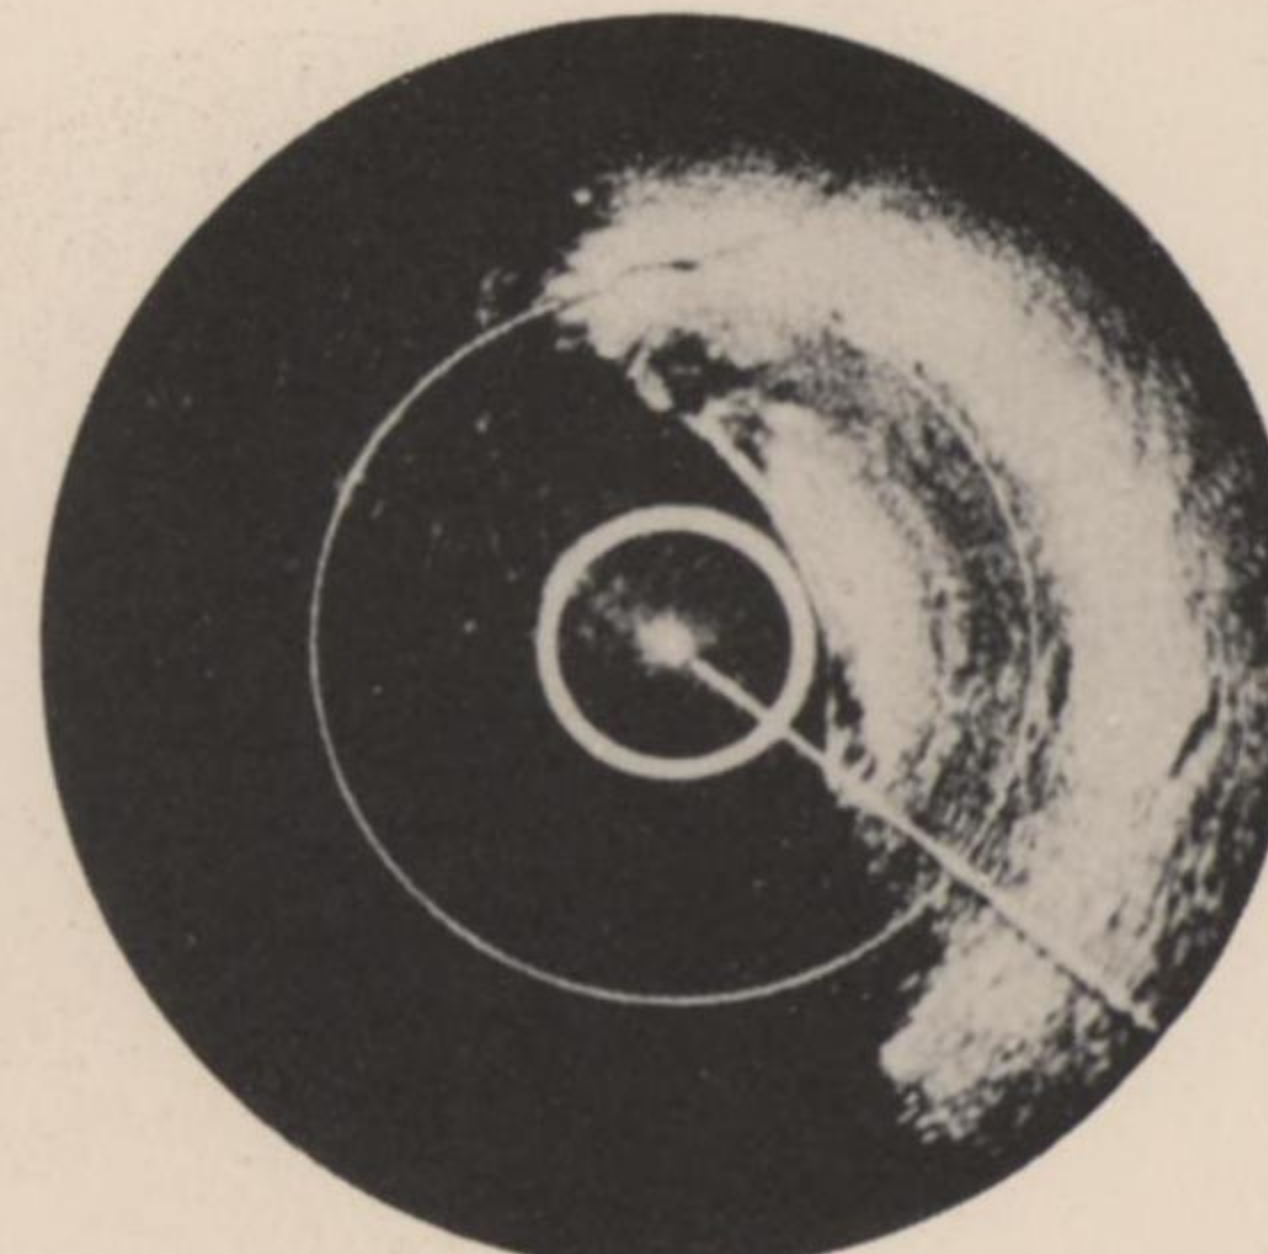
22°53'N  
120°07'E

COURSE 130°11'M (129°00'T)  
SWEEP 20 MILES  
ALTITUDE: 25,400'

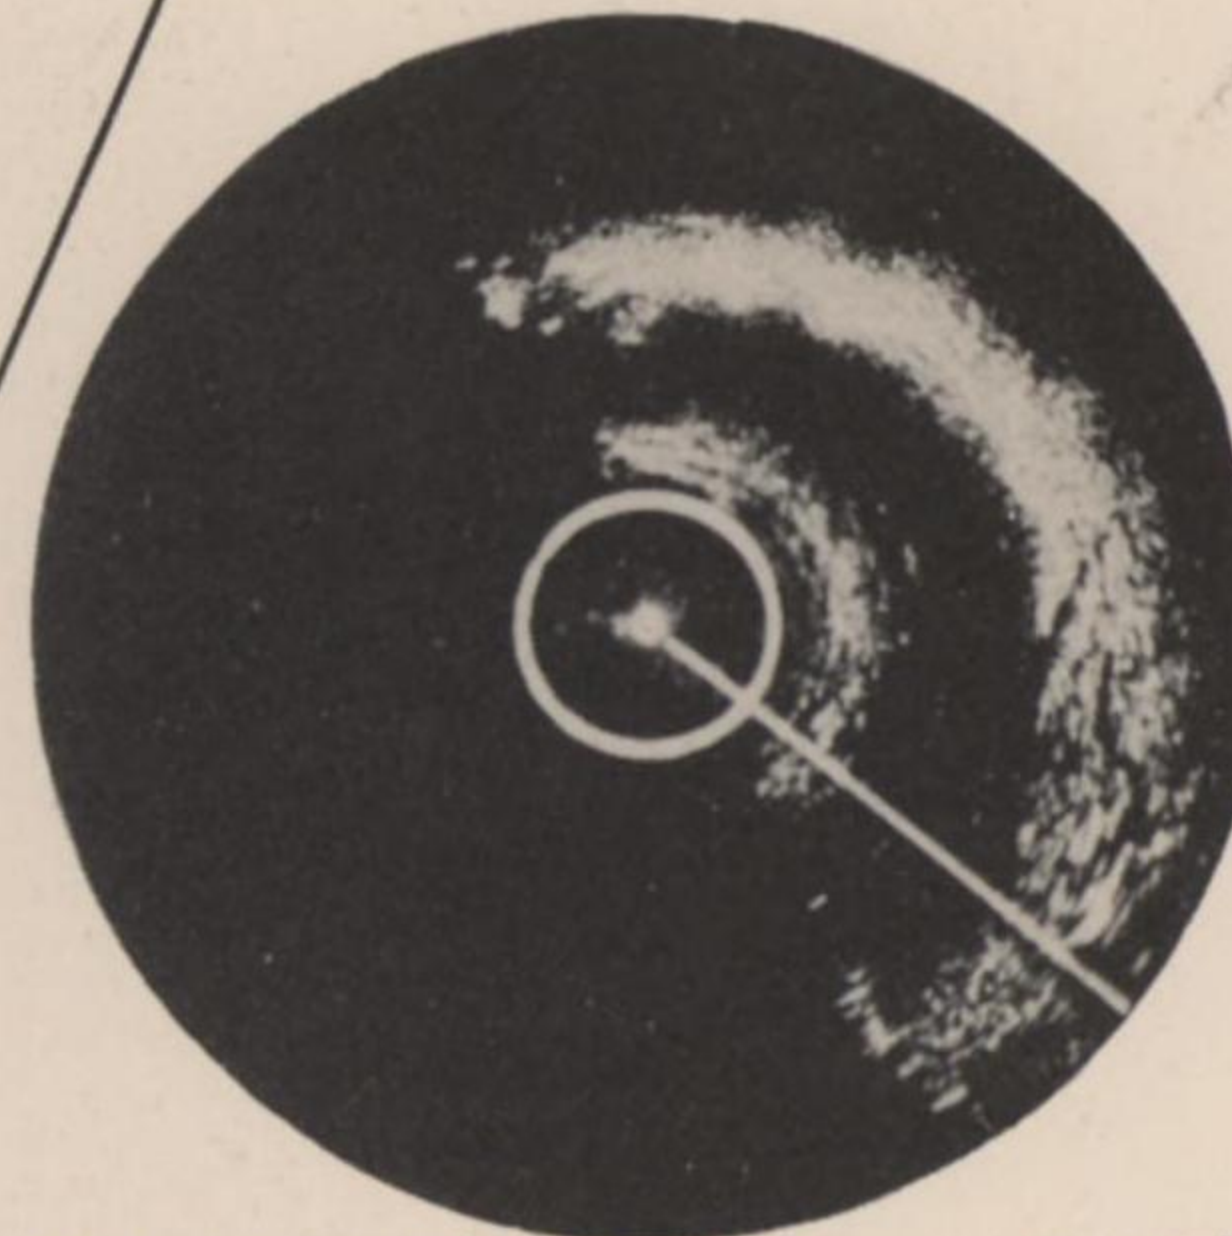
22°50'N  
120°12'E

COURSE 130°11'M (129°00'T)  
SWEEP 20 MILES  
ALTITUDE: 25,400'

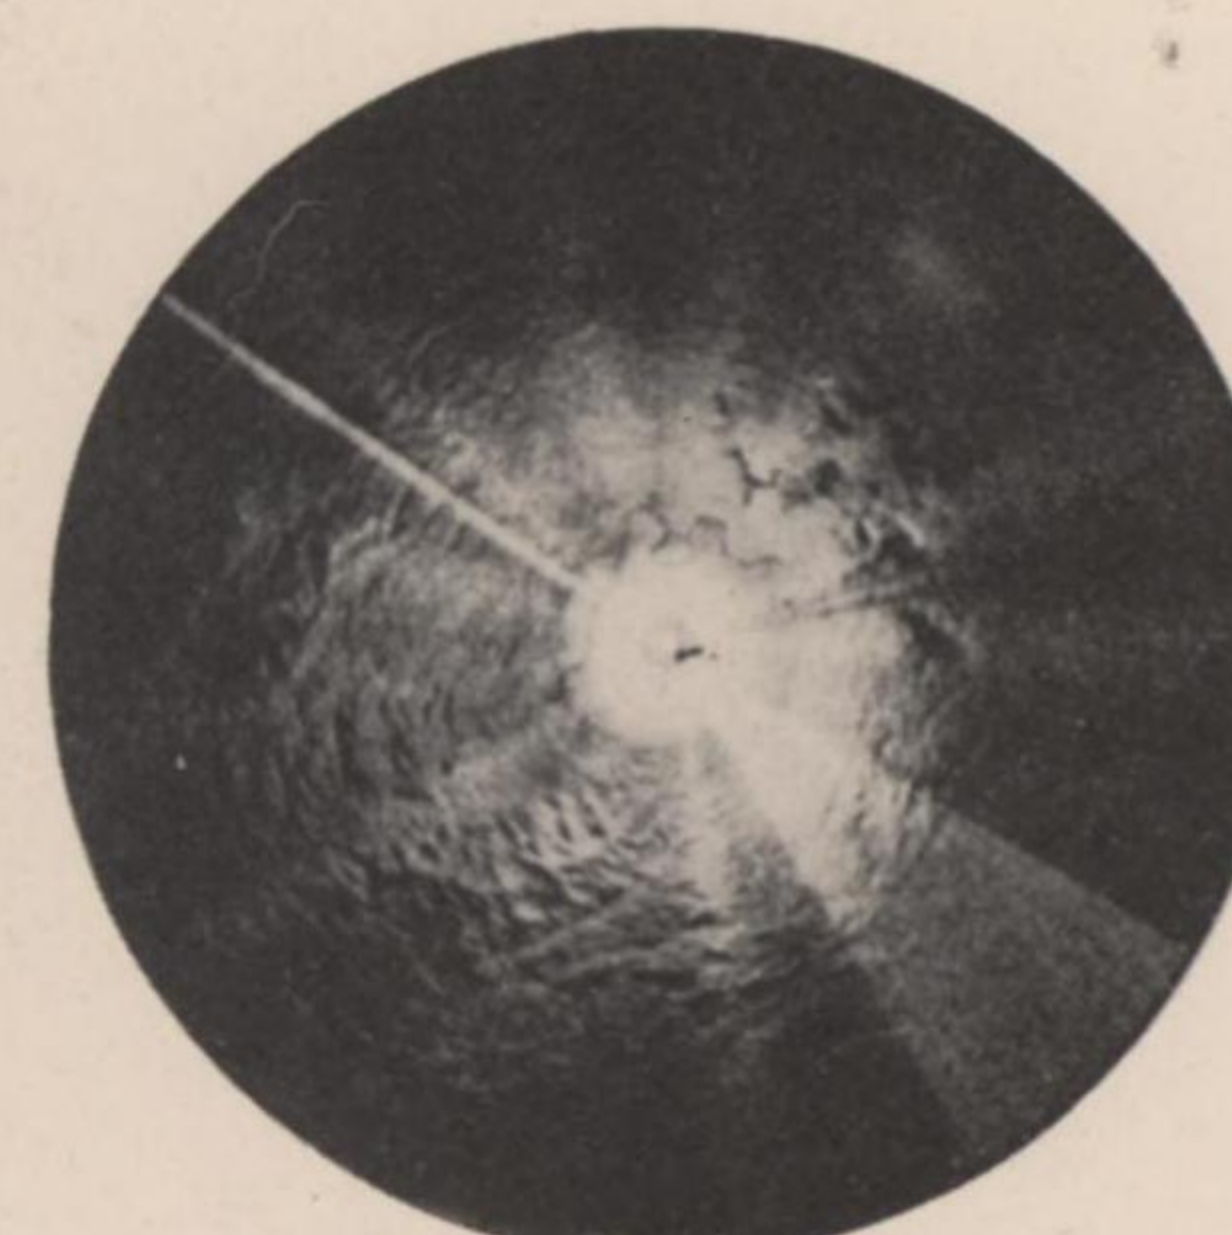
28°42'N  
111°31'E

COURSE 306°11'M (305°00'T)  
SWEEP 50 MILES  
ALTITUDE: 15,000'

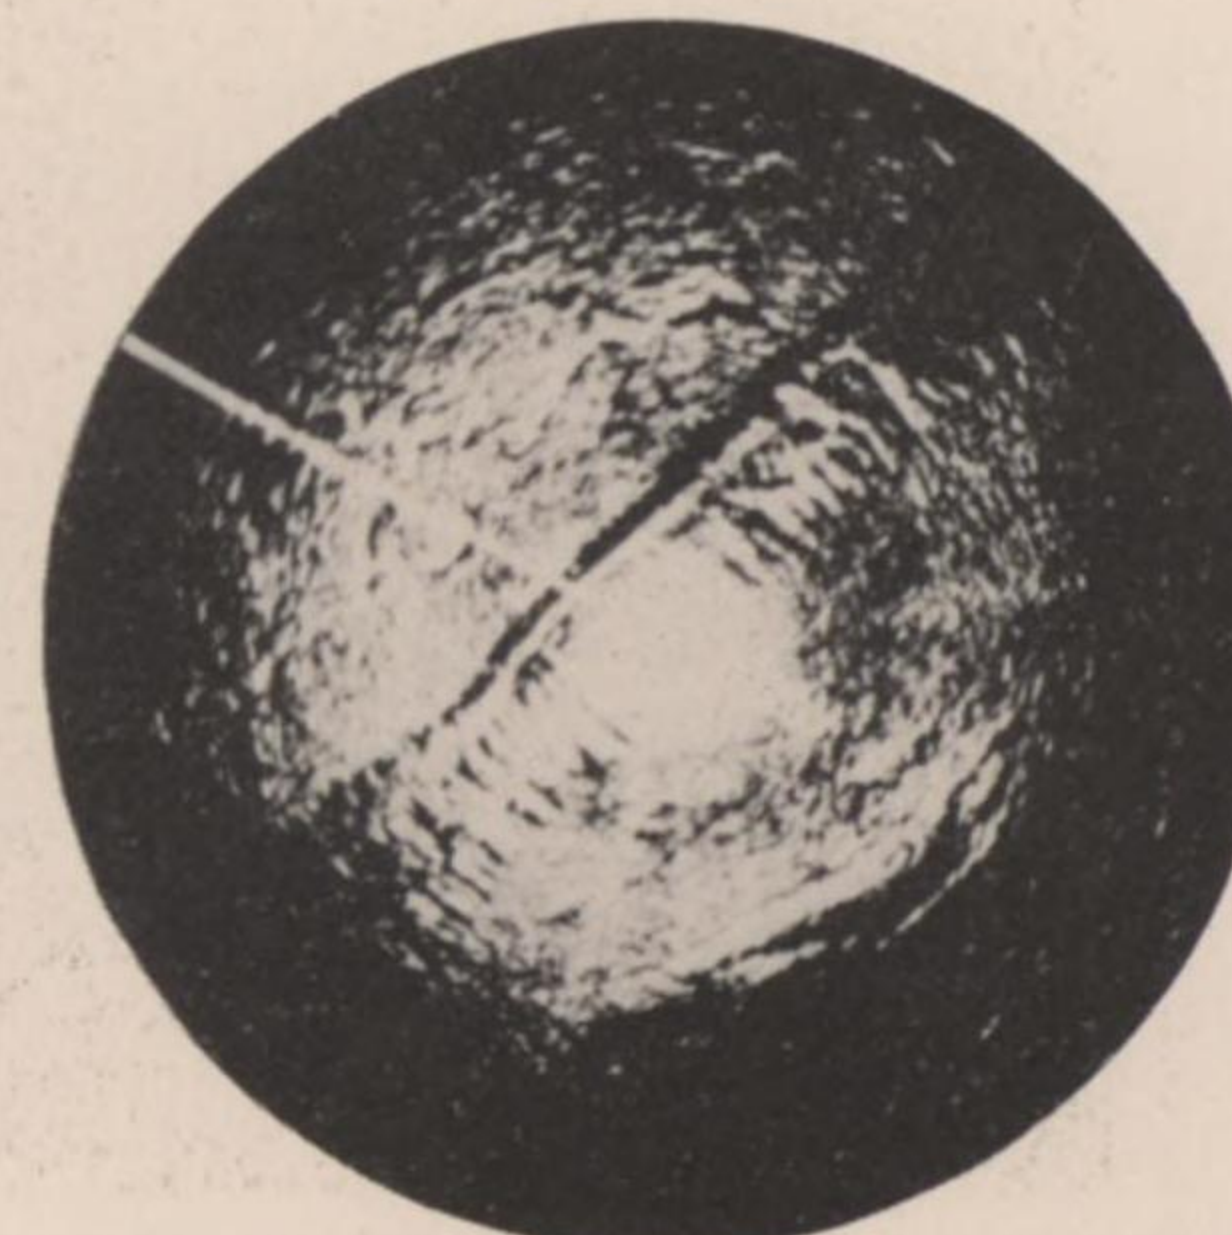
30°18'N  
108°25'E

COURSE 301°11'M (300°00'T)  
SWEEP 20 MILES  
ALTITUDE: 11,000'
