MISSION #10

OKAYAMA  
(FORMOSAO)

**XXB**OMBER **C**OMMAND  
 MISSION NO **10**  
 DATE **14 October 1944**

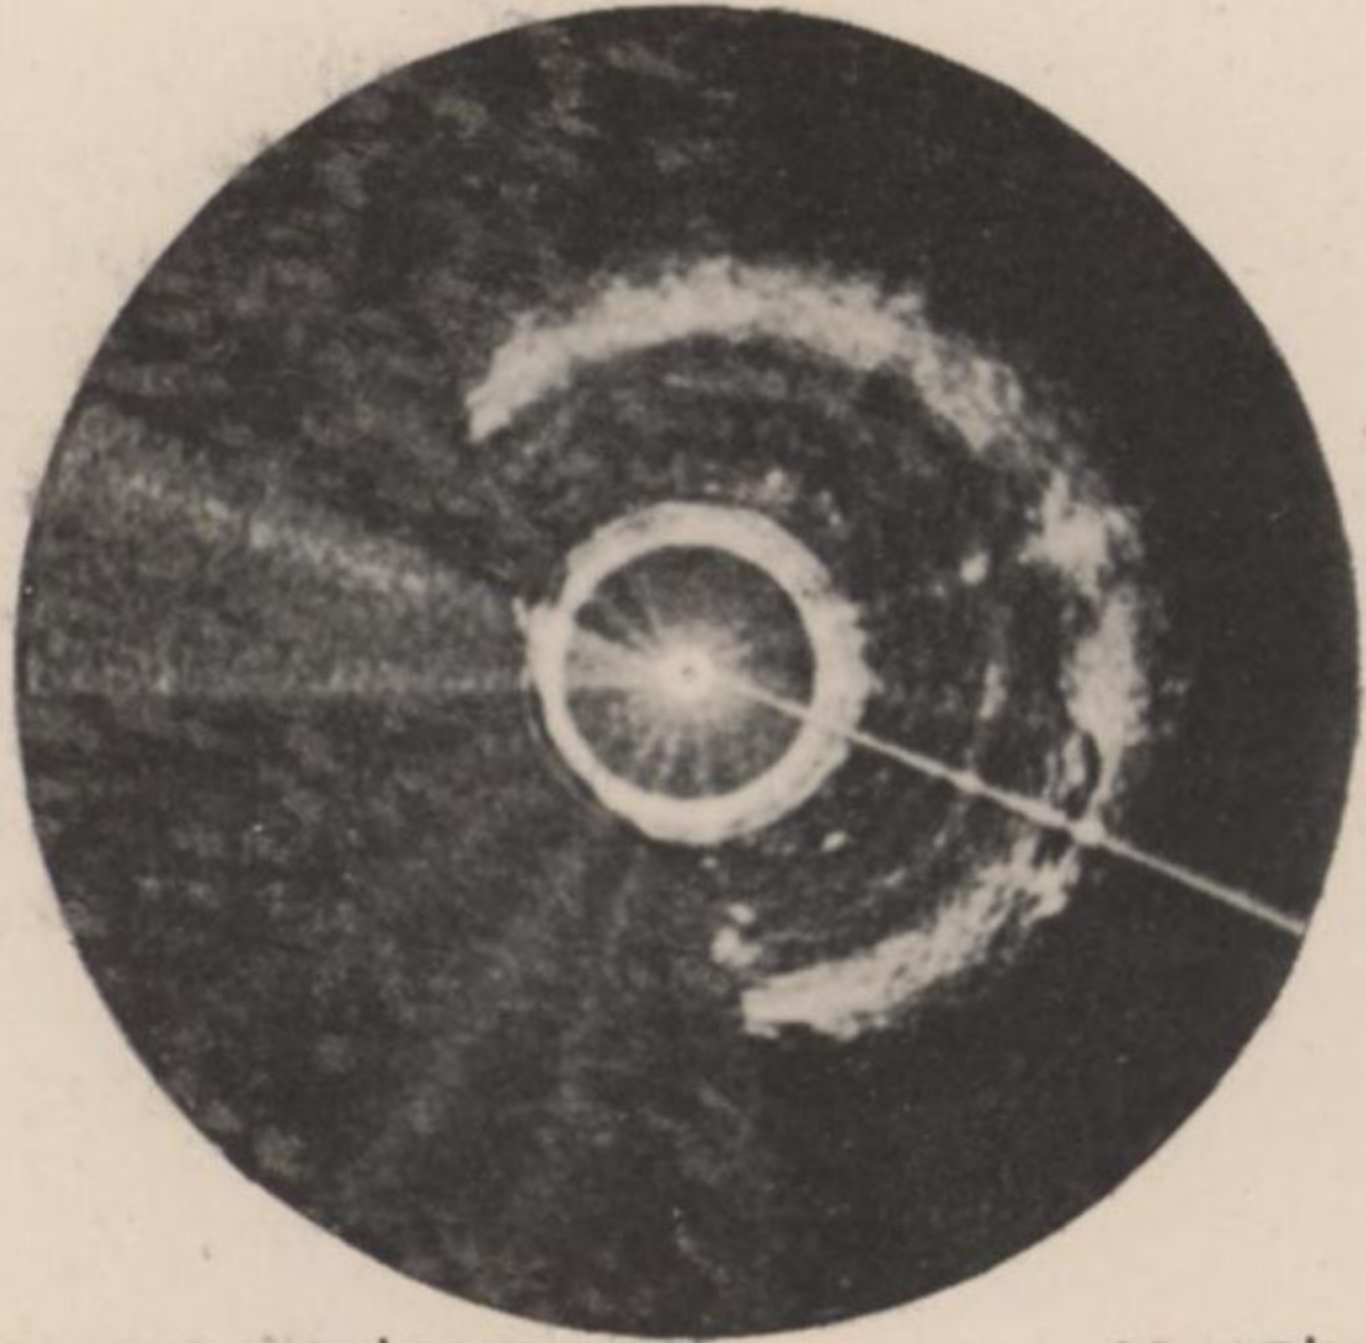
22°47'N  
120°15'E

COURSE 114°11'M (113°00'T)  
SWEEP 20 MILES  
ALTITUDE: 25,000'

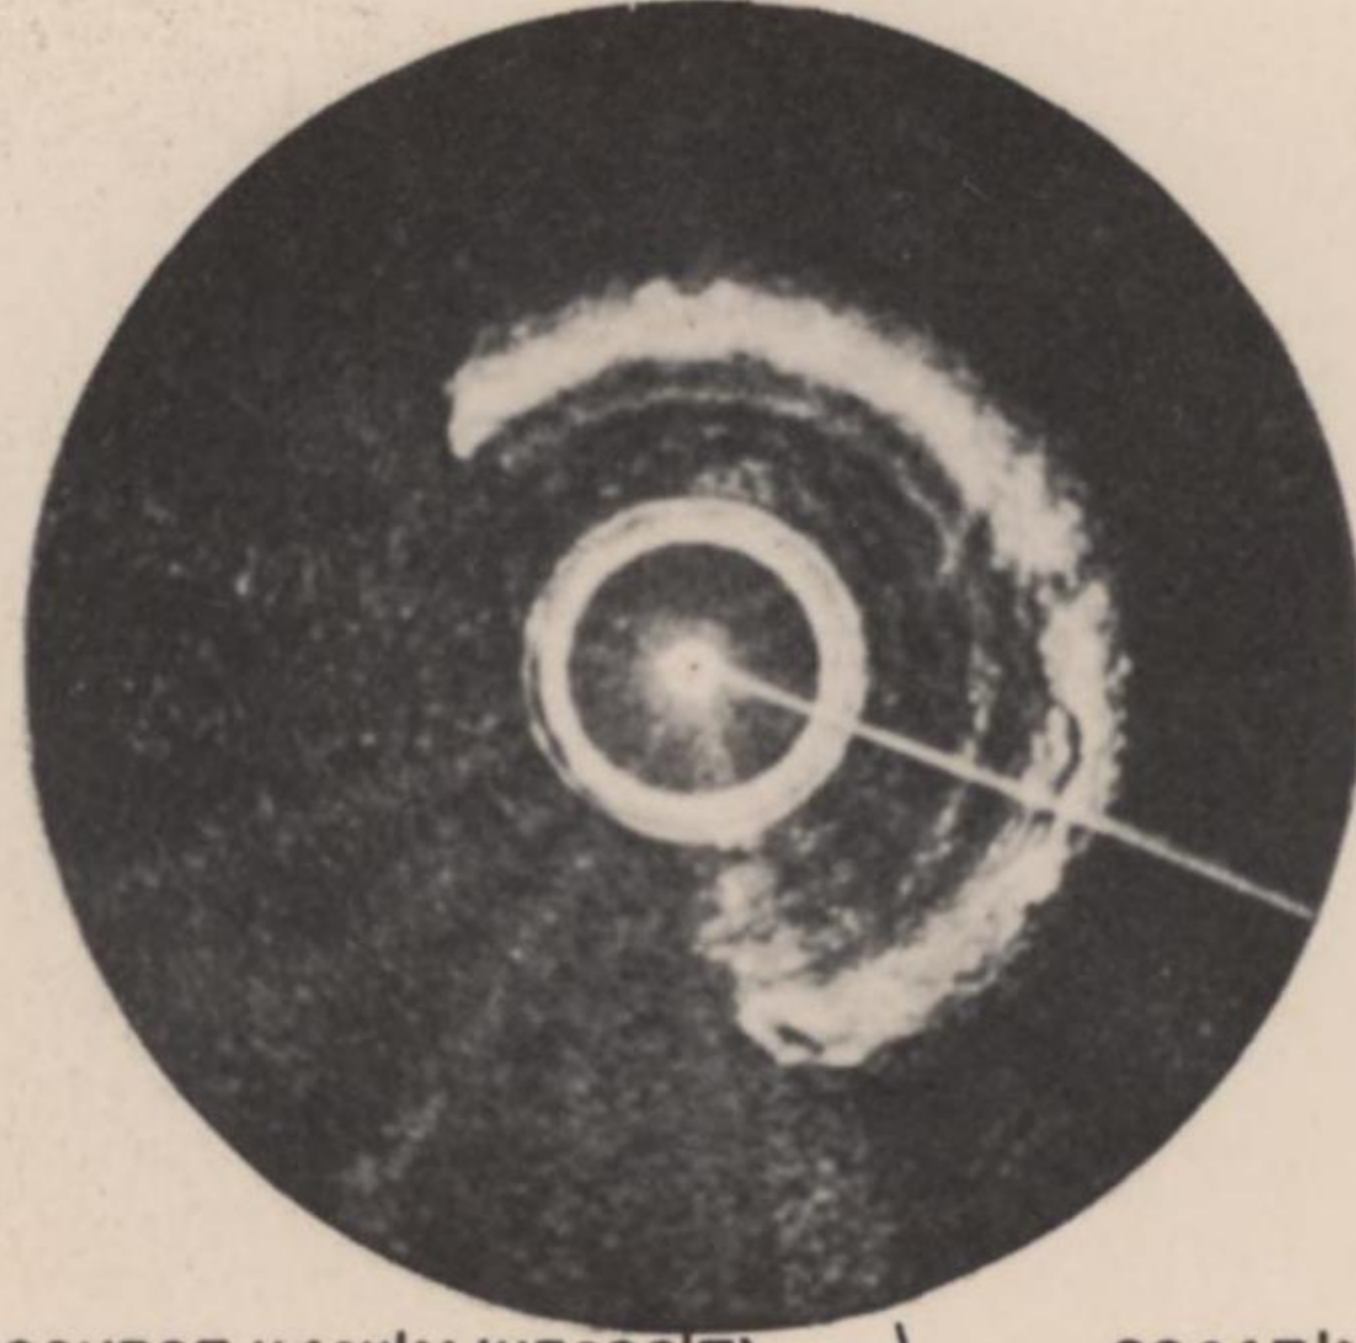
22°47'N  
120°16'E

COURSE 114°11'M (113°00'T)  
SWEEP 20 MILES  
ALTITUDE: 25,000'

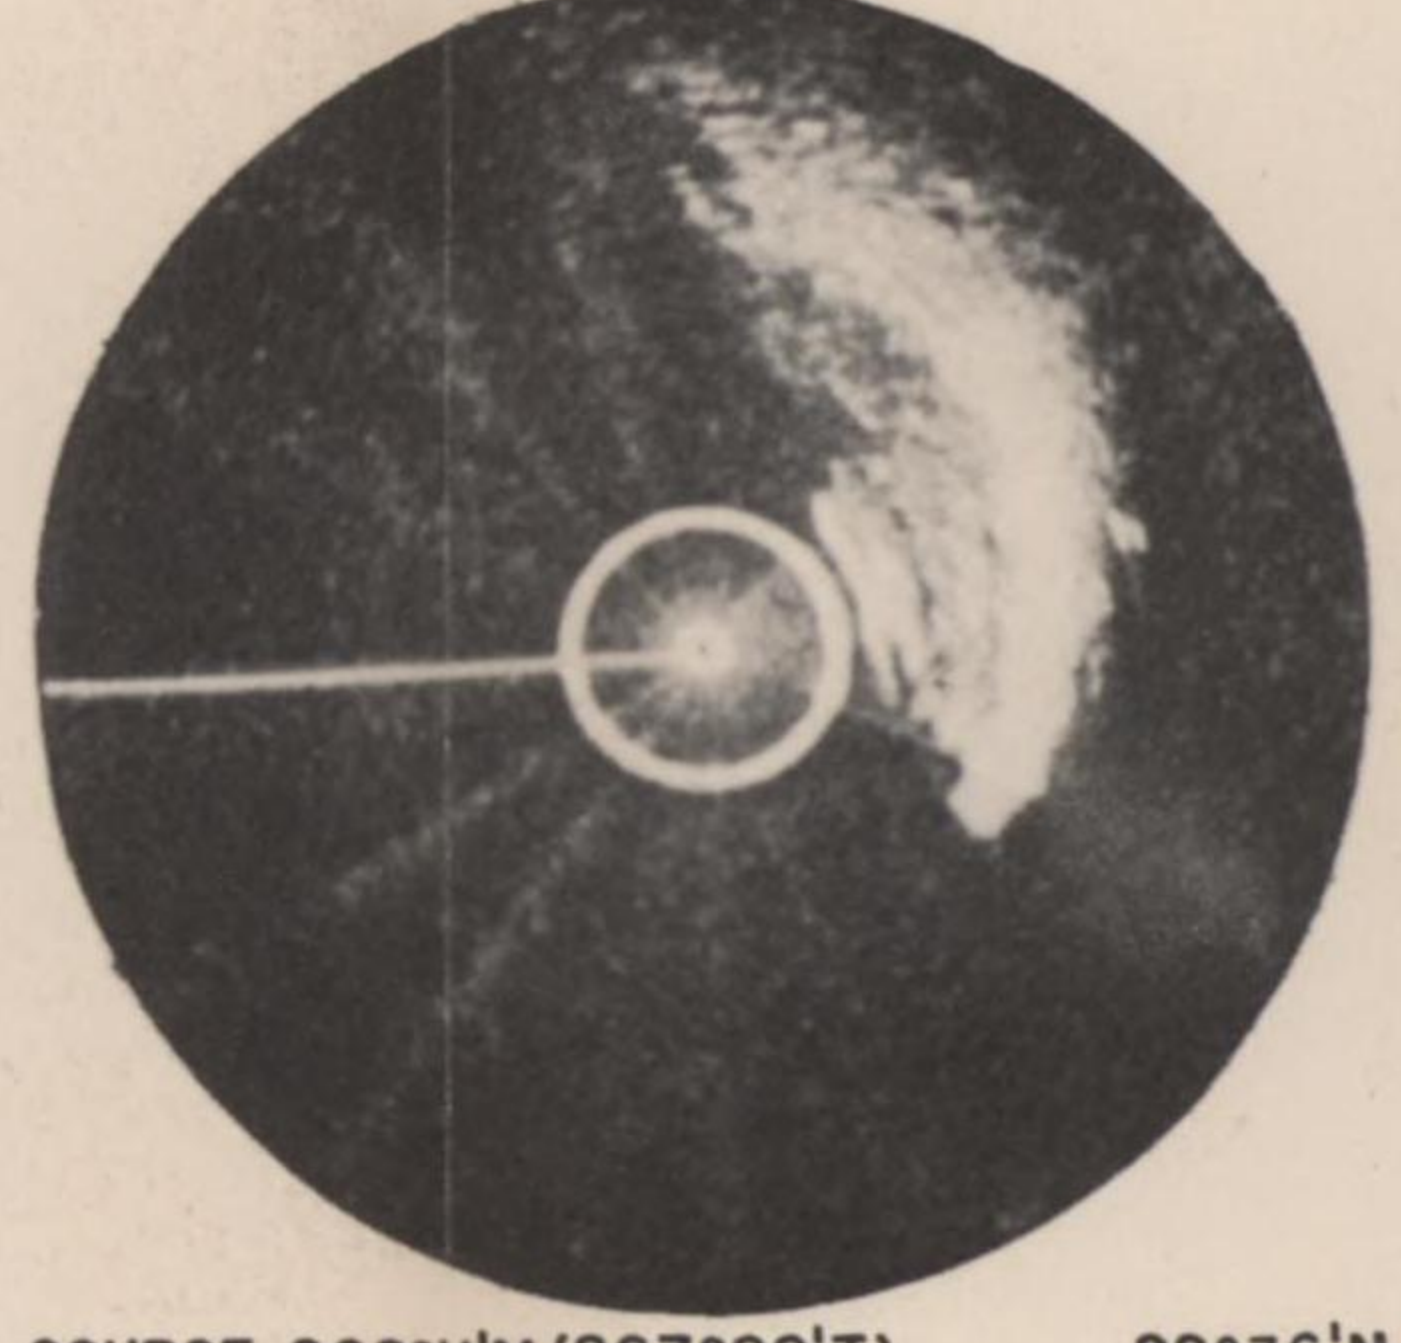
22°36'N  
120°12'E

COURSE 268°11'M (267°00'T)  
SWEEP 20 MILES  
ALTITUDE: 25,000'

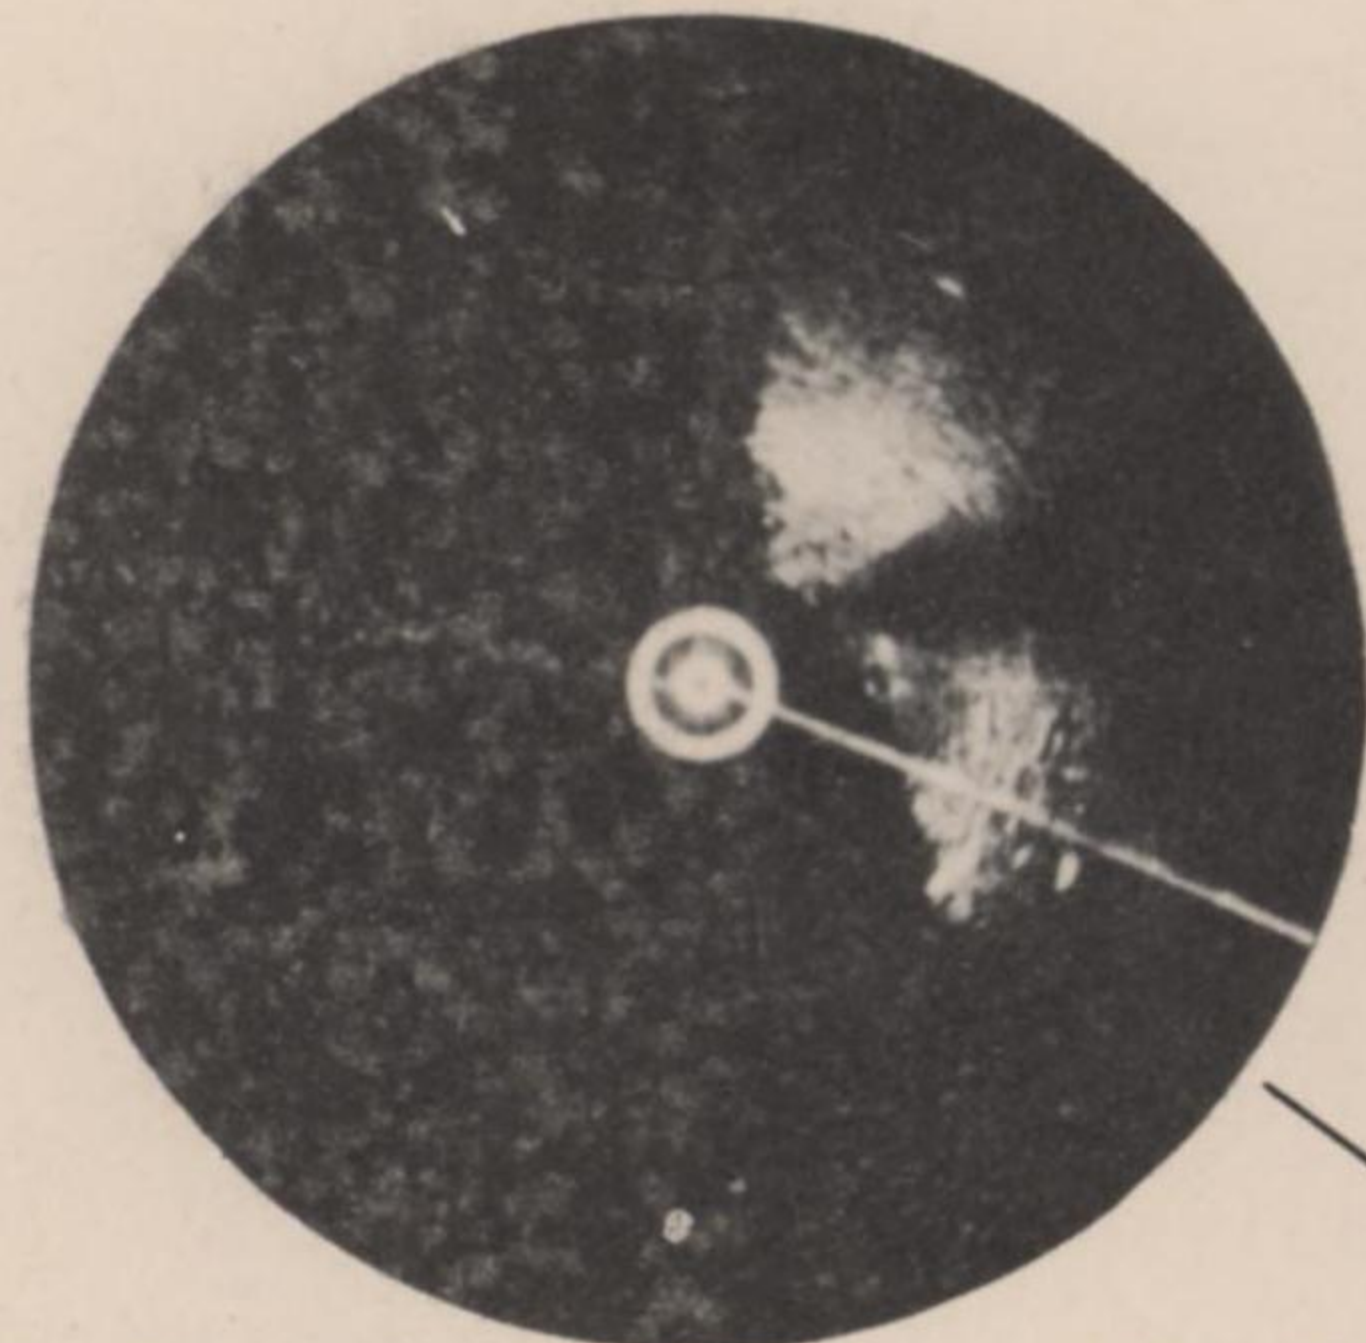
22°57'N  
119°56'E

COURSE 114°11'M (113°00'T)  
SWEEP 50 MILES  
ALTITUDE: 25,000'

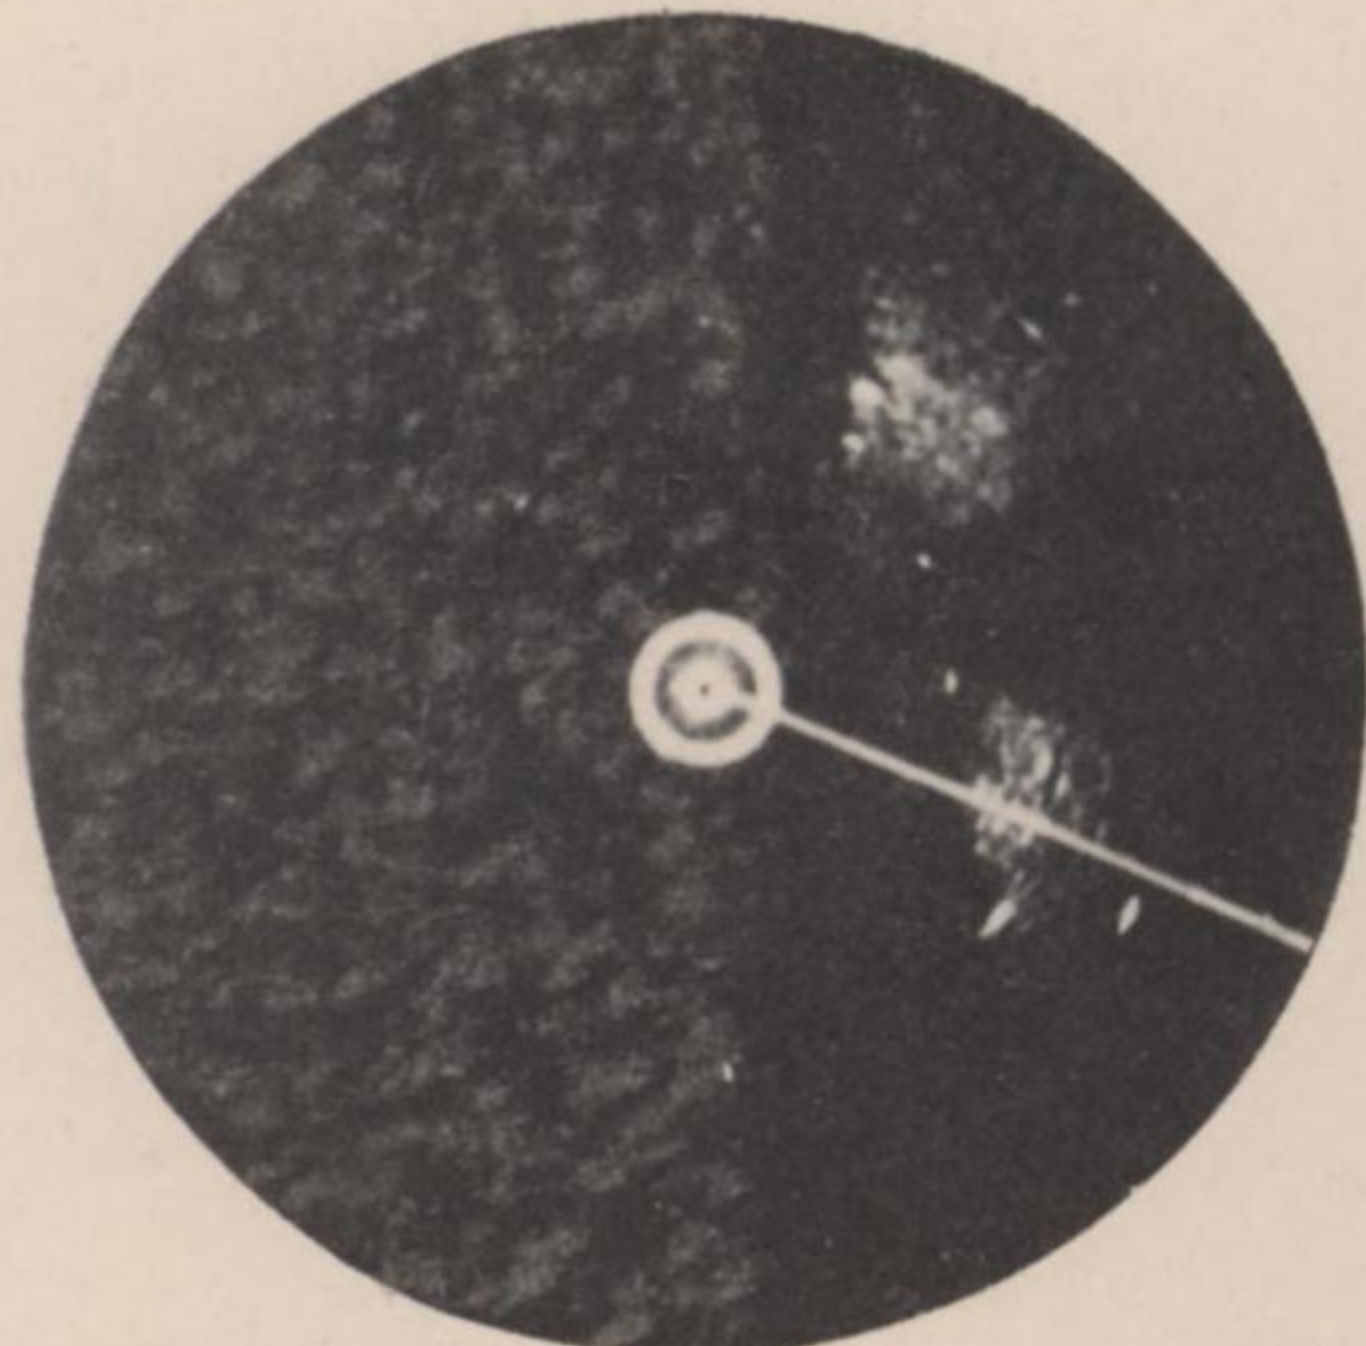
22°59'N  
119°52'E

COURSE 114°11'M (113°00'T)  
SWEEP 50 MILES  
ALTITUDE: 25,000'

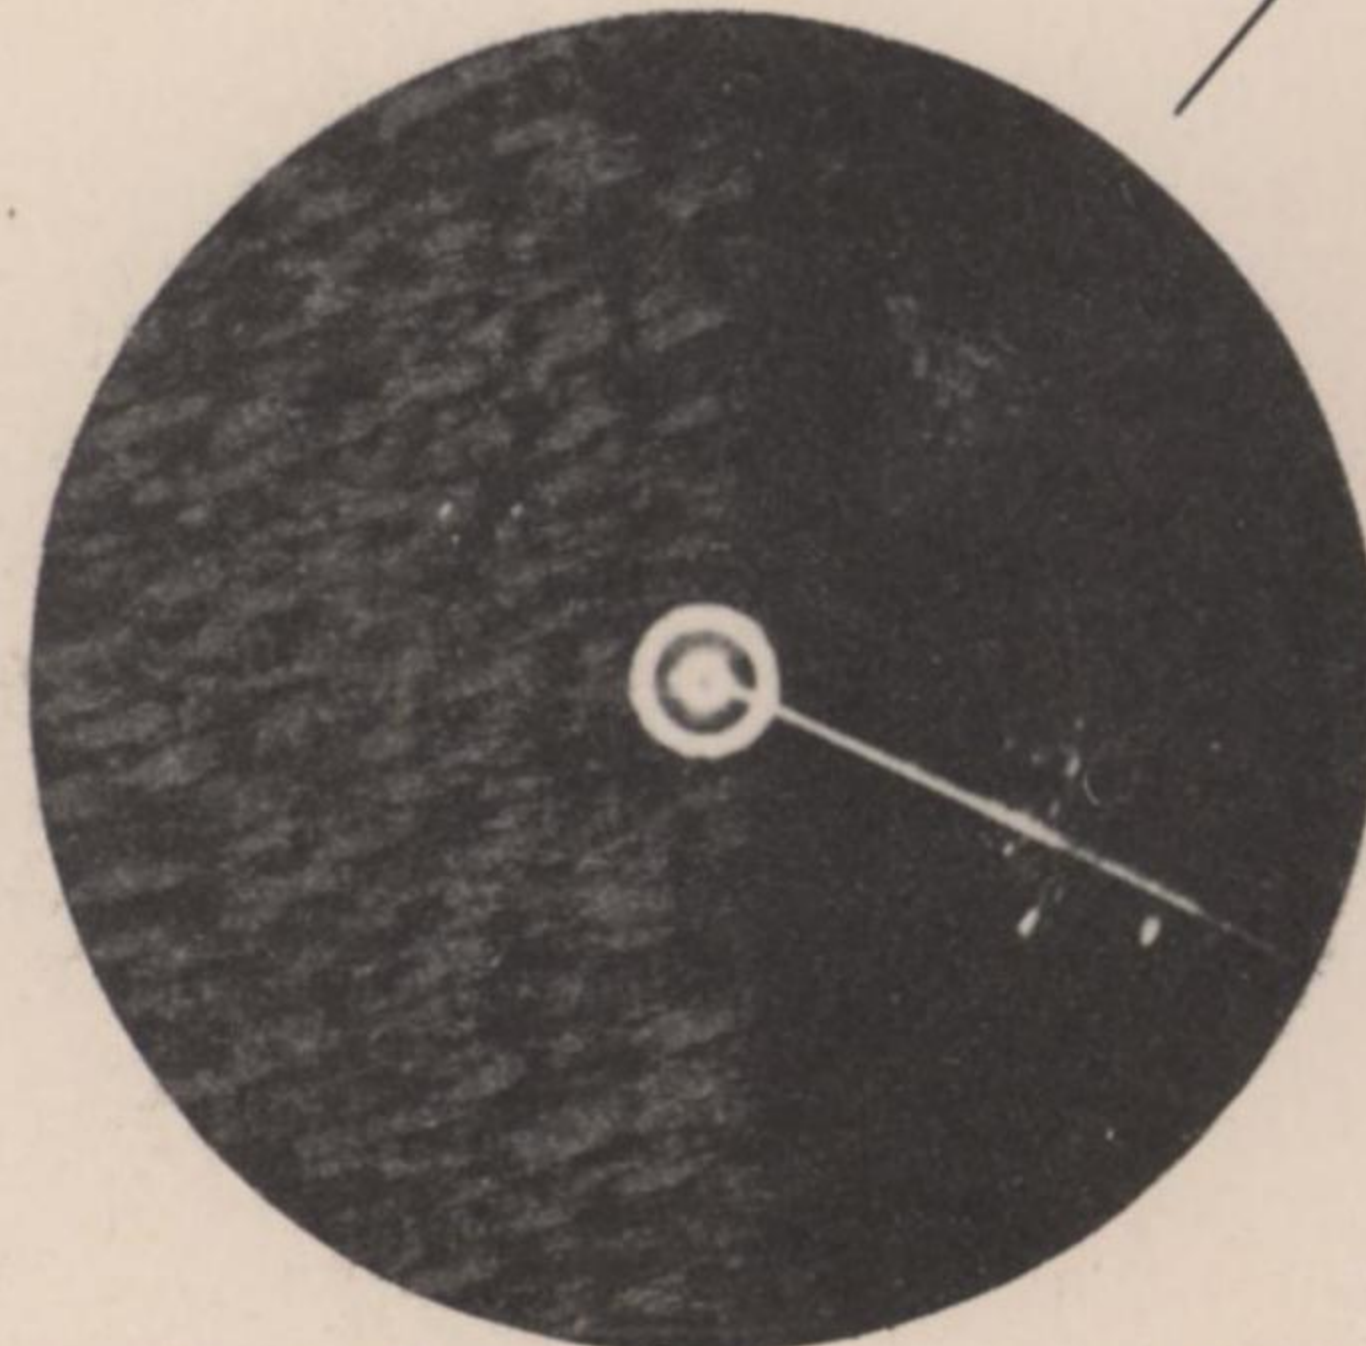
23°00'N  
119°48'E

COURSE 114°11'M (113°00'T)  
SWEEP 50 MILES  
ALTITUDE: 25,000'

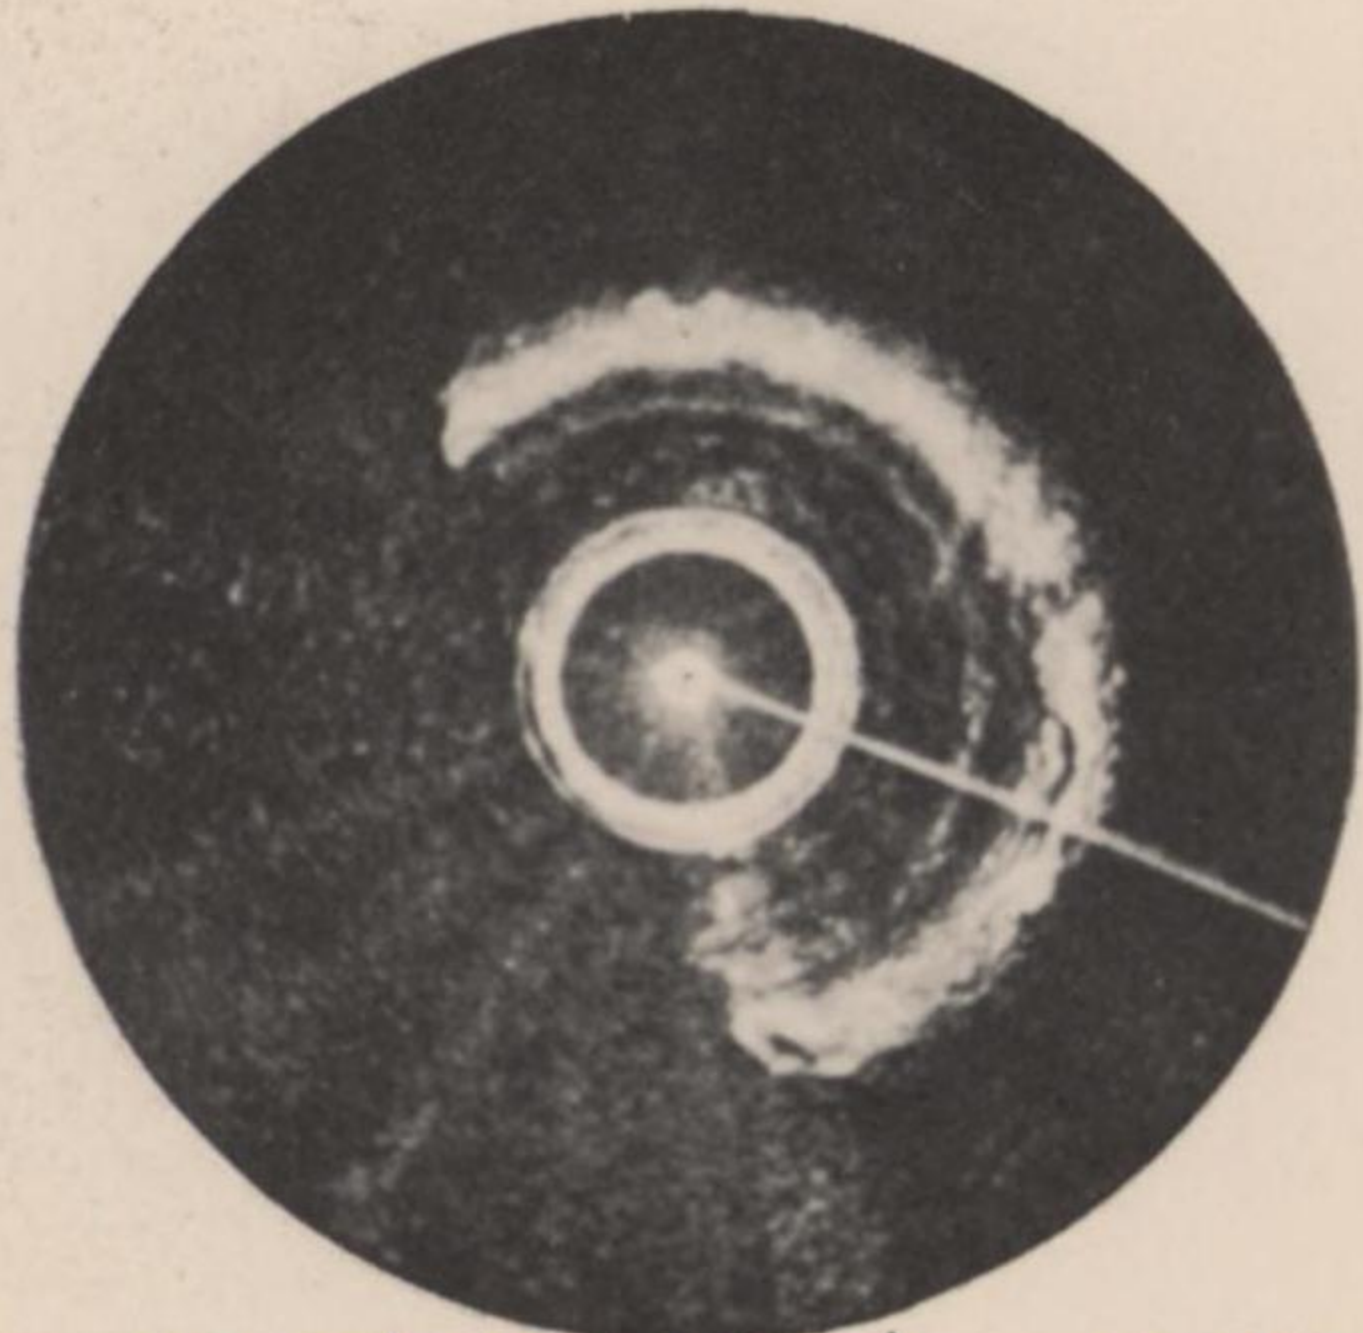
22°47'N  
120°16'E

COURSE 114°11'M (113°00'T)  
SWEEP 20 MILES  
ALTITUDE: 25,000'

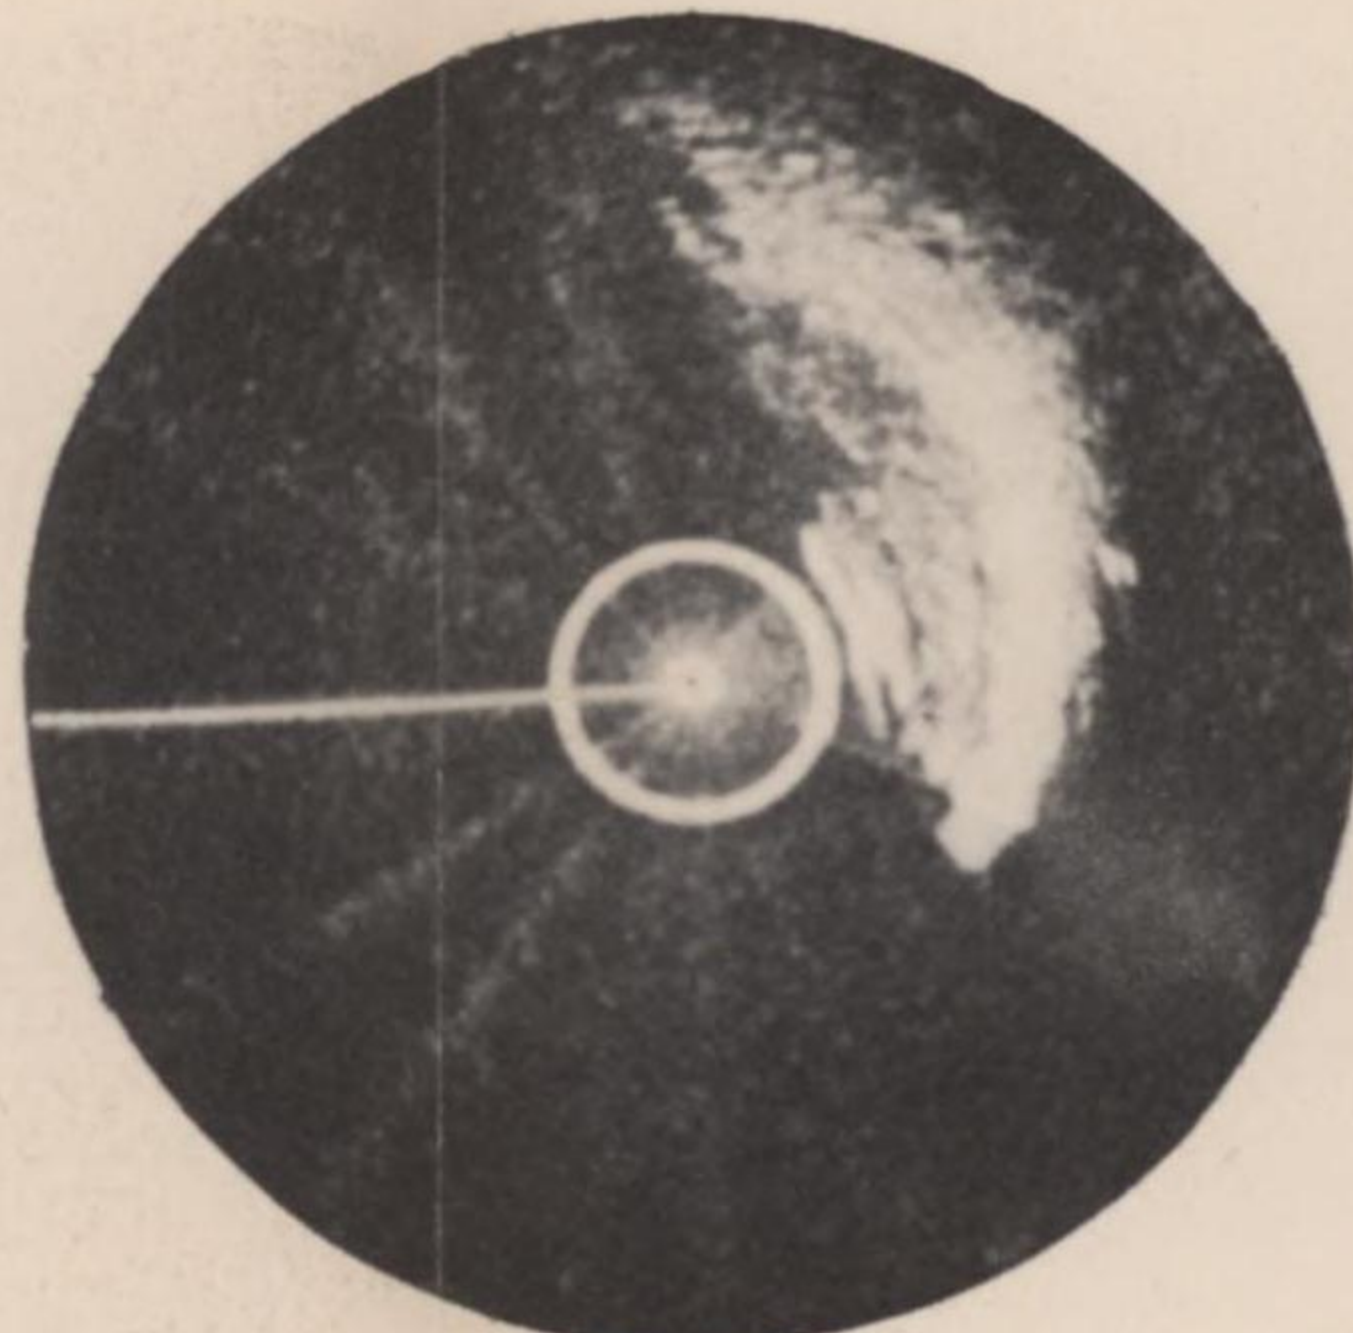
22°36'N  
120°12'E

COURSE 268°11'M (267°00'T)  
SWEEP 20 MILES  
ALTITUDE: 25,000'

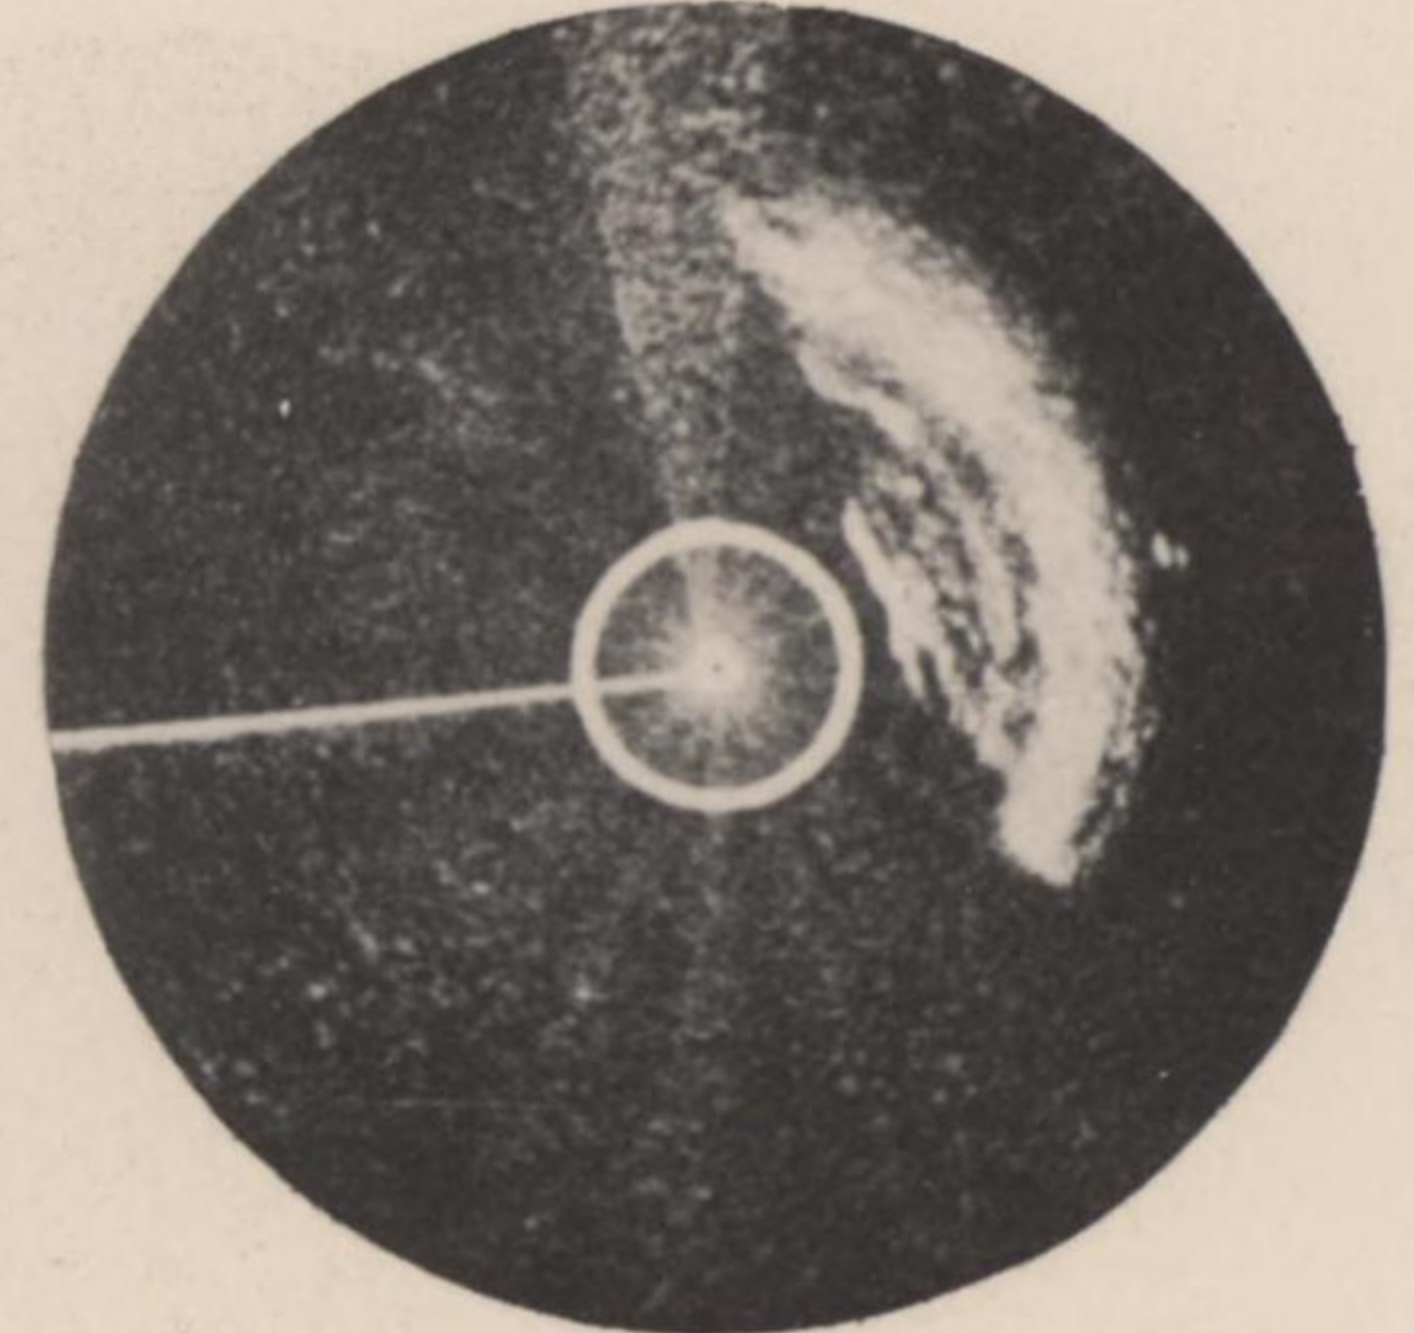
22°36'N  
120°11'E

COURSE 265°11'M (264°00'T)  
SWEEP 20 MILES  
ALTITUDE: 25,000'

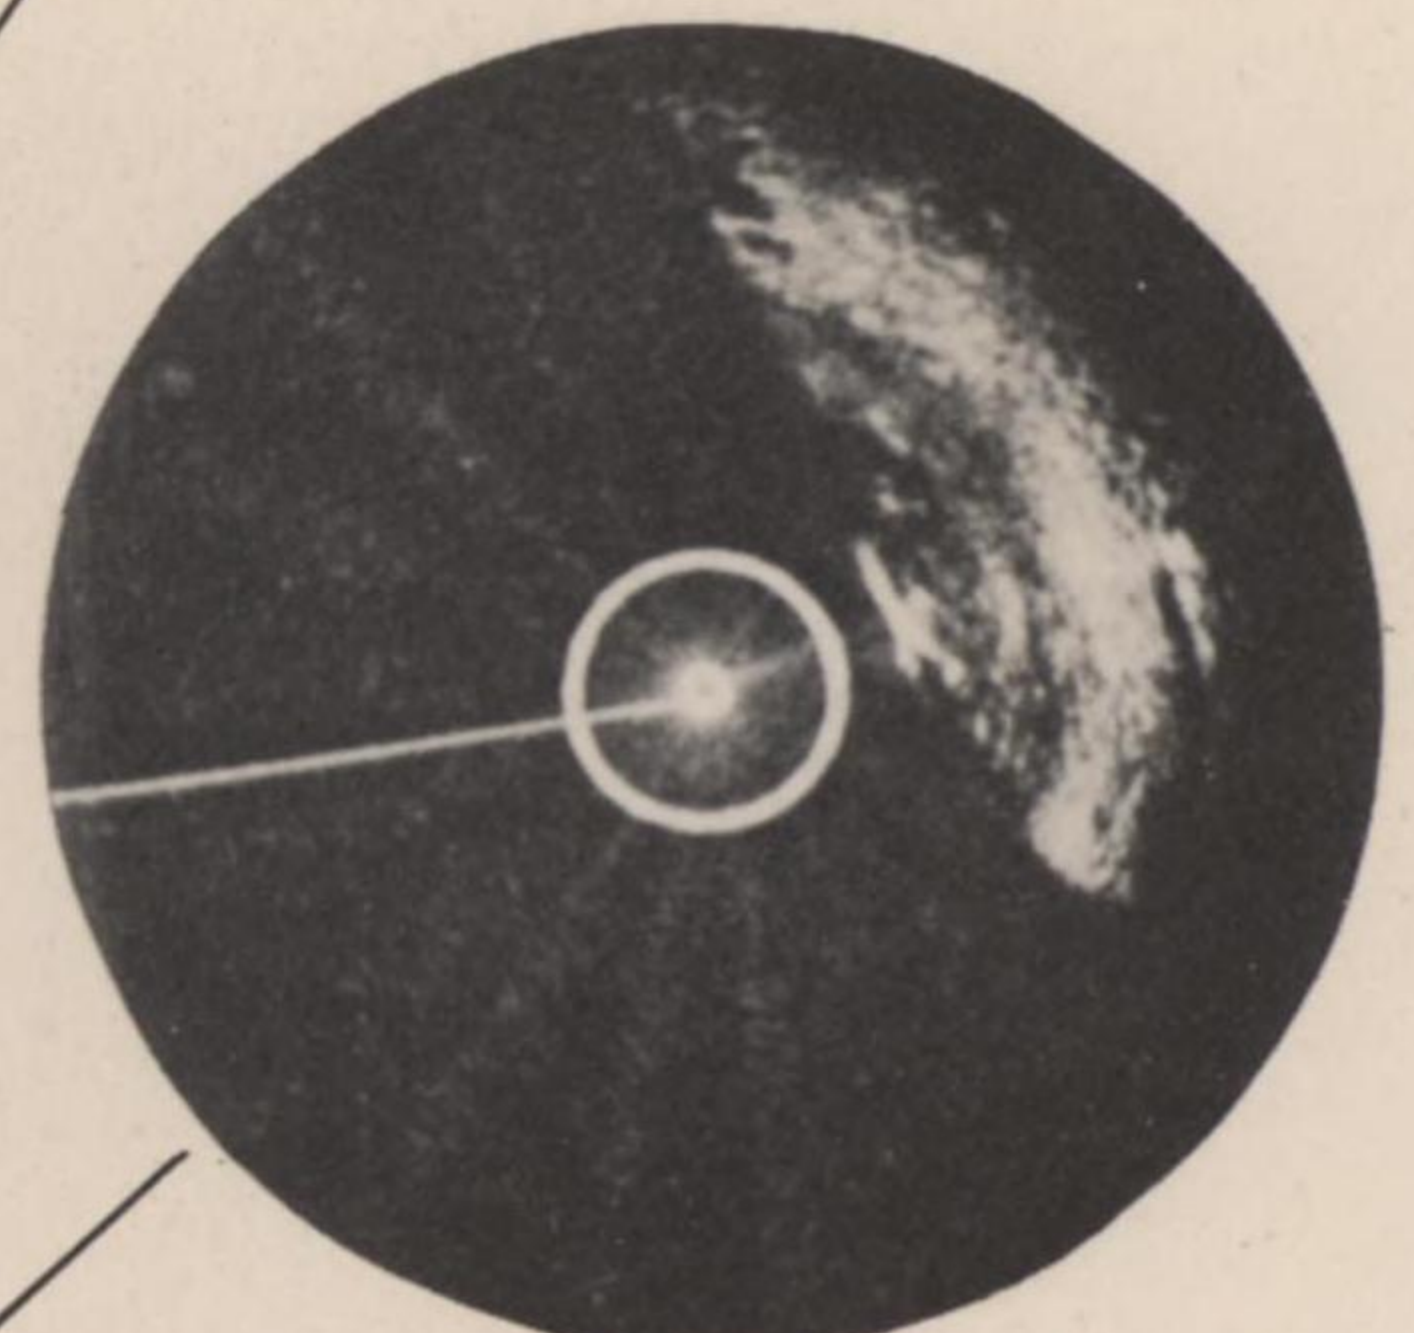
22°36'N  
120°10'E

COURSE 262°11'M (261°00'T)  
SWEEP 20 MILES  
ALTITUDE: 25,000'

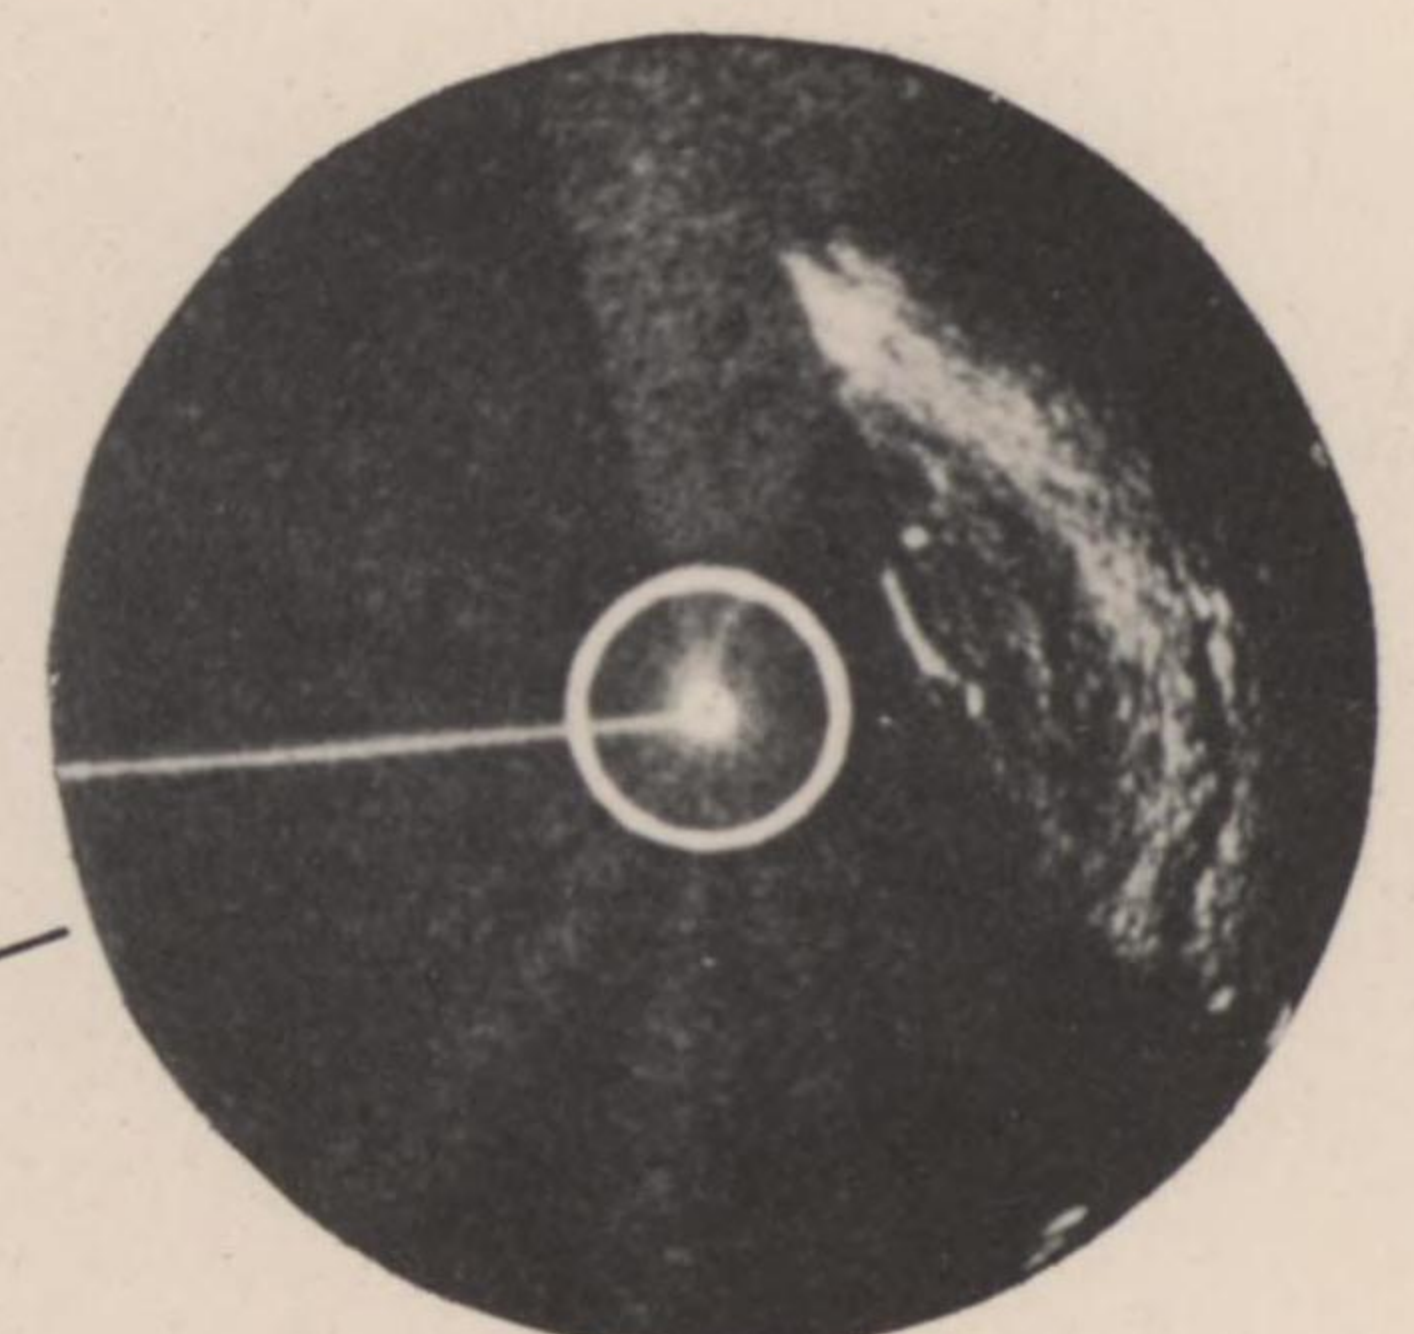
22°36'N  
120°09'E

COURSE 266°11'M (265°00'T)  
SWEEP 20 MILES  
ALTITUDE: 25,000'

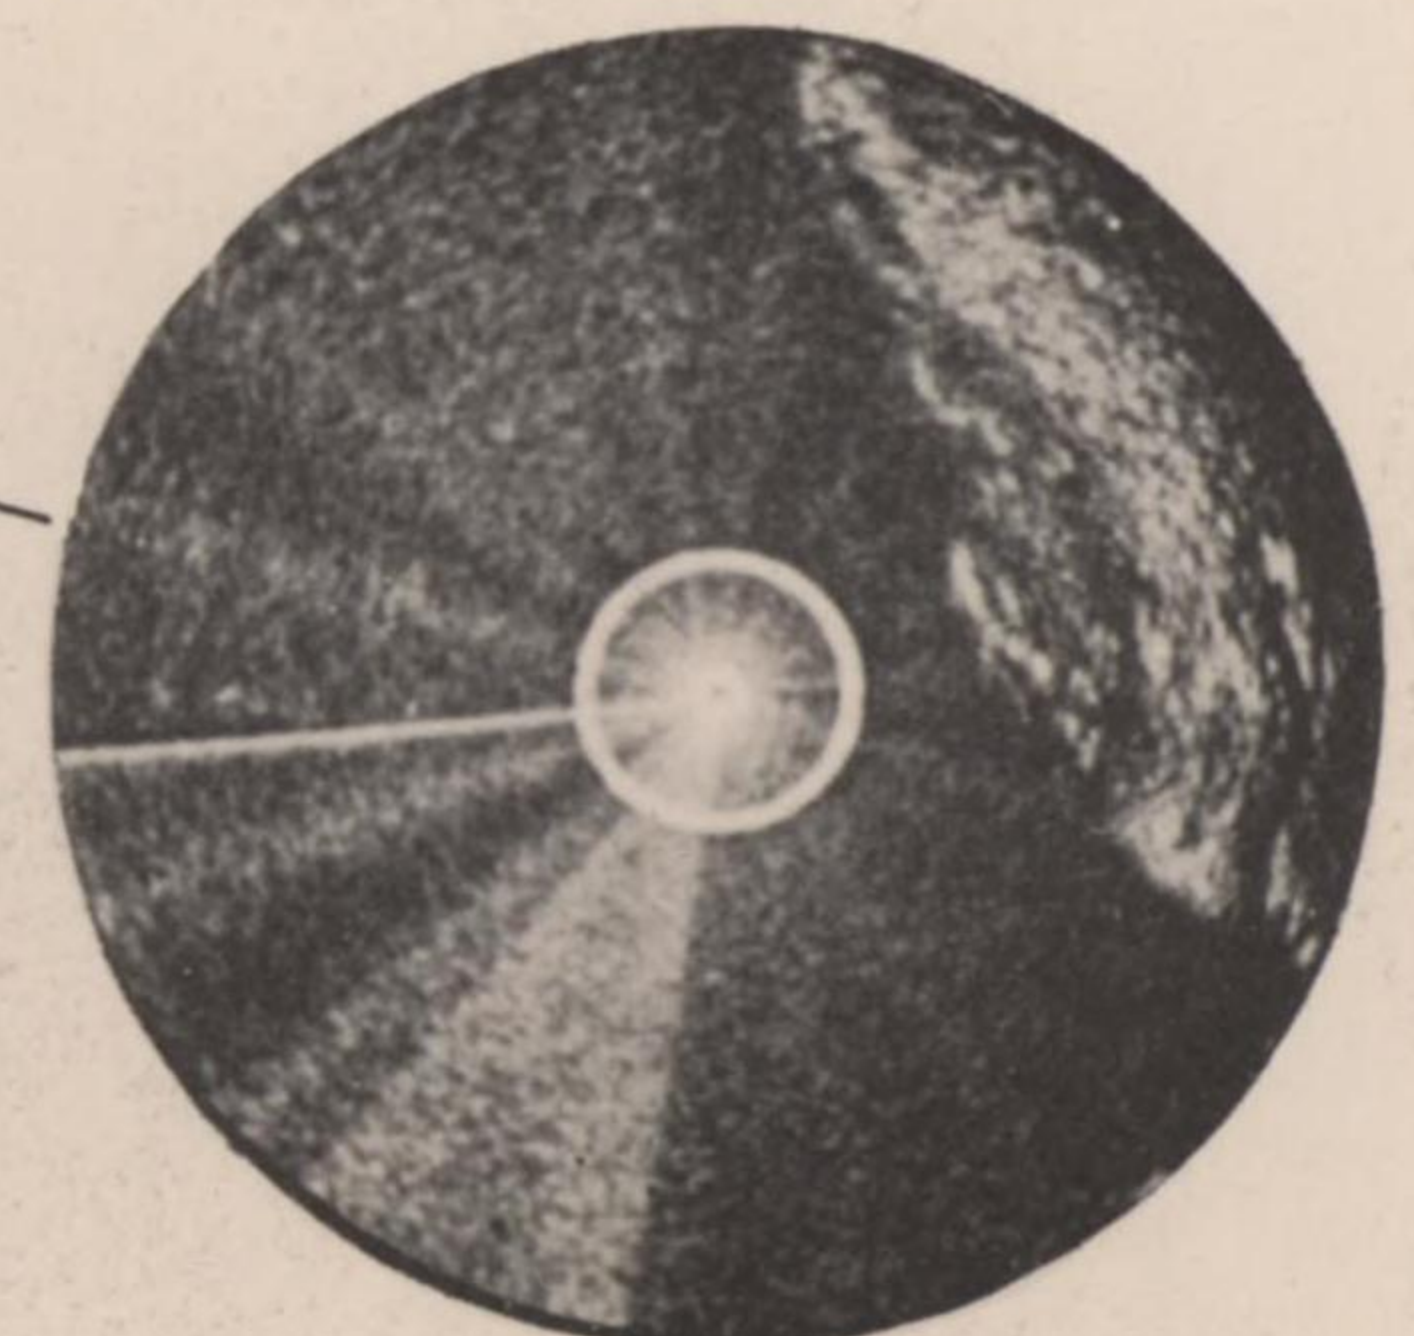
22°36'N  
120°08'E

COURSE 266°11'M (265°00'T)  
SWEEP 20 MILES  
ALTITUDE: 25,000'
