# Tactical Mission Report

No. 29

TARGET: SHINCHIKU AIRDROME

Formosa

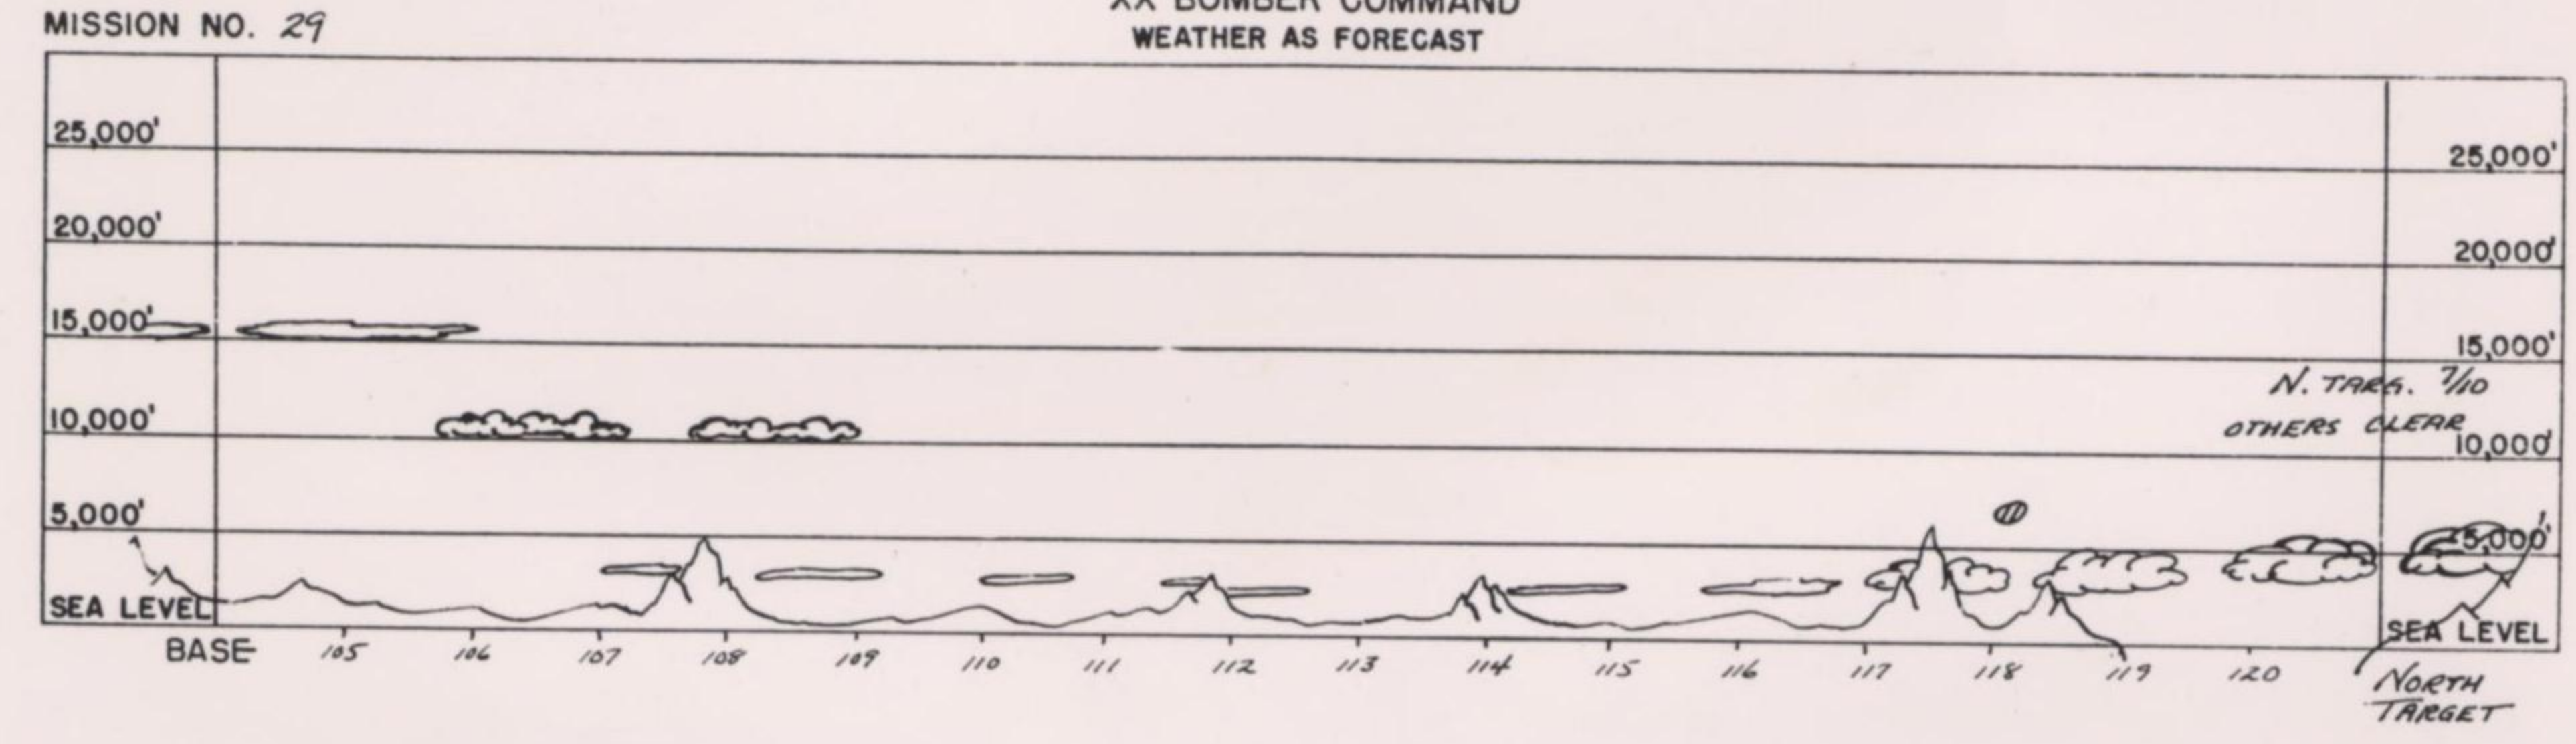
SECRET  
 XX Bomber Command  
 WEATHER AS FORECAST

As Forecast	As Encountered
Base at Take-off	Thin broken altostratus at 15,000'. Visibility 1 mile in haze and light ground fog. Altimeter setting 30.42	<u>HSINCHING</u> : Clear. Visibility 3/4 mile in ground fog. Wind calm. <u>KWANGHAN</u> : Clear. Visibility 1 mile in haze and ground fog. Wind calm. <u>KIUNGLAI</u> : Clear. Visibility 2 miles in haze and ground fog. Wind calm. <u>PENGSHAN</u> : Clear. Visibility 1 mile in ground fog. Wind calm.
Route Out	<u>BASE TO CHINA COAST</u> : Overcast altocumulus, top 11000' over mountain area becoming nil at 109°E. Remainder of route to coast clear except for low stratus and fog in valleys. Haze to 12000' reducing visibility to 15 miles. <u>OVER STRAIT</u> : Broken stratus, top 6000' at coastline becoming overcast enroute to northern target but becoming nil at Formosa coast enroute to southern targets.	1/10 cirrus at 25000' in vicinity of 109°E. Occasional low thin scattered stratus and light ground fog in mountains. Haze restricted visibility to 7 miles from base to China coast. Otherwise conditions were clear.

Target Area	<u>NORTH</u> : 7/10 stratocumulus, top 7,000'. Visibility 30 miles. <u>CENTRAL</u> : Clear. Visibility 30 miles. <u>SOUTH</u> : Clear. Visibility 30 miles. <u>TARGET PRESSURES</u> : <u>NORTH</u> : 30.39 inches <u>CENTRAL</u> : 30.36 inches <u>SOUTH</u> : 30.33 inches <u>MEAN TEMPERATURES</u> : <u>SURFACE TO 22,000'</u> : 1 Deg C. <u>SURFACE TO 25,000'</u> : -1 Deg C.	<u>SHINSEIKU</u> : Clear. 5/10 stratocumulus observed in vicinity but not affecting bombing run. Visibility unrestricted. <u>HENGYANG</u> : Clear. Visibility 10 miles in haze.
Return Route	Stratus in valleys will become fair weather cumulus. Otherwise no change.	Clear. Visibility 5-7 miles in haze over Central China. Top of haze layer at 10,000'.
Bases on Return	Broken altocumulus, base 10,000' top 12,000'. Scattered cumulus at 6,500'. Visibility 3 miles in haze and dust. <u>ALTIMETER SETTING</u> : 30.30	<u>HSINCHING</u> : Clear. Visibility 4 miles in haze. Wind WSW 3. <u>KWANGHAN</u> : Scattered cumulus at 5,000' visibility 5 miles in haze. Wind calm. <u>KIUNGLAI</u> : 2/10 - 4/10 altostratus at 10,000'. Visibility 4 miles in haze. Wind ESE 5. <u>PENGSHAN</u> : 1/10 - 2/10 altocumulus at 6,000'. Visibility 3/4 mile in dust and haze. Wind calm.

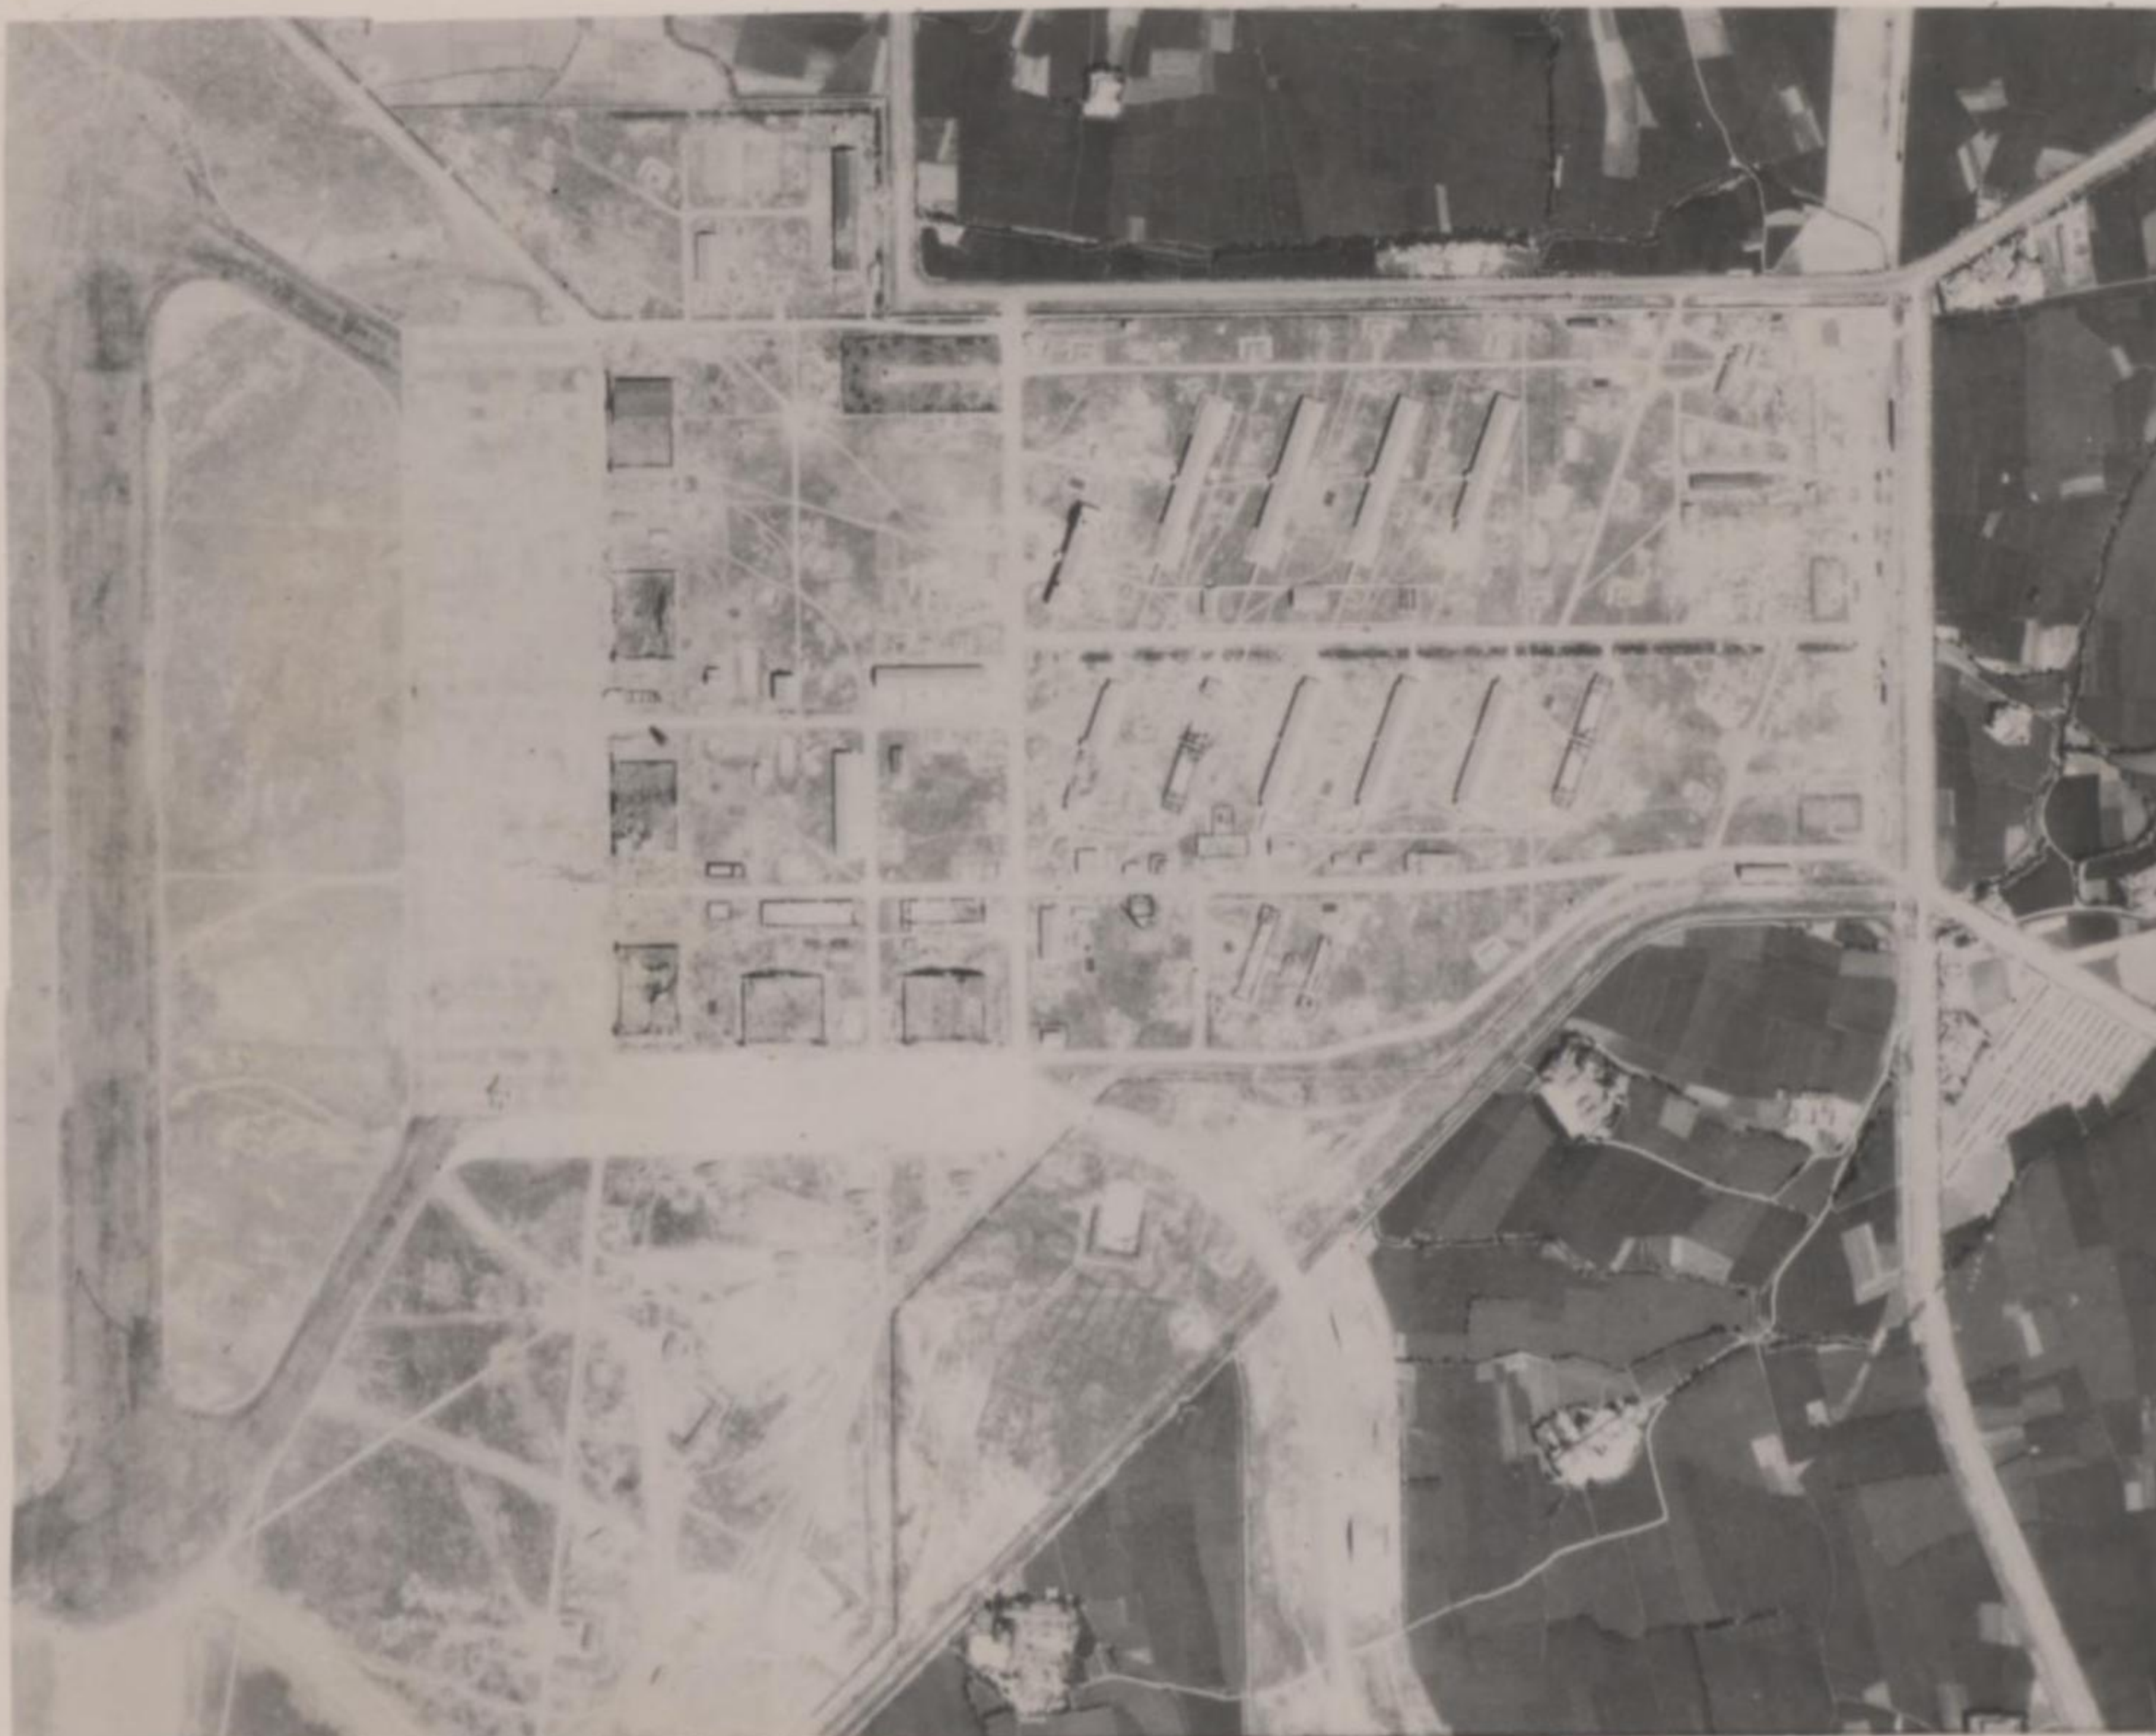
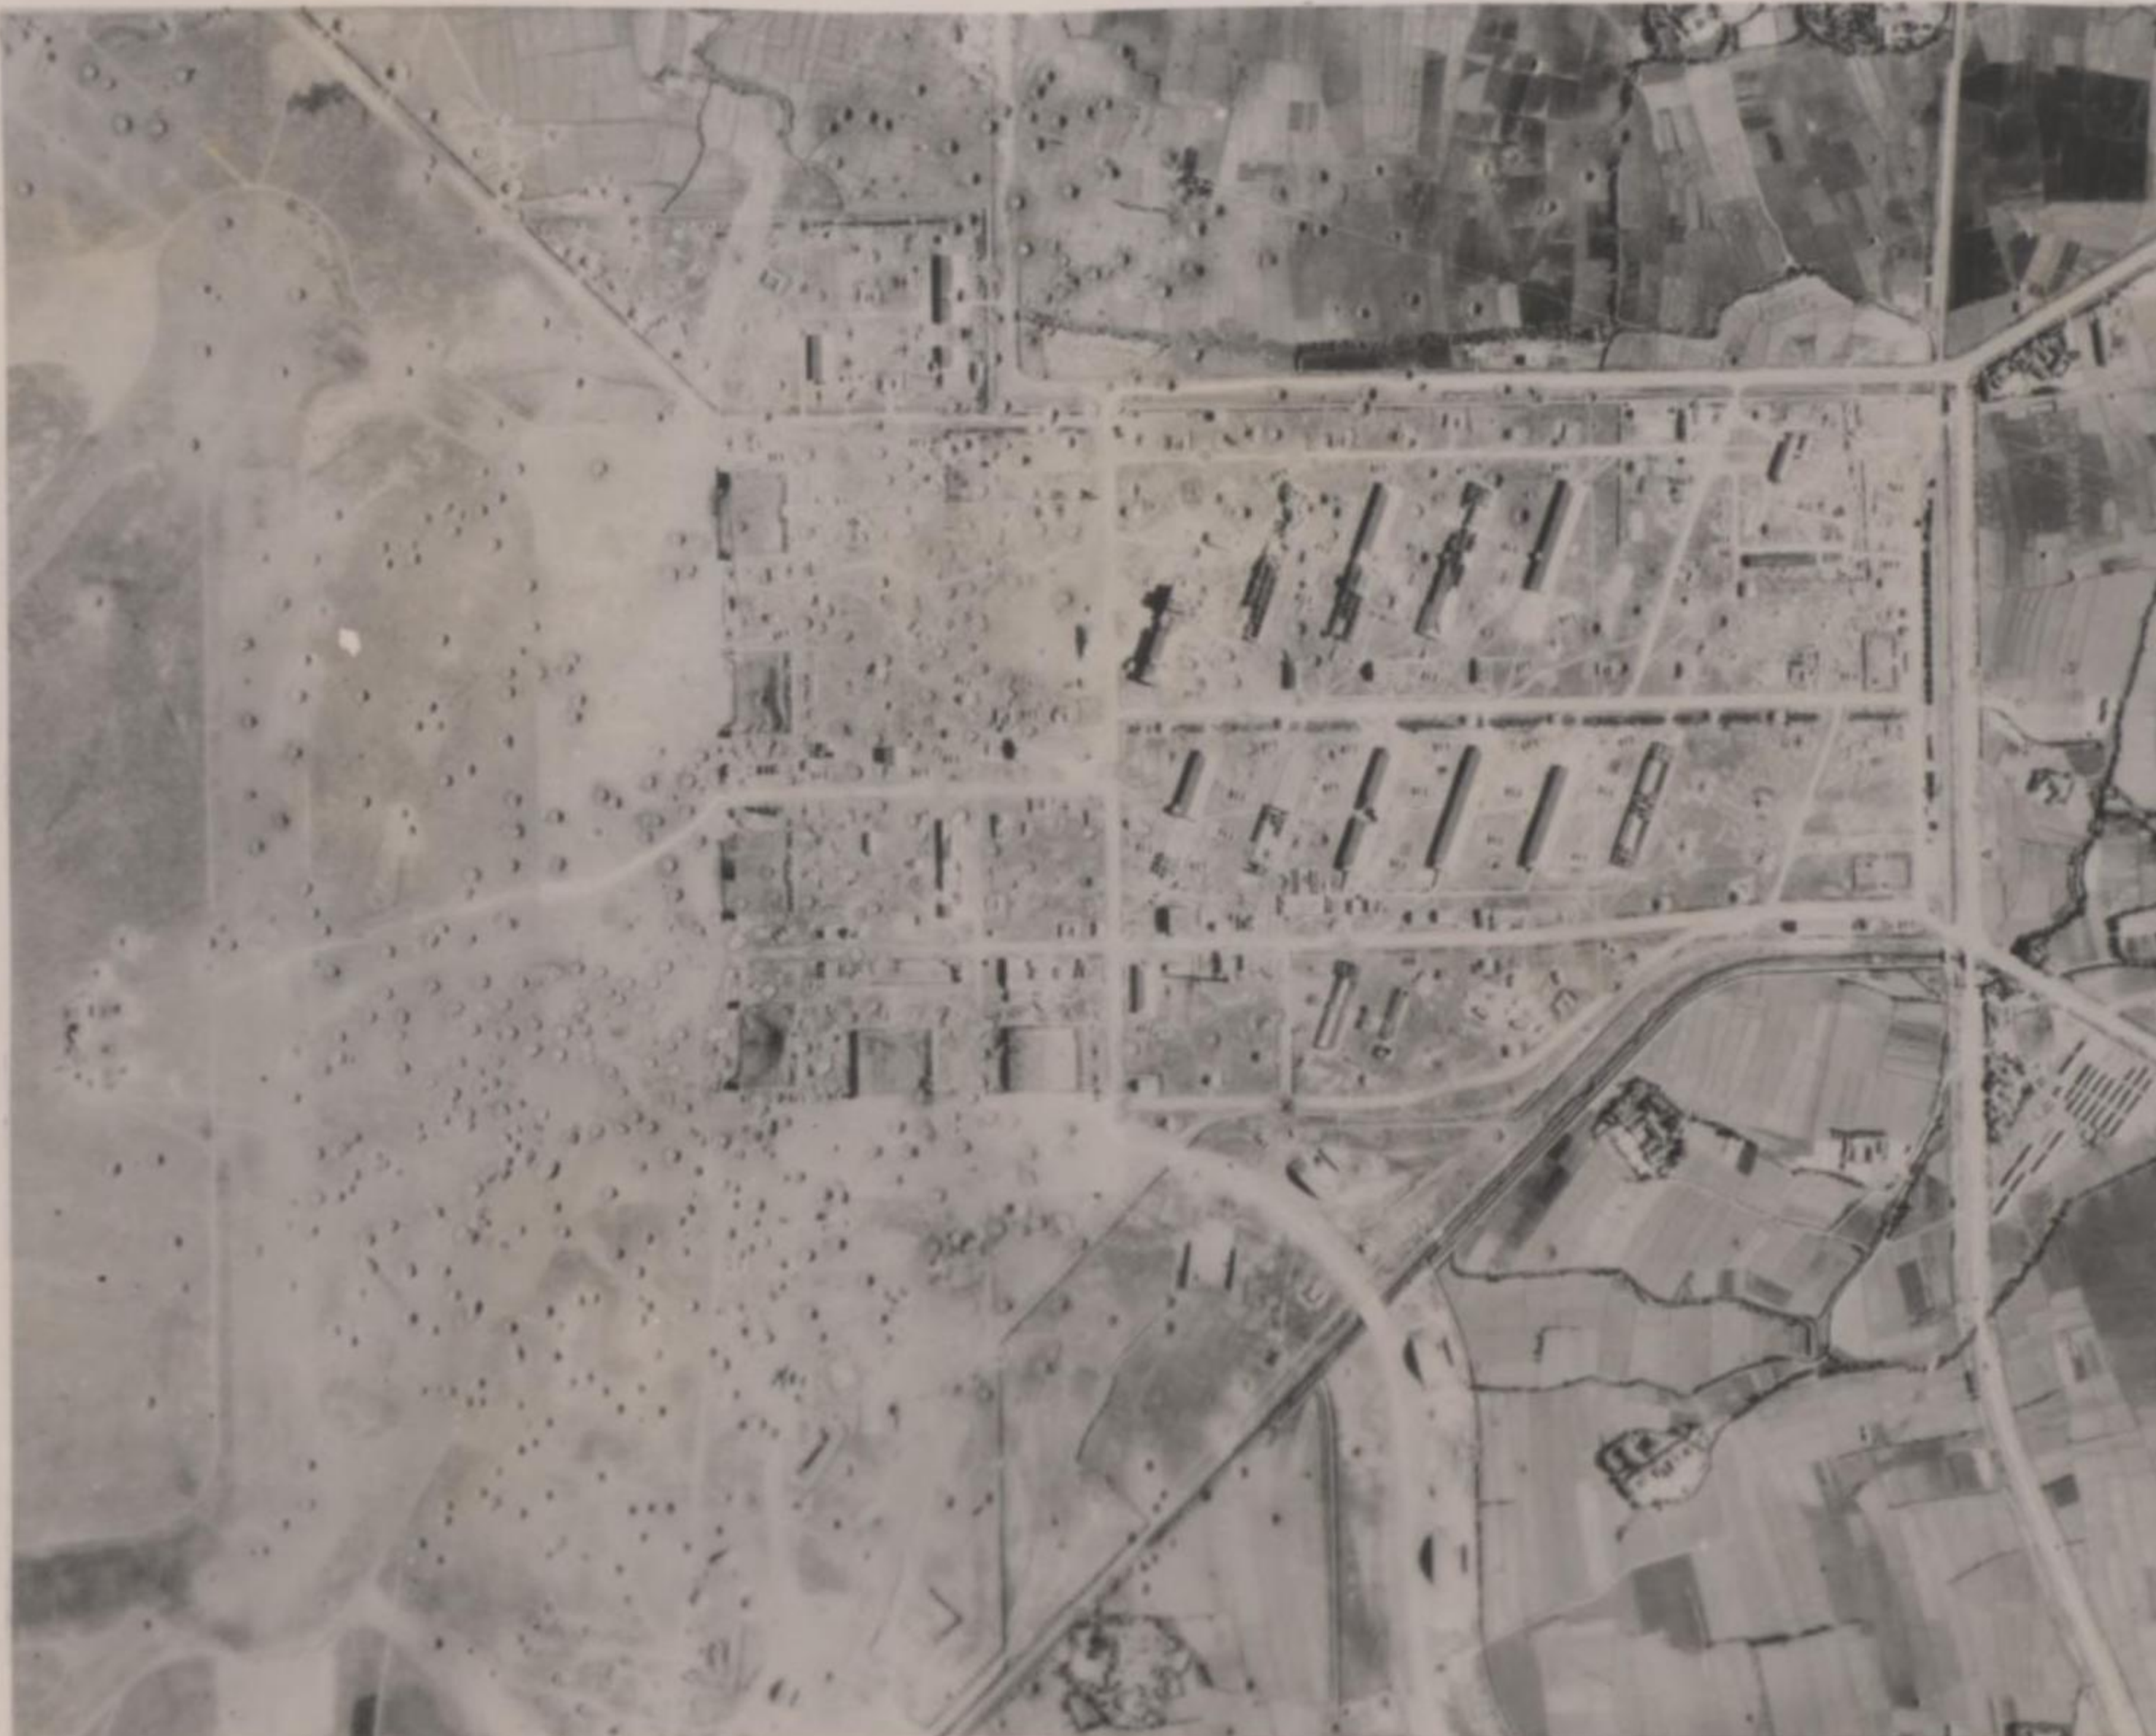
**BEFORE**

Each of the six hangars shows superficial damage as well as structural damage or collapse. Five large warehouses show structural damage as well as the power plant, radio building and nine of the ten large barracks buildings. Service aprons and two of the five runways are severely cratered.

\* Structural damage includes damage which involves the replacement of a principal structural or supporting member. Superficial damage covers other types of damage that could be repaired without involving extensive structural replacements.
