NAKAJIMA A/C KOIZUMI

JOINT TARGET GROUP - WASHINGTON, D.C.

TARGET INFORMATION SHEET (Contd.)

**NAKAJIMA AIRCRAFT, KOIZUMI PLANT**  
**KOIZUMI JAPAN**

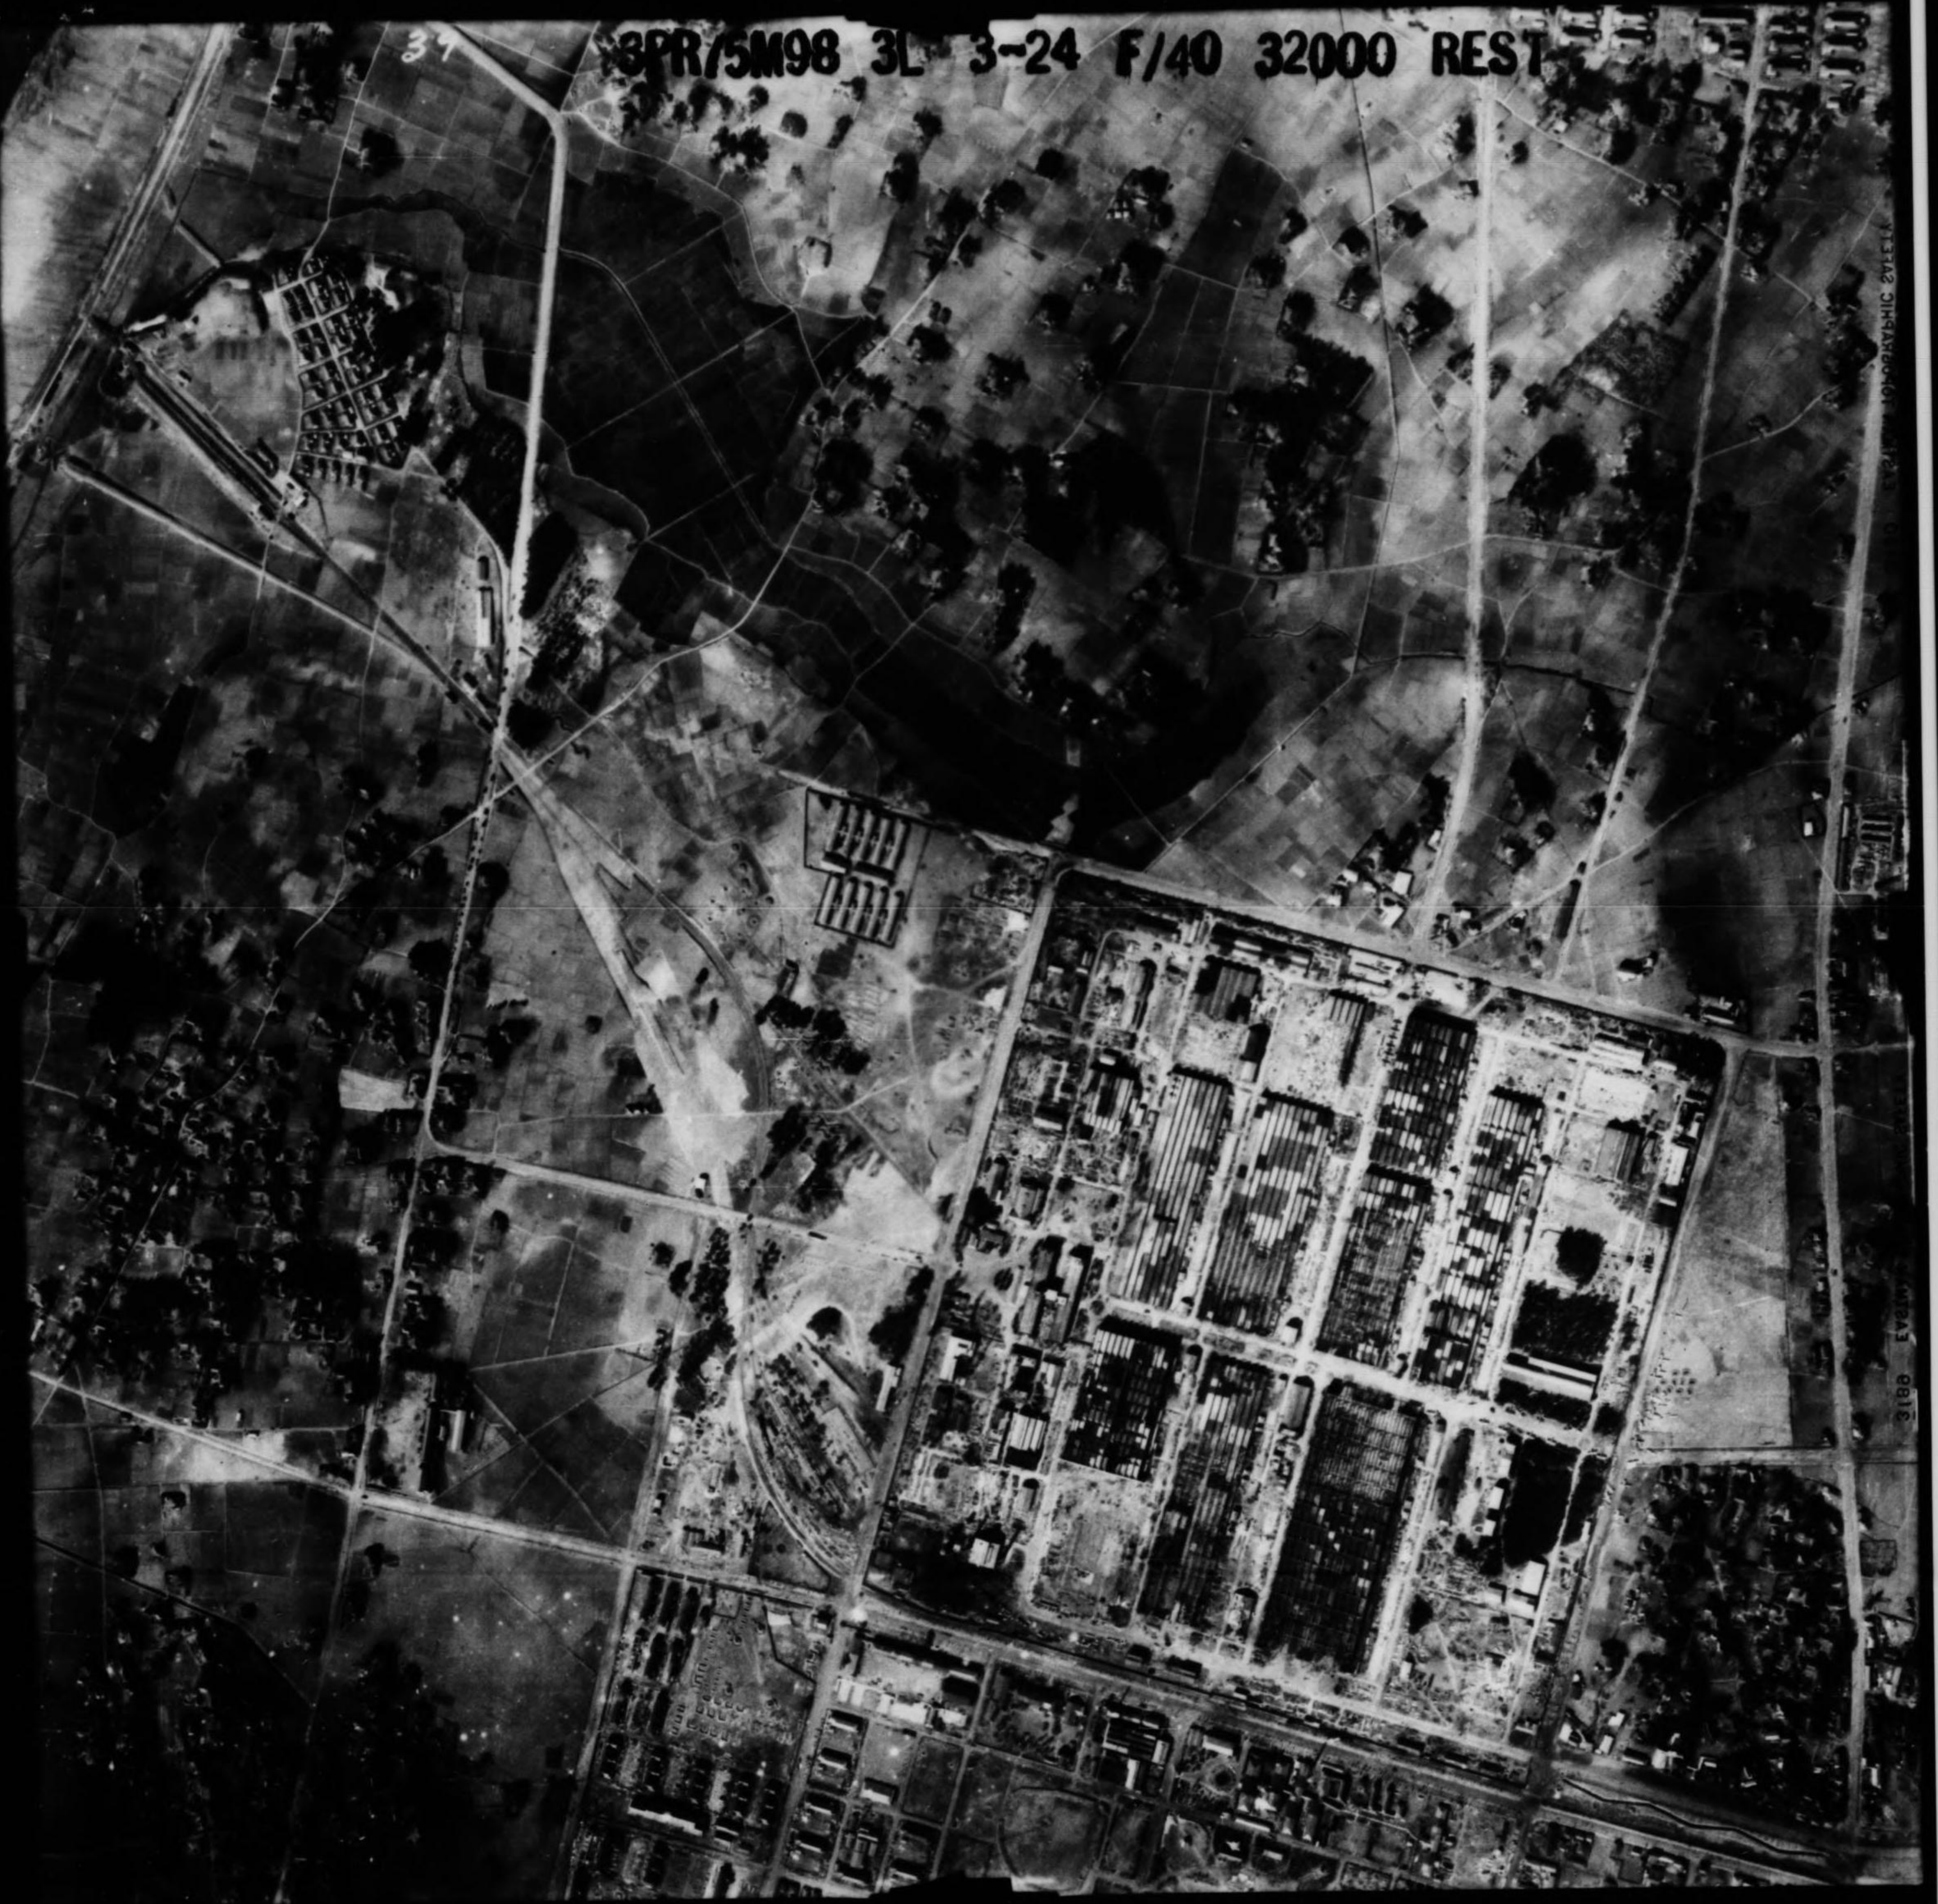
- STRUCTURAL DAMAGE
- SUPERFICIAL DAMAGE
- CIVIL REMOVAL

NAKAJIMA AIRCRAFT CO.  
KOIZUMI, JAPAN

PHOTOGRAPHY OF  
24 MAR 45
