The Locomotive

THE HARTFORD STEAM BOILER
INSPECTION AND INSURANCE CO.

VOL. XXXIV.

HARTFORD, CONN.
1922-1923.

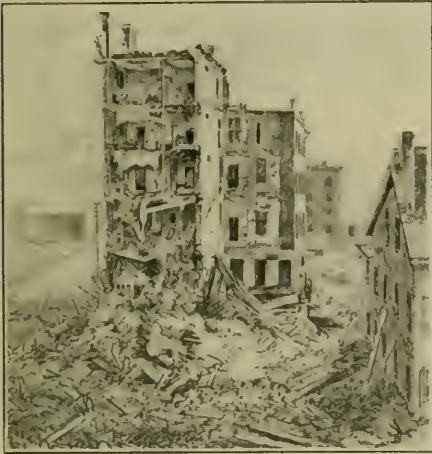
WRECK OF THE PARK CENTRAL HOTEL.

The explosion mentioned above, which was particularly violent, was evidently the result of over-pressure brought about by an inoperative safety valve. A reproduction of the sketch which accompanied the account in THE LOCOMOTIVE showing the wrecked building is given above.

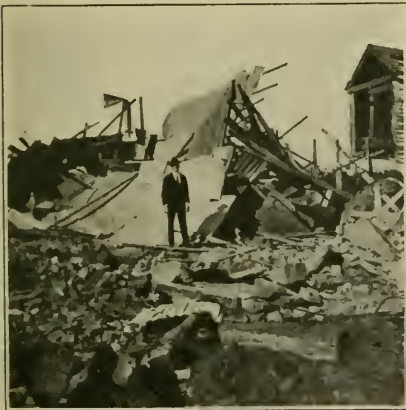
One man was killed, two were injured and the ginning plant of Clark and McCowan, near Florence, S. C., was demolished by a boiler explosion on September 20, 1921. The boiler had been idle for six months and during this time had been repaired by welding on a patch about 14" x 24", the work being done by the oxy-acetylene process. When the boiler was put into service it exploded, the failure having its origin at the welded patch. The boiler was blown into the air and landed about 350 yards away.

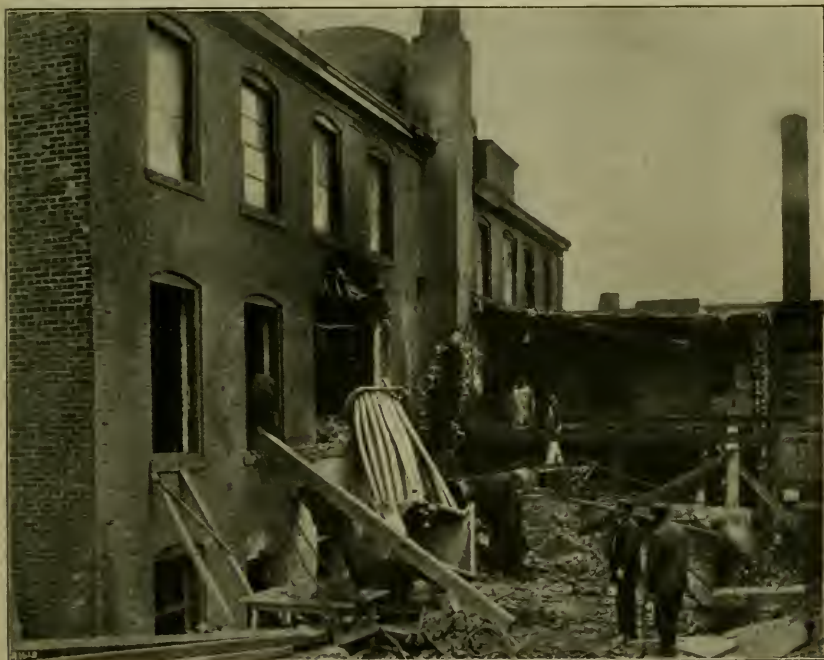
BOILER EXPLOSION AT BRIDGEPORT, CONN.

the explosion occurred, the barrel-sheet of the boiler was torn off and the remainder — by far the larger part — was hurled up and against the brick wall of an adjoining building, tearing a hole in it and coming to rest in the position shown in the picture above. The barrel-sheet itself was blown up and over the remaining part of the shed and landed in an alley-way between the shed and the next building, as shown in the picture on the opposite page. Just above the third window from the left of the picture the scar may be seen where the plate first struck the brick wall.

A close-up view of the part enclosed by a white circle in Fig. 1 is given in Fig. 2 above and in it may be seen the welding that was done at the junction of the longitudinal and girth seams. The other end of the joint is illustrated in Fig. 3 in which the corroded condition of the plate can be fairly well distinguished.

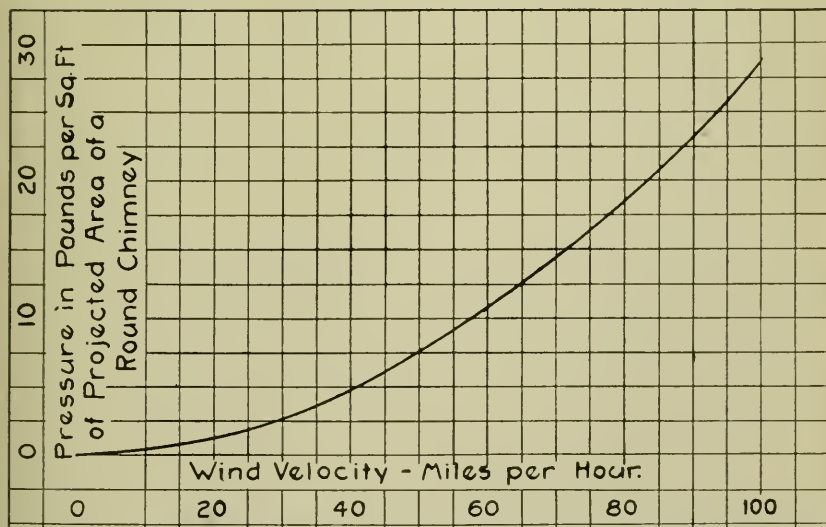
FIG. 1.

The wind pressure varies greatly with the wind velocity. With a round stack the relation between the two is expressed by the formula $P = .0029 V^2$ in which P is the pressure in pounds per square foot of projected area of the stack and V is the velocity of the wind in miles per hour. This relation has been plotted as a curve in Fig. 1. From this curve we see that low wind velocities produce but little pressure

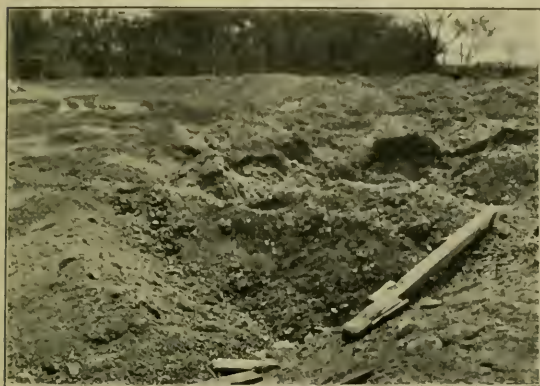
FIG. 2.

If ground is available to spread out the stored coal in low piles, not over 10 feet deep, as illustrated by Fig. 2, the danger of spontaneous combustion is

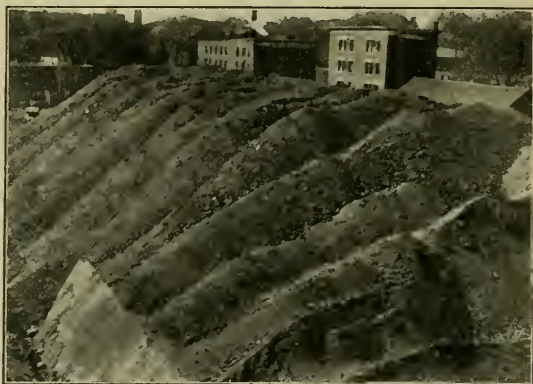
FIG. 3.

materially reduced. Unfortunately, limited space often necessitates the storing of coal in high piles as shown in

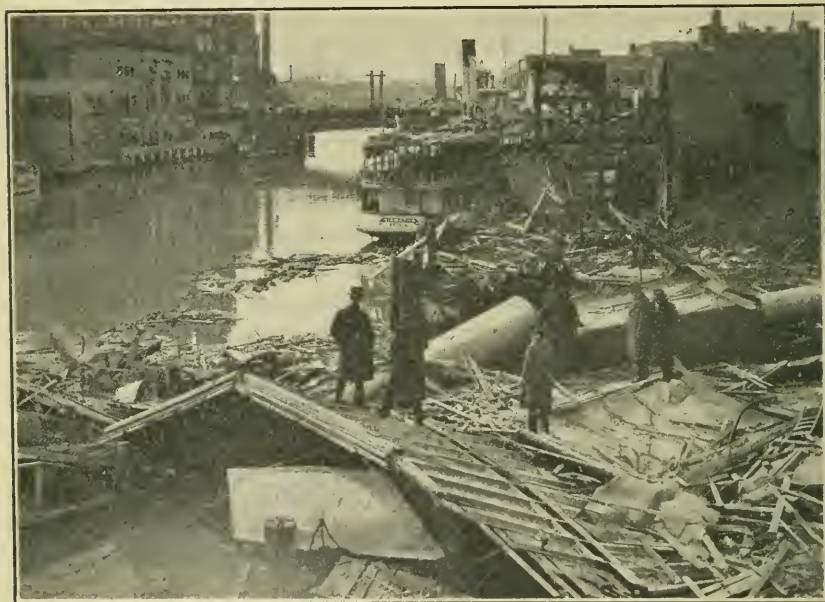
BOILER EXPLOSION AT PORT HURON, MICH.

The flight of the radiator was one of several results caused by the explosion of a steam boiler on board the ferry steamer, Omar D. Conger, at Port Huron on Sunday afternoon, March 26, 1922. The scene of the accident, a general view of which is shown in the accompanying illustration, was on the Black River about 200 ft. east of Military Street bridge, Port Huron's principal street and in the center of the downtown section.

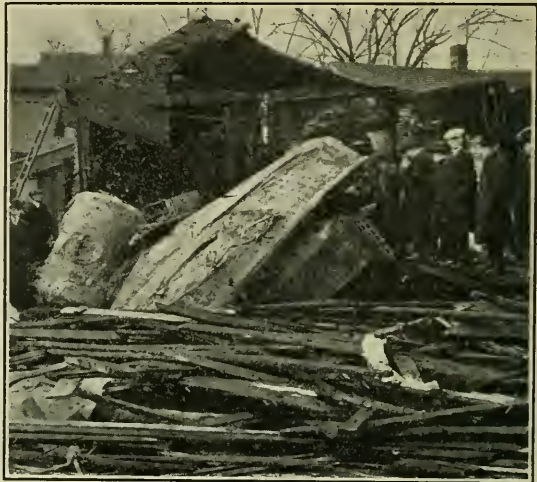
FIG. 3.

space (B in Fig. 3) back of the grate was also enclosed at the rear by a water leg. The boiler was internally fired in two furnaces.

The boiler, a sketch of which is given in Fig. 2, was of the compact marine type made up of a cylindrical shaped upper section (A in Fig. 2) to which was riveted two outside and one middle water leg. The combustion

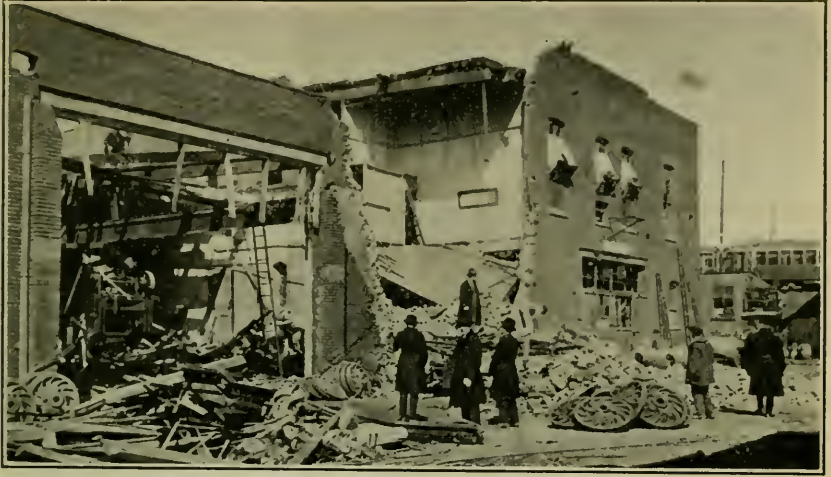
The receiver which exploded was equipped with a safety valve and on the compressor there was an unloading device which was set to operate at 104 lbs. gauge pressure. Furthermore, an attendant was

AIR TANK EXPLOSION AT KANSAS CITY, MO.

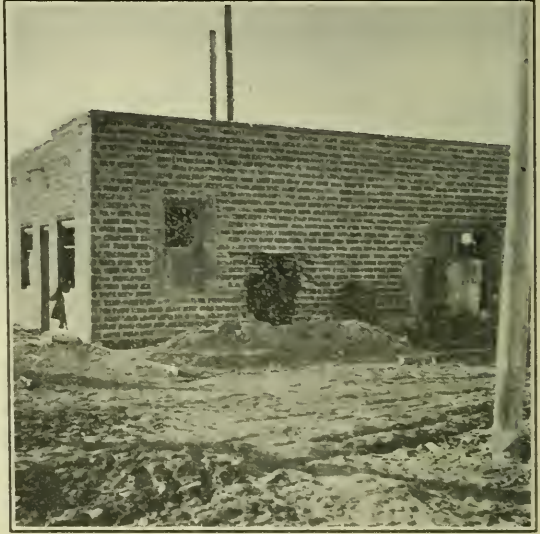
On the 12th of December, 1921, an air receiver exploded at the Winnett Electric Light & Power Co., Winnett, Montana. One man was killed and one was injured. The tank, a secondhand one, which was 22 inches in diameter and 5 feet long, had been installed less than two months before the date of the accident. The longitudinal seam was autogenously welded and the heads were brazed in, failure taking place along these welded and brazed joints. When the explosion took place the tank was blown through the brick wall of the plant as shown in the illustration. The flattened wrapper sheet of the tank with the two heads may be seen in line with the door a little to the right of the center of the picture.

EXPLOSION AT WINNETT, MONT.

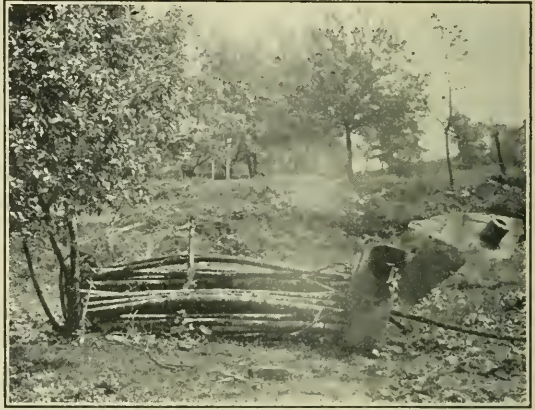
The boiler was located before the explosion in a saw mill two and one-half stories high and was of the horizontal tubular type about 30 years old and operated at 80 lbs.(?) pressure. Up to two years ago the boiler was operated at 100 lbs. pressure, but at the time of the investigation following the accident, the operator stated that two years

LANDING PLACE OF BOILER.

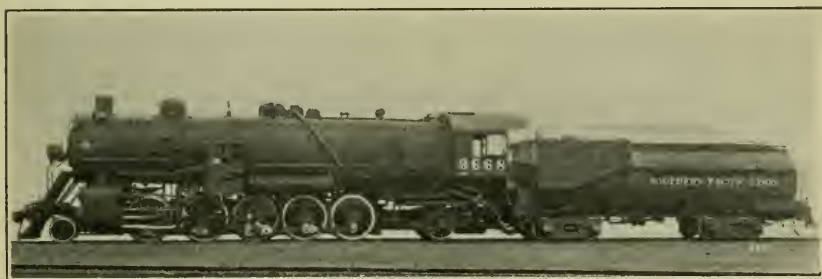
ONE OF THE LOCOMOTIVES.

These locomotives are to be used in heavy freight service on heavy grades in the far West. They are carried on five pairs of driving wheels, with a two-wheeled truck at the front and rear. The large amount of weight on the driving wheels gives a great hauling capacity, while the trucks support the ends of the locomotive and guide it into curves and switches. Each locomotive is nearly 100 feet in length, weighing 621,000 lbs. so that the entire train of twenty weighed in excess of 6,000 tons. The tenders have cylindrical water tanks and a smaller tank at the front end to carry the oil fuel which all Southern Pacific locomotives burn. The oil is sprayed into the furnace by a jet of steam and the fire is controlled by means of valves placed within easy reach of the fireman.

Various modern devices are applied to increase the efficiency and capacity of the locomotives. Before entering the boiler, the feed water is heated; and the steam is also highly superheated before it enters the steam cylinders. An auxiliary engine known as a "booster" is attached to the rear truck for increasing the hauling power when starting heavy trains and climbing steep grades. The locomotive is reversed by a power operated device which relieves the engineer of considerable manual labor.

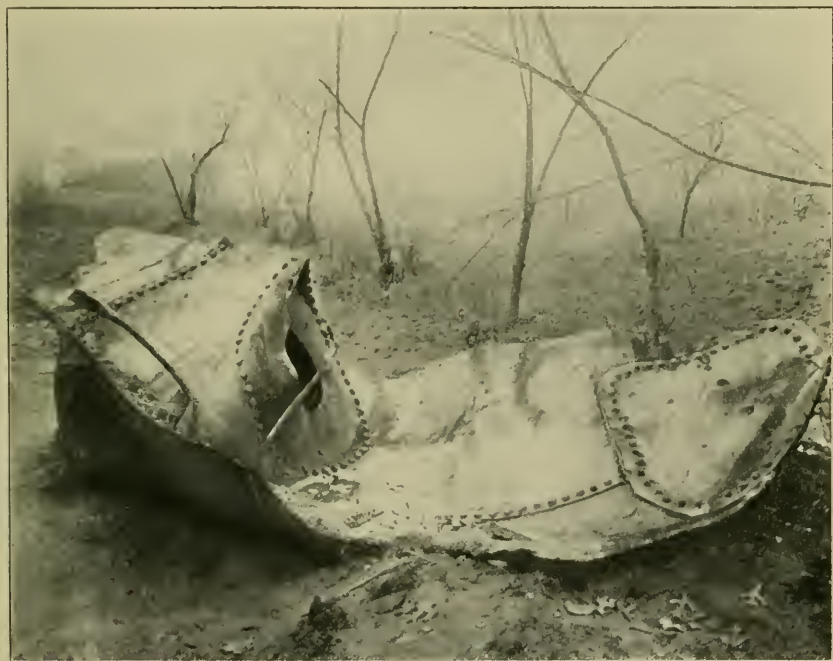
BOILER EXPLOSION CAUSED BY CORROSION.

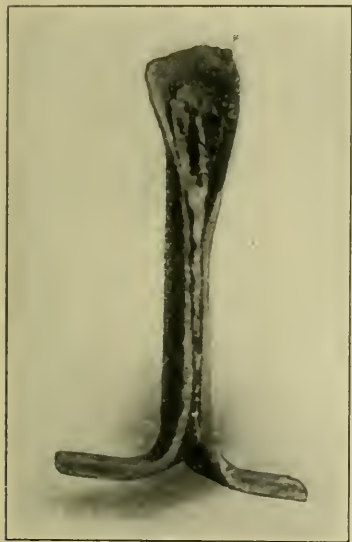
A CORRODED STAY.

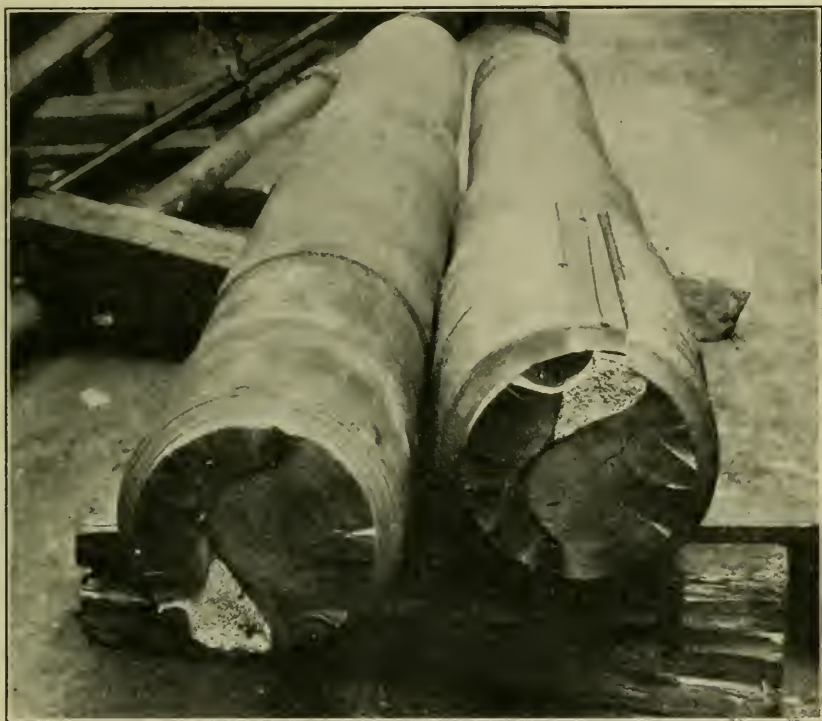
The break in the shaft shown in the accompanying illustration had every earmark of being a failure of this nature. This was practically a new shaft, $10\frac{1}{2}$ inches in diameter, and part of an

FAILURE OF SHAFT CAUSED BY WELDING.

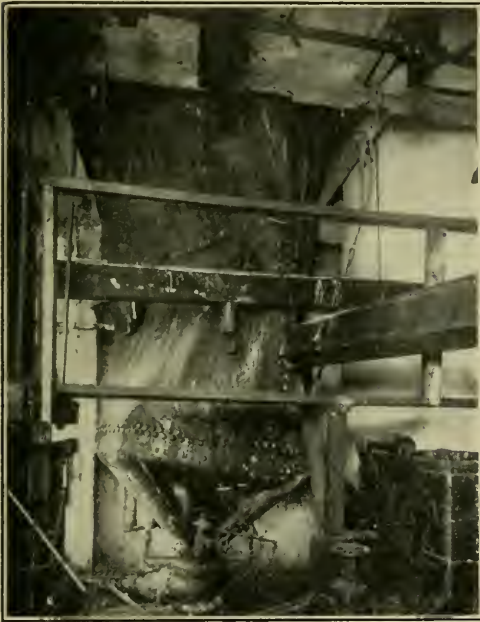
vacuum that allowed the pressure of the atmosphere to exert its power on the outside of the tank shell. While theoretically a cylindrical shell ought to keep its shape when subjected to a uniform outside pressure, in actual practice, pressure on the outside surface of a cylindrical shell is almost sure to cause the failure of the same by collapse unless special bracing is provided to keep the shell in shape. A vacuum of 27 to 28 inches of mercury might be expected under the conditions outlined above and this would allow an atmospheric pressure of $13\frac{1}{2}$ to

A COLLAPSED COOKING TANK.

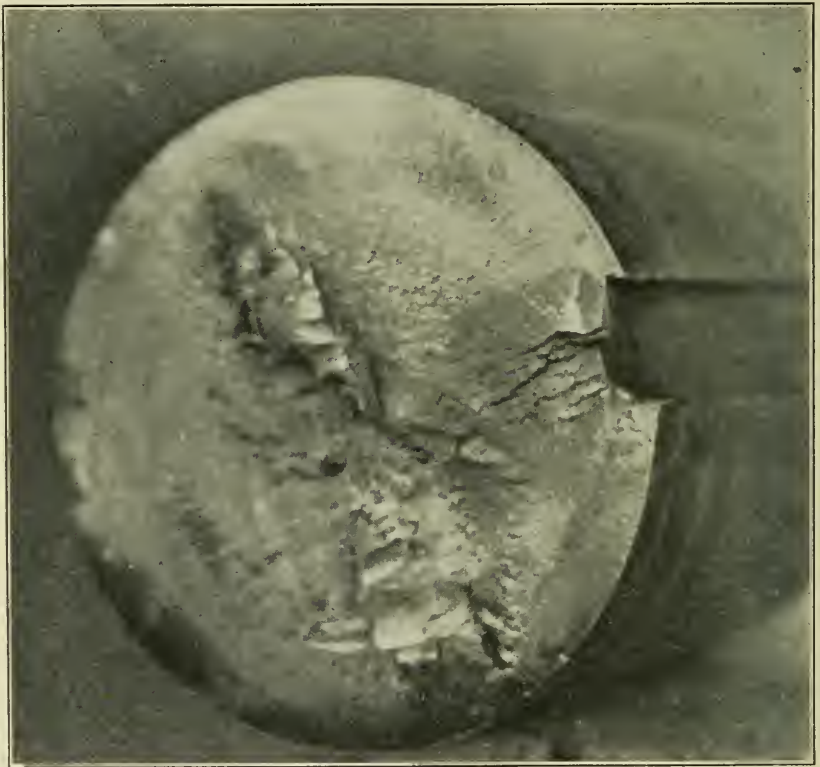
6 inch section was $1\frac{1}{2}$ inches and the stresses which occurred in the cross sectional area of the 9 inch part are much less per unit of area than in that of the 6 inch diameter part because the energy transmitted is the same at all sections. In other words, we have an increase in torsional stresses at the point under discussion, which may result in the breaking down of the crystals in the material if its elastic limit is exceeded by a repetition of alternate stresses, bringing about what is known as a progressive failure.

FRACTURE OF ENGINE SHAFT.

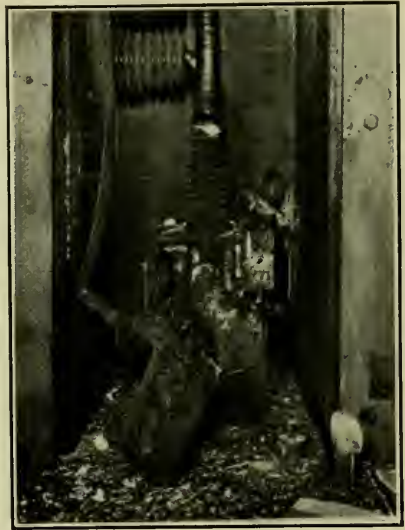
BREAKDOWN OF A HIGH VOLTAGE
POTENTIAL TRANSFORMER.

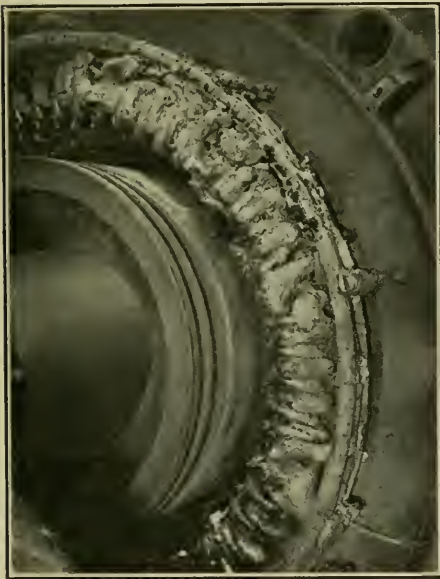
he left the building the commutator of the second machine suffered a failure, and during the night the first machine emitted a large volume of smoke, resulting from short circuits between the risers. A case worthy of special mention was found in a cotton mill where a number of 150 h. p. motors had burned out with no apparent cause. Our inspection disclosed the fact that one of the blades of the oil switch feeding this circuit from a bank of transformers slipped down on the pull rod to such an extent that poor contact was made on first closing the switch and

FAILURE OF LARGE TURBO-GENERATOR.

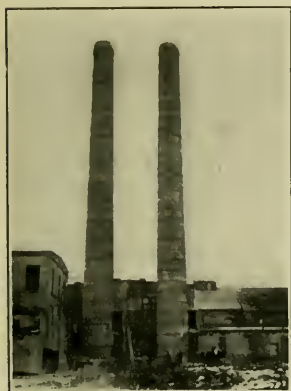
Representatives

In a section four and a half feet high at the base of the stack and extending half around its circumference on the side away from the building, holes were drilled from three to four inches deep and the outer surface of this section was removed by exploding small charges of dynamite in these holes. The reinforcement rods exposed by this means were then cut by a gas torch and removed.

This procedure would have been both slow and expensive and therefore did not appeal to Superintendent L. E. Smith, so he, on his own initiative, worked out a plan by which he succeeded in felling the stack within one foot of the desired line on the ground. As his method was quick, economical and altogether practical, it is described below for the benefit of others who may face a similar problem. The method used was that of felling the stack by dynamite, and was carried out in the following manner.

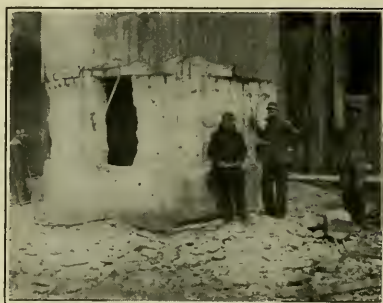
FIGURE 2.

The next step was to make a hole through to the inside of the stack, by blowing out a section about twelve inches wide and four and a half feet high as shown in Figure 2. Since the wall was eighteen inches thick at the base, this part of the work required considerable time and care.

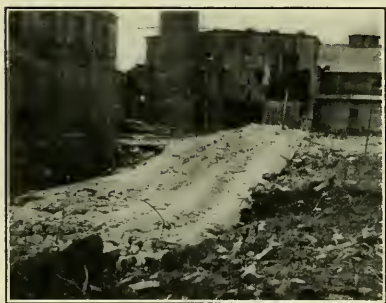
FIGURE 3.

eighteen inches or more and coming to rest at an inclination about ten inches out of perpendicular. After one more charge was exploded on each side of the opening in the base, the stack promptly fell into the designated position on the ground and was reduced to a mass of shattered concrete and steel. Although originally fourteen feet in diameter, the stack, when it fell, made a mound

only three or four feet high as will be seen in Figure 3.

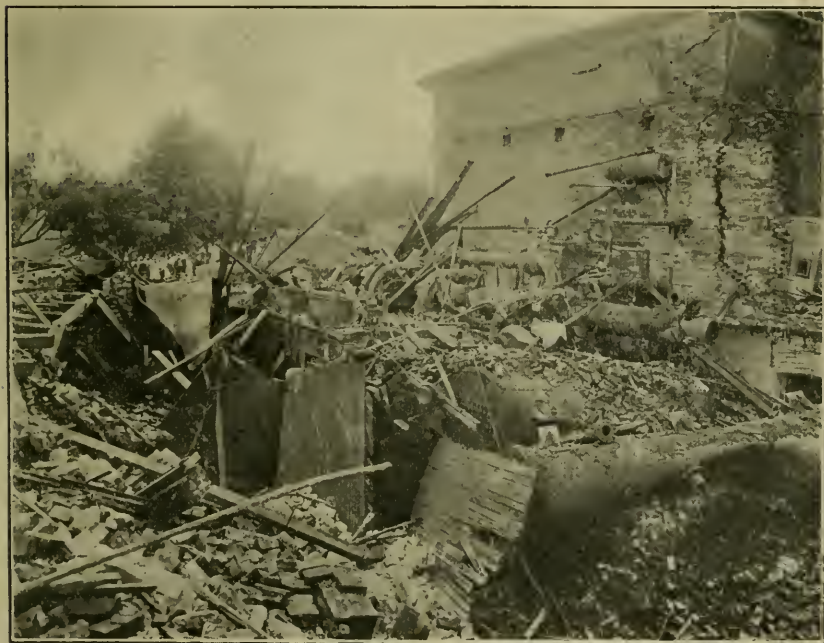
BOILER EXPLOSION AT GREENWOOD, S. C.

SOME degree of appreciation of the extreme violence which boiler explosions frequently attain and of the havoc which results may perhaps be had by a glance at the illustration on the cover page of this issue of THE LOCOMOTIVE. We have seen no picture, however, that can do full justice to the scene presented on the evening of May 15th, 1923, at the Grendel Mills, Greenwood, S. C., where this boiler explosion took place. As a result of the accident two men were killed and two were injured and the property loss, but partly shown in the illustration, amounted to approximately \$50,000. Aside from the destruction of the buildings, considerable damage was done to the cotton yarns and fabrics in process of manufacture.

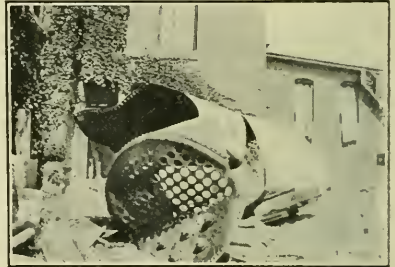
THE EXPLODED BOILER.

The initial rupture appears to have occurred through the nozzle and manhole, both of which were in the second course, and continued along the entire top of the boiler through the solid sheets of the front and rear courses. The front head and first course were thrown diagonally to the front and landed about 30 ft. away. The second and third courses and rear head were thrown as a unit diagonally to the rear and landed about 100 feet away, stopping just short of the main mill building. This portion of

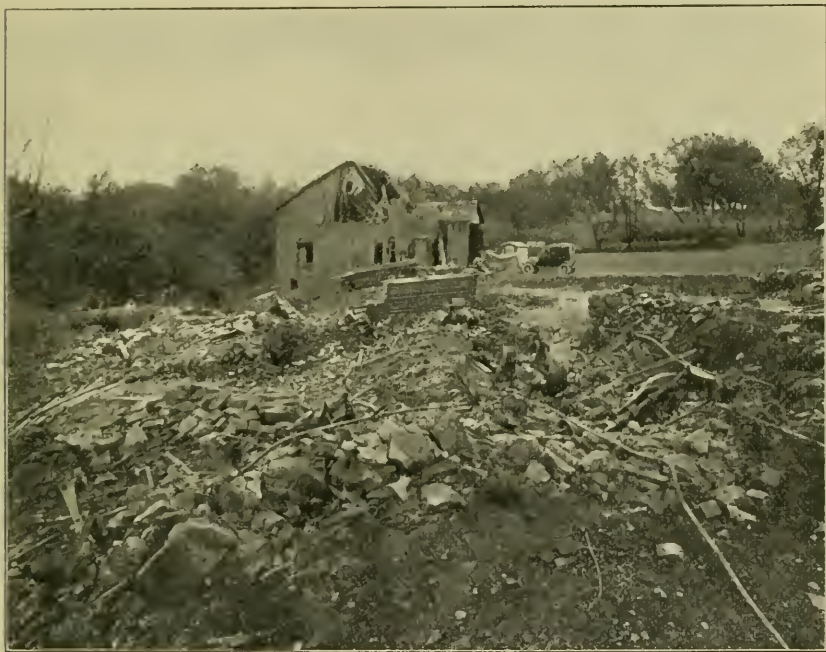
UNFAMILIARITY WITH THE PROPER ADJUSTMENT OF SAFETY VALVES CAUSED THIS BOILER EXPLOSION.

Paragraph 281 of the *A. S. M. E. Boiler Code* states that: "Safety valves shall operate without chattering and shall be set and adjusted as follows: To close after blowing down not more than 4 lbs. on boilers carrying an allowed pressure less than 100 lbs. per sq. in. gage. To close after blowing down not more

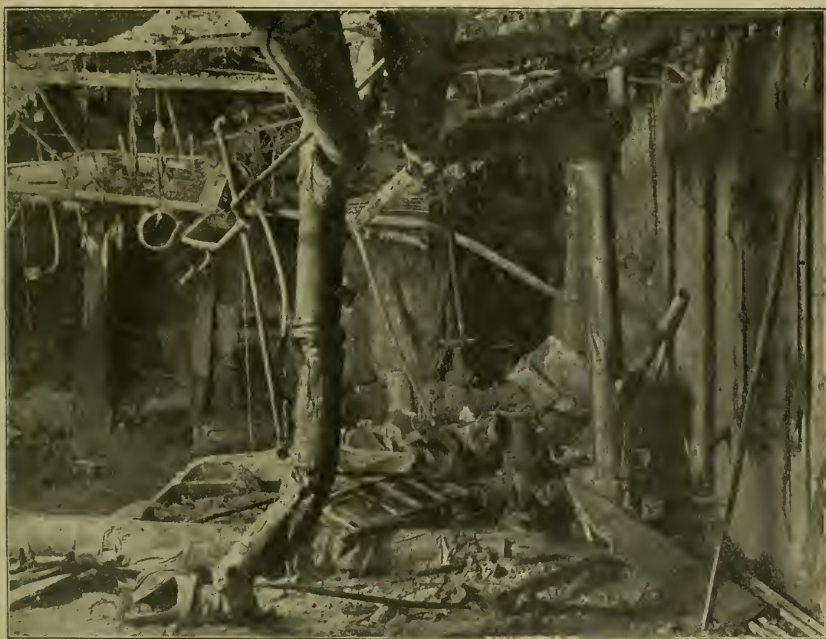
HEATING BOILER EXPLOSION AT ST. LOUIS.

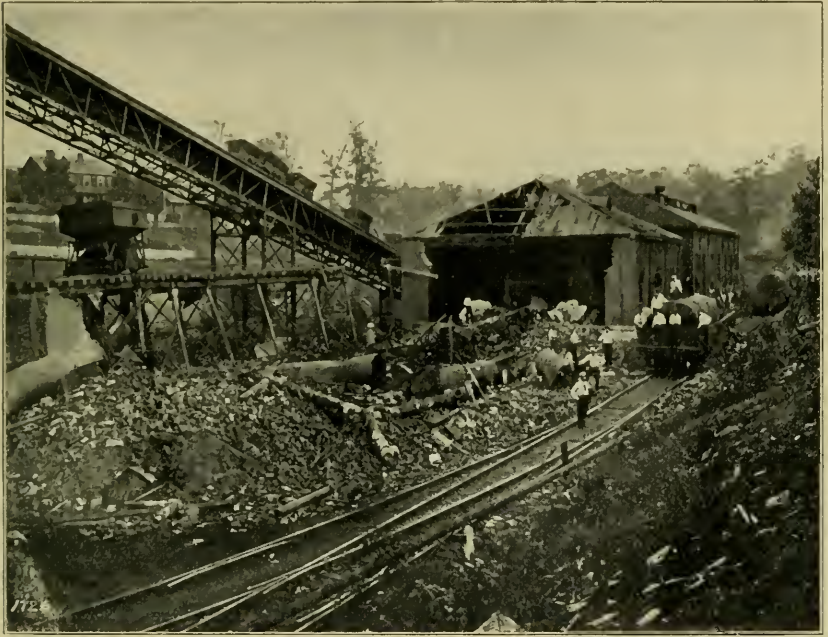
A SAFETY VALVE WHICH FAILED TO OPERATE CAUSED THIS EXPLOSION. ALL THAT REMAINED OF THE BOILER HOUSE WAS THE PILE OF WRECKAGE WHICH EXTENDS FROM THE LOWER LEFT HAND CORNER OF THE PICTURE TO THE BUILDING WHOSE ROOF WAS DAMAGED.

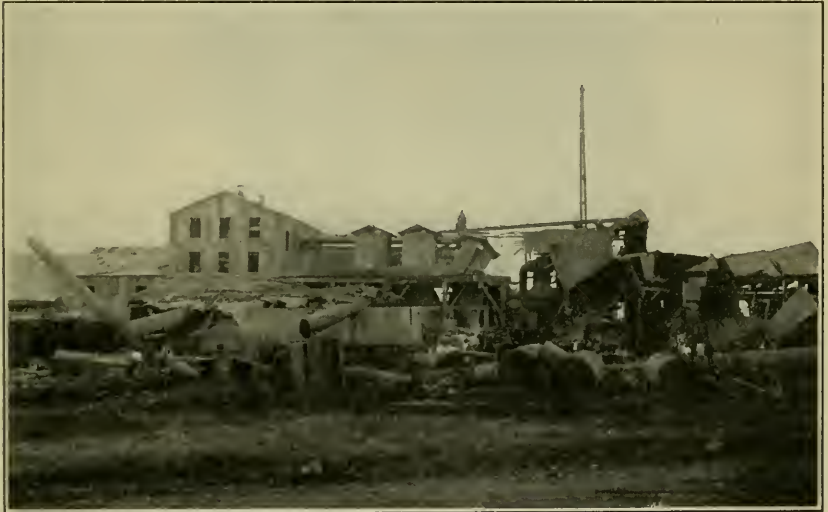
BOILER EXPLOSION AT LOREAUVILLE, LA.

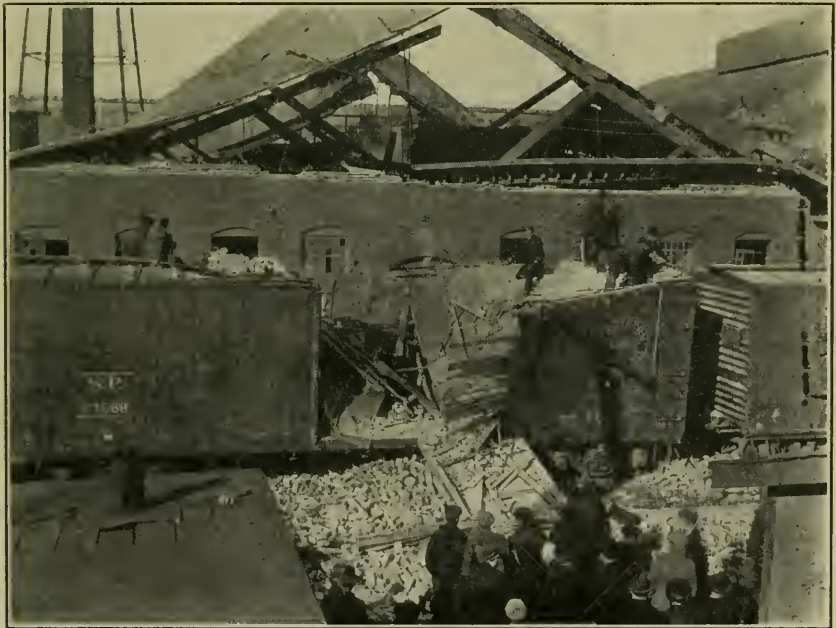
PAPER MACHINE DRYING CYLINDER EXPLOSION AT QUINCY, ILL.

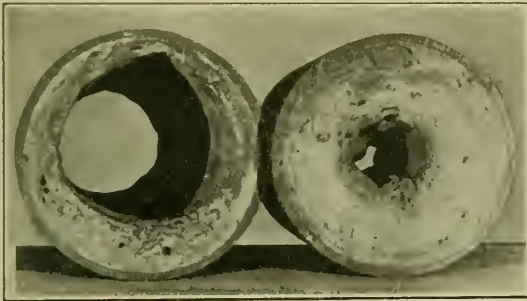
BADLY SCALED TUBES.

perience, particularly during the dry season. Complaints are heard of leaky tube ends, bulged boilers, and other defects usually attributed to scale, and internal inspections and analyses of feed waters confirm the diagnoses. The reason for this natural or seasonal variation in the character of water supplies is well explained in the October 1908 issue of *THE LOCOMOTIVE* from which we will quote.

open the boilers and clean them (or at least examine them) with a correspondingly greater frequency. It is hard to say just *how much* oftener they should be opened, but it is safe to say that they should be opened at least *twice* as often as usual; a boiler that is ordinarily cleaned once a month being opened up, in a dry time, every fortnight.

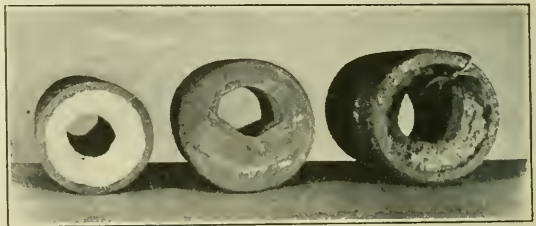
SCALED NIPPLES
THE ONE ON THE RIGHT SHOWS THE RESULT
OF ONE MONTH'S RUN.

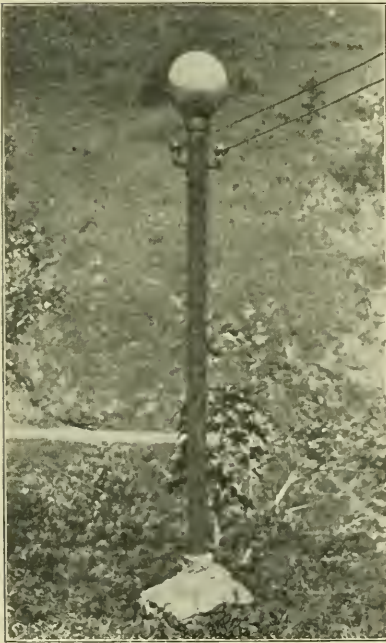
A VERY simple yet decorative lighting post made up from old boiler tubes is used around all the plants and substations of the Porto Rico Railway, Light & Power Company. This company annually discards from its steam plant many 4-in. boiler tubes which, while no longer of value in a boiler, are useful for a variety of other purposes. A great many have been used for ornamental light posts, and for this purpose castings were made up as shown in the drawing. The castings were designed to fit the standard 6-in. x 12-in. "Alba" opal globe.

LIGHTING POST MADE FROM AN OLD BOILER TUBE, AND CASTING ADAPTING IT TO A STANDARD GLOBE.

Some of these posts were wired with underground cable, but in most cases a small stone and concrete base was built around them to give added stability and the wires were carried on iron brackets, as shown in the accompanying illustration. — *Frederick Krug in the "Electrical World," Dec. 1, 1923.*

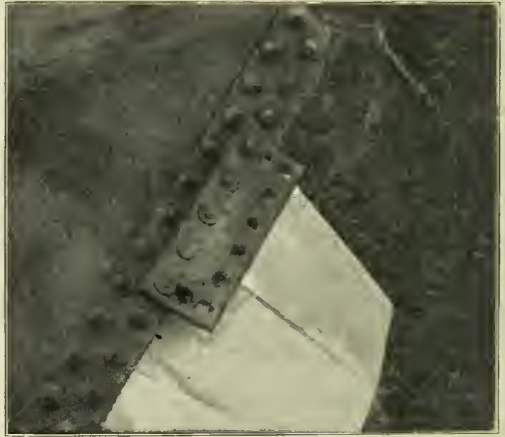
SOFT PATCH USED IN AN UNSUCCESSFUL ATTEMPT TO REPAIR A LONGITUDINAL SEAM CRACK.

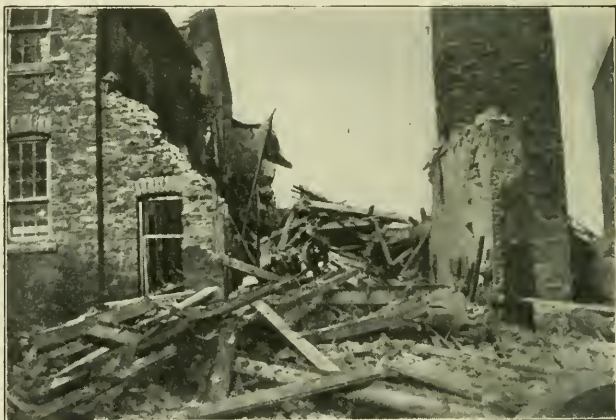
FIG. 1.

ON September 25th, 1924, a rotary boiler exploded in the plant of the Lincoln Paper Mills, Ltd., Merritton, Ontario, with a resulting property loss estimated at \$12,000, part of which is shown in Fig. 1. The failure was in one head, the head being blown about 30 ft. in one direction while the main part of the boiler went about 300 ft. in the opposite direction. It struck the ground once, tumbled endwise and came to rest on the far side of a pond, as shown in Fig. 2.

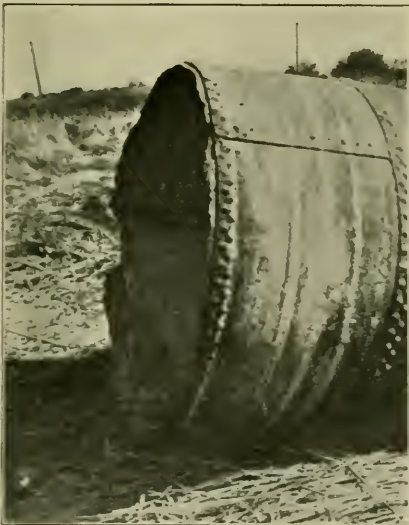
FIG. 3.

The shell of the boiler came out of the accident almost unscathed, but the opposite head suffered some damage, a large piece having been knocked out, most likely by collision with some other object.

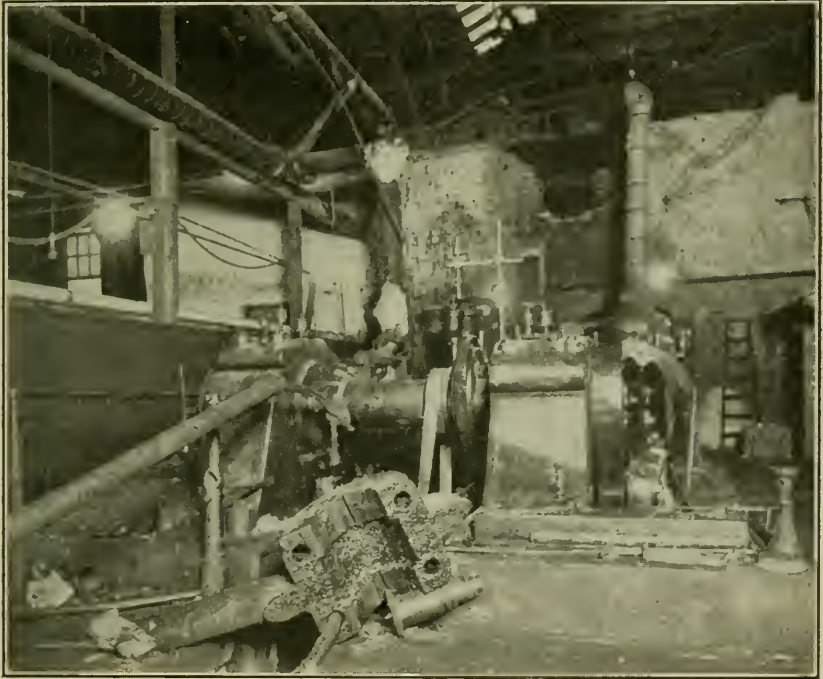
FIG. 1.

Another flywheel explosion, also resulting from a slipping governor belt and shown in Fig. 1, occurred July 18, 1924, at the Greenville Ice &

Fuel Company's plant of the Carolina Public Service Corporation. The suction valve pocket on an ammonia compressor failed and allowed the valve to drop into the compressor cylinder. The cylinder head was knocked out and the ammonia thus released. The engineer advanced toward the throttle spraying water from a hose into the fumes, and inadvertently wetted the governor belt. The engine immediately speeded to destruction.

The wrecked wheel was part of a 75 ton ice machine and was 16 ft. in diameter and weighed 18 tons. Pieces of it traveled over 300 ft. wrecking, amongst other things, the 10 ft. flywheel on another ice machine, several 12 inch x 12 inch reinforced concrete supports for the condenser tower, as well as some motors, piping, and other equipment.

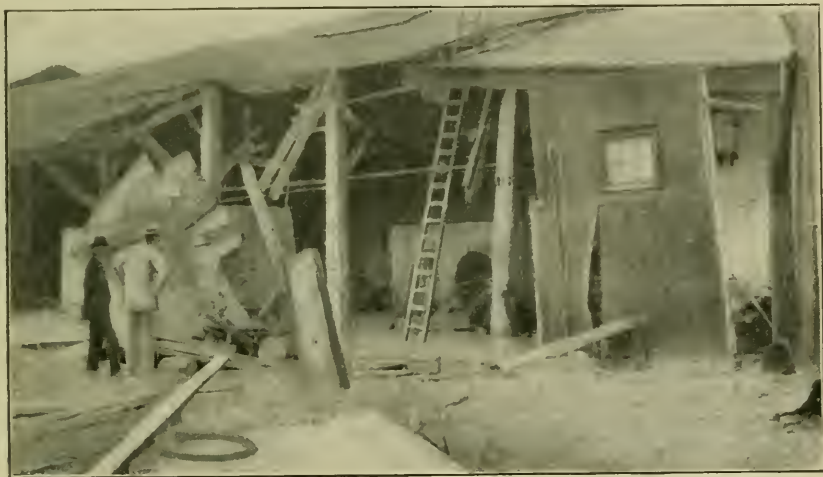
FIG. 1.

AN autogenously welded tank exploded March 21, 1925, at the plant of the Maltose Laboratories, Inc., New Orleans, La., killing five men and seriously injuring three. The tank was used as a malt mixer in connection with a new process for the canning of a malt mash to be sold for making "near beer." Under the supervision of the inventor, the plant was being started up for the first time when the accident occurred.

The vessel was 71 inches in diameter by 10 ft. long and had cone-shaped heads. The material of both shell and heads was $\frac{1}{4}$ inch tank steel. A 2 inch shaft ran through the heads of the tank and carried wooden paddles for the mixing operation, the shaft being driven by an electric motor. A $2\frac{1}{2}$ inch pipe connected directly with the boiler supplied the tank with steam for the process. As there was no reducing valve in the line and no safety valve on the mixing tank, it was apparently the intention to regulate the pressure in the latter by varying the pressure in the boiler. At the time of the accident the pressure is said to have been 20 lbs., but as the safety valve on the boiler was set for 100 lbs., there is no assurance, in the excitement that would naturally prevail in starting up a new process, that the pressure did not go higher than 20 lbs.

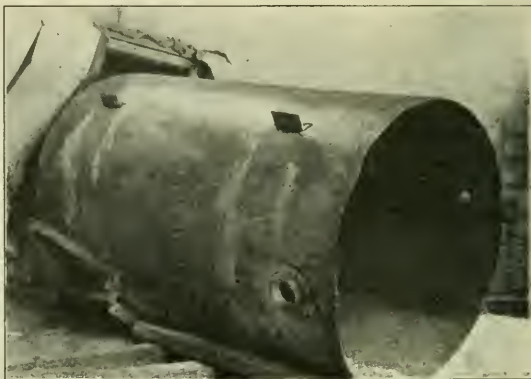
THE MIXER AFTER THE ACCIDENT.

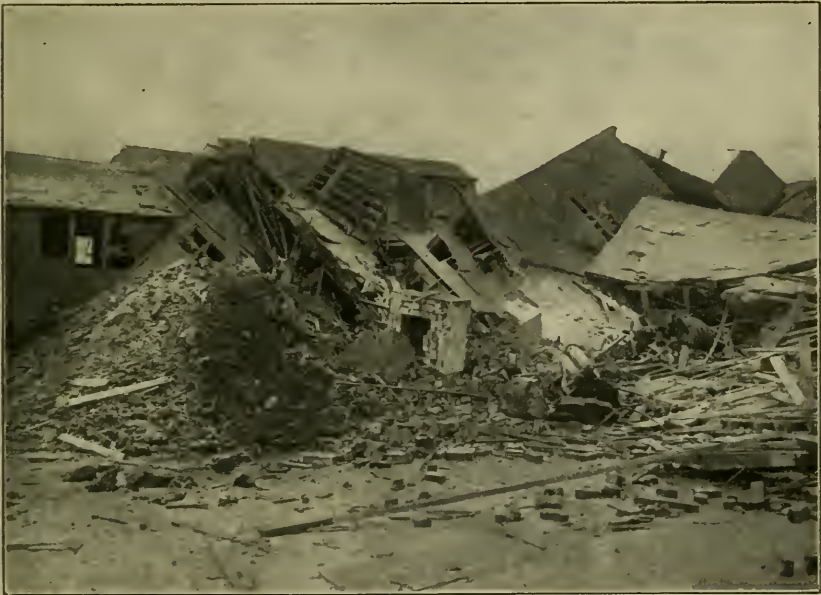
BOILER EXPLOSION AT WOLFEBORO, N. H.

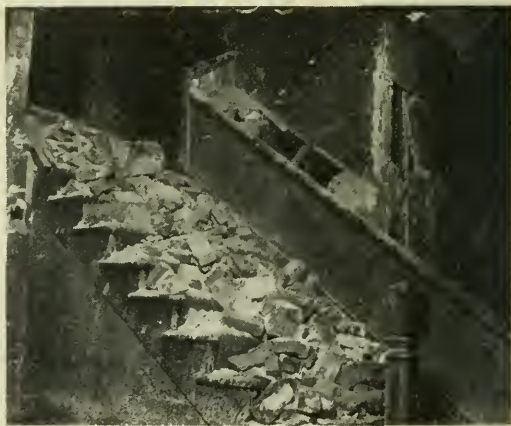
FIG. 1.

The hotel was on the side of a hill and the boiler room was on the uphill side and on the second story level. The head of the boiler was projected through a brick wall and out into the lobby, landing about twenty feet from the original location of the heater. Fig. 1 is a view looking up the stairs from the lobby. Fig. 2 is a view from the head of the stairs looking through the hole in the wall into the boiler room. Considerable damage also was done to the floor above.

The explosion was brought about by the closing of stop valves in both the hot and cold water lines. Just why the valves were closed at this time is not clear, nor is it known what pressure was attained just prior to the accident, but the explosion was very violent as shown by the pictures.
